SLOPE STABILIZATION FOR LOCAL GOVERNMENT ENGINEERS IN MINNESOTA

A THESIS

UNIVERSITY OF MINNESOTA

May 2017

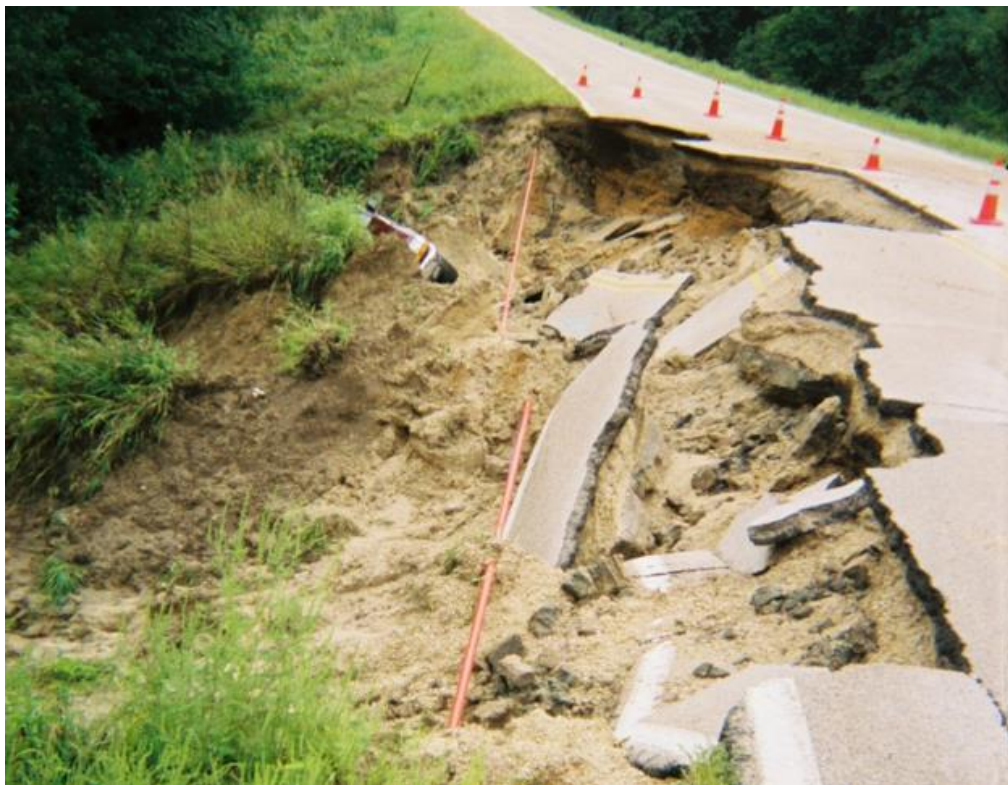
Figure 1: Example of damage from slope failure (from Houston Co. Highway Department)

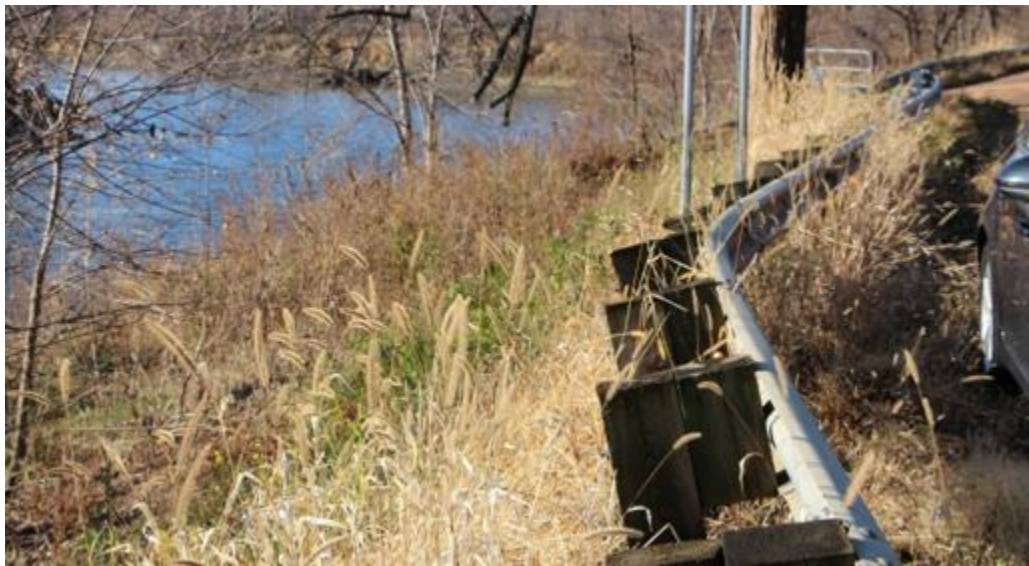
Figure 20: Carver County site slope, crooked guardrails indicate soil creep

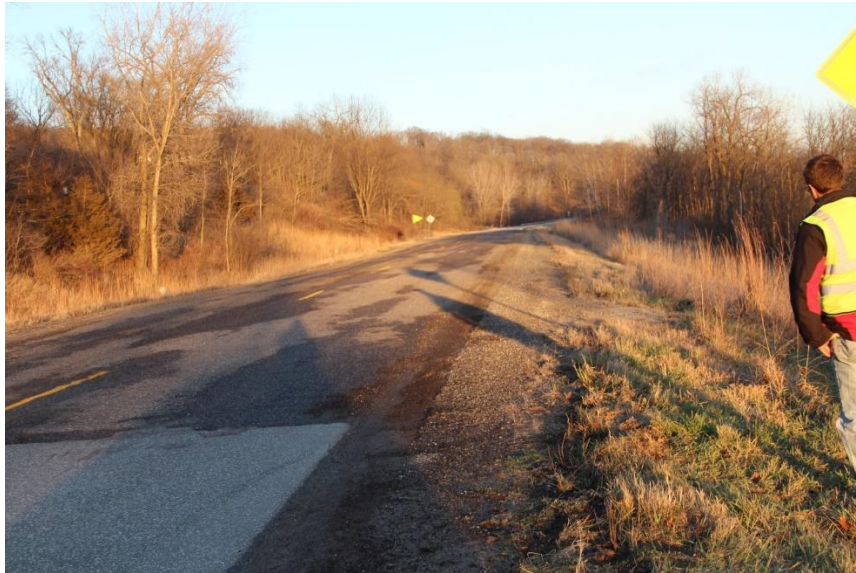
Figure 21: Pavement distress at Fillmore County Site

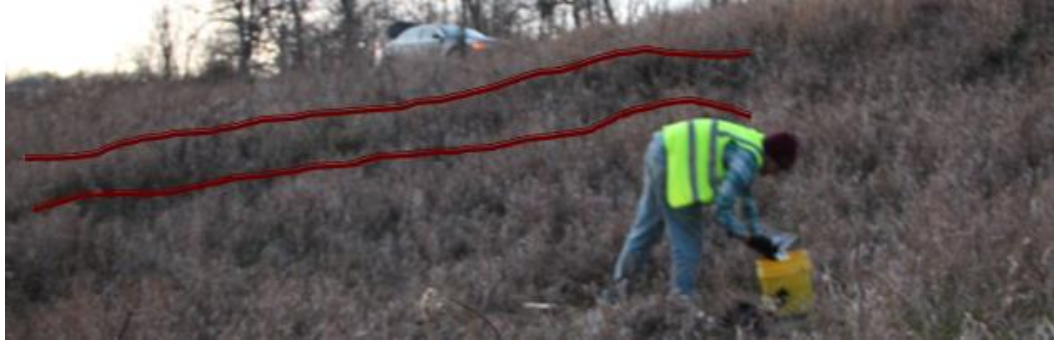
The observed soil was brown, fine-grained sand and silt. S_u values ranged from 1.25 to 1.75 tsf. DCP testing indicated soil's resistance to penetration increased with depth. The soil's correlated N_{60} values were approximately 4 to 5 blows per foot. The geology of the site was weathered material on bedrock (Ojakangas, 2009; Hobbs & Goebel, 1982), as supported by observed soil. With the toe of the slope near a stream, groundwater and drainage conditions were concern. As with several other slopes studied, the side of the road near a stream was failing, illustrating the importance of drainage. No slope stabilization attempts were evident during the investigation.

Figure 22: Clear rotational failure visible behind researcher at Fillmore County site

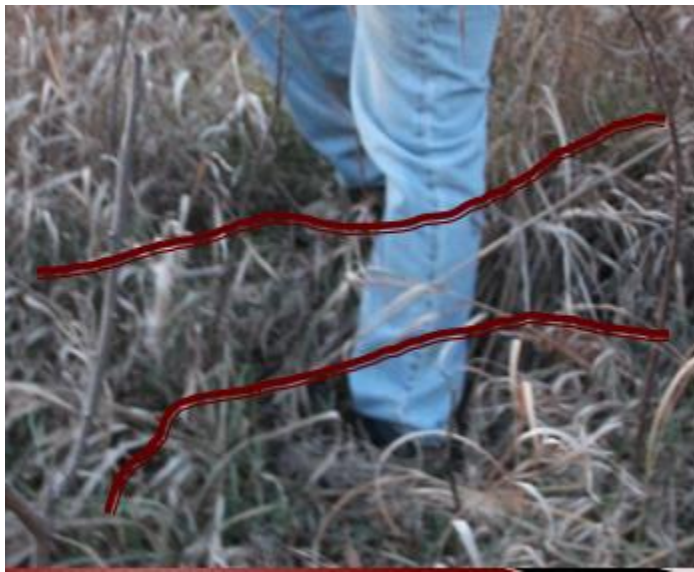
Figure 23: Scarp face at edge of failure at Fillmore County site

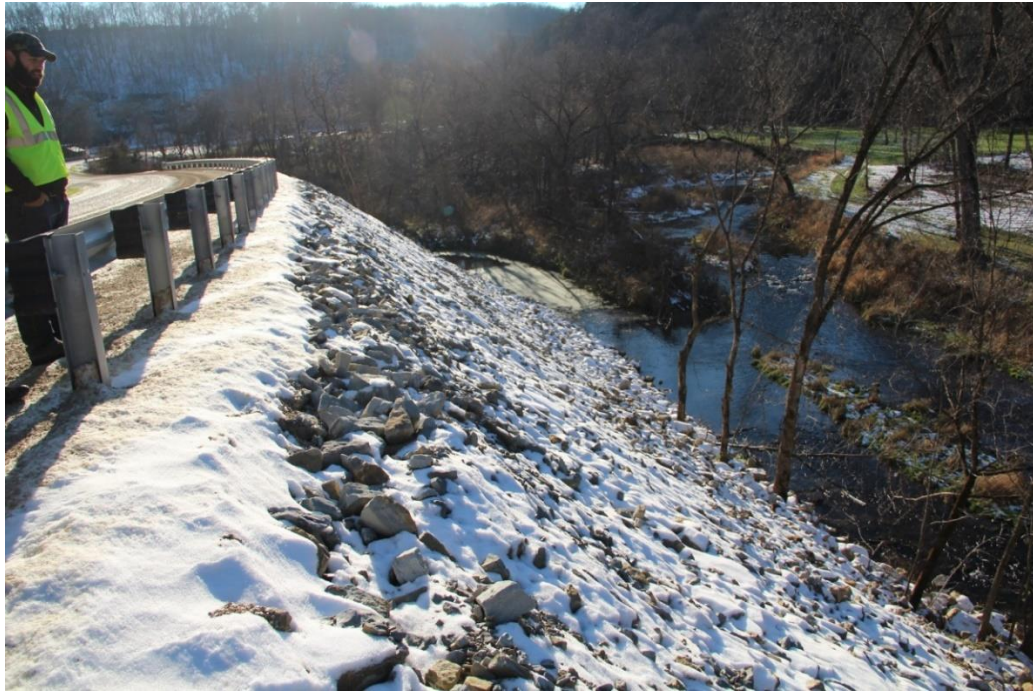
Figure 24: Houston County site slope

Coarse rip rap covered the entire slope face, a common repair approach the county uses for slope failures. The plans specified a quarried rip rap and grass seeding. The county typically does not conduct a geotechnical investigation prior to implementing stabilization methods because maintenance teams have demonstrated success with the rip-rap cover method.

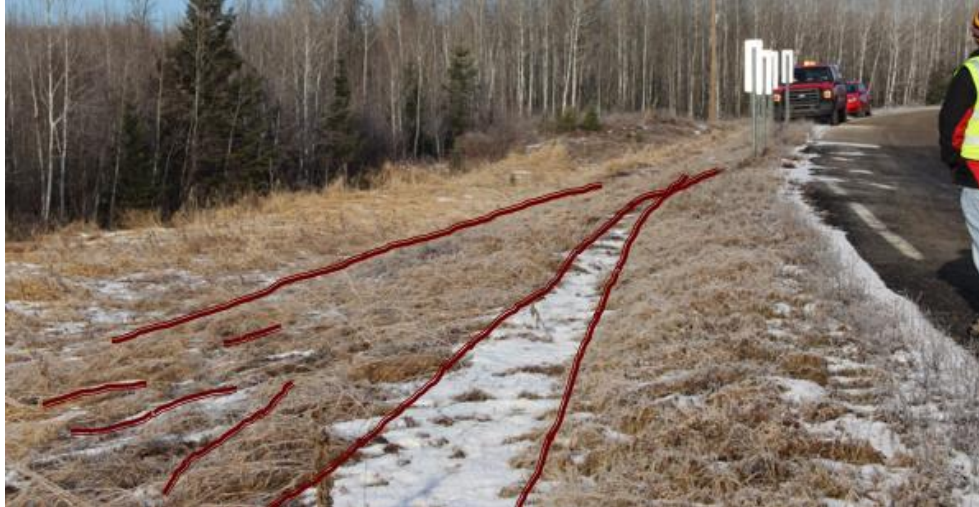
The field investigation was performed at the third site (County Road 8), shown in Figure 26. Like several other slope failures in the region, slope stability issues were first noted 15 to 20 years earlier; maintenance teams repaired the pavement, but did not consider slope stabilization. The site is a good example of seasonal recurring slope issues. The slope featured multiple small failures, exhibiting visible creep failure and evidence of pavement repair.

Figure 26: Koochiching County site with visible soil creep

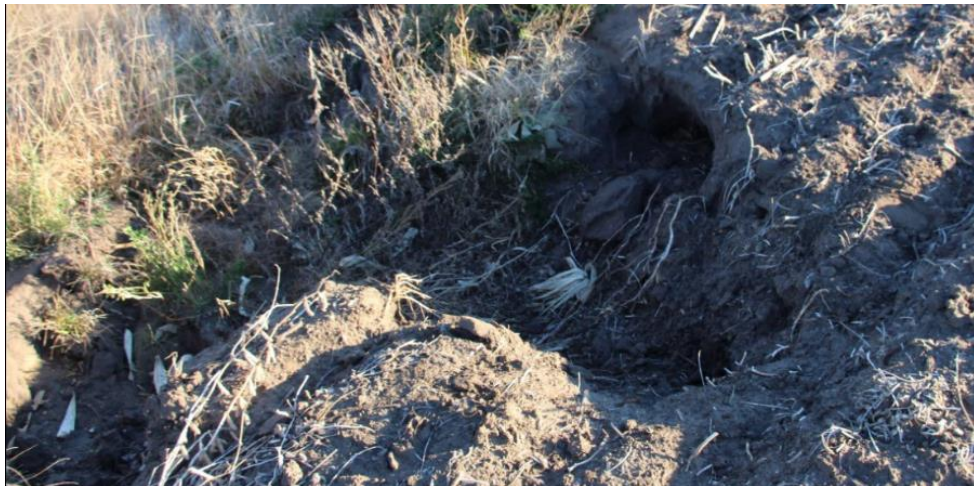
Soil encountered was brown fine to medium-grained sand with trace gravel. The soil had correlated N_{60} values ranging from 5 to 7 blows per foot. *In situ* testing indicated S_u values of 1.25 to 2 tsf. Ojakangas (2009) and Hobbs & Goebel (1982) identified the geology of the region as sediment from the Minnesota River, consistent with granular soil observed. The county engineer provided project documents from recent roadwork (grading in 2013 and surfacing in 2014). Landowner property boundaries and right-of-way concerns caused geometry limitations next to planted fields. Areas with naturally forested uphill cover did not show evidence of failure. Erosion was the driving force of the failure.

Figure 28: Erosion at edge of planted field causes slope failure at the Lac Qui Parle Co. site

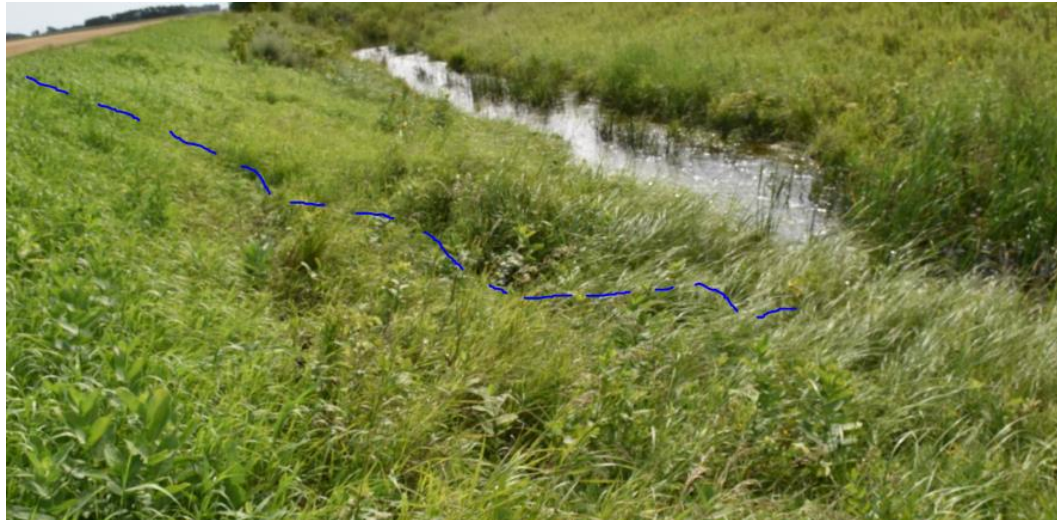
Figure 29: Marshall County site slope

site exhibited multiple small failures down the slope (Figure 29). A ditch with standing water was located near the toe of the slope. The site cover was tall grass with topsoil extending 6 to 12 inches below the surface.

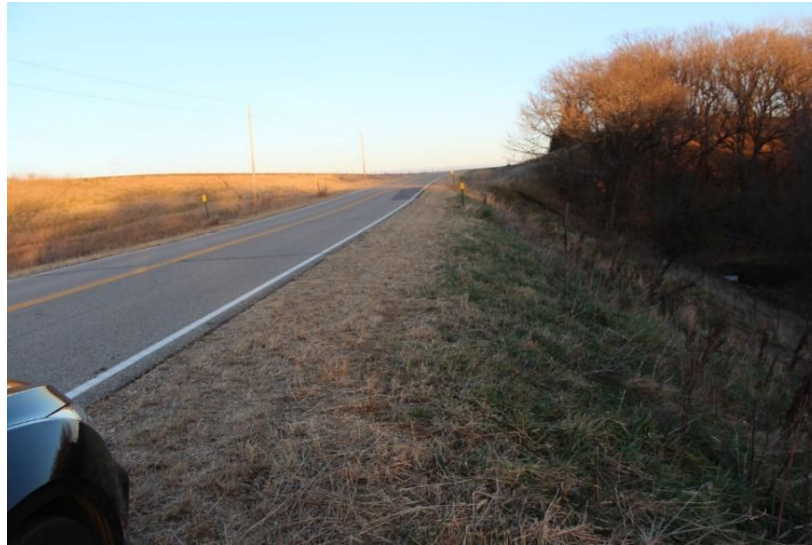
clay or silt. The correlated N_{60} value for the fill was approximately 2 blows per foot, and the native material had a correlated N_{60} value between 3 and 4 blows per foot. Ojakangas (2009) and Hobbs & Goebel (1982) described the geology of the region as the Altamont ground moraine. Glacial till (i.e. moraines) can deposit a variety of soil types. The nearby stream indicated probable groundwater near the toe. Slope steepness, landowner and right-of-way considerations, and groundwater were concerns on this site.

Figure 30: Murray County site slope after reconstruction with visible pavement repair

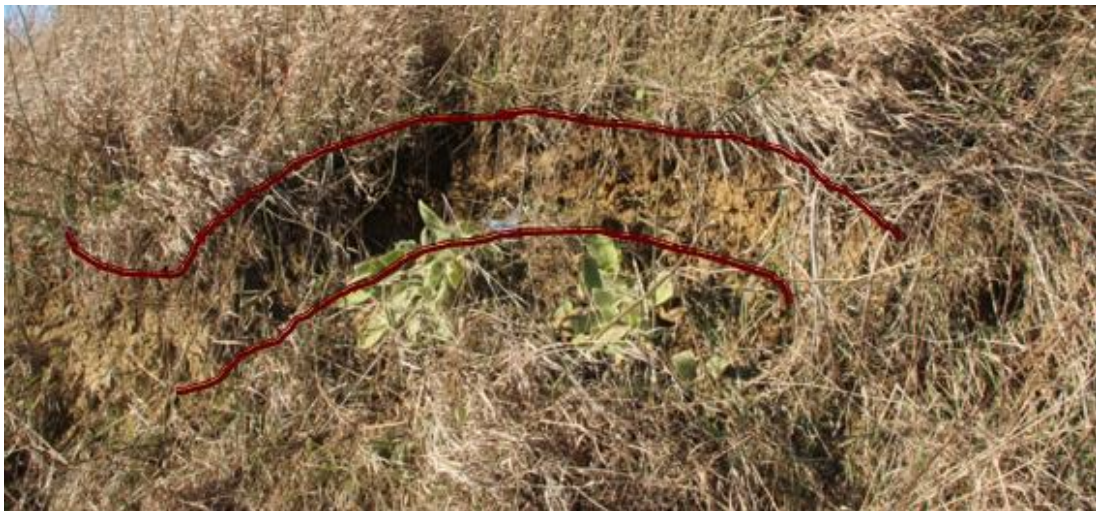
Observed soil was light brown silty sand. Results of DCP testing increasing resistance to penetration with depth. The soil had an average N_{60} value of 2 to 3 blows per foot. Ojakangas (2009) and Hobbs & Goebel (1982) described the geology of the region as glacial drift. No streams or other groundwater indicators were present. There were no stabilization attempts at this site.

Figure 32: Rotational failure scarp at Olmsted Co. site

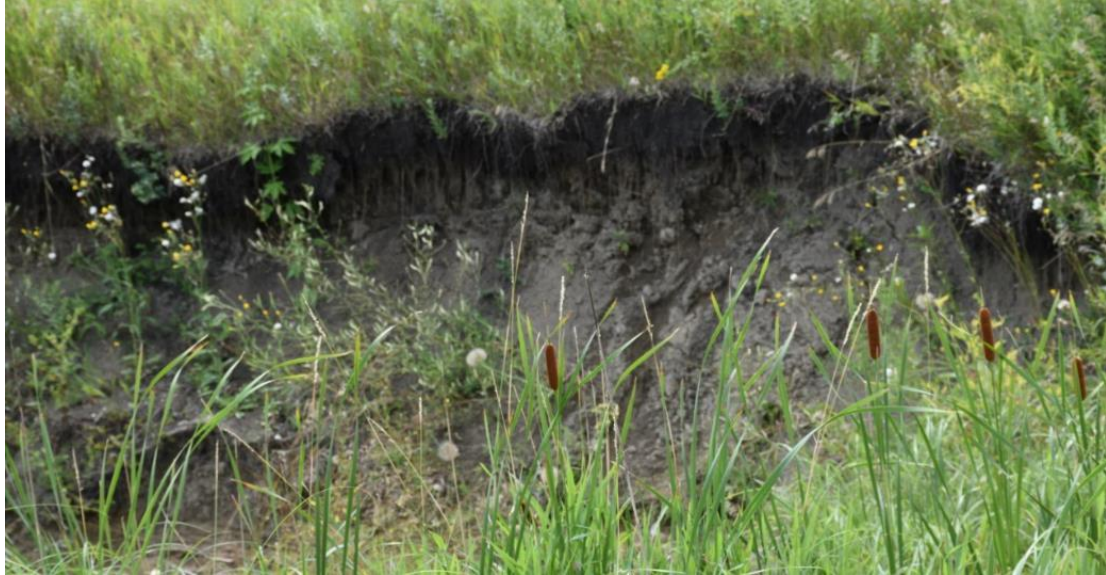
Figure 33: Pennington County site slope, clear rotational failure

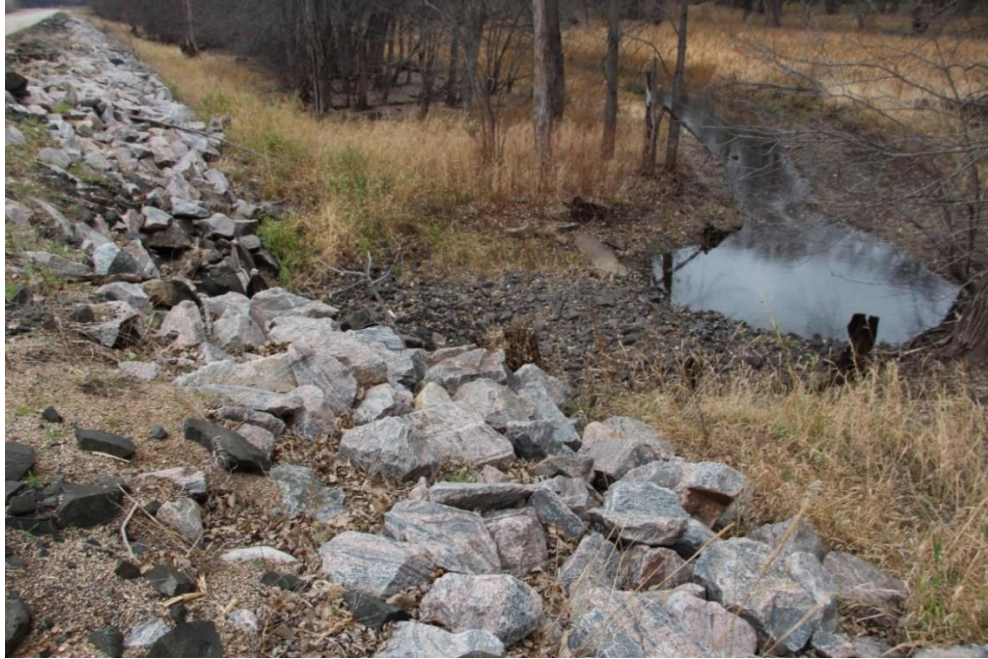
Figure 34: Failed (east) side of Redwood County site slope and nearby stream

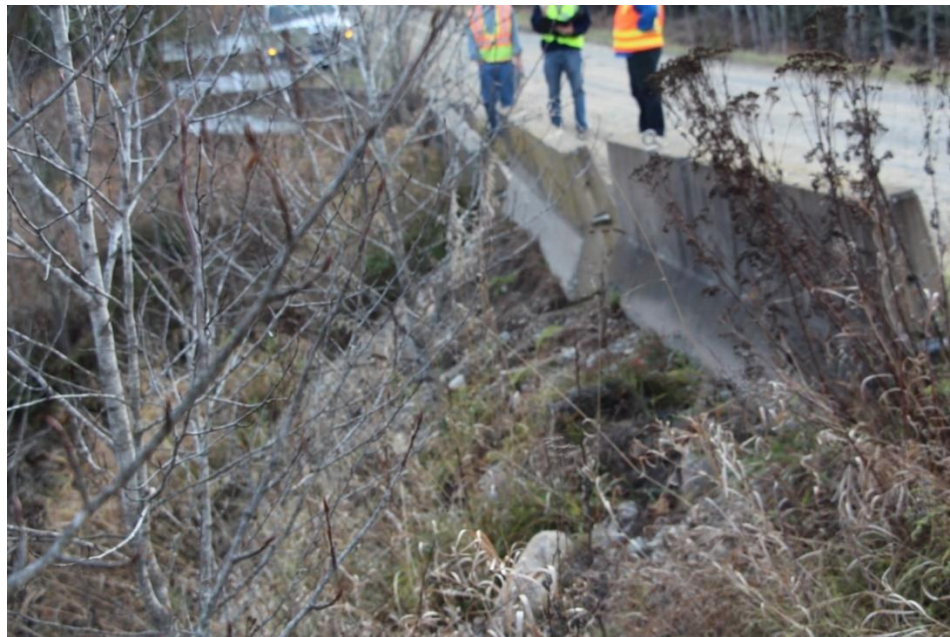
The site representing St. Louis County was located on County Road 535 near Greany, MN. The site featured severe embankment failure over a culvert and displacement of concrete roadway barriers. Slope damage was due to culvert failure and erosion causing the toe of the slope to fail. A county maintenance engineer and regional maintenance superintendent were onsite to discuss the project history. Figure 36 shows the site; cover was grass, brush and small trees.

Figure 36: St. Louis County slope and displaced concrete barriers

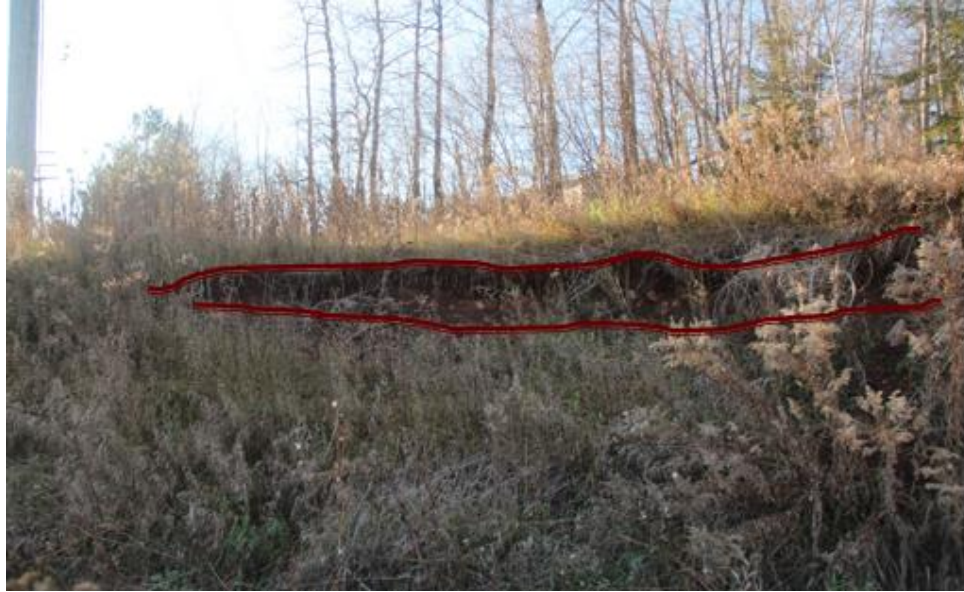
Figure 37: West Duluth site slope

A MnDOT engineer and project adviser identified another slope failure in St. Louis County. The site was located in West Duluth on Grand Avenue. The failure is shown in Figure 37. The slope was covered with grass and the top of the slope was wooded.
