I N V E S T I G A T I O N O F A I R F I E L D D R A I N A G E
A R C T I C A N D S U B A R C T I C R E G I O N S

SUPPLEMENT TO PART I
FIELD RECONNAISSANCE AND ANALYSIS

Project Report No. 18

January, 1950

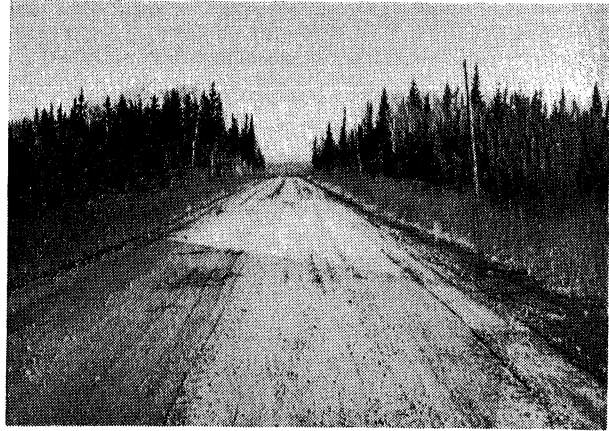
About 30 Miles East of Smith, Alberta, the Road Traverses Flat Terrain

Soft spots could be improved by drainage.

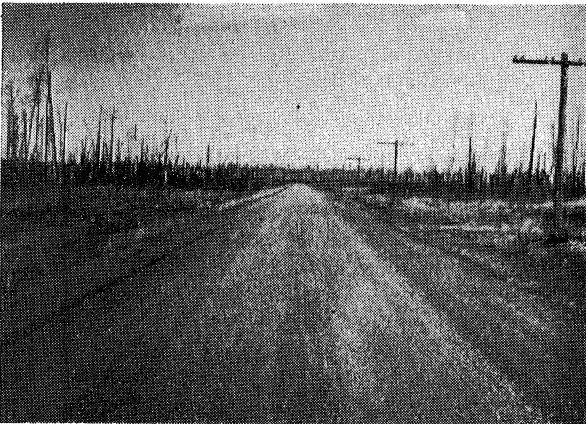
Burned-over Area near Valley View

There are no side ditches to convey runoff.

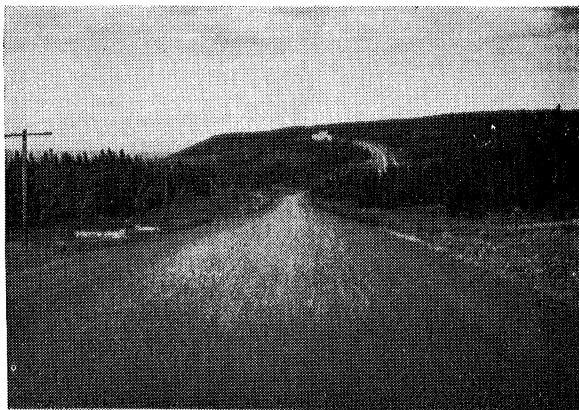
At mile 128 there was evidence of erosion in road ditches.

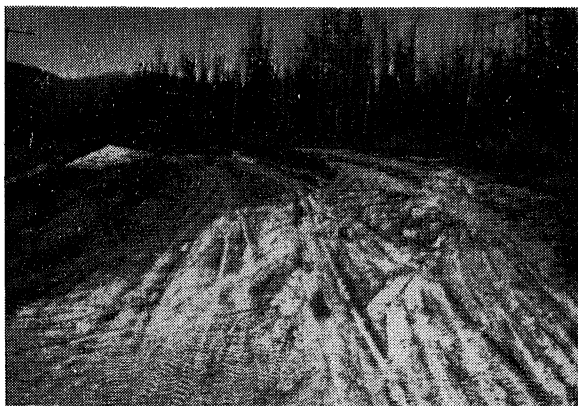
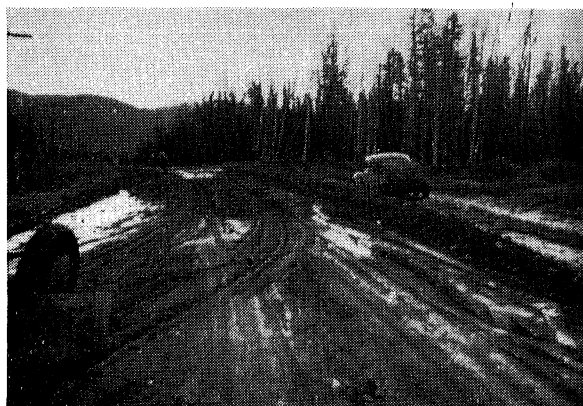
Scenes near Mile 515 on the Alaska Highway

Other sections of road in this vicinity on April 21, 1949 were frozen. Subdrainage to remove water from underground sources is obviously essential.

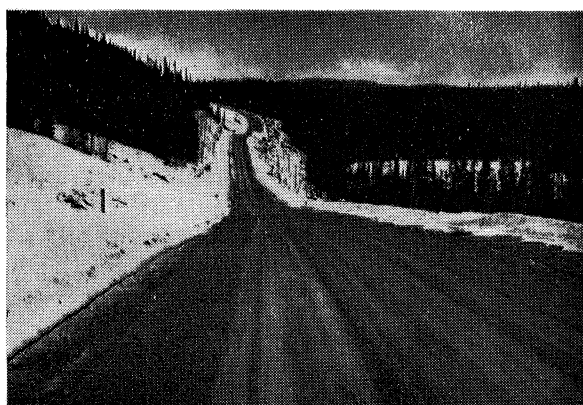
Scenes near Coal River on the Alaska Highway

A prominent center crown would eliminate this situation.

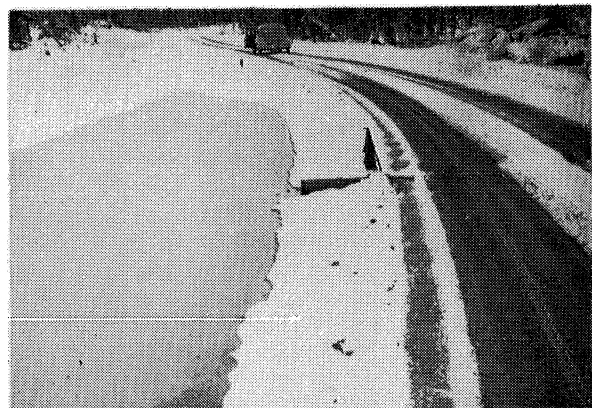
A six-inch diameter pipe had been placed across the road at mile 1134 to relieve a poor drainage condition.

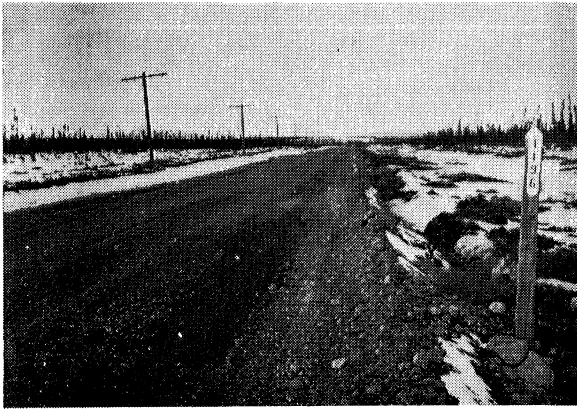
Settlement of the road grade was very uneven through this section which traversed flat terrain where the permafrost table was close to the ground surface.
Alaska Highway in Western Yukon Territory

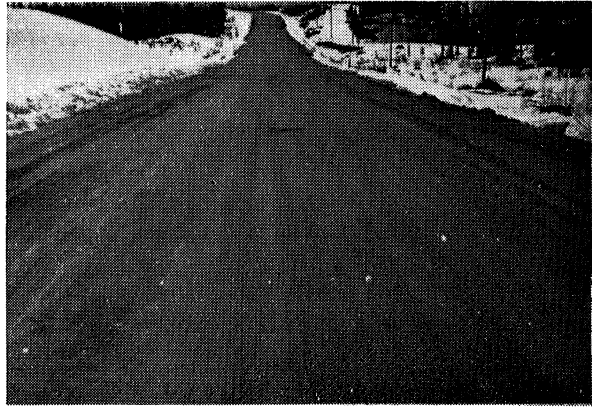
The condition of the highway here was good despite sloughing shoulders at numerous locations.
Alaska Highway at Mile 1250 in Alaska

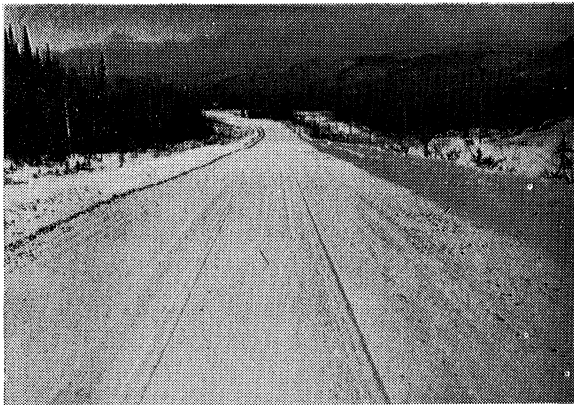
It is not a good policy to leave snow windrows on the road shoulder as indicated in the above picture.
View from Mile 1354 on Alaska Highway

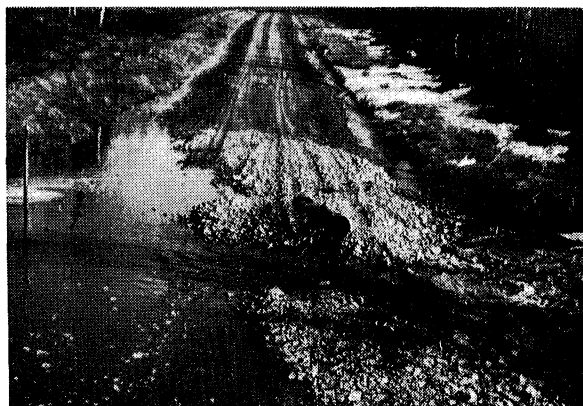
Farmers Loop Road near Fairbanks

Even though spring breakup occurred very slowly, many sections of road were inundated on May 14, 1949.

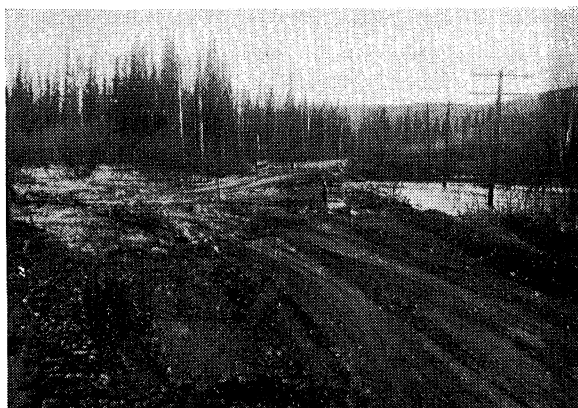
Richardson Highway at Shaw Creek

On May 15, 1949, high stages of Shaw Creek overtopped the highway and washed out a section of the grade.

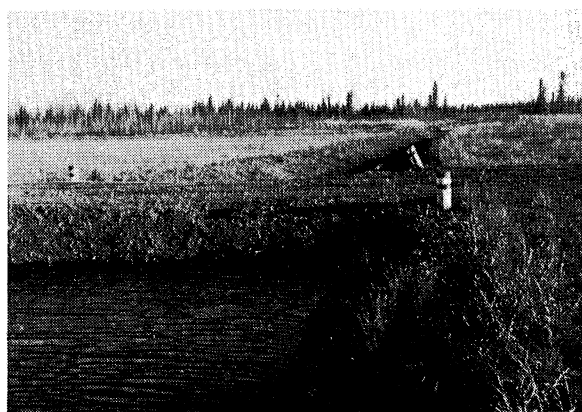
Road Ditch near Gulkana

The culvert through this road grade was completely filled with ice.

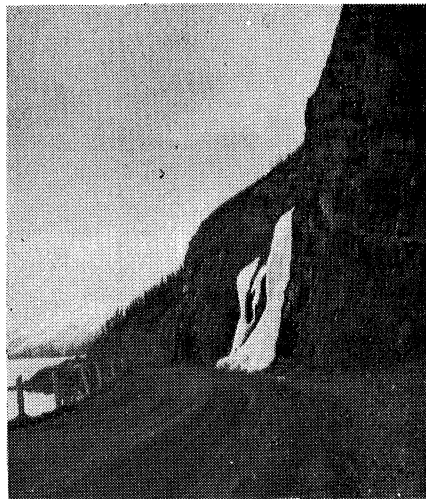
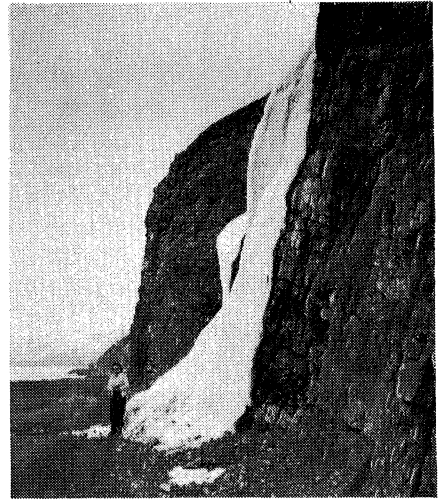
Icing at Muncho Lake

(b) Muncho Lake, British Columbia. The source of water for the icing at Muncho Lake at mile 459 on the Alaska Highway is apparently from seepage along a seam in the rock bluff. While the major portion of the ice is in the form of a huge icicle, as indicated in the picture, there was evidence that at one time it had covered the road. It is of interest to note that this site is also a considerable distance south of the southern limit of permafrost.

Water forming the icing comes from seepage through the fissures and crevices in the rock bluff.

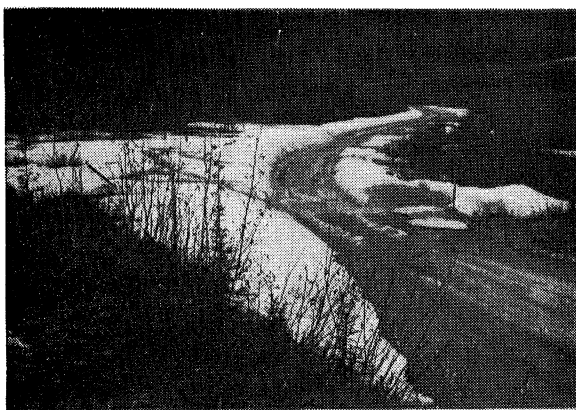
Icing at Mile 15 on Steese Highway

It is estimated that one acre-foot of ice is stored at this location.

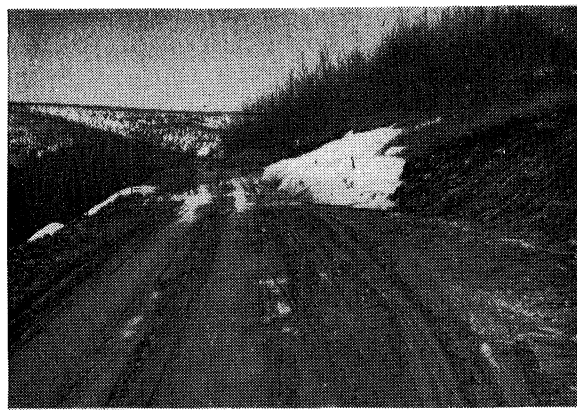
Icing at Mile 18 on Steese Highway

This icing is relatively small in areal extent, but it is quite thick.

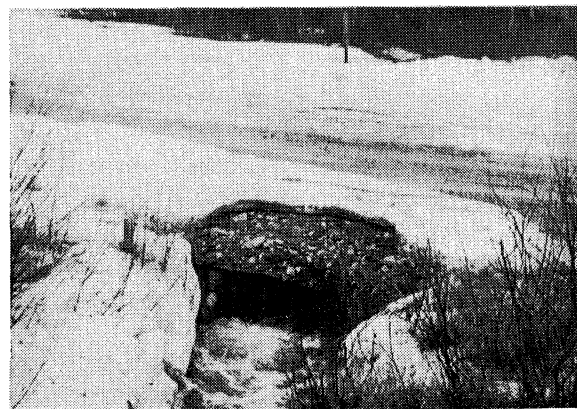
This is a view of the downstream end of the culvert.

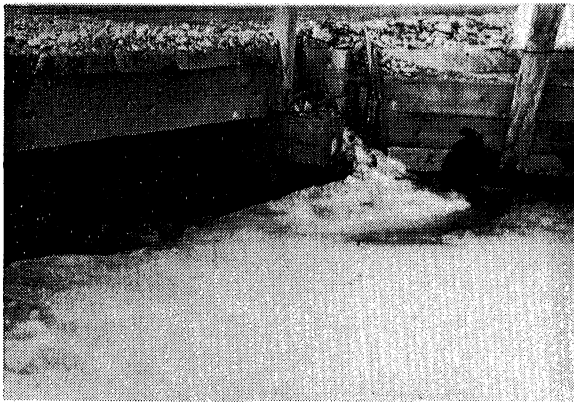
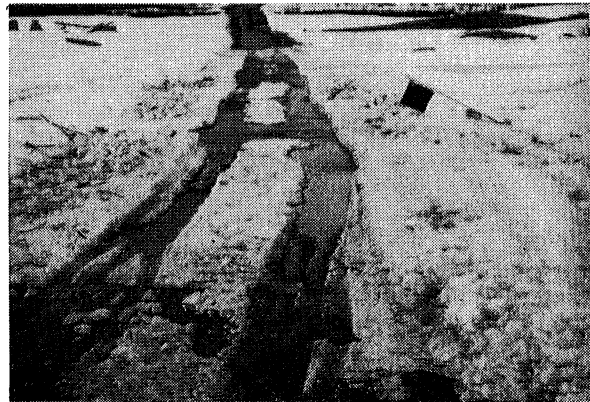
Icing on Elliot Highway at Fox Creek near Fox, Alaska

The bridge over Fox Creek was nearly filled with ice. This caused seepage through pervious tailings and overtopping of a low section of the road a short distance from the bridge.

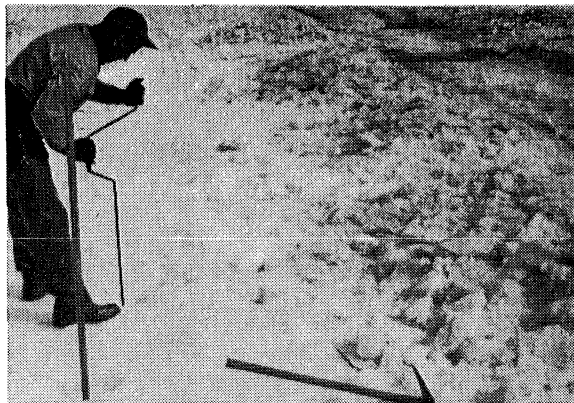
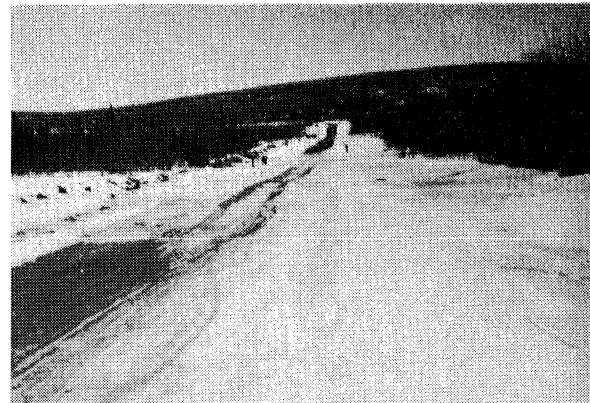
Icing on Elliot Highway at Dome Creek

(h) Elliot Highway near Dome Creek. At this point about 300 ft of highway was overlaid with ice to depths that ranged from a few inches to 4 ft. or more. On April 27 repair work was in progress, as indicated on Plate 11. Charges of dynamite were placed to clear Dome Creek below the site of the road. The photographs taken on May 6 show results of the blasting. One of these photographs indicates the depth of ice at the bridge. The ice surface was actually 1 ft above the top of the handrail. The view taken longitudinally on May 6 indicates that this section of road was passable. The frame of the car dragged at several points and without considerable momentum the vehicle would hang up as the low parts of the car made contact with high points of ice. On May 14 the ice between the two ruts had disappeared, but then the road was inundated to 2-ft depths. Apparently the bridge spanning Come Creek still was restricted by ice and could not handle springtime runoff.

On April 27, 1949, highway maintenance men were drilling holes through the icing preparatory to a blasting operation to clear an outlet channel.

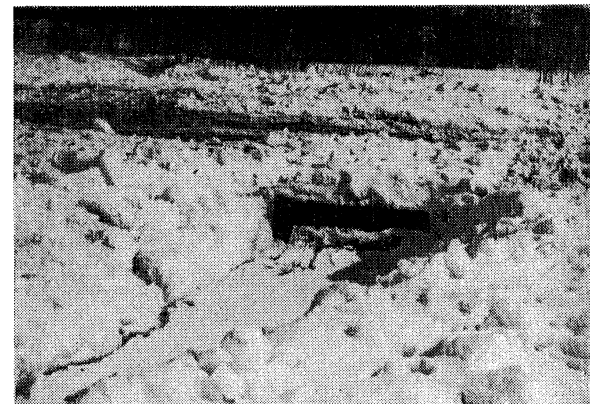
Icing on Elliot Highway at Dome Creek

On May 6, 1949, the blasting operation of April 27 revealed the handrail of a culvert which had been completely covered with ice.

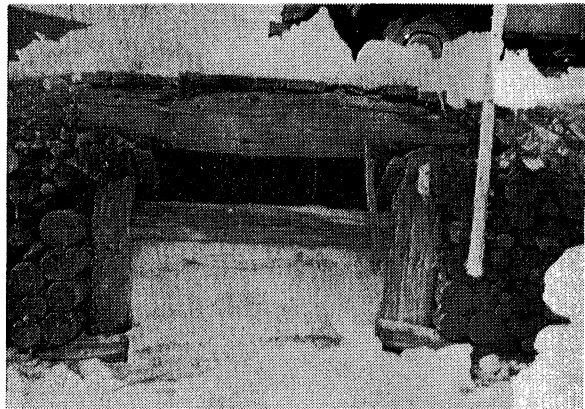
Icing at Mile 48 on Steese Highway

The upstream end of the culvert at this location was completely filled with ice.

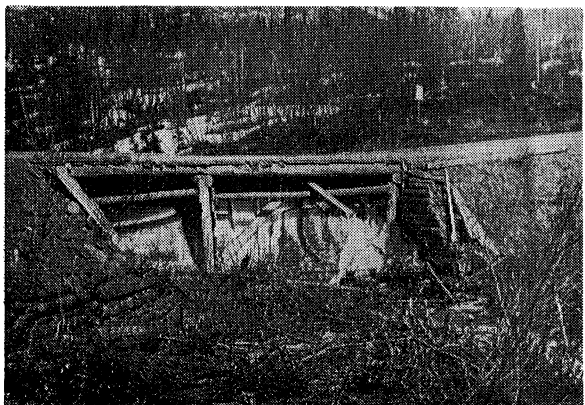
Bridge at Mile 83 on Tok Highway

This bridge was completely filled with ice at the time of inspection on May 18, 1949.

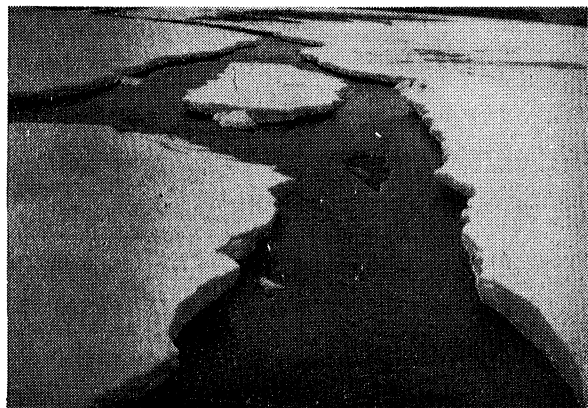
Icing on Johnson River, Alaska

The discharge during formation and growth of the icing was considerably less than indicated in the photograph.

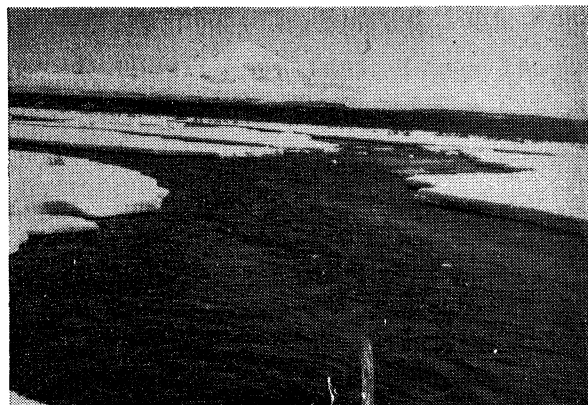
Icing on Slana River, Alaska

The elevation of the top of the ice is several feet higher than the river stages even though discharges at the time of the pictures were greater than at the time of ice formation.

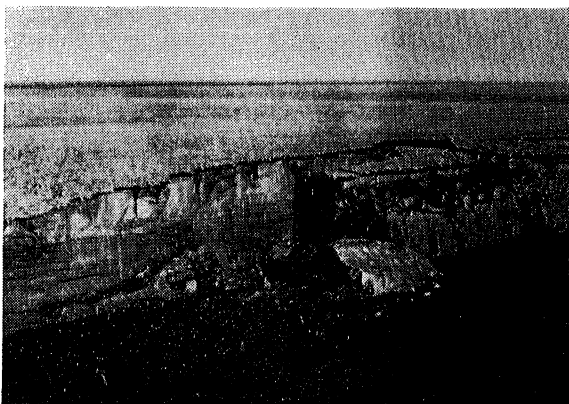
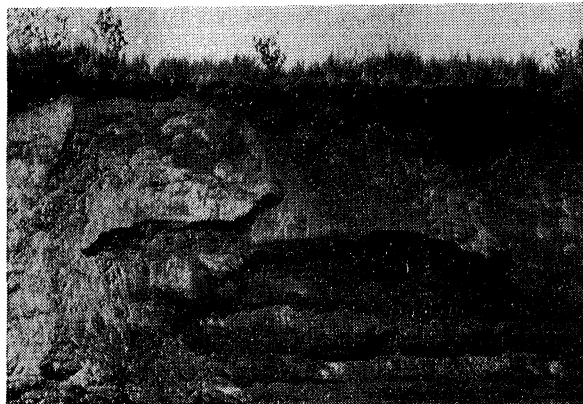
Erosion Resulting from Thawing Permafrost

Permafrost thaws quickly at the waterline creating an undermining action which causes huge chunks of earth to break off. This action is severe along the Kuskokwim River at Bethel.
