University of Minnesota
ST. ANTHONY FALLS HYDRAULIC LABORATORY

Project Report No. 132
Hydraulic Model Studies for the
GURI HYDROELECTRIC PROJECT
REPORT ON SPILLWAY CAVITATION DAMAGE

Prepared for
HARZA ENGINEERING COMPANY
and the
CORPORACION VENEZOLANA DE GUAYANA
Republic of Venezuela

A STUDY OF CAVITATION DAMAGE ON THE
DAM SPILLWAY OF THE GURI PROJECT

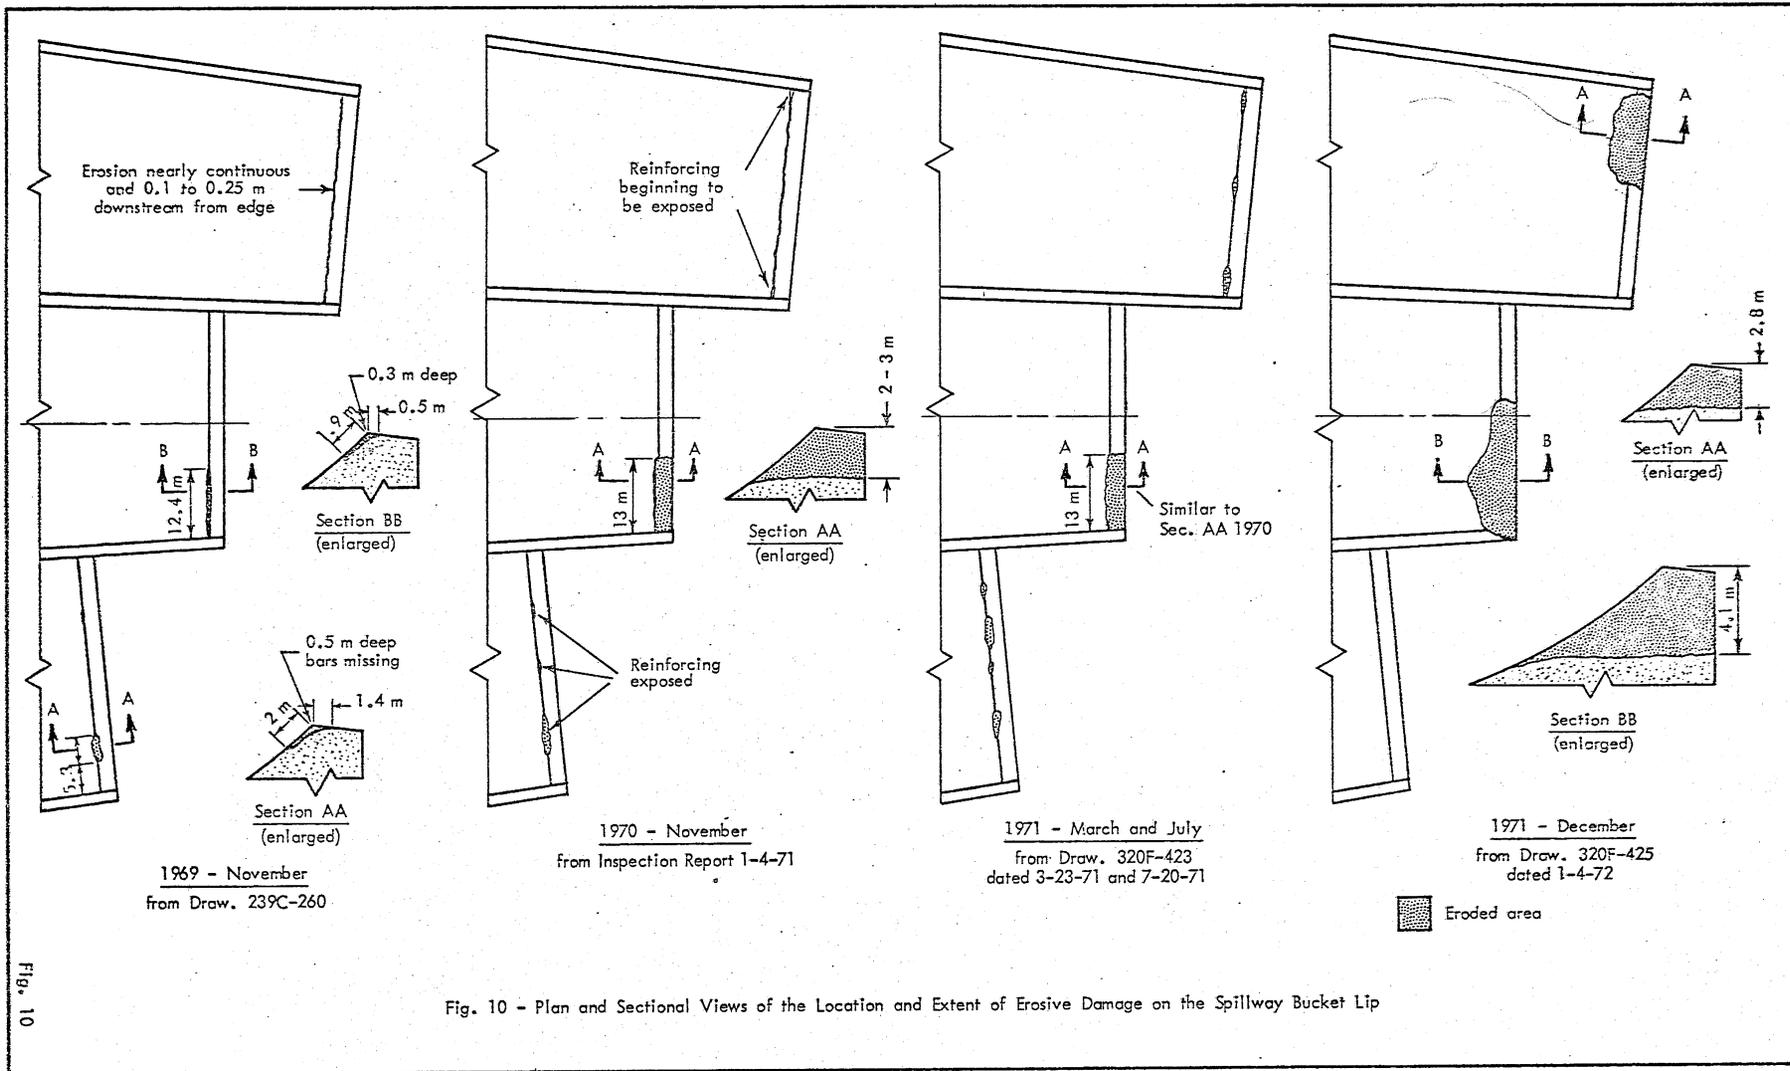
The material eroded from the bucket lip during the 1969 or first flood season is shown in location and extent in Fig. 10. The deepest erosion, about 0.5 m, occurred in a limited strip of the lip near the east end of the east chute, and its character is shown in the photo of Fig. 11. A somewhat shallower, but similar erosion occurred near the east end of the sill of the center chute. The sharp, pitted nature of the damage is characteristic of that found in other structures which have been damaged by cavitation.

The holes eroded in the bucket lip during the 1970 flood season are also shown in Fig. 10; this damage was rather moderate with the exception of the loss at the east end of the center chute. The hole in this case went to a depth of 2 to 3 m. The seriousness of this particular loss precipitated the investigation covered by this report.

felt that the damage might be self-arresting at some point. Diver observations of the damage were made in March 1970 and yielded the findings shown in Fig. 10. Observations which were made in July 1971 disclosed that conditions were much the same as in March 1971, but with a slight additional erosion.

Fig. 10 - Plan and Sectional Views of the Location and Extent of Erosive Damage on the Spillway Bucket Lip

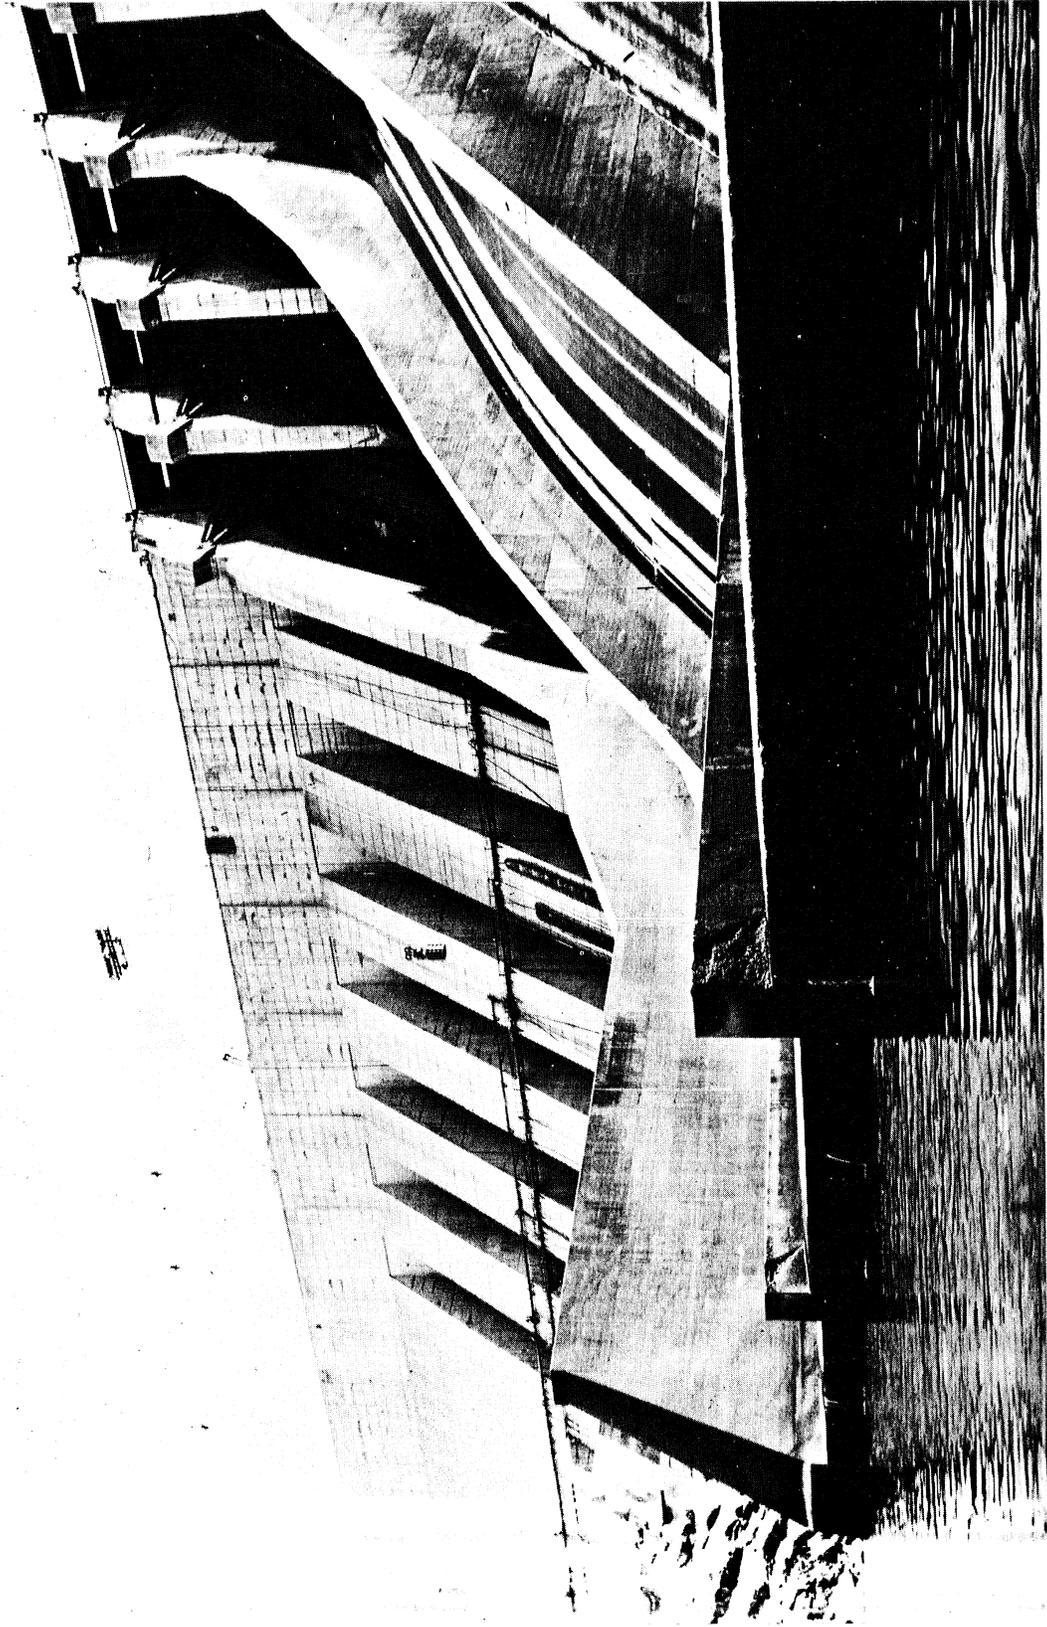
Concurrently with the previously described sill damage, damage was taking place on the vertical faces of the training walls adjacent to the chute sills. Of the four training walls abutting the three chutes, only the most easterly wall showed negligible erosive damage. The nature of this damage is shown in Fig. 12. Of the five training wall surfaces which showed damage, the appearance of four was essentially the same. The volume removed was in general shaped roughly like a half-cone. The tip of the cone began at the bucket lip and the axis of the cone ran up the wall at approximately 45° with the bucket sill as seen in Fig. 12. The depth of erosion was virtually zero adjacent to the bucket lip and was greatest near the top of the training wall. In 1969 some of these cones had already reached a depth of 0.3 m near the top of the wall. In subsequent years virtually the entire end of the wall has disappeared in some instances.

In addition to the conical pattern of damage, the east wall of the west chute showed damage in the area between the cone and the sill (Fig. 12). This shallow surface damage was somewhat similar to that found on the immediately adjacent sill which showed damage on the top and downstream side of its east end. This erosion was described previously under "Sill Damage" and was attributed to abrasion by rocks entrained from the pool. The shallow damage on the lower portion of this training wall is also believed due to this same rock abrasion.

The fact that the high wall on the east side of the east chute did not evidence significant erosive damage, as is shown in Fig. 12, led to the comparative model tests with high and low training walls adjacent to the bucket.

Fig. 12 - Downstream View of the Spillway Sill showing Erosive Damage on the Training Walls (Harza Engineering Co.)
