Project Report No. 78

Report on
STUDIES OF THE STABILIZATION OF THE BIG SIOUX RIVER
AT THE INTERSTATE 29 BRIDGE CROSSING

by
Alvin G. Anderson

Prepared for
South Dakota Department of Highways
and the
Iowa State Highway Commission

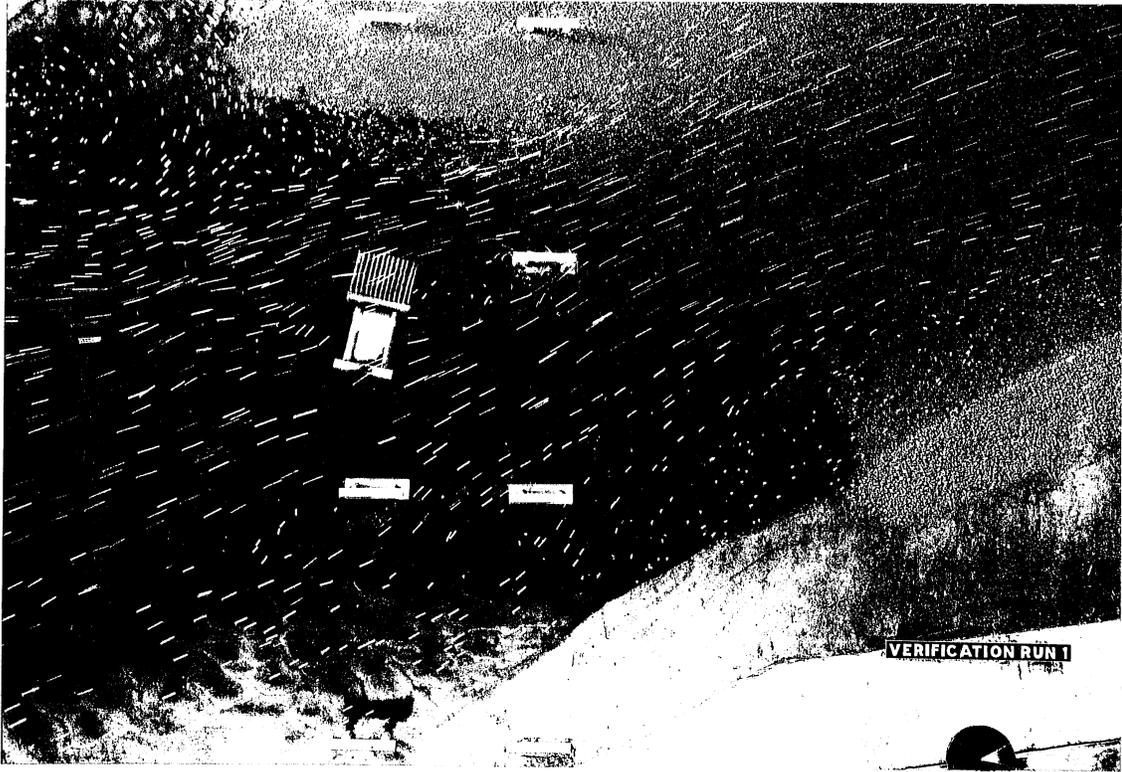
Photo 4

PHOTO 4 (Serial No. 142-58) During verification test V-1 and for a discharge of 55,000 cfs, pier 3 of the downstream bridge collapsed in the model. In this test there was no stabilization of the left bank and the riprap stockpile on the right bank upstream of the bridges was omitted. The flow pattern consequently did not simulate that observed in the prototype. The direction of flow is from right to left.

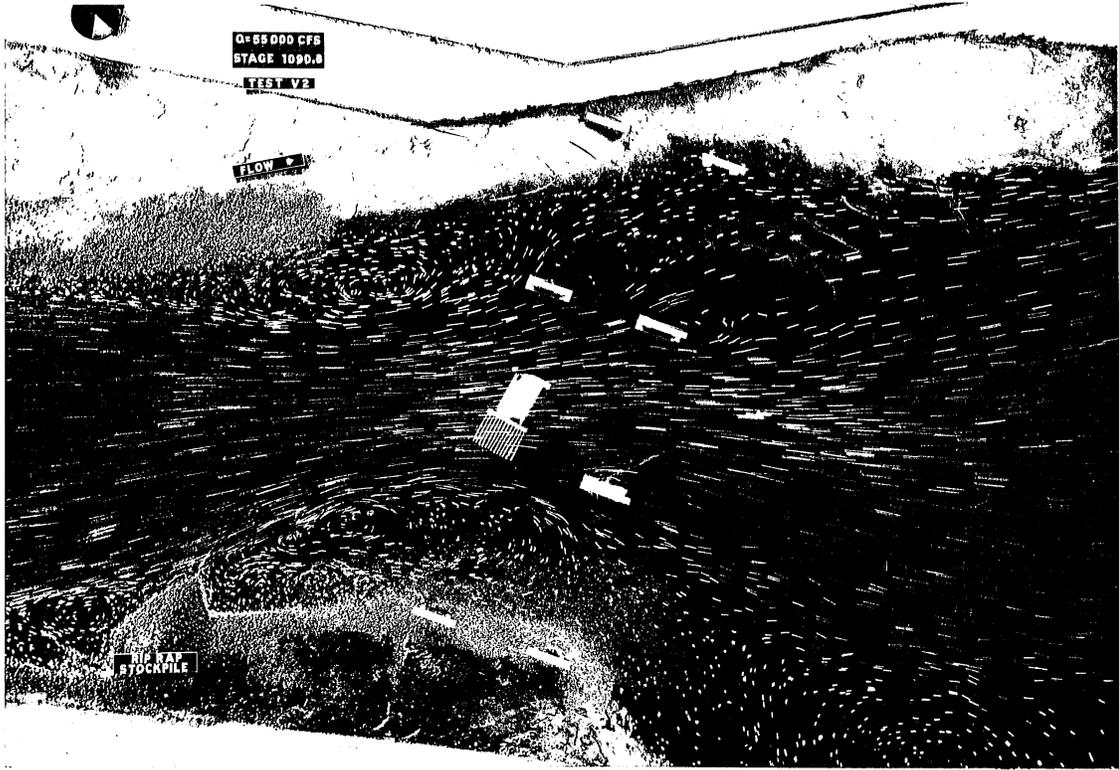
Photo 6

- PHOTO 6 (Serial No. 142-61) Big Sioux Verification Test V-2. This test was made after the banks had been adjusted and the stockpile replaced on the right bank. Pier 3 of the upstream bridge has been undermined and fallen in a manner somewhat similar to that observed in the prototype.

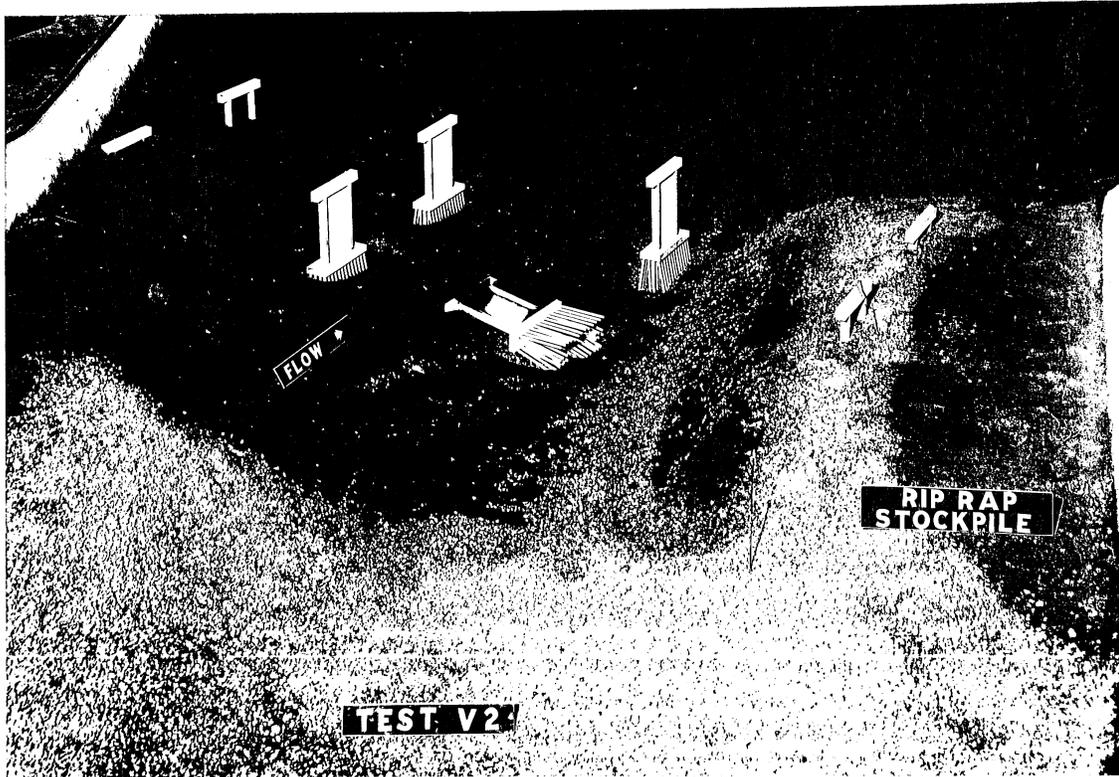
Photo 7

PHOTO 7 (Serial No. 142-62) Big Sioux Verification Test V-2. This photo shows the undermined pier at the end of the experiment. It will be noted that pier 3 of the downstream bridge has also been seriously undermined.

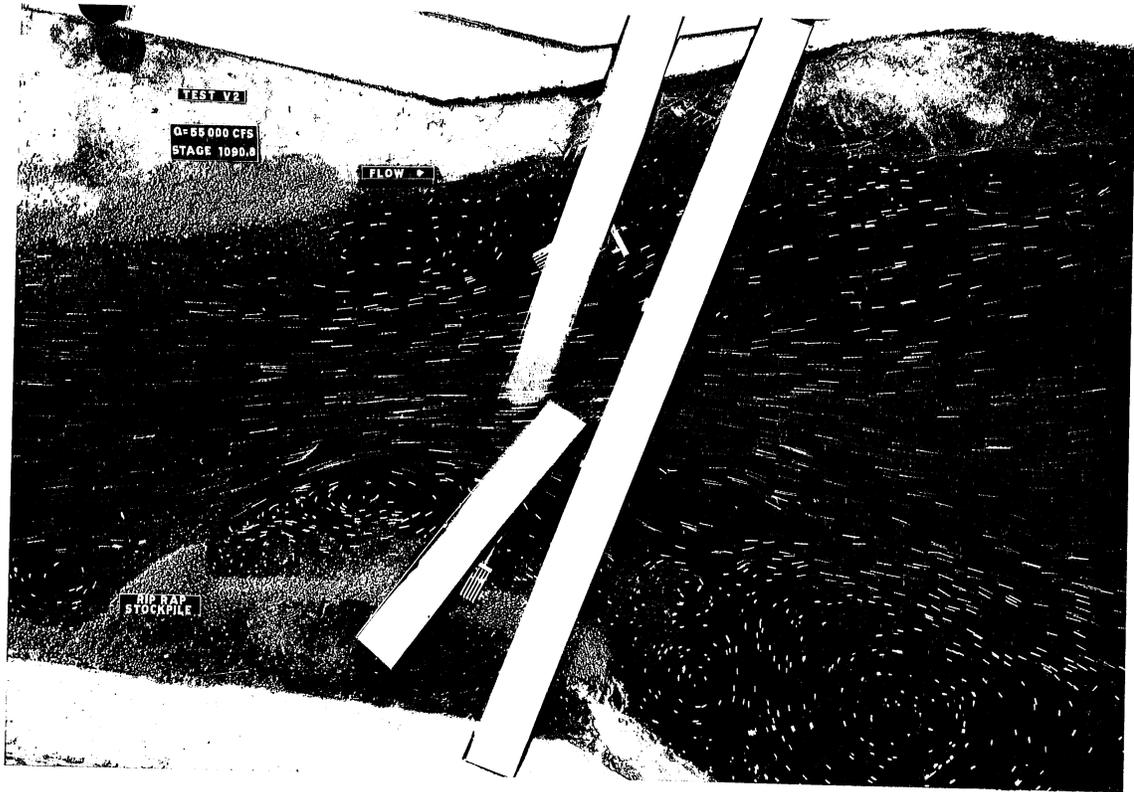
Photo 8

- PHOTO 8 (Serial No. 142-65) Big Sioux Verification Test V-2. After pier 3 had fallen into the river the superstructure was also placed in the flow similarly to that observed in the prototype. This photo shows the flow pattern through the bridge section and the collapsed upstream bridge.

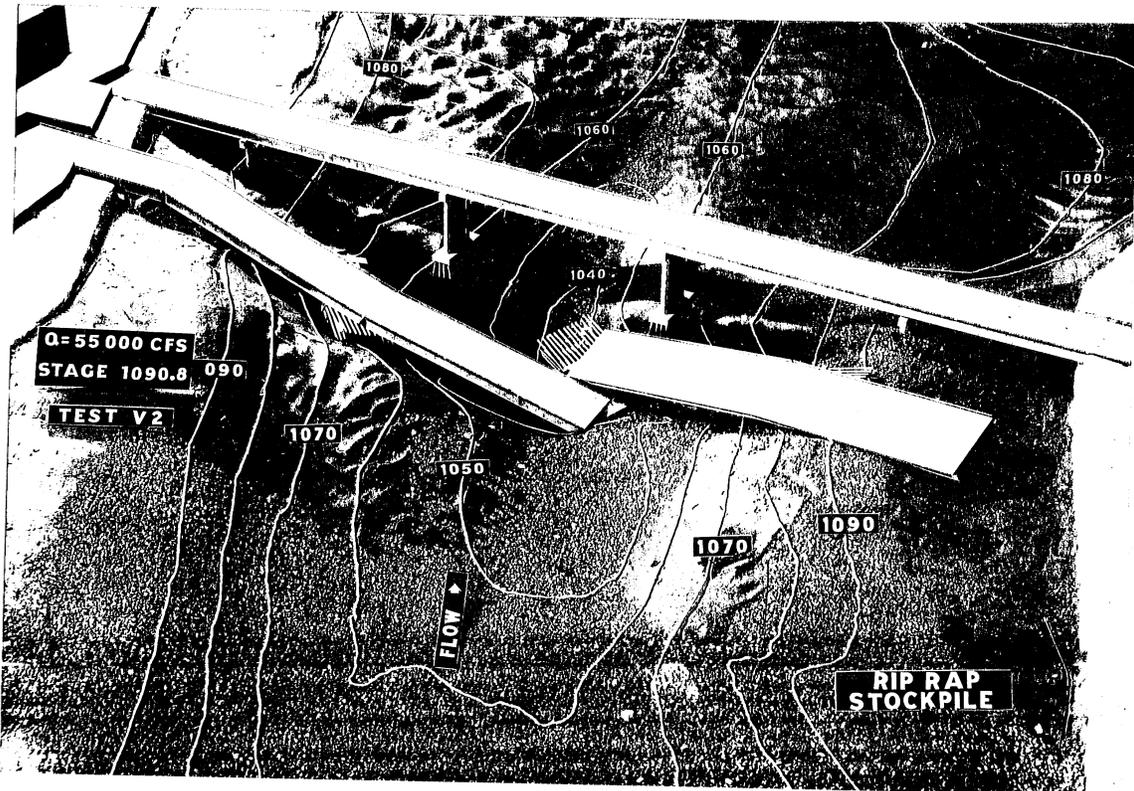
Photo 9

PHOTO 9 (Serial No. 142-66) Big Sioux Verification Test V-2. This photo shows the erosion pattern at the completion of the test with the superstructure in place.

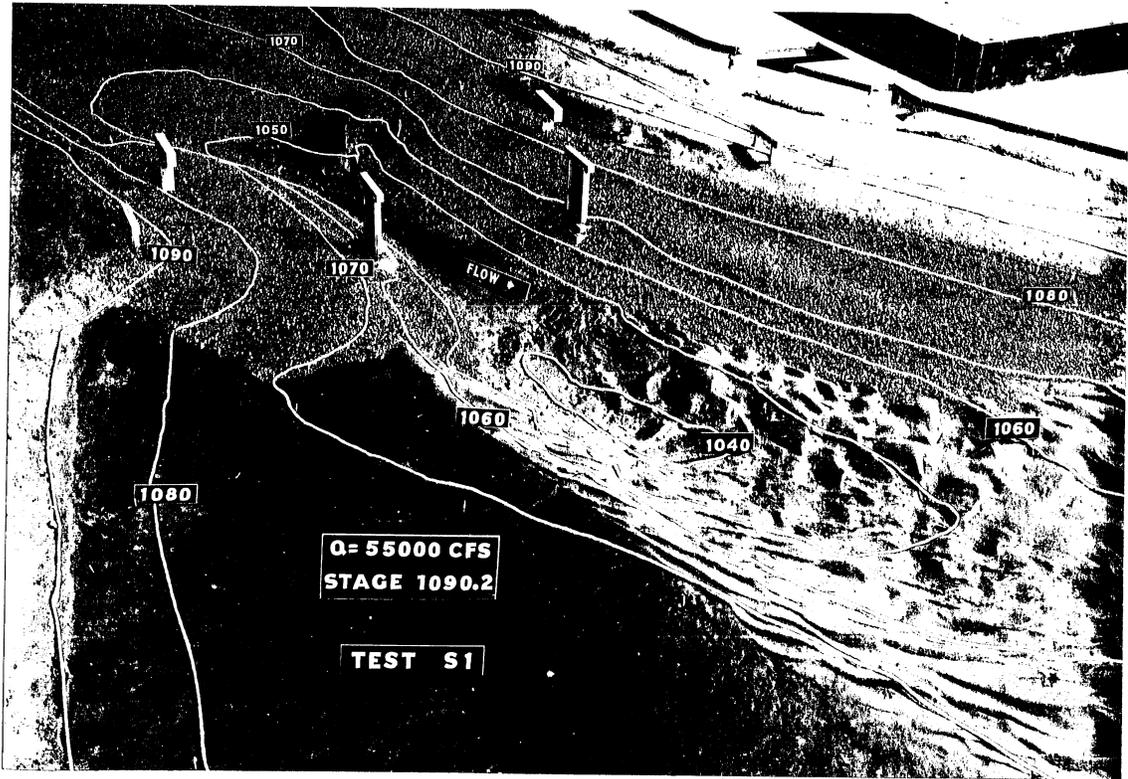
Photo 24

PHOTO 24 (Serial No. 142-89) This photo shows the erosion pattern in the neighborhood of the bridge piers developed by a discharge of 55,000 cfs. For these conditions, the revetment is relatively undisturbed and the greatest erosion occurred in the bed downstream of the bridge section.

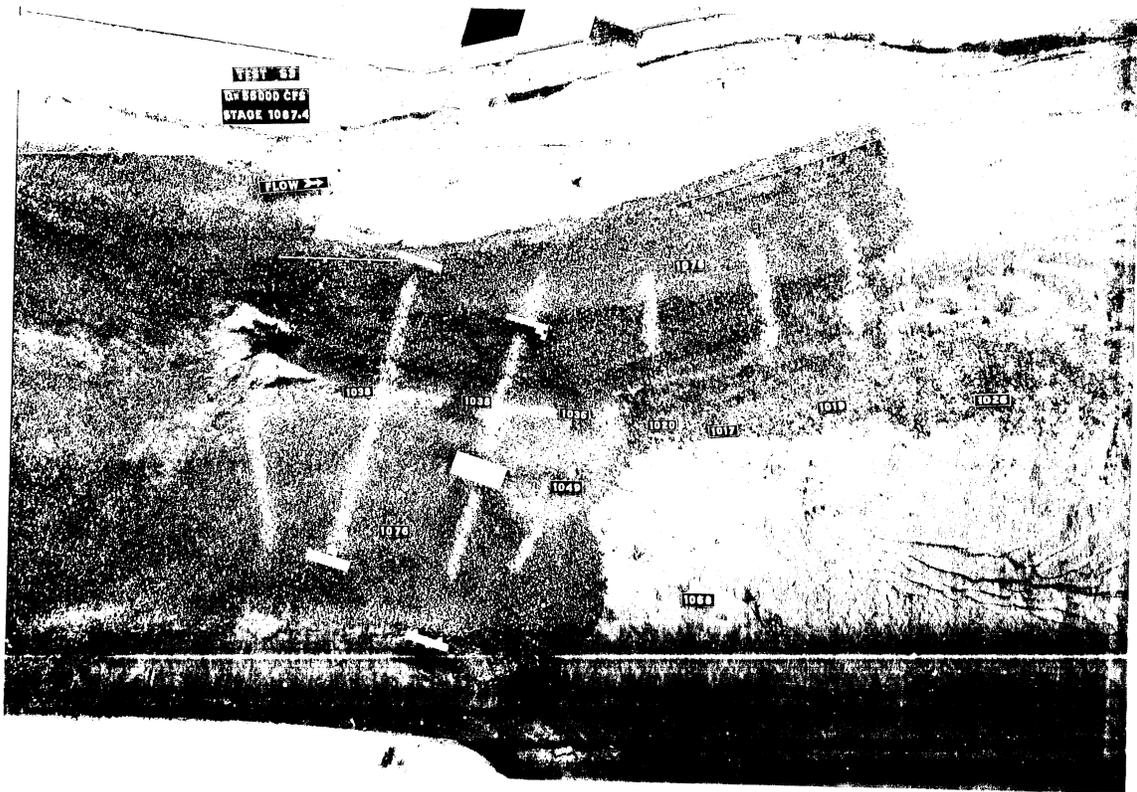
Photo 29

PHOTO 29 (Serial No. 142-95) This photo shows the same bed at the end of the test with a discharge of 55,000 cfs and the stage reduced to Elev. 1087.4. The revetment is relatively undisturbed except immediately downstream of pier 3 of the downstream bridge. Here the revetment has been eroded to a considerable extent by the flow in the wake of the pier. On the left bank downstream of the bridge section, it appeared that some of the rock revetment may have been moved and deposited further downstream on the bed.

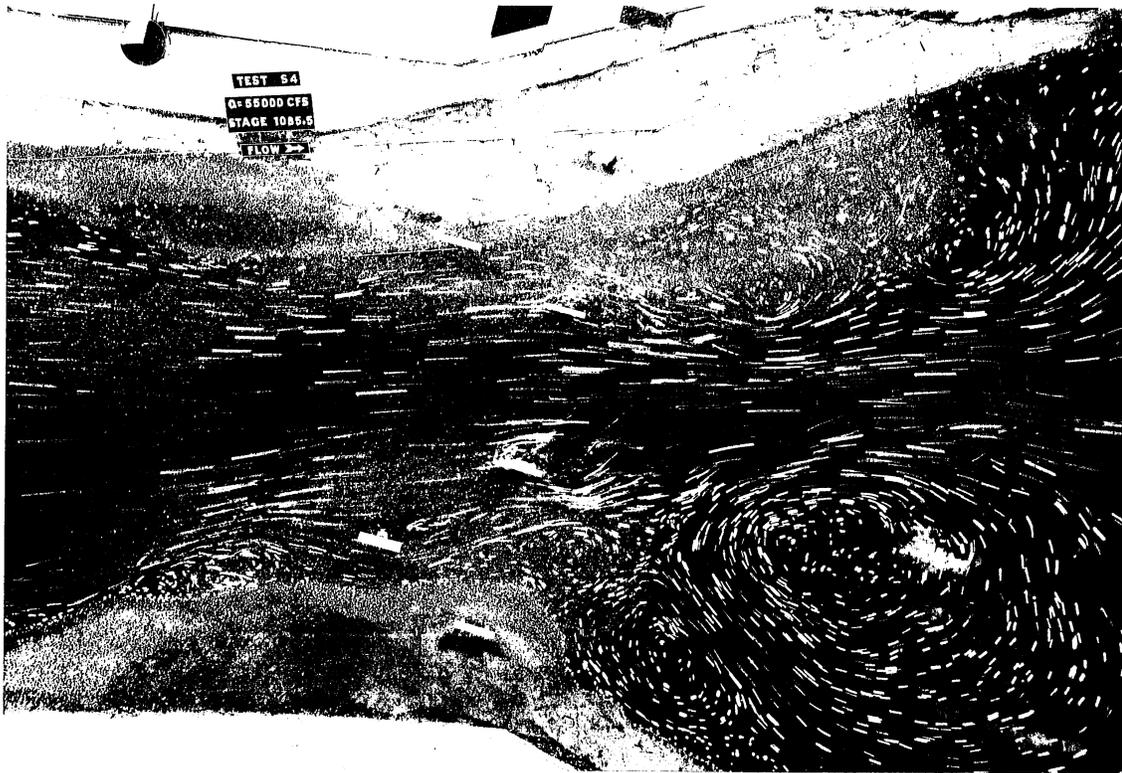
Photo 30 shows the surface flow pattern for a discharge of 55,000 cfs with the stage still further lowered to elevation 1085.5 ft. The high velocities through the constricted section and the development of vortices on both sides of the channel downstream of the constricted section is apparent. The maximum velocity through the bridge piers was of the order of 16 ft per second. The erosion pattern (Photo 31) resulting from this flow has been contoured to show the character of the scour hole downstream of the bridge piers. The photograph shows that even for these extreme conditions the revetment has

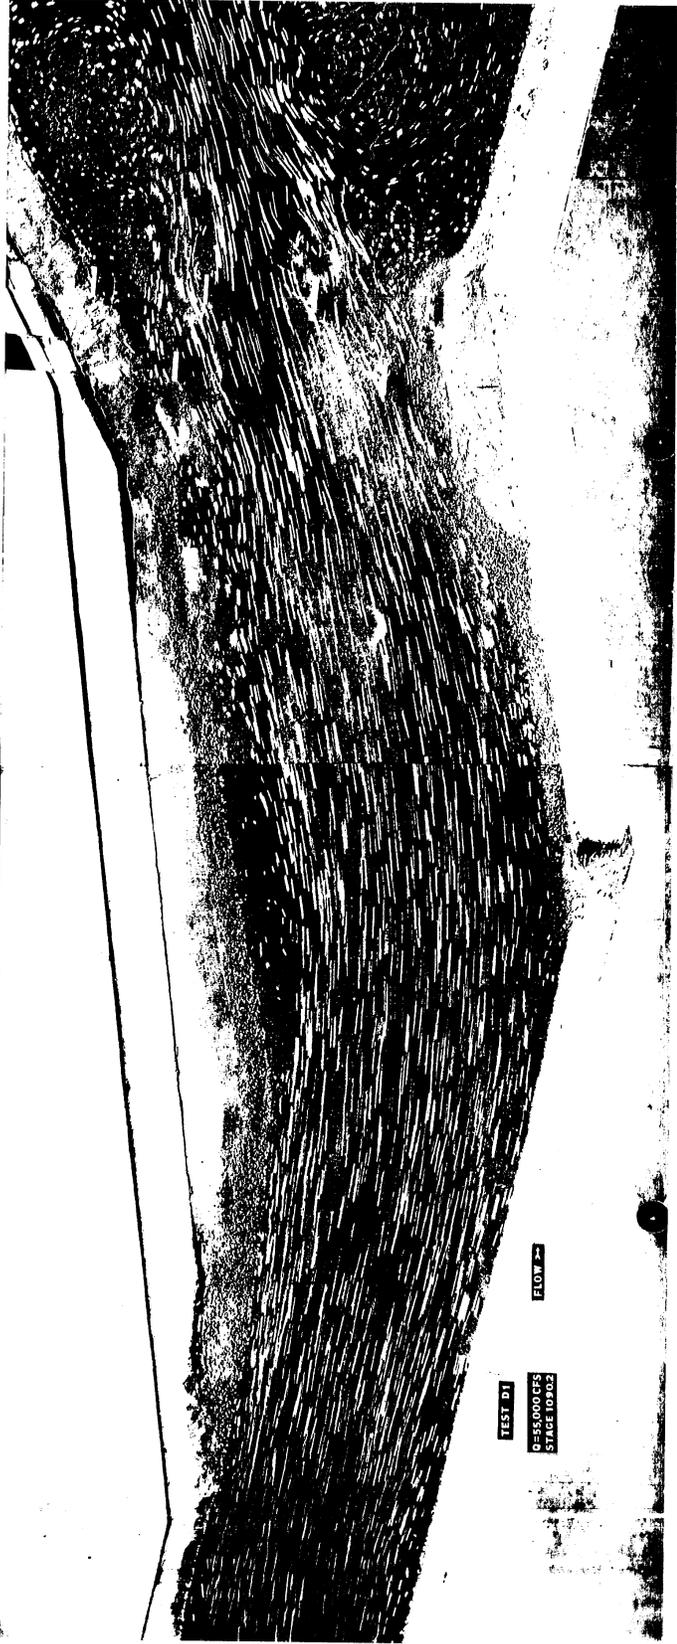
Photo 32

PHOTO 32 (Serial No. 142-118) This photo shows the original conditions of the stream channel and the flow pattern upstream of the bridge cross-sections before any protective devices were installed along the right bank. The significant aspect of this flow is the angle of attack on the bridge piers of the downstream bridge and the extent of the zone of separation along the left bank. It appears that in time of flood, the right bank may be attacked by the high velocities in this neighborhood.

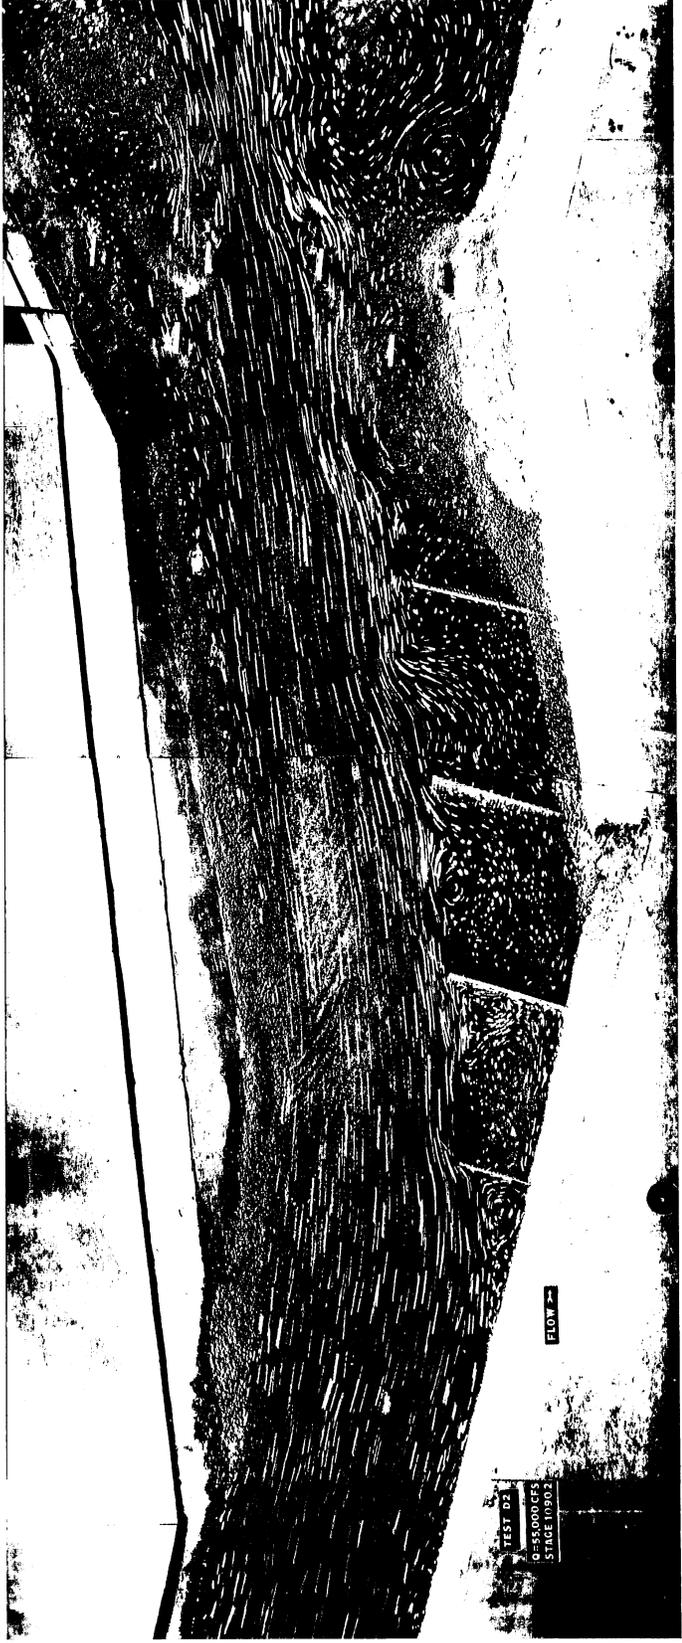
Photo 33

PHOTO 33 (Serial No. 142-119) For this test four relatively long dikes have been installed along the right bank. The effect of the dikes is to push the flow over towards the left bank and to create relatively large areas of quiet water between the dikes on the right bank. The angle of attack on the bridge piers has been greatly reduced.

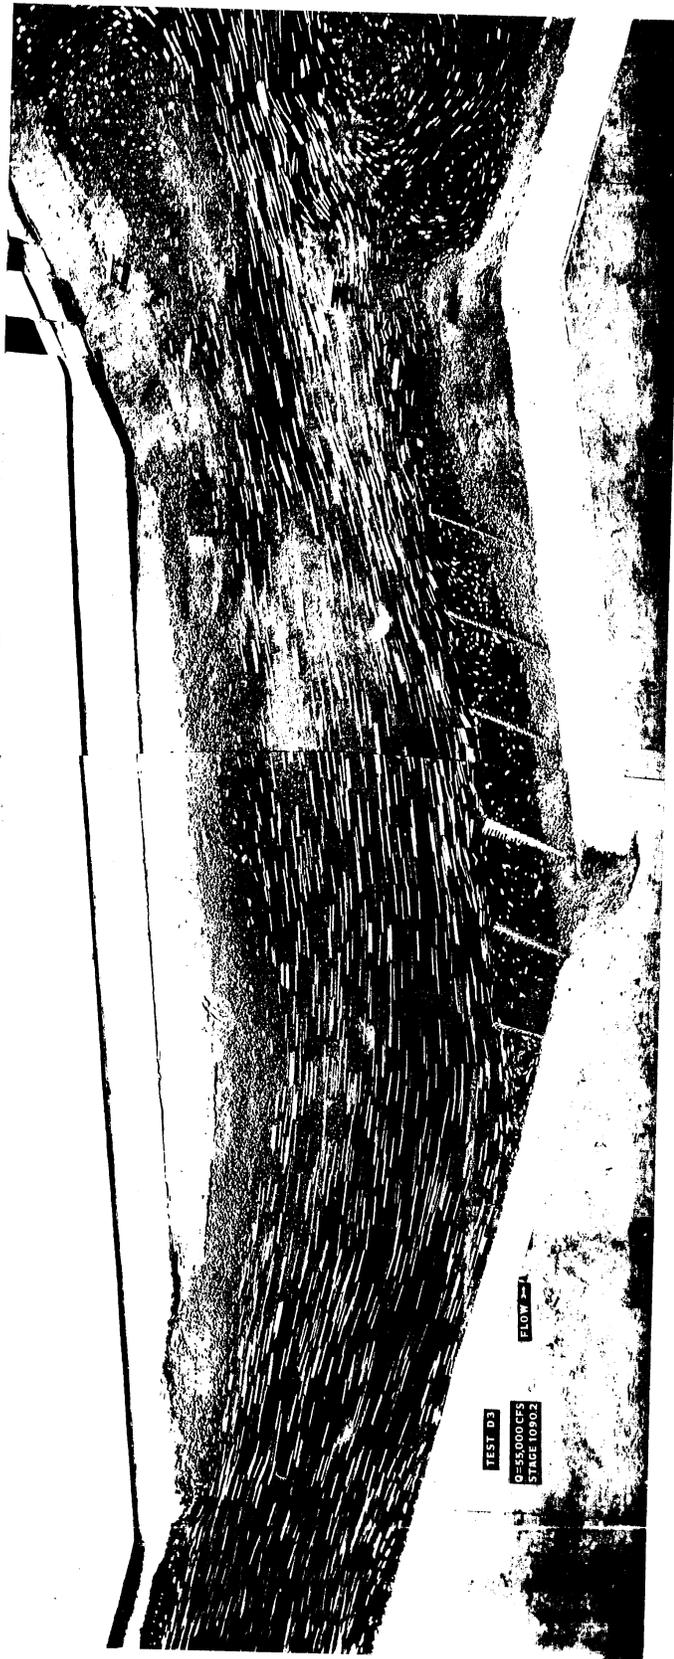
Photo 34

PHOTO 34 (Serial No. 142-120) By shortening the dikes and decreasing the spacing, the flow pattern is somewhat improved in that the mean velocity has been reduced. The right shore is still protected from erosion and the angle of attack has been decreased below that for the original conditions.
