The Cause and Morphology of Fracture in Acetal Quick Disconnect
Couplings used in a Residential Water Filter Application

A DISSERTATION
SUBMITTED TO THE FACULTY OF THE GRADUATE SCHOOL
OF THE UNIVERSITY OF MINNESOTA
BY

IN PARTIAL FULFILLMENT OF THE REQUIREMENTS
FOR THE DEGREE OF
Master of Materials Science and Engineering

June 2012

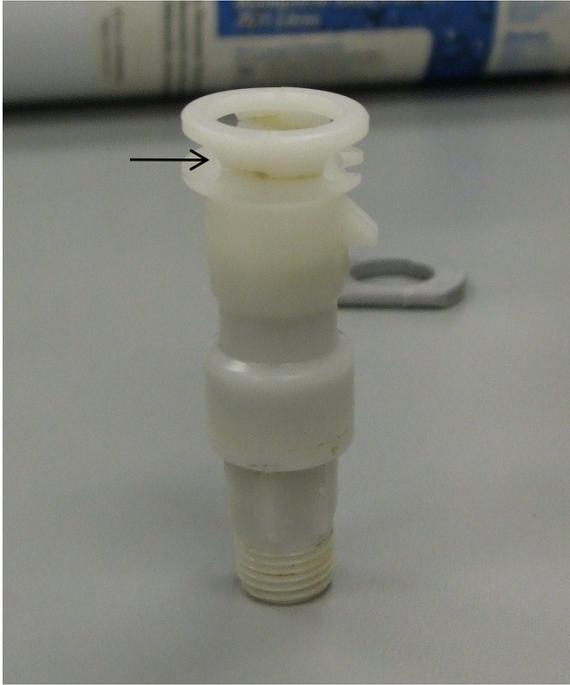
Figure 3: Photograph showing the location of the crack in the mode of interest to this analysis. The crack passes through the "ears" responsible for retaining the latching mechanism. An arrow indicates the crack location in the figure.

The mode of interest in this thesis is the fracture of one of the two the body components at the section which is responsible for retaining the locking clip. This area is referred to as the “ears” of the body, and is the region noted in Figure 3. The ears join the main body of the component to the ring-like face of the part that encloses and secures the locking clip. A break through the ears will release the locking clip from the body and allow a coupling insert to be ejected, breaking the connection. This break can occur on either the valved or non-valved body component; both parts have the same clip component, and the geometry of the plastic retaining the clip is the same in both as well.

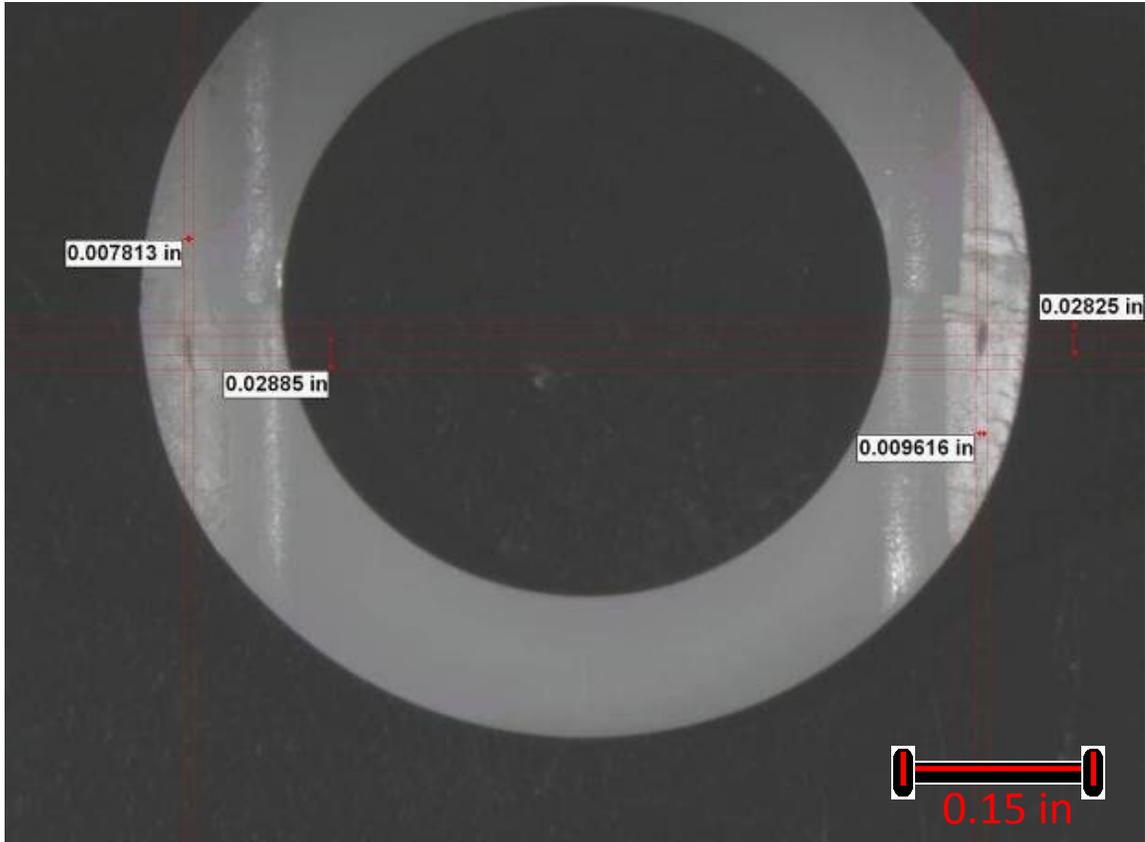
It was noted in the course of testing the product in this manner that shrinkage voids were present in some parts in the middle of these sections. This feature is worth analyzing in some detail. Figure 4 shows a micrograph of a fractured clip face which has two voids in the ear regions. These voids are found in a significant fraction of these components. Indeed, Voids are a normal feature in injection molded components with sophisticated geometries, and are often (as is the case here) the result of normal cooling of a highly crystalline polymer, such as the acetal used to make this component. These voids are caused by shrinkage related to the volume change the material experiences upon crystallizing and cooling from the molten state during molding.

Figure 4: Optical micrograph showing voids in the center of the "ear" cross sections. These voids are caused by shrinkage of the acetal material, and are commonly found in this location. This particular image was captured in analyzing a filter assembly returned for analysis in a lawsuit.

presence or absence of voids in this location does not have a significant effect on part strength, and further, that voids do not predict rupture strength. Test results have indicated no strong relationship between the presence of voids and the force to break parts through the void.

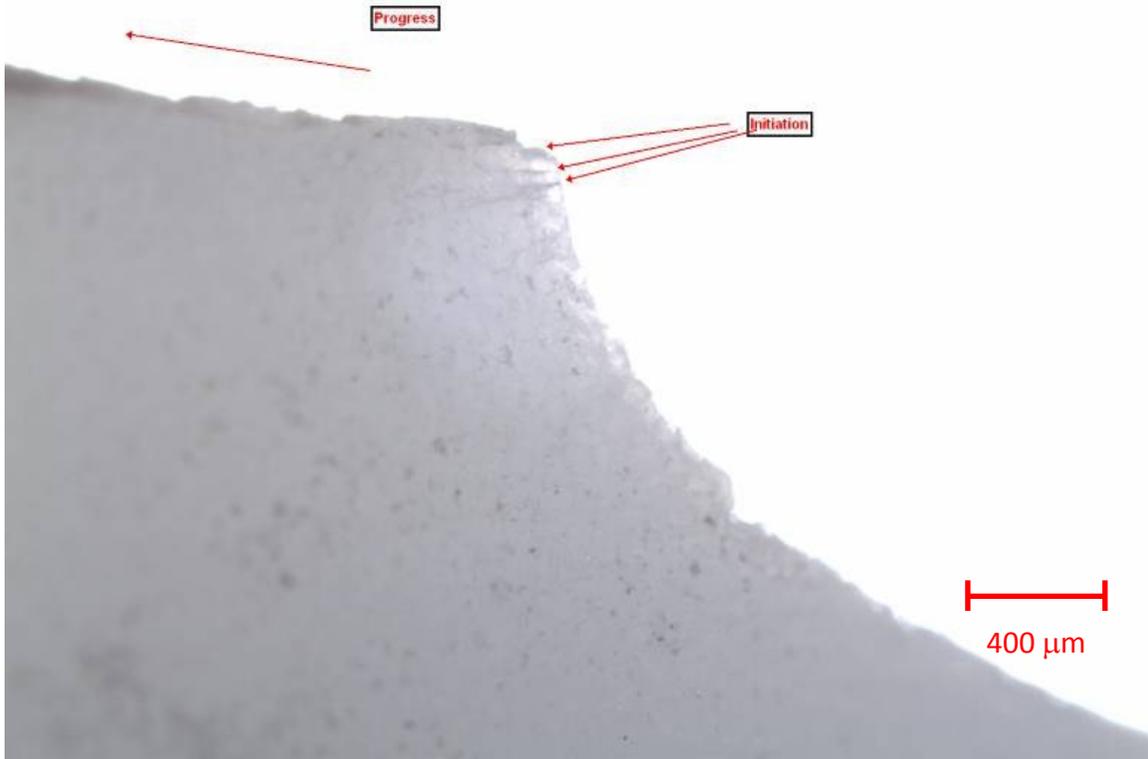
Figure 6: Optical micrograph of the initiation location at the end of the ear. Multiple cracks initiated at this location, one of which progressed across the entire fracture surface. These cracks would not have formed had the crack initiated in the center of the ear near the void, as the overall area when the crack reached this point would have been so small and the effect of the sharpness of the crack tip so large that the material in the plastic zone would simply have fractured, not generated additional, parallel cracks off-plane.

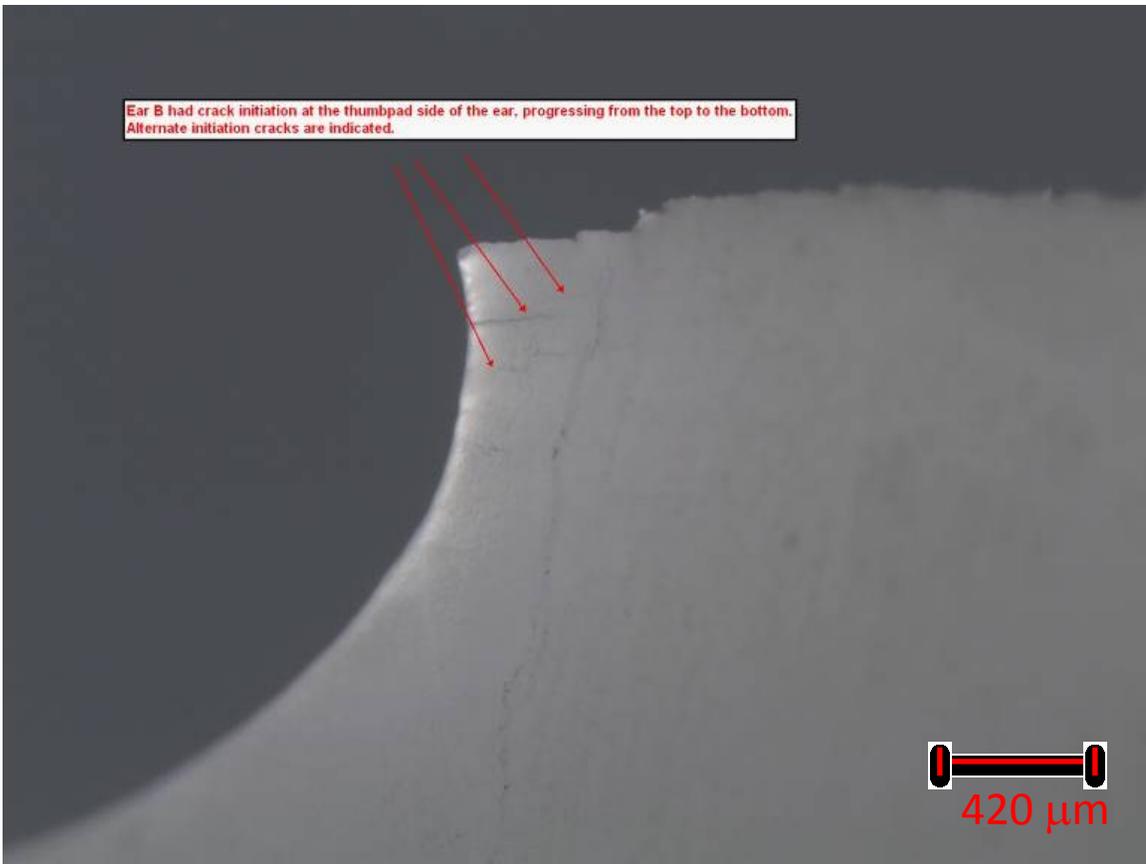
Figure 7: Optical micrograph of the true initiation location at the end of the other ear. Again, multiple cracks are noted. These indicate a relatively uniform state of stress across multiple planes in the material, which would not occur had the plastic material cracked from the center (voids) outward. The crack tip's plastic zone and stress concentration influence would have concentrated stress on the actual fracture plane, not initiated additional cracks near its termination. Further, the vertical stepping seen in this location is not consistent with a rapidly terminating crack, but rather with a "wandering" of a crack between pre-formed crazed regions caused by steady state or fatigue stress.

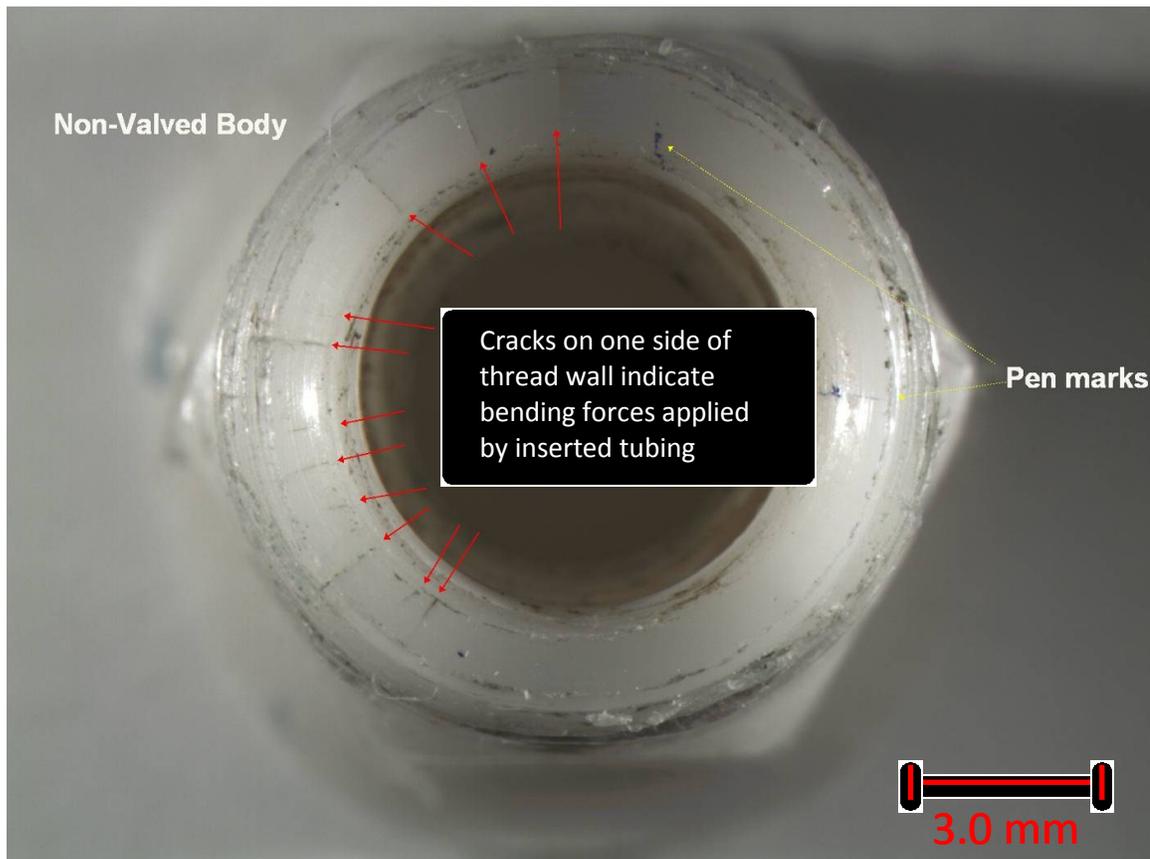
Figure 20: Optical micrograph showing cracks in the thread wall of a non-valved APC product used in the water filter application. Cracking along one half of the circumference indicates bending loads were applied to the tubing and transferred to the coupling. Had over tightening caused these cracks, they would be expected to occur around the whole circumference.

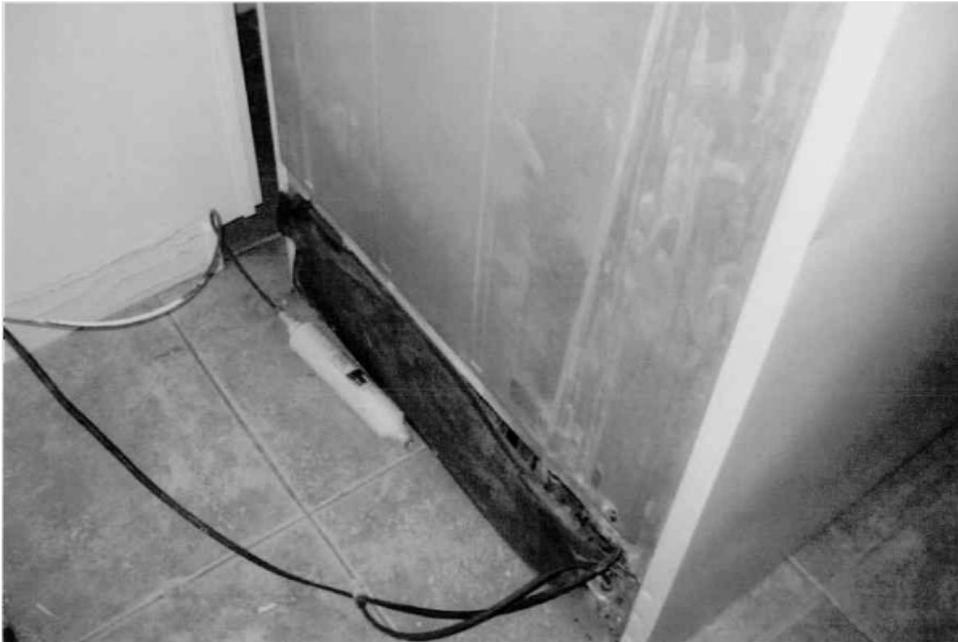
Figure 21: Photograph of a return where the filter was plumbed with copper tubing and was unsupported. As the tubing stiffens over time due to cold work the bending forces produced will continue to increase.

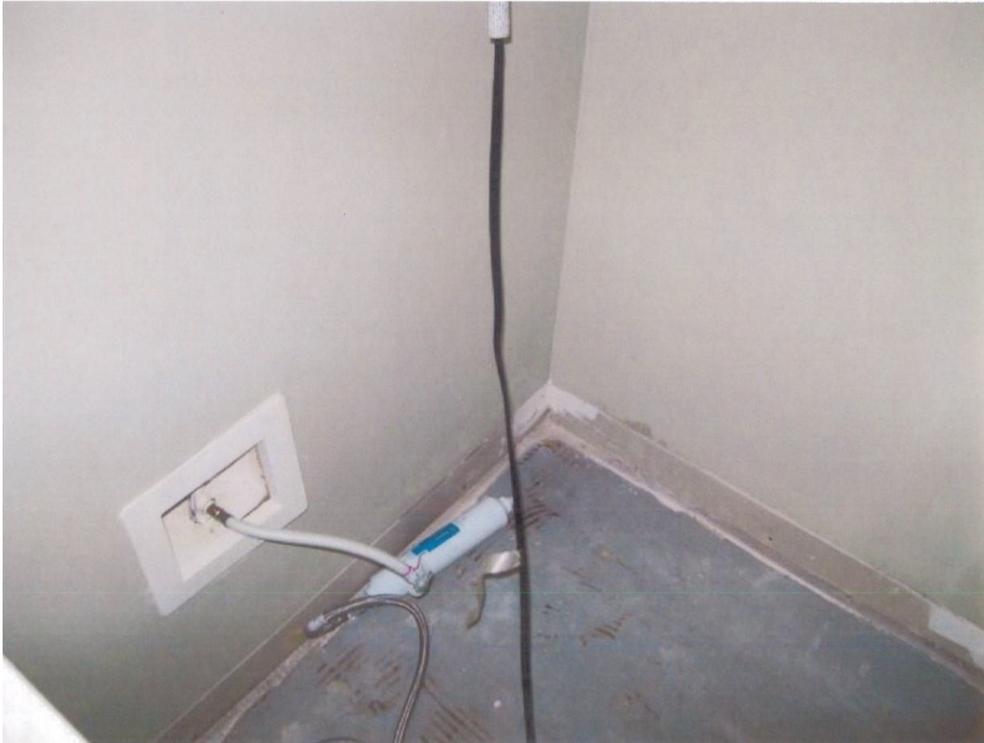
Figure 22: Photo of a filter installation where braided tubing was used and the filter appears to be unsupported.

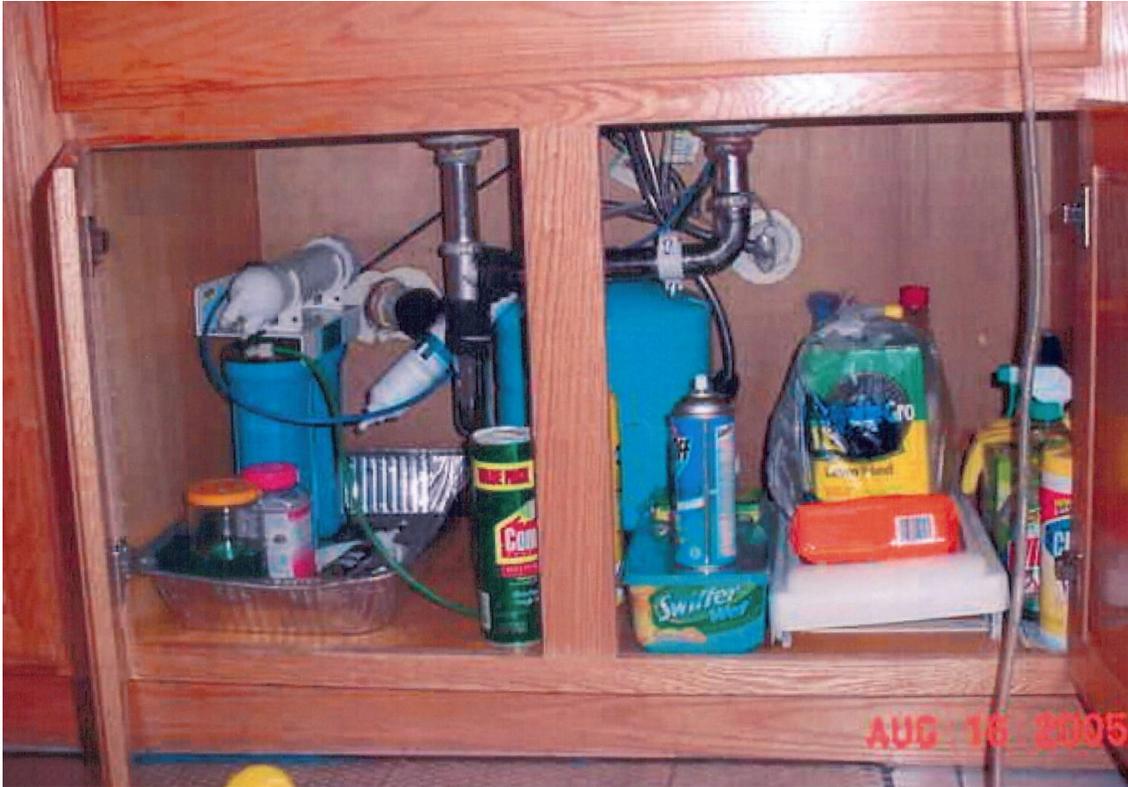
Figure 23: Photo of a filter installation under a sink. The kind of tubing used is unknown, but this filter was plumbed with hot rather than cold water, and was an inlet filter to an "instant" water heater.

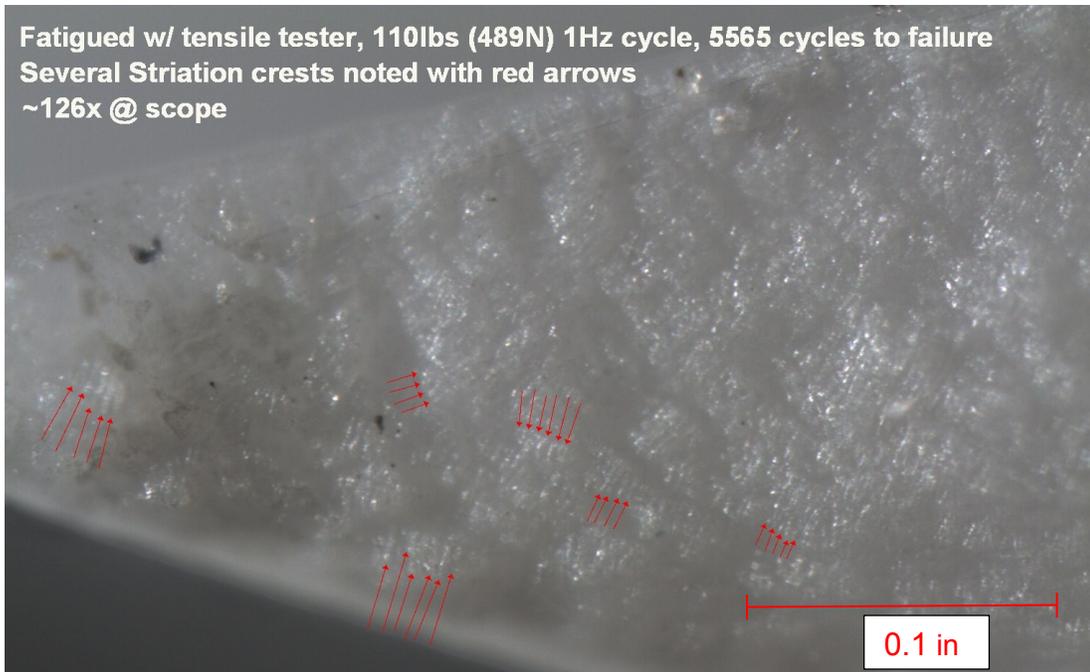
Figure 30: Optical micrograph of intentionally fatigued exemplar part.

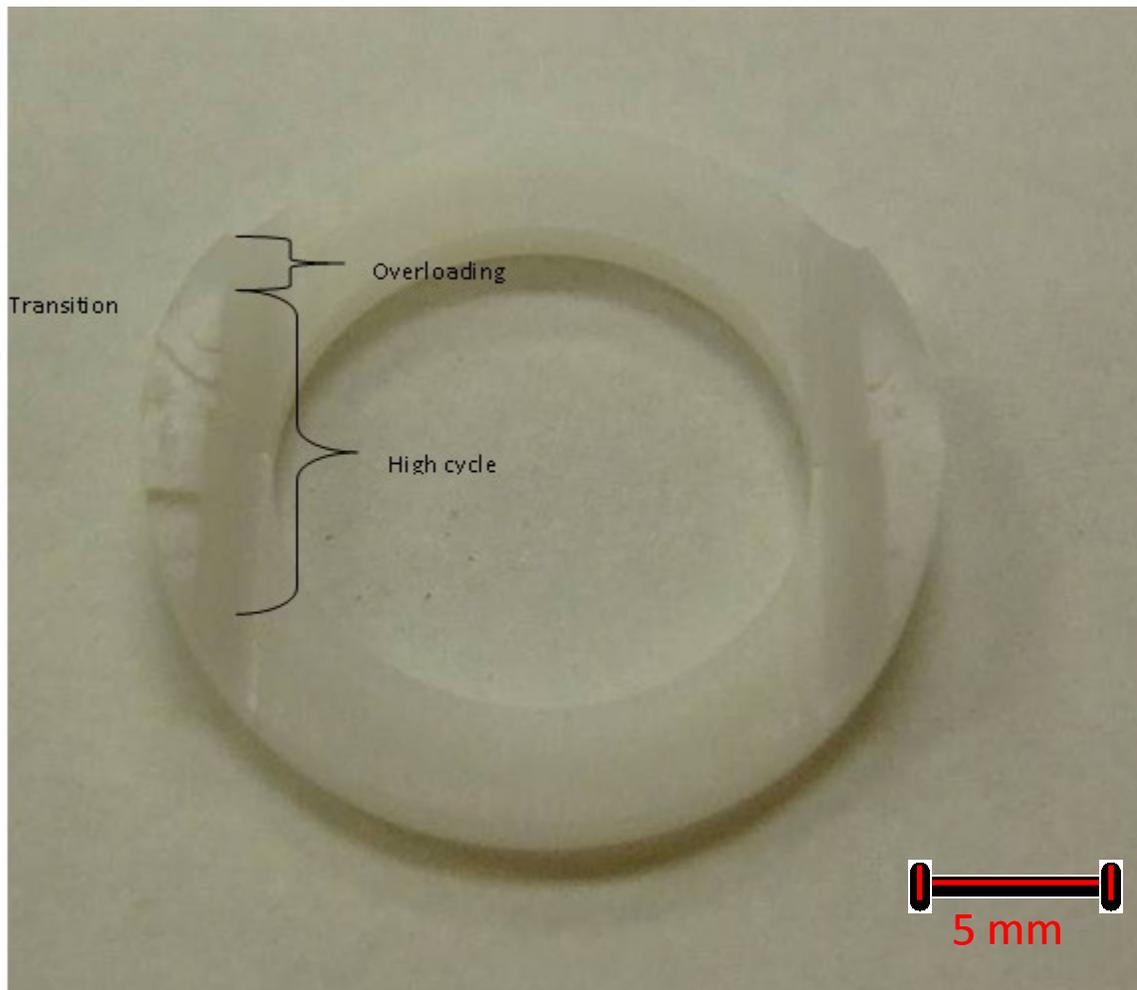
Figure 31: Photograph showing the fatigue and overload portions of the fracture surface of a known high cycle fatigued component.

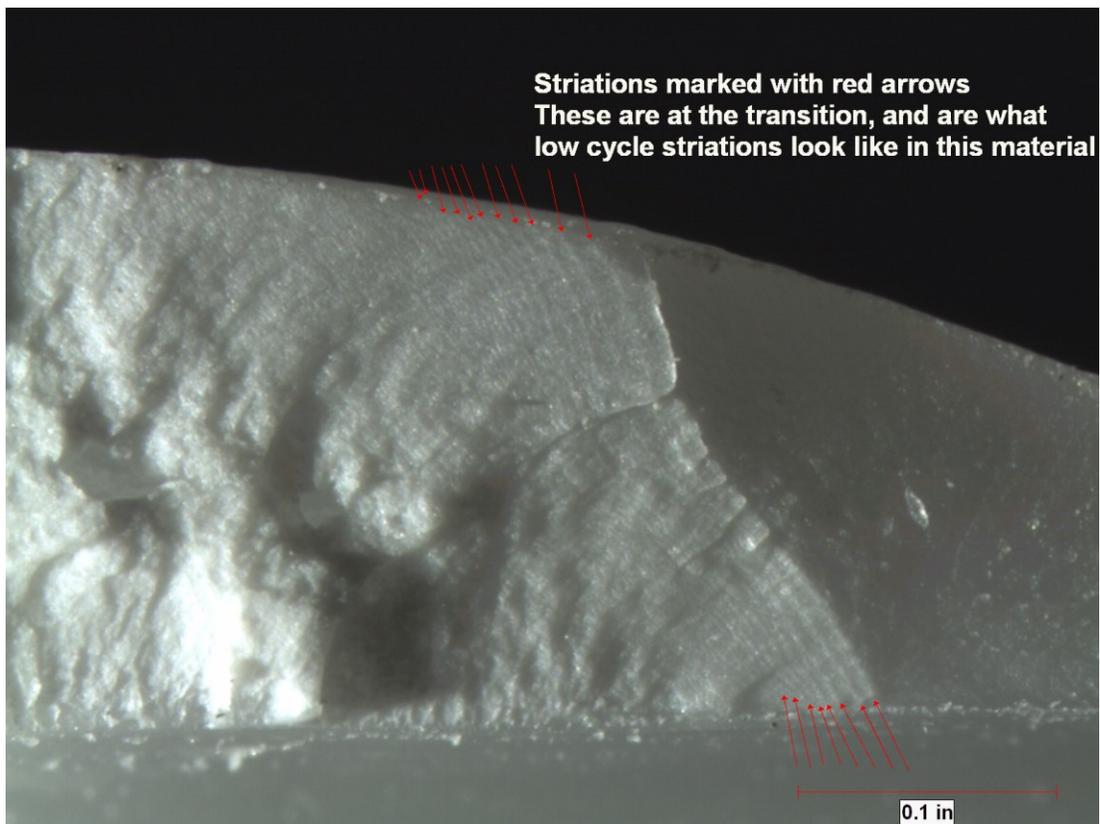
Figure 32: Optical micrograph of the transition region of the sample shown in Figure 31. Red arrows indicate the location of striations showing crack arrest during the transition from fatigue into overloading.

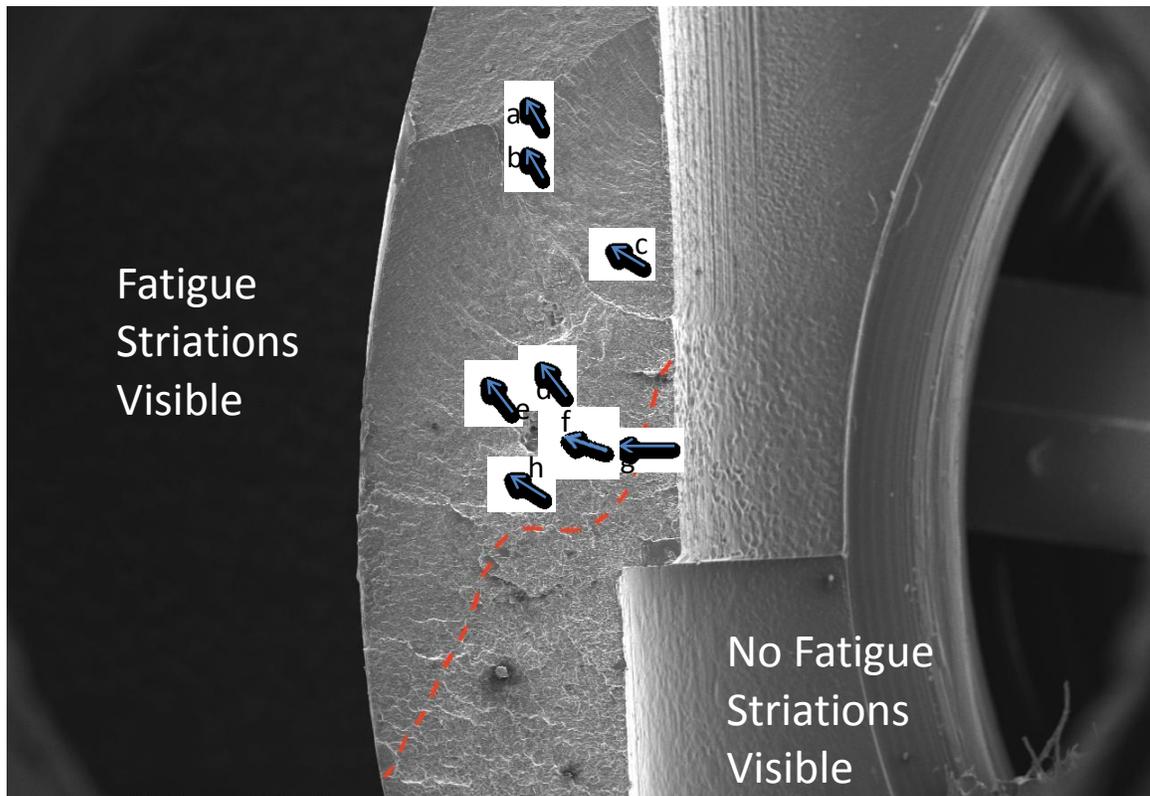
Figure 33: SEM image of high cycle fatigue sample. Above the red line, evidence of striations was visible. Below the line, striations were not found. Letter references indicate relative positions of subsequent SEM image captures referenced below. Arrows show direction of crack progression in each image.

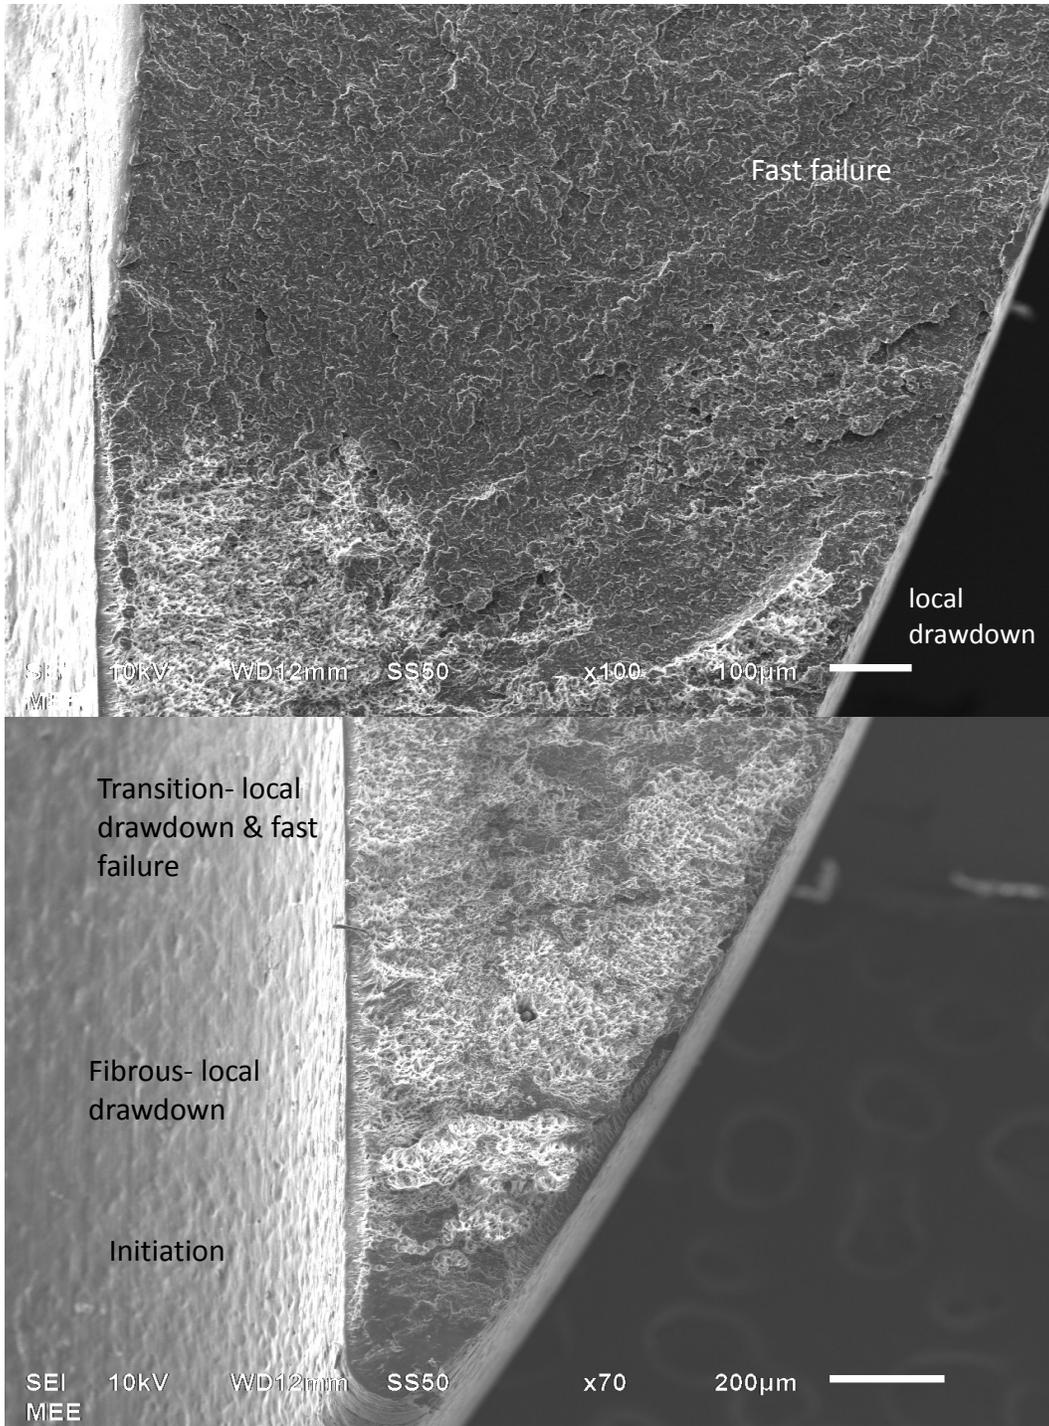
Figure 40: SEM images showing three different surface morphologies near the point of initiation. The two images shown are of adjacent portions of the same surface.

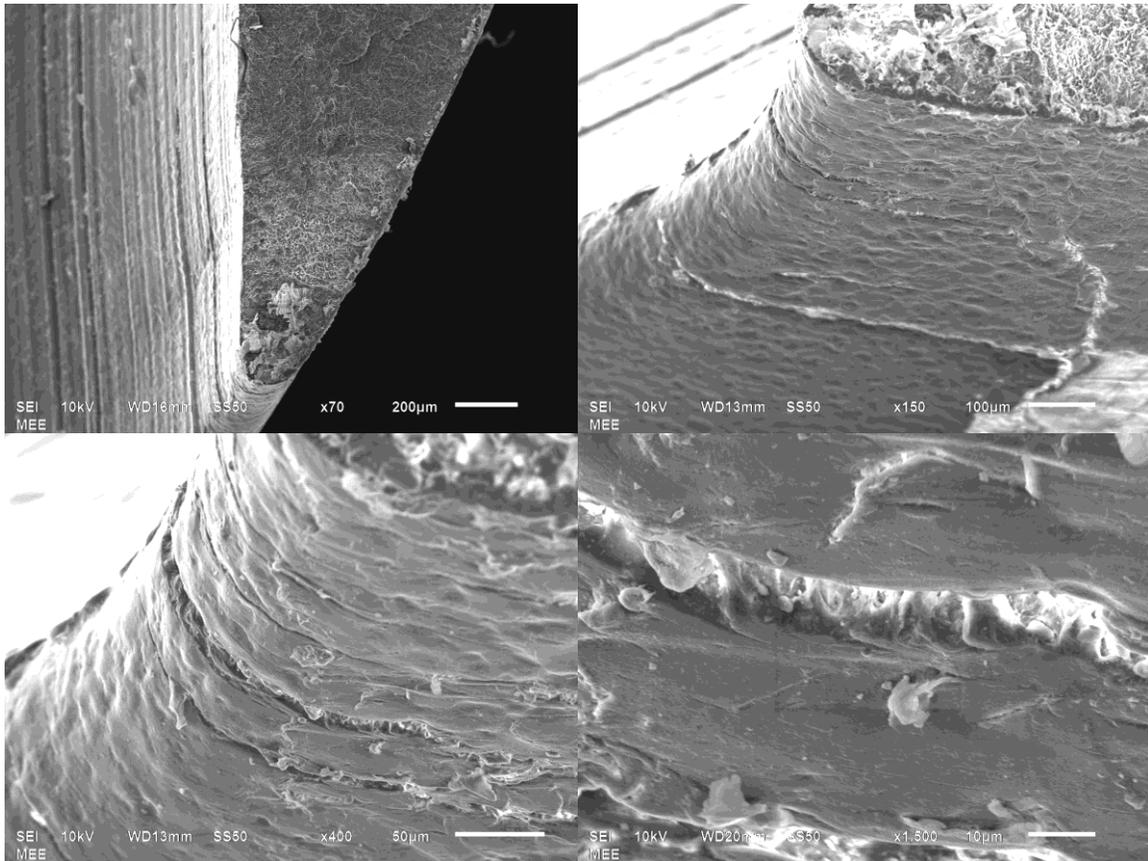
Figure 41: SEM micrographs showing the initiation region of the opposite half of the part shown in Figure 40. Top left: overview showing the same initiation, local drawdown, and fast fracture regions. Top right: oblique view of the edge of the part with the fracture still in view. Note points of separation under the fracture plane where additions fractures began to develop as crazes before the final fracture occurred. Bottom left: closer view of the crazes/secondary fractures. Bottom right: closer view of the crazes.

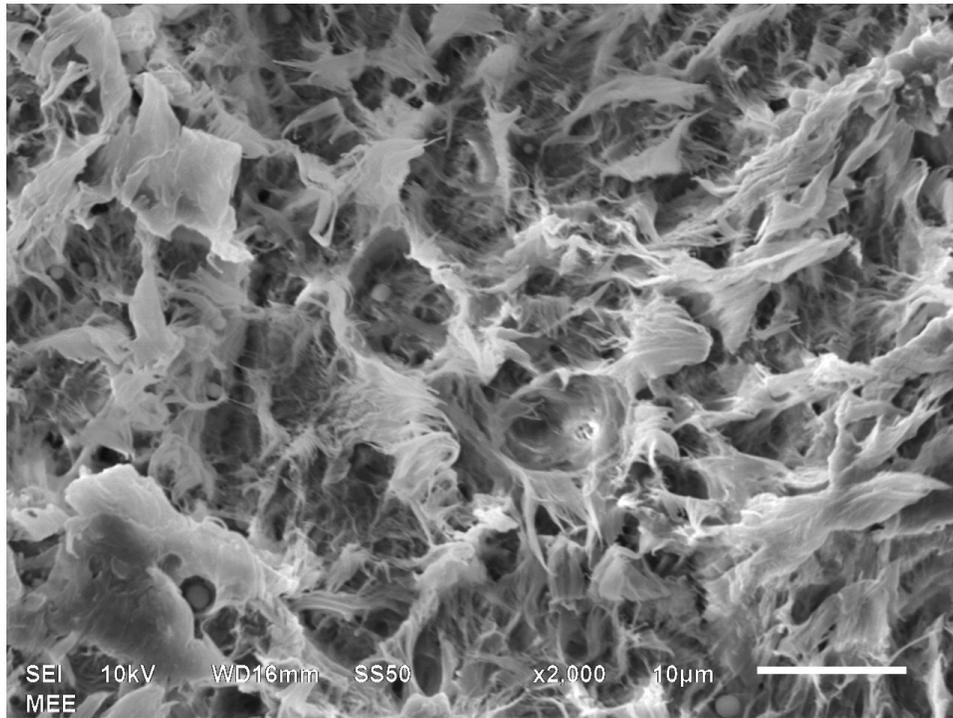
Figure 42: SEM showing local drawdown zone of creep sample.

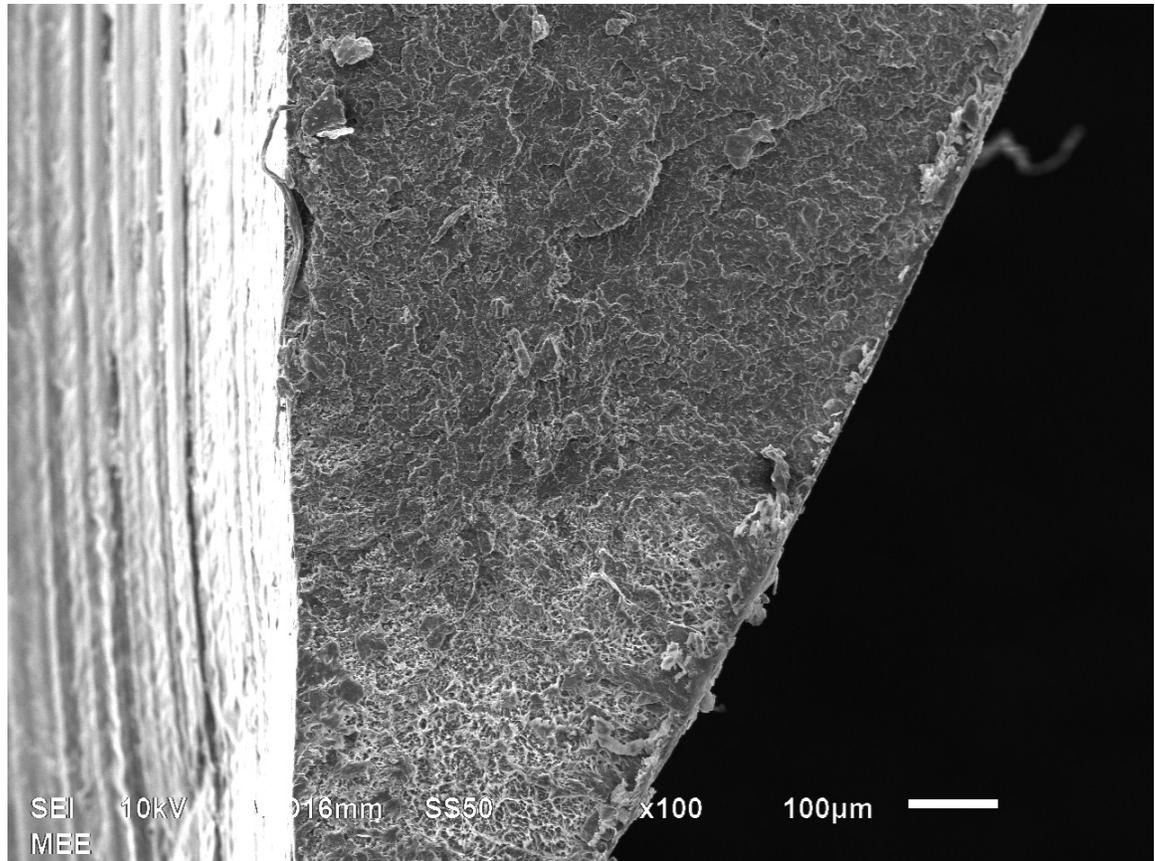
Figure 43: SEM of the transition region in the creep sample.

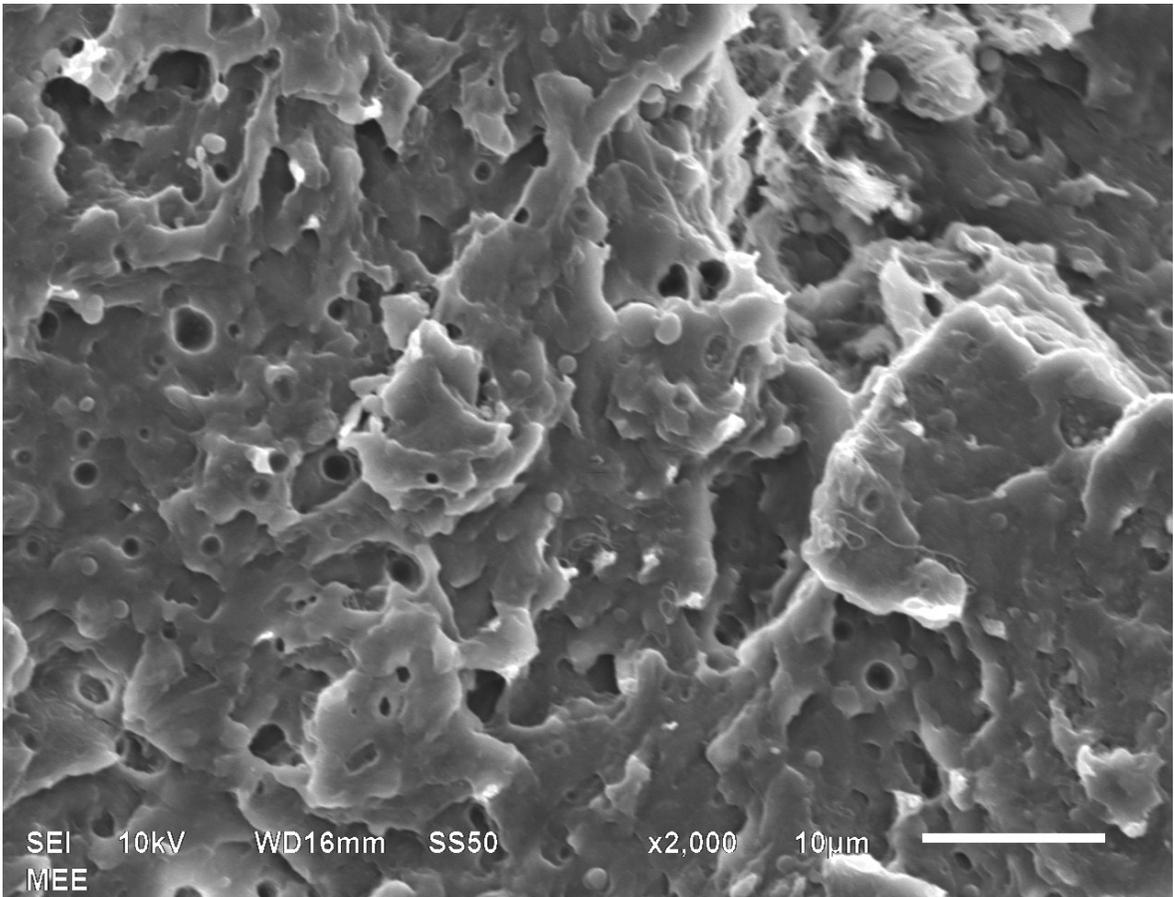
Figure 44: SEM of the fast fracture surface morphology in the creep sample.

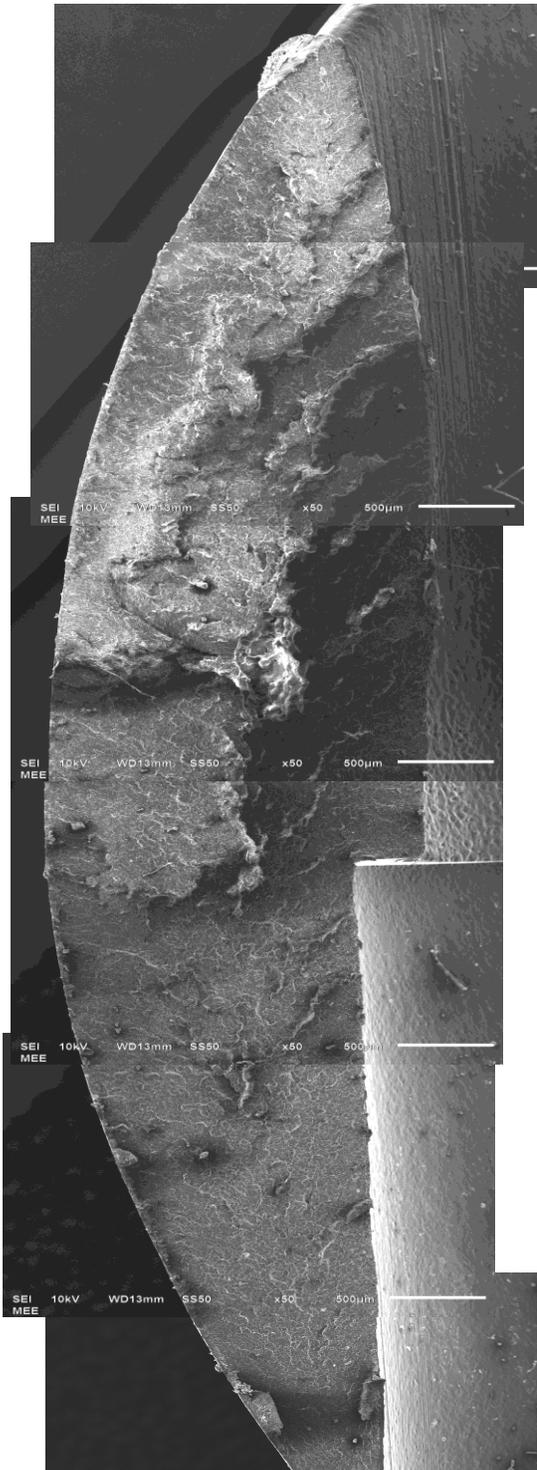
Figure 45: Knit images of the overload fracture sample showing the complete fracture surface.

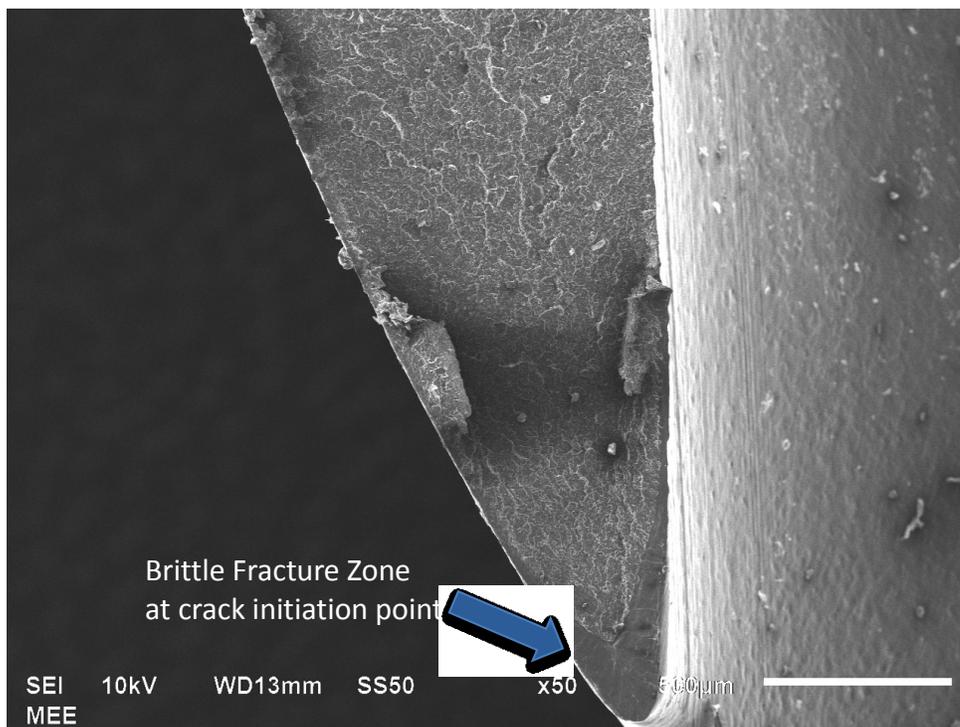
Figure 46: SEM image showing initiation region on an overload sample. Note the brittle crack region at the initiation point, displaying a smooth, featureless area. The crack growth mechanism in this region was apparently different than the mechanism which dominated the majority of the crack advance.
