Minnesota
Department of
Transportation

Evaluation of the SafeLane™ Overlay System for Crash Reduction on Bridge Deck Surfaces

March 2010

Research Project
Final Report #2010-13

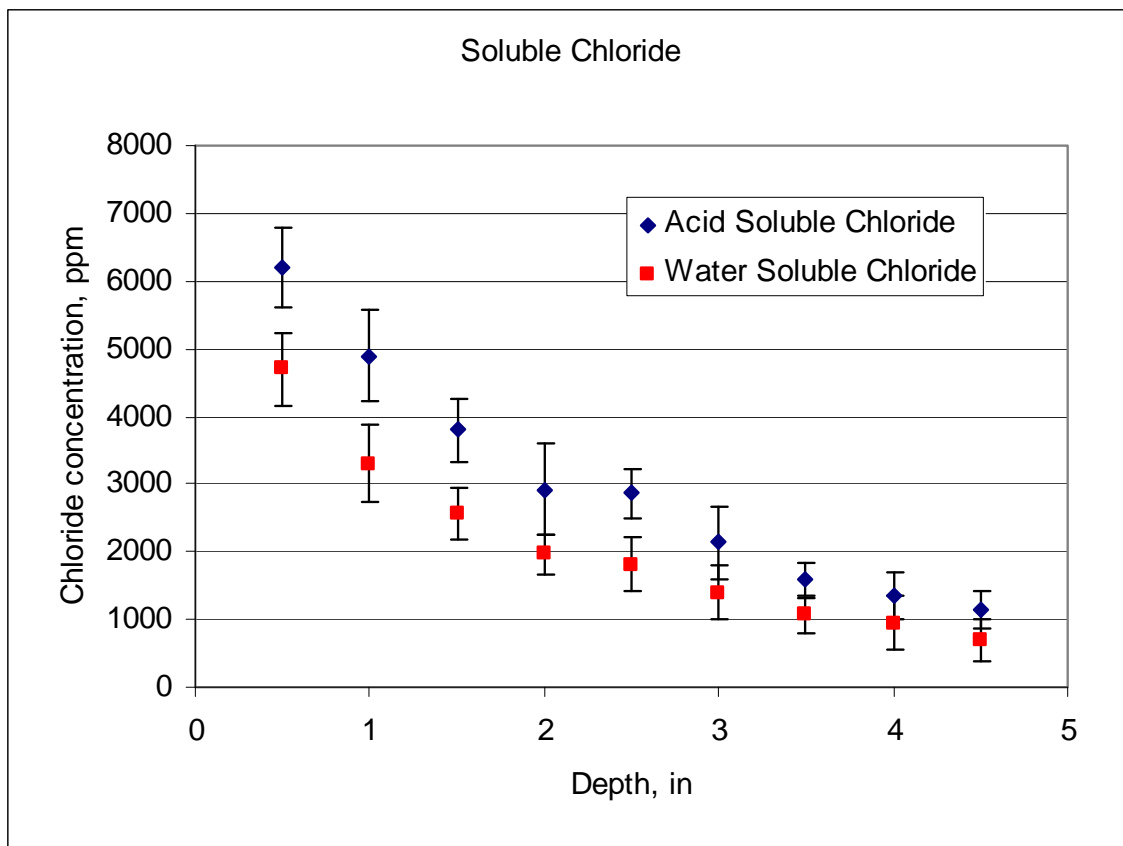
Unfortunately, this installation was made on a deck that had been in service for some time, so that there was significant chloride content already present in the deck. Figure 4.1 shows the pre-installation water and acid soluble chloride profile for the southbound lanes. The data were subjected to statistical analysis, and plotted as a function of depth for the six samples. The error bars give a 95% confidence level for each depth for each type of analysis. Because both the water and acid soluble data have similar depth dependencies, yet the values for the latter are larger, further comparisons have been limited to the results for acid soluble chloride.

Figure 4.1. Pre-installation chloride concentration variation with depth, southbound lanes. Error bars are at the 95% confidence level for six samples taken at each depth.

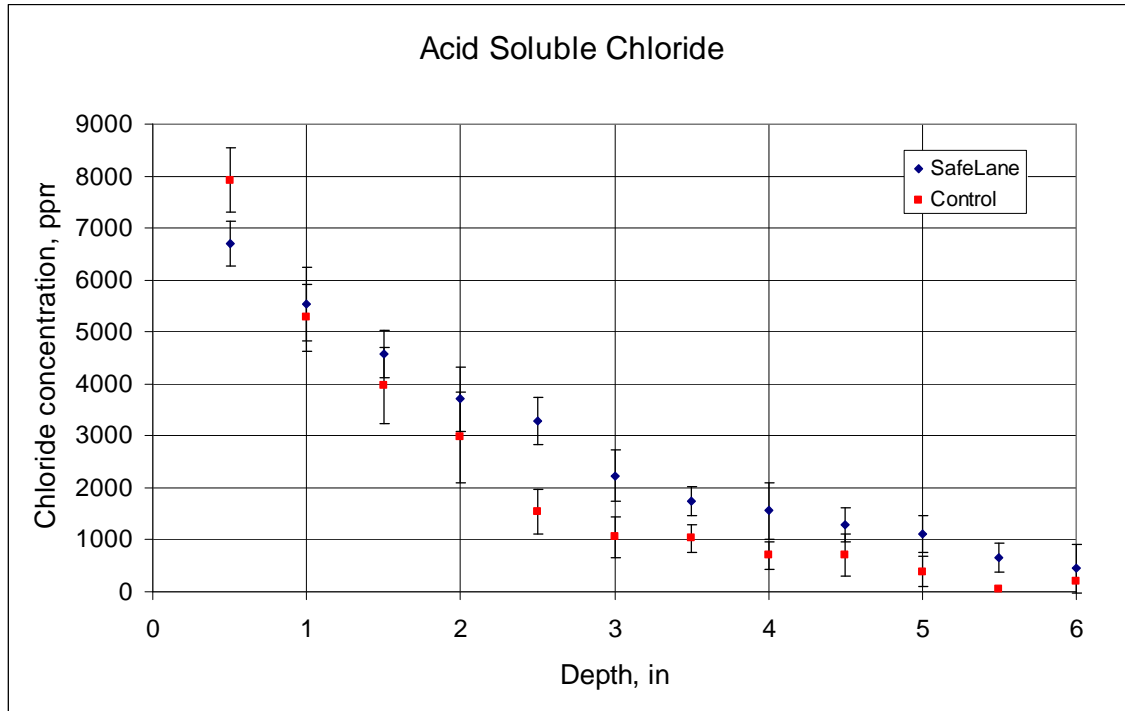
Figure 4.2 compares the acid soluble chloride for the SafeLane™ installation (southbound lanes) to that from the northbound control lanes (no overlay) for core samples taken two years after installation. Clearly, the SafeLane™ overlay has provided significant protection against chloride intrusion on the southbound decks.

Figure 4.2. Comparison of SafeLane™ (southbound) and control (northbound) lanes for acid soluble chloride content as a function of depth two years after installation (2008). Error bars are at the 95% confidence level for nine samples taken at each depth.

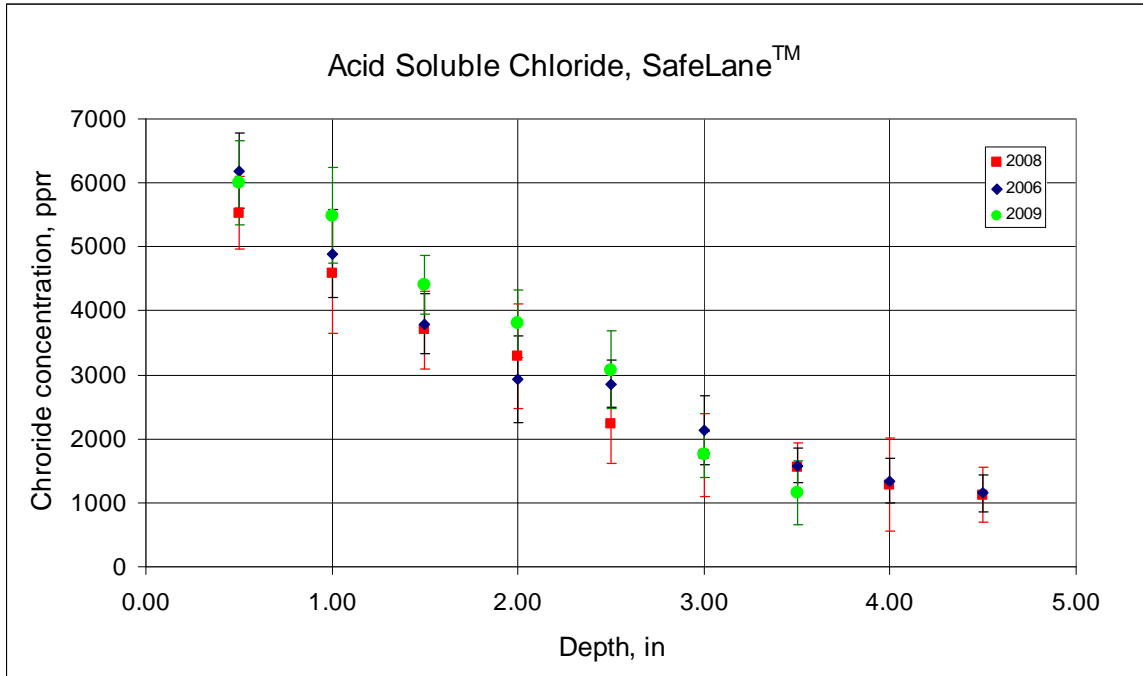
The plot on the following page (Fig. 4.3) shows a comparison of the acid soluble chloride data for pre-installation (2006), after two years of service (2008), and after three years of service life (2009). There are no statistically significant differences between these data sets, further confirming the efficacy of the SafeLane™ overlay from the perspective of its performance as a sealcoat.

Figure 4.3. Comparison of pre-installation (2006) and post-installation (2008, 2009) chloride concentration profiles. Error bars are at the 95% confidence levels. Data sets ranged in size from three samples to nine samples at each depth.

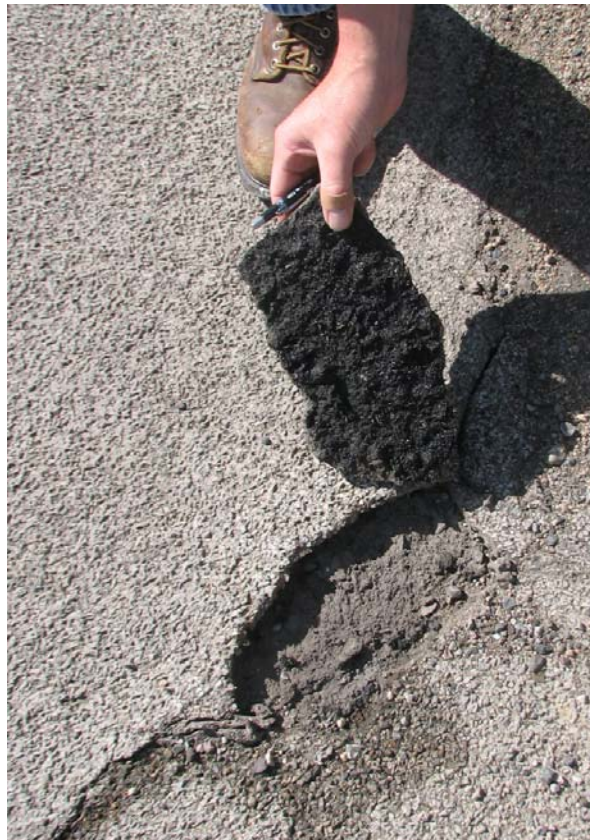
Figure 4.6. De-bonding over an asphalt repair patch.

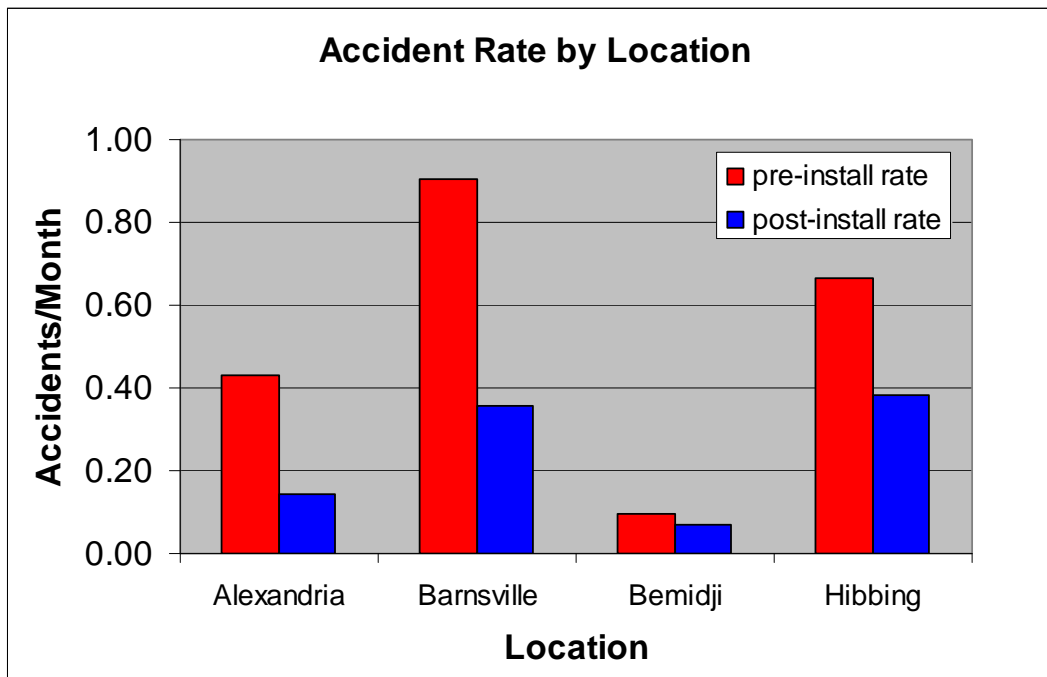
The most important potential benefit from the application of an overlay system such as SafeLane™ is improvement in traffic safety at the installation site. Improvement in traction can result from the presence of rougher edges of the exposed aggregate imbedded in the sealcoat, and/or the retention of deicing chemicals within the regions between aggregate particles. Indeed, for the Hibbing installation, during the first winter season following installation no accidents were reported, compared to 3, 4 and 7 accidents attributable to poor winter traction during the preceding three winters. By contrast the number of accidents in the uncoated northbound lanes totaled 8 during that same season. The winter accident rate data (1 October – 30 April) for all four installations for the three years preceding installation through the 2008-9 season are tabulated in Appendix B. In general, for all sites, the *winter accident rate decreased* following the installation of the SafeLane™ as summarized in the following figure.

Figure 7.1. Summary of accident rate data by location. Year specific data provided in Appendix B.
