Relationship Between Timber Bridge Characteristics and Asphalt Pavement Wear Surface Performance

SUMMARY

Minnesota Local Road
Research Board

June 1997

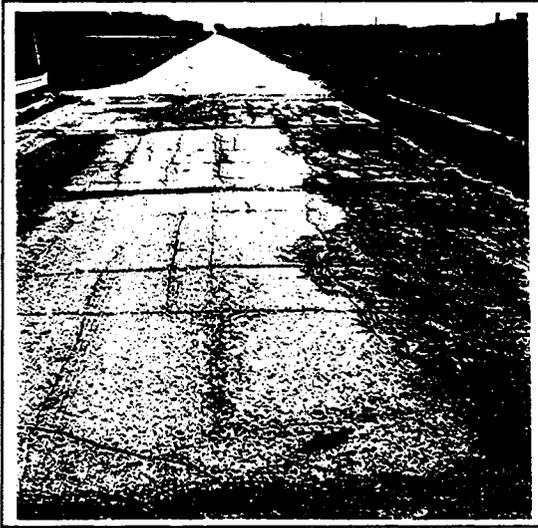
Both asphalt cracking and fatigue can occur as a result of differential lamination movement and loss of transverse load transfer capability. For example, severe longitudinal pavement cracking can be seen in the pavement overlay covering a Minnesota LNL bridge due to both of these factors (Figure 4).

Figure 4 - Longitudinal and Transverse Pavement Cracking on a Field Laminated LNL Deck

Transverse pavement cracks over the pier-caps and abutment-caps are about the most common form of pavement cracking observed in timber bridge wear surfaces (Figure 4). Both bridge deflection and differential movement between laminations over the abutment caps and pier caps will focus stress in the asphalt overlay producing a well defined transverse pavement crack.

- 1) Tightening of all bolts connecting the TSB to the bridge deck, and adding lock nuts.
- 2) Hammering wood shims into the remaining gaps between deck laminations and the TSB (Figure 6). The shims should be made from a species at least as dense

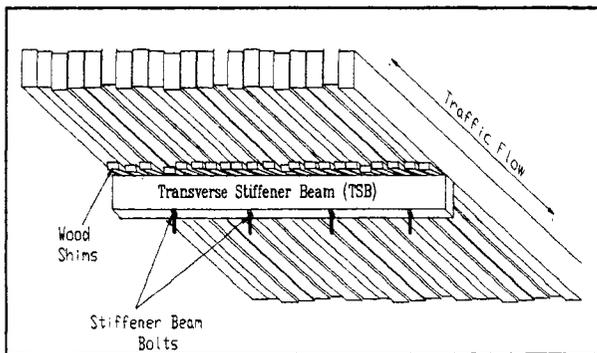
Figure 6 - Placement of Shims Between the Deck and the Transverse Stiffener Beam

A simple maintenance procedure, developed in Sibley County for restoring transverse load transfer in LNL bridges, has effectively demonstrated the reduction in cracking parallel to deck laminations. The procedure involves two simple steps:

as Douglas fir, white oak is a good alternative.

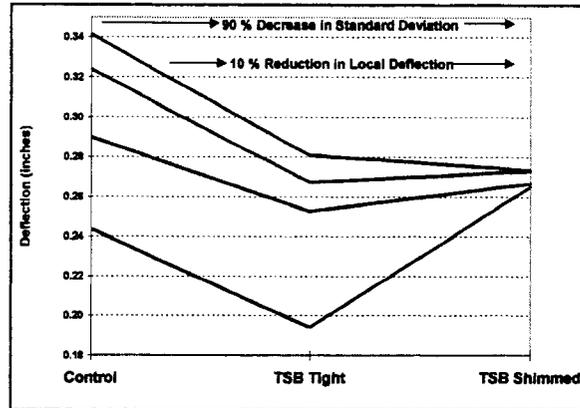
This procedure was recently implemented and analyzed on several LNL timber bridges in Freeborn County. The experiment involved recording inter-lamination deflection on four consecutive lamination before and after tightening and shimming the TSB. The standard deviation of inter-lamination deflection decreased by 90%, and the mean local deflection was reduced by 10% (Figure 7). These results help to explain the improved performance of asphalt wear surfaces on timber bridges in Sibley County where all LNL bridges have had TSBs tightened and shimmed.

Figure 7 - Decrease of Inter-Lamination Deflection After Tightening and Shimming the TSB

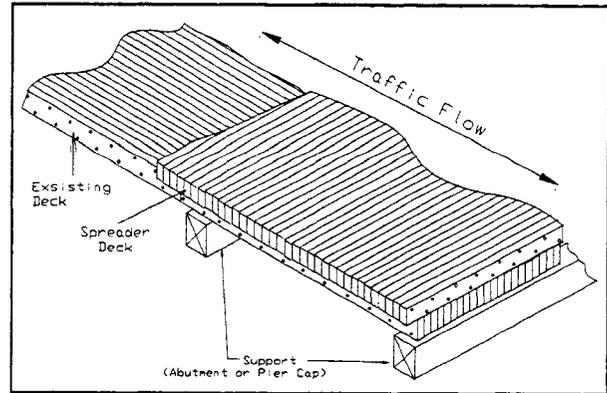
Figure 9 - Retrofit Deck Rehabilitation of Longitudinal Superstructure Timber Bridge Decks

Deck rehabilitation is also an option for improving the bridge load transfer capability and/or widening an existing bridge to meet new road width specifications [5]. Installation of a retrofit nail-laminated deck over the existing deck is an option worth considering for accomplishing both of these needs (Figure 9).
