Final Report 1998-07

Relationship Between Timber Bridge Characteristics and Asphalt Pavement Wear Surface Performance

Minnesota Local Road
Research Board

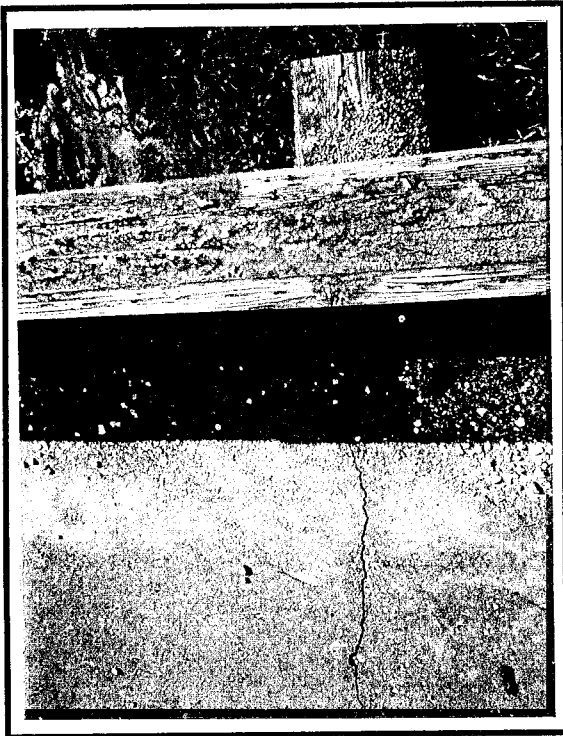
Pavement distress patterns which appeared to be common among all longitudinal timber bridge decks include transverse cracks directly over all deck supports and longitudinal cracks along the traffic lanes. Transverse pavement cracks commonly align themselves with the center of

bridge pier-cap supports, as seen in this overhead view (Figure 2.2), notice the pier cap support extends past the edge of the bridge deck and the pavement crack has formed nearly on center with the cap. Also, transverse cracks appear at end of the decks over the abutment-cap support (Figure 2.3). An exception to transverse crack

Figure 2.2 Transverse Pavement Crack Over Pier Cap Deck Support

- 1) Stiffen the timber deck by tightening the bolts along the length of the transverse stiffener beam and adding wood shims to take-up space between the deck and the stiffener beam [Gene Isackson, P.E., Sibley County](described further in chapter 3.5d). This practice should help the transverse stiffener beam to better disperse loads laterally across the bridge deck, and therefore decrease both local deck deflection and independent movement between deck lamina. By stiffening the timber deck, asphalt pavement crack initiation and/or propagation may be minimized because the magnitude of stress applied to the pavement at a given location would be reduced. This method is currently being practiced in Sibley County, Minnesota, and is to be tested elsewhere for its effectiveness.

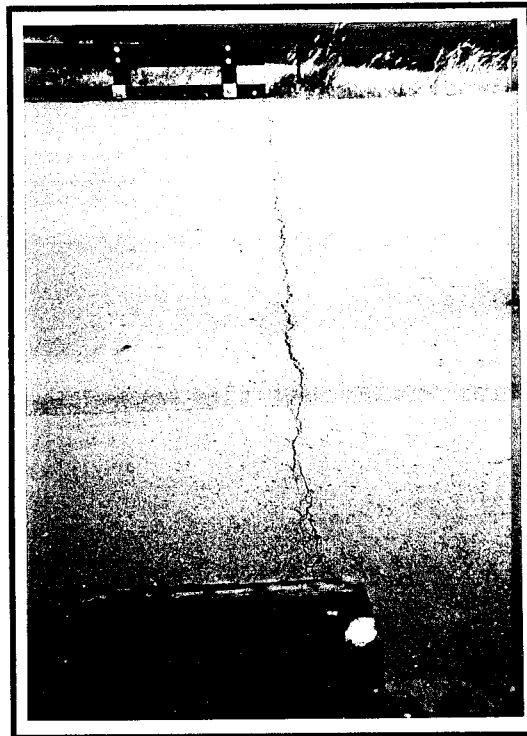
Figure 2.3 Transverse Pavement Crack Over Deck Abutment Cap Support

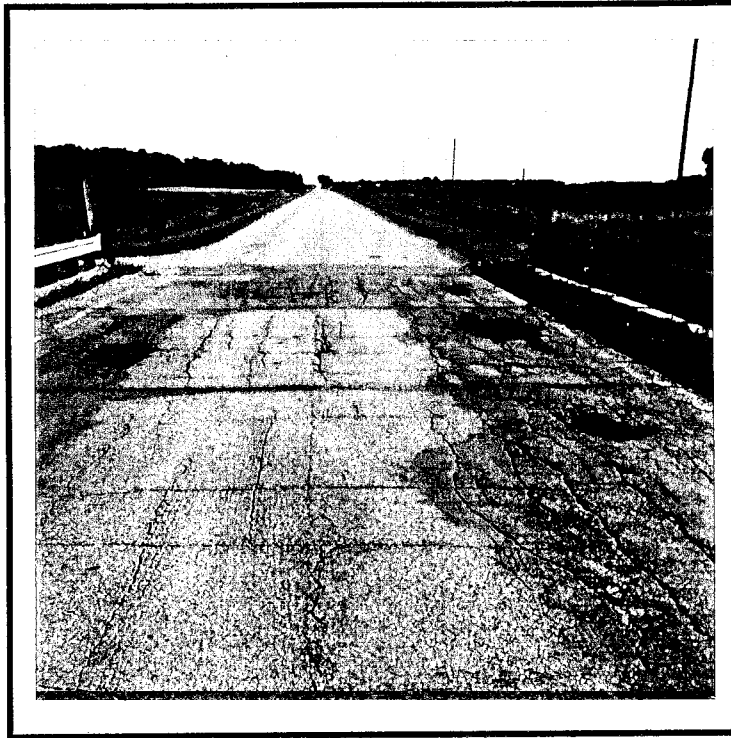
location of was observed on a rehabilitated LNL bridge with a transverse nail-laminated retro-fit deck, in this instance the transverse cracks were observed half way between the abutment caps and pier caps; in other words at mid-span. Beam (stringer) TNL bridges also had transverse cracks located over the abutment caps and other random transverse cracks across the bridge decks, possibly above deck panel joints. On longitudinal decks, longitudinal pavement cracks were observed both above panel joints and along gaps between the deck laminations, except on the SL

deck (Figure 2.4).

Figure 2.4 Longitudinal Pavement Crack

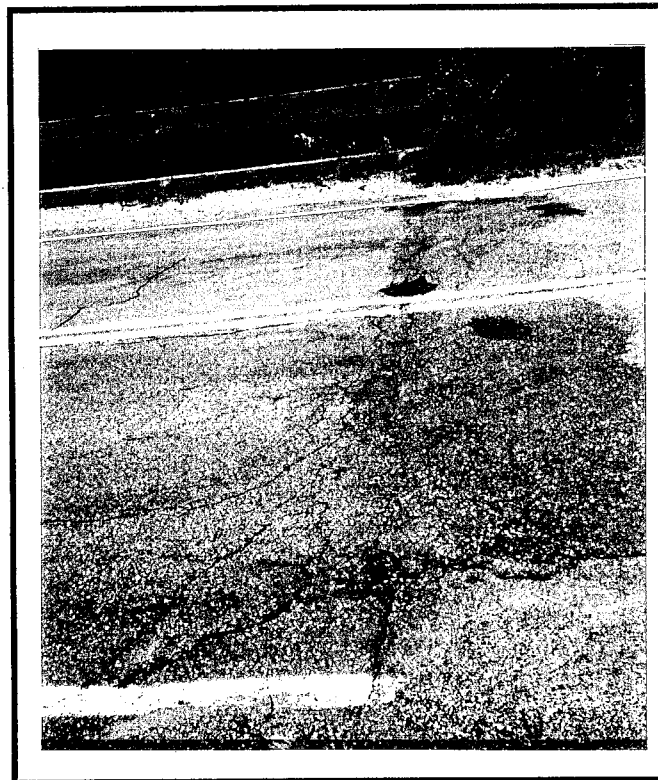
Asphalt fatigue including “alligator” cracking, asphalt de-bonding and pavement raveling was observed in various locations across the timber decks. The worst cases of fatigue seemed to be in proximity to existing transverse and longitudinal pavement cracks (Figure 2.5 and 2.6). While the mechanical nature of the timber deck was determined to be largely responsible for initial transverse and longitudinal pavement crack formation due to independent movement among deck panels and laminations [Ken Johnson, P.E., Wheeler Consolidated, Inc. and Gene Isakson, P.E., Sibley County, MN], the severe pavement distress surrounding these cracks is likely a result of the pavement mix design rather than bridge deck performance. According to Dr. David Newcomb [Associate Professor, Department of Civil Engineering, University of Minnesota], asphalt deterioration is commonly influenced by the presence of excessive pavement voids due to improper pavement mix design or inadequate compaction. Proper asphalt compaction on timber bridge decks is difficult because only small compactors can be used. Excessive percent pavement voids can affect pavement durability through both diminished asphalt adhesion to the aggregates and increased pavement susceptibility to moisture damage. Dr. Newcomb attributes pavement voids to insufficient quantities of asphalt binder presence in the mix and improper pavement compaction. New pavement design specifications incorporate higher quantities of asphalt and higher compaction standards, when these design requirements are followed much of the asphalt fatigue should be effectively reduced. Also the sever cracking observed in **Figure 2.4** may be attributed to poor asphalt adhesion due to inadequate tack coat application on the deck prior to paving (John Isackson, Mn/DOT Road Research). Under conditions of poor adhesion the asphalt may move free from the deck which may allow excessive cracking during deck deflection.

Figure 2.5 Asphalt Fatigue and Transverse Cracking

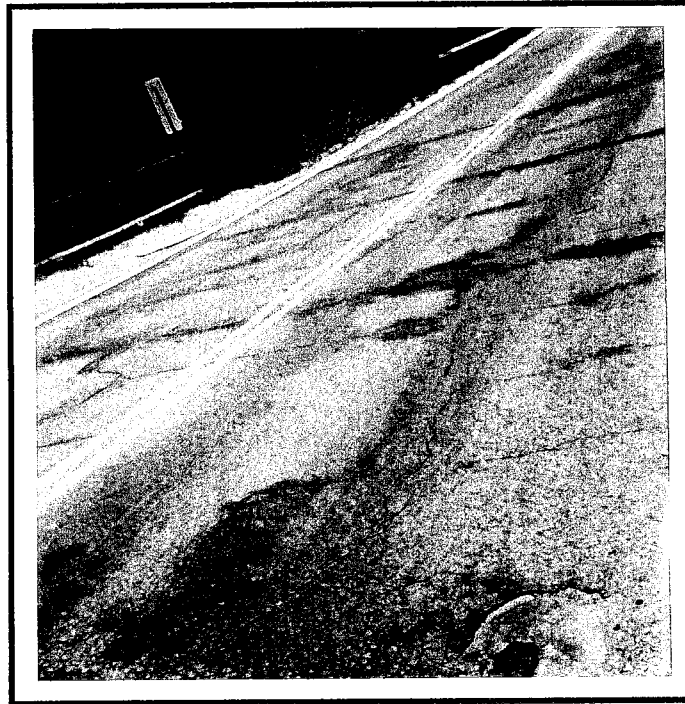
Figure 2.6 Asphalt Fatigue and De-Bonding interactions.

Wood preservatives used to treat timber bridge components were also identified as a possible threat to asphalt pavement performance because they may dissolve asphalt. Creosote, the primary preservative used for treating bridge components, is coal tar distillate derived entirely from the tar produced by the carbonization of bituminous coal [6], and is a solvent of asphalt [Minnesota Asphalt Association and Koch Materials Company]. The only viable alternative, pentachlorophenol an oil-borne preservative, incorporates diesel fuel which is also a solvent of asphalt. After bridge installation these preservatives may extrude out of the timber deck and soften the asphalt pavement overlay. As a result, the asphalt pavement overlays have been observed to easily de-bond from the bridge deck surface.
