Scour Monitoring Technology Implementation

Jeff Marr, Principal Investigator
St. Anthony Falls Laboratory
University of Minnesota

September 2014

Research Project
Final Report 2014-37

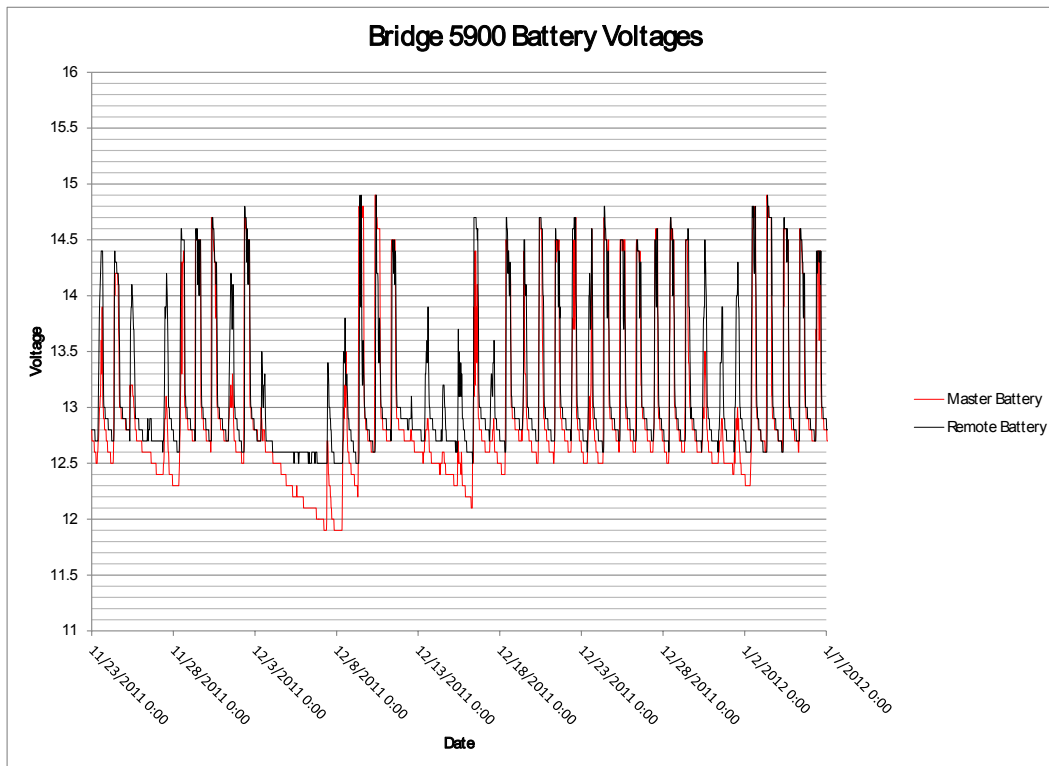
Figure 41: Bridge 5900 Voltage

The gap in reported voltage shown in Figure 41 is due to a communication error with a Gmail server during the weekly update email. The time of the last reported data was 6:00 AM and the weekly message was due to be sent at 6:25 AM. This communication error caused the program to stall and no data was collected from 3/10 to 3/24. ETI likely restarted the program to remove the error. The portion of the code that sends the email has been removed until the operating system is updated, which according to Campbell Scientific, should resolve the Gmail communication issue.

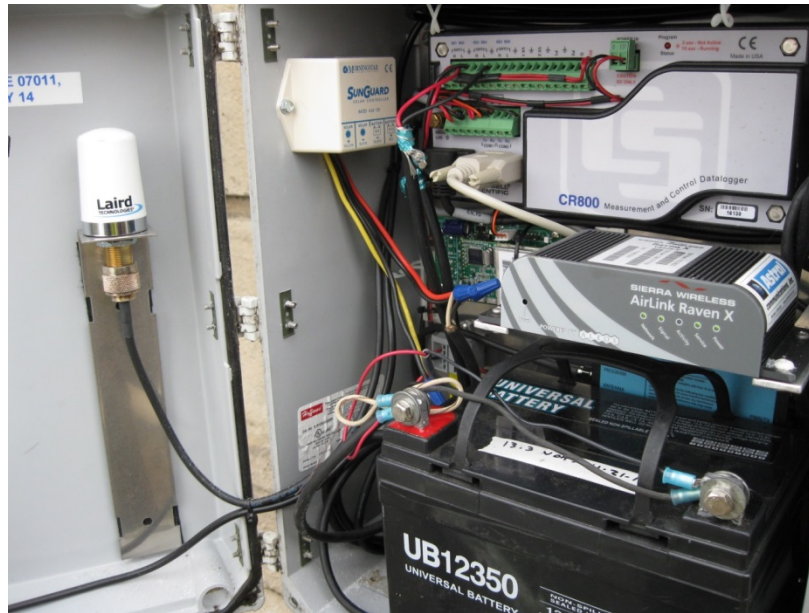
Figure 56: Relocated Solar Regulator
