# Development and Integration of Advanced Timber Bridge Inspection Techniques for NBIS

**January 2015**

Research Project  
Final Report 2015-01

**BRIDGE # 69529  
CSAH 52 over DITCH**

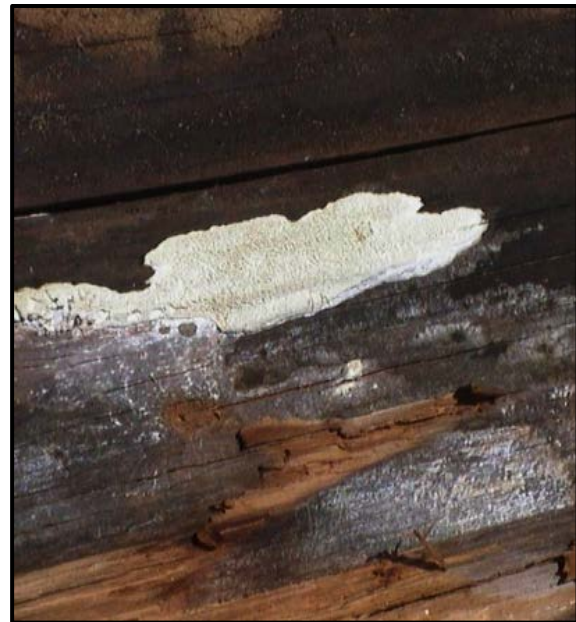
Figure 3.2. Douglas fir bridge member showing visual evidence of a fruiting body on the surface in addition to visual evidence of decayed timber.

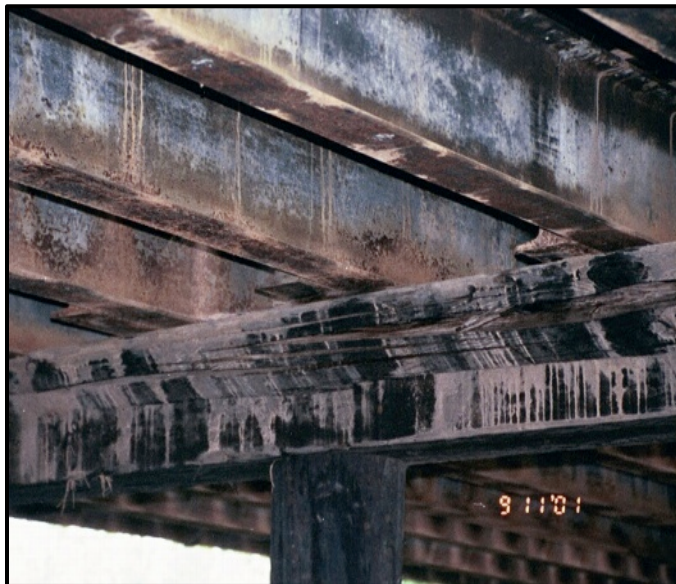
Figure 3.4. Timber abutment cap showing visual evidence of localized failure demonstrated by longitudinal cracking. Photo courtesy of MnDOT.

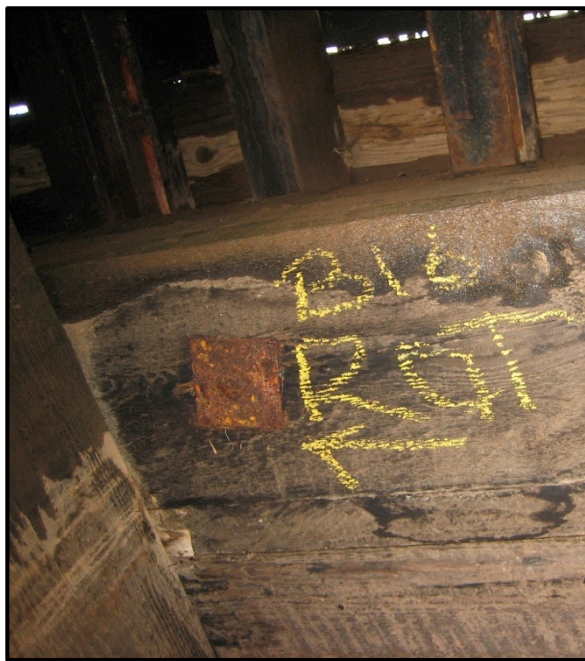
Figure 3.6. The timber members were stained and discolored due to high levels of water. The hardware shows significant corrosion.

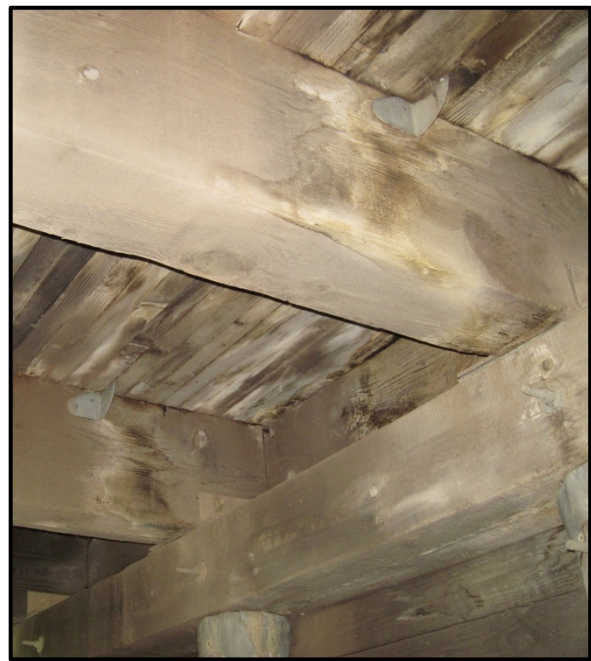
Figure 3.7. Water staining and discoloration caused by water that infiltrated through the bituminous wear layer and nail-laminated deck.

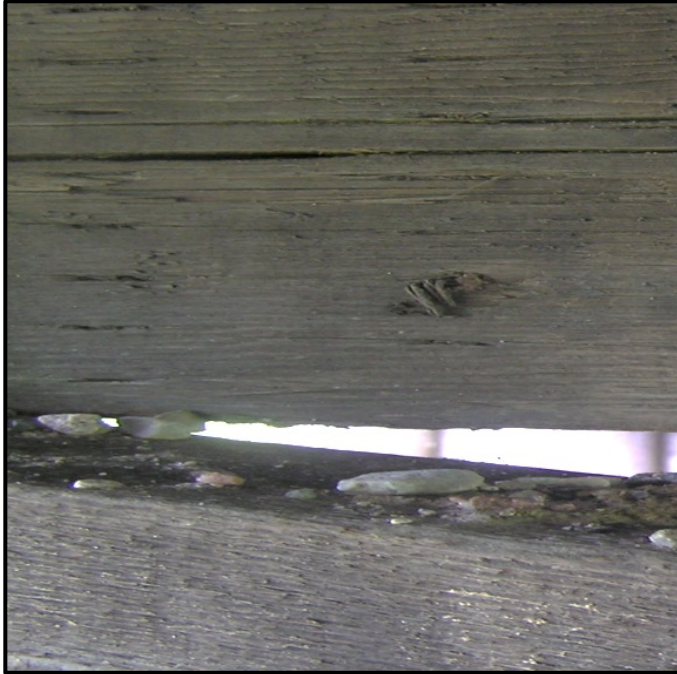
Figure 3.8. A timber abutment cap that has been initially deteriorated by decay. Carpenter ants are nesting in the cap, with frass being deposited onto the cross bracing member.

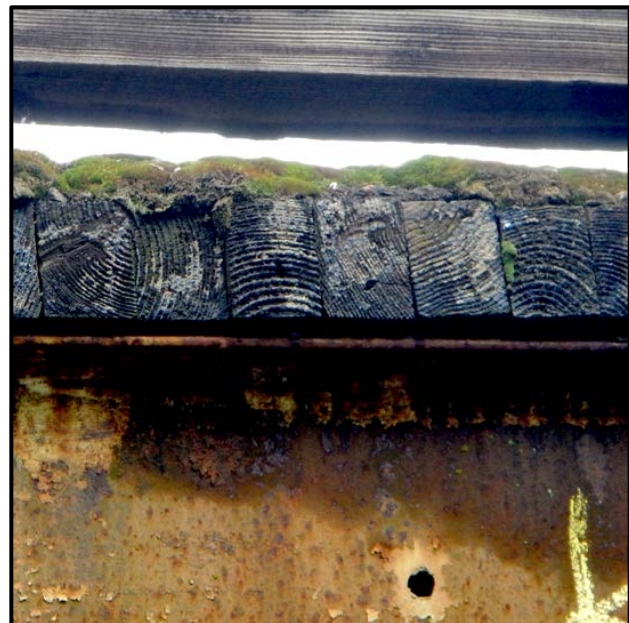
Figure 3.10. Moss growing on the surface of a nail laminated timber deck supported by steel beams along the curb/scupper zone.

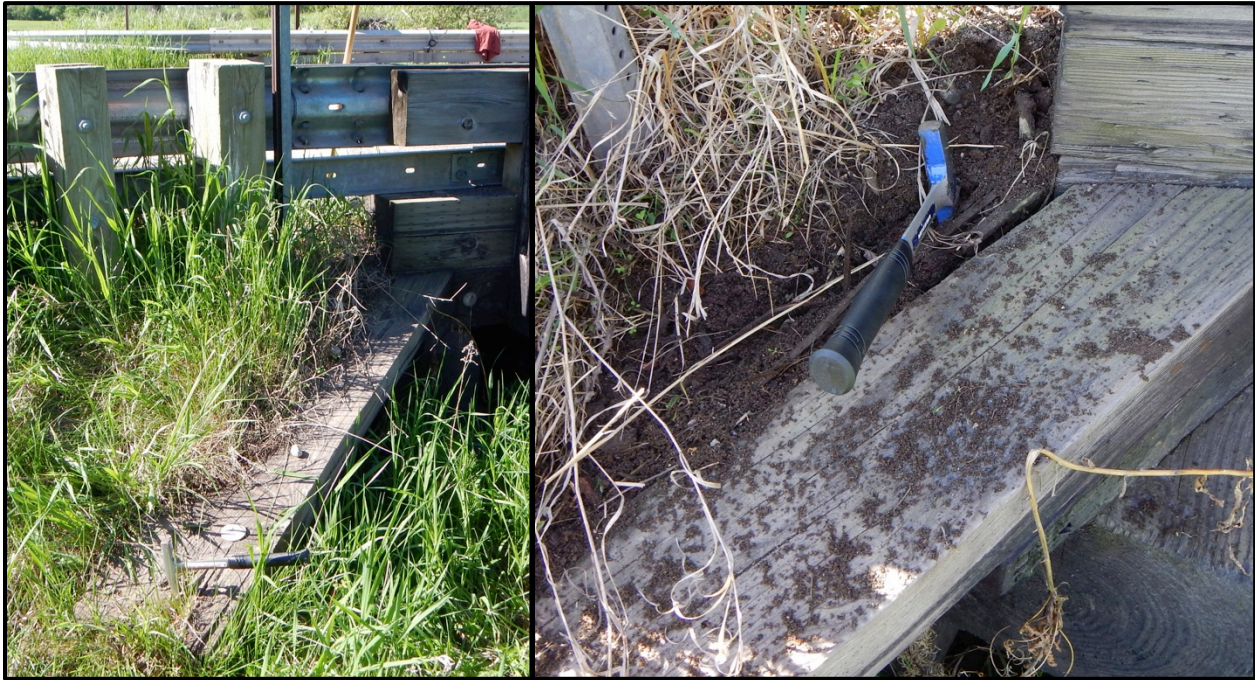
Figure 3.11. A wing wall timber abutment has substantial plant growth on the cap surface. Once removed, visual and probing inspection showed that 75% of the cap cross-section had been severely decayed. This will eventually result in damage to the wing wall pile elements.

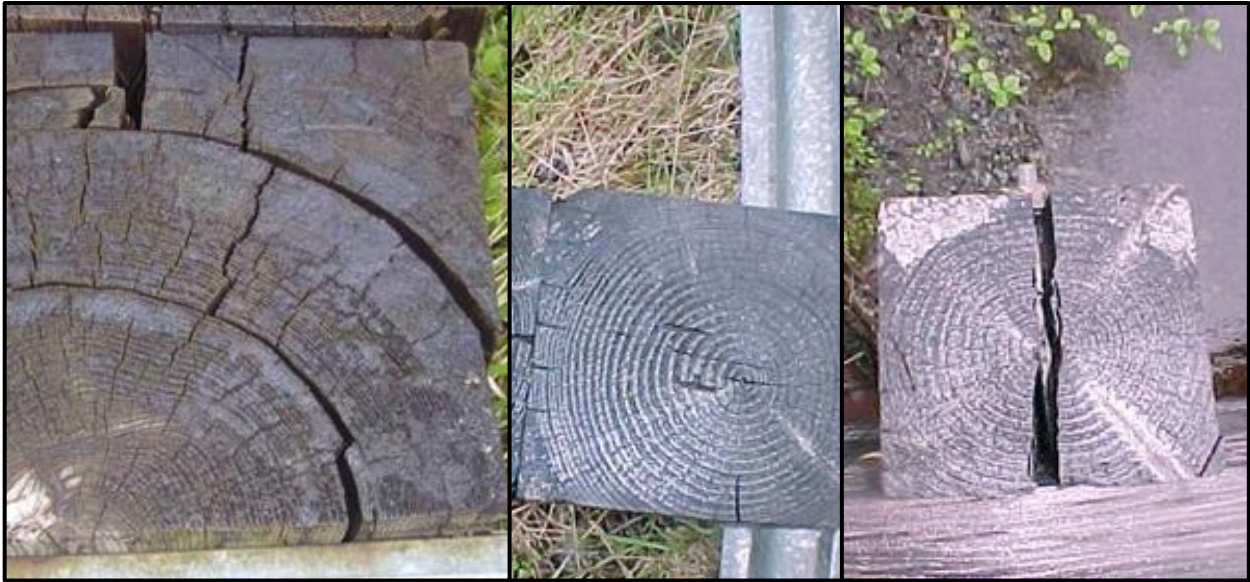
Figure 3.12. Timber railing posts showing various types of deterioration. From left to right, the posts show ring shake, small end checks, and severe through splits.

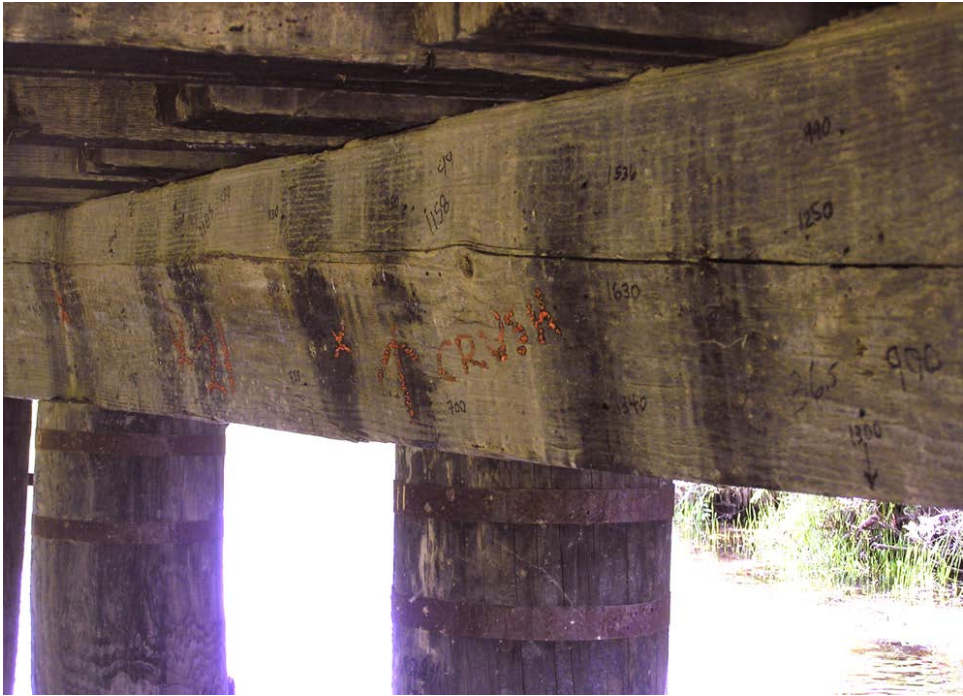
Figure 3.13. A long horizontal split provides an opportunity for moisture passing through the timber deck to enter the abutment cap, leading to substantial decay.

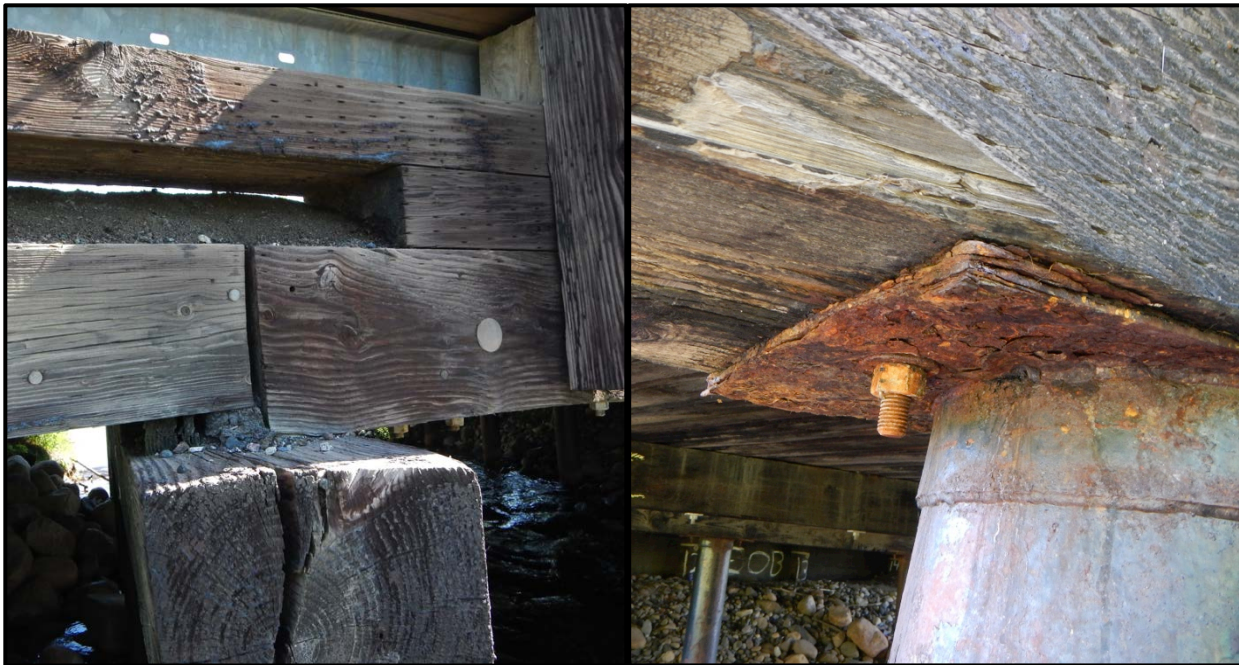
In **Figure 3.14**, a severe through split in an abutment cap provides an opportunity for moisture to absorb into the element, resulting in conditions that allow for potential decay as well as deterioration of the surrounding steel elements such as the CIP bearing plate.

Figure 3.14. Visual assessment of a pier cap split. The split allows moisture from the deck to enter the member beyond the protective layer of preservative treated wood, resulting in increased likelihood of future decay and allows for deterioration of hardware such as the CIP bearing plate that supports this element.

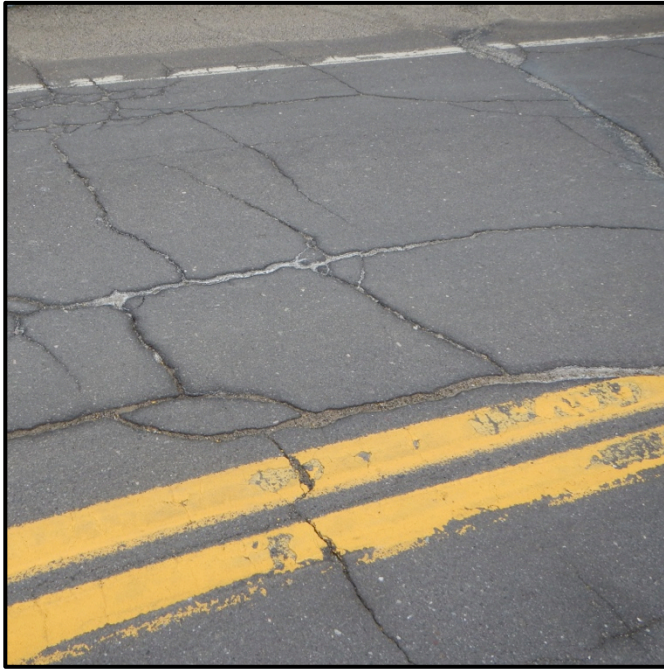
Figure 3.16. Cracking and deterioration of bituminous wear layers create opportunities for water to pond on the deck and seep into the superstructure elements creating decay potential.

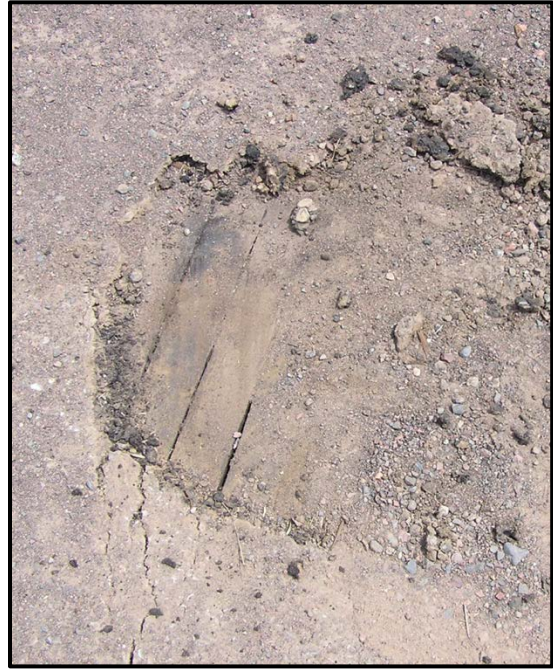
**Figure 3.17** shows an exposed timber deck on the surface of a bridge where the wear layer has been completely removed. This creates an entry point for moisture infiltration into the timber decking, beams, abutments and piers.

Figure 3.17. The bituminous wear layer has deteriorated exposing structural timber decking to moisture and potential deterioration.

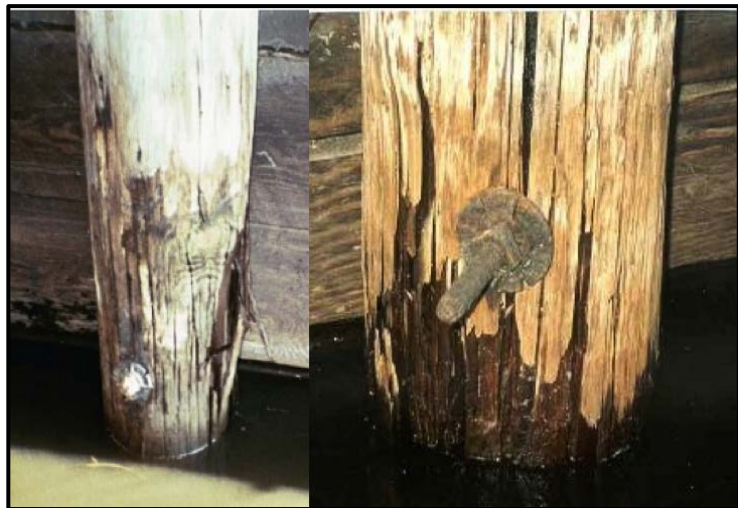
Figure 3.18. Shell damage to timber piling at or near the water line, often caused by freeze thaw cycles, ice damage or flotsam floating down the river.

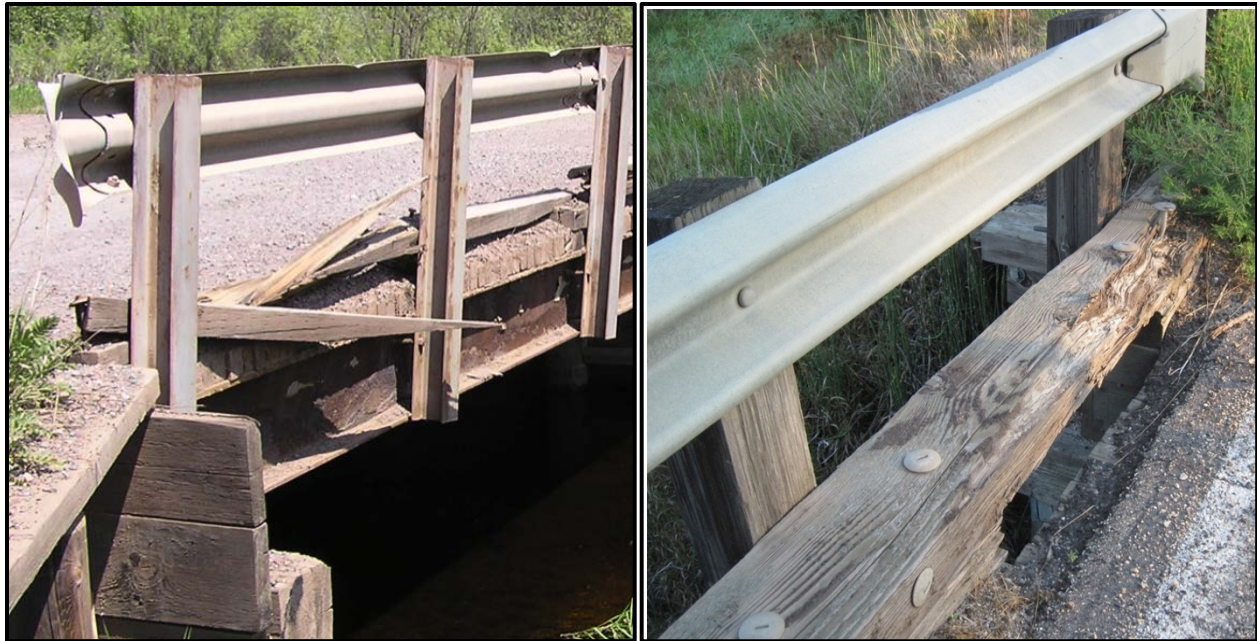
Figure 3.19. The timber curbs shown have significant damage from a snowplow or other vehicle exposing untreated wood to high levels of moisture.

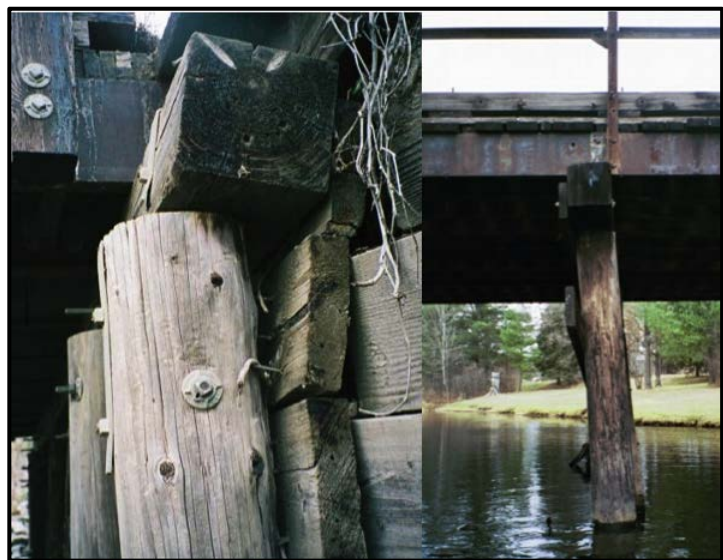
Figure 3.20. Rotation of timber pilings and pile caps in an abutment (left) and timber pier (right).

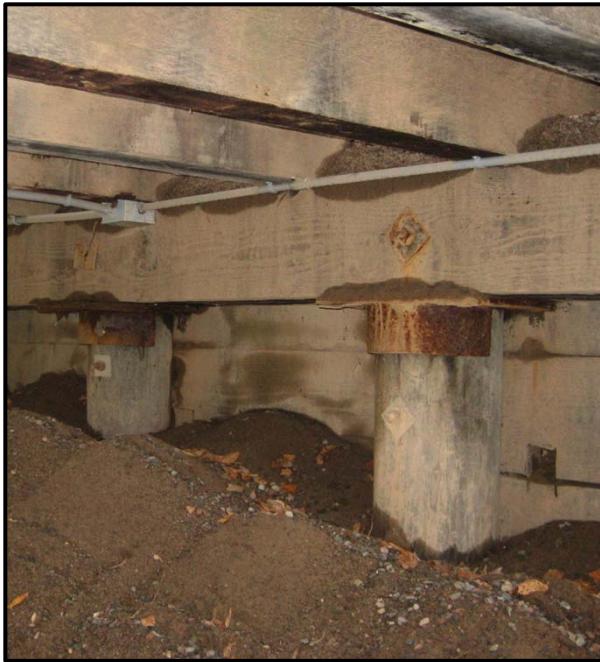
Figure 3.21. Sand and gravel are shown on top of the timber abutment cap as deposited through vehicle traffic or road maintenance through a timber deck.

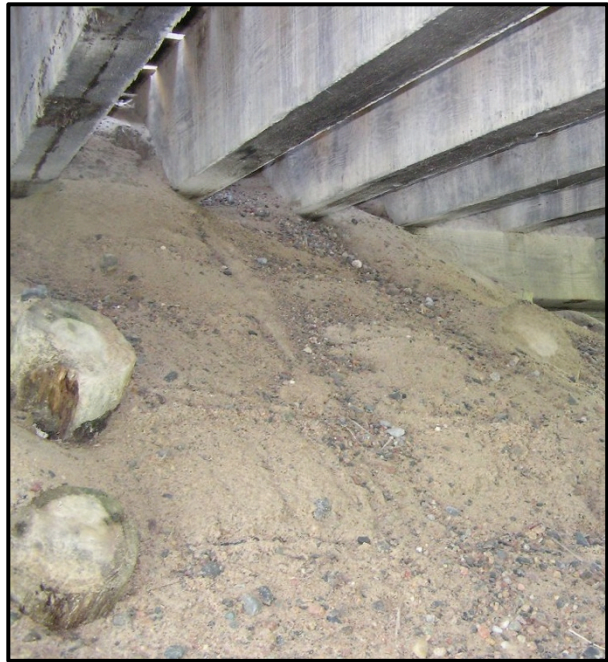
Figure 3.22. Sand and gravel are covering the timber abutment cap and the longitudinal timber beams, holding moisture against these elements.

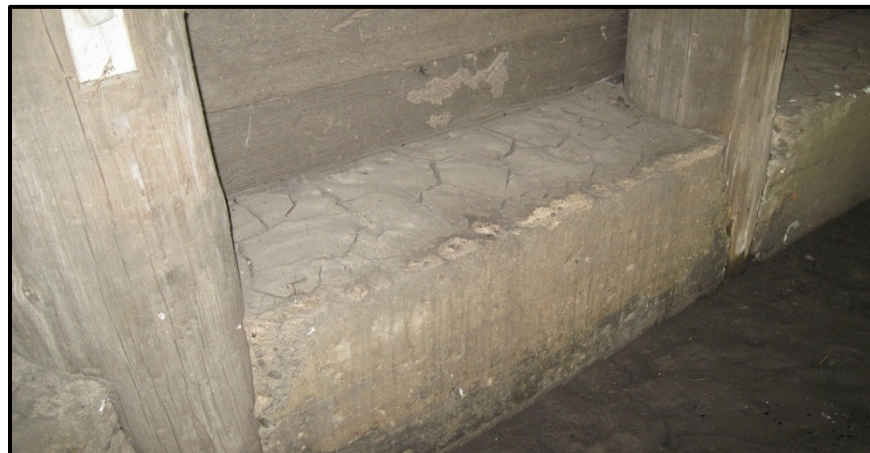
Figure 3.23. Timber piling in direct contact with concrete footing, creating high moisture content conditions.

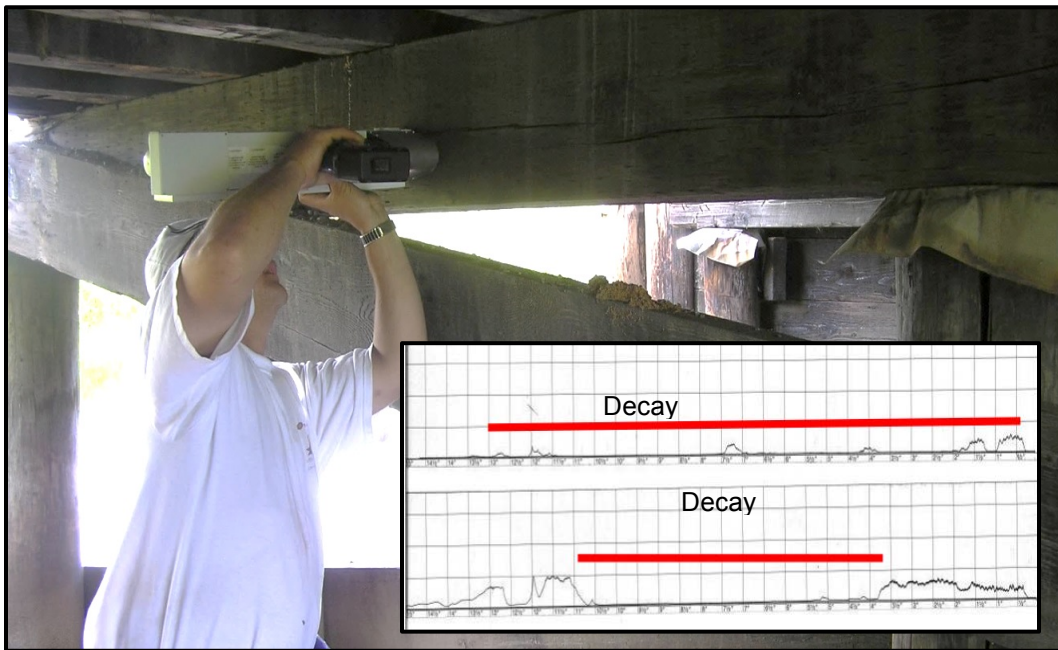
Figure 6.5. Resistance microdrilling showing significant decay in the bridge pile cap. The inlay shows the paper chart readout from a commercial drilling unit.

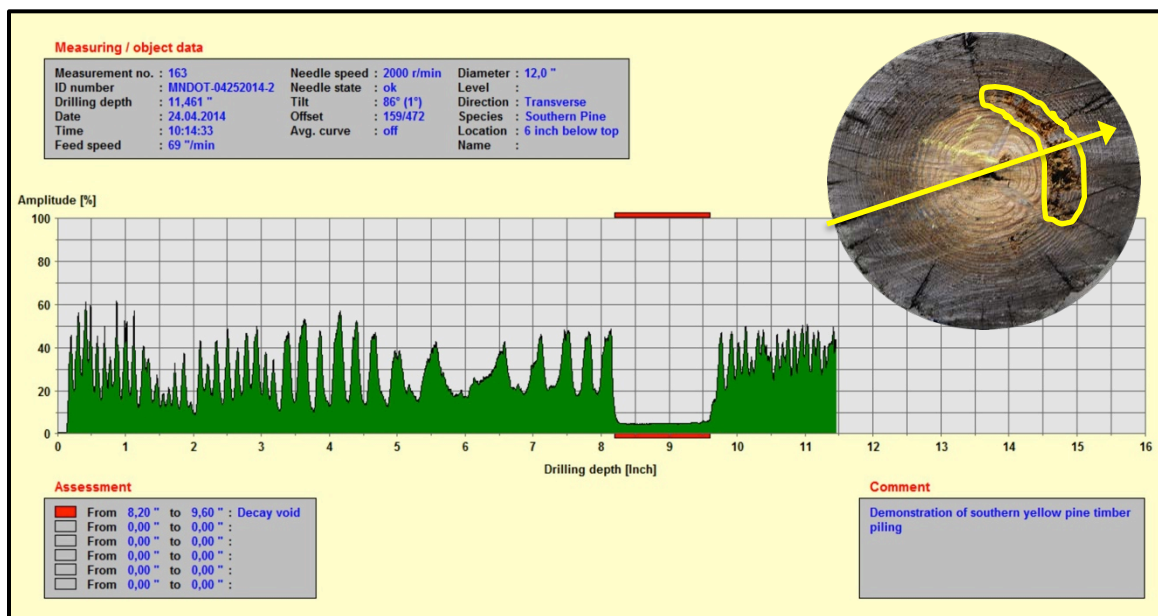
Figure 6.8. Electronic view of a southern yellow pine timber piling showing a decay pocket between 8 and 10 in. of the drilling profile.

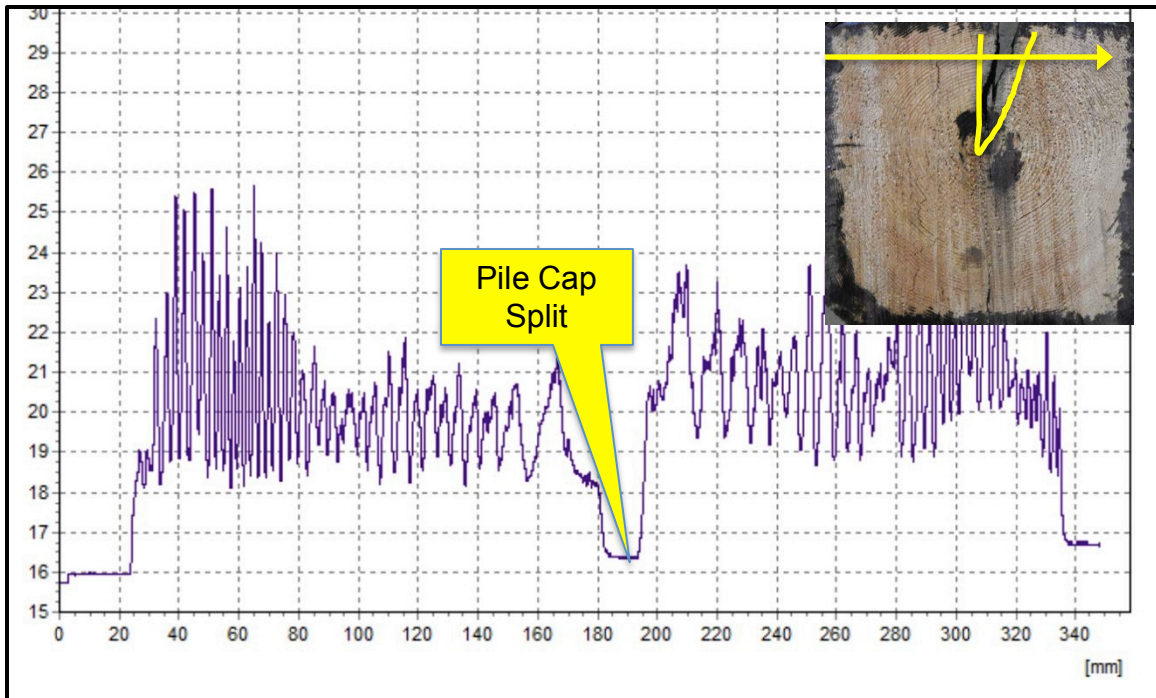
Figure 6.9. Electronic resistance chart of a Douglas fir pile cap showing a large crack between 180 and 200 mm (7.0 and 7.9 in) along the drilling path.

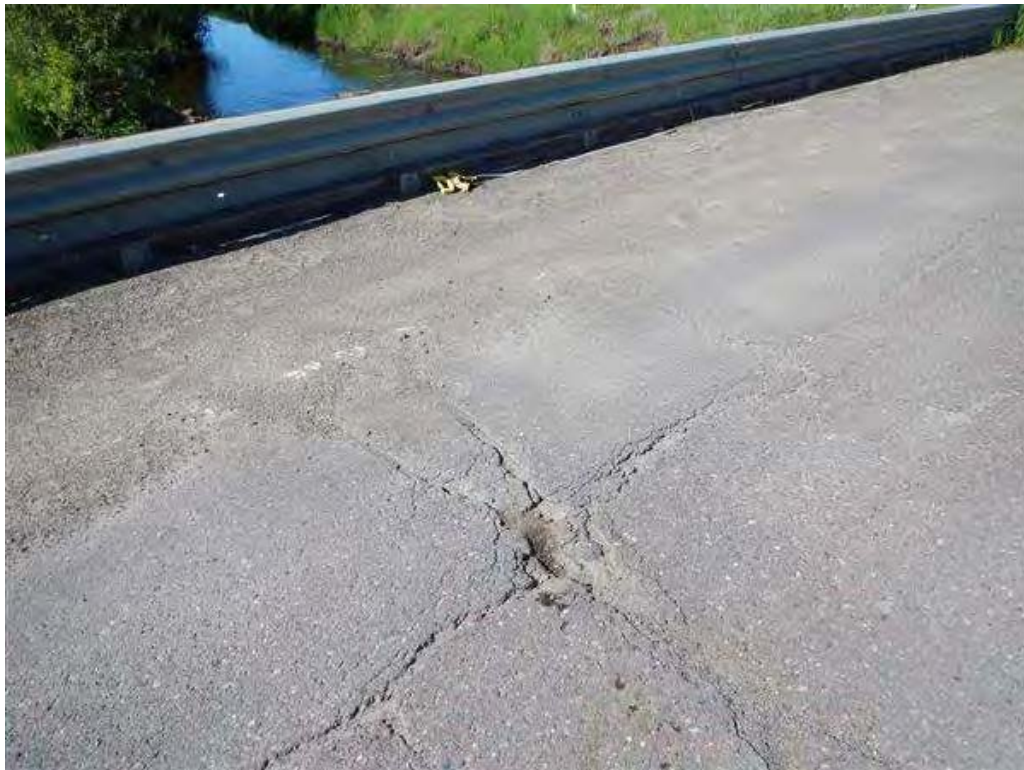
Photo 2 - Deck - Pot hole above Pier 2 with longitudinal cracking

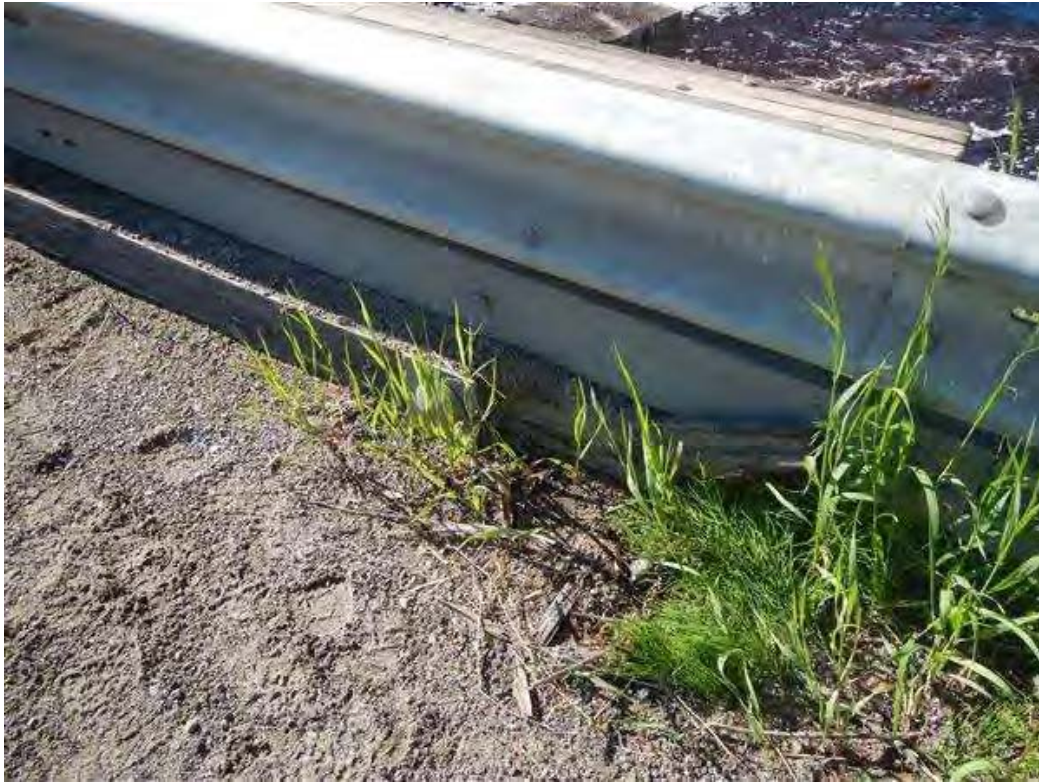
Photo 5 - SW corner of bridge showing vegetation and gravel/sand near curb. Deterioration noted.

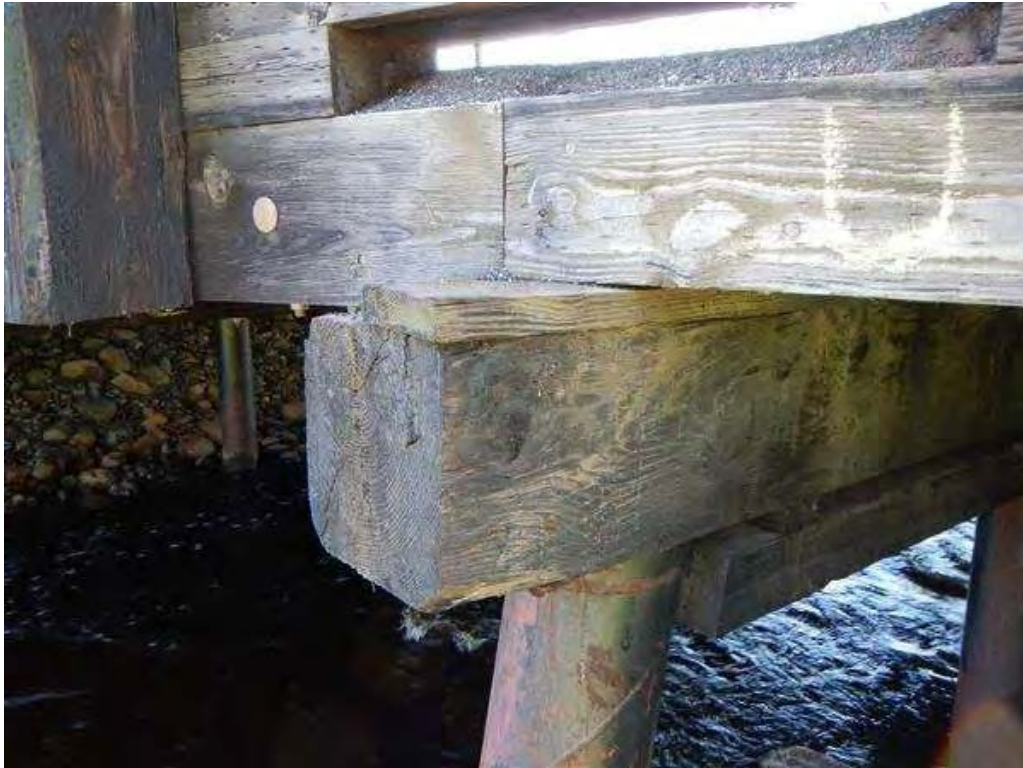
Photo 6 - Pier 1 - North End - Through split extending 80% of full length of cap. SWT over 500 but R drill showed only crack with no decay

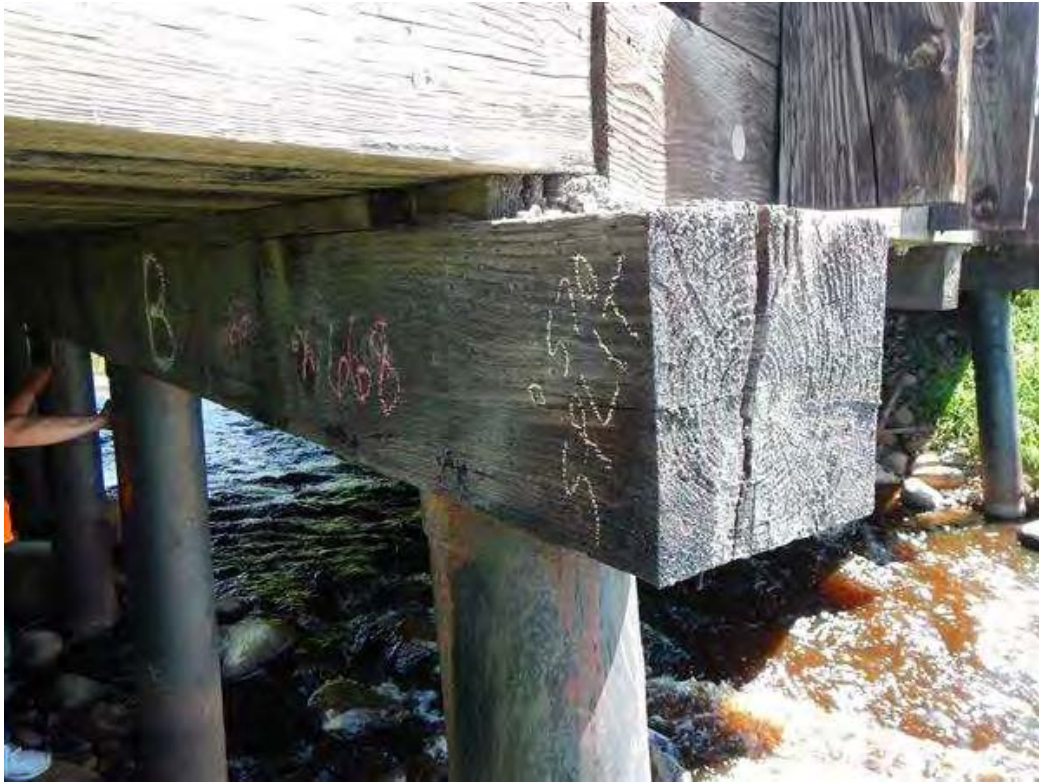
Photo 7 - Pier 1 - South End - Through split extending 36"

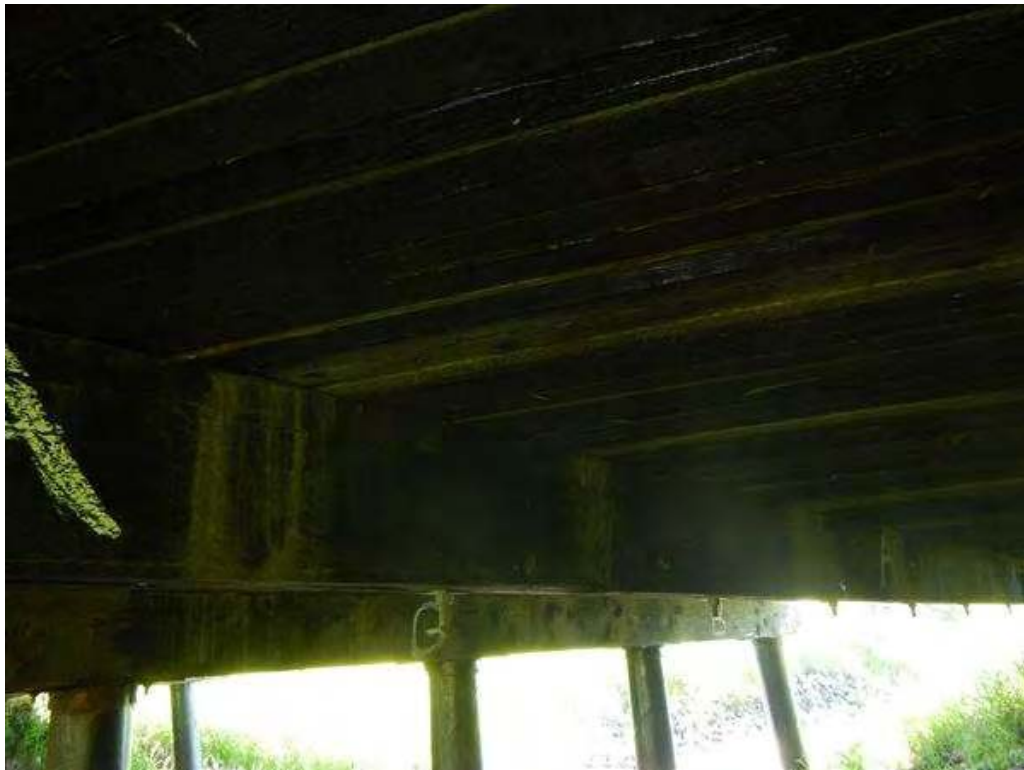
Photo 8 - Span 1 - Moisture pen. through deck.

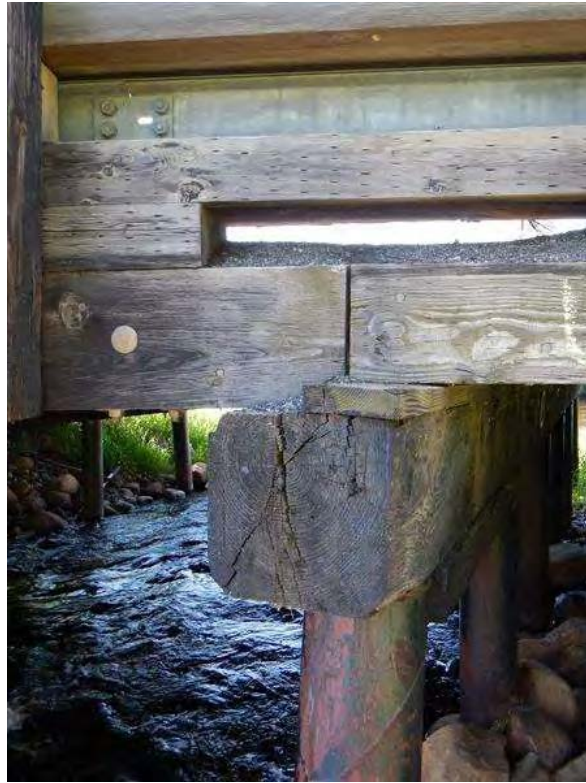
Photo 9 - Pier 2 - South end - Through split continuing 24 inches into cap.

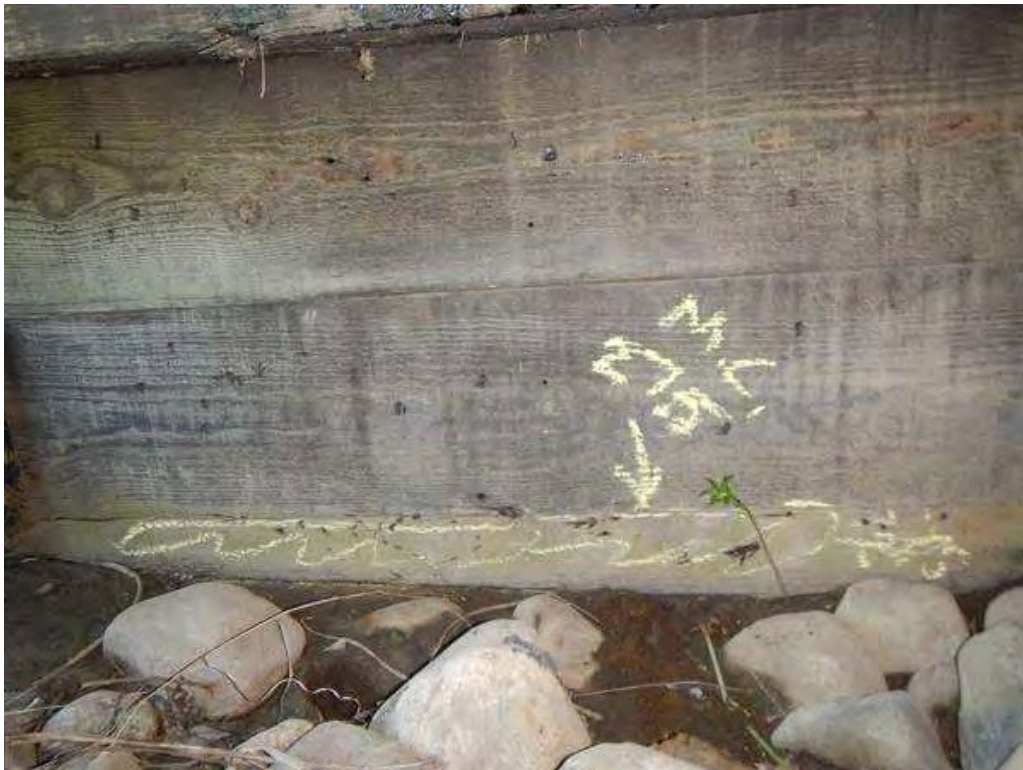
Photo 12 - High moisture abutment wall between piles 8 and 9. Moisture content over >25% but no decay present.

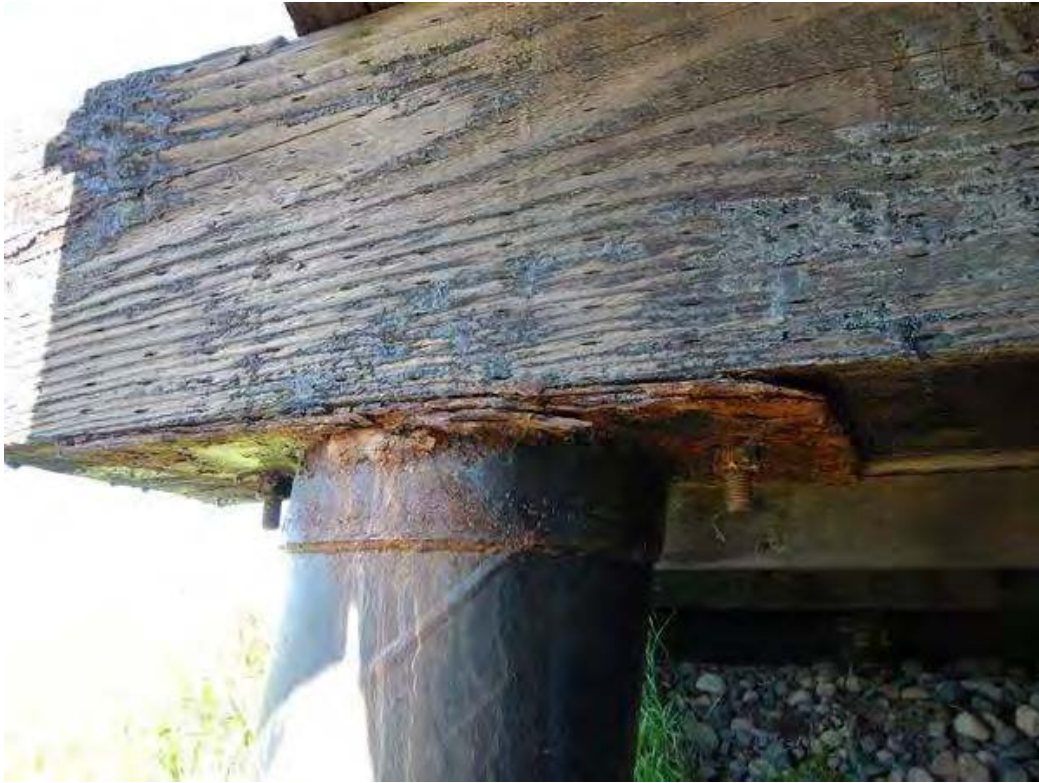
Photo 13 - Pier 1 -CIP cap plate rusting with section loss.

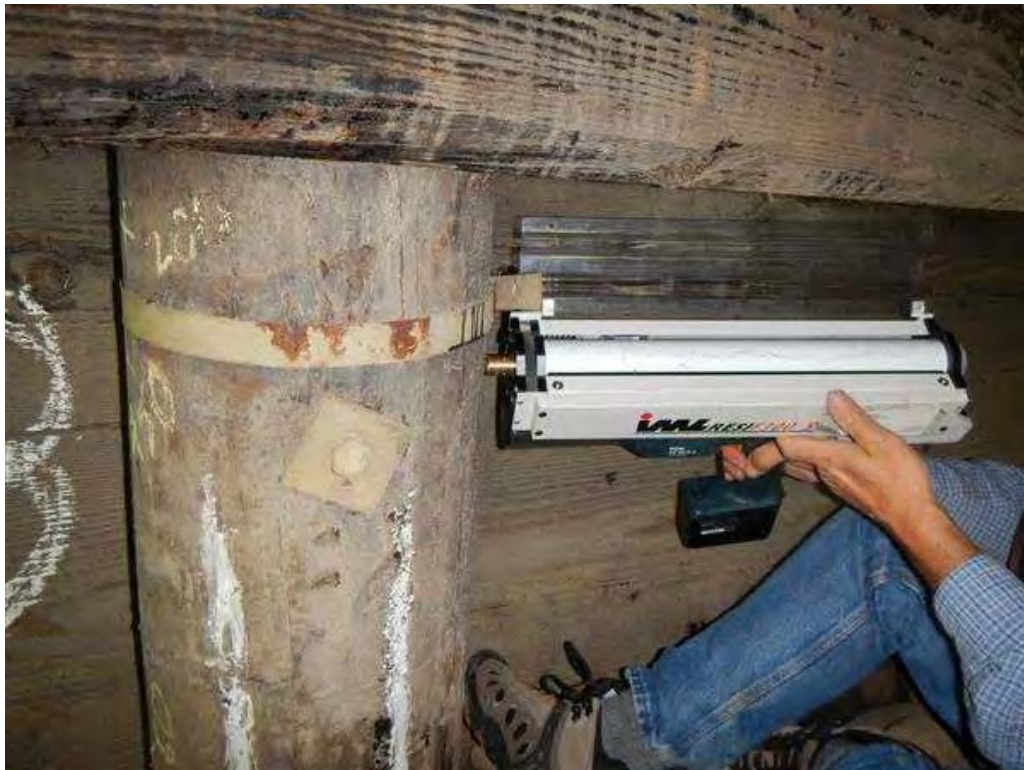
Photo 14 - E abut - Pile 11 - Sound condition

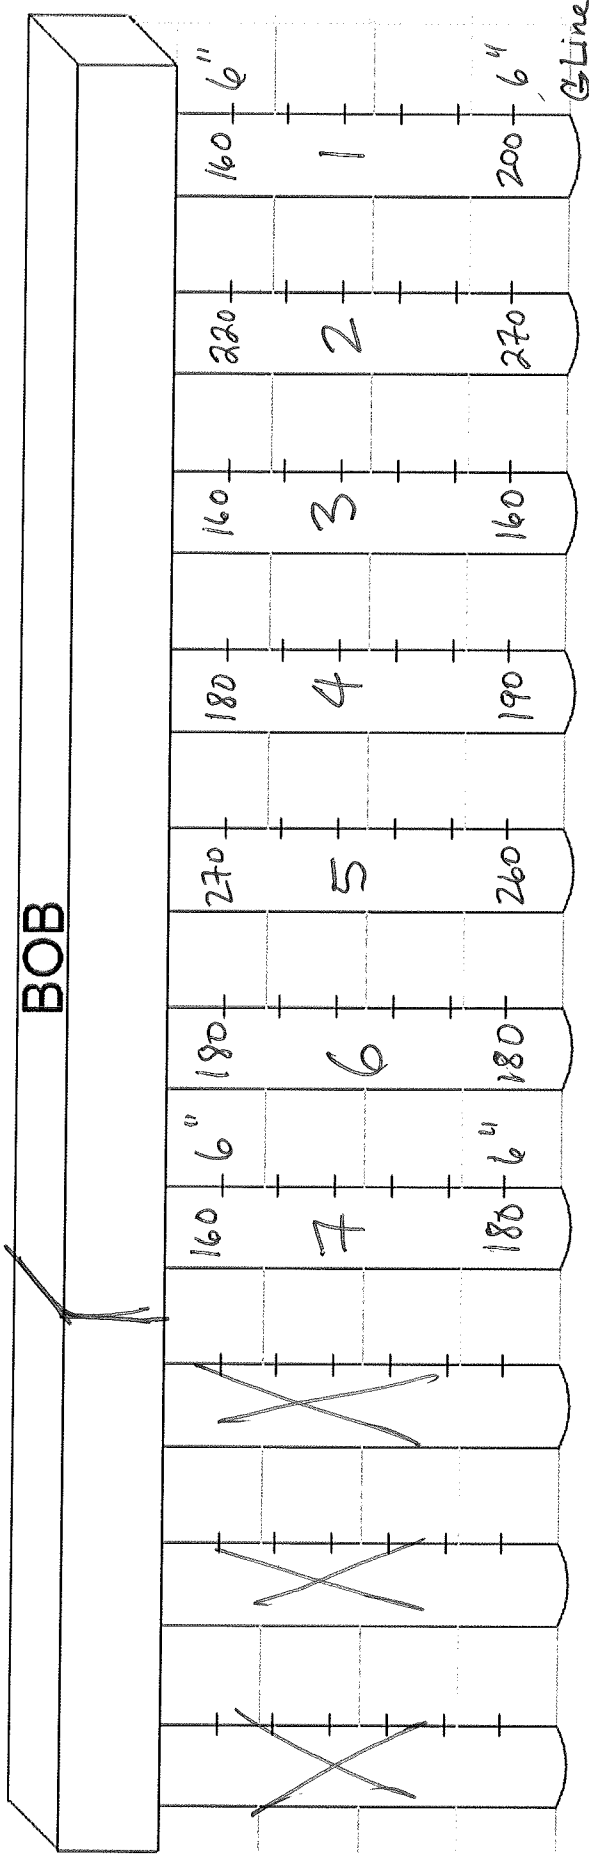
Notes: Timber pilings. Minimal surface checking. Stress wave timer shows good condition on all pilings. Full cross-section sound.

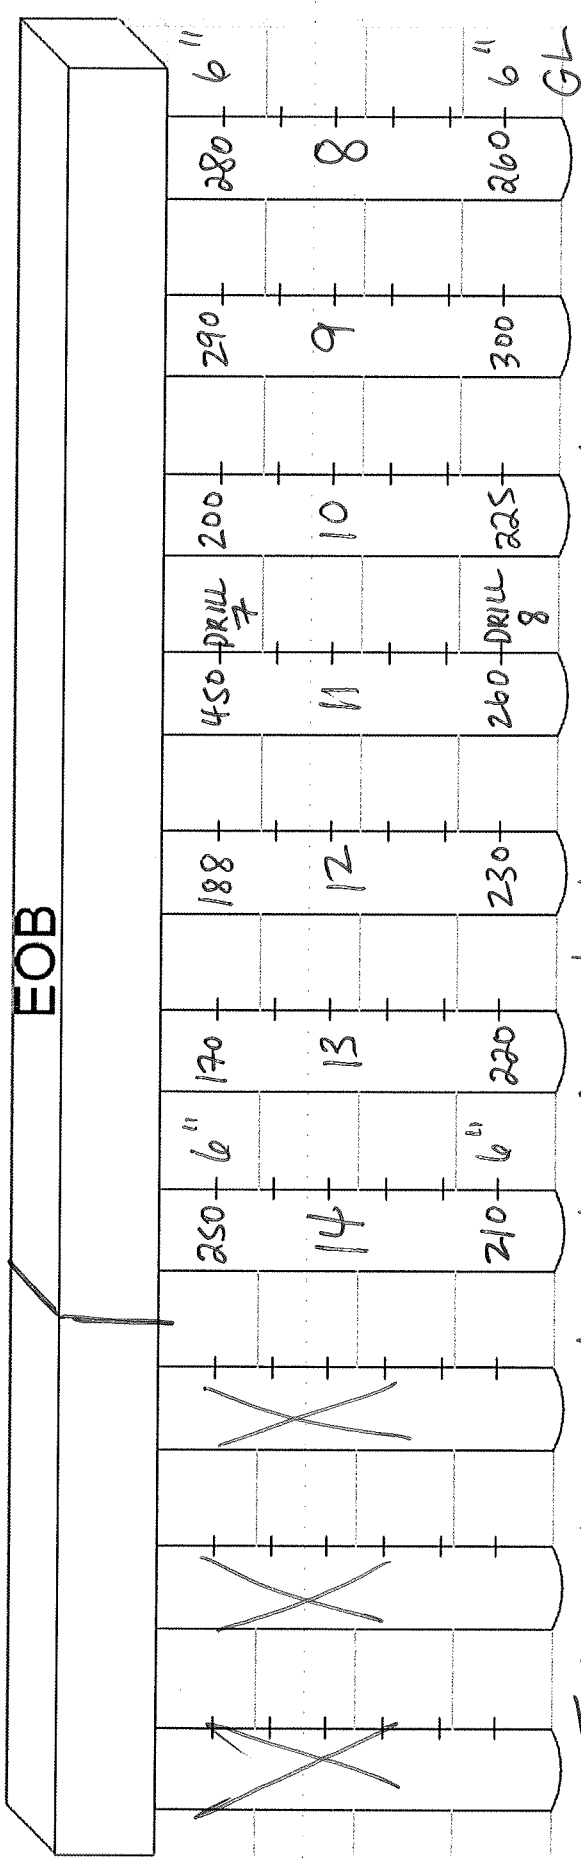
Notes: Timber pilings. Minimal surface checking. Stress wave timer on pile 11 affected by vertical crack/split. Resistance drill @ 460ms on pile 11 showed good condition.

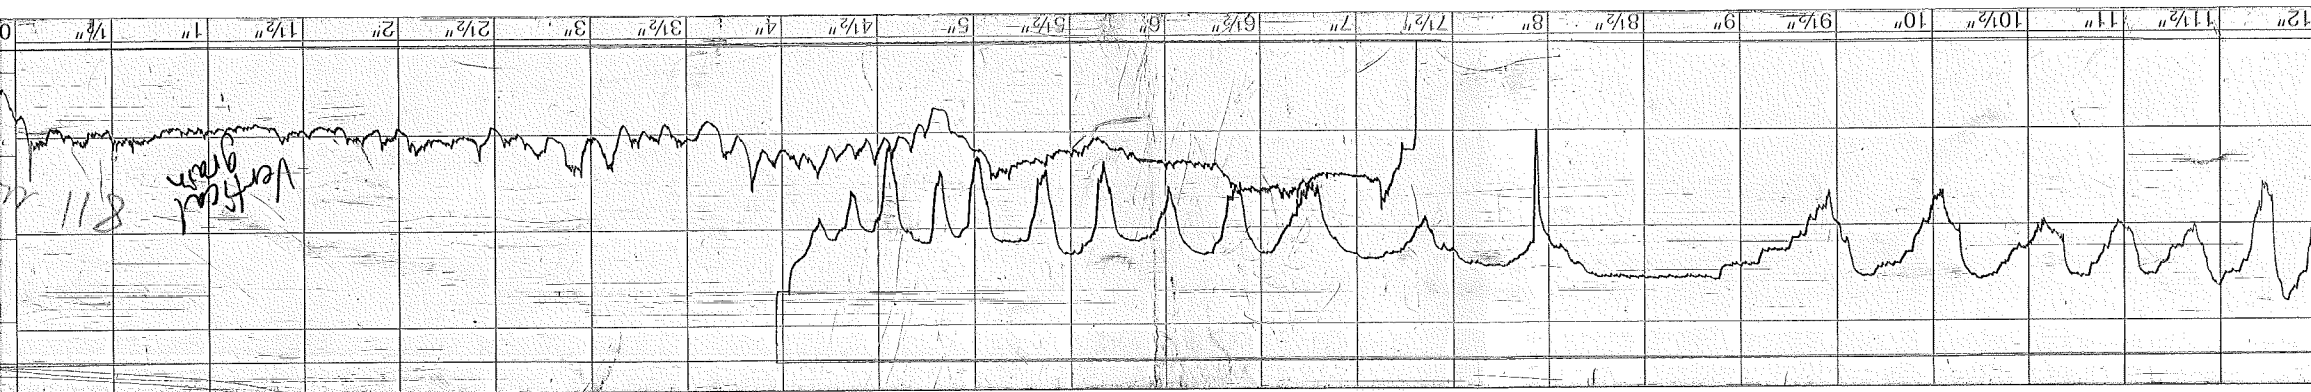
Bridge ~~821-1~~  
 Deck Board  
 5th in from UP (BOB)  
 bounded a bit soft  
 looks OK here w/  
 Drill, Drilled vertical  
 ~ 10 deep beam
