# Development and Integration of Advanced Timber Bridge Inspection Techniques for NBIS

**January 2015**

Research Project  
Final Report 2015-01

**BRIDGE # 69529  
CSAH 52 over DITCH**

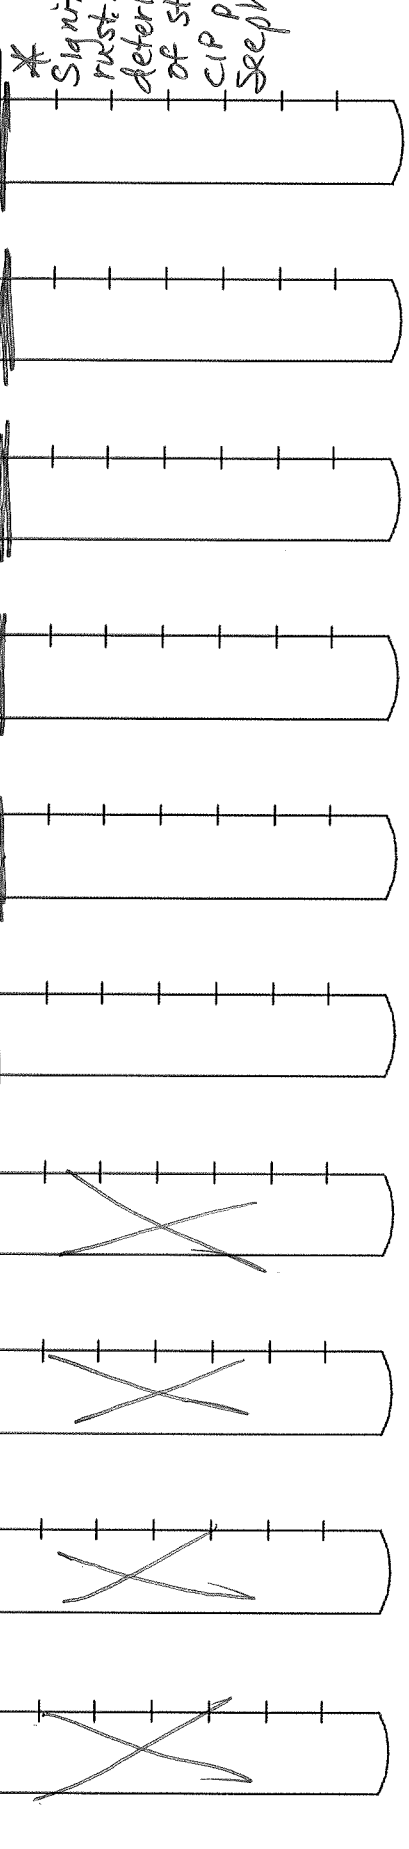
\* Significant rust and deterioration of steel CIP plate. See photos.
