A Comprehensive Evaluation of High Friction Overlay Systems  
on Bridge Decks in Cold Climate Regions

A Thesis

SUBMITTED TO THE FACULTY OF  
UNIVERSITY OF MINNESOTA

Robert D. Kostick

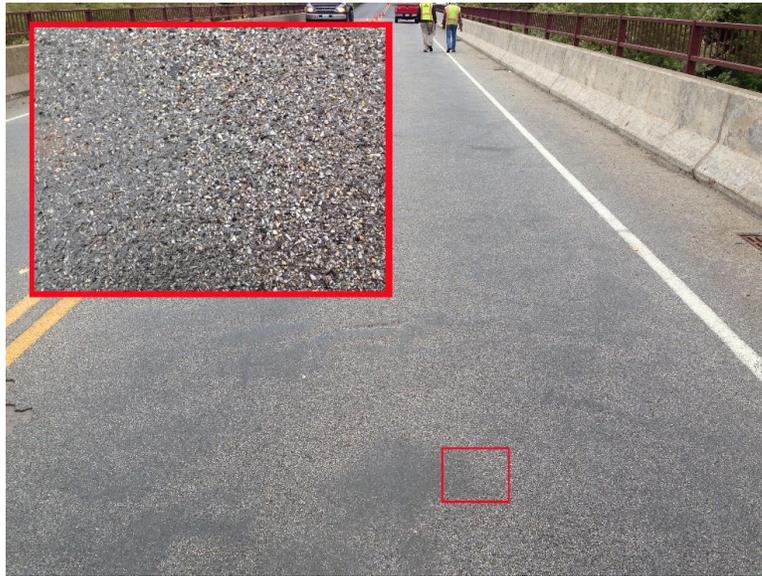
Another type of distress caused by construction is polished areas due to the excessive placement of epoxy. This distress occurred on Bridge 6347 where a significant amount of polished areas existed. Looking along the wheel path in Figure 25, the darker areas are where polished areas exist. The magnified section of this figure provides an example of the difference in texture between a polished (left side) and normal (right side) area. As vehicle traffic and snow plows cause abrasion to the roadway, the aggregates are broken along the plane of the epoxy leaving the polished area.

Figure 25: Polished Areas along Bridge 6347

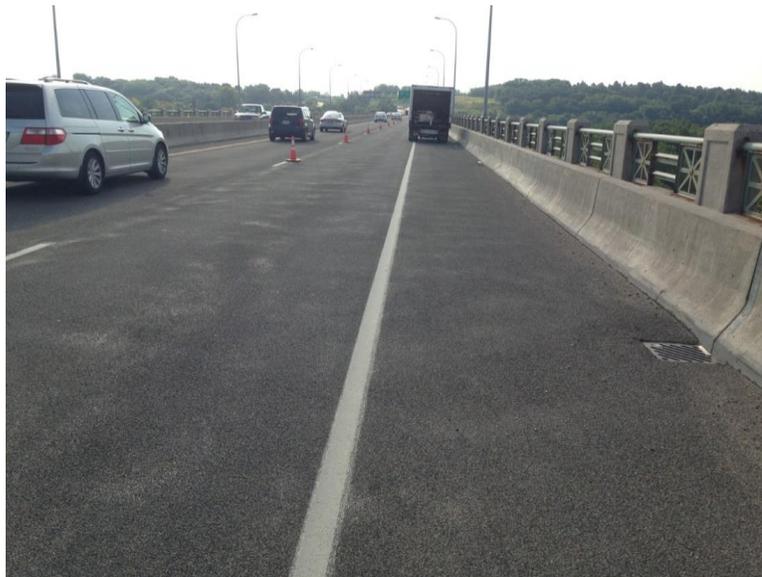
A common distress in snowy regions, such as Minnesota, is damage caused from the service of snowplows. Driving a snowplow blade across a roadway can cause severe abrasion and involves a series of impact events. Damage most often occurs at the crown of a roadway or in between rutted wheel paths. This snowplow abrasion is shown in Figure 27. The damage is most prevalent along the centerline as well the right wheel path in the driving lane. On this bridge the abrasion removes some of the aggregate which gives the roadway the appearance of a lighter color. Snow plow abrasion is detrimental to HFO systems because even with the use of aggregates that are proficient against deterioration due to abrasion, the bond between epoxy and aggregates are not strong enough to resist the shear force a plow blade imposes. Also if aggregate is being removed from the surface, the potential safety benefit quickly diminishes.

Figure 27: Transverse Snowplow Abrasion (Br 4190)

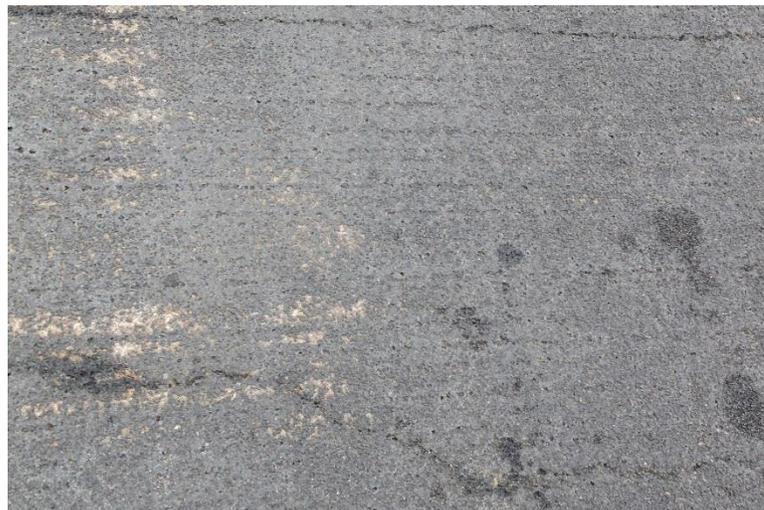
Figure 29: Polished Area on Bridge 27758 along with Transverse Cracks

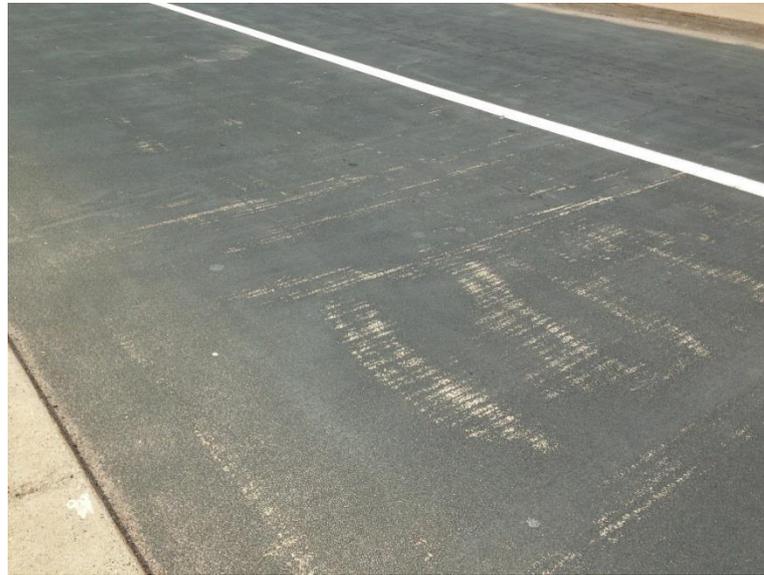
One distress on Bridge 27758 that has not occurred with any other system is the complete removal of epoxy and aggregates from the bridge deck surface due to abrasion. The removal from snow plow abrasion has occurred near joints or at the edges of other systems but not in the middle of the system as seen on Bridge 27758. Depicted below in Figure 30, the localized abrasion has removed strips of the system. The pattern of removal suggests that the epoxy was removed due to the high impact of a bouncing snow plow blade. This system is thinner than any other system in the study, with a thinner cross section less removal of material is required to reach the deck surface.

Figure 30: Excessive Snow Plow Abrasion (Br 27758)

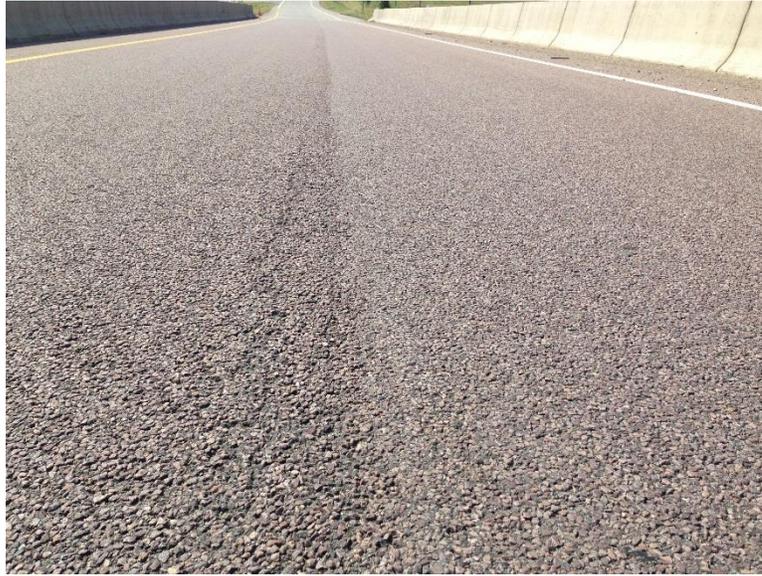
In the Novachip systems, the worst snowplow abrasion came from an uneven roadway elevation. The right side of the Novachip system on Bridge 86019 (Figure 32) has a significant amount of abrasion compared to the left side. During the site visit, settlement was visible on the left side of the bridge suggested by uneven approach panels and mismatched Jersey barrier heights. This settlement has lowered the left side of the bridge causing uneven seating of snowplow blades on the right side. This seating increases the rate of abrasion compared to the left side of the system.

Figure 32: Uneven Snowplow Abrasion due to Uneven Roadway Elevation (Br 86019)

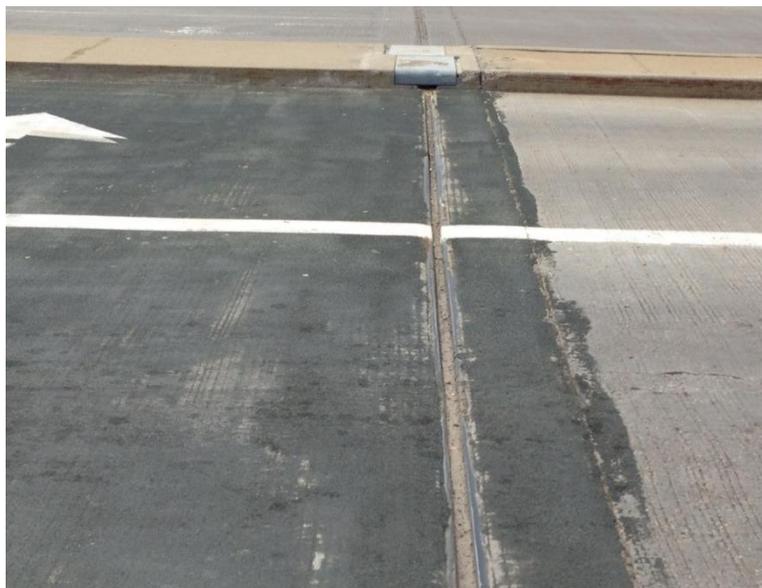
The area most damaged on this system is along the expansion joints. A common distress among the different epoxy systems, snowplows seem to cause catastrophic deterioration near joints. As shown in Figure 33, traffic is flowing from left to right. The right side of the figure is the concrete departure panel of the bridge. More area is missing on the departure side of the expansion joint.

Figure 33: Missing Overlay System near Expansion Joints on Transpo System (Br 27758)

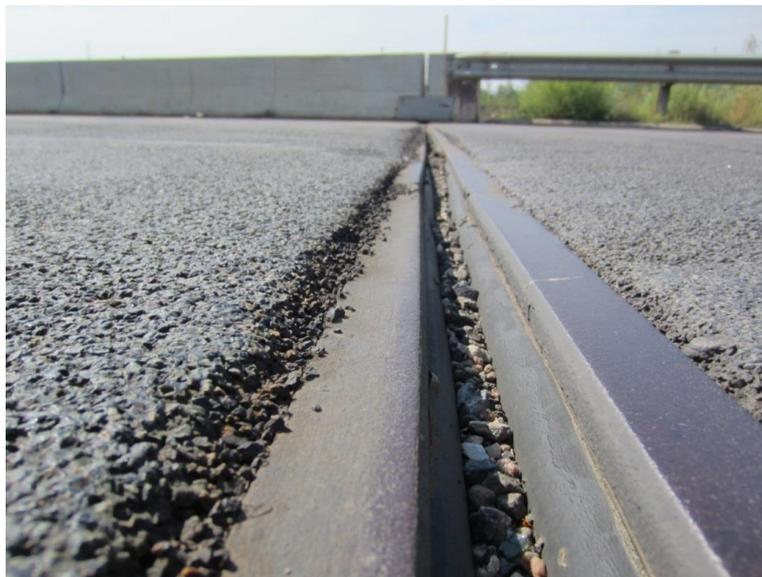
This damage is also shown in Figure 35 with a joint from Bridge 9066. Bridge 69006 and 9066 had their overlay systems placed in 2009 and 2010 respectively. So the damage in Figure 34 is from three winters and the damage in Figure 35 was caused over two winters.

Figure 34: Joint Abrasion on Bridge 69006 (Traffic Moves from Left to Right)

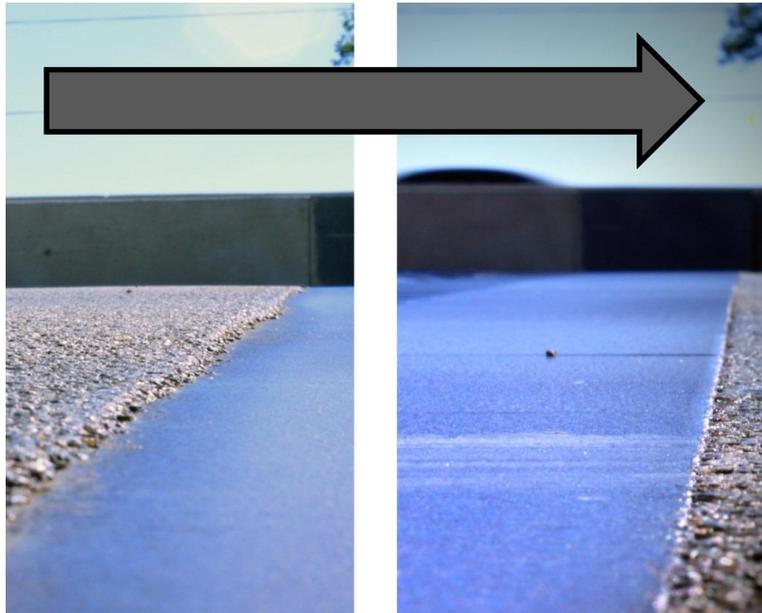
Figure 35: Joint Damage on Bridge 9066 (Traffic Moves from Left to Right)

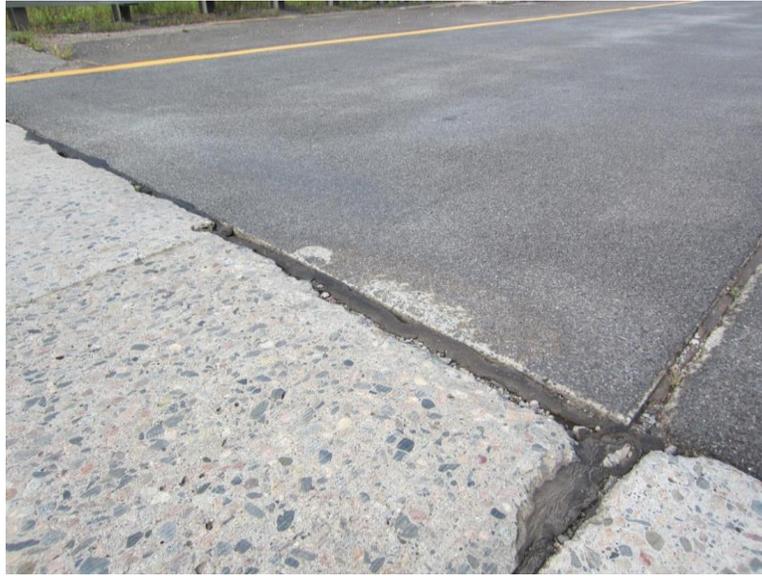
Damage is also produced as snow plows cross from approach panels to the bridge deck. The mismatch between the approach panel and the bridge deck causes part of the epoxy system to be scrapped off the bridge deck (Figure 36). Transverse abrasion from snow plows in high elevation areas is also apparent in Figure 36.

Figure 36: Damage near Approach Panels on Poly-Carb System (Bridge 69006)

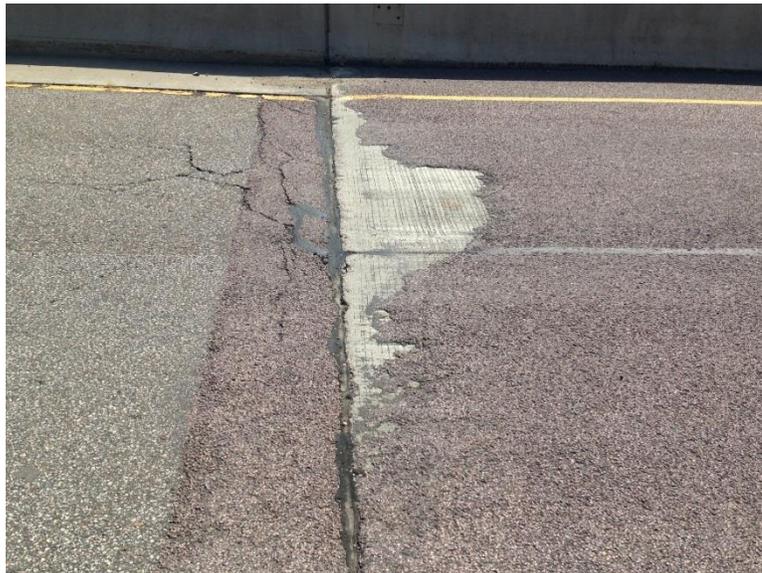
As shown in Figure 37, the HFO system removal due to snow plows occurs across all HFO types. The removal in Figure 37 is especially bad due to the uneven elevation between the roadway and the approach panel. The asphalt roadway on the left side of the figure has settled exposing the concrete approach panel and overlying HFO system.

Figure 37: System Removal near Joint on NovaChip System (Bridge 86019)

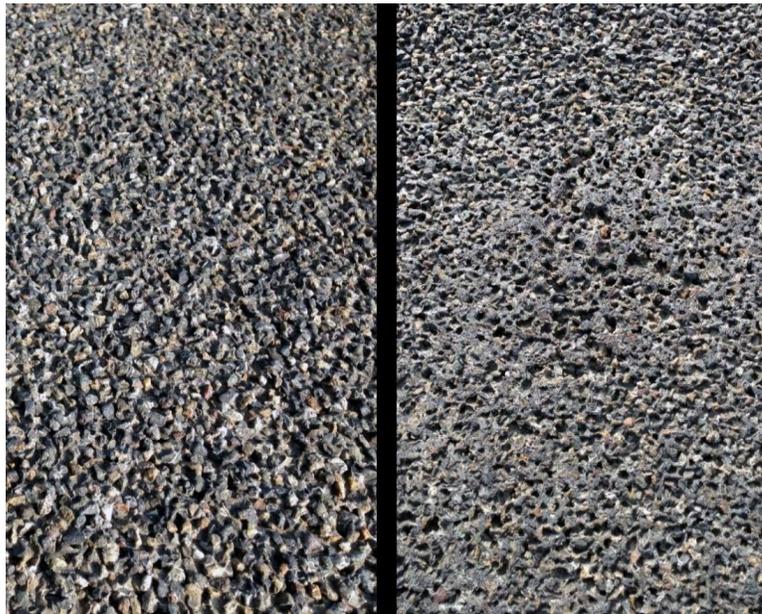
Removal of aggregates from the HFO system is due to inadequate binding to the system. Abrasion forces are most commonly responsible for aggregate removal in the epoxy based systems: Poly-Carb, SafeLane, and Transpo. Aggregate raveling was more apparent in the wheel path and was more common in polished areas. These systems had large amounts of aggregate raveling at every bridge location. Figure 38 contrasts a surface with the proper aggregate coating against a surface with significant amount of polishing and raveling.

Figure 38: Texture Comparison of Br 4190 (Left: Proper Aggregate Macrotexture, Right: Aggregate Raveling)

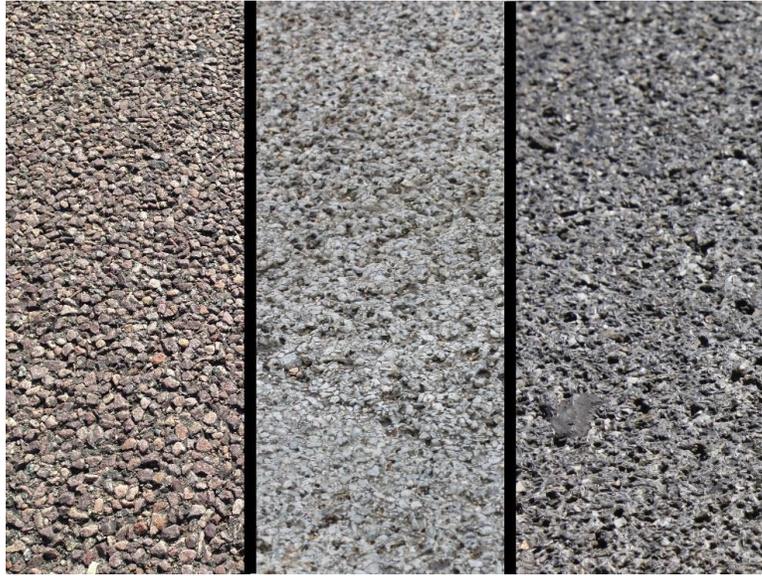
Novachip systems are constructed similar to asphalt overlays, thus the system is compacted with a roller during construction. This compaction helps to push the aggregates further into the asphalt matrix and achieve a higher bond. Additionally, asphalt remains pliable while it ages, therefore aggregate in the Novachip systems are able to compress into the asphalt under a load even after the initial placement. The continued embedment of aggregate into the asphalt membrane is noticeable in the Novachip systems (Figure 39, left). These two features prevent the excessive raveling found in epoxy systems. In an epoxy system, once hardened, the aggregates do not have the capability to compress further into the epoxy matrix, which may lead to protruding aggregate. These protruding aggregates are more susceptible to abrasion, polishing, and raveling.

Figure 39: Comparison of Loss of Aggregate between Novachip (Left), SafeLane (Middle), and Poly-Carb (Right) Systems

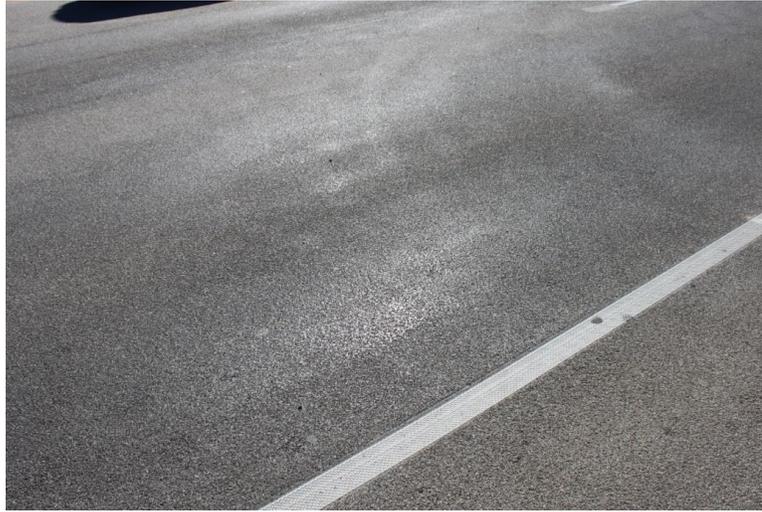
Aggregate polishing was a common distress found in the wheel paths. An extreme case of polishing was found on Bridge 9066. In Figure 40 and Figure 41 the reflection of sunlight on polished areas makes it much easier to spot locations with poor friction.

Figure 40: Wheel Path Polishing (Br 9066)

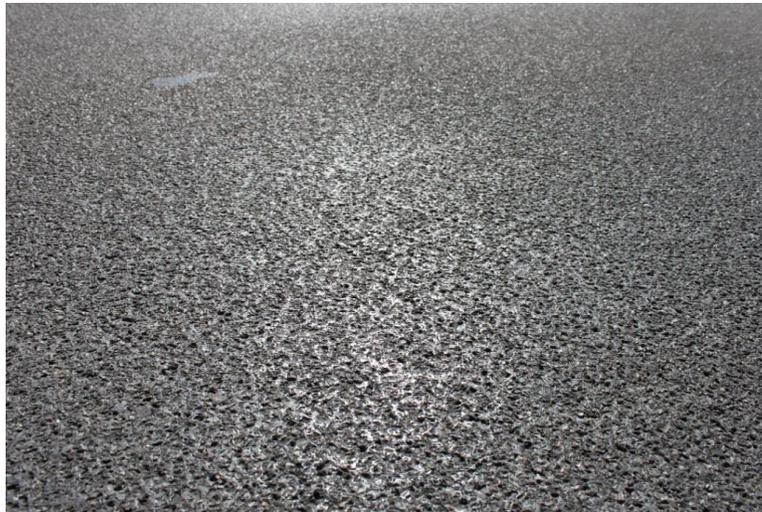
Figure 41: Close View of Polished Area (Br 9066)

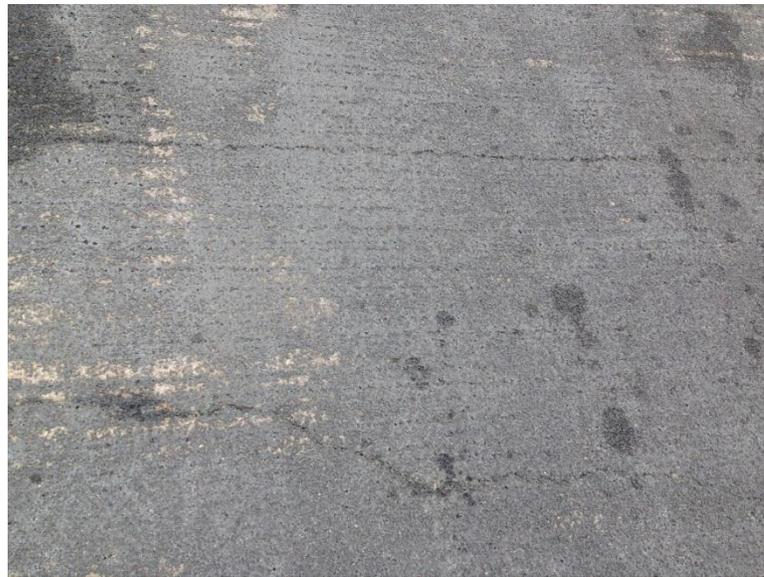
Similar to concrete and asphalt pavements, cracks in HFO systems also occur. Several hairline cracks exist in the Poly-Carb and SafeLane systems but none of the cracks appeared to propagate through the entire thickness of the system. In the Transpo systems, cracks that propagated through the entire system did occur. On Bridge 27758 (Penn Ave) the cracks appear to be due to the system being thinner than any other system allowing reflective cracks from the underlying bridge deck to propagate through the system. These cracks are shown below in Figure 42.

Figure 42: Transverse Cracks on Bridge 27758

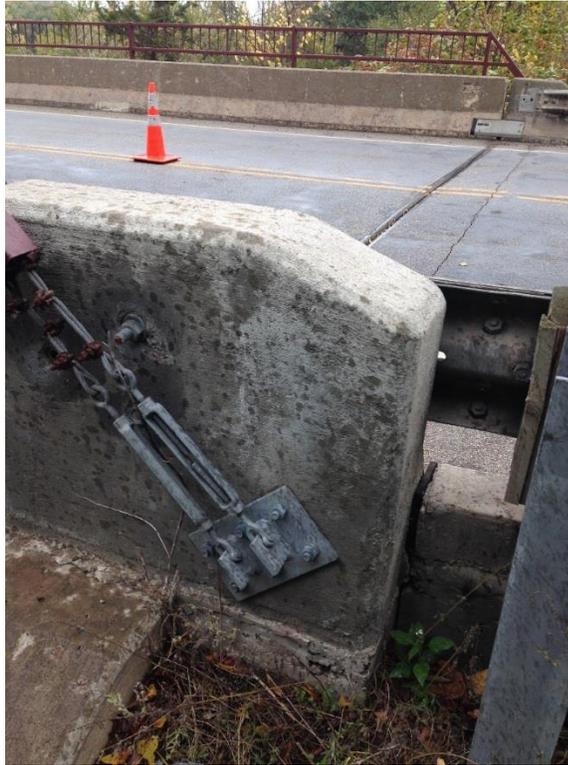
Cracking also occurred on Bridge 6347. This cracking was completely through the thickness of the HFO systems. The approach panels on either side of the bridge have a transverse crack near the expansion joints. The transverse crack occurs along the back edge of the concrete abutment wall (Figure 43) which suggests that settlement behind the abutment has occurred. The settlement lowered and cracked the approach panel and the HFO system. This settlement may also have detrimental effects on the expansion joint and could render the joint ineffective.

Figure 43: Transverse Crack near Expansion Joint of Bridge 6347

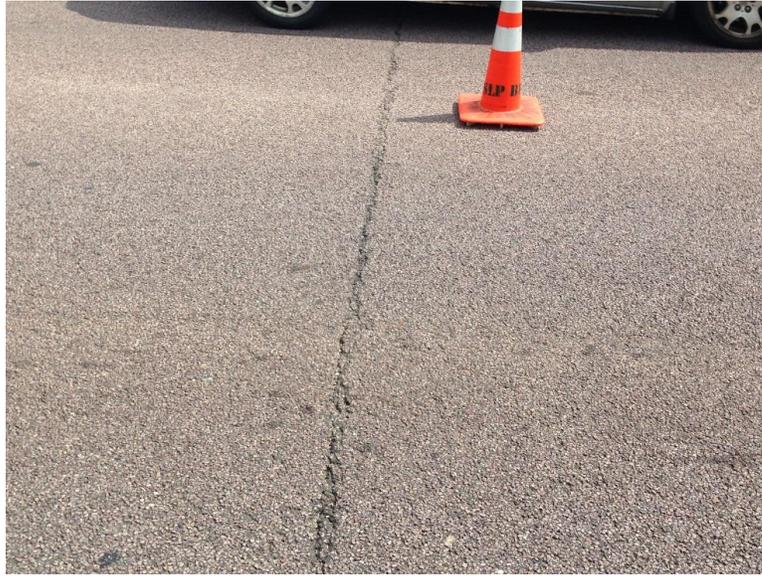
Transverse cracking (Figure 44) and reflective cracking along expansion joints (Figure 45) both existed in the Novachip systems. The Novachip systems are asphalt overlays and thus distress differently than the other epoxy systems. Novachip systems distress similar to conventional asphalt pavements. The cracks reflected through the Novachip systems from existing cracks or settlement in the approach panels and bridge decks. The placement of Novachip systems on well-performing bridge decks would eradicate a majority of the crack distresses observed in this study.

Figure 44: Longitudinal Crack in Novachip System (Br 27019)

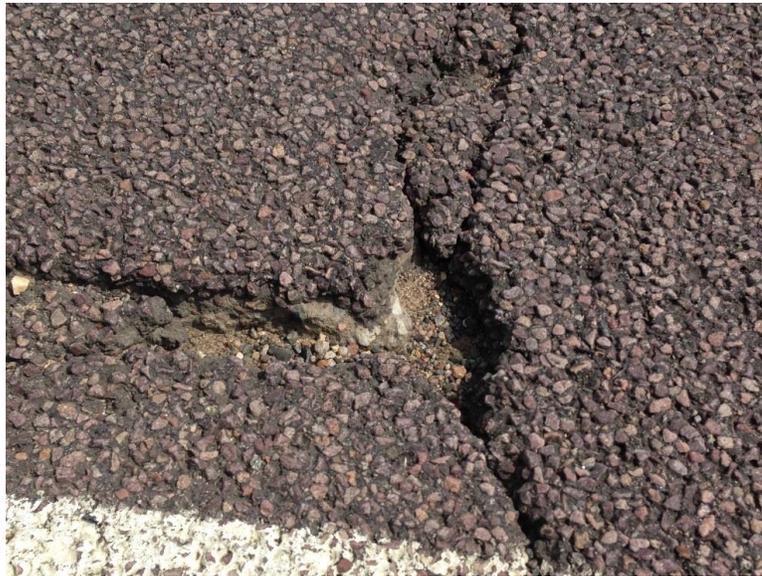
Figure 45: Reflective Cracking in Novachip System (Br 27019)

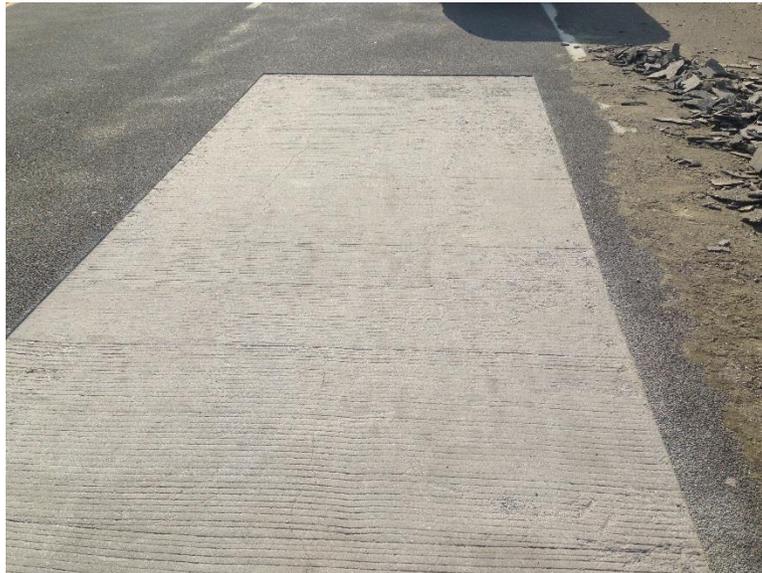
Figure 49: Delaminated Area during Maintenance (Br 4190)

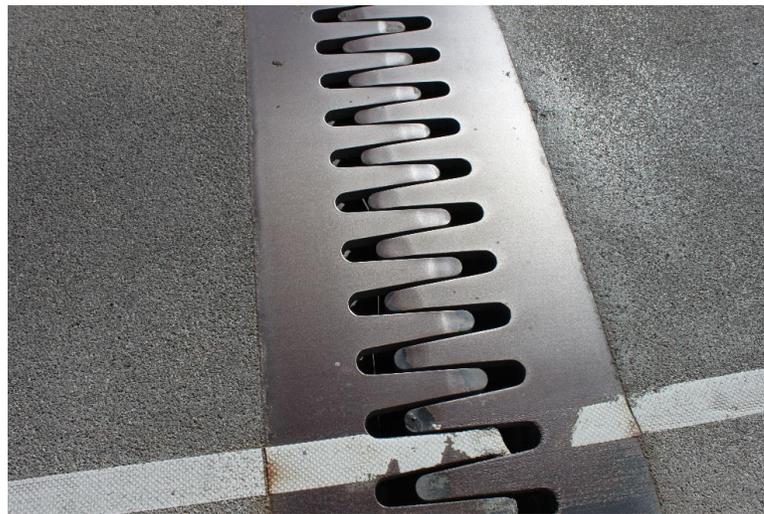
There appears to be two similarities between the bridges where this delamination occurs, crossing water and lower functioning expansion joints. The epoxy systems crossing water in this study are found on Bridges 6347 (TH 243 in Otsego, Transpo), 9066, and 9067 (I-94 in Moorhead, Poly-Carb). Delamination has occurred on Bridge 6347 but not on either 9066 or 9067. One main difference between Bridges 9066, 9067 and the other bridges with delamination is the expansion joints. On Bridge 9066 and 9067 the expansion joints are significantly larger compared to the other bridges. The expansion joint of Bridge 9066 is shown below in Figure 50.

Figure 50: Expansion Joint on Bridge 9066

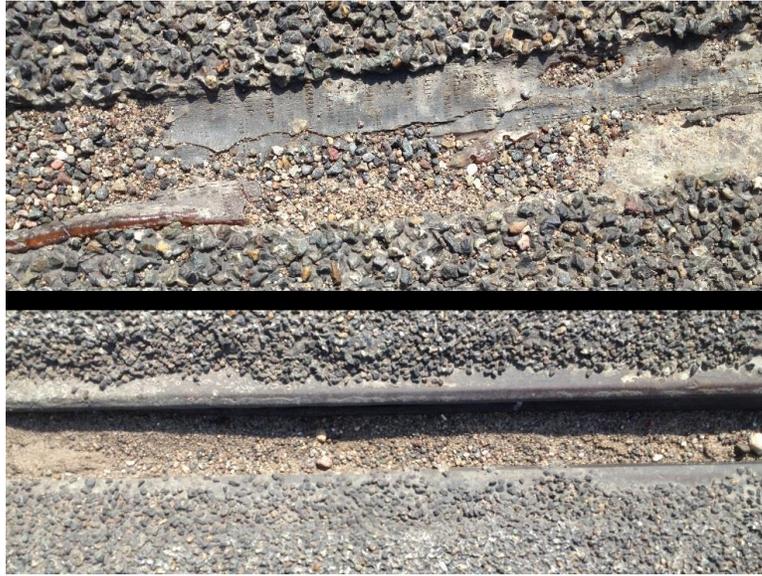
Bridge 27019 and 86019 (Otsego, Novachip) also cross water however the Novachip systems, with their elastic properties from asphalt, would be able to absorb the internal stresses compared to the rigid epoxy system. As discussed in the previous section, Bridge 6347 (TH 243 in Osceola, Transpo) has settlement behind its abutment which could be interfering with its expansion joints ability to operate.

Figure 51: Robert Street (Br 9036) Expansion Joints, Both North (Bottom) and South (Top) of Delamination

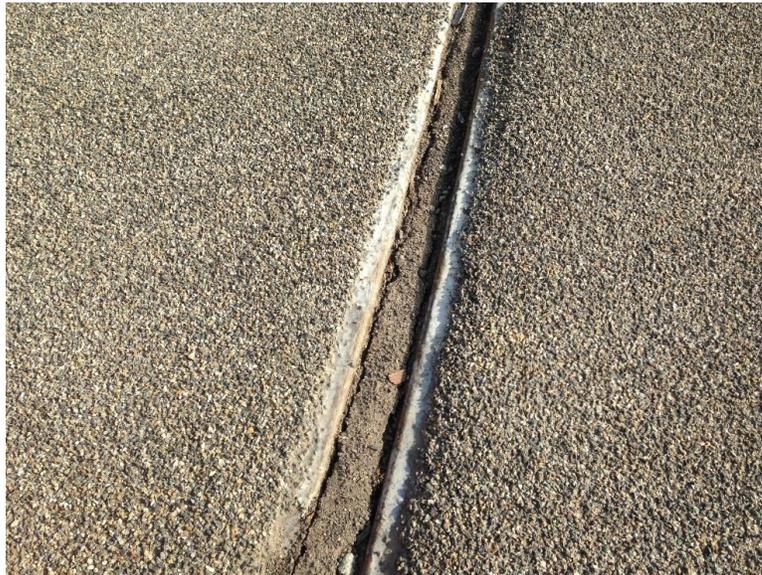
Figure 52: Bridge 4190 (TH 55) Expansion Joint

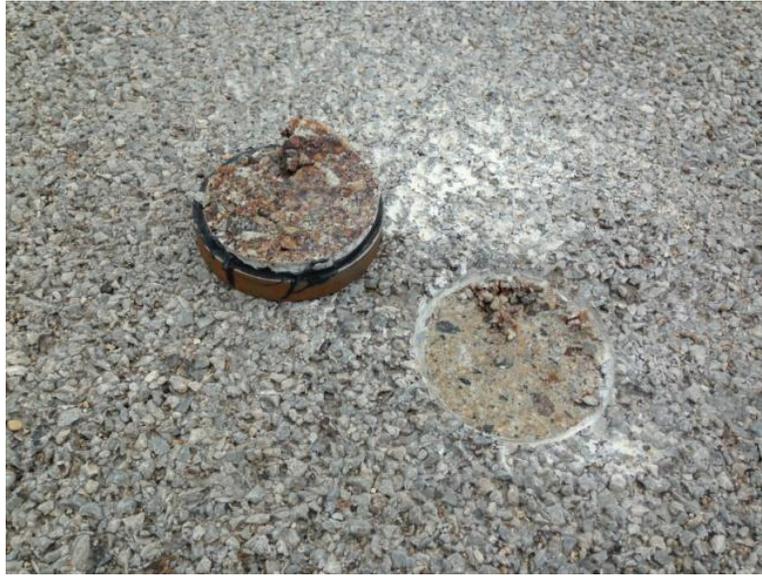
Figure 57: Plate with Debonded Overlay (Br 14810)

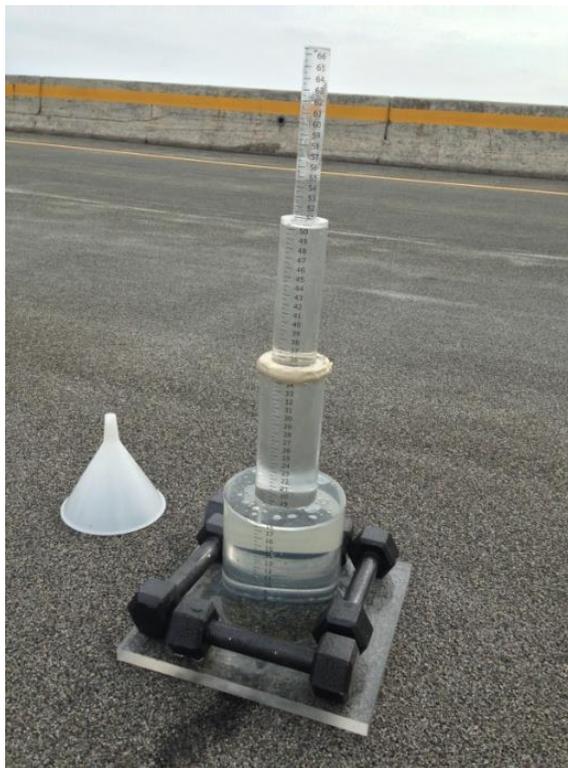
Figure 58: Permeability Test over Cracked Overlay (Br 9823)
