UNIVERSITY OF MINNESOTA
TWIN CITIES

Re: JOML B remodeling
First notice of damage
Room 301 and 302, Owre Hall

TO: Mr. Gordon Dahlen, Construction Superintendent, U of M
FROM: Gerald T. Bratt, Dept. of Biochemistry *GTB*
SUBJECT: JOML-13 Construction Project-
Water Damage - Deionized Water Line Breakage 2/25/79

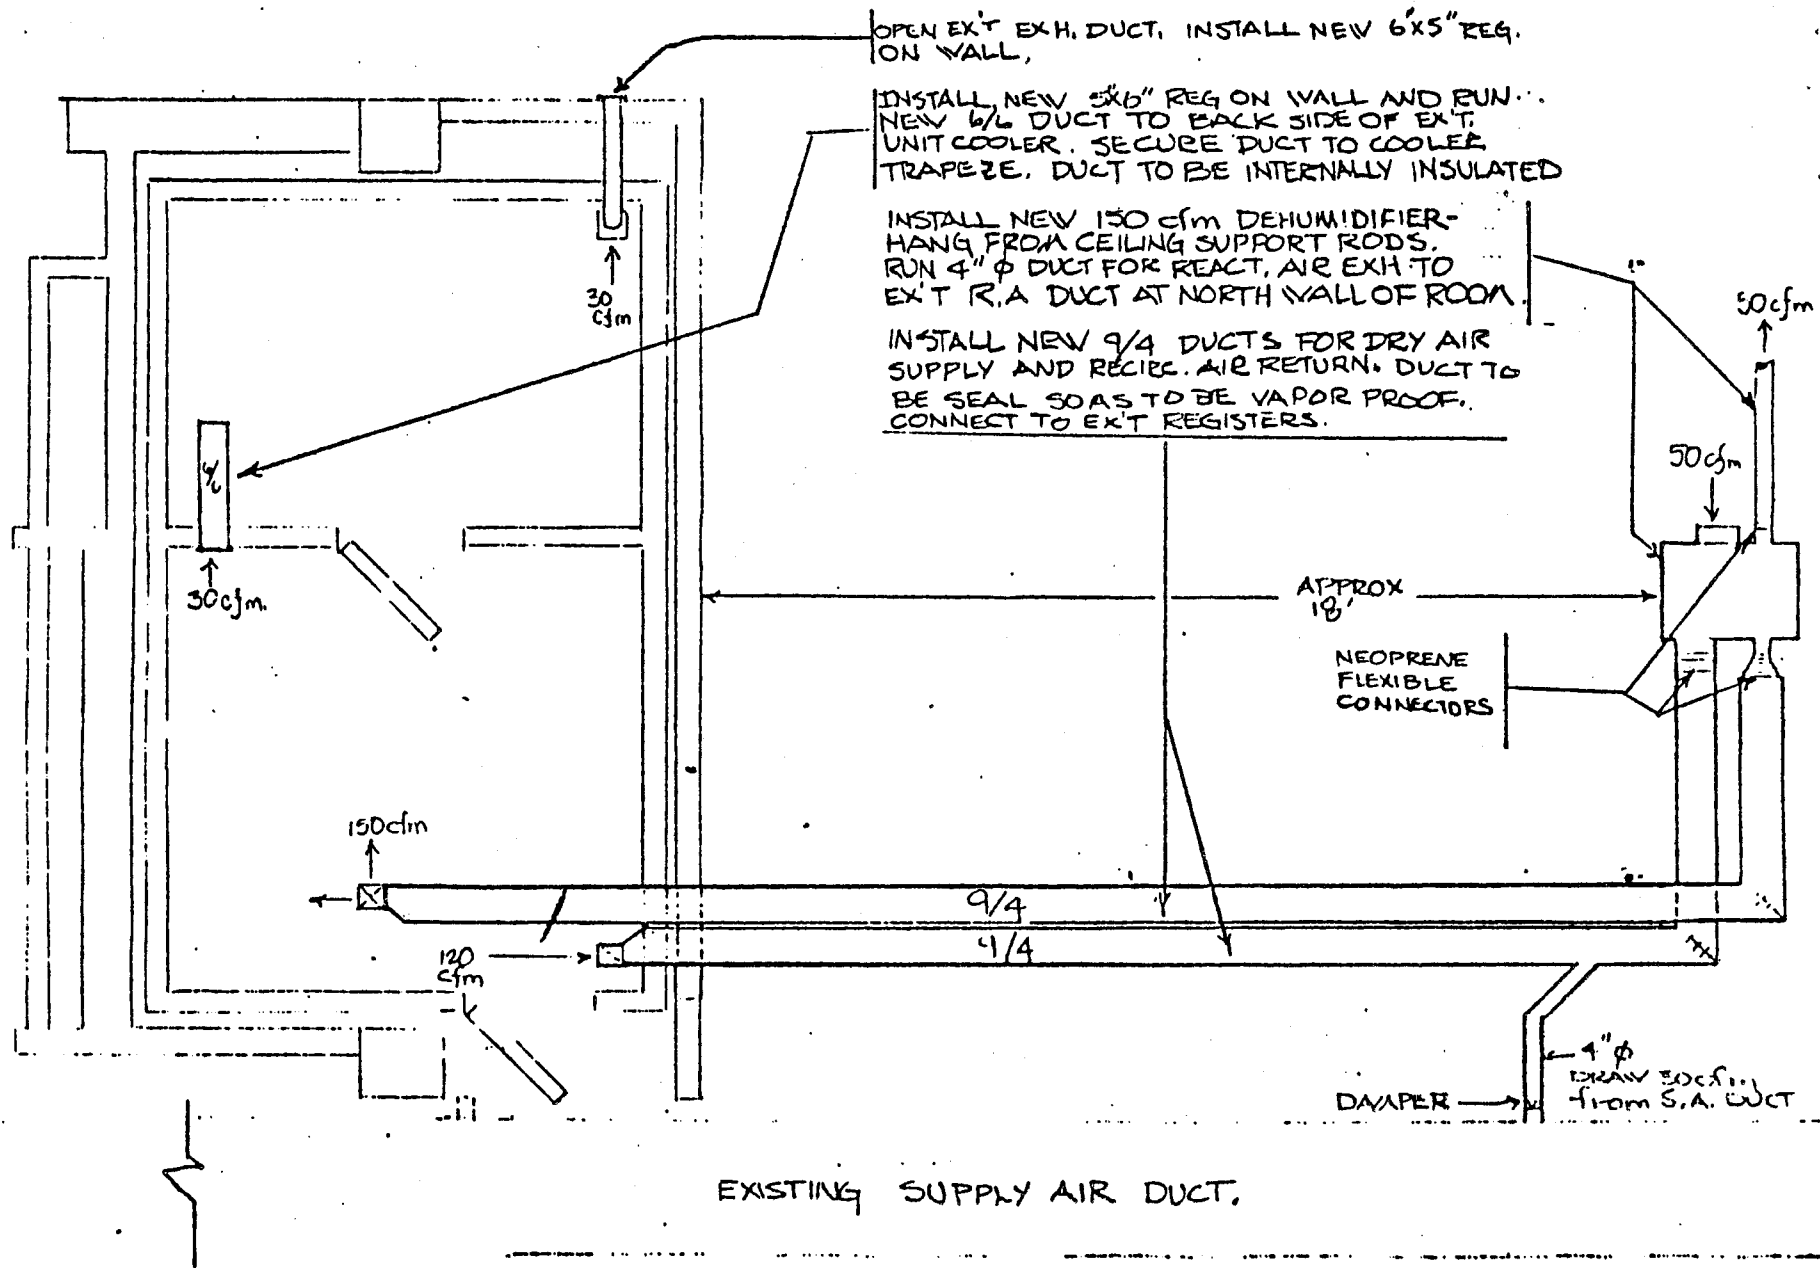
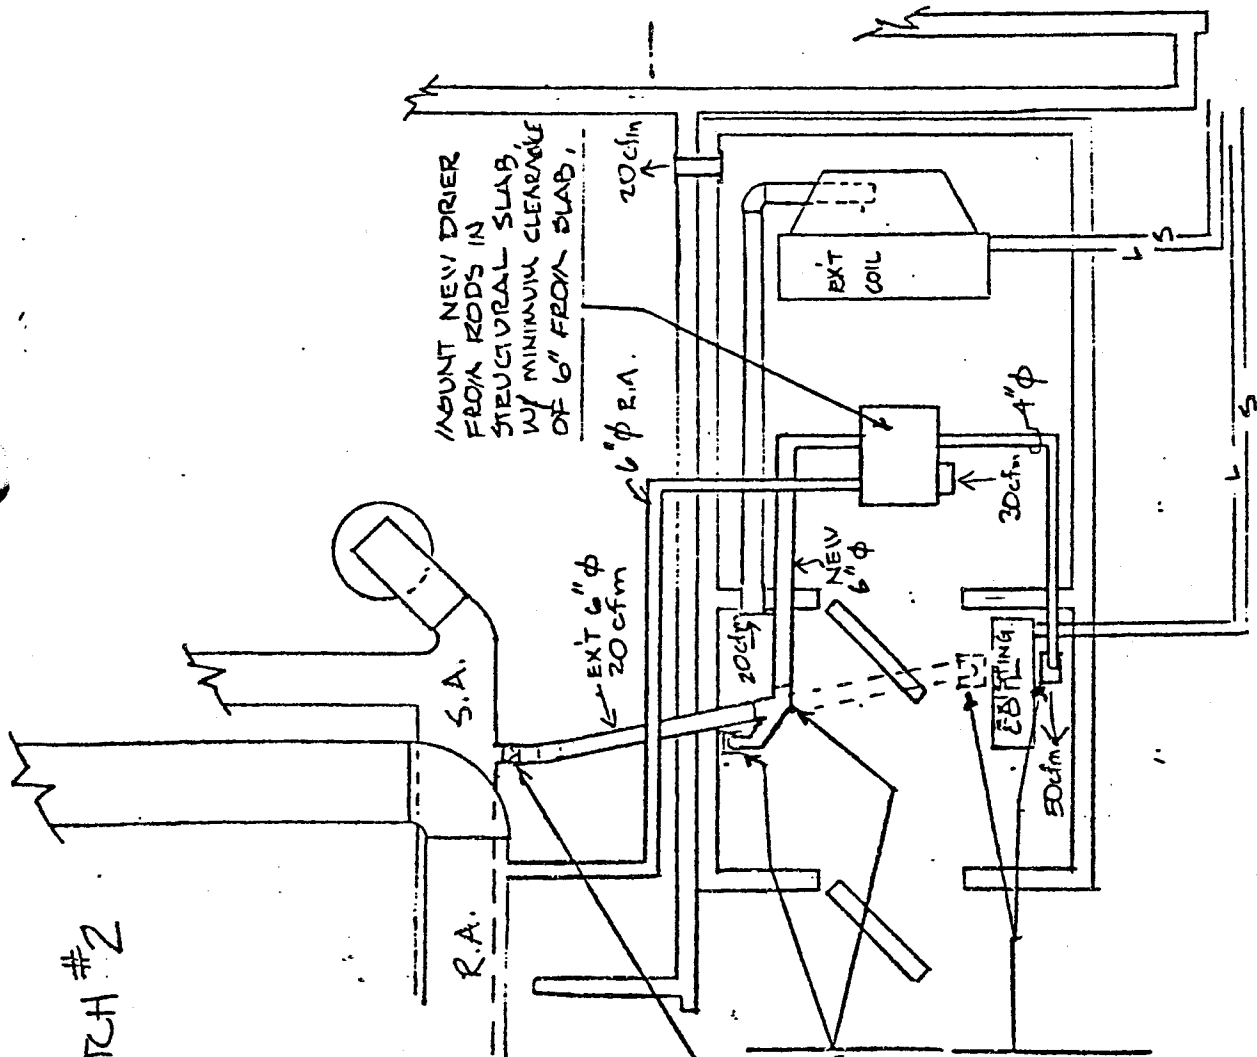
INSTALLATION OF DEHUMIDIFIER FOR COLD ROOM # 4-178, JOML

At these inlet conditions the BryAir Model A-0.5-B will supply 50 CFM of air with a 4 gr/lb moisture content. See Sketch #2 for installation.

INSTALL NEW DRIER FROM REBARS IN STRUCTURAL SLAB W/ MINIMUM CLEARANCE OF 6" FROM SLAB.

INSTALL LOCKING DAMPER EXT 6" DUCT FROM S.A.
 INSTALL NEW 5x6" RA REBAR AT CEILING W/ DAMPER. CONNECT NEW 4" φ DUCT AND CONNECT TO EXT 6" φ SA DUCT. RUN NEW 6" φ DUCT FROM CONNECTION TO NEW DRIER. ALL DUCT INTERNALLY INSULATED W/ VAPOR BARRIER. RELOCATE EXT SA DIFFUSER AS SHOWN - RUN NEW 4" φ DUCT FROM DISCH. SIDE OF DRIER TO DIFFUSER. PATCH HOLE - PACK WITH FIBERGLASS INSULATION W/ MOISTURE BARRIER.

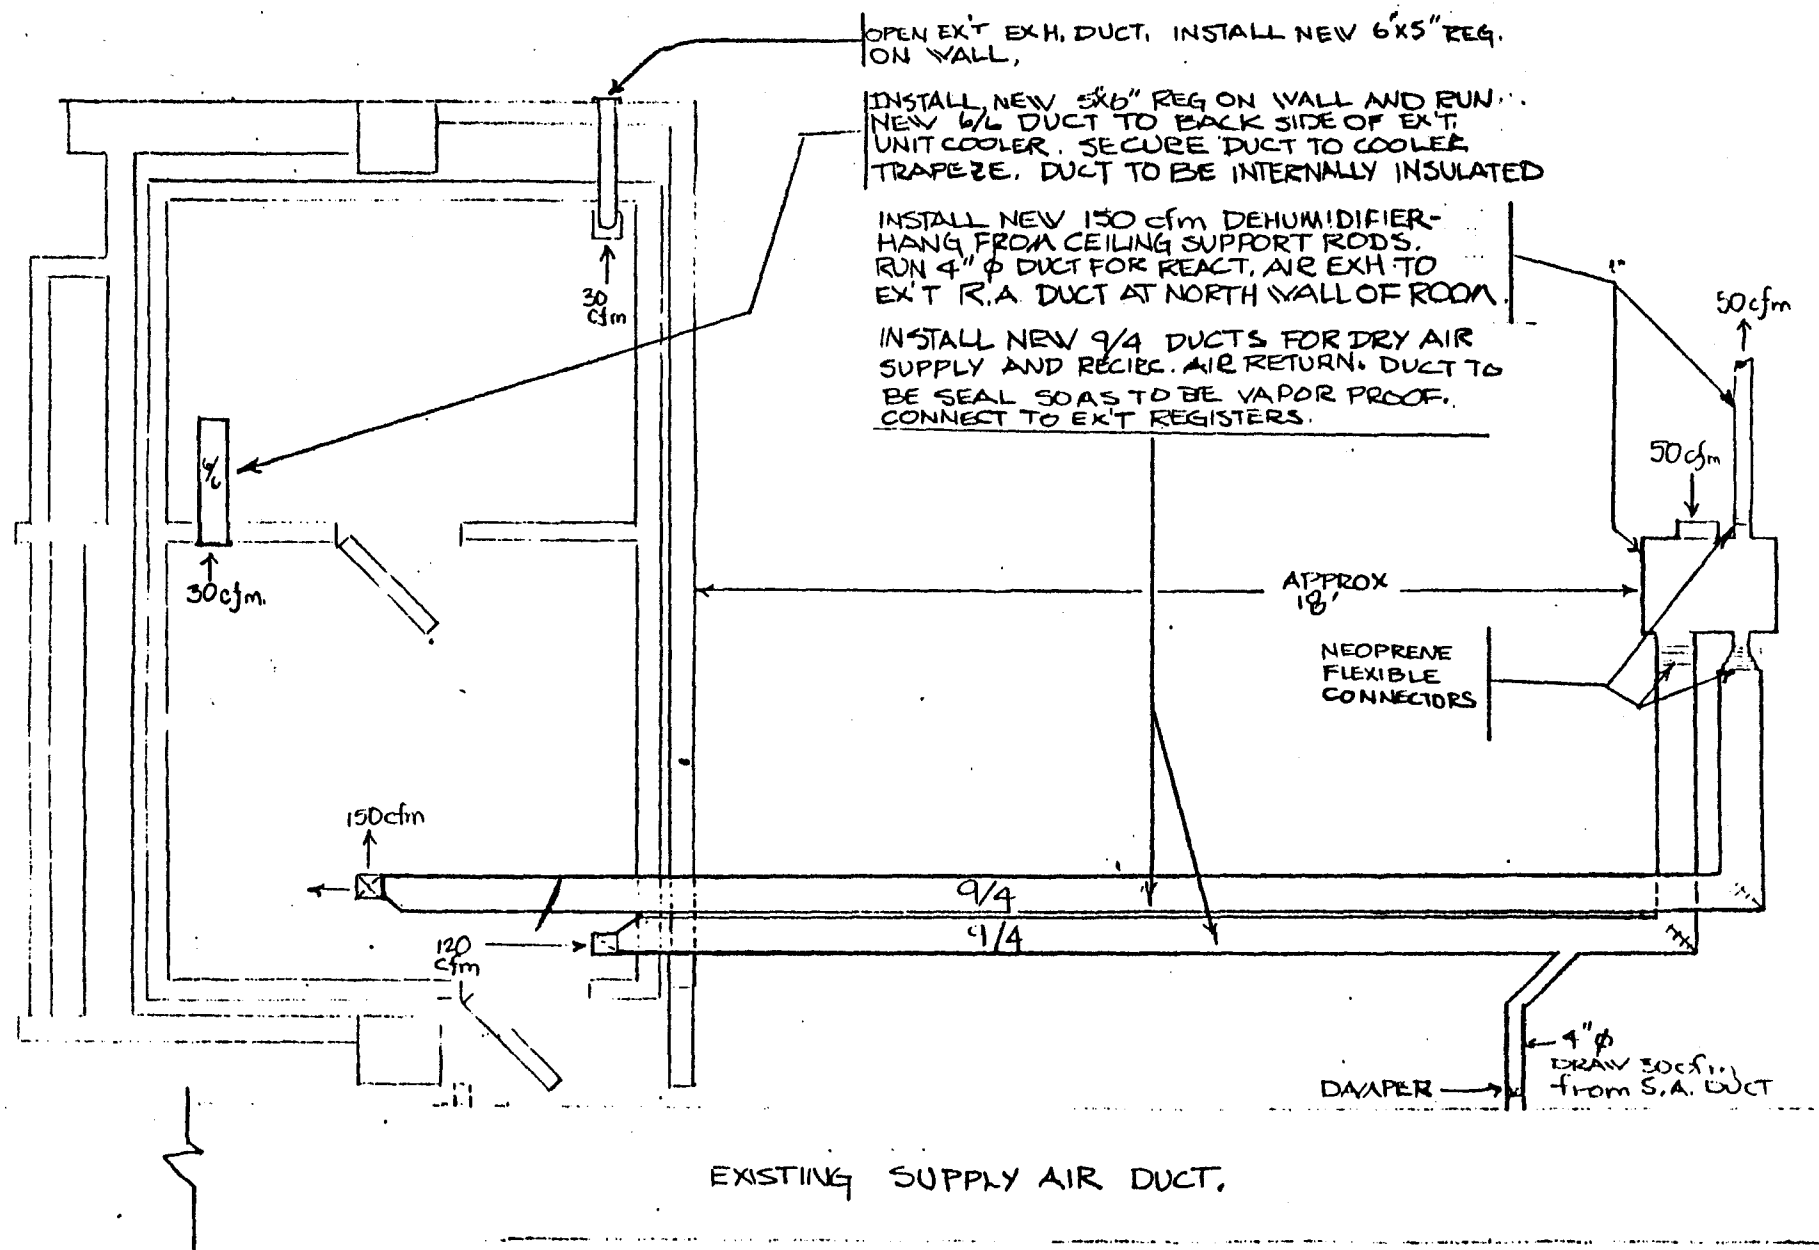
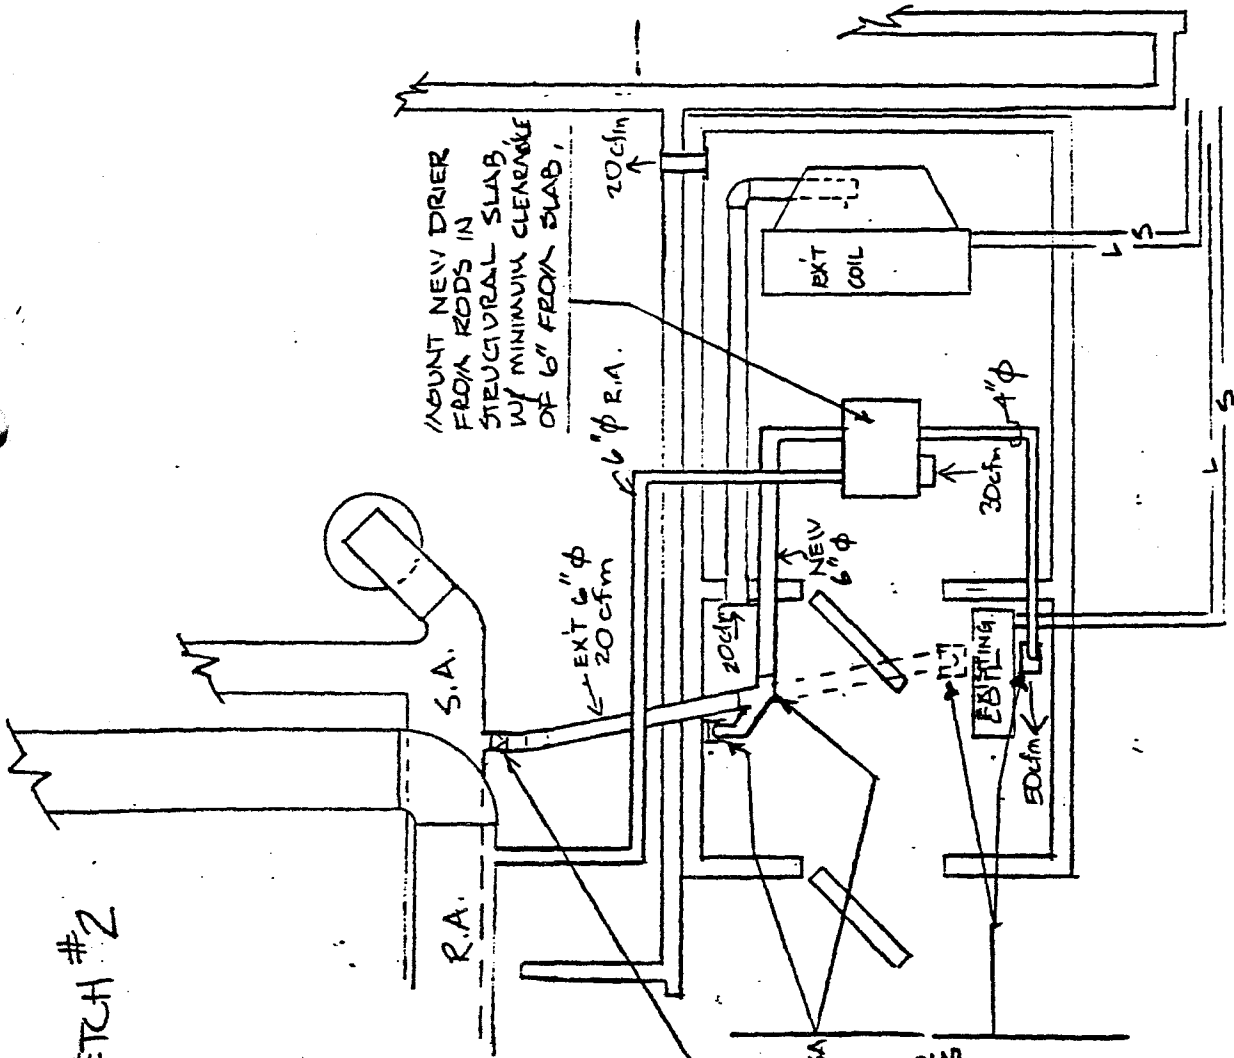
INSTALLATION OF DEHUMIDIFIER FOR COLD ROOM # 4-178, JOML

At these inlet conditions the BryAir Model A-0.5-B will supply 50 CFM of air with a 4 gr/lb moisture content. See Sketch #2 for installation.

ADJUST NEW DRIER FROM RODS IN STRUCTURAL SLAB W/ MINIMUM CLEARANCE OF 6" FROM SLAB.

INSTALL LOCKING DAMPER IN EXT 6" DUCT FROM S.A.
 INSTALL NEW 5x6" RA REG AT CEILING W/ DAMPER. CONNECT NEW 4" Ø DUCT AND CONNECT TO EXT 6" Ø DUCT. RUN NEW 6" Ø DUCT FROM CONNECTION TO NEW DRIER, ALL DUCT INTERNALLY INSULATED W/ VAPOR BARRIER. RELOCATE EXT SA DIFFUSER AS SHOWN - RUN NEW 4" Ø DUCT FROM DISCH. SIDE OF DRIER TO DIFFUSER. PATCH HOLE - PACK WITH FIBERGLASS INSULATION W/ MOISTURE BARRIER.

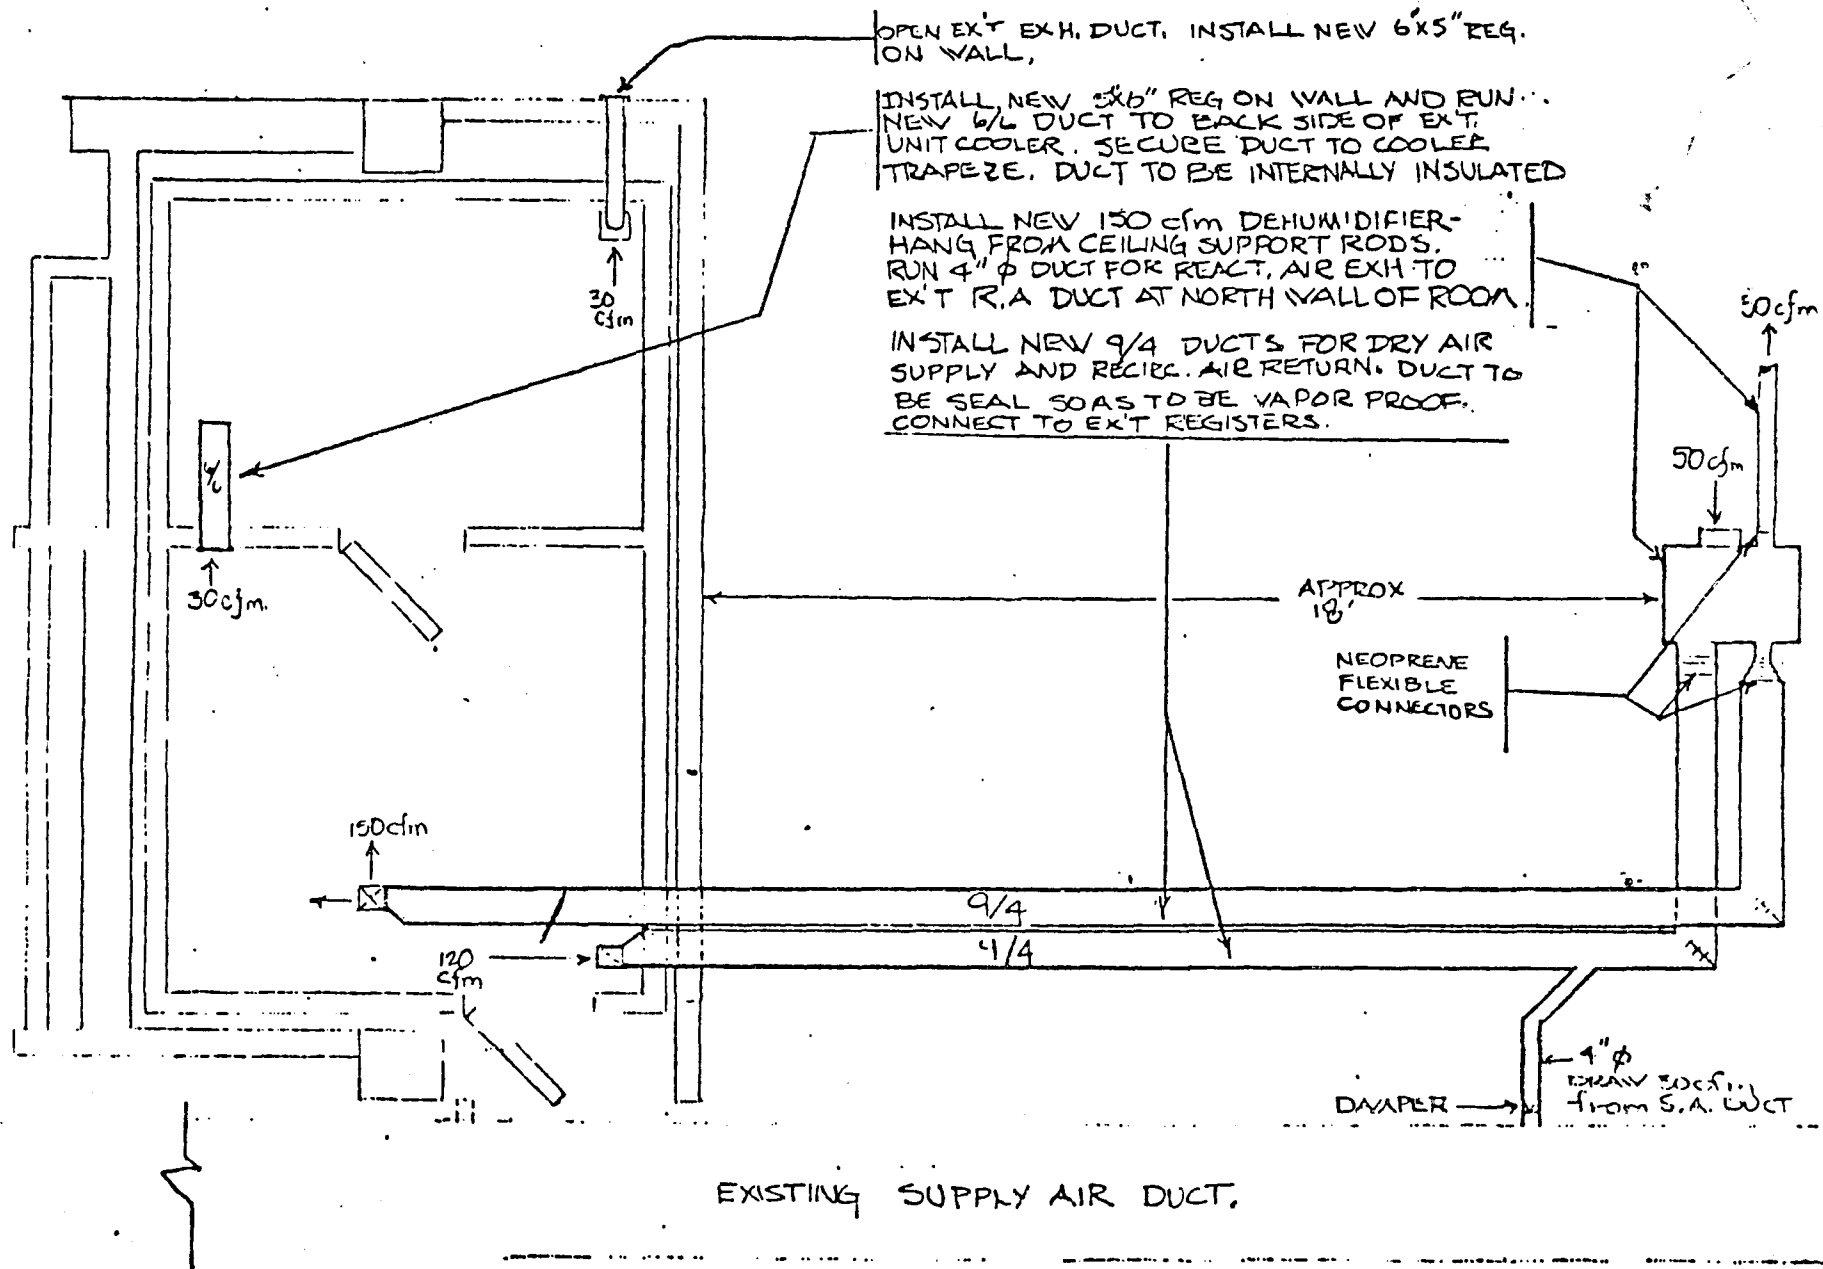
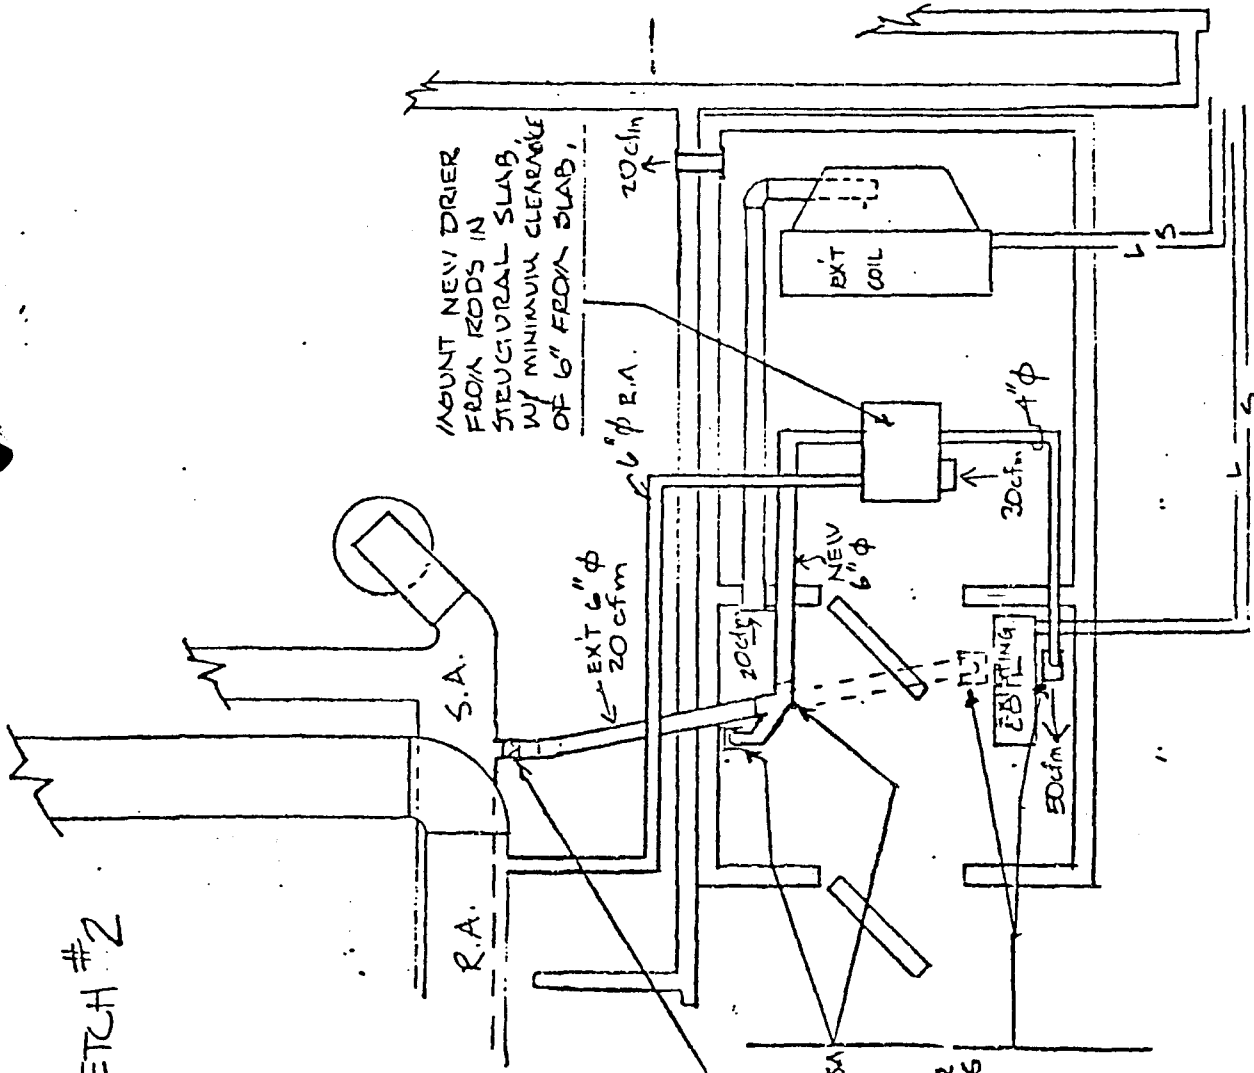
INSTALLATION OF DEHUMIDIFIER FOR COLD ROOM # 4-178, JOML

At these inlet conditions the BryAir Model A-0.5-B will supply 50 CFM of air with a 4 gr/lb moisture content. See Sketch #2 for installation.

INSTALL NEW DRIER FROM RODS IN STRUCTURAL SLAB, W/ MINIMUM CLEARANCE OF 6" FROM SLAB.

INSTALL LOCKING DAMPER EXT 6" DUCT FROM S.A.
 INSTALL NEW 5x6" RA REG AT CEILING W/ DAMPER. CONNECT NEW 4" φ DUCT AND CONNECT TO EXT 6" φ DUCT. RUN NEW 6" φ DUCT FROM CONNECTION TO NEW DRIER, ALL DUCT INTERNALLY INSULATED, W/ VAPOR BARRIER. RELOCATE EXT SA DIFFUSER AS SHOWN - RUN NEW 4" φ DUCT FROM DISCH. SIDE OF DRIER TO DIFFUSER. PATCH HOLE - PACK WITH FIBERGLASS INSULATION W/ MOISTURE BARRIER.
