January 27, 1975

Subj: Load Test of Spandrel Beam
Oak Street Parking Ramp

REPORT OF: LOAD TEST OF SPANDREL BEAMOAK STREET PARKING RAMP
UNIVERSITY OF MINNESOTA
MINNEAPOLIS, MINNESOTA**PROJECT:****DATE:**

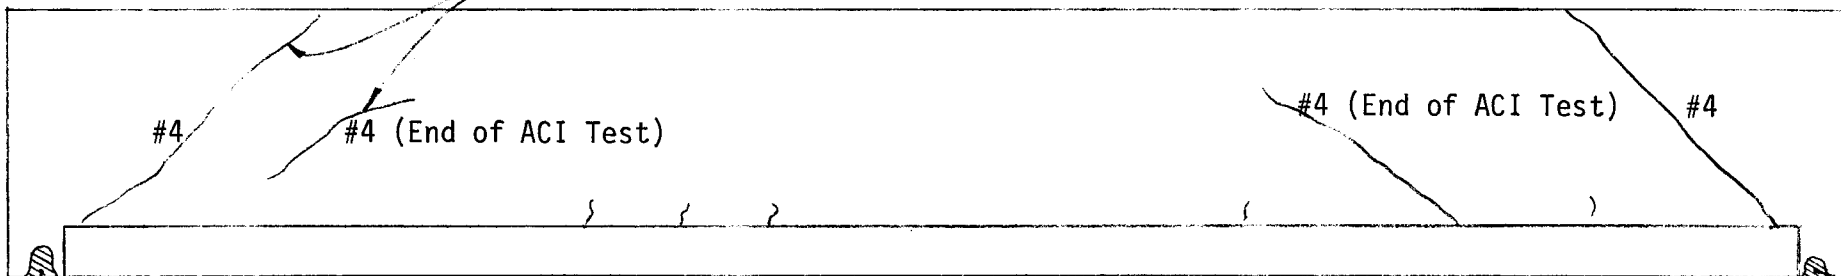
Elevation - Inside Face of Spandrel Beam

Diagonal Hairline Cracks - Typical
(See Photographs 13 and 14)

Spalled Concrete
(7/8" in Depth)
Occurring during
Load Stage #4

Spalled Concrete (1/2" in
Depth) Occurring Immediately
upon Application
of Load
Stage #3

Hairline Flexural Cracks
- Typical - (See Photograph #20)

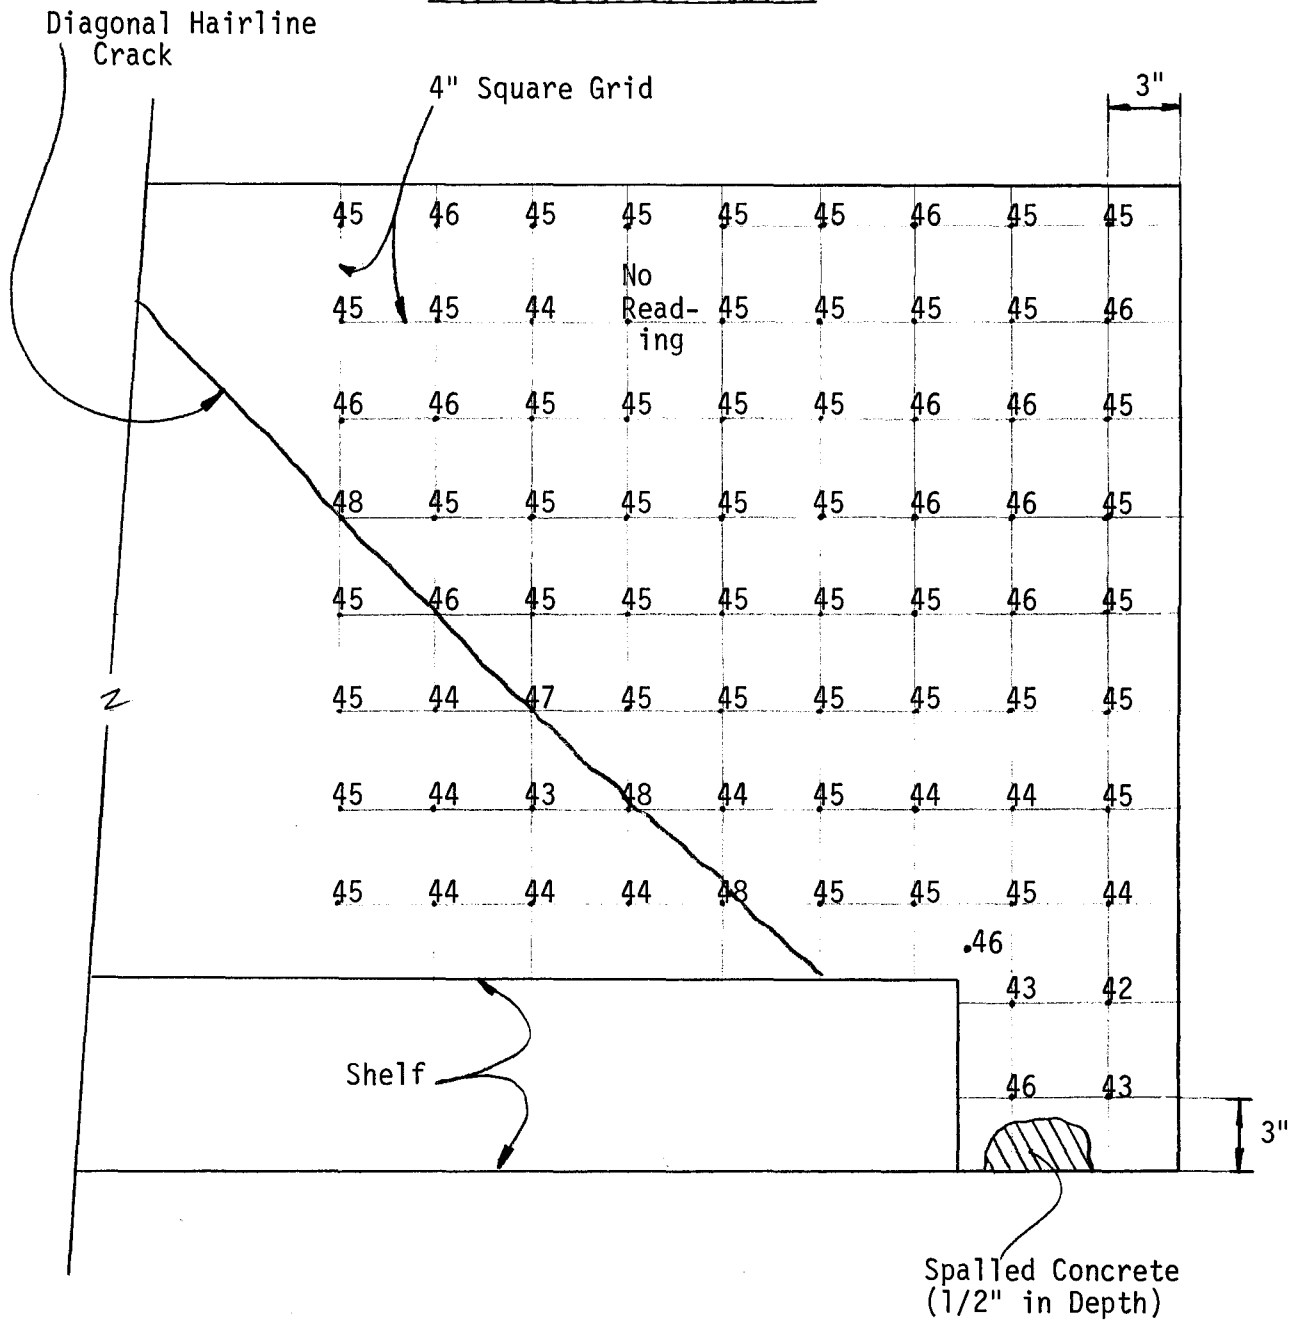
Elevation - South End Reaction - Inside Face

Upon completion of the ACI load tests, we removed the concrete spandrel beam from the column bearing pockets and examined the end regions of the beam with ultrasonic testing equipment. The ultrasonic meter is equipped with transmitting and receiving low frequency sonic transducers, together with monitoring instrumentation. Internal fracturing and discontinuities in the test item are revealed by higher required sonic transmission time. The test results from the sonic scanning are shown in one of the attached appendixes. The sonic transmission of both ends of the test beam compared with the 8 in. thickness of the test member indicate that no discontinuities (splitting or other fracturing) had developed in the spandrel beam during the load test.

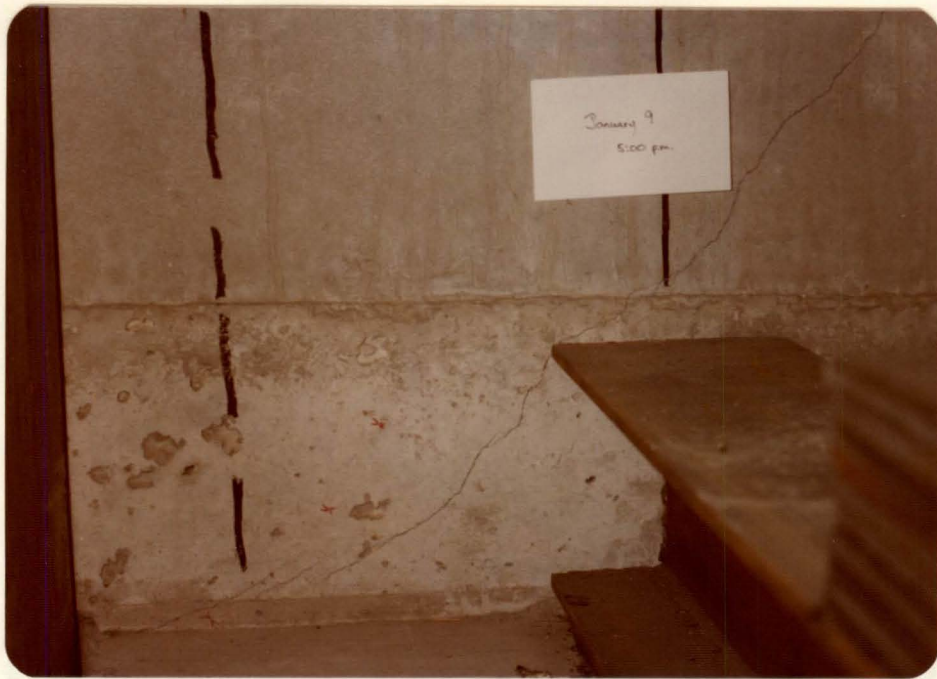
12:00 (Midnight)		Diagonal hairline cracks (on the inside face of the stem) observed at both end reactions.
Tuesday	12-31-74	4:15 p.m.		Grout placed between concrete beam and 6" steel I-beam, to simulate the concrete topping.
				Diagonal cracks observed to have increased in separation (See Photograph #14)
Monday	1-6-75	9:00 a.m.		Spalling observed at the north end reaction. Additional grout also placed between haunch and concrete slab at each end reaction.
Tuesday	1-7-75	1:30 p.m.		Grout placed between steel haunch assembly and spandrel beam.
Friday	1-10-75	10:15 a.m.	5	START OF ACI LOAD TEST
				Hairline cracking observed in grout between steel haunch assembly and spandrel beam (Both end reactions)
				(See Photograph #22)

Photograph #13 - Front-View Stem, Displaying Diagonal Hairline Crack at Load Stage #4. (North-End Reaction)

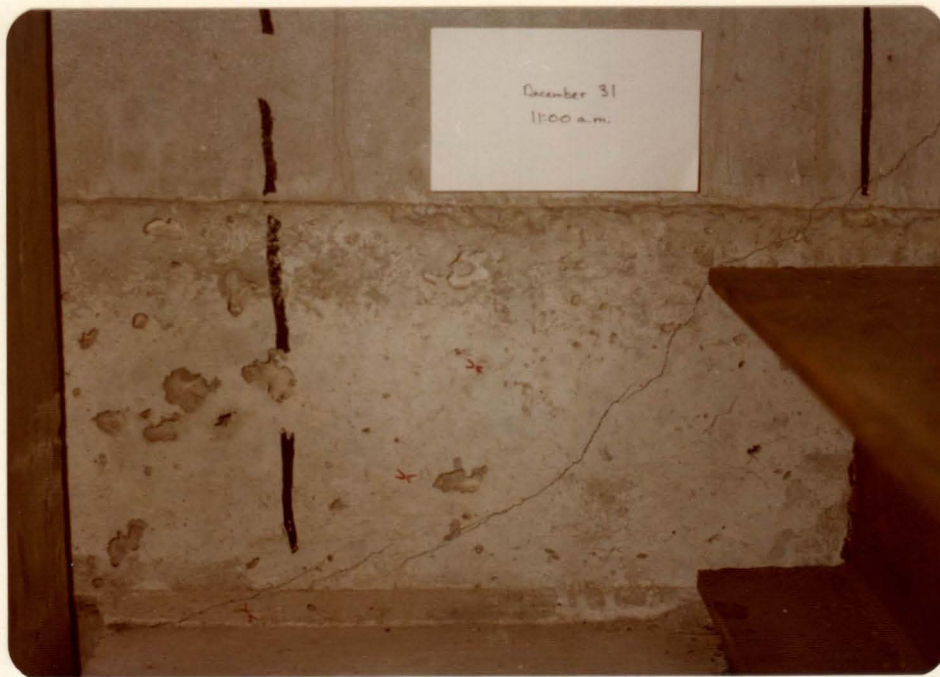
Photograph #14 - Front-View of Stem, displaying Diagonal Hairline Crack at Load Stage #4. (North-End Reaction)

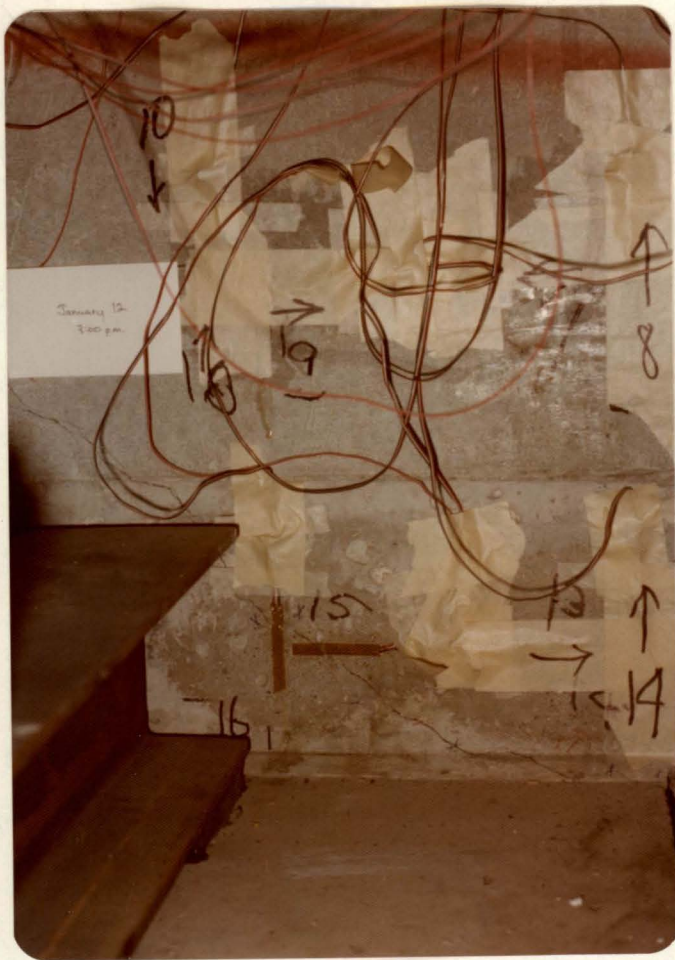
Photograph #19 -

Front-View of Stem, Displaying Diagonal Hairline Crack. (South-End Reaction)
Note Crack Propagation Through Strain Gage Numbers 15 and 16.

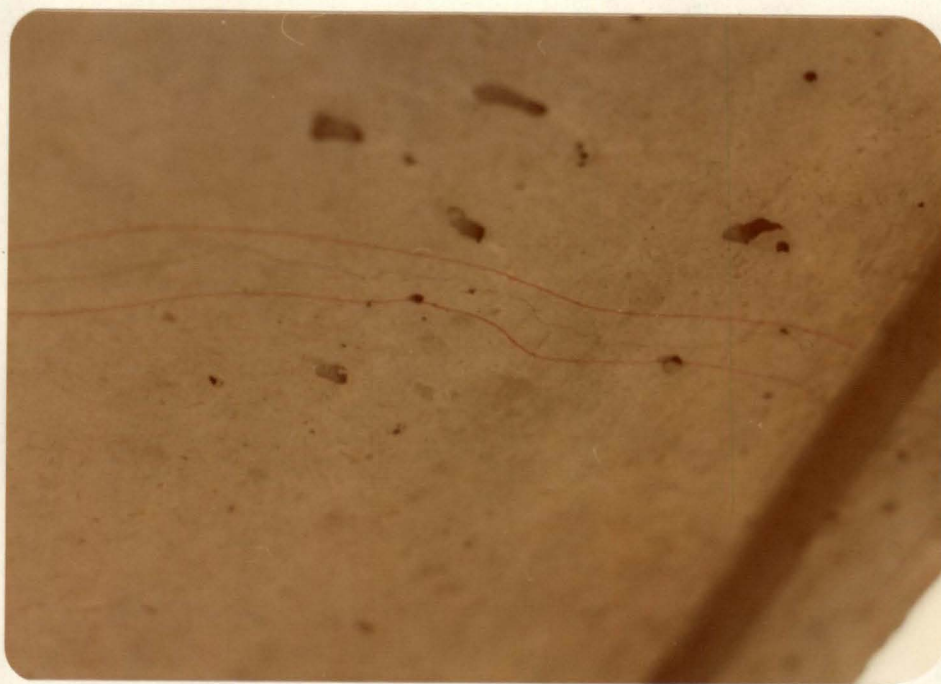
<u>DAY</u>	<u>DATE</u>	<u>TIME</u>	<u>STAGE</u>	<u>REMARKS</u>
Friday	1-10-75	11:30 a.m.	6	Hairline flexural cracks observed on underside of beam (See Photograph #20)
		1:45 p.m.	7	Hairline cracking observed on both the shelf and underside of beam.
		2:45 p.m.	8	
		3:00 p.m.	9	
		3:45 p.m.	10	No new cracking observed. ACI test load in place for 24 hr.
Saturday	1-11-75	4:45 p.m.	8	
		5:15 p.m.	6	
		5:45 p.m.	4	
Sunday	1-12-75	5:45 p.m.	4	END OF ACI LOAD TEST (END OF 24 HR REBOUND). Fine hairline diagonal cracks observed at each end reaction. Also, several small areas of horizontal micro-cracking observed above shelf on stem.

Photograph #20 - Bottom-View of Shelf Exhibiting Hairline, Flexural Crack - Typical

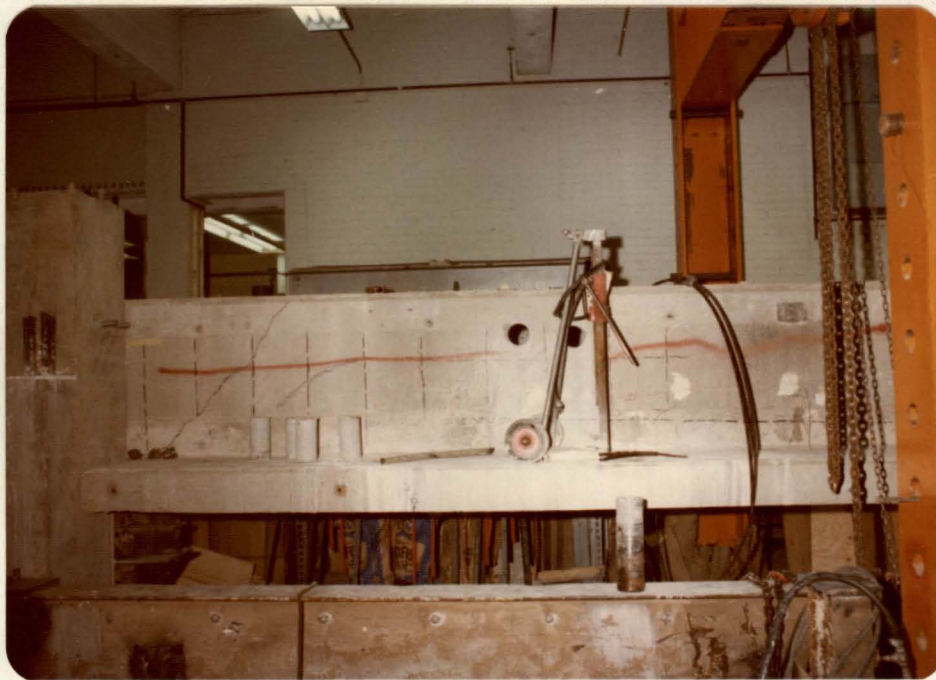
We should note that a pair of diagonal cracks did develop in the vertical portion of the spandrel beam under the full ACI test load. In addition, what appeared to be the first signs of horizontal crack development in the vertical leg were also noted during the final hours of the full ACI 24 hour test load. Nondestructive testing of the vertical portion of the end bearing regions of the spandrel beam indicated that no internal splitting of the member in the direction of the axis of the beam had occurred. This test information and all concrete core data are included in an appendix of this report.

Photograph #24 - Side-View of Concrete Spandrel Beam, During Coring Operation (North-End Reaction) Note - The Two Diagonal Cracks (near the Column) Outlined in Black.

The end cracking of the spandrel beams at the project site does present a problem with regard to pressure grouting. Therefore, we recommend that additional field investigation be performed to determine extent of splitting in the end regions of the beams and to develop the most feasible method of repair. We should note that both this investigative work and any epoxy pressure grouting can be performed while the structure is in service, since neither of these items affects the immediate safety of the construction but only the long-term performance and safety of the structure.

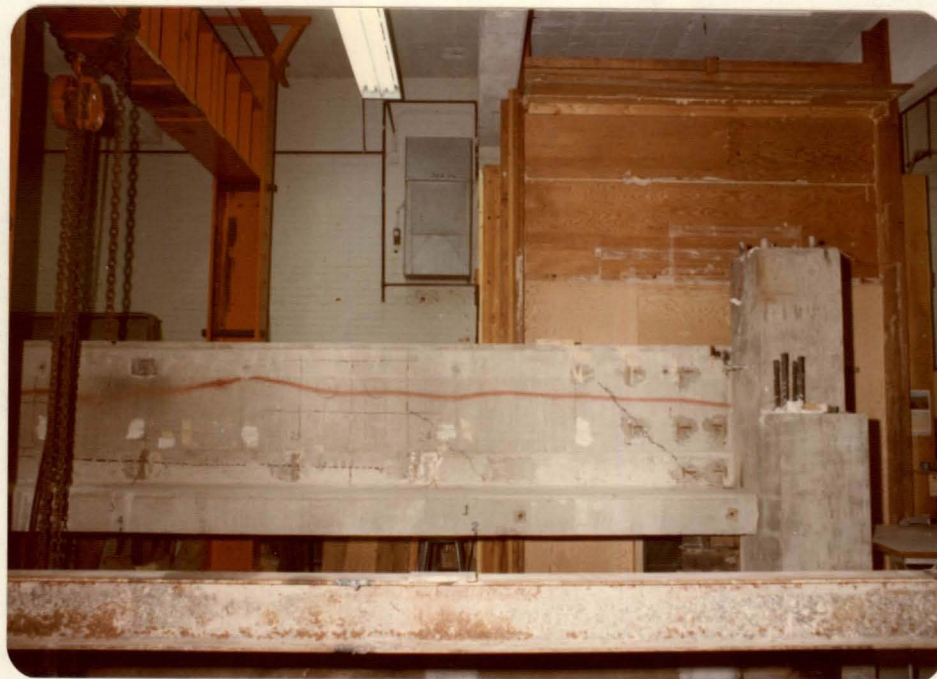
Photograph #25 - Side-View of Concrete Spandrel Beam, South-End Reaction. Note - the Two Diagonal Cracks (near the Column) Outlined in Black.
