Durability of Post-Tensioning Grout Systems with Mixed-In Chlorides

A THESIS
SUBMITTED TO THE FACULTY OF
UNIVERSITY OF MINNESOTA
BY

Benjamin L. Thiesse

January 2014

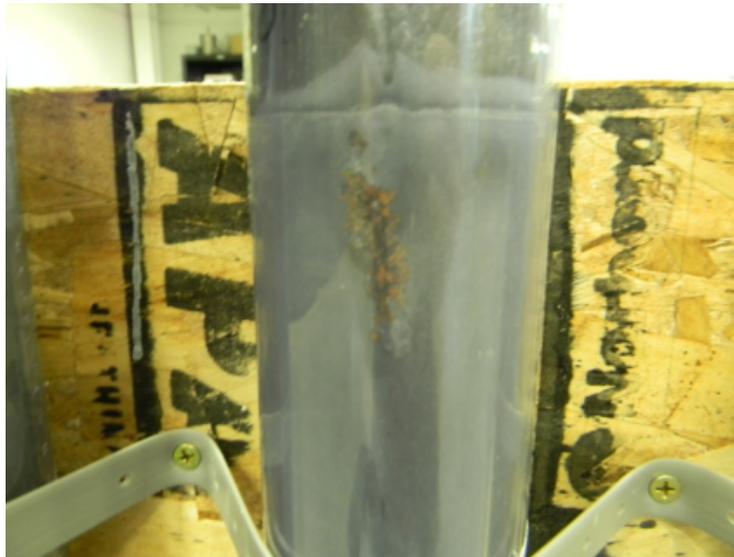
Figure 15: Specimen R-H-1.0-11.5-B

water – sample B. Figure 15 illustrates the corrosion stain that was observed during the inspection. This specimen contained the largest amount of chlorides that were tested along with the least amount of water that was mixed in the batch. This specimen had a stain that measured 4 centimeter long and 1 centimeter wide and was located where the strand was in contact with the plastic tube. As was common in the other specimens, this stain was located about 1/3 the way down from the top.

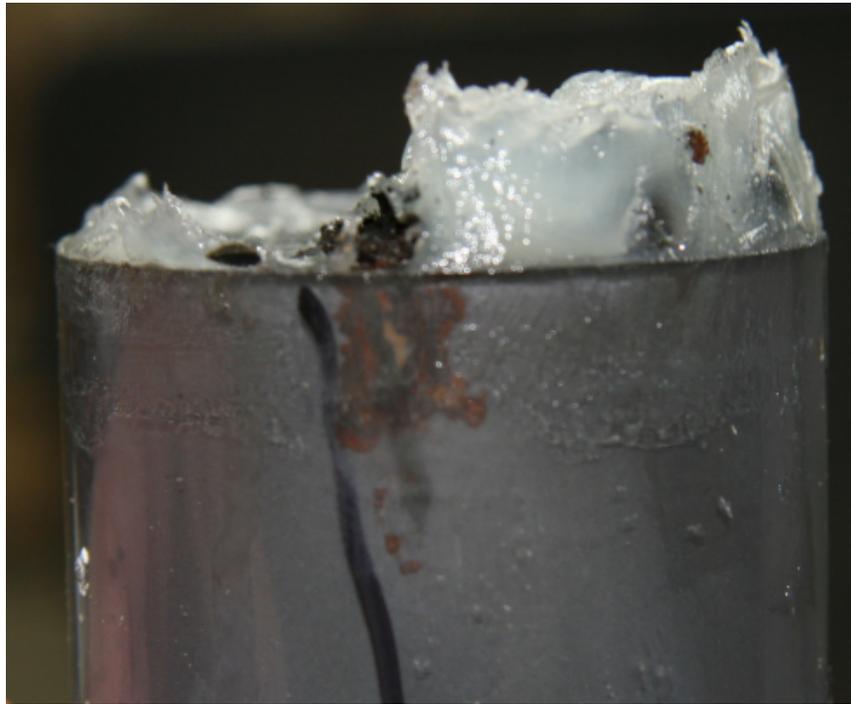
Figure 16: Specimen F-H-1.0-14-B

February 24th, 2012 was the date of the second inspection on all of the specimens inside the humid chamber. This inspection found five new corrosion stains and two new cracks. The new stains that were observed all happened on samples with 1.0% chlorides. However, instead of being similar to the January inspection, four of the five new corrosion stains occurred in higher water contents. Two of the new specimens were mixed with 13 pints of water, and two specimens were mixed with 14 pints of water. Specimen F-H-1.0-14-B (which is solid, has a drilled hole, 1.0% chloride, and 14 pints/bag of water) is one of the specimens that suffered corrosion with the highest mixed water content. This stain was measured to be 2 centimeters wide by 2 centimeters long and occurred at the top of the specimen, near the three strands. This stain was surprising because it grew substantially in the small amount of time between inspections. One justification for the corrosion is a lack of Vaseline that was applied to this specific area. Figure 16 shows a dark gap of Vaseline that should have been covering the steel to stop the corrosion from happening around it.

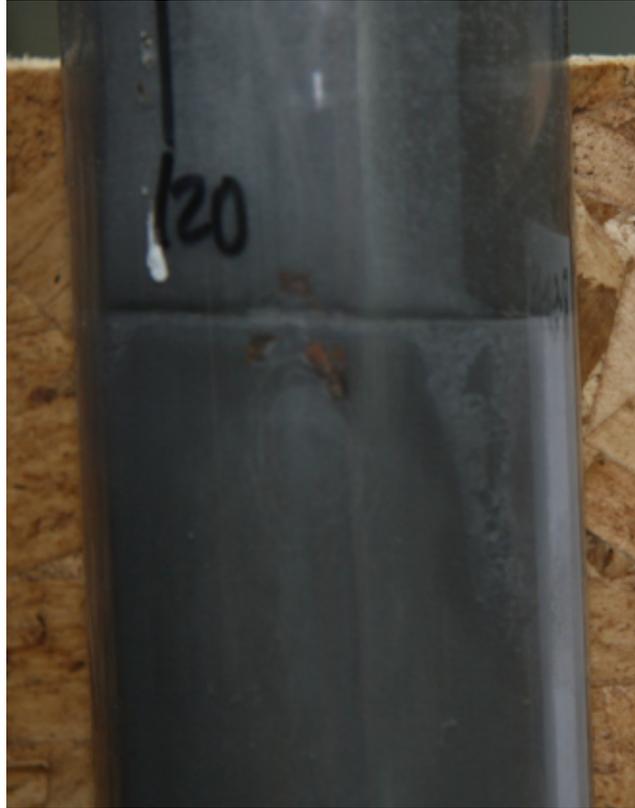
Figure 17: Specimen R-S-1.0-11.5-C

which is above the repair line, is a normally mixed grout with no added chlorides. While the grout below the repaired line is the grout with 1.0% chlorides and mixed with 11.5 pints of water.

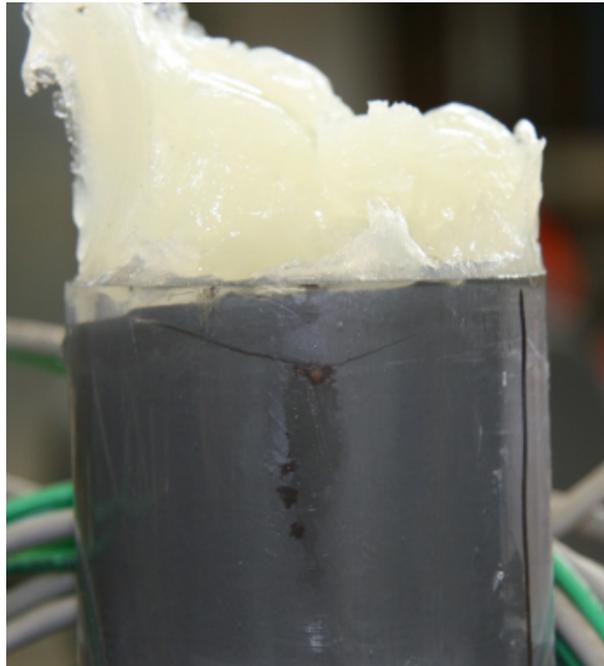
Figure 19: F-S-1.0-11.5-C

One of the new stains that were observed during this inspection was a little more interesting than the others. Specimen F-S-1.0-11.5-C (solid, sealed, 1.0% chloride and 11.5 pints/bag of water) had developed a stain that was near the strand location and was near the top. But, the notable characteristic of this stain was the crack that had developed with the stain. When corrosion occurs, the resulting material has a larger volume than the material consumed. This expansion creates tensile stresses in the concrete and causes cracks. This stain and crack were noted so that it could be determined if changes occur during the upcoming inspections, a picture of this specimen can be seen in Figure 19.

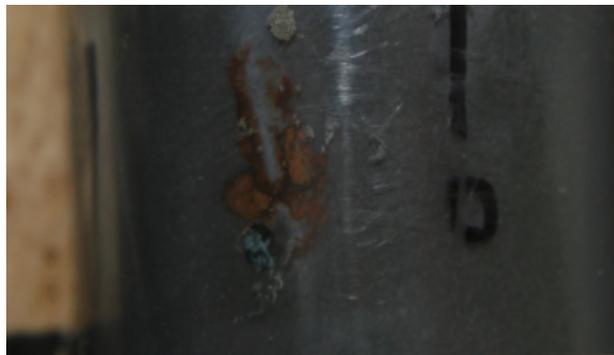
Figure 20: Specimen - V-S-.85-13-C

The April inspection was the first inspection that was conducted on the new samples that were created and placed into the environmental chamber in late March of 2012. The inspection on April 27th, 2012 saw the largest jump in corrosion stains of all the months of inspecting; there were 46 samples that showed new corrosion stains. When observing the month old samples, the majority of the stains were happening between the 0 and 120 degree markers. As stated previously, this is typically a surface-contact corrosion stain. A common stain that was occurring on the new specimens was a roughly 1-2 cm tall and 1 cm wide stain that was orientated just to the left of the 0 degree line. Figure 20 below illustrates how some of these stains were appearing. Another interesting relationship between these corrosion stains was the location vertically in the tube. Many of the new stains were occurring on the top half of the testing tubes. This was primarily due to the close proximity of the strand to the sidewall at the top and to the drilled hole in some of the samples.

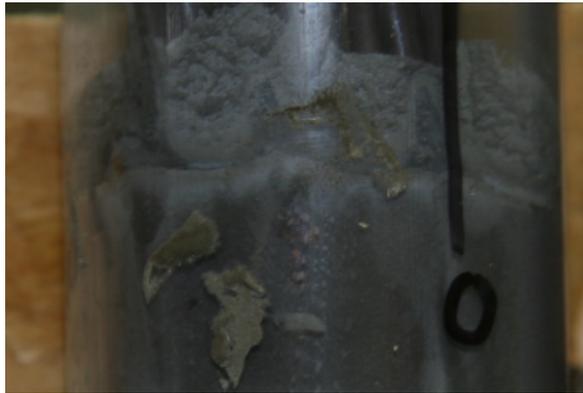
corrosion. Specimen V-S-.85-13-B (voided, solid, 0.85% chlorides, 13 liters of water) was experiencing a much more rapid rate of corrosion. As figures 21 through 23 illustrate, this specimen had more than 3 corrosion stains. Figure 21 is a picture of the top portion of the specimen. Although it is difficult to see past the dried grout attached to the outside and the positioning of the glare from the flash; there lies a stain that measures to be 1cm x ½ cm. This stain is very similar to the stains that were recorded to the other specimens; it lies left of the 0 degree line, it lies within the top 4 cm of the top, and its shape is consistent with the other samples.

Figure 21: Specimen V-S-.85-13-B, Top portion of specimen

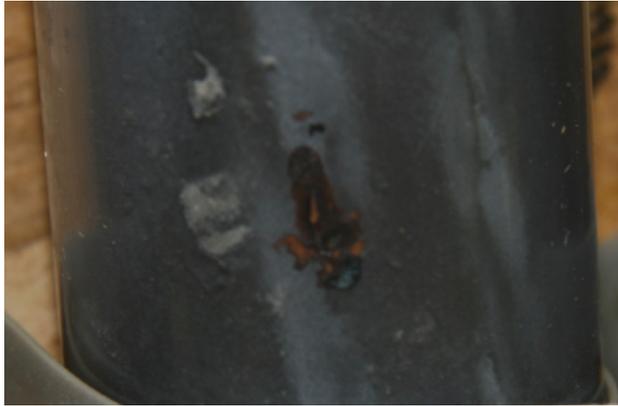
The second corrosion stain that occurred was the largest of the three stains. This stain measured to be 1.5 cm long and 1 cm wide. The stain location was expected when compared to other specimens. The stain occurred nearest to a strand, with the longest dimension of the stain along the direction of the strand. Figure 22 shows the stain. In this picture, it is clearly seen that there are two lighter colored grout channels. This differentiation in color on the grout is due to the strands being in such close proximity to the side of the container.

Figure 22: Specimen V-S-.85-13-B, Middle portion of specimen

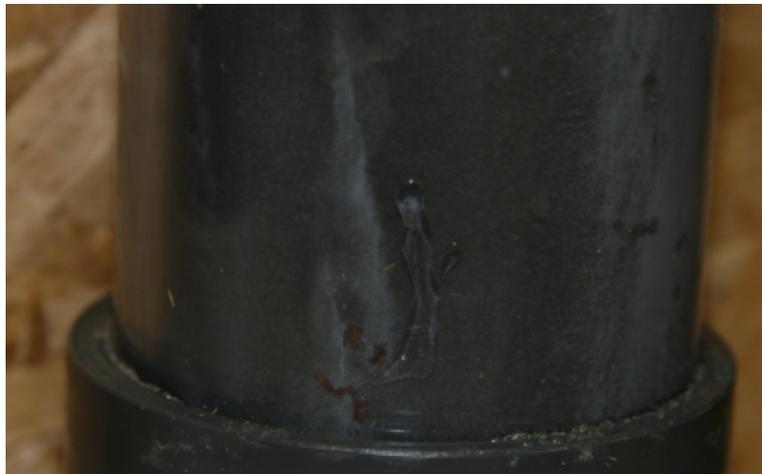
Figure 23 illustrates a stain that was recorded due to the strand being close to the side wall of the tube near the bottom of the specimen. This stain which resembles a “frown face” was measured to be two $\frac{1}{4}$ cm dots and a $\frac{1}{2}$ cm long stain that was occurring on the opposite side of the strand. Again, in this figure the proximity of the strand to the sidewall of the tube can be seen in the light coloration of the grout. This condition represents a common situation in the field; whenever a post-tensioned duct deviates from linear, the strand will compress against the sidewall when it is tensioned.

Figure 23: Specimen V-S-.85-13-B, Bottom portion of specimen

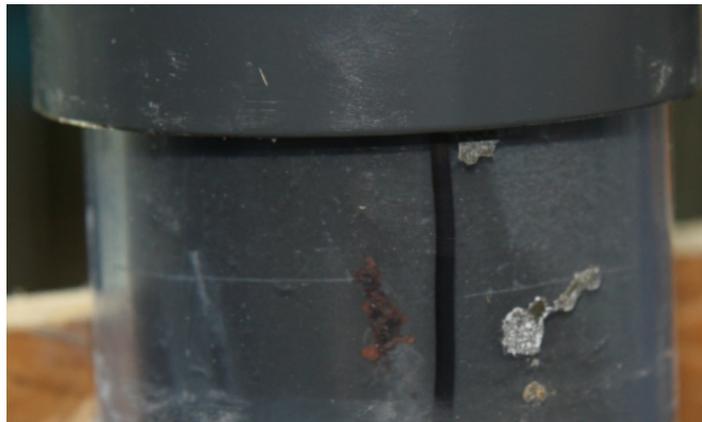
Figure 24: Specimen F-H-1.0-13-A-2

Looking further into these four samples, all three had roughly the same size of corrosion stain. Figure 24 illustrates one of these four samples. As it is clearly seen, the sample only experienced a small stain; it measured 1 cm in height and ½ cm in width. The black line that is just right of the corrosion stain is the zero degree line. This means that this stain, along with the other three new stains, were all next to the strands.

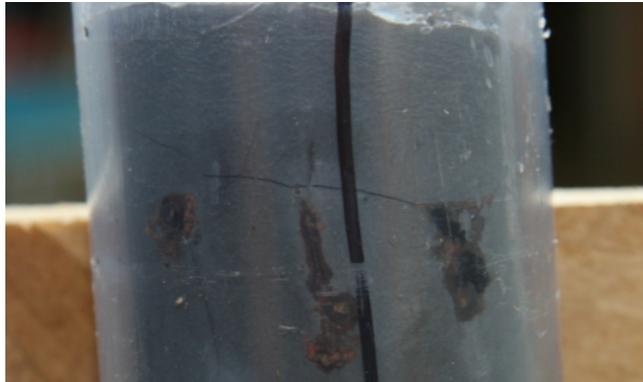
Figure 25: Specimen F-S-1.0-11.5-B-2

chlorides, 11.5 pints of water) changed rapidly in the month since the previous inspection; it can be seen in Figure 25. This specimen is only two months old and during this inspection, had one new stain, a changed stain, an unchanged stain, and a growing crack.

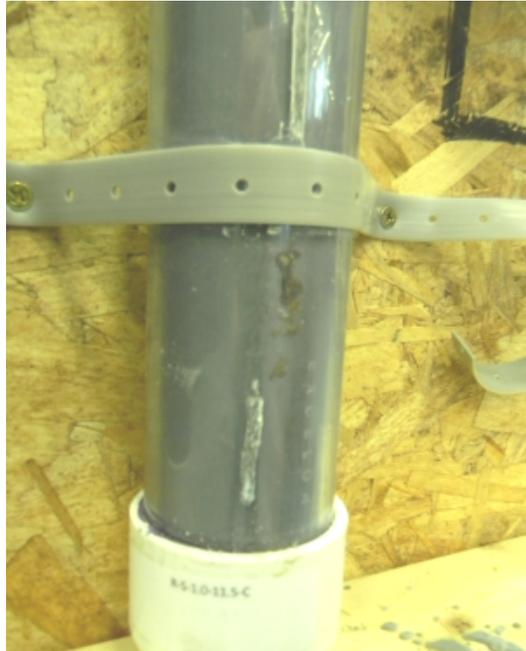
Figure 3: Specimen R-S-1.0-11.5-C – First Stain

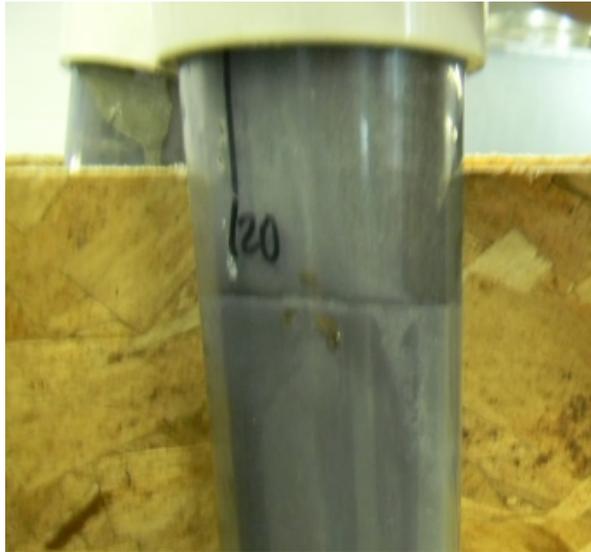
Figure 4: Specimen R-S-1.0-11.5-C – Second Stain

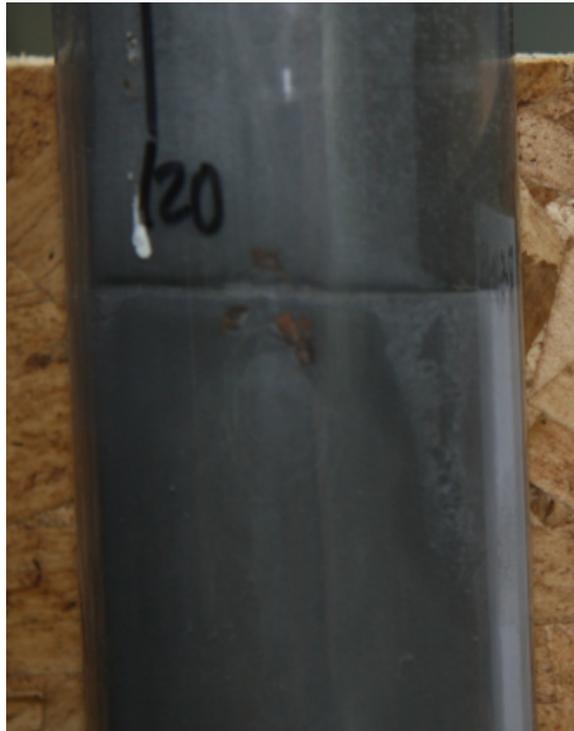
Figure 4: Specimen R-S-1.0-11.5-C – Second stain with cracking below the stains

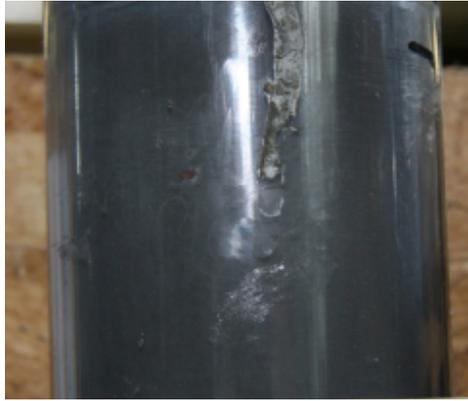
Figure 5: Specimen R-H-1.0-11.5-A, Stain and cracks surrounding stain

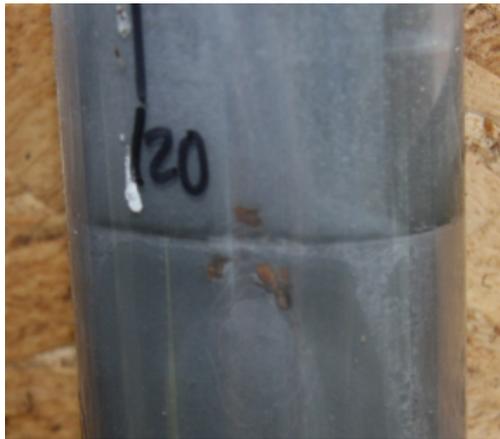
Figure 4: Specimen R-S-1.0-11.5-C – Second stain with cracking below the stains

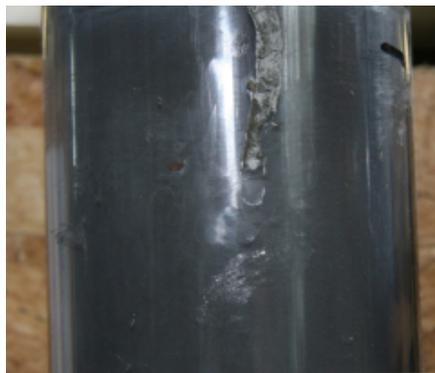
Figure 5: Specimen R-H-1.0-11.5-A, Stain and cracks surrounding stain

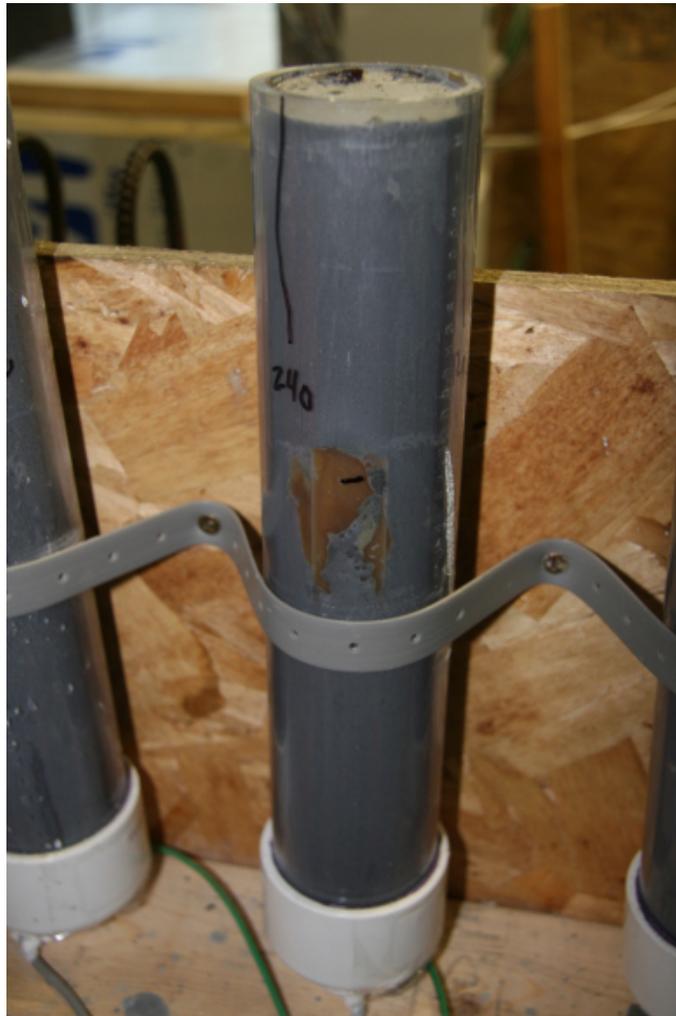
Figure 21: Corroded Electrode Pad

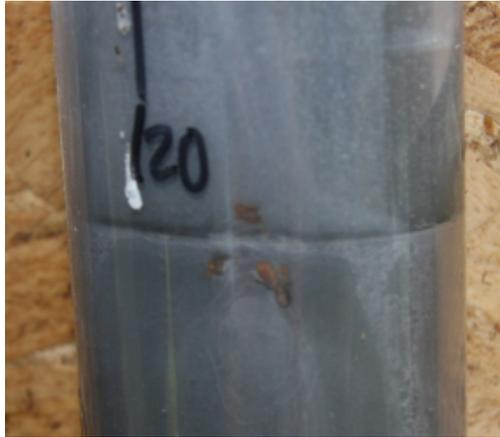
Figure 3: Specimen R-S-1.0-11.5-C – Second stain with cracking below the stains

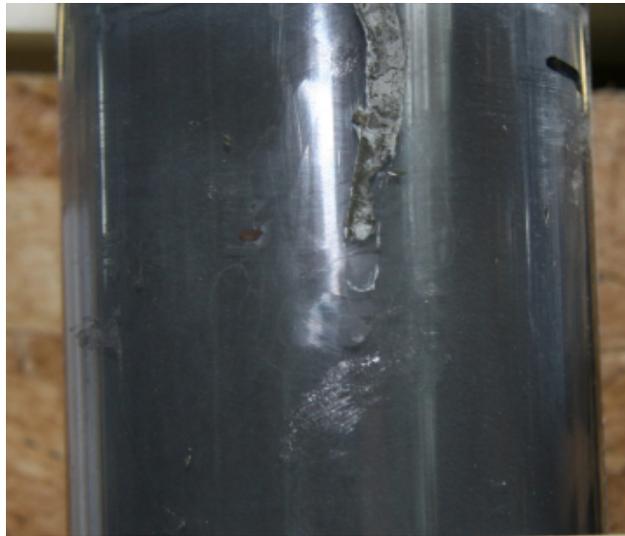
Figure 4: Specimen R-H-1.0-11.5-A, Stain and cracks surrounding stain

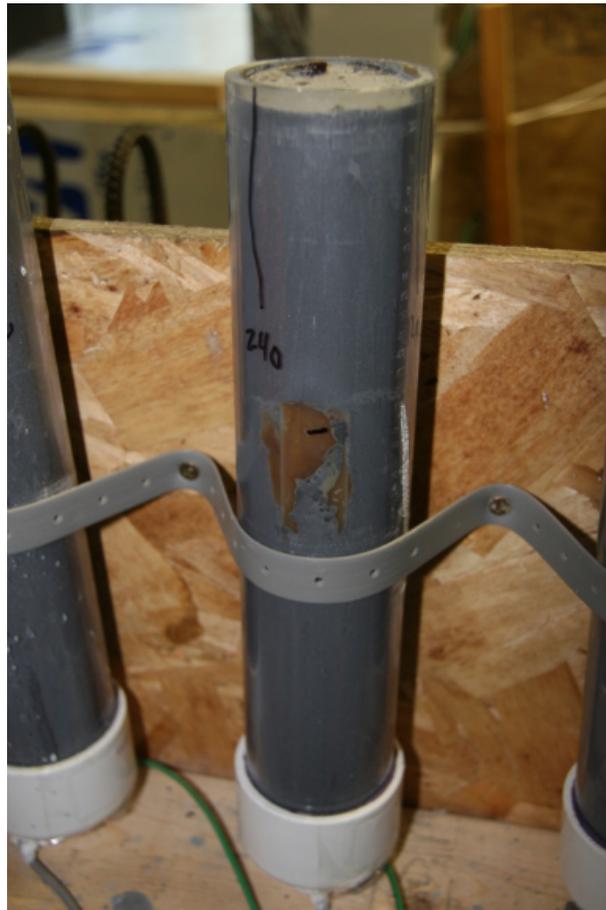
Figure 70: Corroded Electrode Pad

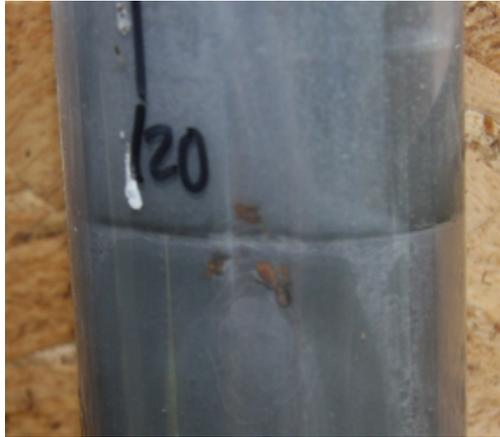
Figure 3: Specimen R-S-1.0-11.5-C – Second stain with cracking below the stains

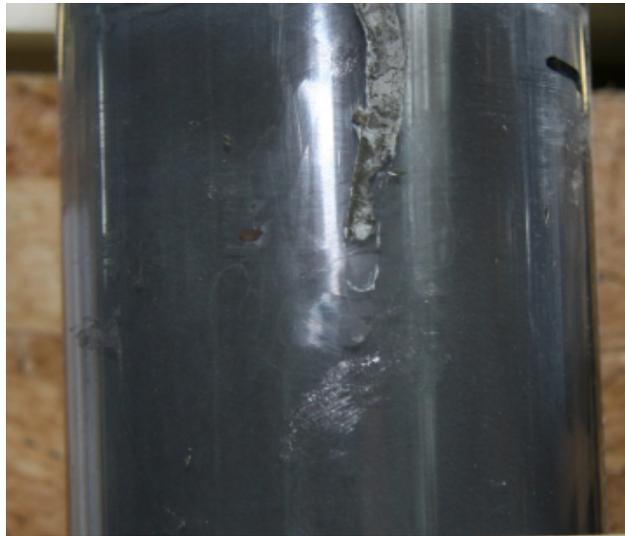
Figure 4: Specimen R-H-1.0-11.5-A, Stain and cracks surrounding stain

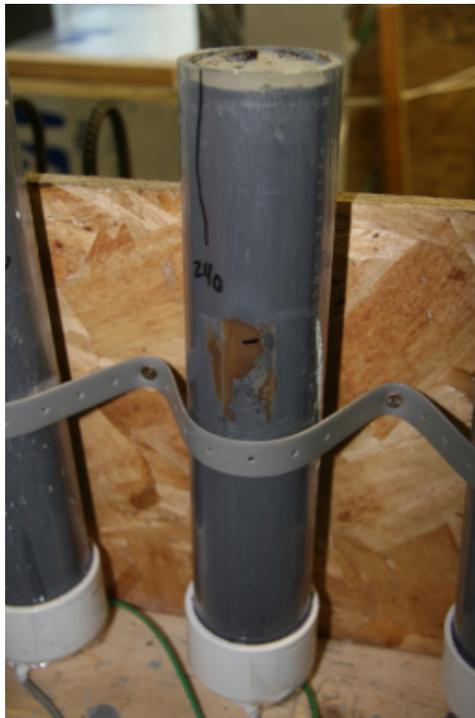
Figure 73: Staining on Electrode Pad
