Hati Flight 01 Analysis

Synopsis

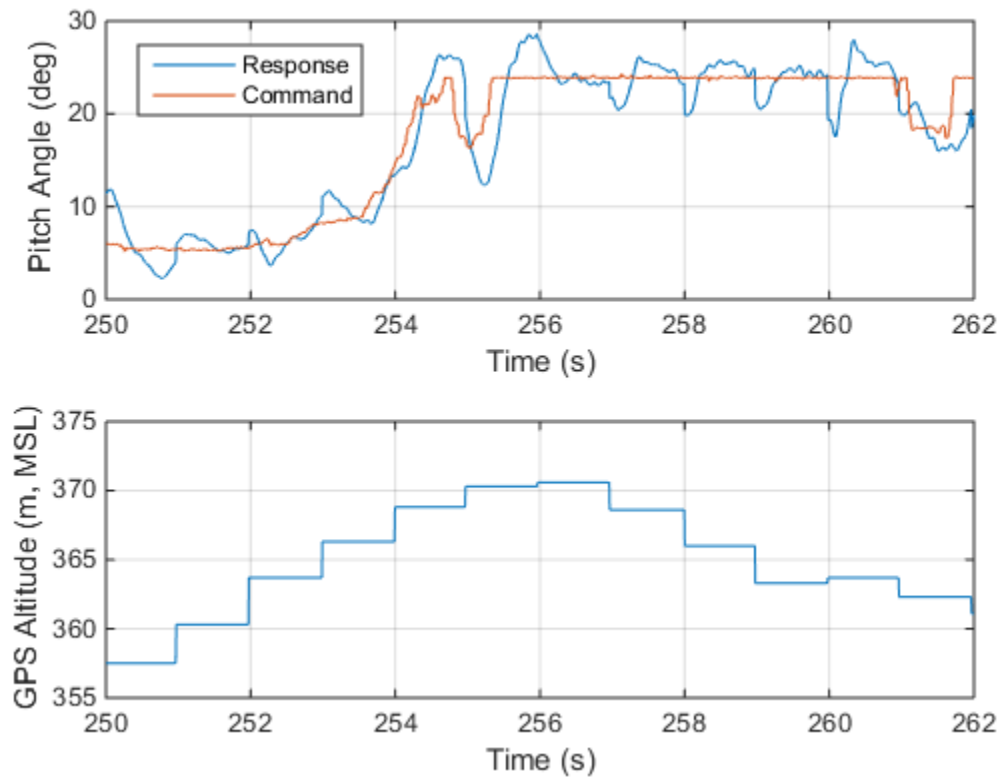
During Hati Flight 01, poor Euler angle tracking was discovered leading to suspension of tests and a return to landing shortly after engaging the autopilot. In autopilot mode pitch and roll stick are mapped to pitch and roll angle commands. This behavior was observed during flight as an unresponsiveness to pilot input. Post-flight, a poor Euler angle solution can be observed as a mismatch between the computed angles and the aircraft dynamics. Below is an example where the pitch angle is reported at its upper saturation limit while the aircraft is descending and the throttle command is decreasing to maintain speed.

Figure 1: pitch command unresponsiveness in descent

The GPS data truncation will be corrected. Additionally, accelerometer data will be used to compute pitch and roll attitude angle to initialize the navigation filter. Either magnetometer or GPS course data will be used to initialize the navigation filter heading. If we use GPS course data, the aircraft will need to be in motion during heading initialization. As a short term solution, the initial heading could be set based on the launch direction. An additional correction would be the addition of a trigger to begin data recording to allow for a longer timer after navigation filter initialization before the beginning of flight.

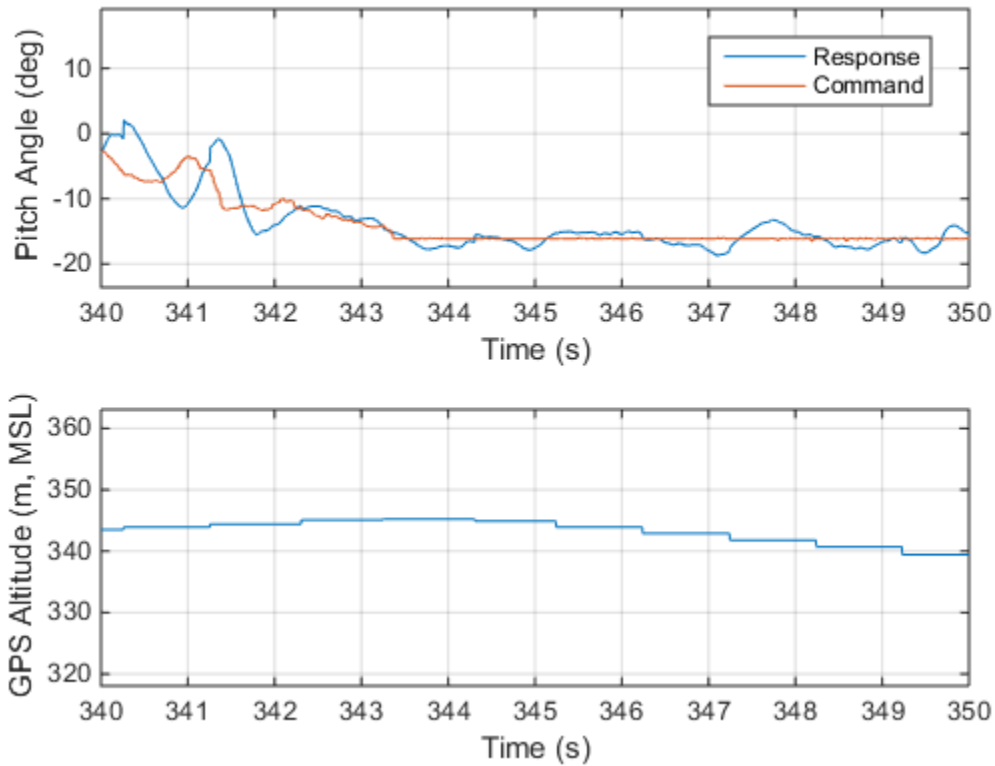
Similarly, below is an example where the pitch angle is reported at its lower saturation limit while the aircraft does not respond.

Figure 2: pitch command unresponsiveness in level-flight

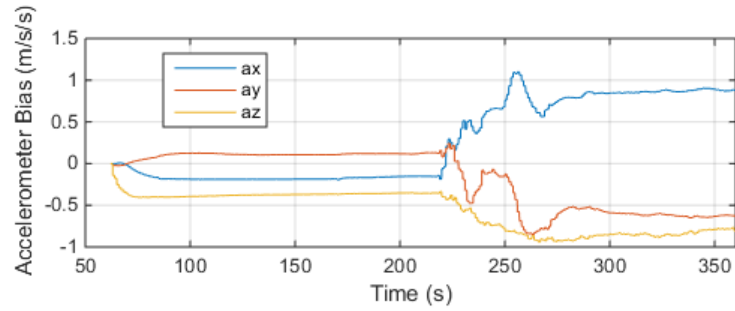
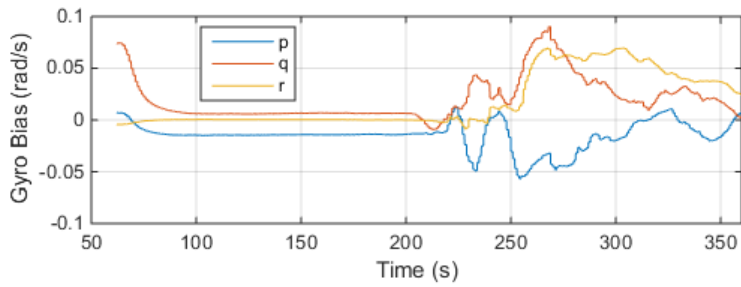
The 15 state EKF filter computes and records accelerometer and gyro biases. Initially, these biases converge, but immediately following the aircraft release at about 220 seconds, these biases diverge.

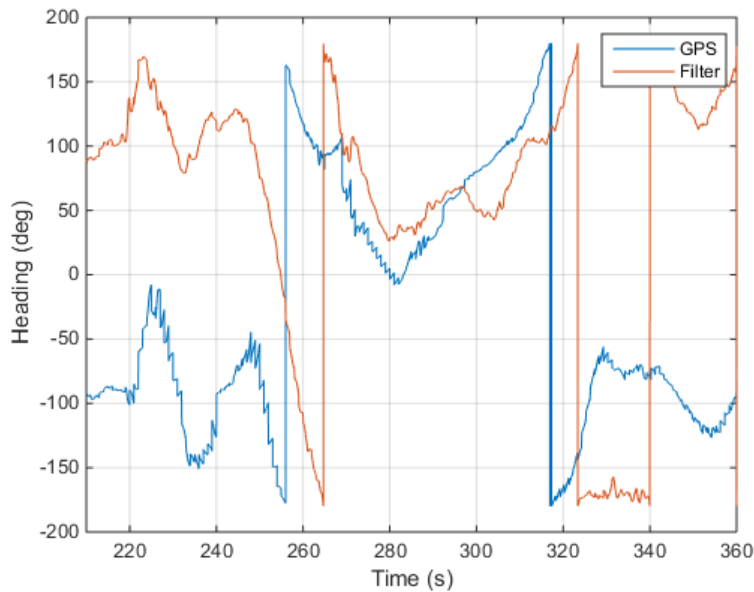
The 15 state EKF was initialized with hard coded values of +8 degrees pitch angle, 0 degrees roll angle, and +90 degrees heading. These values were used because this is how the filter was flown in the past with multiple hundred flights over several years without noticeable problems. Following initialization, these should converge to the true values. During this flight, heading angle did not converge prior to flight.

For Hati Flight 01, a West launch heading was used, but the software was reset on the truck because of the new higher sampling rate. This flight was the first using a 150 Hz sampling rate, which limits the flight data recording time to just over 8 minutes. With flight times of about 6 minutes, the decision was made to reset software on the truck just prior to launch. The hypothesis is that without significant heading motion or time prior to launch, and the initialization of a value 180 degrees from the true value, the EKF did not converge prior to launch.

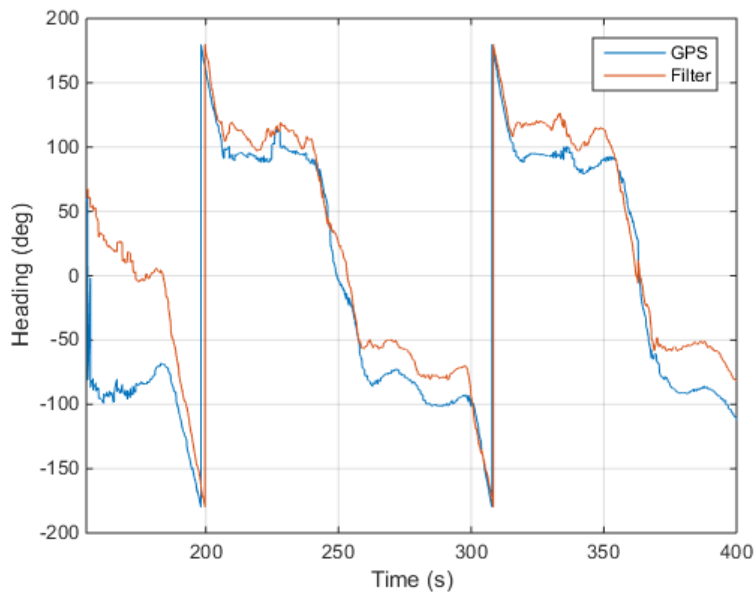
The one other flight where a West launch direction was used immediately following a software reset occurred on Skoll Flight 09. It is interesting to note the similarities between Skoll Flight 09 and Hati Flight 01. First, the heading angle was not correct until the first turn to the East to set up for the initial test point.

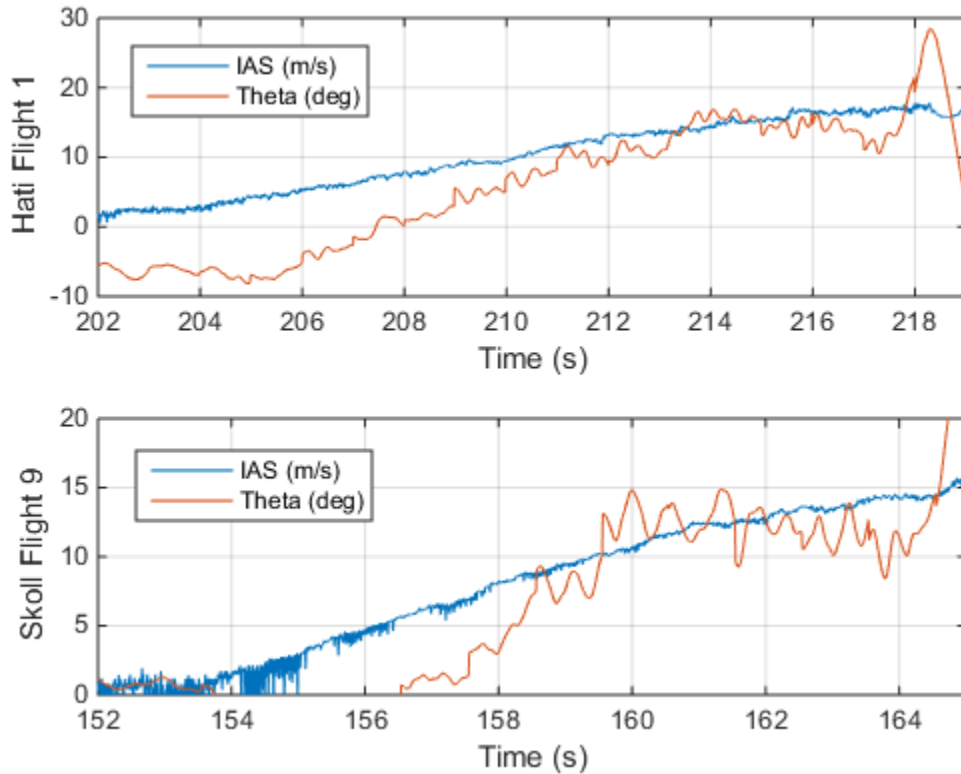
Second, on both flights, the pitch angle increases during the truck acceleration up to launch speed. This behavior was not observed on any other Skoll flights and is known to be inaccurate based on launch videos.
