The Andrew Peterson Farmstead

ARCH 5672: Historic Building Conservation

There are many historic structures existing on the farmstead. For the purposes of this project, the class was asked to focus on the Farmhouse (1870), the 1917 Barn, the Granary, and the South Barn. Groups from the class conducted conditions assessments of each of these structures. The resulting document prepared by the class is to be used as a tool for the Carver County Historical Society in the preservation of the farmstead. The document not only provides recommendations for each structure's ultimate use and interpretation, but also provides a list of high-priority items for the immediate stabilization of the structures, and information on on-going maintenance and preservation.

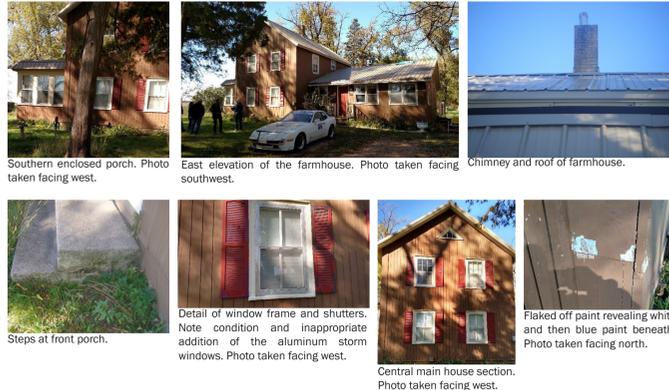
Although structurally sound, the exterior of the building is in need of some repairs that exceed routine maintenance. Portions of the brown paint on the south facade shows flaking, peeling, and water damage. It is recommended that the paint on the boards and the window trim be removed and repainted. The Carver County Historical Society plans to restore the building to its 1885 appearance, which would mean the house would be repainted its historic blue color. It is also recommended that the windows on the front facade be replaced with six-over-six windows as seen in historic photographs. The window shutters should also be removed, since no shutters are evidenced in the 1885 photographs.

Southern enclosed porch. Photo taken facing west.

East elevation of the farmhouse. Photo taken facing southwest.

Chimney and roof of farmhouse.

Steps at front porch.

Detail of window frame and shutters. Note condition and inappropriate addition of the aluminum storm windows. Photo taken facing west.

Flaked off paint revealing white and then blue paint beneath. Photo taken facing north.

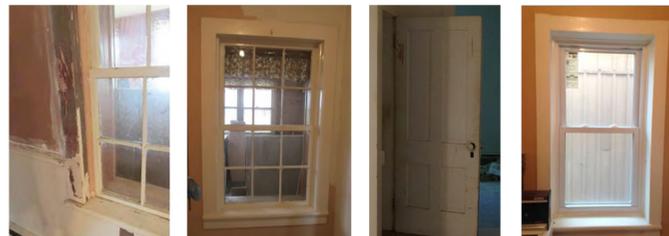
The original trim on this window in the kitchen is in good condition, but should be repainted to a historically appropriate color based on paint sampling.

This window between the kitchen and the enclosed porch on the first floor is in excellent condition.

The door leading to the basement is a historic four panel, traditional stile and rail door. The original knob and lockset are intact.

This non-historic window is in the small room to the northwest of the kitchen. Several other new vinyl windows exist, and should be replaced with windows that match the historic appearance of the adjacent windows for interpretive purposes.

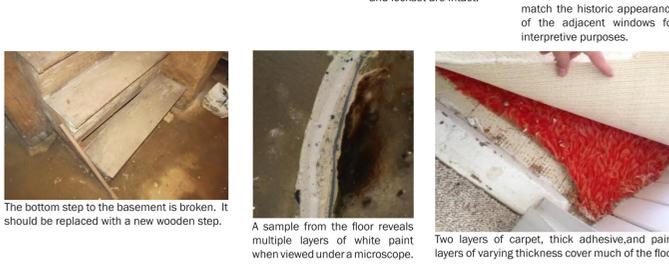
The bottom step to the basement is broken. It should be replaced with a new wooden step.

A sample from the floor reveals multiple layers of white paint when viewed under a microscope.

Two layers of carpet, thick adhesive, and paint layers of varying thickness cover much of the floor areas.

Closer microscopic analysis may be used to determine precisely paint layer and color. Most paint is chipped or peeling, and sometimes not applied correctly; the materials should be repainted properly in the appropriate color. The underlying material is in good condition; some chips may need to be filled. Paint on the floors, railings, and doors, because of its condition, should be completely removed. The floor should be sanded to remove paint; chemical treatments are preferable for detail areas such as beadboard, railings and windows. Some paint will remain in areas that are repaired. Since there is almost certainly lead paint, this layer should be sealed in. Removed paint will need to be disposed of in accordance with state laws for hazardous material. Removal of large areas of paint should be carried out by a professional.

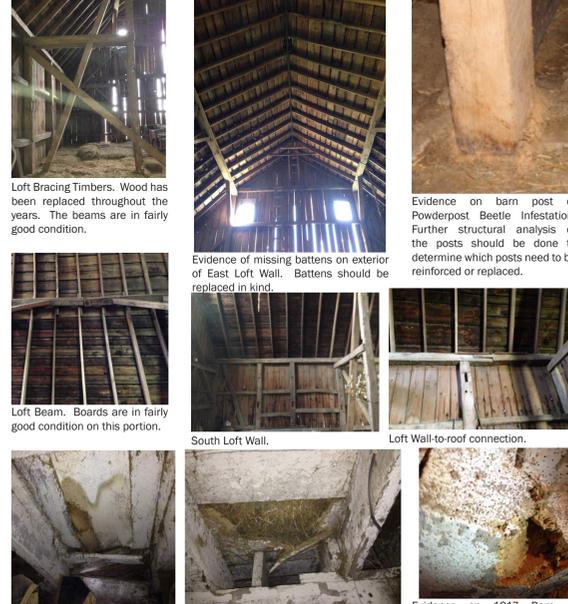
Loft Bracing Timbers. Wood has been replaced throughout the years. The beams are in fairly good condition.

Evidence of missing battens on exterior of East Loft Wall. Battens should be replaced in kind.

Evidence on barn post of Powderpost Beetle Infestation. Further structural analysis of the posts should be done to determine which posts need to be reinforced or replaced.

Loft Beam. Boards are in fairly good condition on this portion.

Water damage in the floor visible from the lower level. Floor repair is a high priority.

Floor damage seen from lower level. Several floor boards are missing and hay is falling through. The floor should be repaired before visitors enter the barn for safety issues.

Evidence on 1917 Barn of Powderpost Beetle Infestation. Powderpost beetles are a sign of moisture in the wood. Measures should be taken to ensure water is not infiltrating the barn.

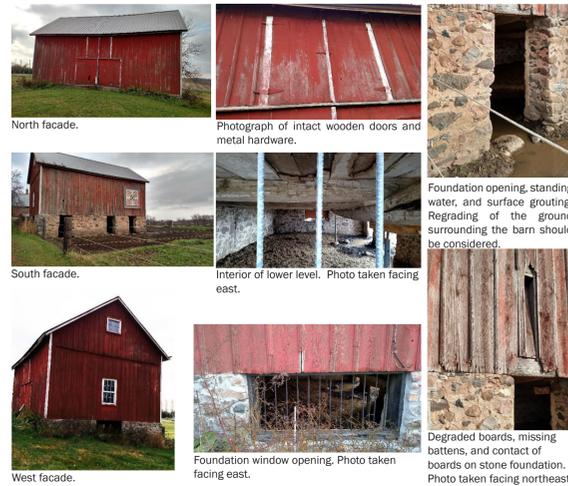
The South Barn was built during Andrew Peterson's lifetime in 1884 to be used as a cow barn. Similar to the Big Barn, we recommend that damaged wood be replaced for aesthetics, but also after the professional assessment of structural integrity. The foundation appears to be in decent condition, but should be repointed.

Photograph of intact wooden doors and metal hardware.

Foundation opening, standing water, and surface grouting. Regrading of the ground surrounding the barn should be considered.

Degraded boards, missing battens, and contact of boards on stone foundation. Photo taken facing northeast.

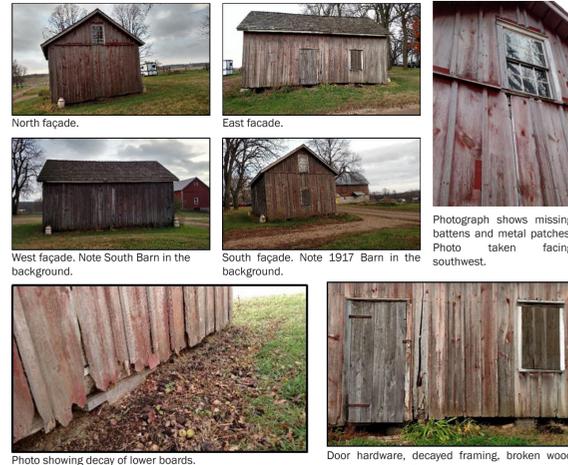
Photograph shows missing battens and metal patches. Photo taken facing southwest.

Door hardware, decayed framing, broken wood and second boarded window space.

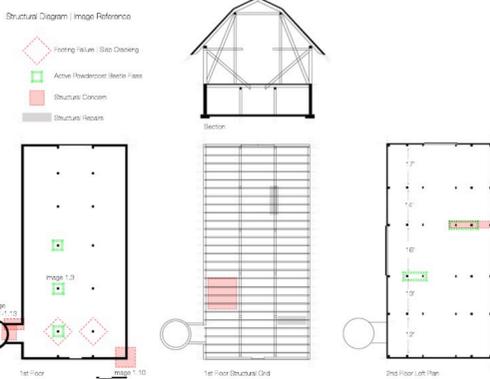
Structural Diagram | Image Reference

Roofing Issues (See Decking)

Active Powderpost Beetle Infestation

Structural Concern

Structural Repair
