Conditions Assessment for the Andrew Peterson Farmstead

Peggy Anderson, Alejandro Sanchez, Mohamed Alqari, Fred Counts, Anne Drolet, Holly Engle, Joel Holstad, Elizabeth Kinney, Jenna Rempfert, Sarah Ward, Alexandr Young, and Lisa Zeeb

Students in ARCH 5672: Historic Building Conservation
Instructor: Todd Grover, AIA

ANDREW PETERSON FARMSTEAD Carver County, Minnesota

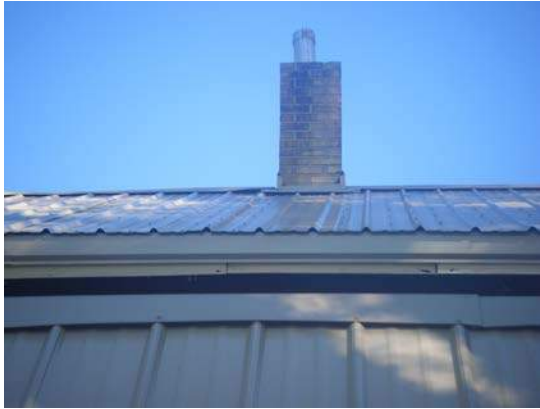
There is a brick chimney made of Chaska brick, see Figure 4. It has 14 courses visible above the roof flashing, and appears to be in good condition. It was impossible to get a close look of the chimney, so further inspection would be recommended. The flashing appears to be new and was probably installed when the new roof was installed. From our visual inspection from the ground it looks like it is possible that the flashing is inadequately sealed, but this would need to be verified. The chimney flue appears to have a metal liner with a screen cap, but it was not possible to determine whether this metal liner went full height of the chimney flue. There is some staining on the chimney exterior, but this should not affect its durability.

Figure 4: Chimney and roof of farmhouse

The farmhouse was recently re-roofed with standing seam metal roofing. It is a tan colour. The timber fascia boards below the roof were not replaced at this time, and are showing some deterioration.

It is recommended to paint any deteriorating painted wood of the building exterior. This would include window frames and the fascia boards.

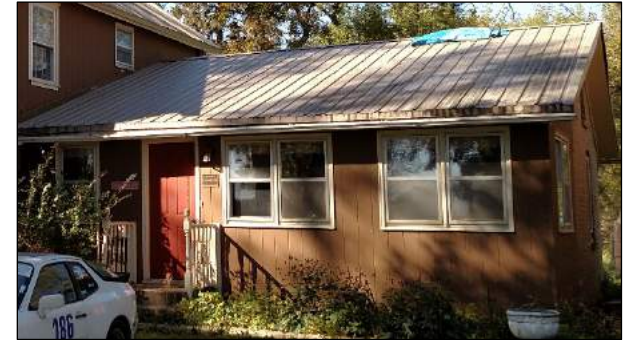
The roofing material does not show deterioration or failure, although the soffits do have some water staining. The north wing's downspout does not show any deterioration of the paint. (fig. 5)

Fig. 5) North wing; enclosed porch. Note windows, door placement, and gutters. Photo taken toward the southwest.

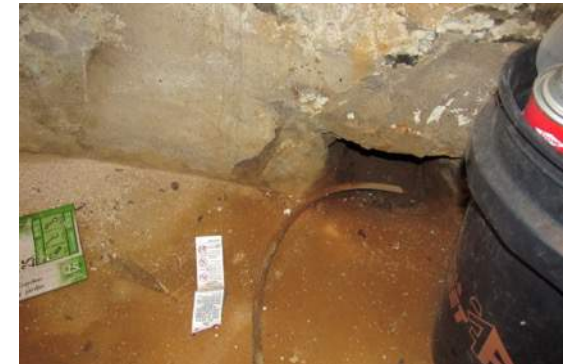
Basement- Hole in Foundation by Main Stairs

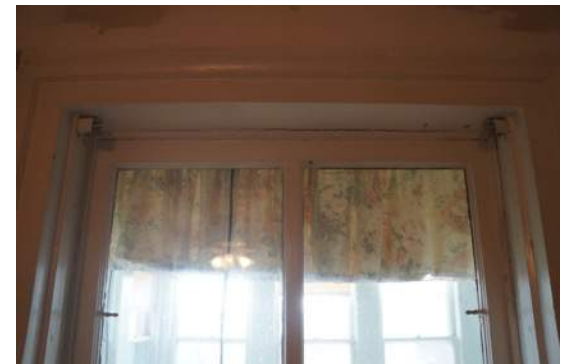
Window 6d- Missing Blinds

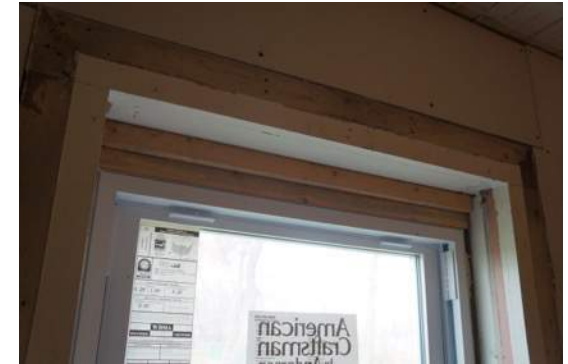
For Window 5a, there is a non-historic screen on the exterior. The installation is poor, and spray filler is visible around the window edges. The new vinyl window is not tall enough to fill the original frame. A wood infill panel has been added to close the opening. On the interior of the historic wood frame, there is a strip of missing paint. Examination of other original wood frames of the farmhouse suggests that the unpainted strip was once concealed by a wood guide. The top right interior of the frame shows water damage. Investigation into the source of this damage must be made and the issue should be addressed as soon as possible in order to prevent further damage. There are also insect holes in the top of the window frame. These are most likely caused by powderpost beetles. The presence of these insects is an indicator of moisture problems within the wood. Before repairing the window, overall moisture problems should also be addressed.

Window 5a- Wood Filler at Head

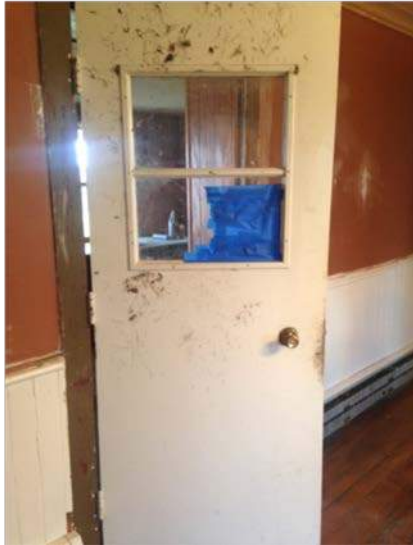
Door 3-1, Broken Light

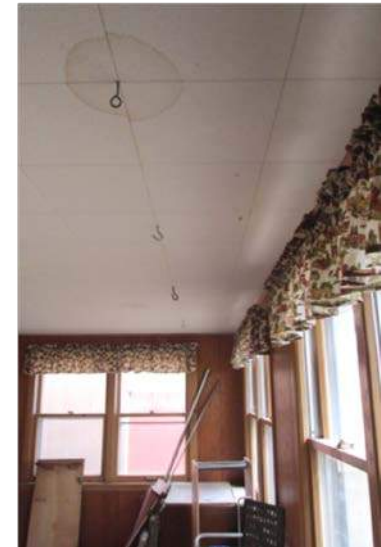
Room 4- Ceiling Water Damage

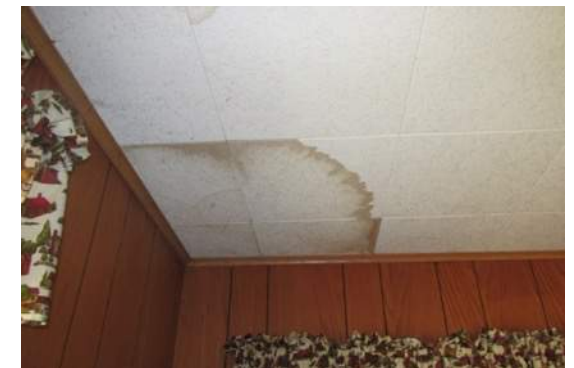
Room 4- Ceiling Water Damage in Southwest Corner

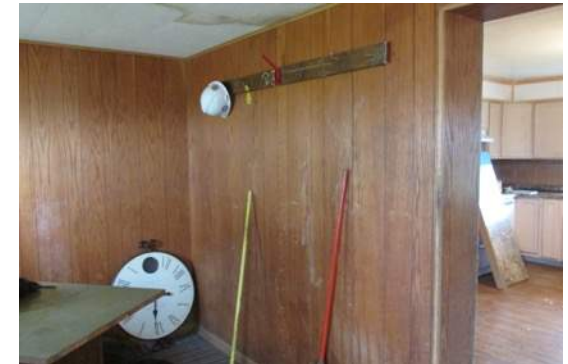
Room 4 Water Damage on West Wall

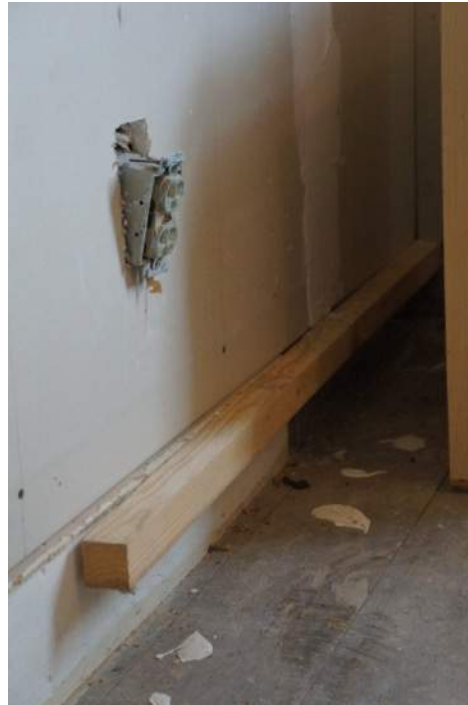
Room 5- Electrical Outlet with No Cover, Hanging Out of Wall, Missing Baseboard

In Rooms 4 and 5, an electrician should inspect the wiring and stabilize as necessary. In Room 4 specifically, a new faceplate should be added to hide visible wires. In Room 5, depending on the function and interpretation decided for this room, the wires may need to be concealed. If they are determined to be desired as part of the new function, they should be properly secured. In addition, the style and date of the fixture in Room 5 may not be desirable for certain interpretations of the house. If determined undesirable, the light fixture should be taken down and the residual ceiling hole should be repaired. New faceplates should be added prior to use of electrical outlets. Rooms 1, 2, and 3 have no exposed wiring.

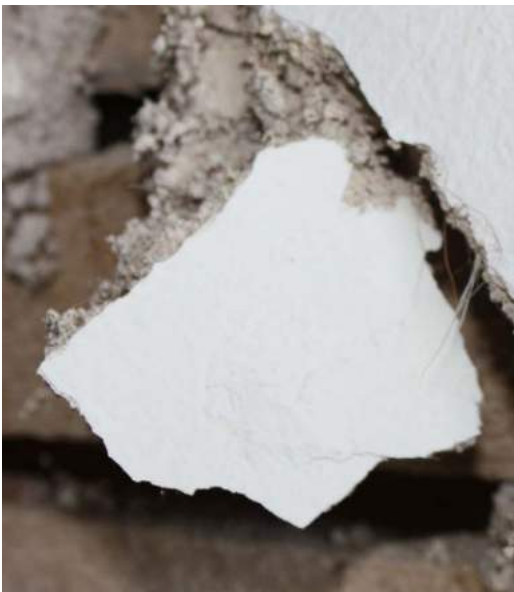
Several of the plaster walls have holes that need to be repaired. There is animal hair mixed in with the plaster. The vent in the wall at the top of the stairs next to the small window appears to be added on at a later date because the opening in the wall behind it is rough-cut and irregular shaped. It was hard for us to determine wall color on the plaster, but glue residue was evidence that the walls had been papered over at some point. A partition wall by the bathroom is recent and constructed with gypsum board. Beadboard walls are in good condition.

Figure 11. The horse hair matrix is clearly visible in this damaged portion of the wall.

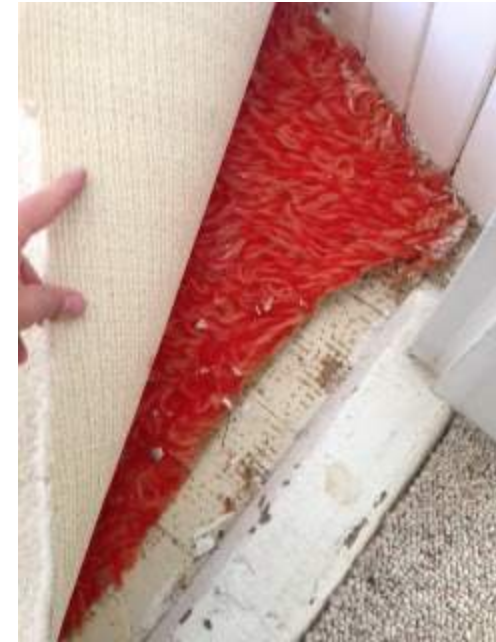
Figure 12. Two layers of carpet, thick adhesive, and paint layers of varying thickness cover much of the floor area.

Recommendations: Check the Peterson Diary for a reference of painting done to floors. It may be appropriate to repair and refinish some floors while leaving others painted. As can be seen in Figure 12, much of the floor area is covered with carpet and adhesive. We recommend scraping and sanding down these areas, followed by repainting. For the detailed areas on and around the stair railing, which have areas of very thick, poorly applied and peeling paint, scraping and chemical paint remover should be used. Chemical removal methods require ventilation of the work area, and since the paint almost certainly contains lead, appropriate safety measures should be taken. The first layer of paint on the floor is white; there is more about paint in a following section.

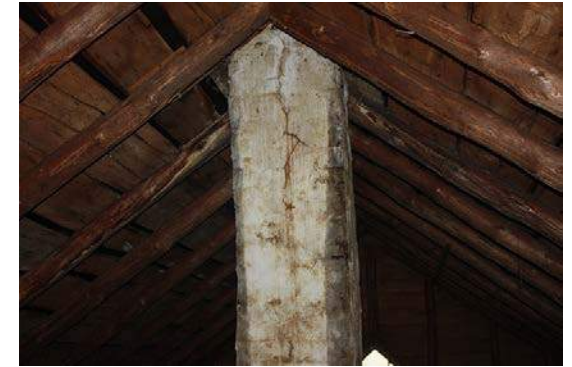
The parging of the chimney is cracked and discolored. This is probably due to water that had been leaking at the opening. More analysis is required to determine the structural integrity of the chimney.

Figure 17. The chimney parging is cracked and discolored. Although water infiltration appears to have been halted, discoloration and insect nests remain.

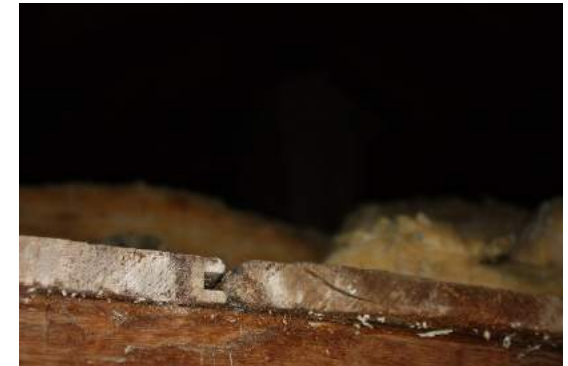
Figure 18. Old, dirty insulation should be removed.

There does not appear to be any ventilation in the attic space. To prevent moisture build up in the future, this should be added in such a way as not to disrupt the appearance of the house. Any ventilation scheme should take into consideration the purpose and final plan for the house. Adjustments will vary based on whether the attic is to remain closed off, or to be opened up to reveal construction. If the attic remains closed, a combination of low-profile ridge vent and soffit vents and new insulation may suffice. If the house is to be visited year-round and the attic significantly opened, it will need to be analyzed in the larger context of an HVAC scheme devised by a qualified engineer.

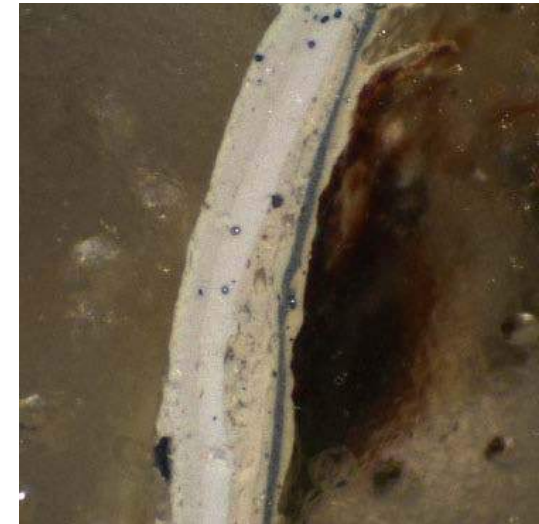
Figure 20. A sample from the floor reveals multiple layers of white paint when viewed under a microscope.

completely removed. The floor should be sanded to remove paint; chemical treatments are preferable for detail areas such as beadboard, railings and windows. Some paint will remain in areas that are repaired. Since there is almost certainly lead paint, this layer should be sealed in. Removed paint will need to be disposed of in accordance with state laws for hazardous material. Removal of large areas of paint should be carried out by a professional.

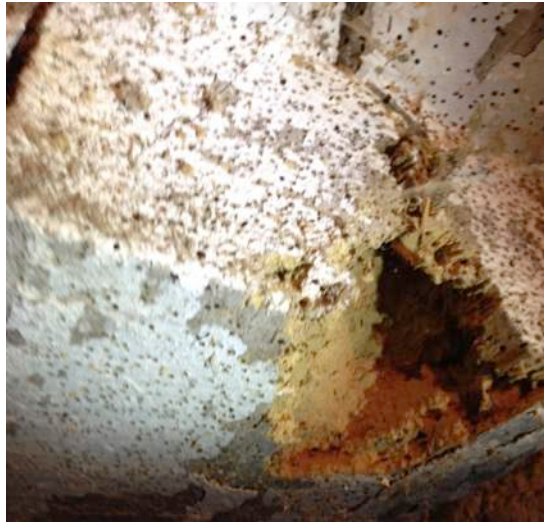
1.2 Evidence of PPB infestation - beam condition in Lower Level

PPB infested structural components should be individually assessed using core drillings to determine structural integrity. Components that have been compromised should be replaced to match existing structure. Finally, all wood components should be treated or painted to reduce further PPB damage from occurring.

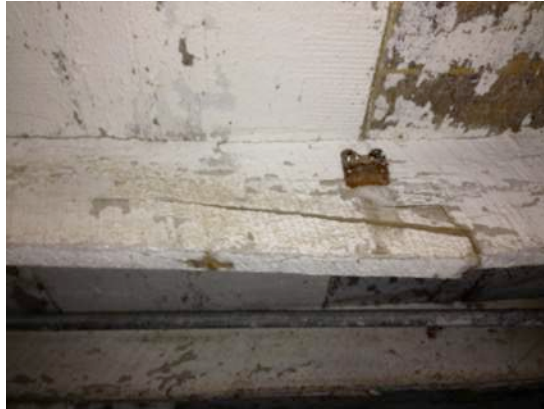
1.5 Joist cracking at mid-span

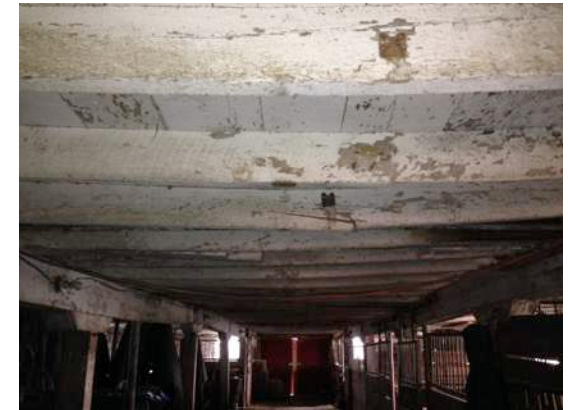
1.7 Joist deflection

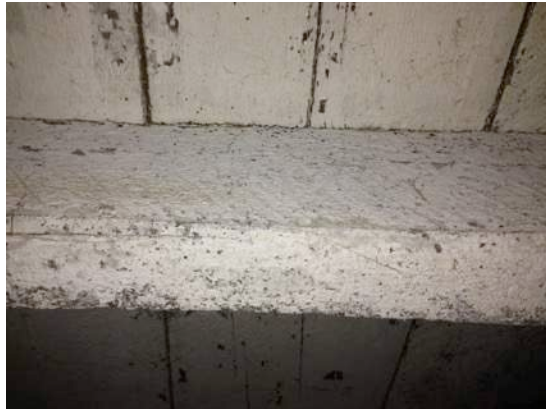
1.8 Close-up of joist condition. Evidence of PPB holes

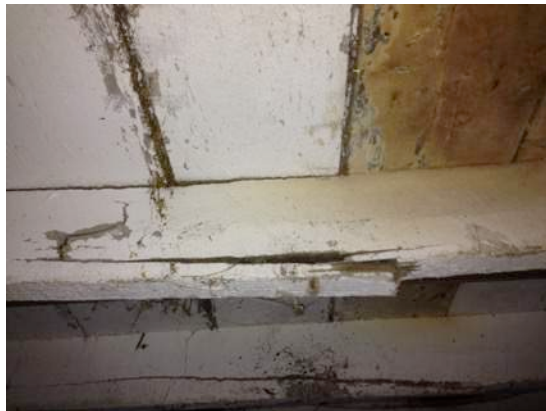
1.9 Joist fracture

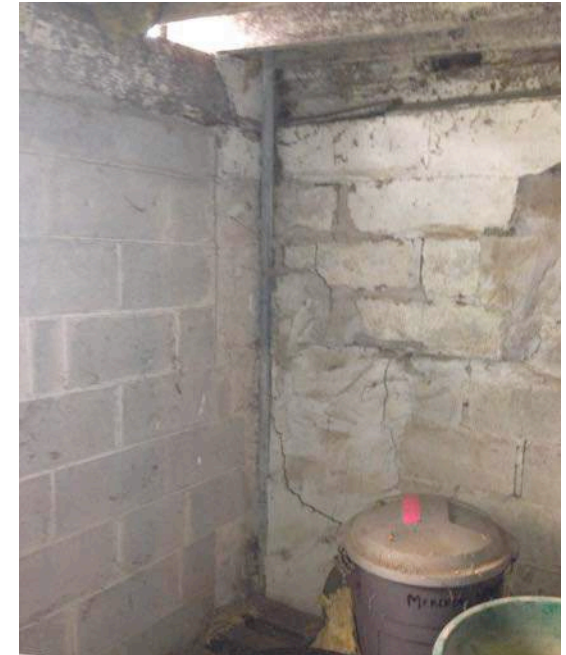
1.10a CMU condition at West corner

The cause of differential wall settling/expansion should be determined by a structural engineer and possibly with some exploratory excavations. The causes should be addressed consistent with long-term program expectations. Consider repointing joints at corner to facilitate insertion of reinforcing wire to provide lateral stability at corner.

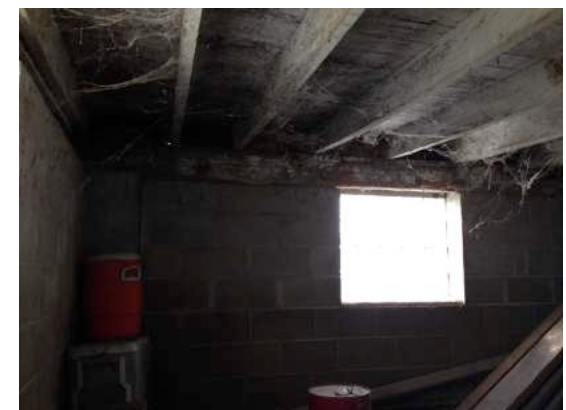
1.10b CMU condition at East Corner

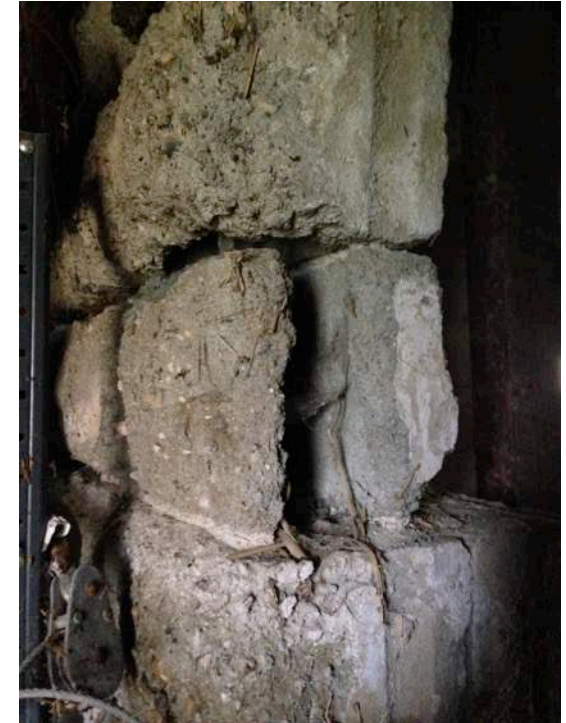
1.11 South silo wall CMU contains course, large aggregate with sandy mortar. Missing mortar in this area

South wall: Determine load on wall from the future loading consistent with the anticipated programming, and whether it is necessary to stabilize, repair or replace the south wall. This will require a structural engineer to perform the calculations. The concrete masonry is original and is an unusual size and composition. It should be preserved if at all possible.

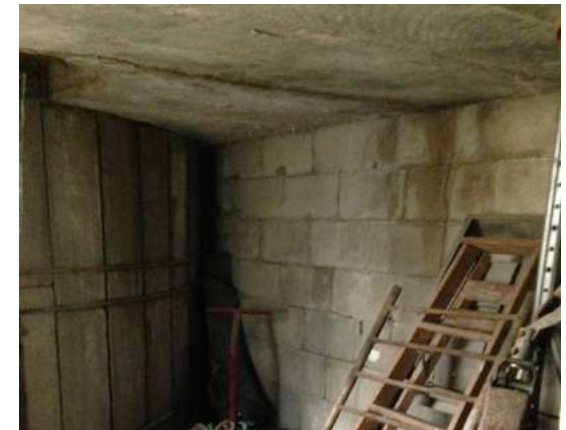
1.12 East silo wall and ceiling contain evidence of water

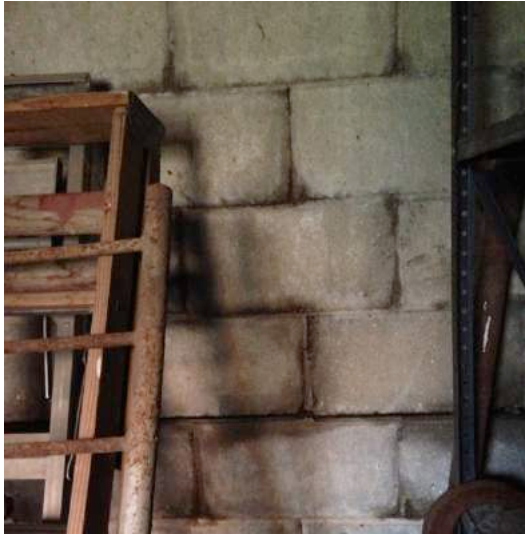
1.13 Mortar joints on East silo wall show evidence of water infiltration and a horizontal crack, above the first course in the photograph.

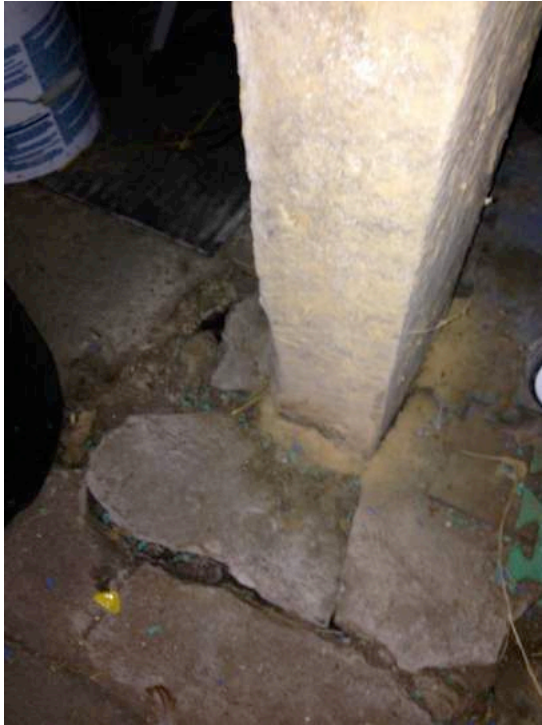
1.15 Evidence of footing failure

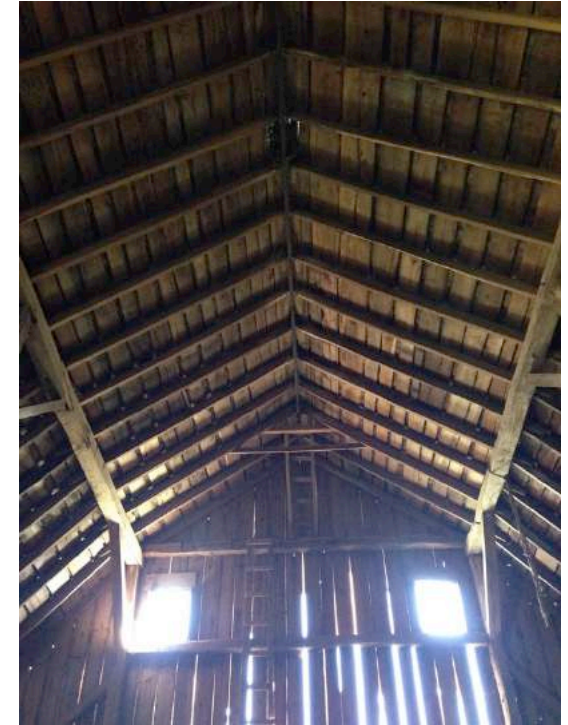
1.16 Evidence of missing battens on exterior of East Loft Wall

Provide for weather integrity to protect interior components by replacing battens and damaged siding as needed. Additional comments and considerations can be found in the exterior assessment of this report.

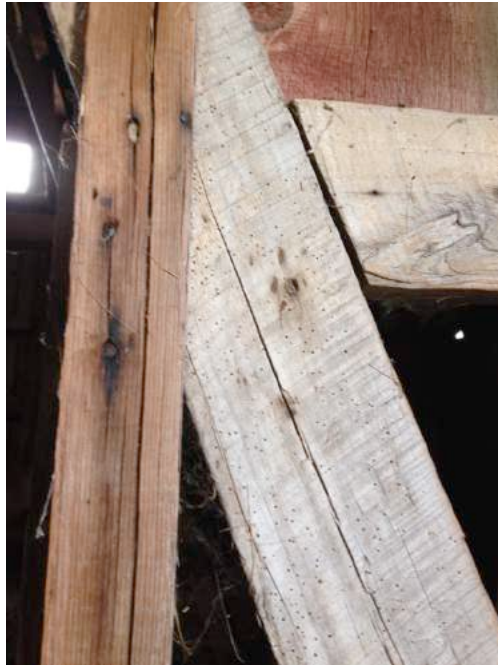
1.24 Close-up of Bracing Timbers with PPB Damage

in replacement sections, or if necessary entire members might need to be replaced.

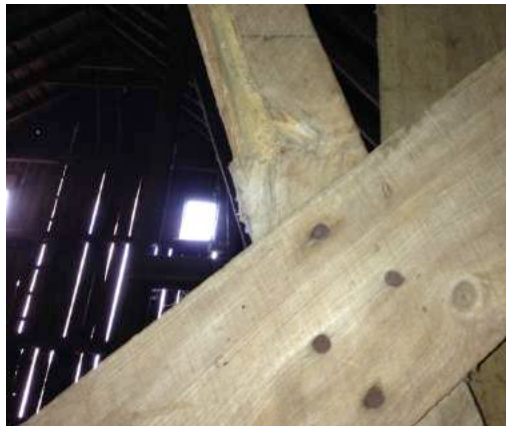
1.25 Close-up of Bracing Timbers with PPB Damage

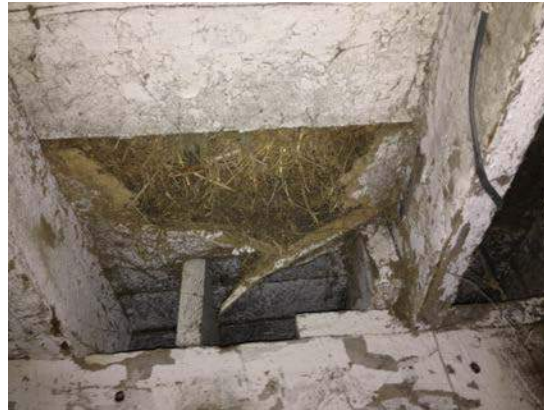
1.28 Floor damage seen from lower level

The hay should be removed to allow for a full assessment. A complete structural analysis of the floor will ensure that preservation work can begin safely for contractors. As with most of the wood in the barn, the extent of PPB damage has greatly reduced the strength and quality of each floorboard in the barn.

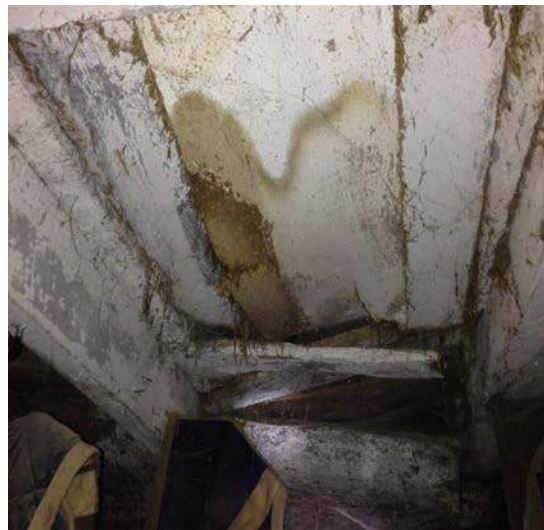
1.29 Floor damage seen from lower level

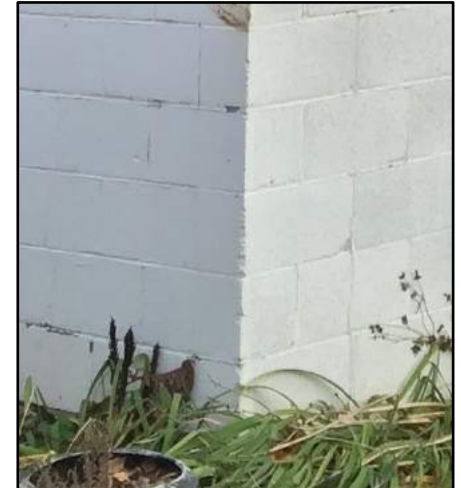
Figure 7: Concrete chipping at the corners.

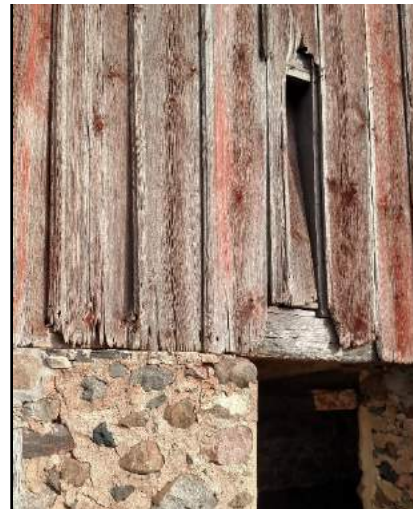
Fig. 14: Sill beam and broken boards. Photo taken facing north.

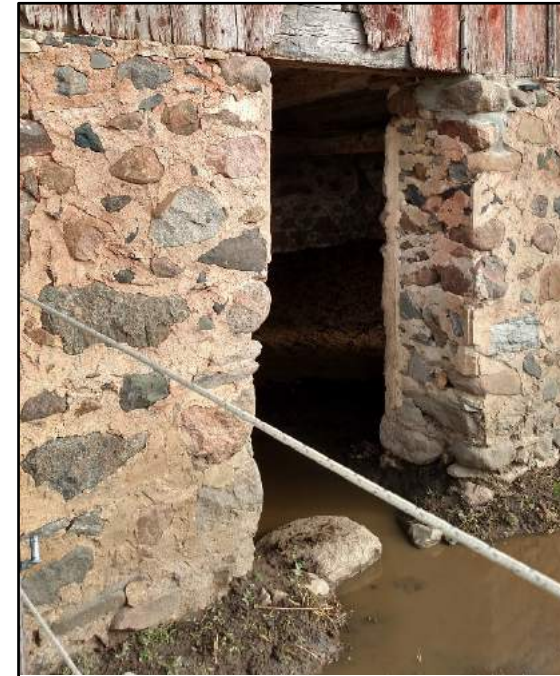
Fig. 15: Foundation opening, standing water, and surface grouting. Photo taken facing north

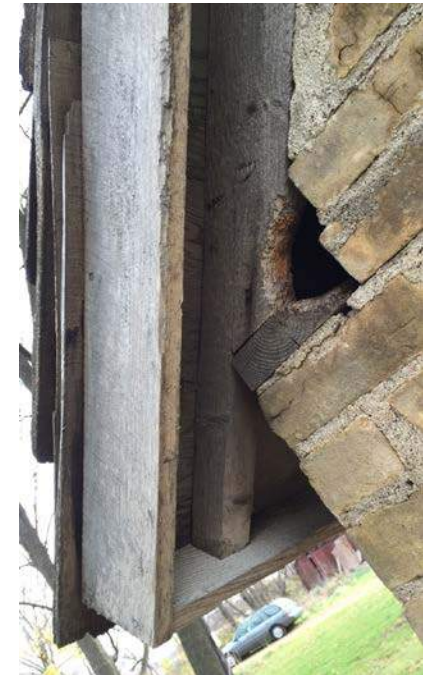
Figure 3: Damage to fascia on north elevation
