Deterioration of Mixed Rebar and Fiber-Reinforced Concrete Bridge Decks

February 2019

Research Project
Final Report 2019-09

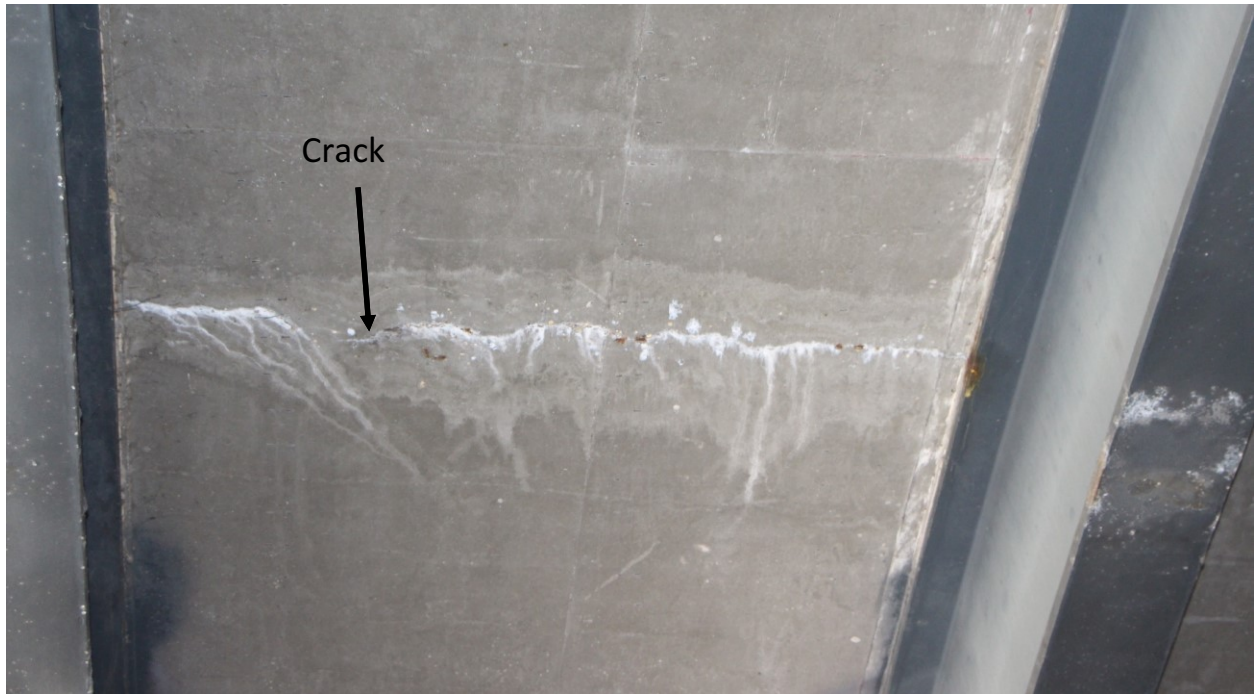
Deterioration of the concrete deck is often identified by cracks with efflorescence and/or rust staining, delamination, and spalling on the underside of the deck. Efflorescence occurs when the de-icing materials leach through full-depth cracks to the bottom of the concrete deck. Severe leaching may cause the formation of stalactites (The Concrete Society, n.d.). A stalactite is a formation, typically resembling an icicle, caused by significant build-up of leaching materials (National Oceanic and Atmospheric Administration [NOAA], 2018). Occasionally, these cracks with efflorescence will also have rust staining from the steel rebar. Rust staining can also occur where metal rebar chairs have been placed. Rebar chairs are used to support the rebar and keep it in place as concrete is poured around it. Expansion of the corroding rebar causes the surrounding concrete to crack and separate, which is referred to as delamination. If severe delamination occurs, the concrete may become loose and break off entirely from the structure. This is referred to as spalling and can be hazardous to traffic and pedestrians traveling under the bridge (Concrete Preservation Technologies, 2017). Typically, the rebar will become exposed when spalling occurs. The bridge deck may need to be replaced if extensive spalling occurs. Scaling is the loss of mortar or aggregate on the surface of the concrete, typically on the top of the deck. Examples of cracking with efflorescence and rust staining, delamination, spalling with exposed rebar, and scaling are shown in Figure 1.1, Figure 1.2, Figure 1.3, and Figure 1.4, respectively.

Figure 1.1 Crack with efflorescence and rust staining on the underside of the deck

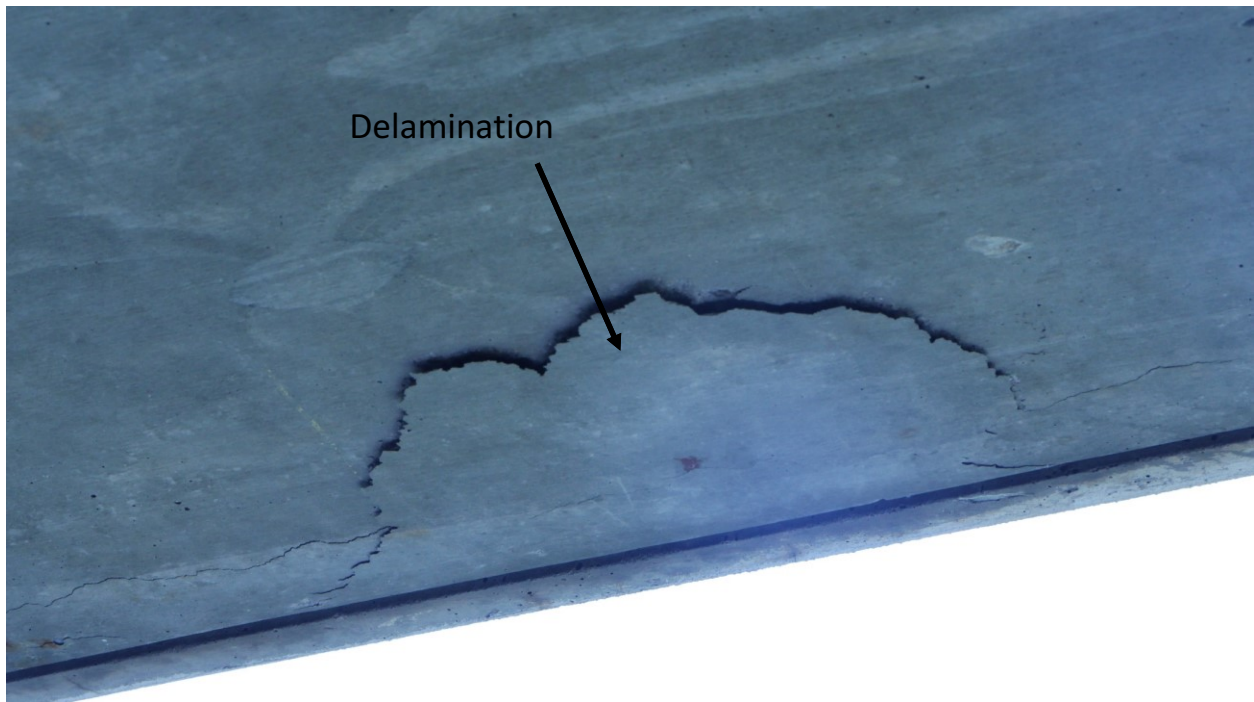
Figure 1.2 Delamination on the underside of the deck

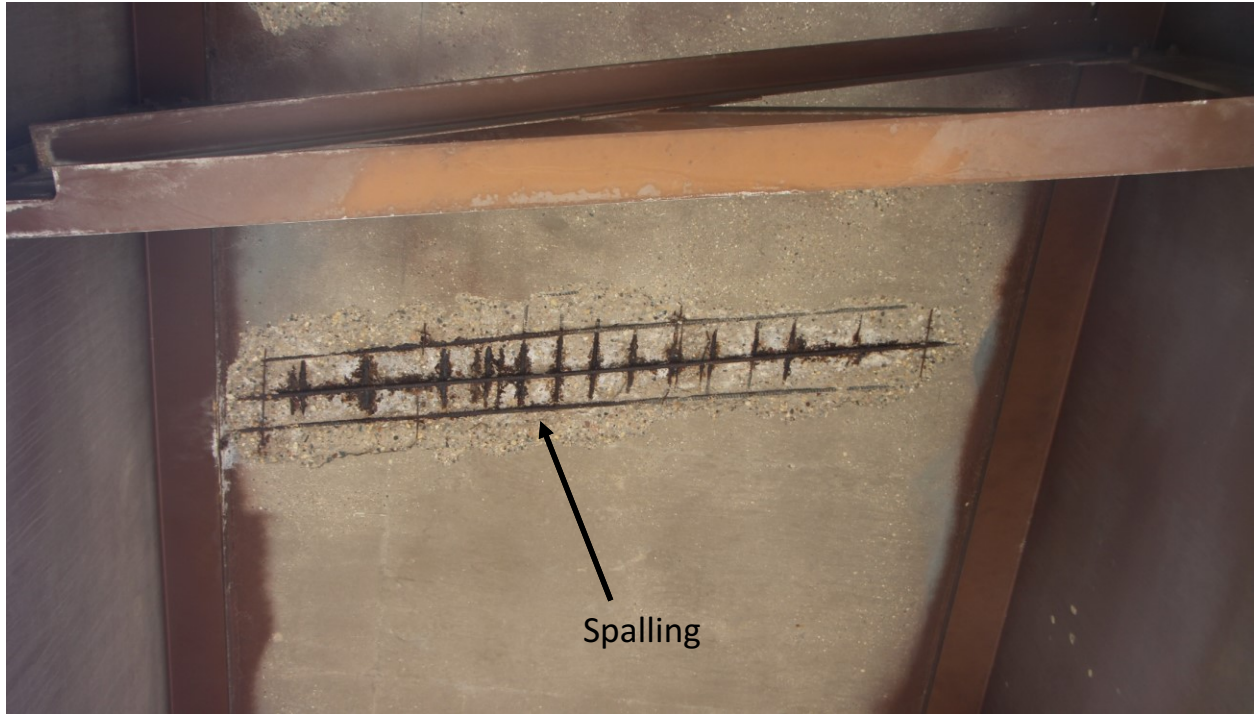
Figure 1.3 Spalling with exposed rebar on the underside of the deck

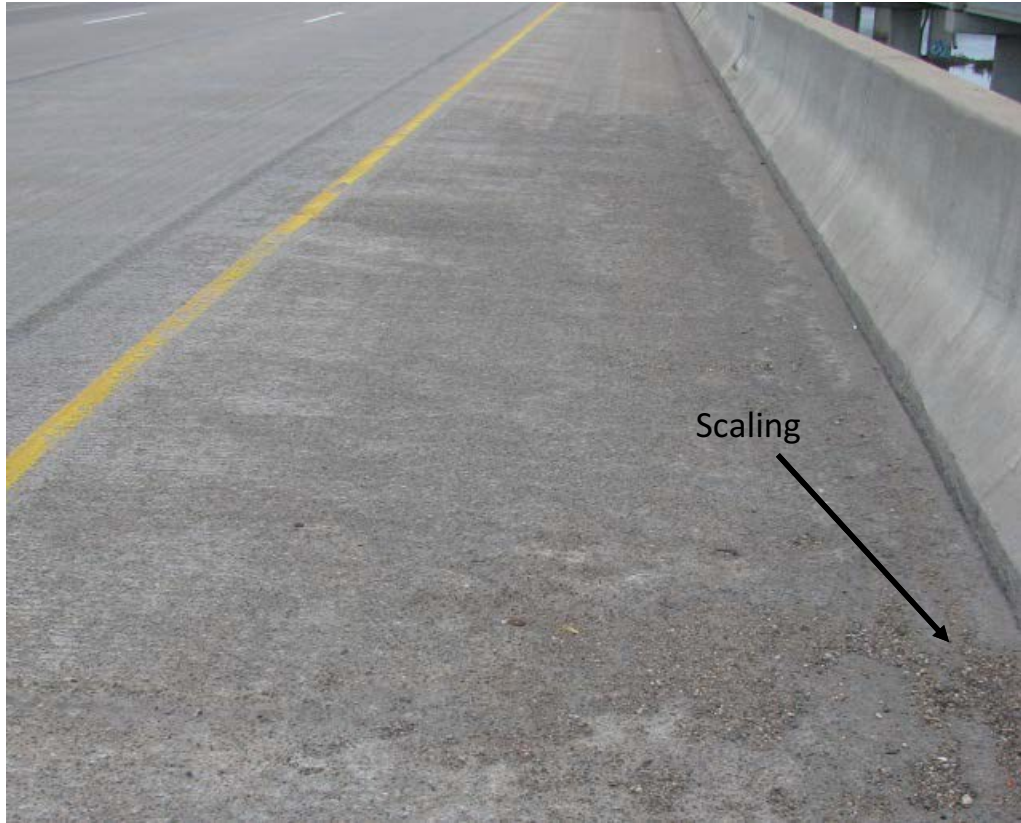
Figure 1.4 Scaling of concrete on the top of the deck (MnDOT, 2017)

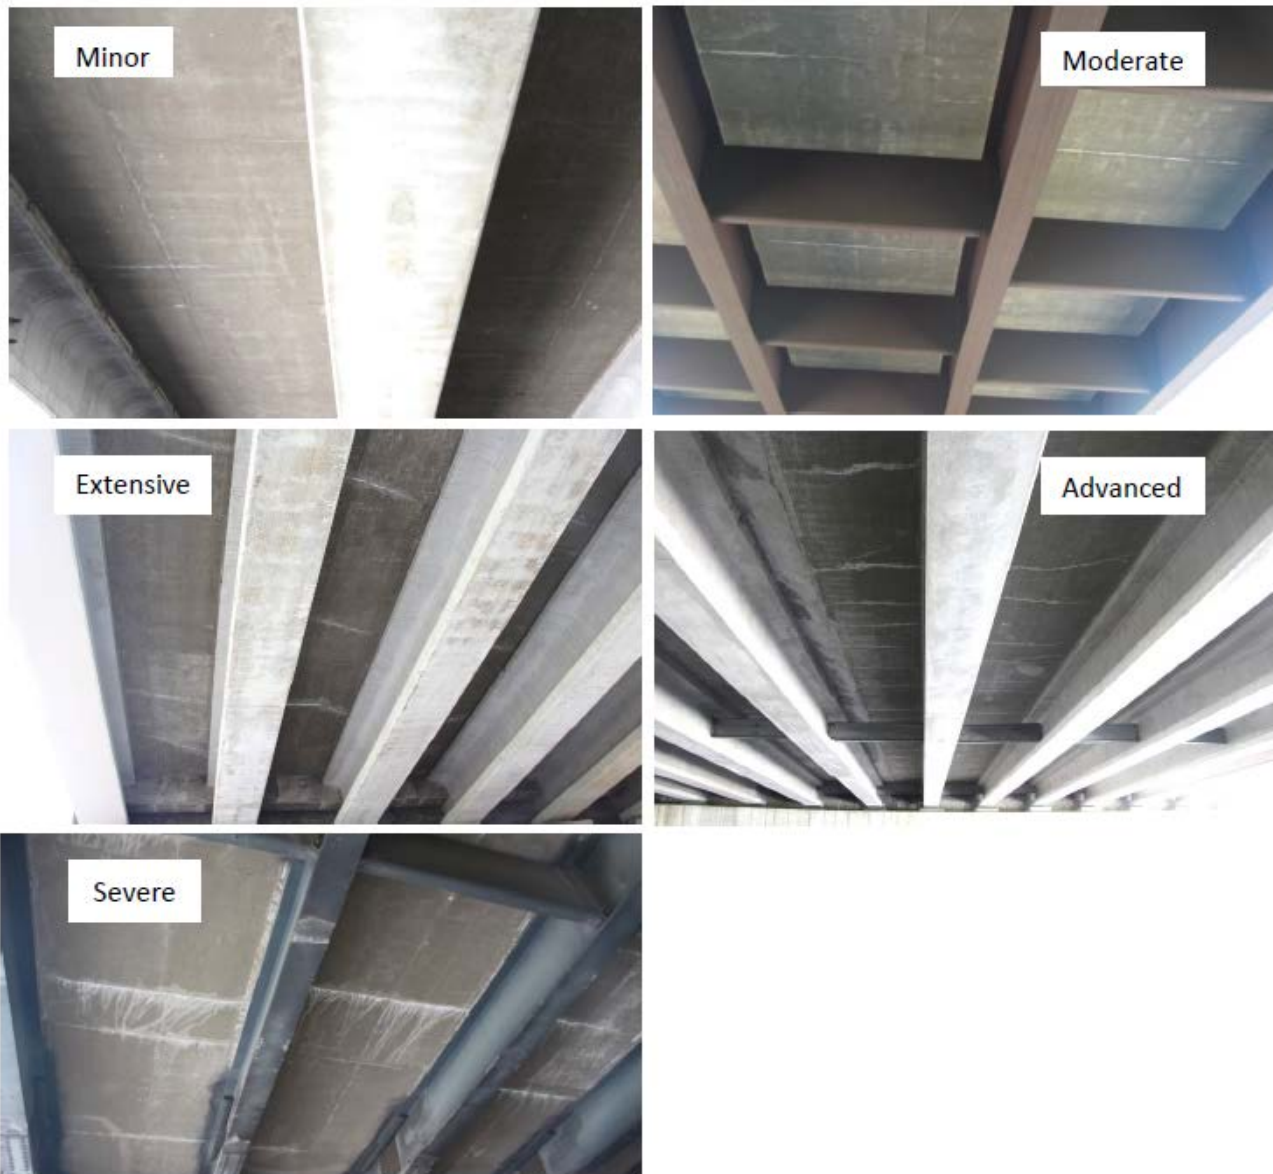
Category	Description
None	No visible cracks with efflorescence
Isolated	(not used)
Minor	> 20 ft spacing, isolated cracks, or cracks with very light efflorescence
Moderate	Approximately 10 to 20 ft crack spacing
Extensive	Approximately 5 to 10 ft crack spacing
Advanced	Approximately 2 to 5 ft crack spacing
Severe	Approximately 2 to 5 ft crack spacing with very heavy efflorescence

Figure 2.5 Representative images for each category of cracking with efflorescence

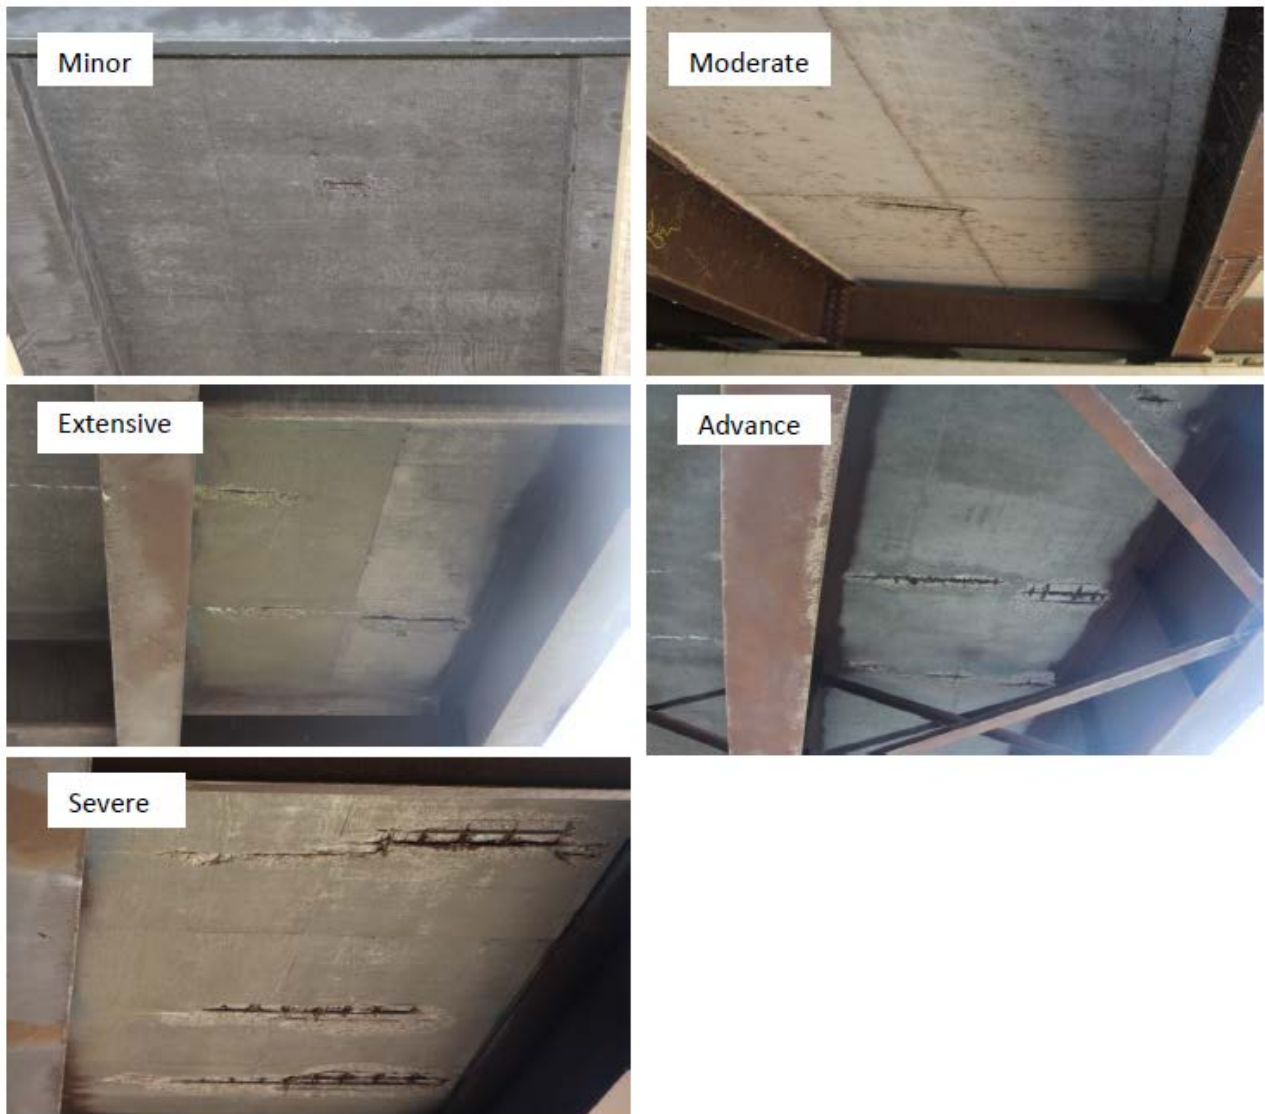
Category	Description
None	No visible spalling with exposed rebar
Isolated	Isolated spalling, typically at the deck joint
Minor	All spalls < 1 SF in area
Moderate	Largest spalls approximately 1 to 2 SF
Extensive	Largest spalls approximately 2 to 3 SF
Advanced	Largest spalls approximately 3 to 5 SF
Severe	Largest spalls approximately > 5 SF

Figure 2.6 Representative images of each category of spalling with exposed rebar

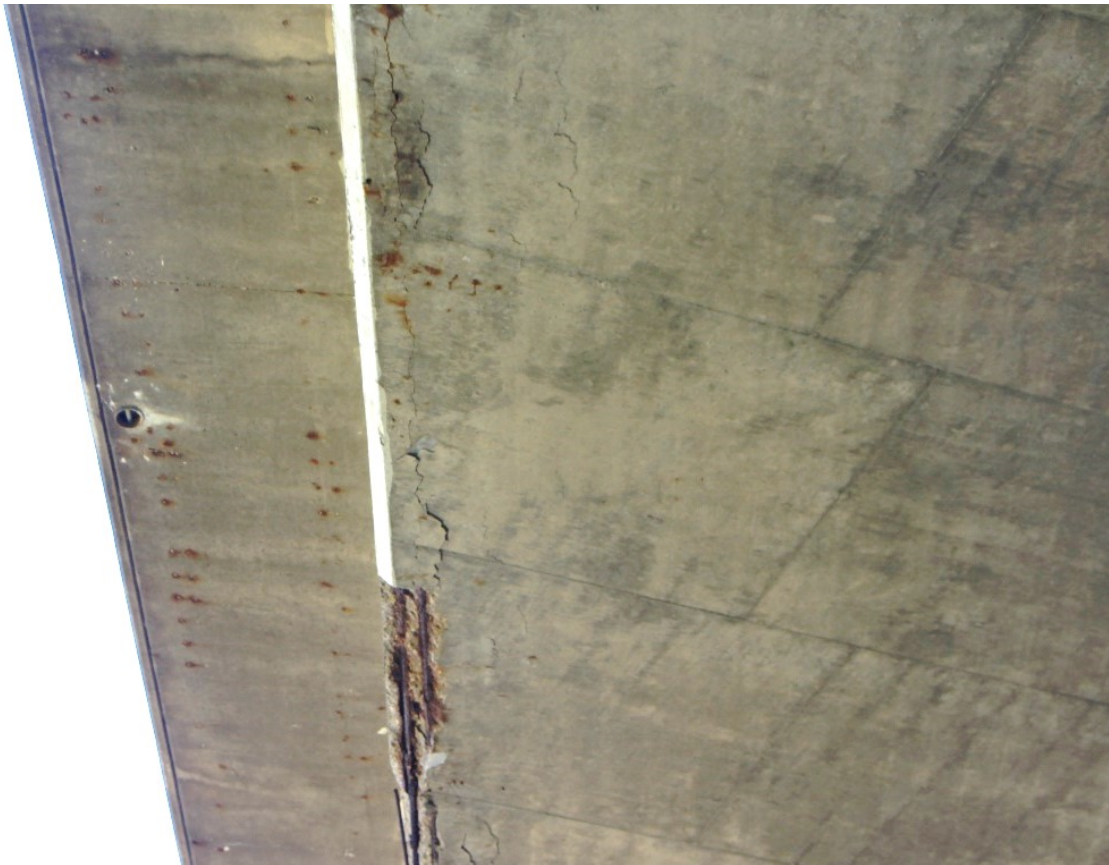
Category	Description
None	No visible delamination
Isolated	Isolated delamination, typically at the deck joint
Minor	All areas < 1 SF in area
Moderate	Largest areas approximately 1 to 2 SF
Extensive	Largest areas approximately 2 to 3 SF
Advanced	Largest areas approximately 3 to 5 SF
Severe	Largest areas approximately > 5 SF

Figure 2.7 Representative image for advanced delamination
