Optimized Taconite-Based Pavement Repair Compound and Deployment System

Lawrence Zanko, Principal Investigator
Natural Resources Research Institute
University of Minnesota-Duluth

December 2019

Research Project
Final Report 2019-46

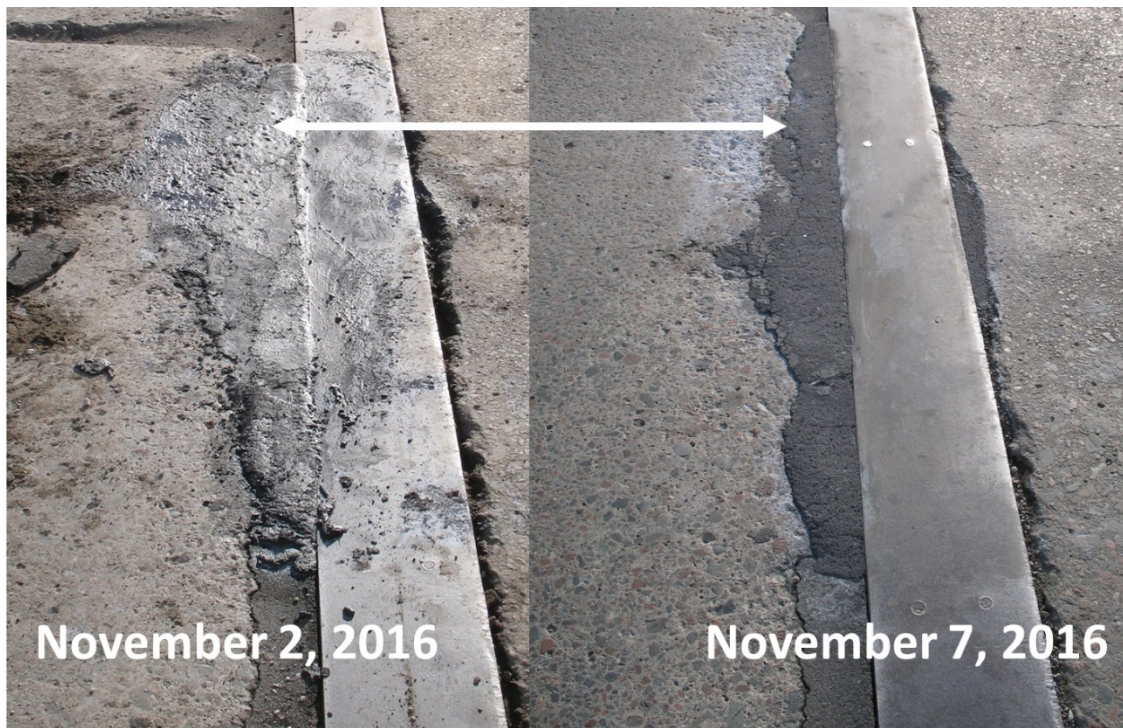
The condition of the repairs was observed and documented following installation, revealing that the formulation needed further modification to improve performance and optimize set times relative to ambient pavement and air temperatures. Excessive expansion of the compound following placement in the repair can lead to a weaker product, especially at the surface. Abrasion and deterioration of the repairs occurred within a week, as Figure 2.17 shows, especially where the repair was thin and shallow. The repair compound is better suited for deeper/thicker repairs. Formulation modification is underway and continuing, as described previously.

Figure 2.16 Condition of repair made at Mesaba Avenue expansion joint: November 2 (left); and November 7 (right), 2016.

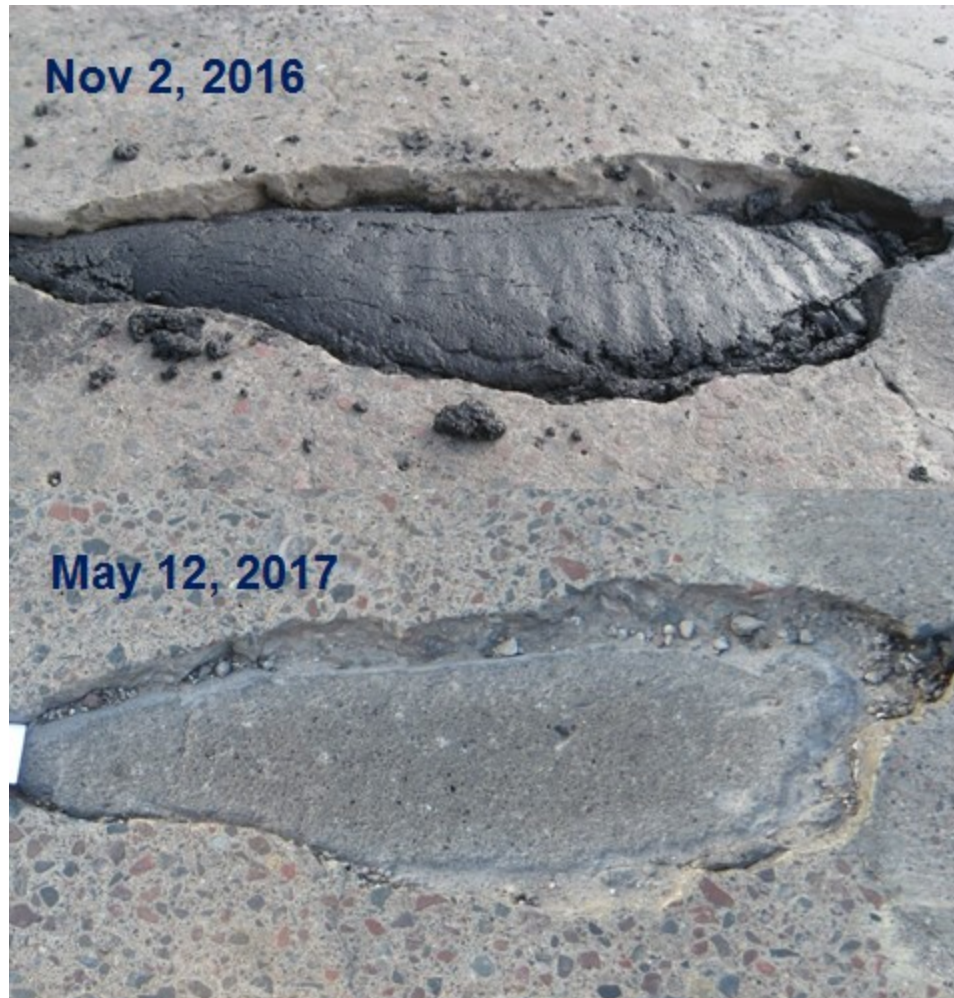
The Mesaba Avenue site was visited again on May 12, 2017. Surprisingly, many of the repairs were still in place six months later, albeit with some loss. This was not entirely expected, given the early rapid abrasion evidence. While the repair compound had abraded fairly quickly following its installation, especially where it had expanded above the plane of the pavement, it remained largely intact below the plane of the pavement, as Figure 2.18 shows. Similar results were shown for some of the narrow but deeper crack repairs. This outcome suggests the repair compound could be an effective tool for partially filling cracks and other pavement distresses, and act as a foundation for finishing the repair with mastic. By filling most of the volume of a pavement distress, the compound could significantly reduce the quantity of mastic used for completing the repair, saving cost and reducing mastic cure time.

Figure 2.17 Condition of Mesaba Avenue repair following installing on November 2, 2016 (top photo) and on May 12, 2017 (bottom photo).

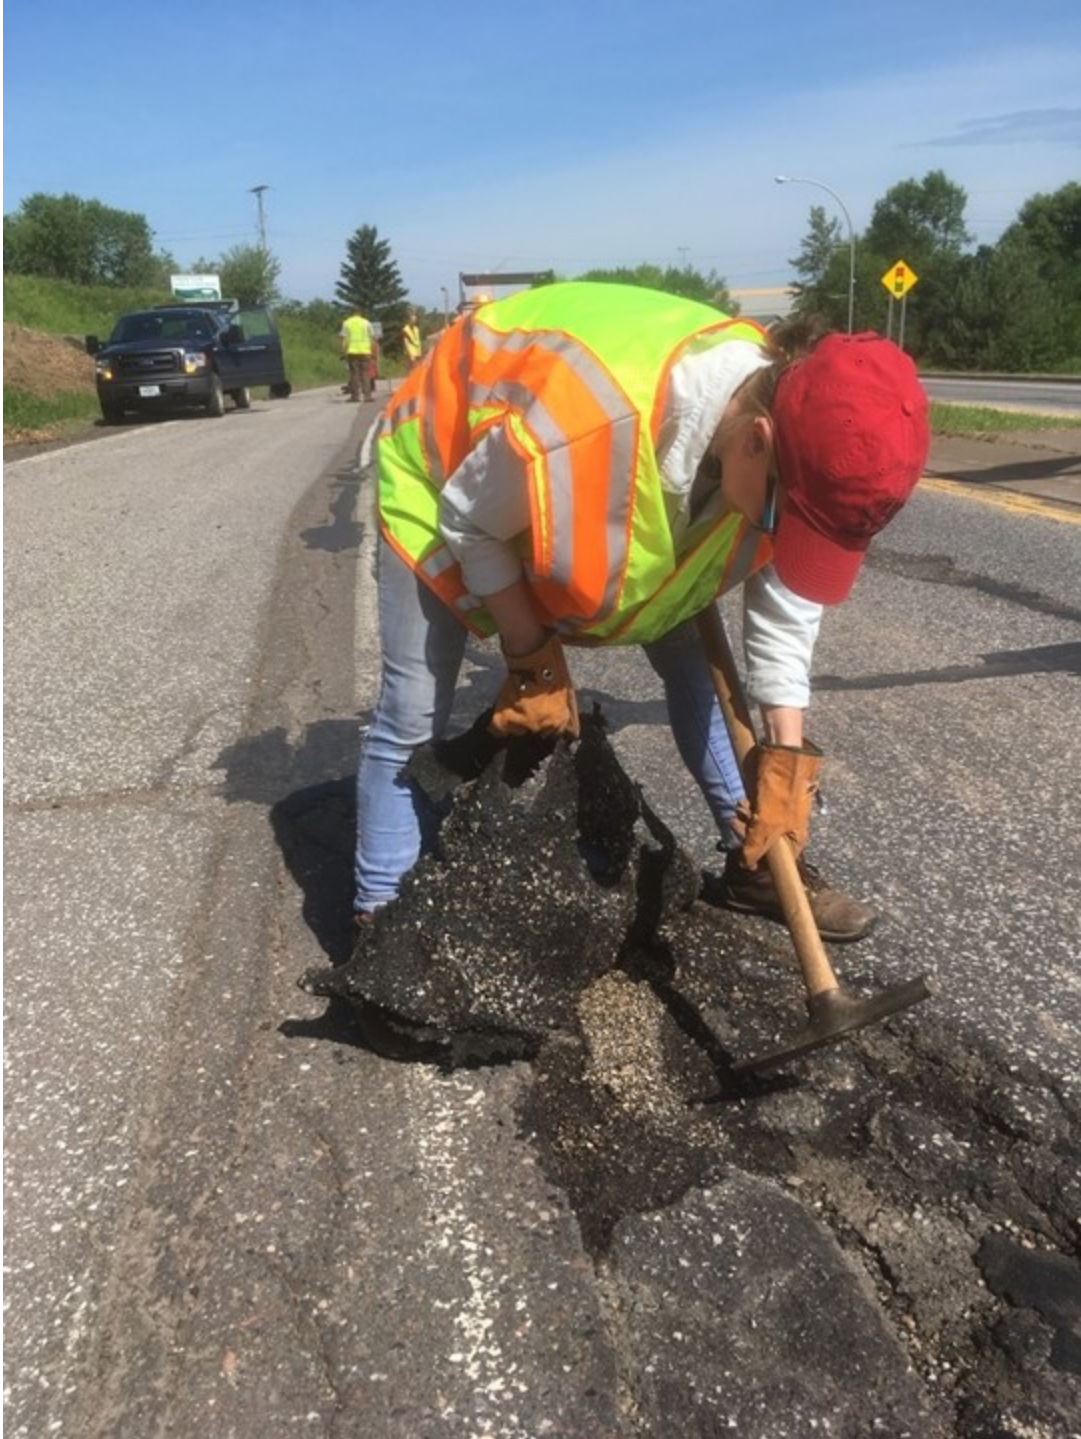
Figure 2.50 Delaminating mastic repairs, Proctor, MN, field trial site: June 20, 2018.

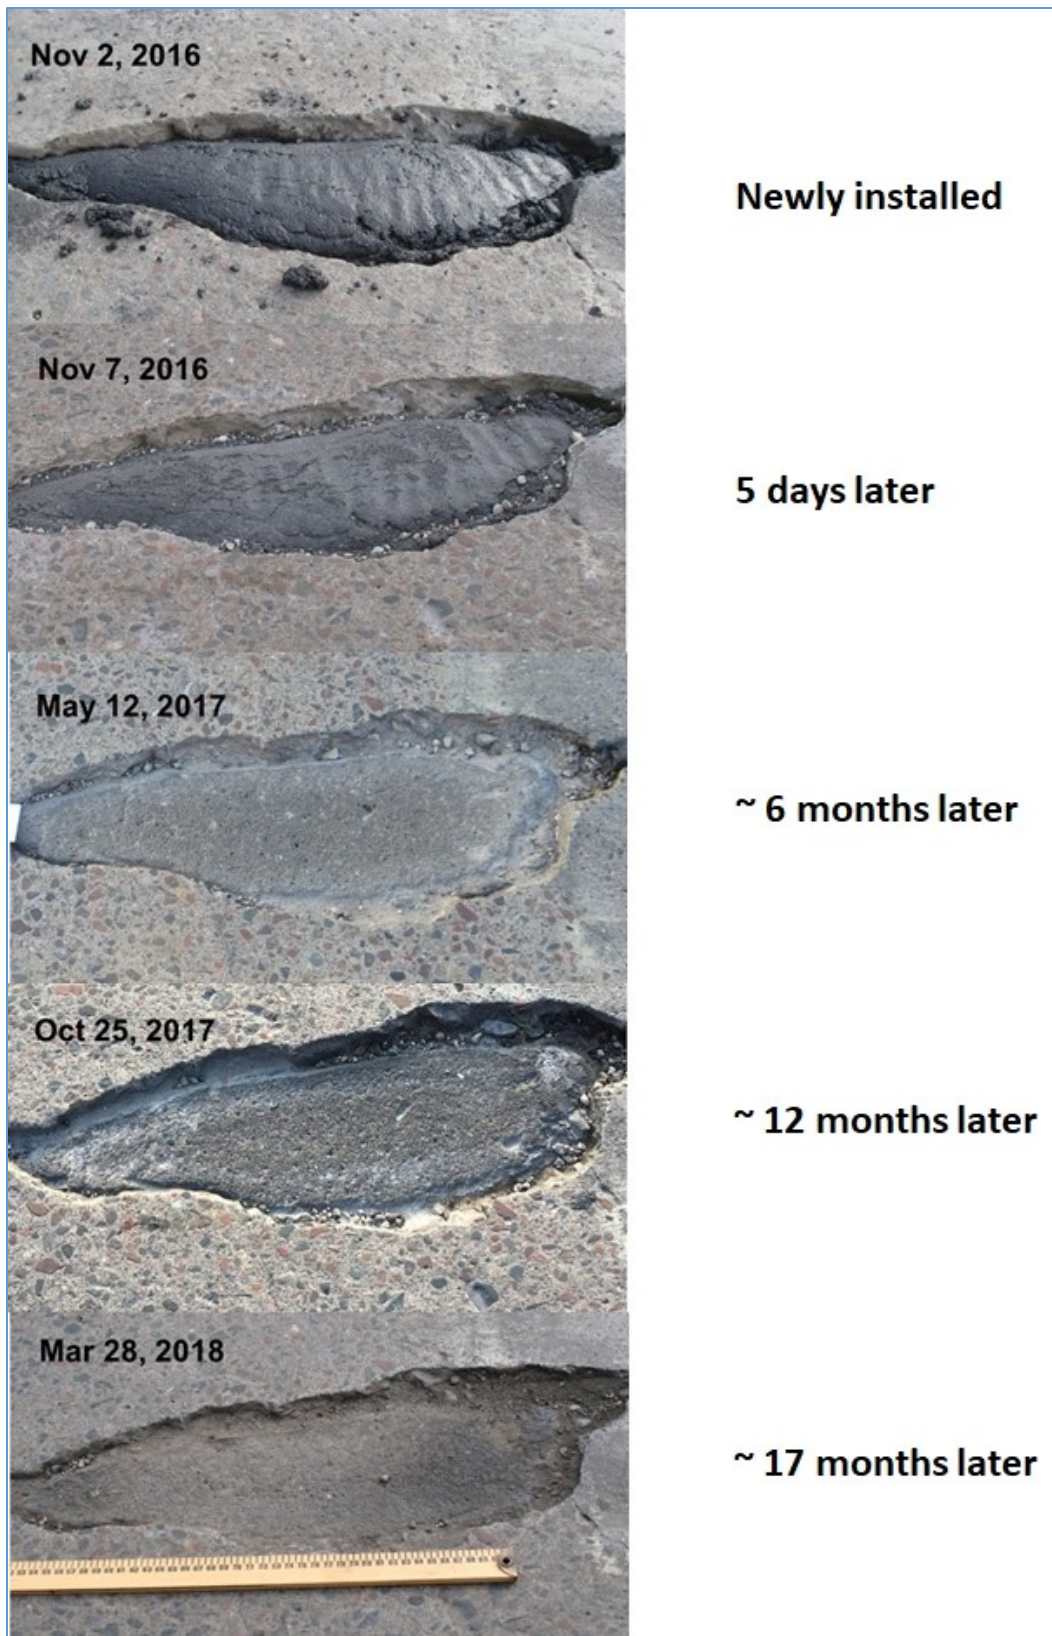
Figure 2.58 Condition of Mesaba Avenue repair from November 2, 2016, to March 28, 2018.

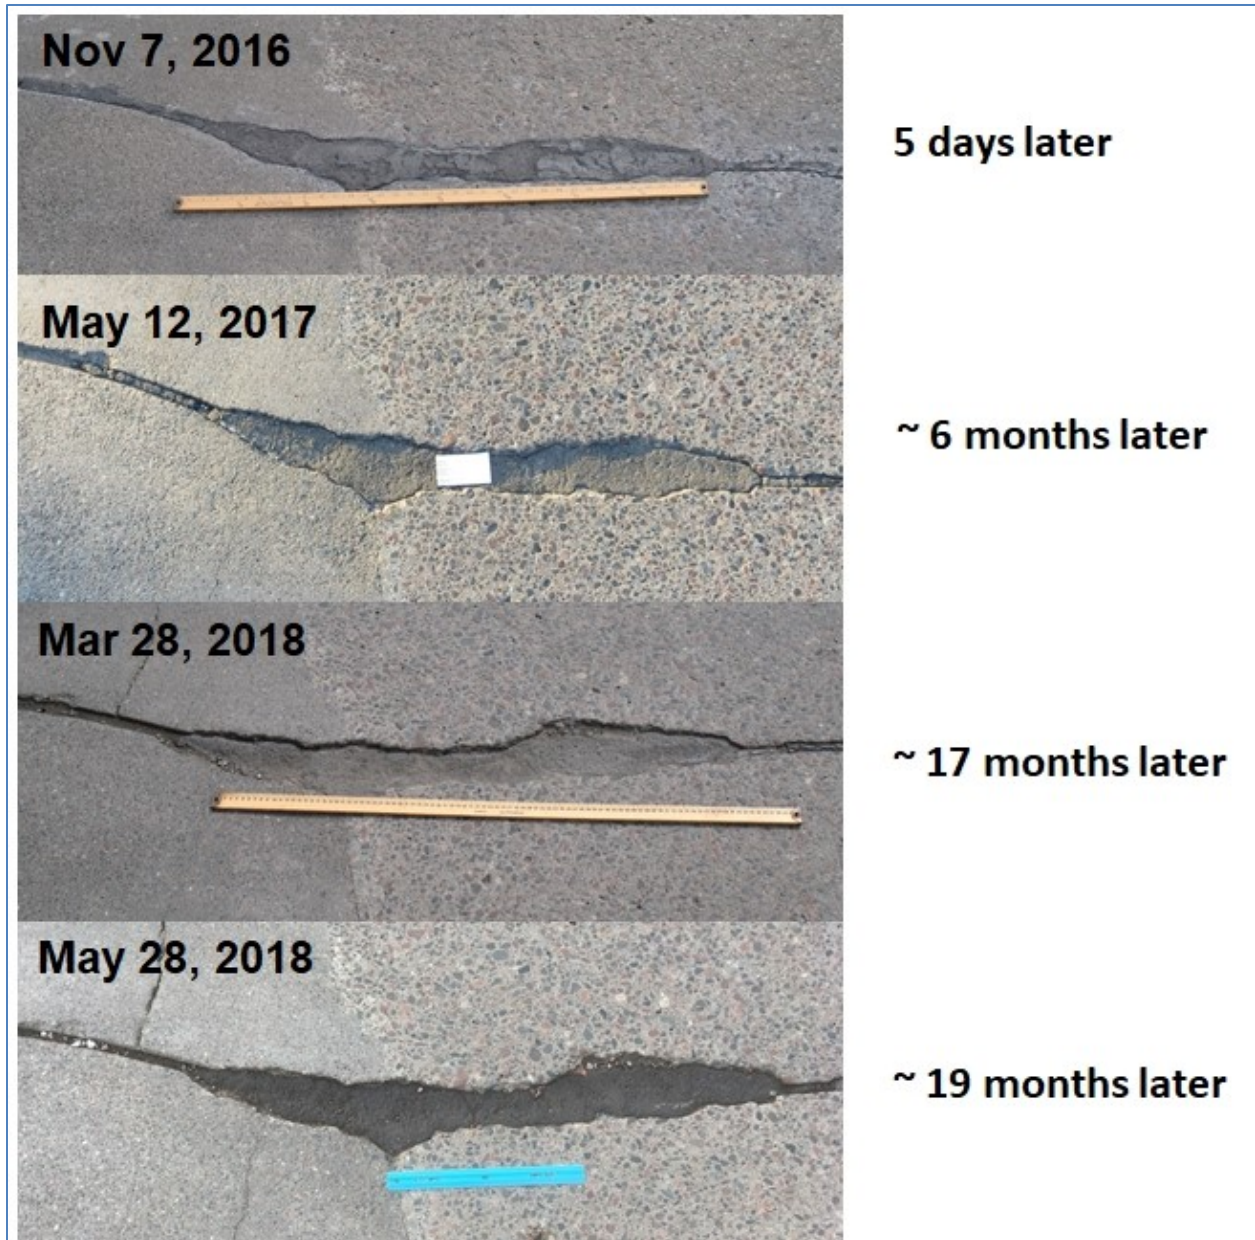
Figure 2.59 Condition of Mesabi Avenue crack repair from November 7, 2016, to May 28, 2018.

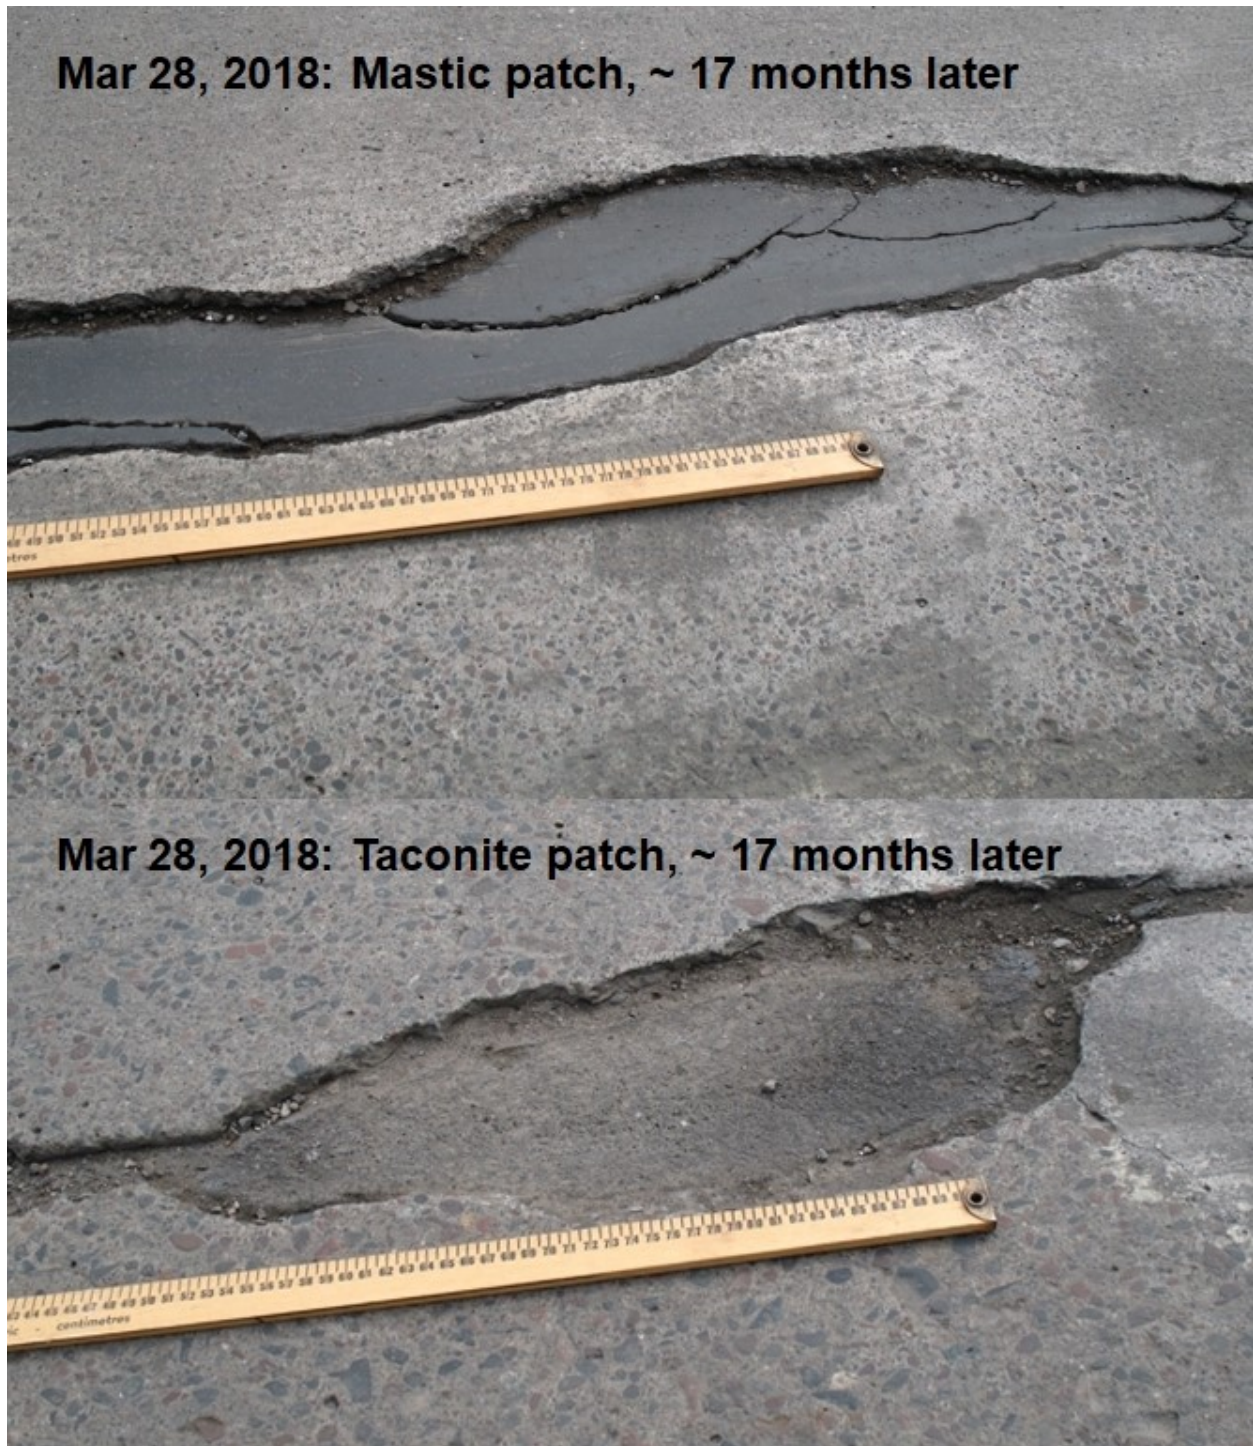
Figure 2.60 Comparison of mastic and taconite patch repairs after 17 months (as of March 28, 2018).

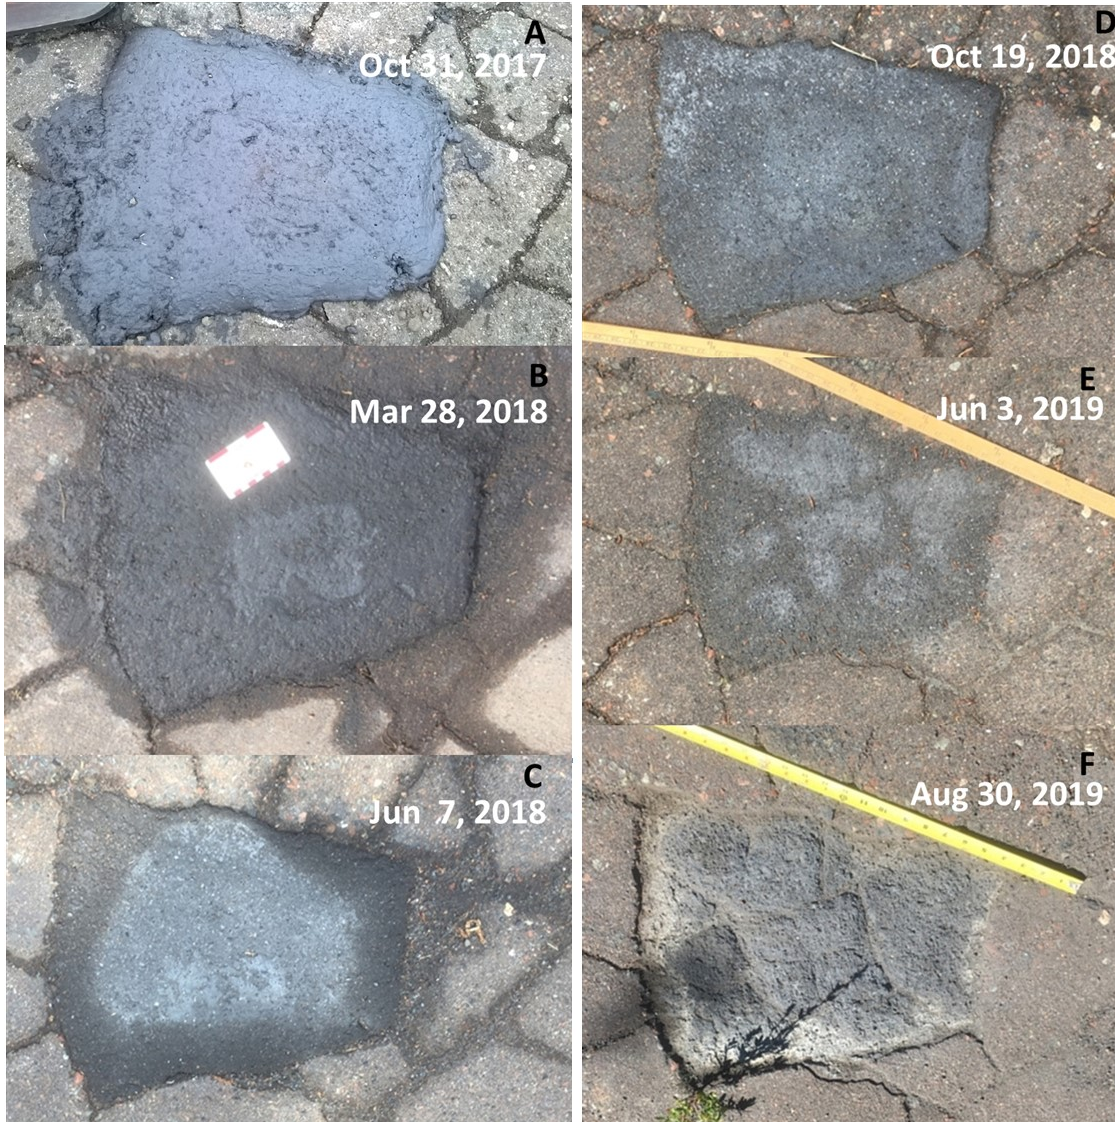
Figure 2.62 October 31, 2017, NRRI parking lot repair: Completed repair (A); and conditions of repair on March 28, 2018 (B); June 7, 2018 (C); October 19, 2018 (D); June 3, 2019 (E); and August 30, 2019 (F).

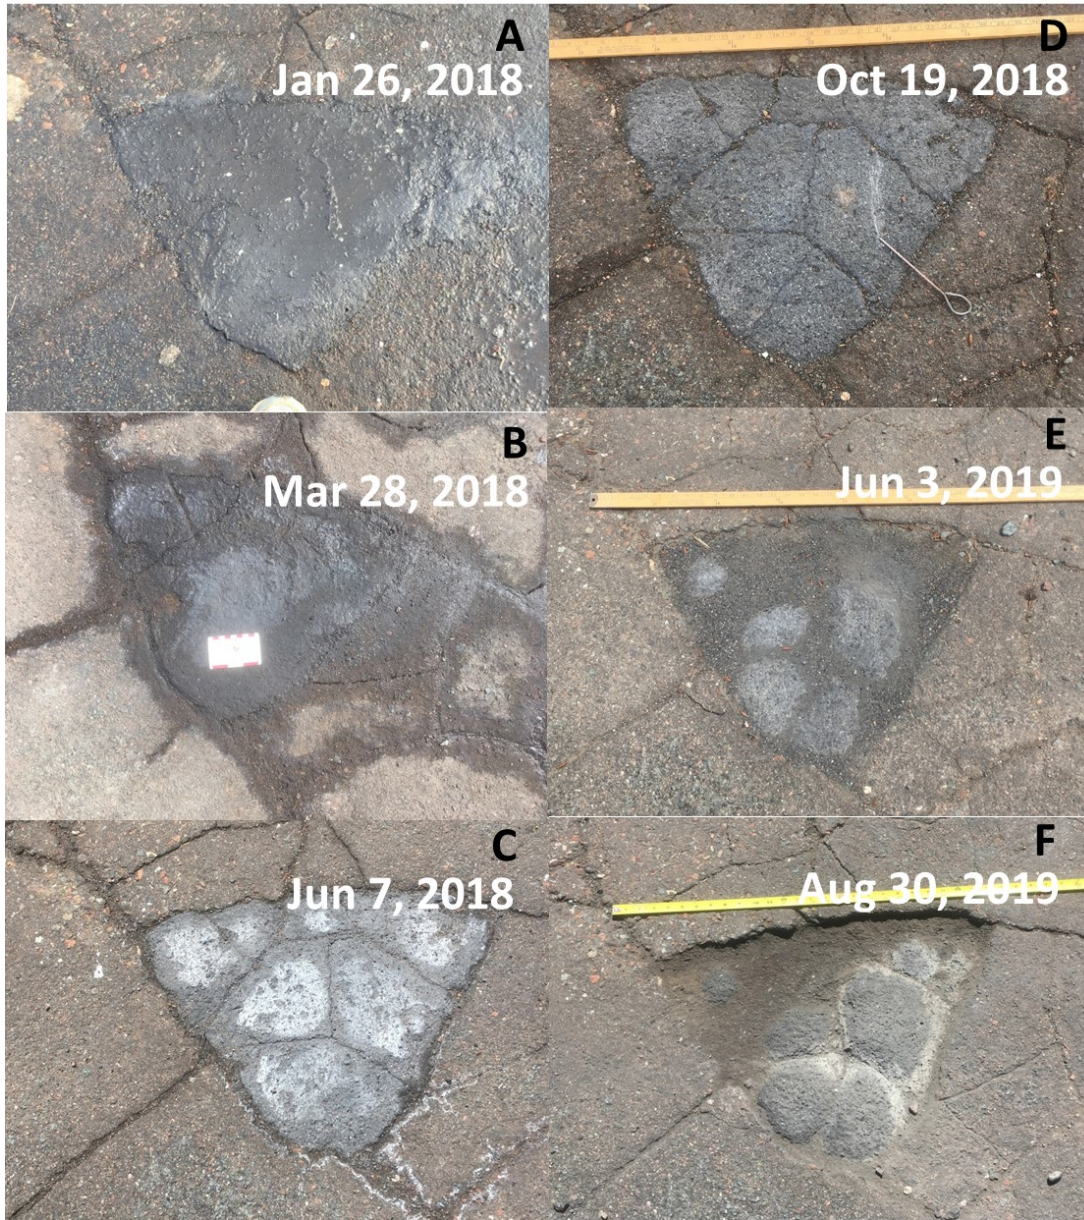
Figure 2.64 Condition of the November 20, 2017 repair from January 26, 2018 to August 30, 2019.

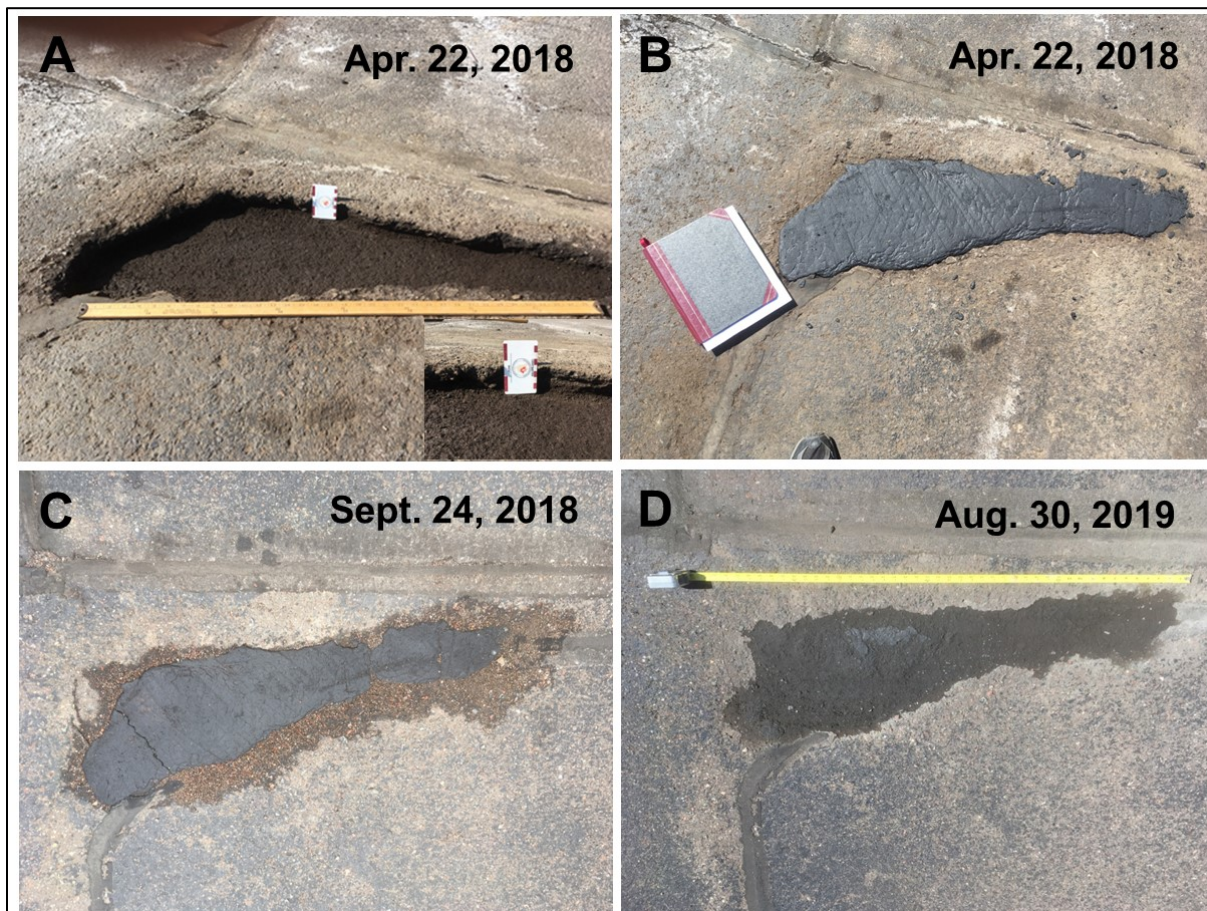
Figure 2.65 April 22, 2018 NRRI parking lot repair: A) prepared hole, with inset photo showing depth; B) completed repair; C) condition of repair on September 24, 2018; and D) condition of repair on August 30, 2019.

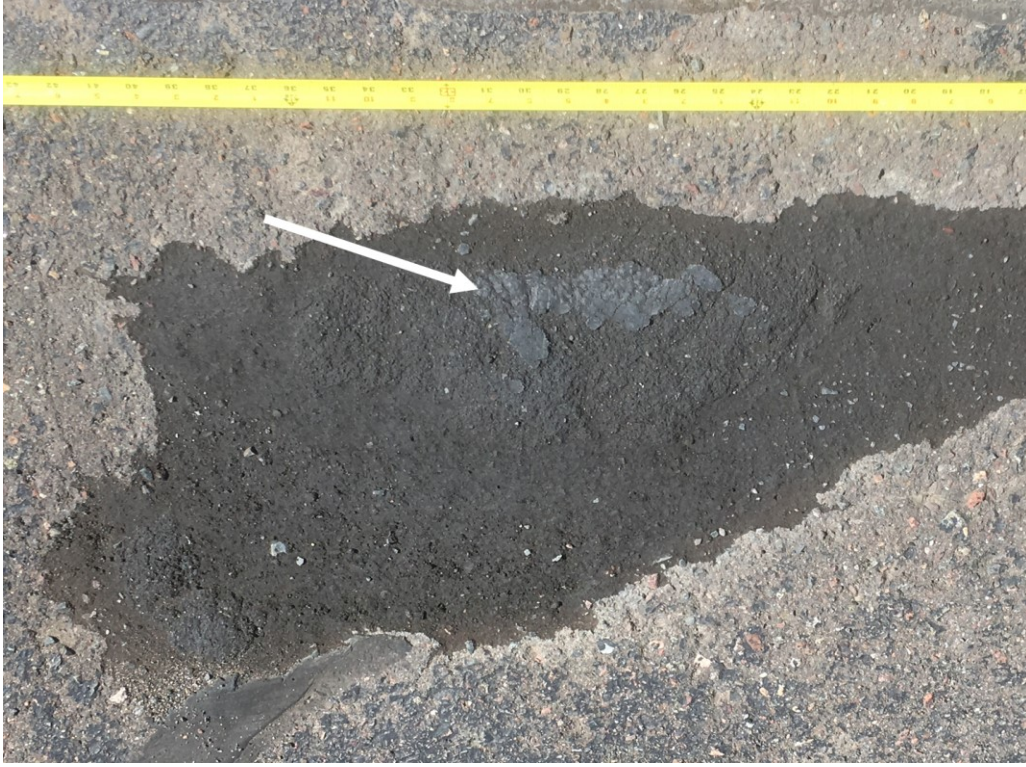
Figure 2.66 Close-up of April 22, 2018 repair, with arrow pointing to original remaining surface.

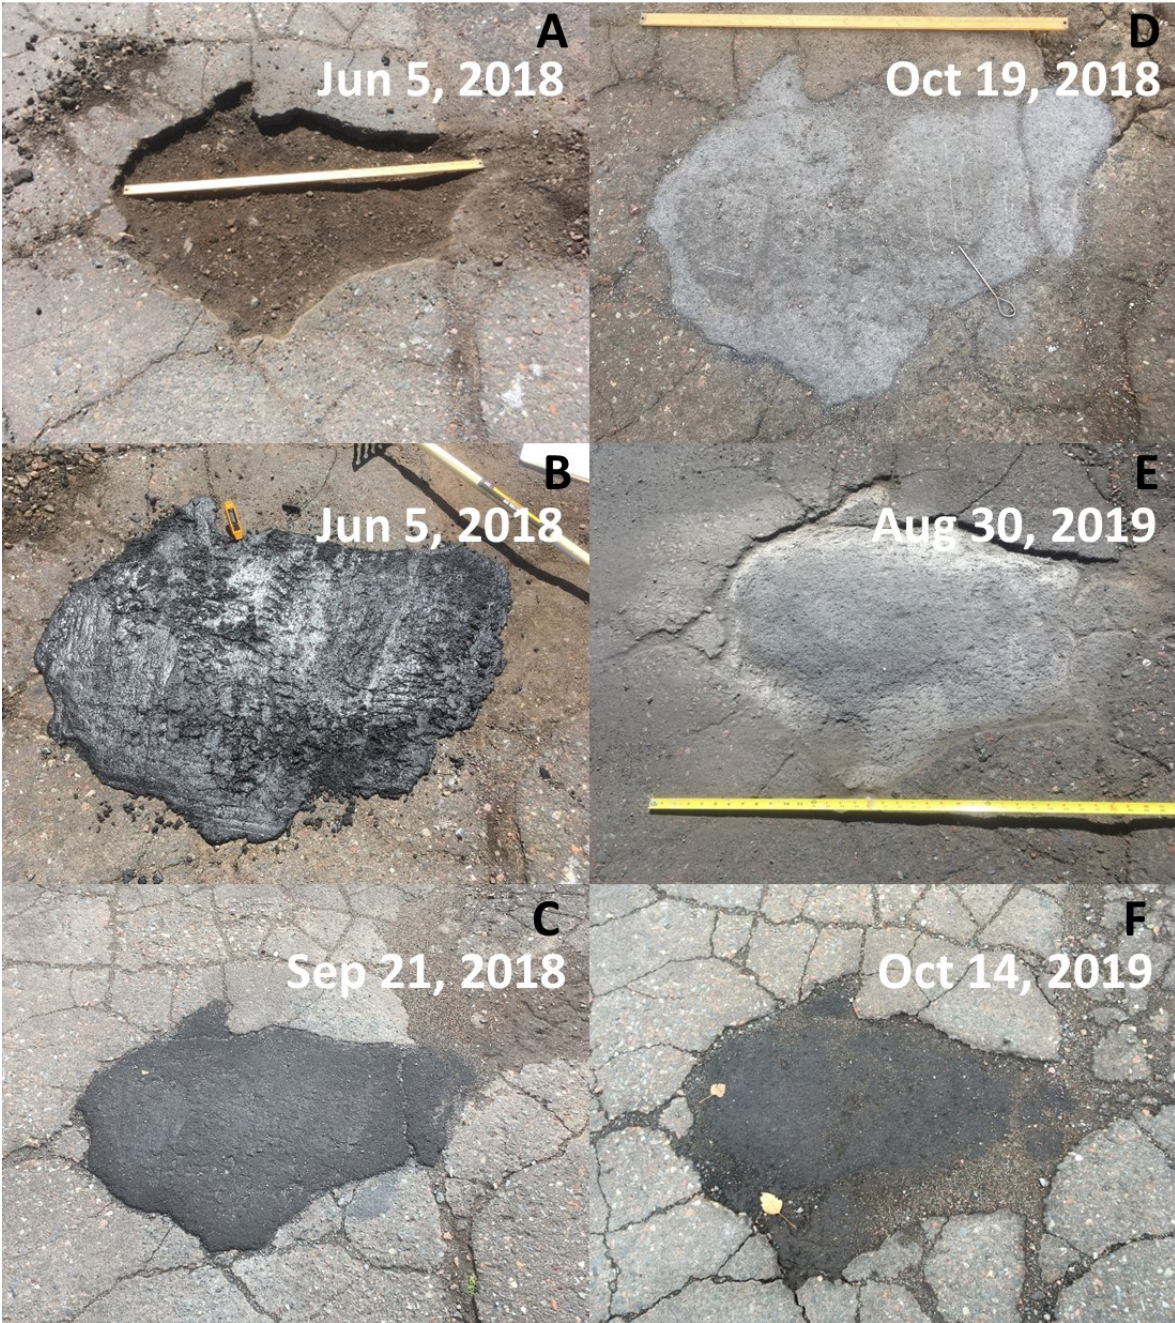
Figure 2.68 Condition of the June 5, 2018 repair from June 5, 2018 (A and B) to October 14, 2019 (F).

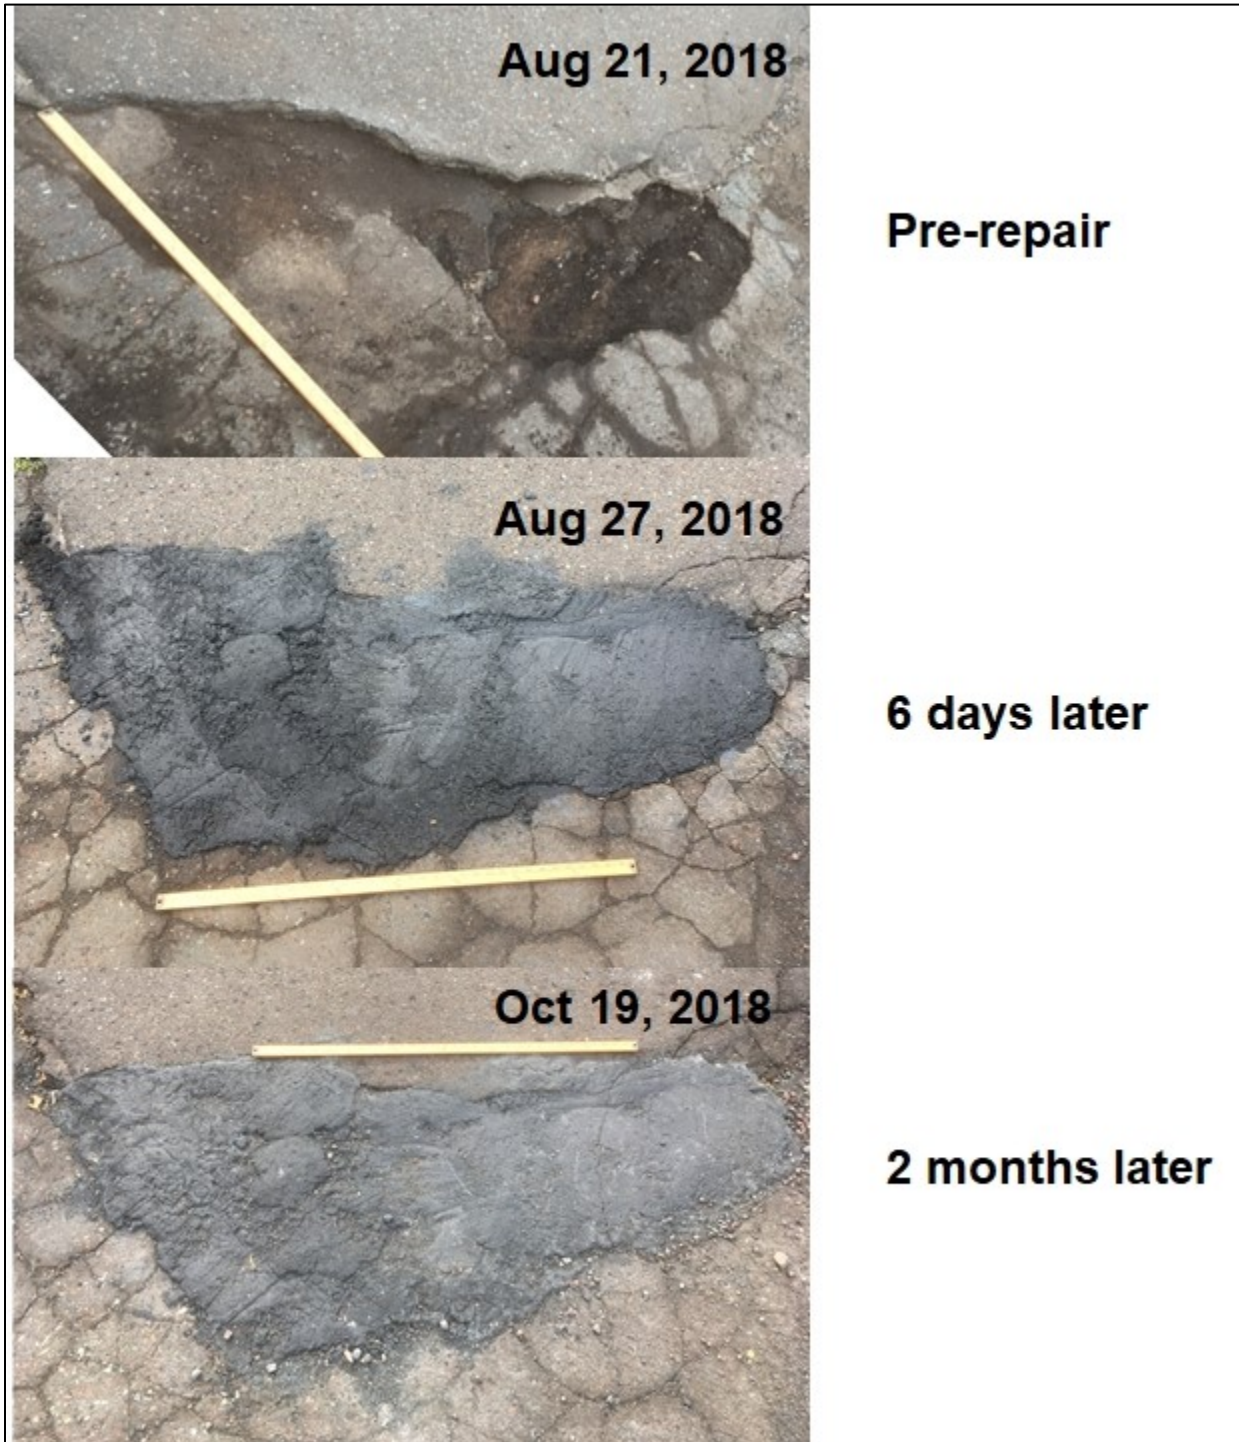
Figure 2.69 August 21, 2018, NRRI parking lot test repair condition through October 19, 2018 (yard stick for scale).

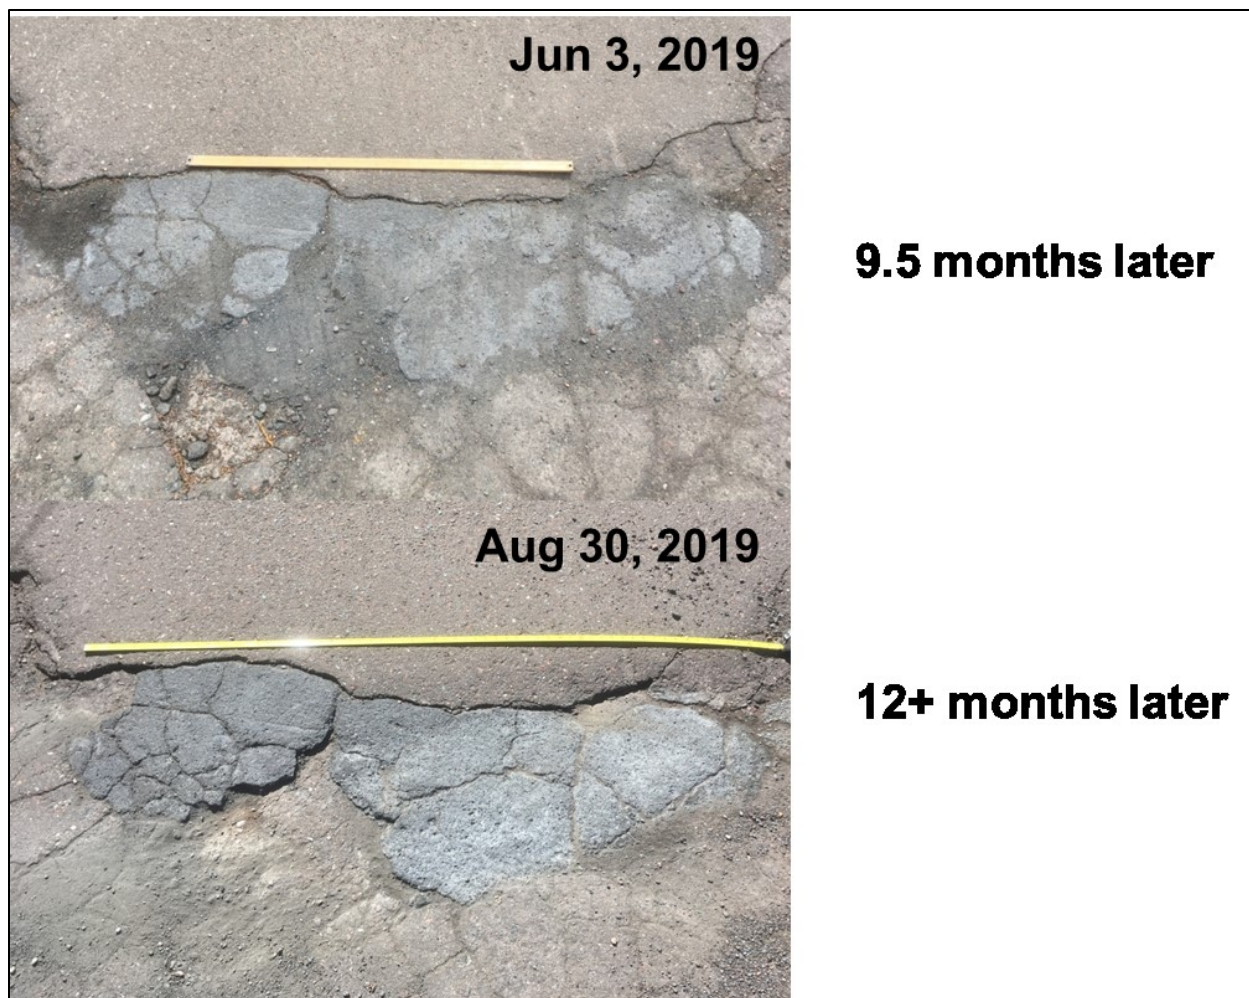
Figure 2.70 August 21, 2018, NRRI parking lot test repair condition on June 3, 2019 and August 30, 2019 (yard stick for scale).

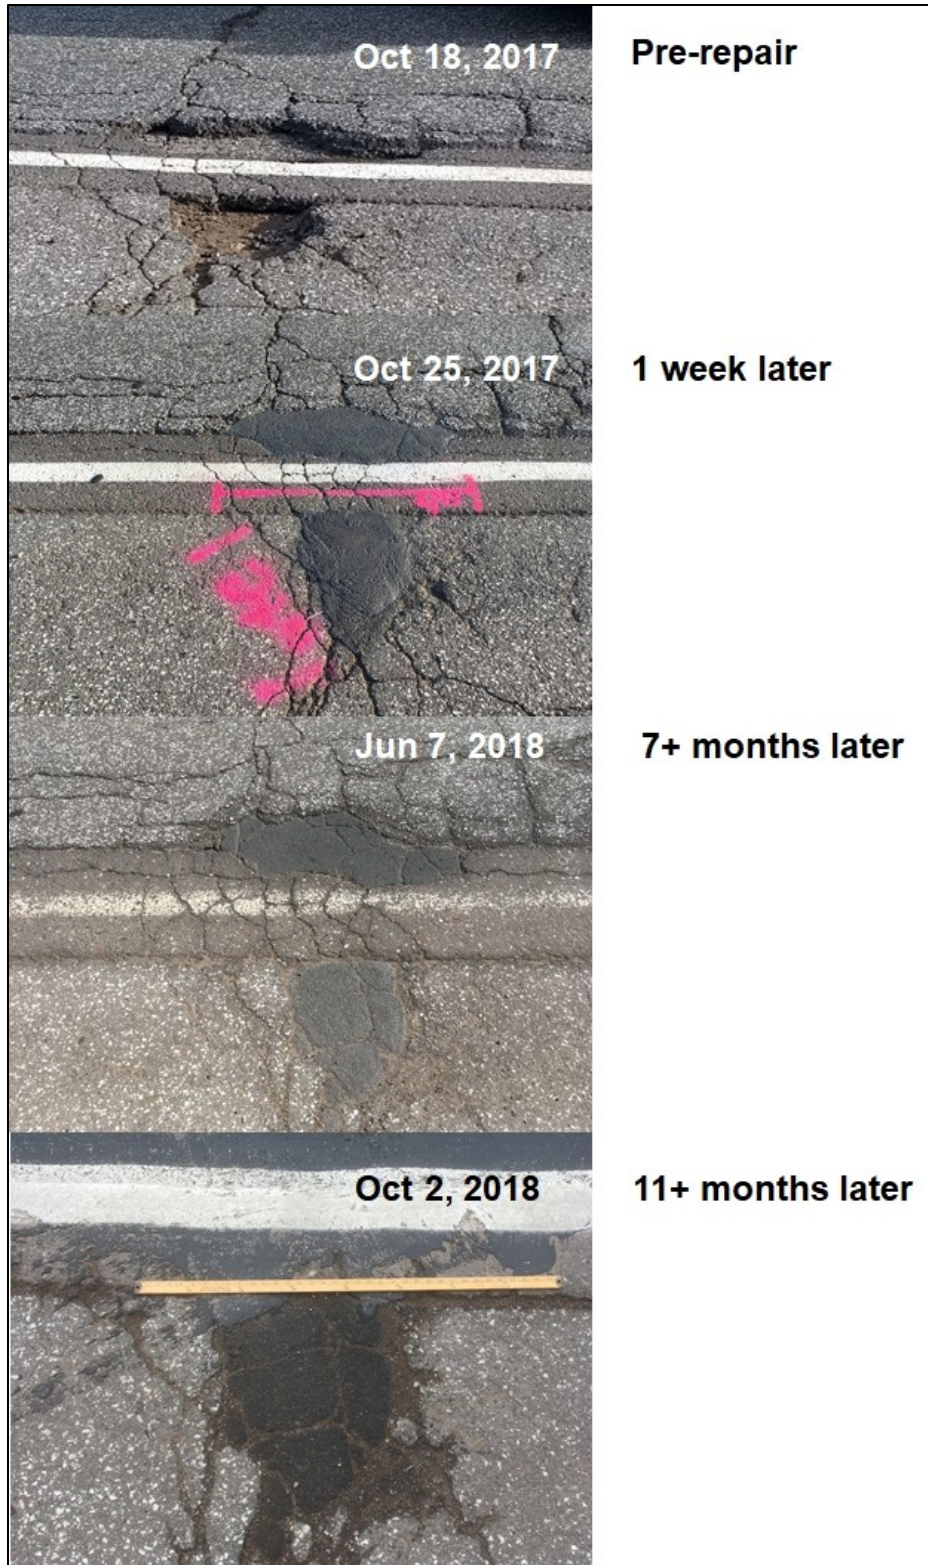
Figure 2.71 Condition of Proctor/Hwy 2 repair from October 18, 2017, to October 2, 2018.

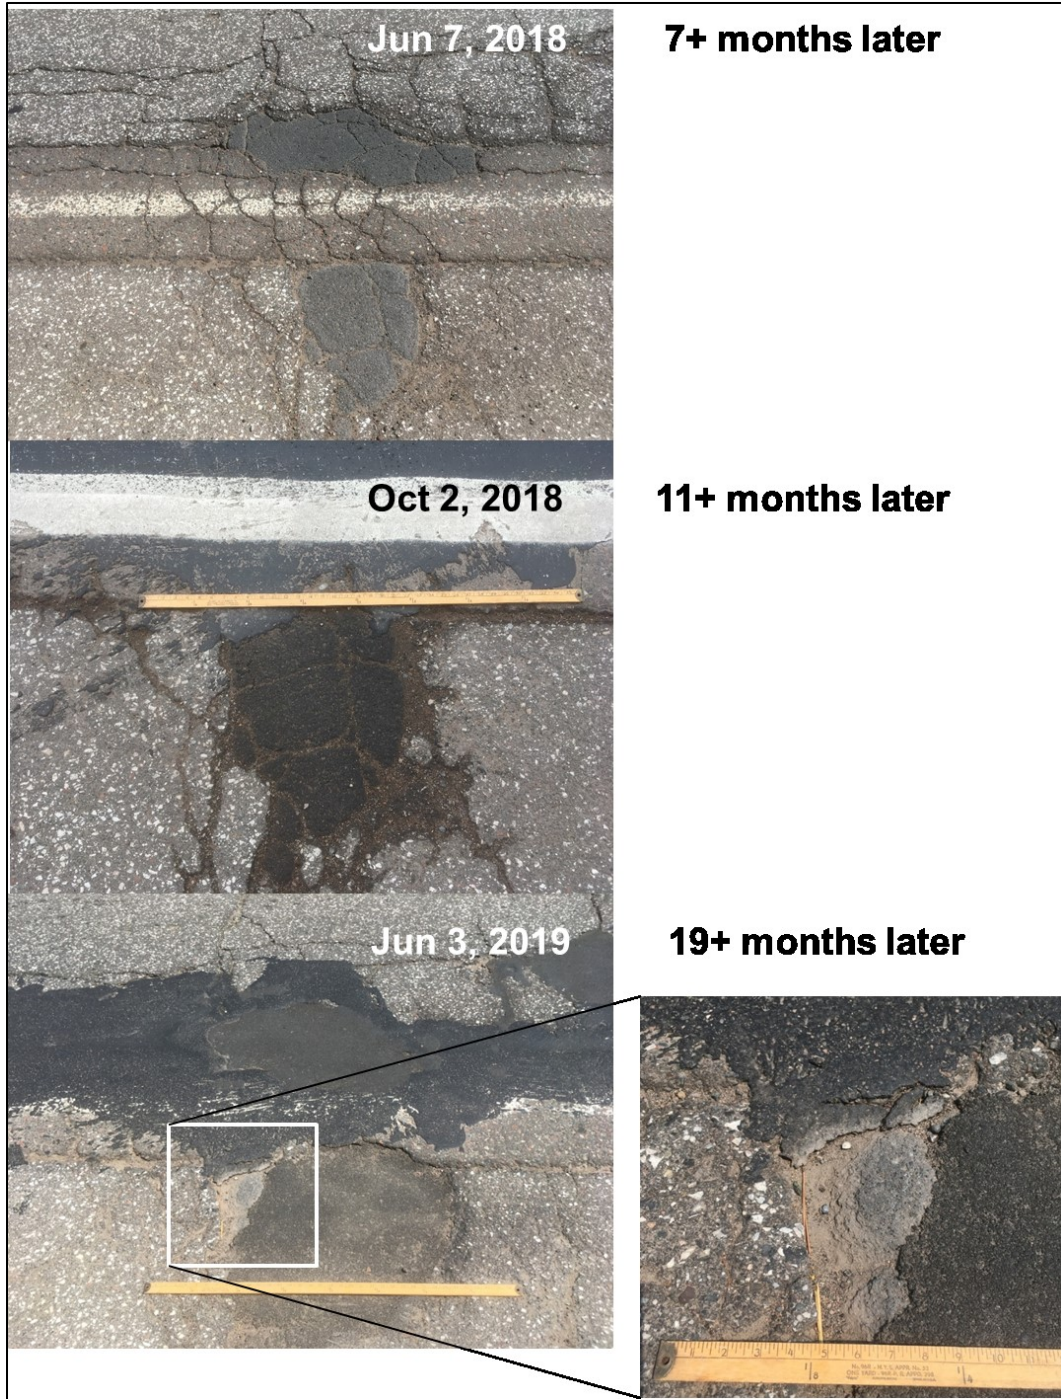
Figure 2.72 Condition of the October 18, 2017 Proctor/Hwy 2 repair: from June 7, 2018 to June 3, 2019.

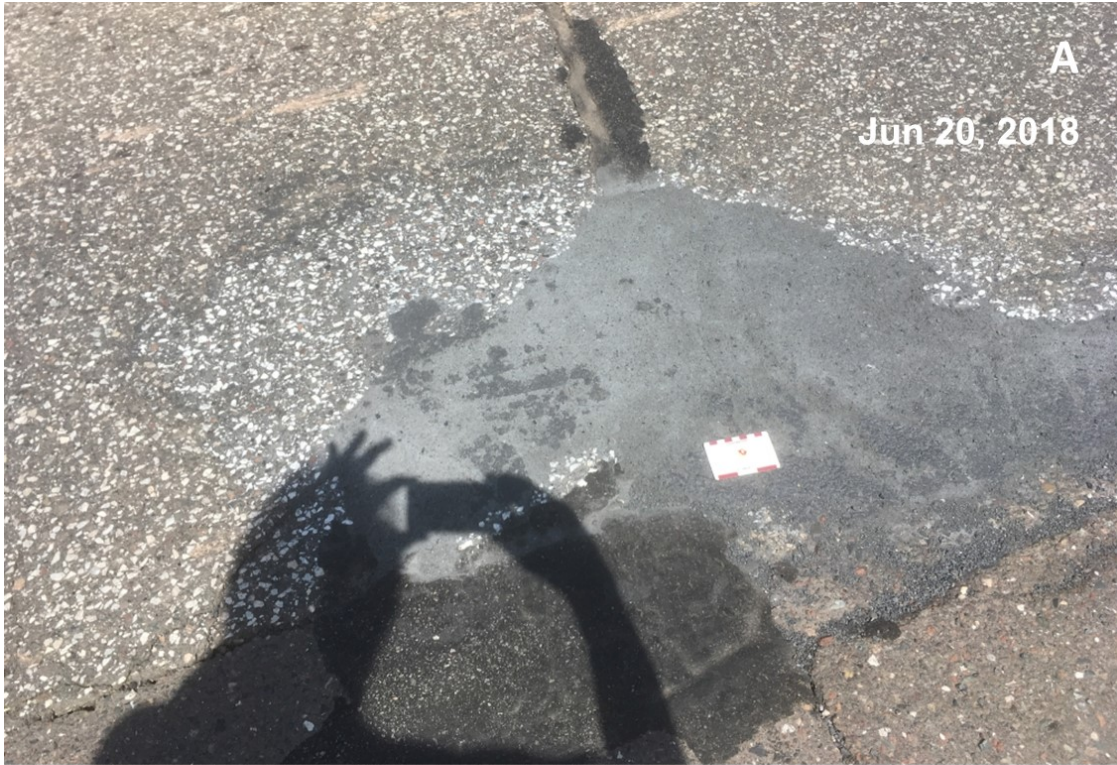
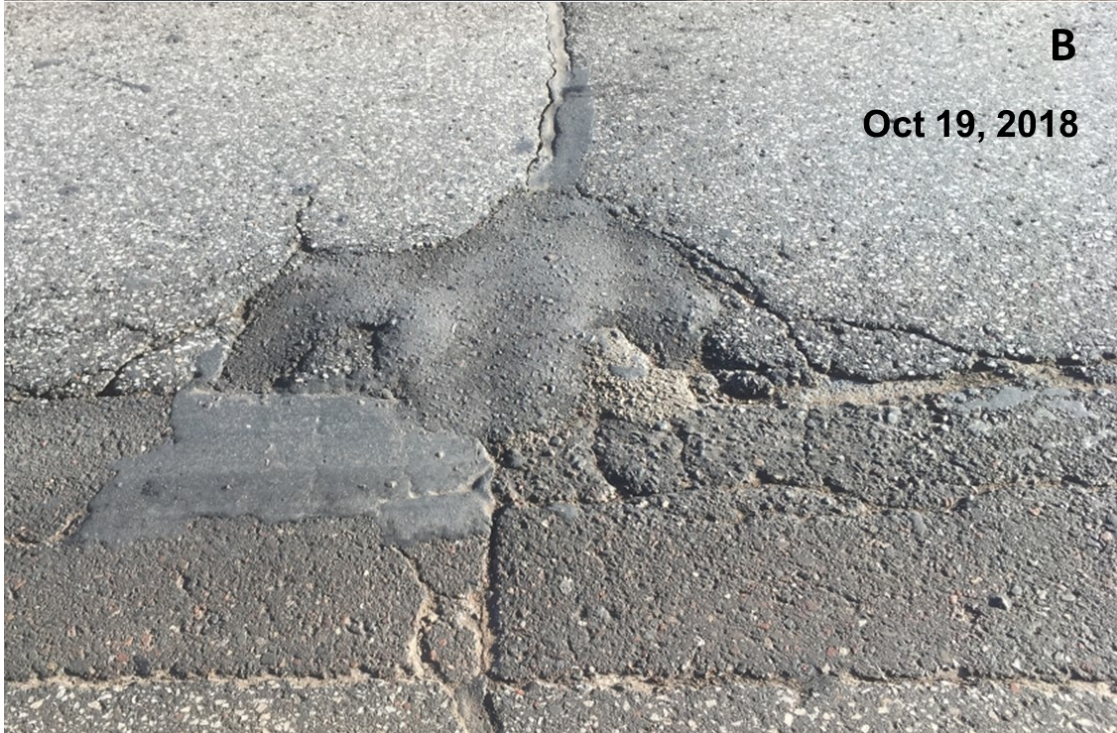
Figure 2.73 Condition of June 20, 2018 Proctor repairs on June 20, 2018 (A) and October 19, 2018 (B).
