Optimized Taconite-Based Pavement Repair Compound and Deployment System

Lawrence Zanko, Principal Investigator
Natural Resources Research Institute
University of Minnesota-Duluth

December 2019

Research Project
Final Report 2019-46

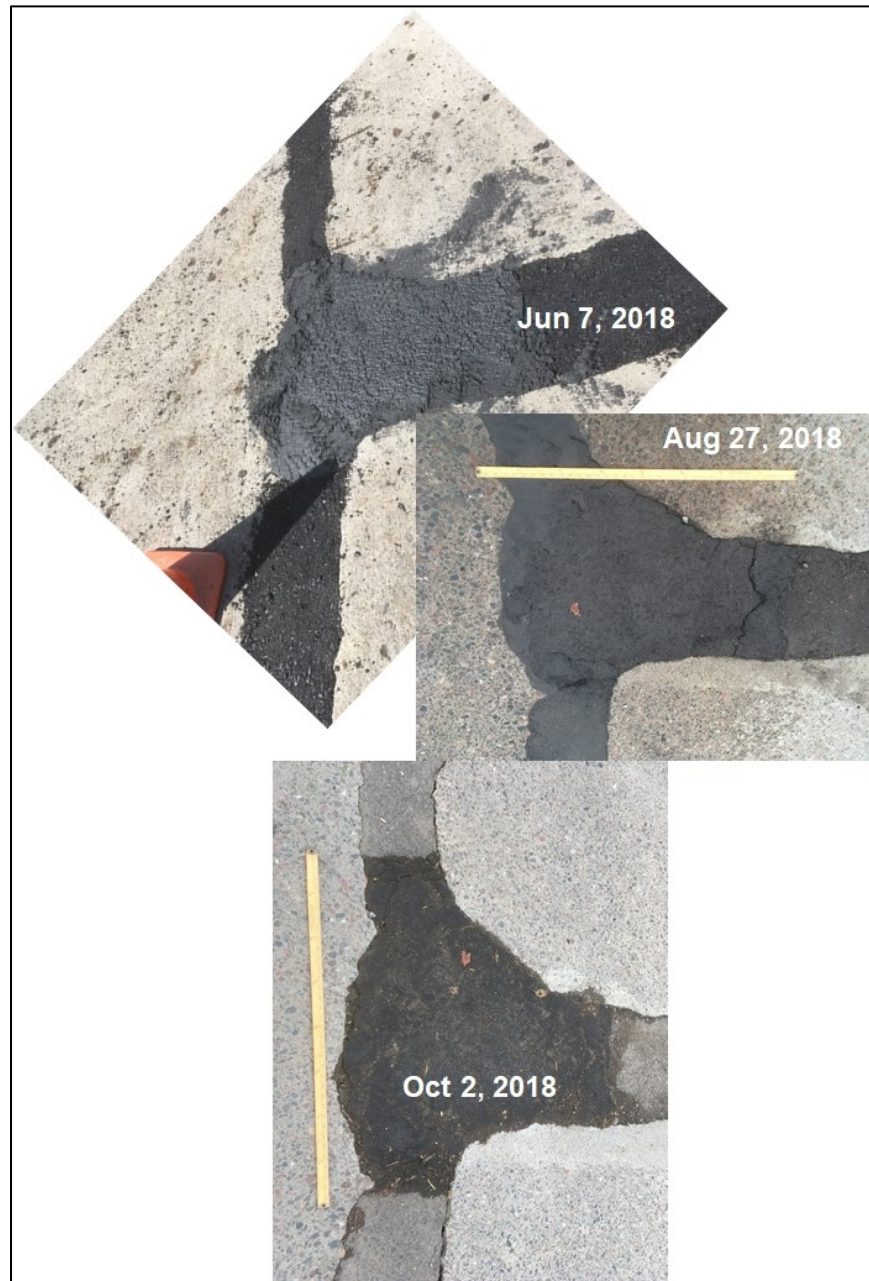
Figure 2.74 Condition of June 7, 2018, city of Duluth field trial repair through October 2, 2018.

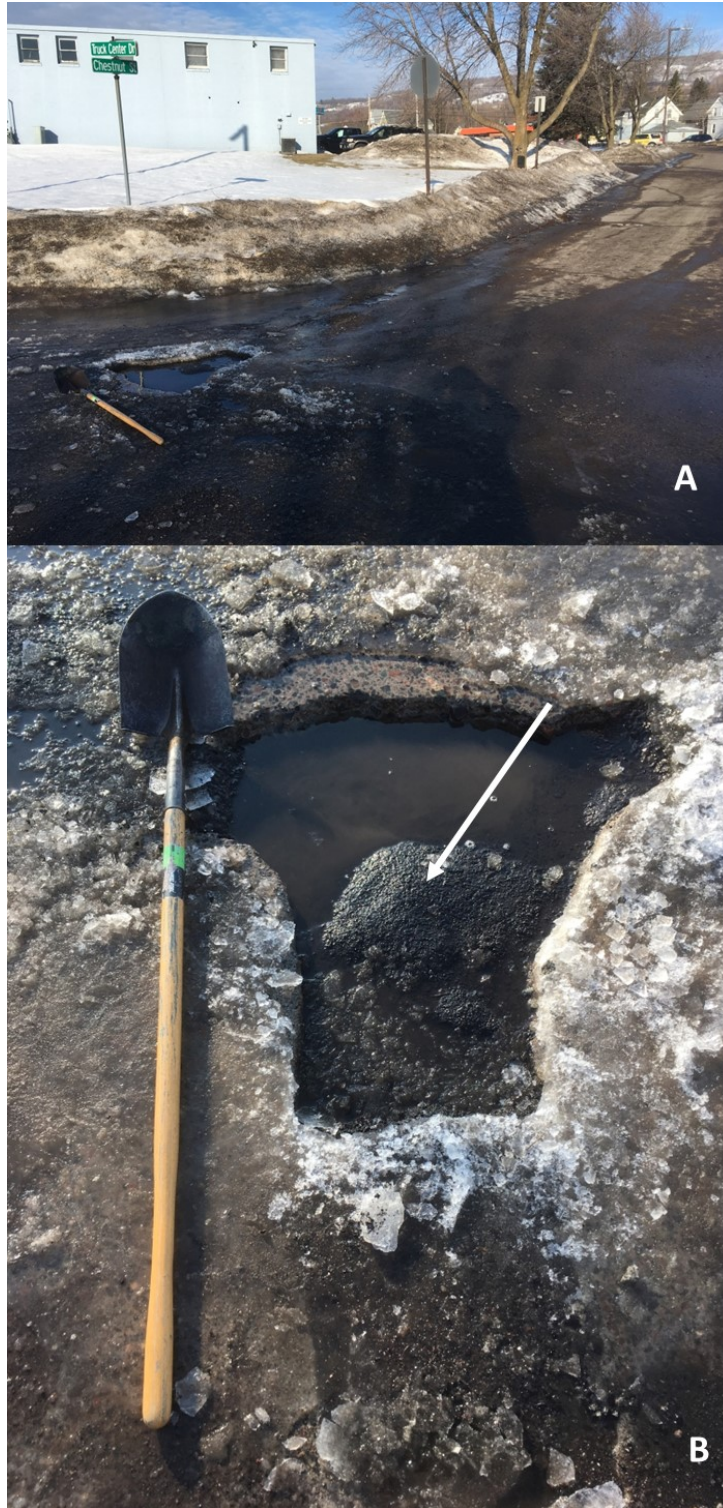
Figure 2.77 Site conditions (A); and resistant remnant of June 7, 2018, Duluth field trial repair (B); as of March 19, 2019.

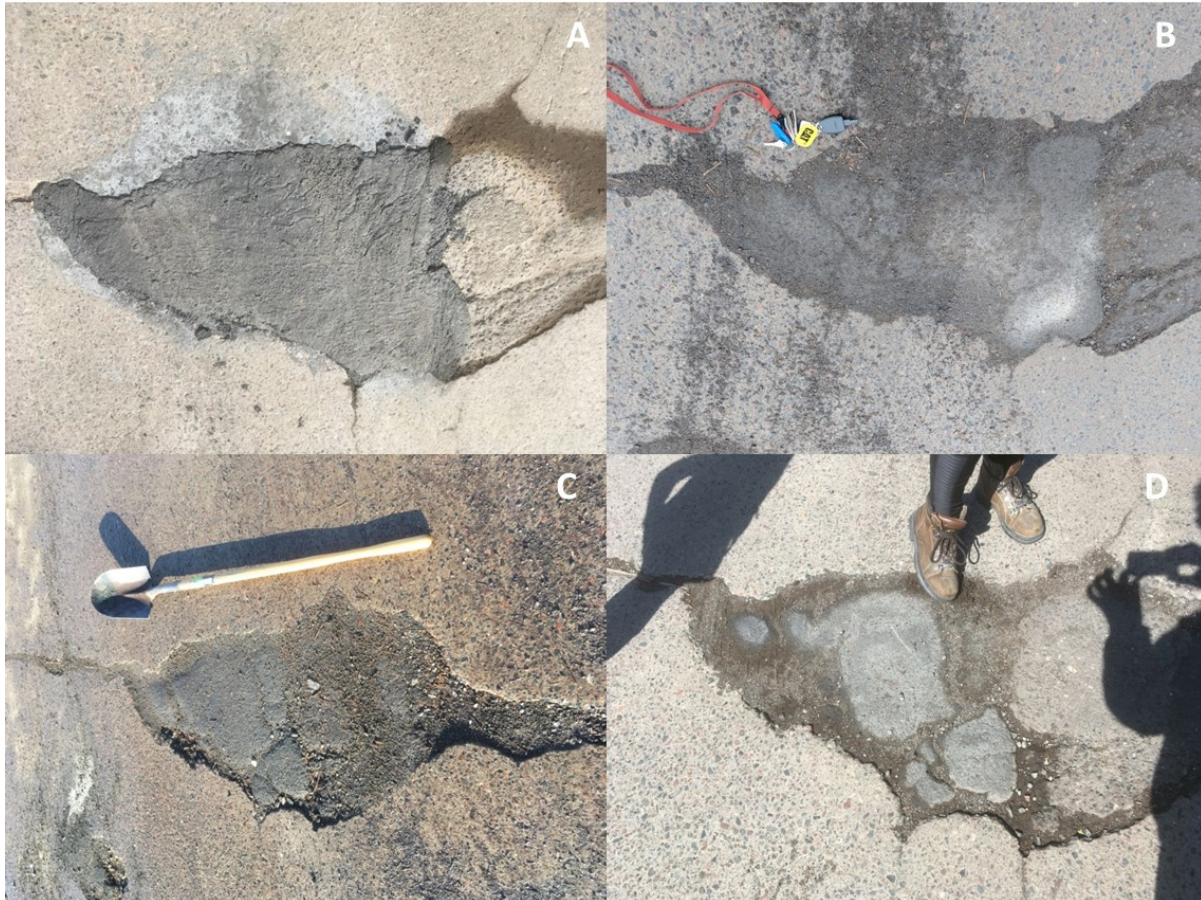
Figure 2.78 Condition of June 6, 2018, city of Duluth field trial repair on: (A) June 7, 2018; (B) December 12, 2018; (C) March 19, 2019; and (D) August 29, 2019.

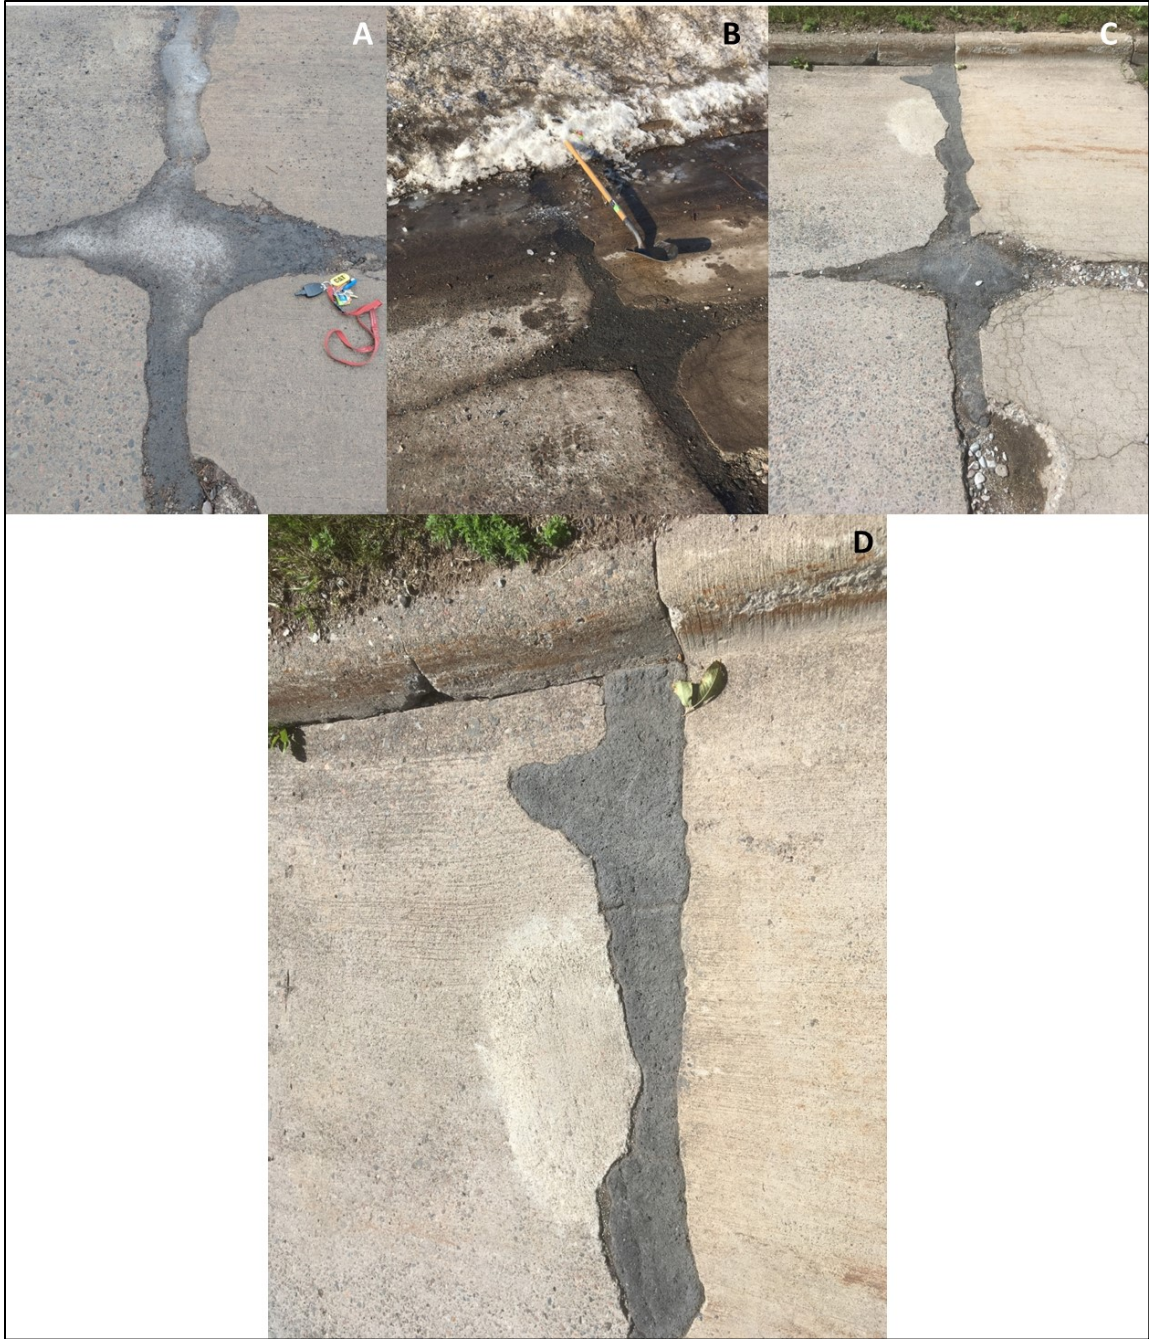
Figure 2.79 Condition of September 27, 2018, city of Duluth field trial repair on: (A) December 12, 2018; (B) March 19, 2019; (C) August 29, 2019; and (D) August 29, 2019 (close-up).

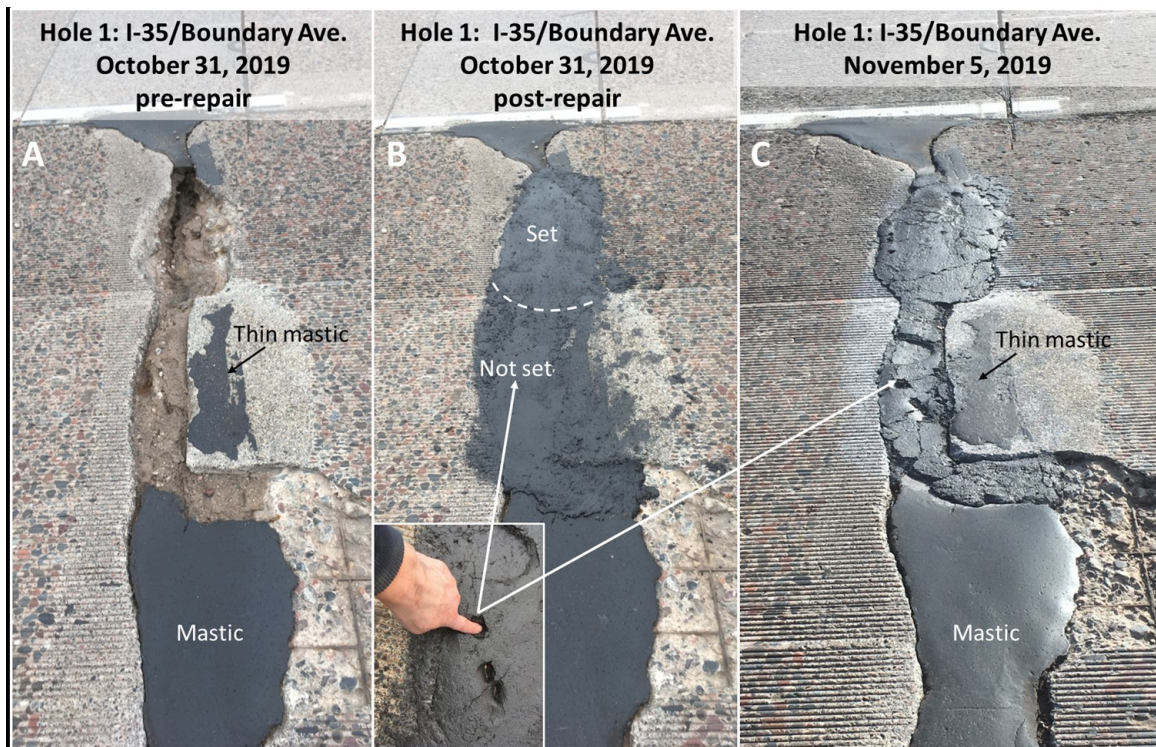
Figure 2.104 Hole 1 repair at I-35/Boundary Avenue location: pre-repair (A) and post-repair (B) on October 31, 2019, with inset showing soft (not set) condition of the thinnest portion of the repair; and on November 5, 2019 (C).

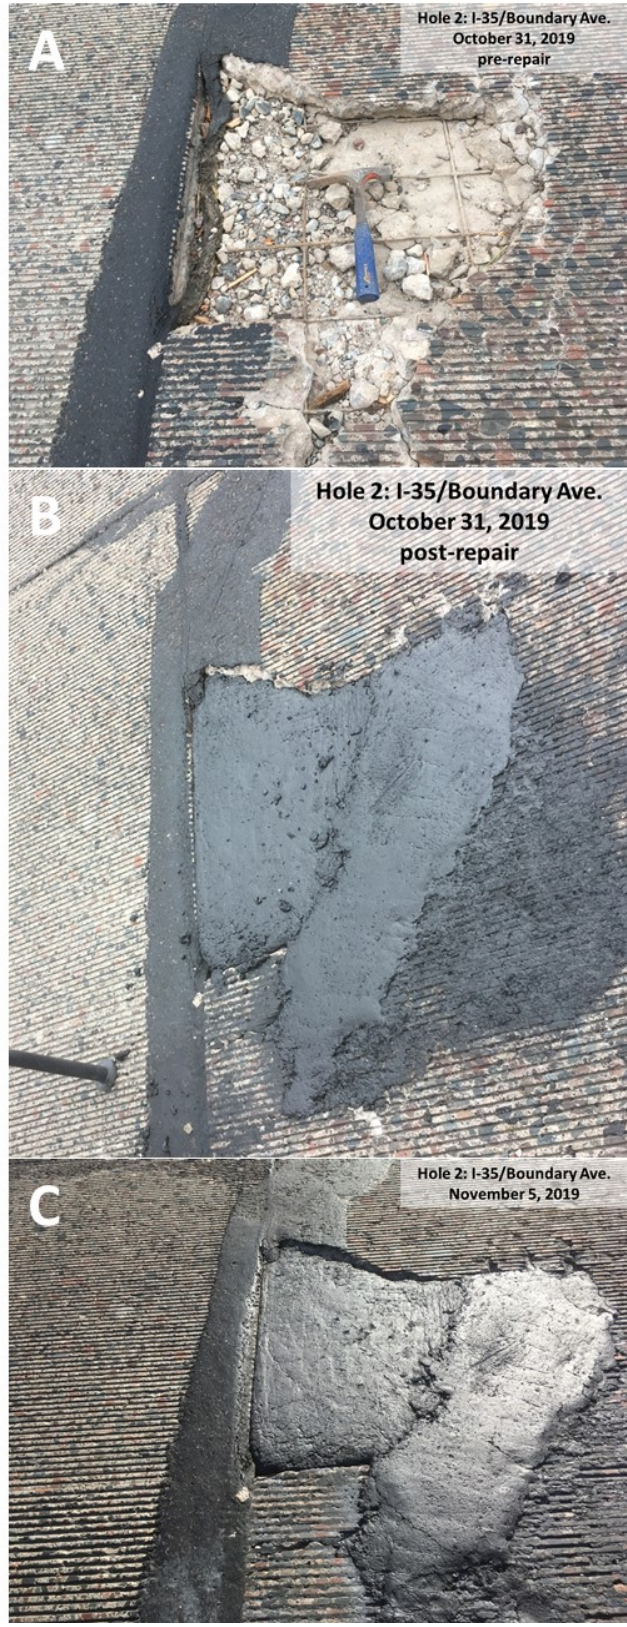
Figure 2.105 Hole 2 repair at I-35/Boundary Avenue location: pre-repair (A) and post-repair (B) on October 31, 2019; and on November 5, 2019 (C).
