Condition and Durability of Segmental
Concrete Block Retaining Walls Along
Roadways in Minnesota

| 4. Title and Subtitle CONDITION AND DURABILITY OF SEGMENTAL CONCRETE BLOCK RETAINING WALLS ALONG ROADWAYS IN MINNESOTA | | 5. Report Date July 2001 | |

Final Report

July 2001

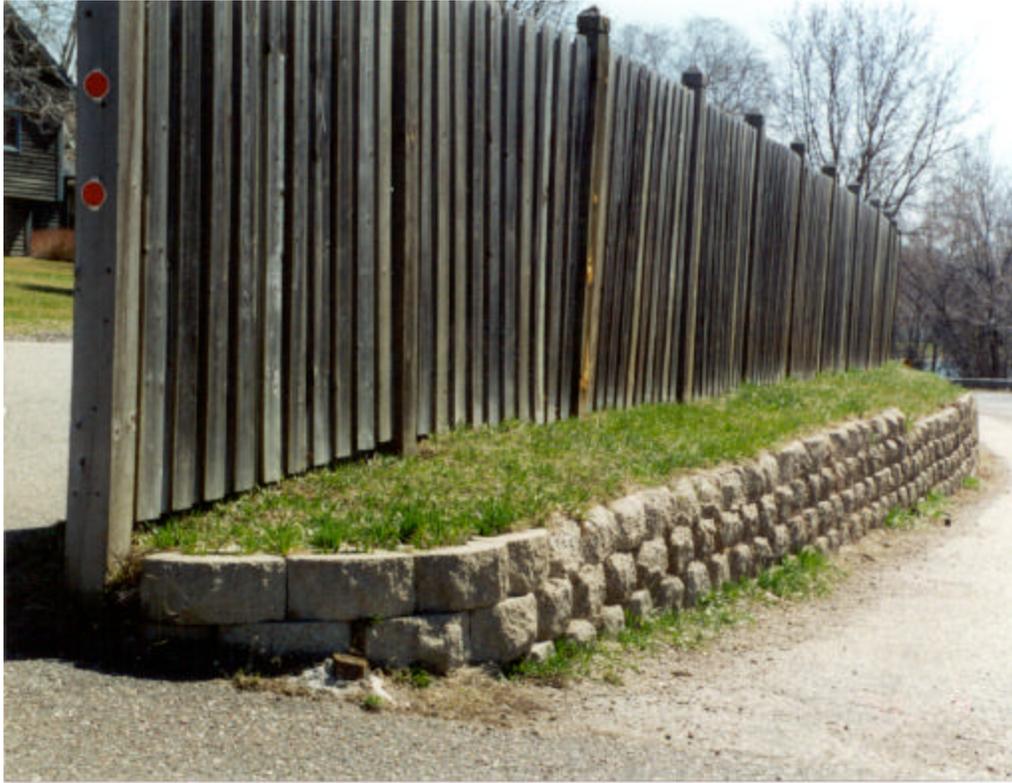
Figure 3.1. Overall photo of northern portion of south wall (CSAH 101 and 24th Ave.).

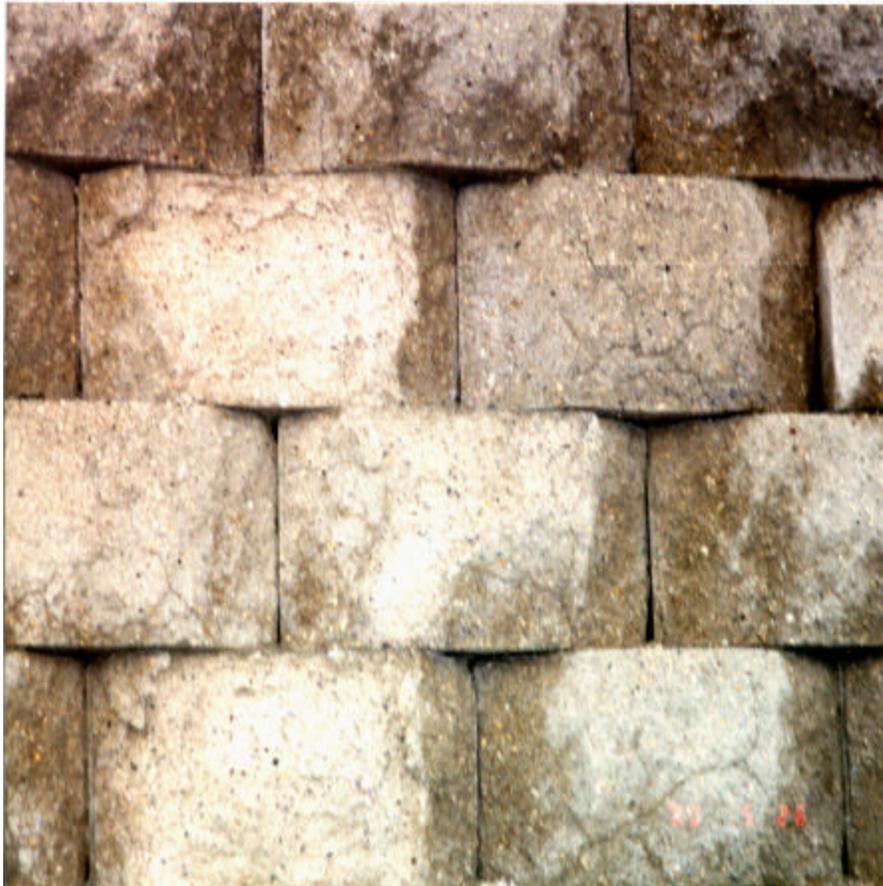
Figure 4.16. Close-up photo of high-severity scaling and high-severity freeze-thaw damage on SCBRW subjectively rated as “poor”.

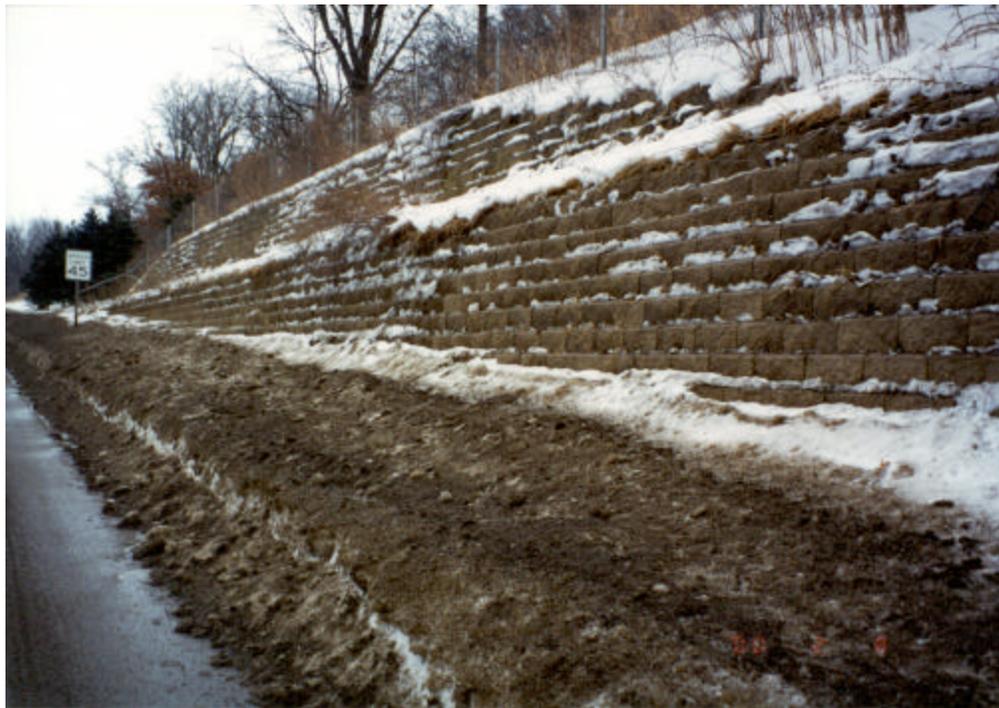
Figure 4.17. Photo illustrating high quantity of deicing sand/salt in snow accumulation.

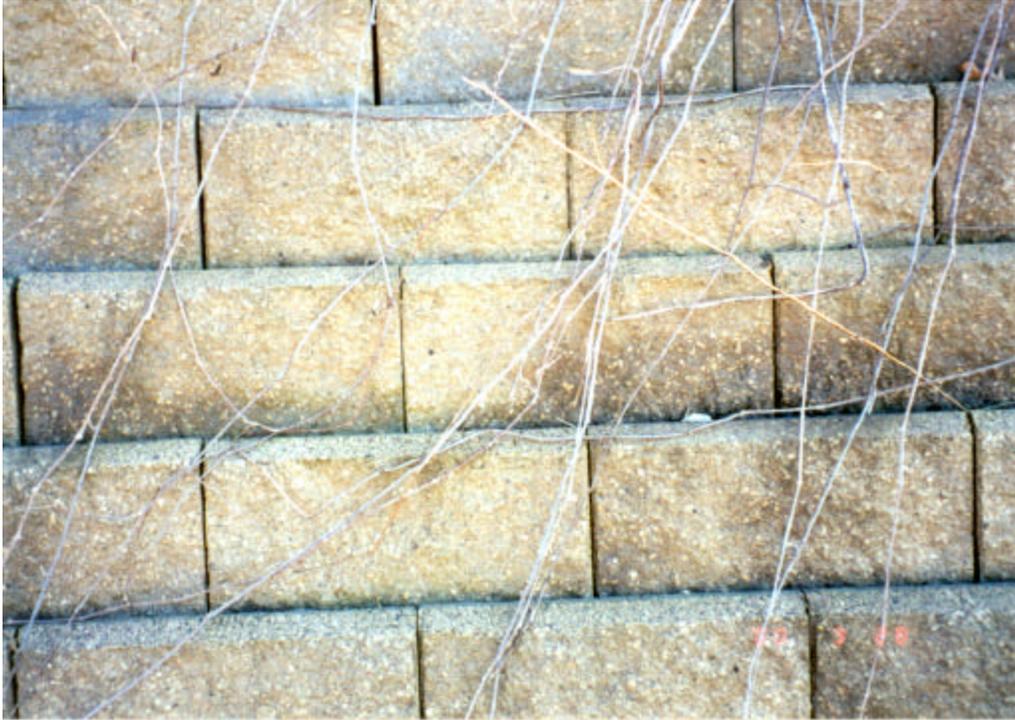
Figure 4.19 is photo illustrating the general condition of the masonry block units used in this SCBRW. Figures 4.20 and 4.21 are photos illustrating regions of the wall exhibiting the greatest amount of distress. Low-severity freeze-thaw damage on the lower portions of the masonry block units and behind the position guides is readily apparent in figure 4.19. Figures 4.20 and 4.21 both show distresses due to poor freeze-thaw durability. High-severity position guide damage (high-severity freeze-thaw damage) is exhibited in figure 4.20. In addition, the sand used to spread the deicing salts can be seen behind all of the position guides. As stated earlier, the presence of the deicing chemicals increases the saturation of the block units (or the position guides for this case). Most likely, the presence of these chemicals and the ability of water to sit behind the position guides exacerbated the potential for freeze-thaw durability problems. Low-severity freeze-thaw damage can also be seen on the lower portions of the block units in this figure. High-severity scaling is readily apparent in figure 4.21. This photo illustrates the complete scaling of the position guides (the guides have completely scaled away) and severe scaling of the block unit vertical surfaces.

Figure 4.19. Photo of general condition of masonry blocks used in SCBRW subjectively rated as “fair”.

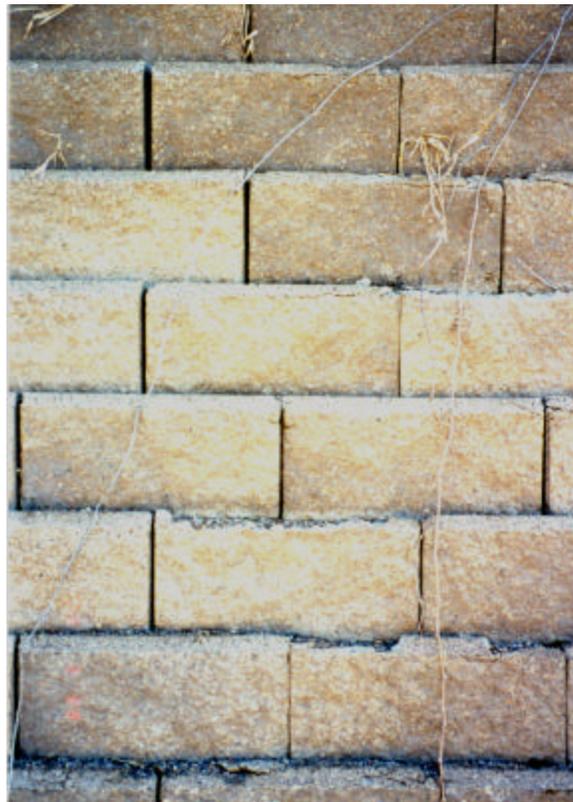
Figure 4.20. Close-up photo of high-severity position guide damage (high-severity freeze-thaw damage) on SCBRW subjectively rated as “fair”.

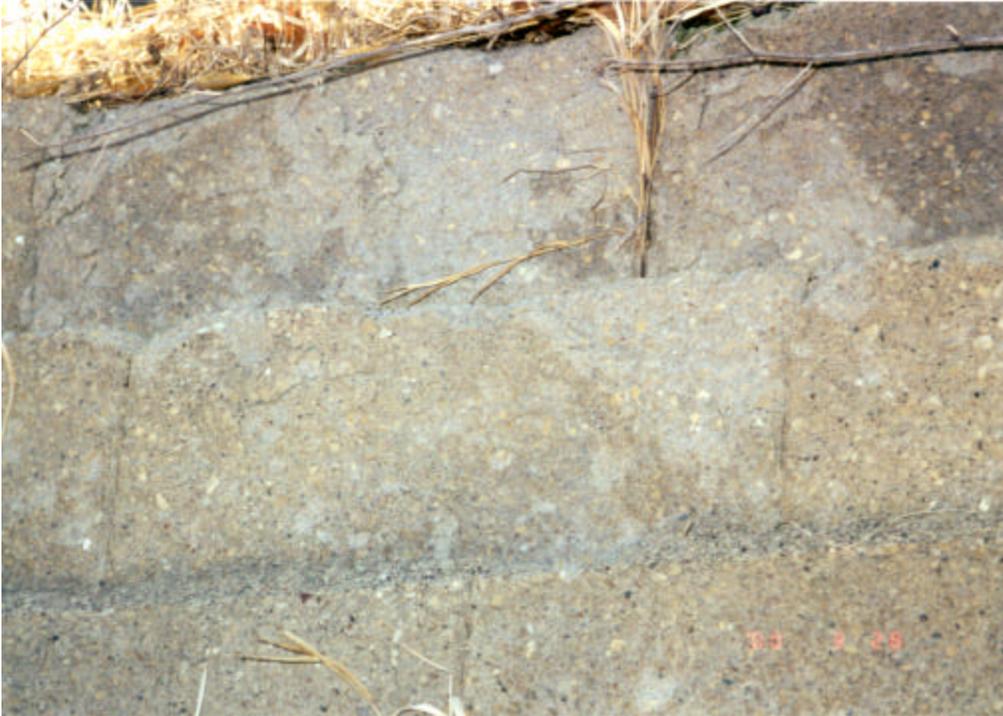
Figure 4.21. Close-up photo of high-severity scaling on SCBRW subjectively rated as “fair.”

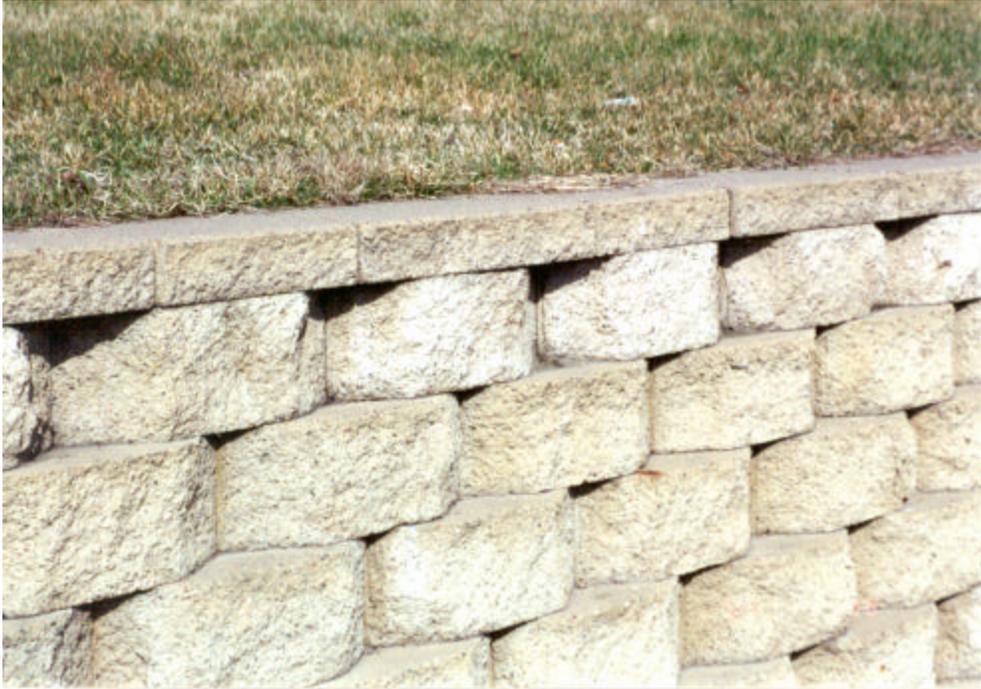
Figure 4.27. Photo of general condition and low-severity freeze-thaw damage of masonry units used in SCBRW subjectively rated as “good”.

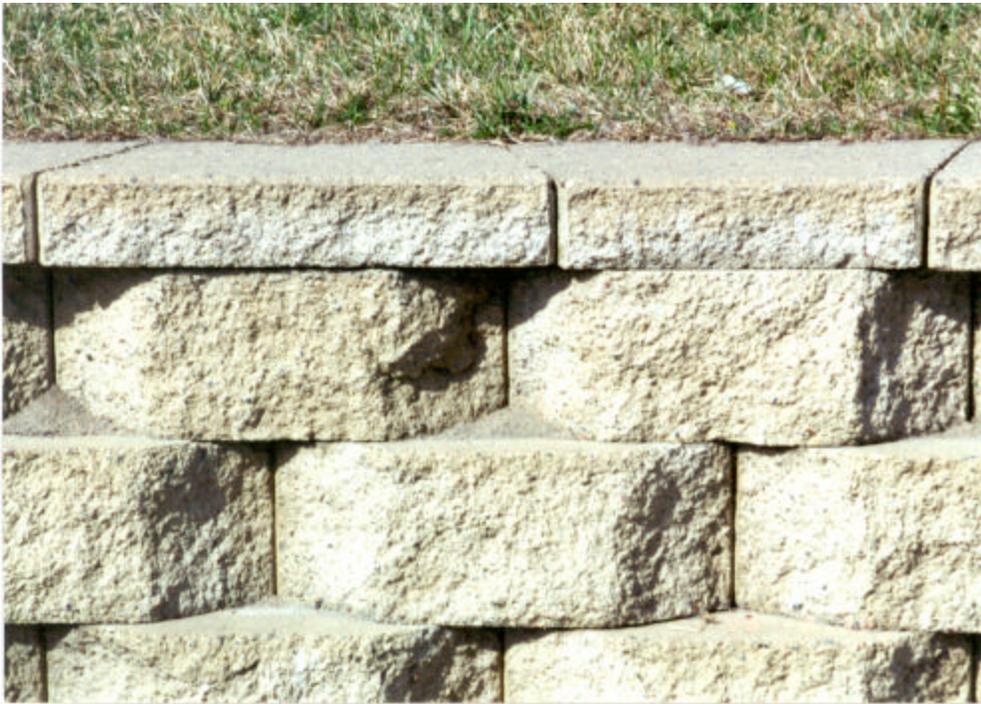
Figure 4.28. Photo of low-severity freeze-thaw damage on SCBRW subjectively rated as “good”.

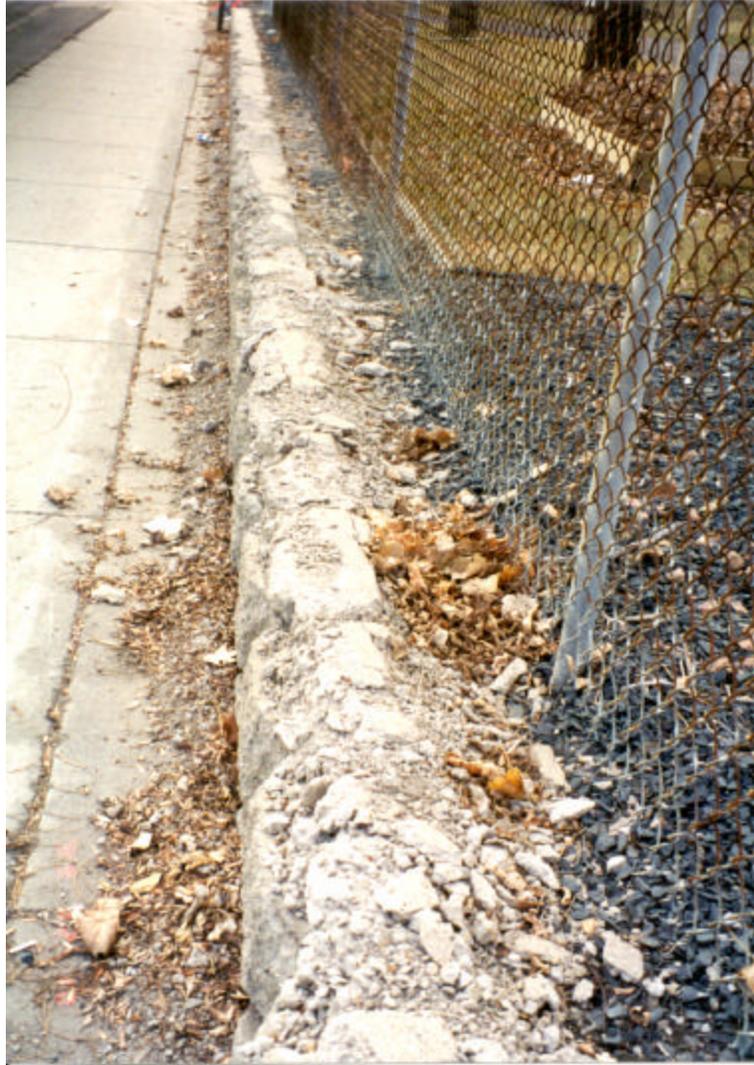
The F/C (face-to-curb) distance also appeared to have an effect on the severity or presence of freeze-thaw deterioration. In general, walls constructed at greater distances from the road had less freeze-thaw damage than those immediately adjacent to the mainline and subjected to greater amounts of snow accumulation and deicing chemicals. Figures 4.29 and 4.32 (photos of a wall rated as very good) and figures 4.17 and 4.20 (photos of a wall rated as fair) illustrate wall locations with F/C distances of 18 ft and 6 ft, respectively. Additionally, figure 4.33 presents a photo showing high-severity scaling of capstone units located at a F/C distance of 8 ft and at a region with a large amount of ground water runoff from behind the wall (the wall was subjectively rated as poor).

Figure 4.33. Photo illustrating high-severity freeze-thaw damage (top block layer) for wall with F/C distance of 8 ft.

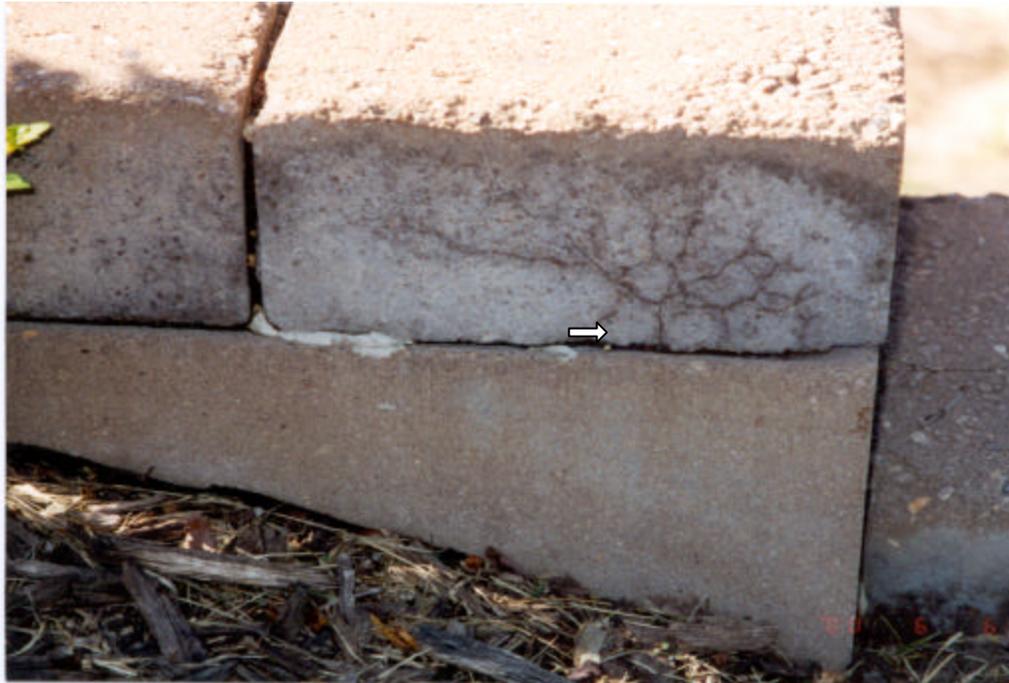
Freeze-thaw deterioration was frequently observed in locations of high moisture accumulation or water runoff. The exposed backs of a large amount of block units (a location susceptible to a immense amount of moisture) exhibited freeze-thaw deterioration in the form of cracking (see figures 4.34). Conversely, figure 4.35 demonstrates the reduced presence of freeze-thaw deterioration in locations of decreased water accumulation. The portion of the wall located at the bottom of the hill (where water accumulates) was presented in figure 4.33. As stated previously, the capstone units on this section exhibited high-severity scaling.

a. Medium-Severity Freeze-Thaw Damage (Top Block Layer).

Figure 4.34. Photos (a and b) illustrating medium-severity freeze-thaw damage in a location of high water runoff.

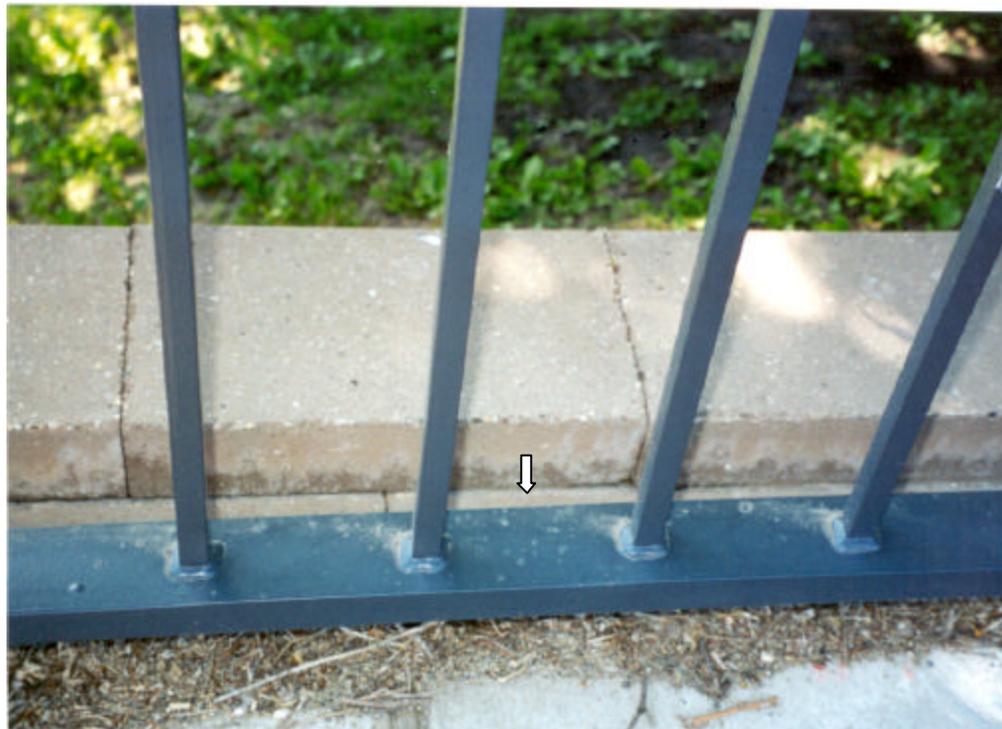
b. Low- and Medium-Severity Freeze-Thaw Damage (Top Block Layer).

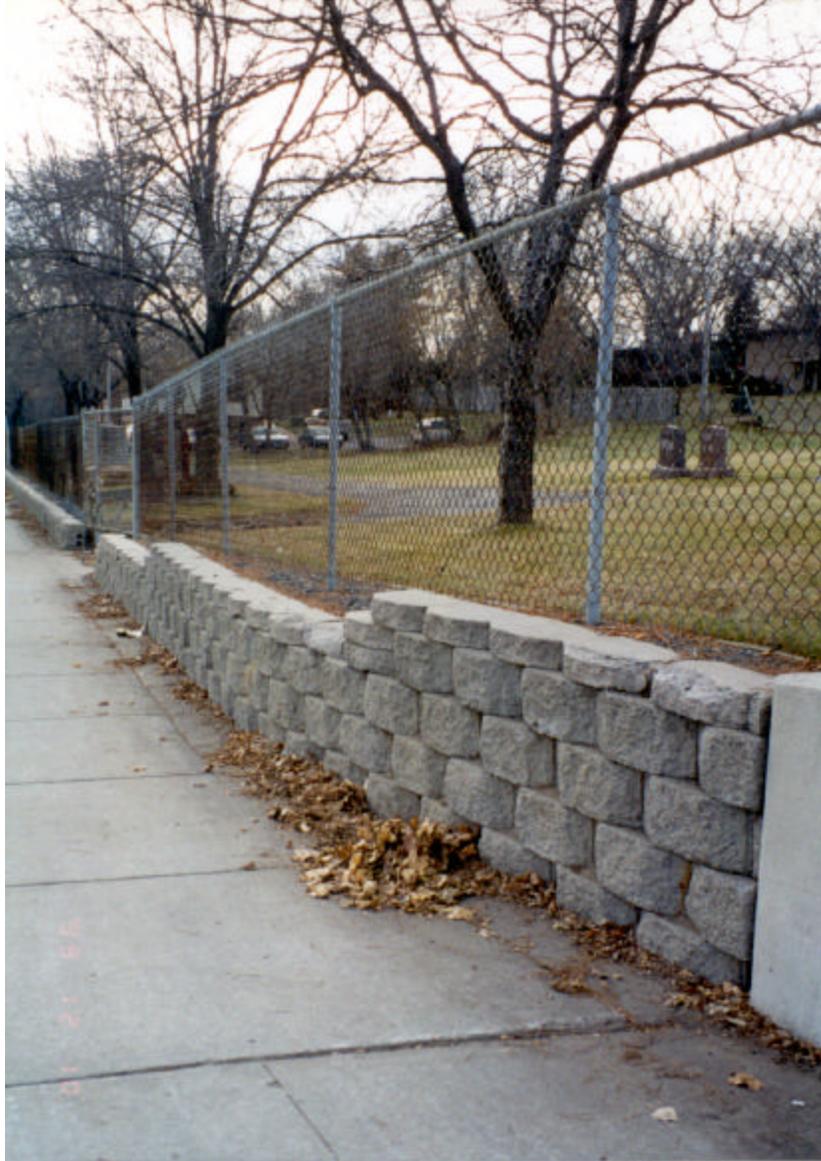
Figure 4.35. Photo illustrating reduced freeze-thaw deterioration at a location of minimal water runoff.

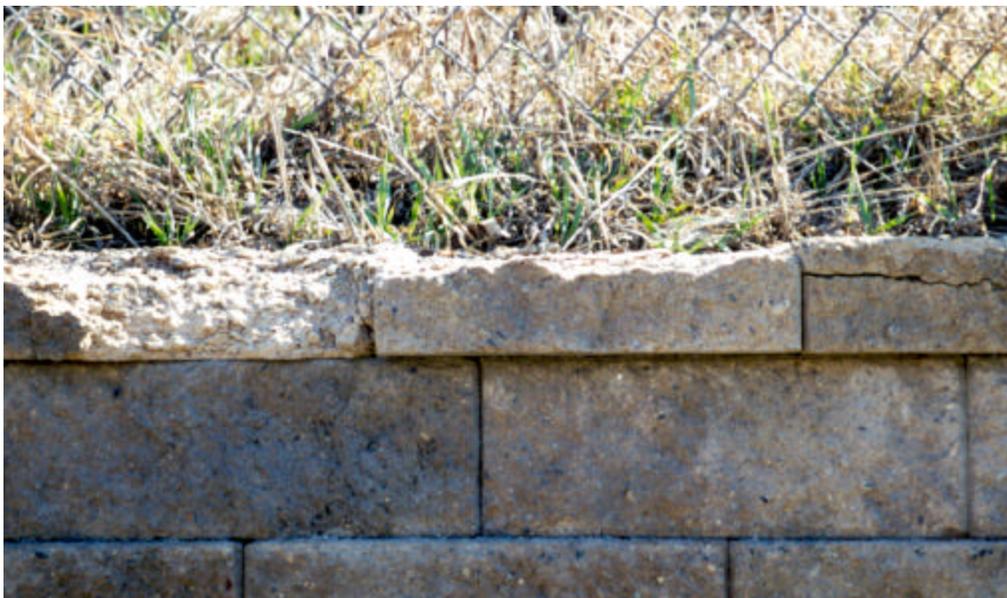
b. SCBRW adjacent to golf course.

Figure 4.37. Freeze-thaw deterioration exacerbated by the presence of fertilizers.

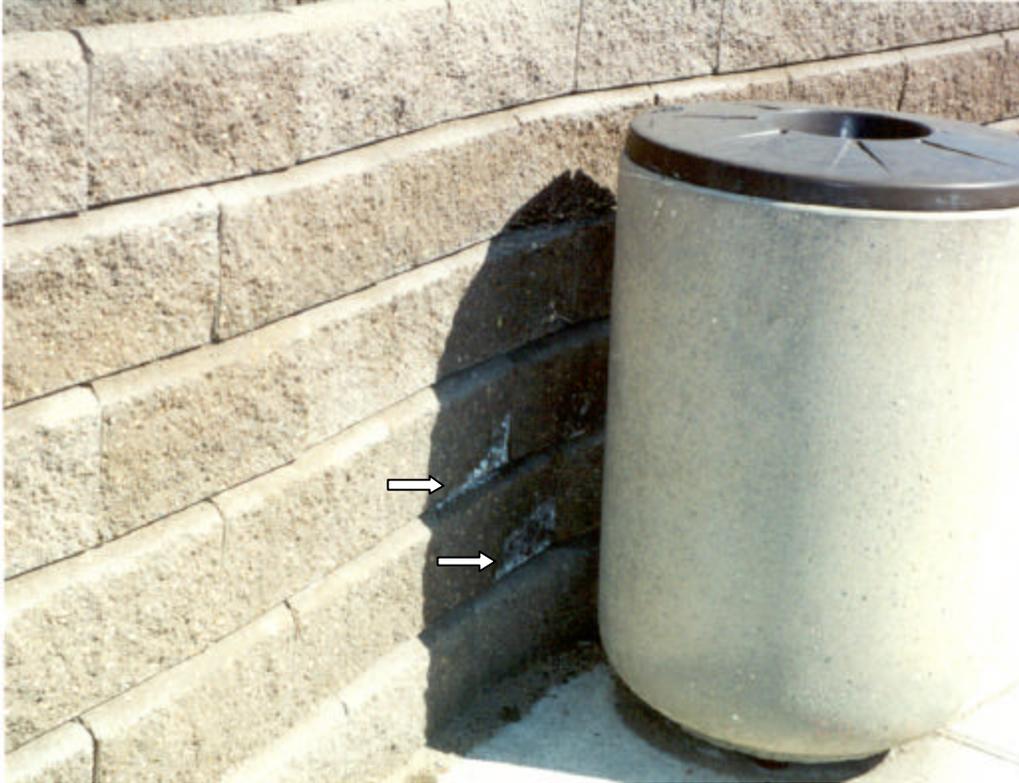
a. Efflorescence behind obstruction.

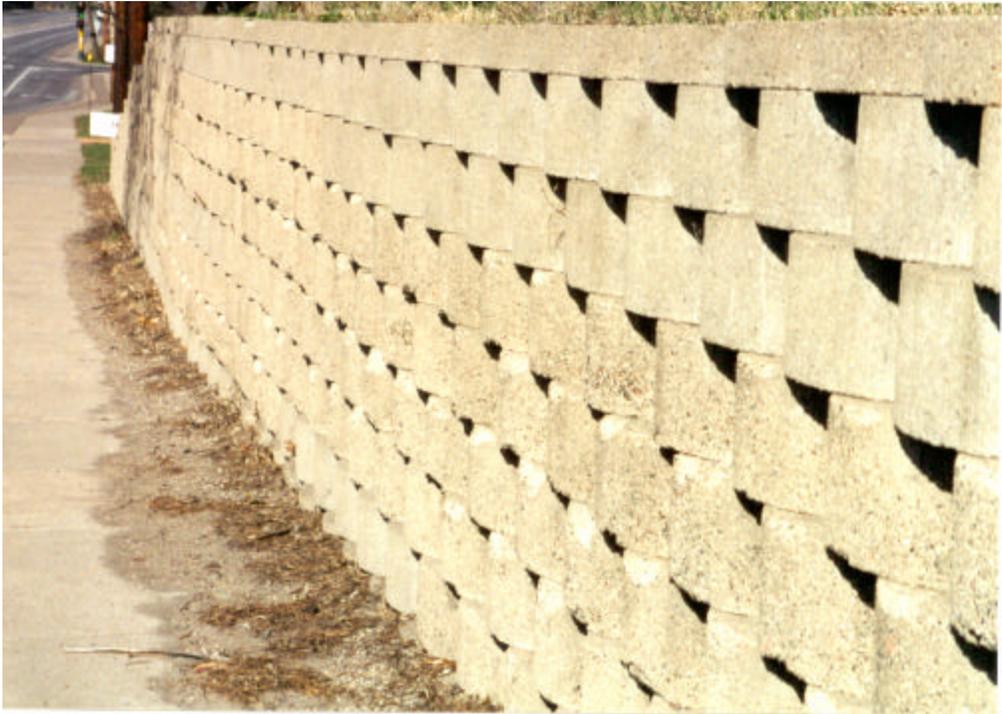
The description of this distress type is the same as that described above for scaling (top block surfaces). Again, the presence of vertical surface scaling was strongly associated with a given block manufacturer, thereby indicating that durability problems are largely due to improper mix designs. Figures 4.52 and 4.53 illustrate the association of durability problems with mix design. Sections of durable and non-durable masonry block units are visible in this wall, indicating variations of mixes from batch to batch affecting the block performance.

Figure 4.52. Example of apparent variations in mix design affecting block performance (CSAH 6 and 481 ft East of Dunkirk (north side)).

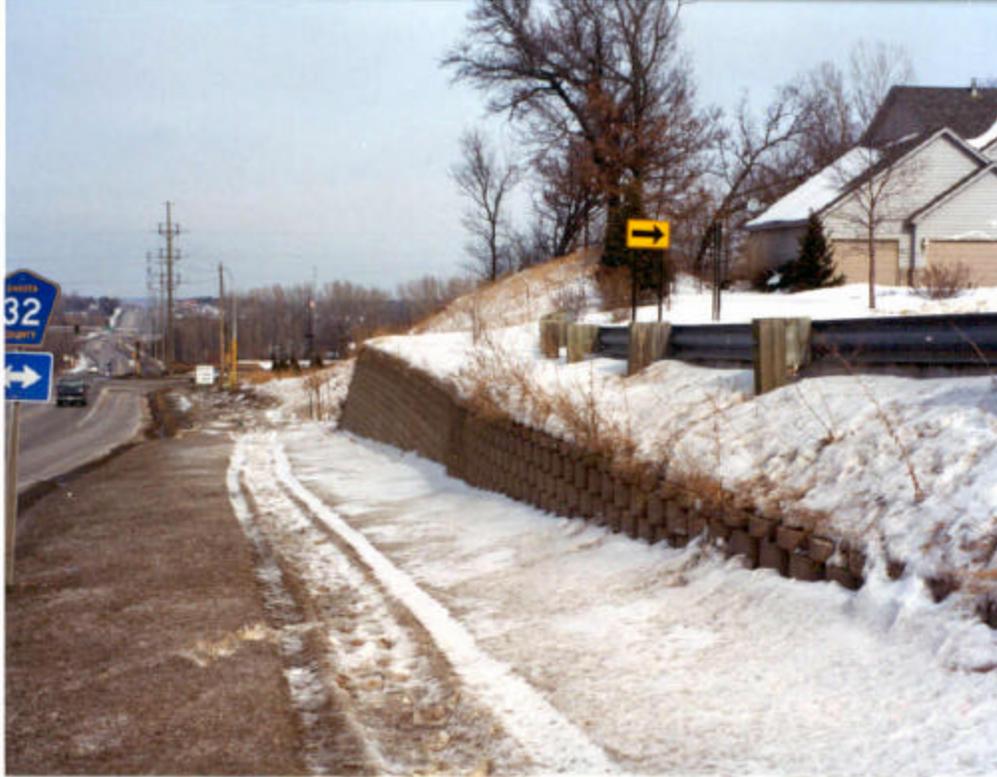
Figure 4.66 presents a photo illustrating how the offset distance of SCBRW vertical surfaces and the type of snow removal near the wall affects the amount of snow and quantity of deicing sand/salt in the snow accumulation on or adjacent to the SCBRW. For the case illustrated in this photo, mainline snow removal is the only type of snow removal present. Snow accumulation containing a high quantity of deicing sand/salt snow is located approximately 4 to 5 ft away from the vertical surfaces. Therefore, the vertical surfaces are exposed to only a minimal amount of snow accumulation with deicing chemicals. The snow accumulation on 25-50 percent of the top block layer is due to the snow removal from the residential roadway behind the SCBRW. As illustrated in the photo, the guardrail present behind the top block layer allows a larger amount of snow to accumulate on the capstone.

Figure 4.66. Photo illustrating the effect of the type of snow removal and offset distance on snow accumulation and quantity of deicing chemicals (SE Quadrant of Pilot Knob and Cliff Road).

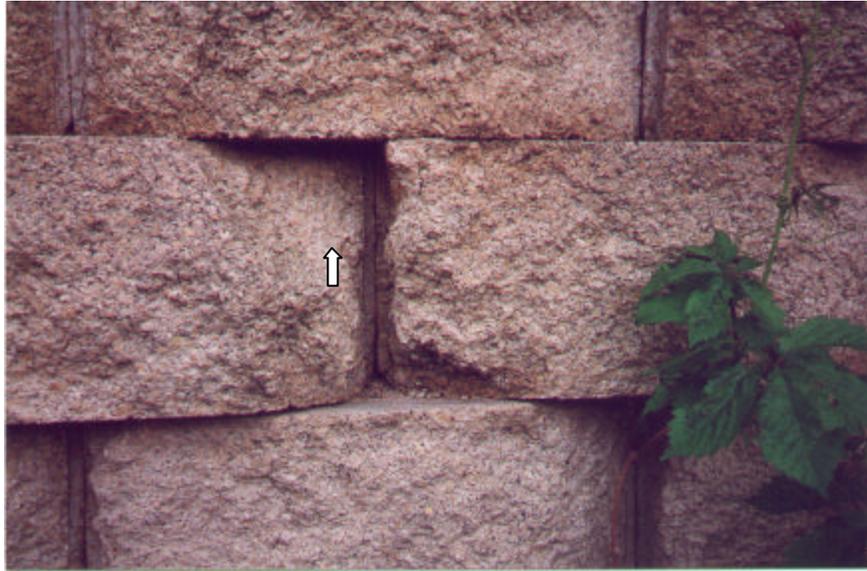
Medium-Severity Corner Break

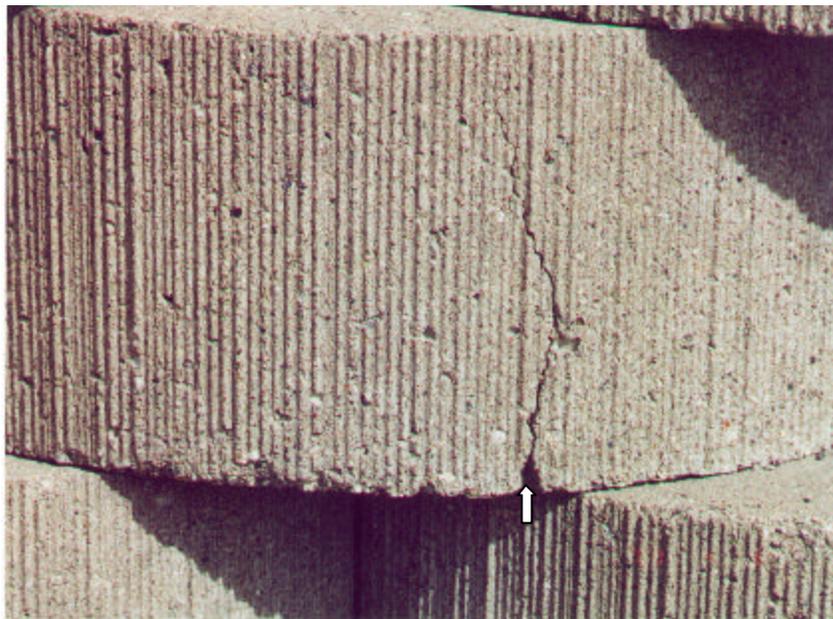
Low-Severity Cracked Block

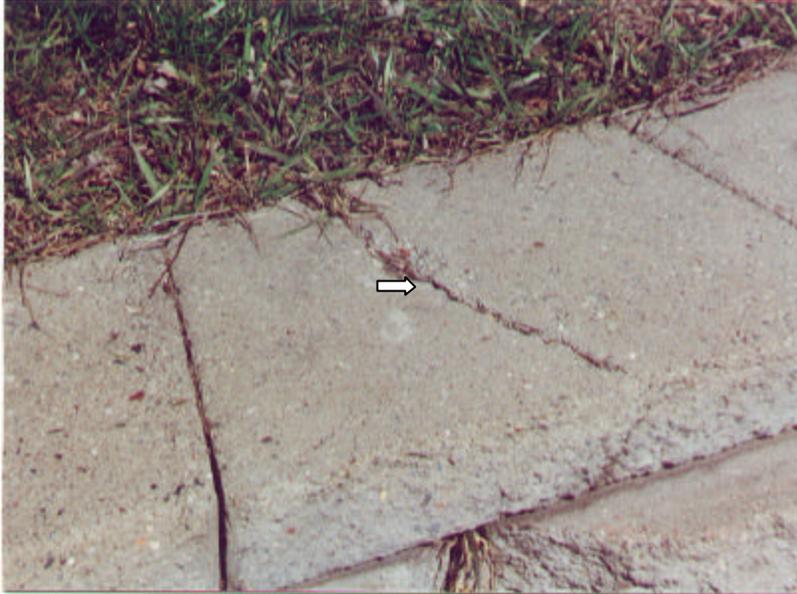
Medium-Severity Cracked Block

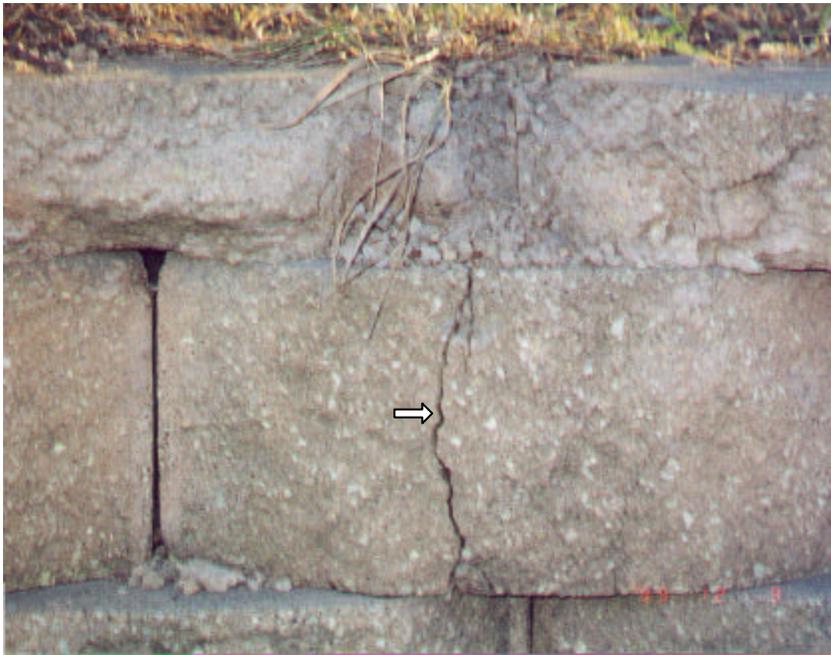
High-Severity Cracked Block

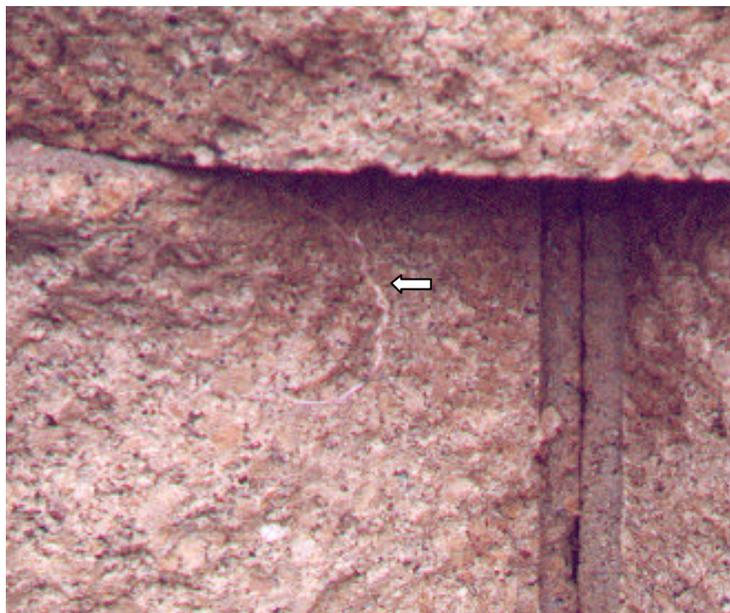
Low-Severity Efflorescence along Crack

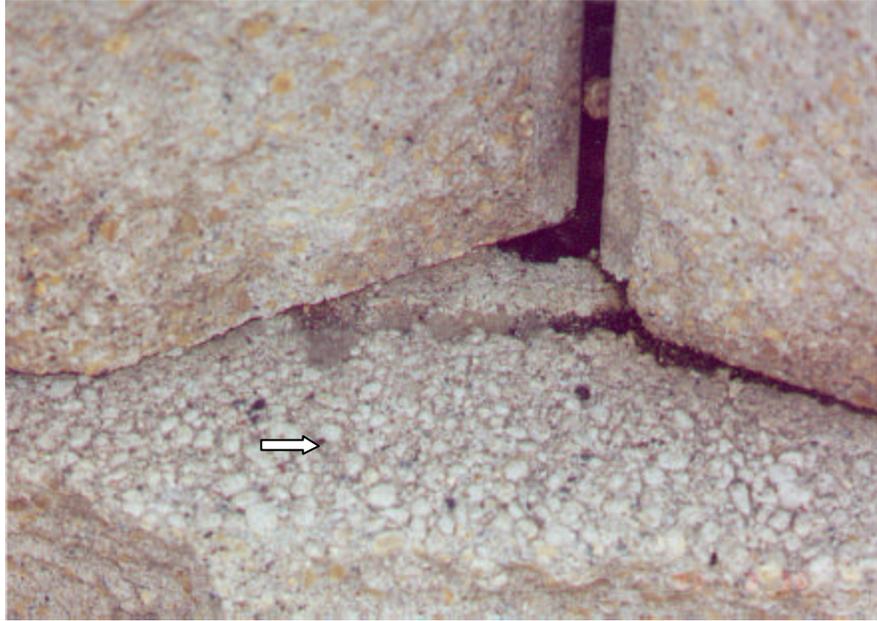
Medium-Severity Erosion

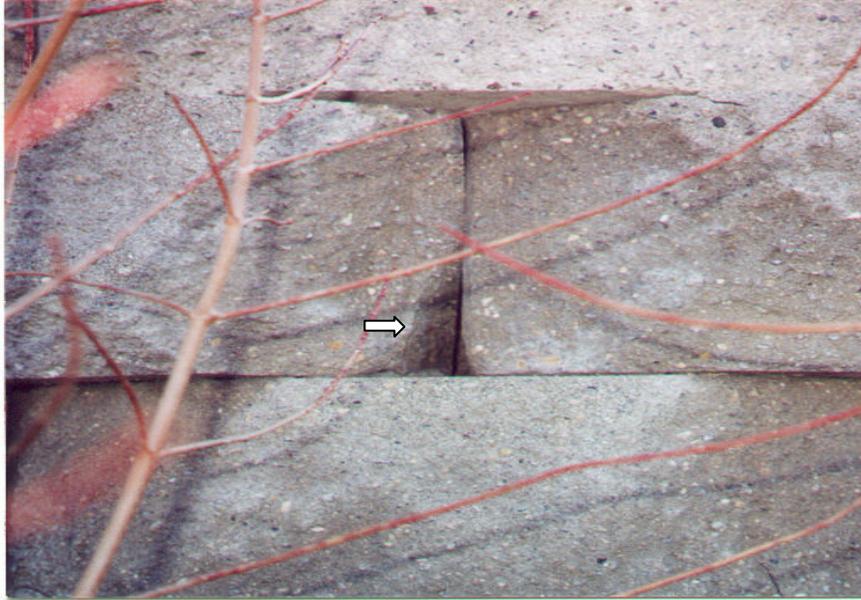
Medium-Severity Spalling

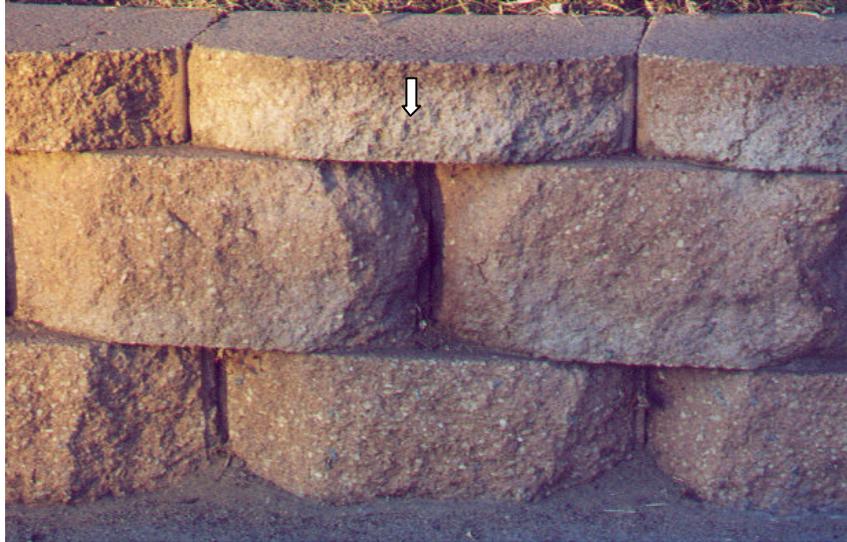
Low-Severity Capstone Freeze-Thaw Damage

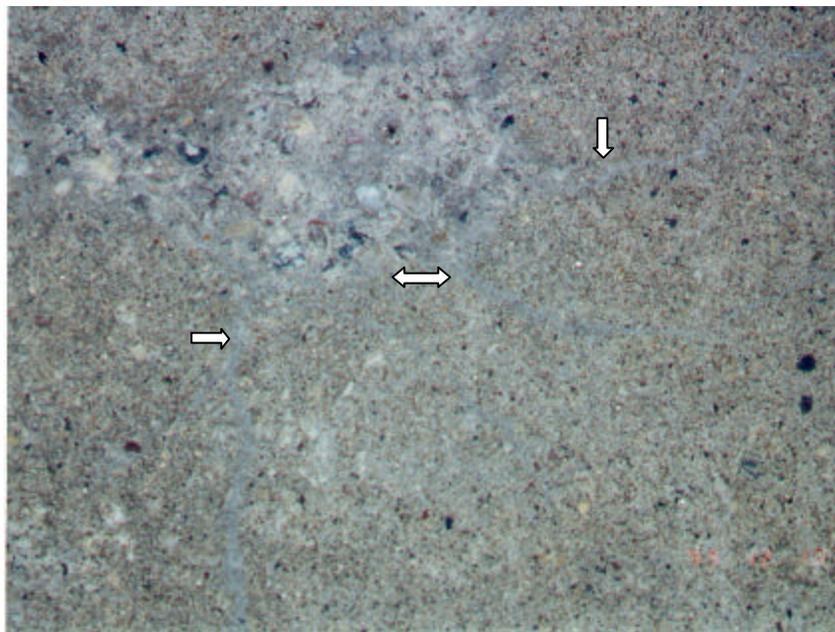
Medium-Severity Capstone Freeze-Thaw Damage (Spider-Web Crack)

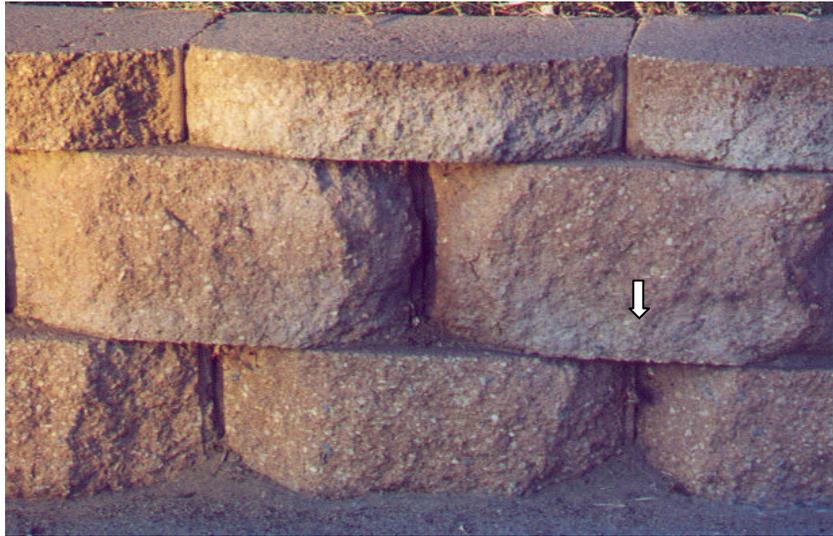
Low-Severity Vertical Surface Freeze-Thaw Damage

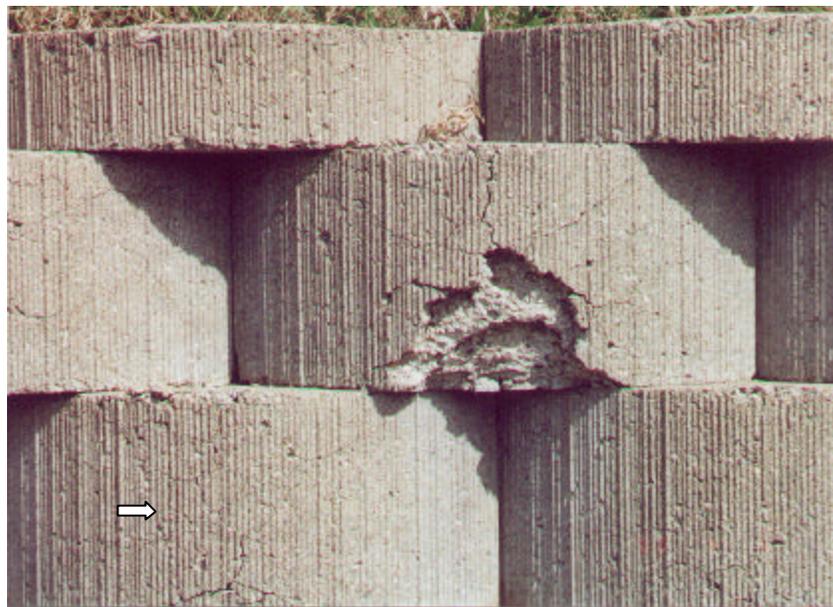
Medium-Severity Vertical Surface Freeze-Thaw Damage

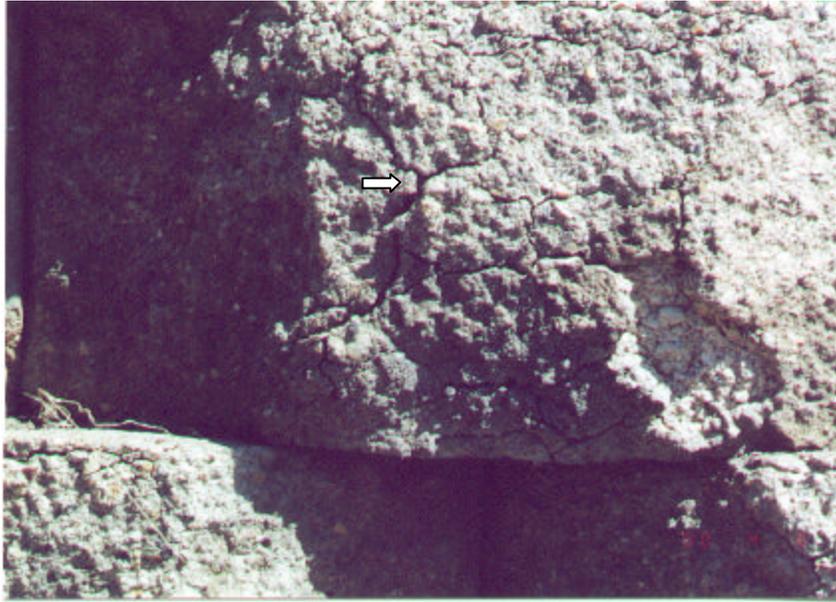
High-Severity Vertical Surface Freeze-Thaw Damage

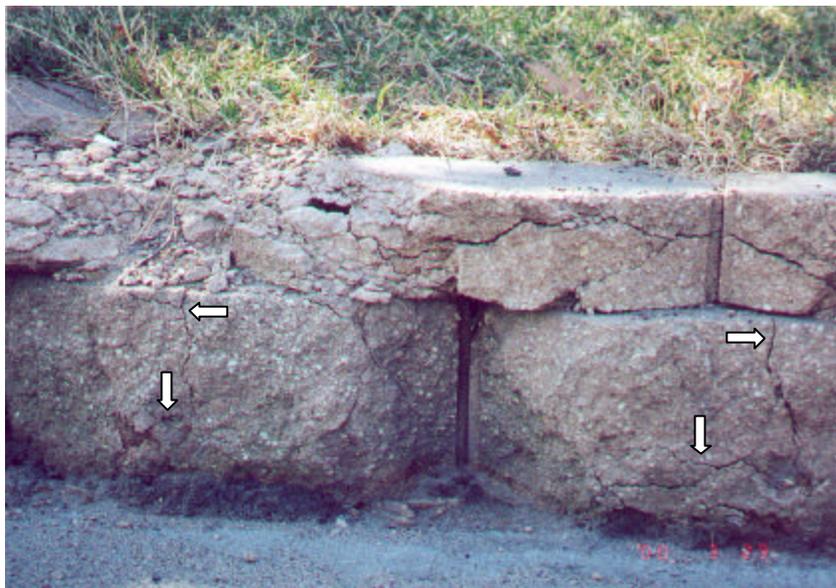
High-Severity Vertical Surface Freeze-Thaw Damage

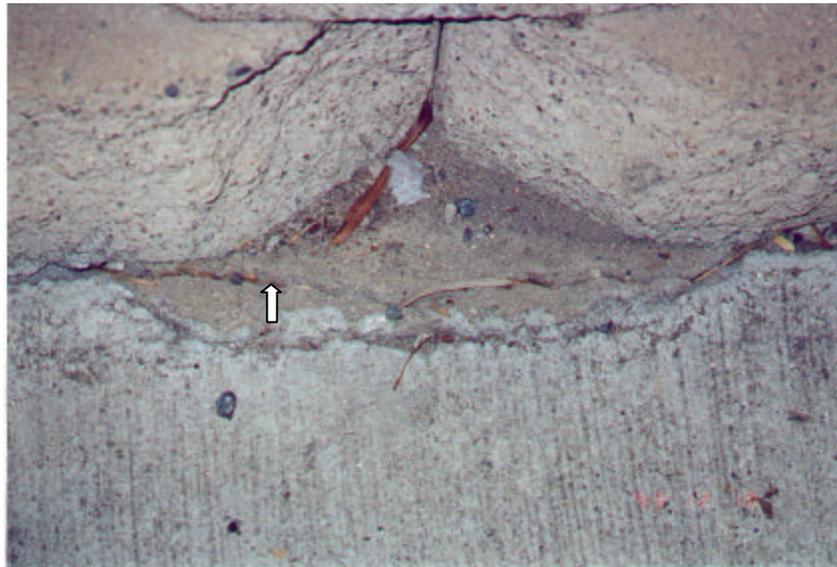
Reflective Crack across Recessed Bottom Block

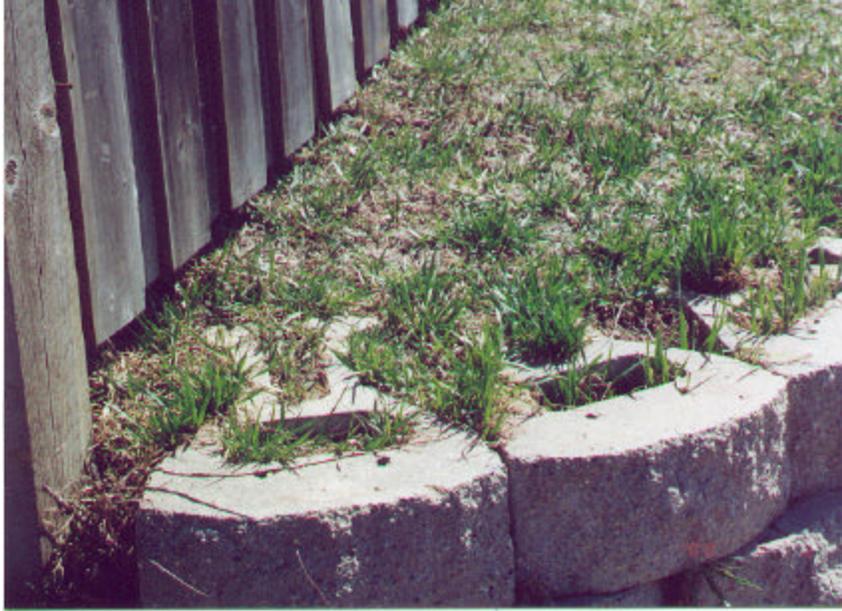
Missing Backfill behind Top Block Layer

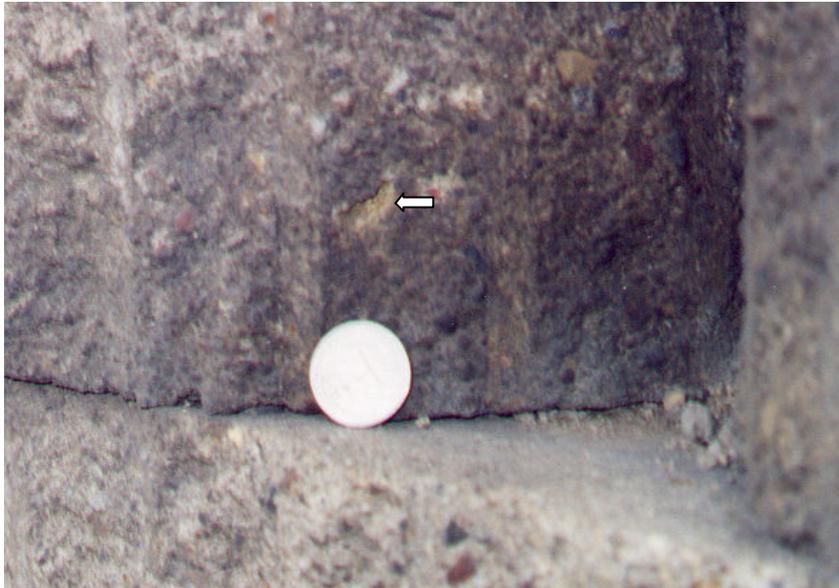
Popout Present in Top Course Block

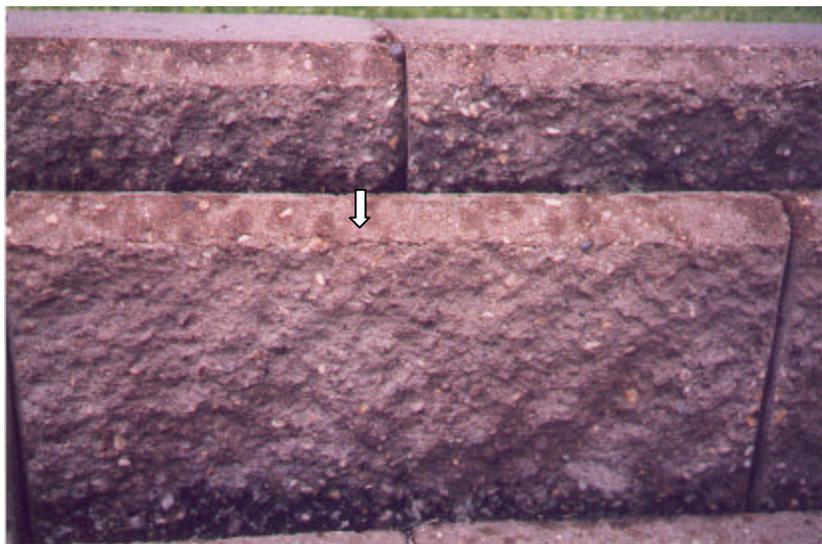
Low-Severity Block Position Guide Damage

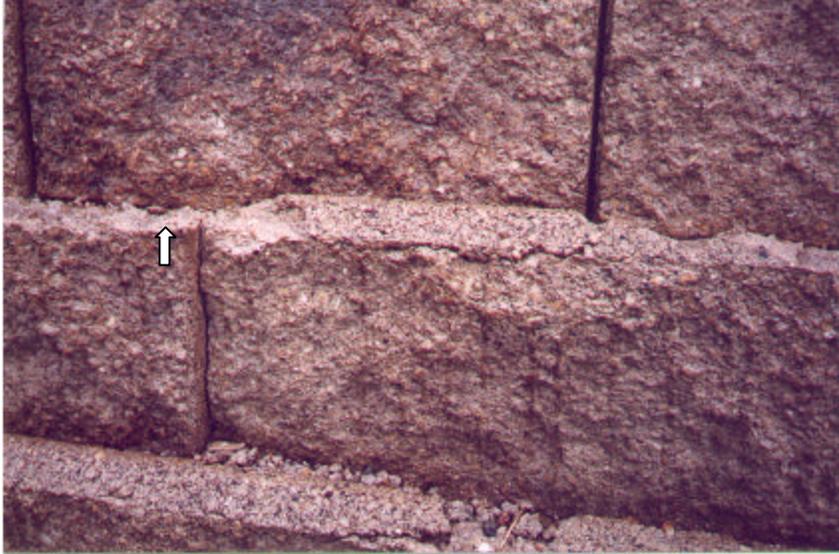
High-Severity Block Position Guide Damage

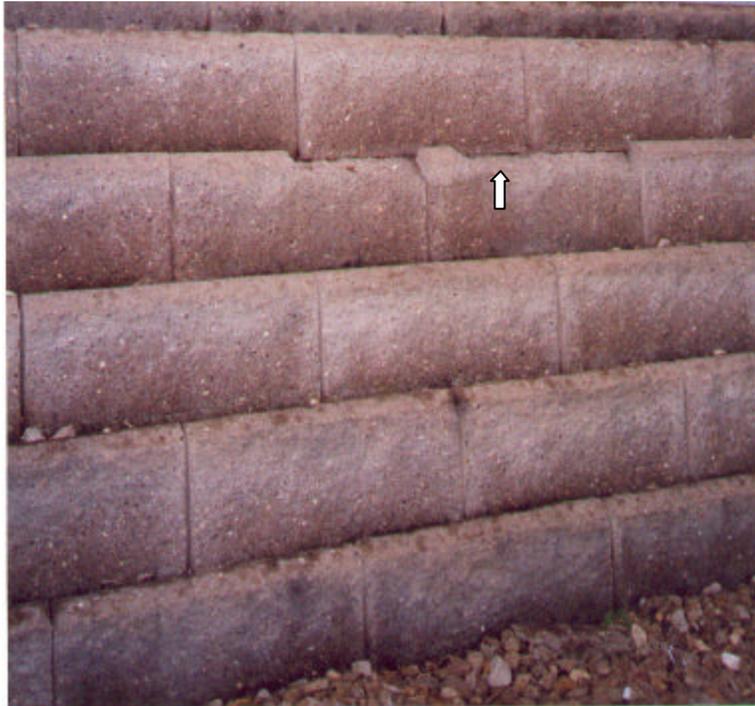
High-Severity Block Position Guide Damage
