Condition and Durability of Segmental
Concrete Block Retaining Walls Along
Roadways in Minnesota

| 4. Title and Subtitle CONDITION AND DURABILITY OF SEGMENTAL CONCRETE BLOCK RETAINING WALLS ALONG ROADWAYS IN MINNESOTA | | 5. Report Date July 2001 | |

Final Report

July 2001

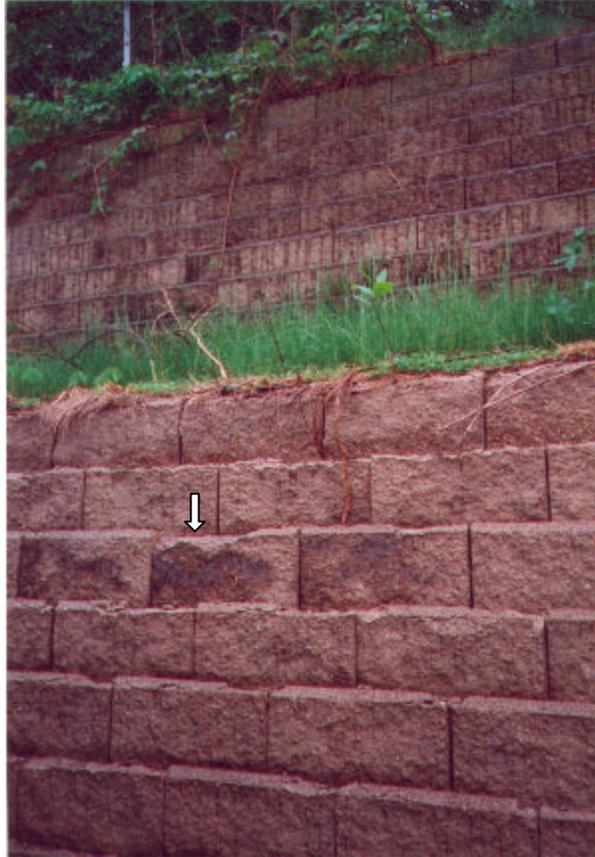
High-Severity Block Position Guide Damage

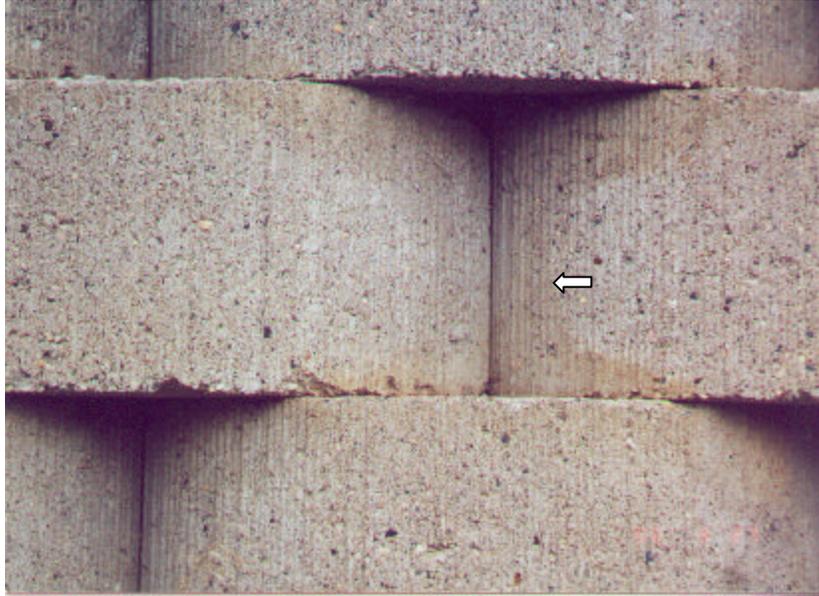
Low-Severity Staining (External Source)

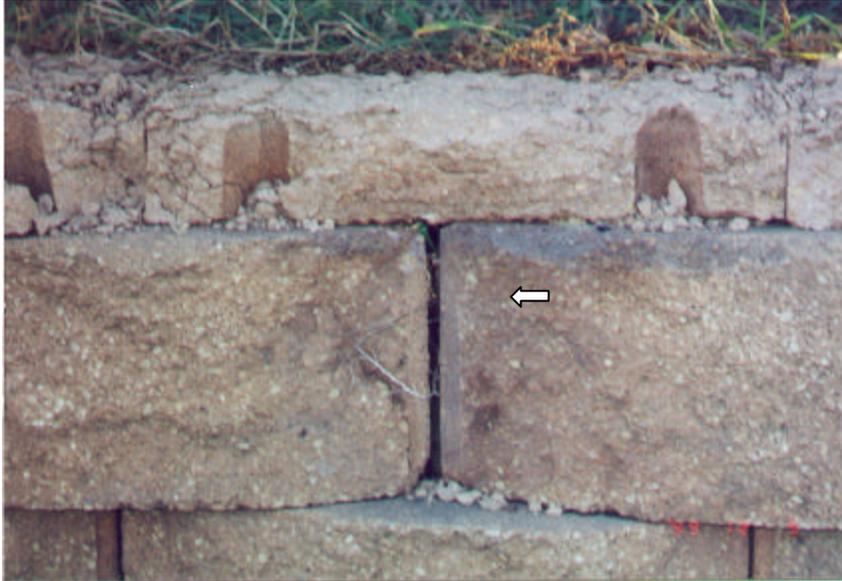
Medium-Severity Staining (External Source)

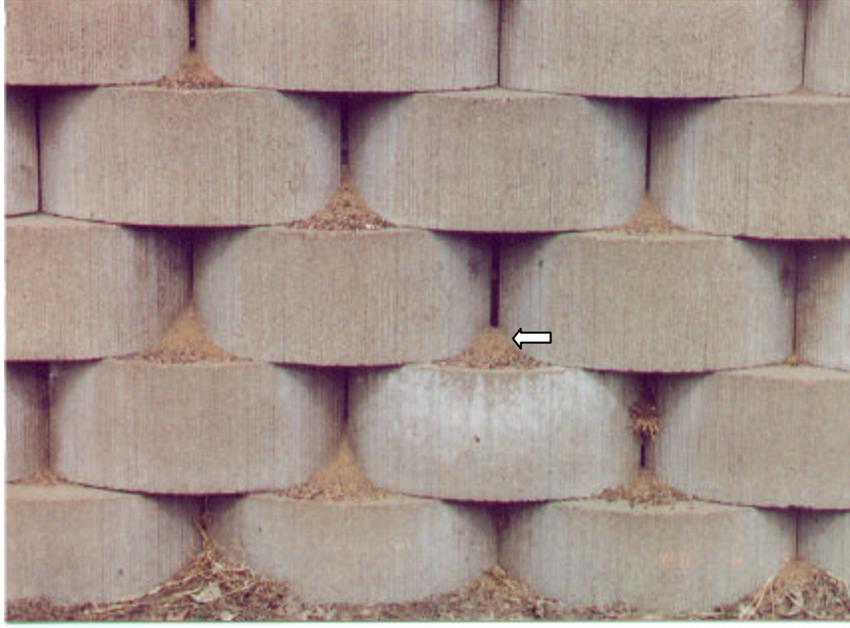
High-Severity Wash-Through
