CONDITION ASSESSMENT OF THE MASTS OF HIGHLANDER SEA

November 2006
Project No. 187-2419
NRRI/TR-2006/24

Prepared for:
Captain Micah David Faust-Allnutt
Highlander Sea, Inc./Acheson Ventures
2336 Military St.
Port Huron, MI 48060

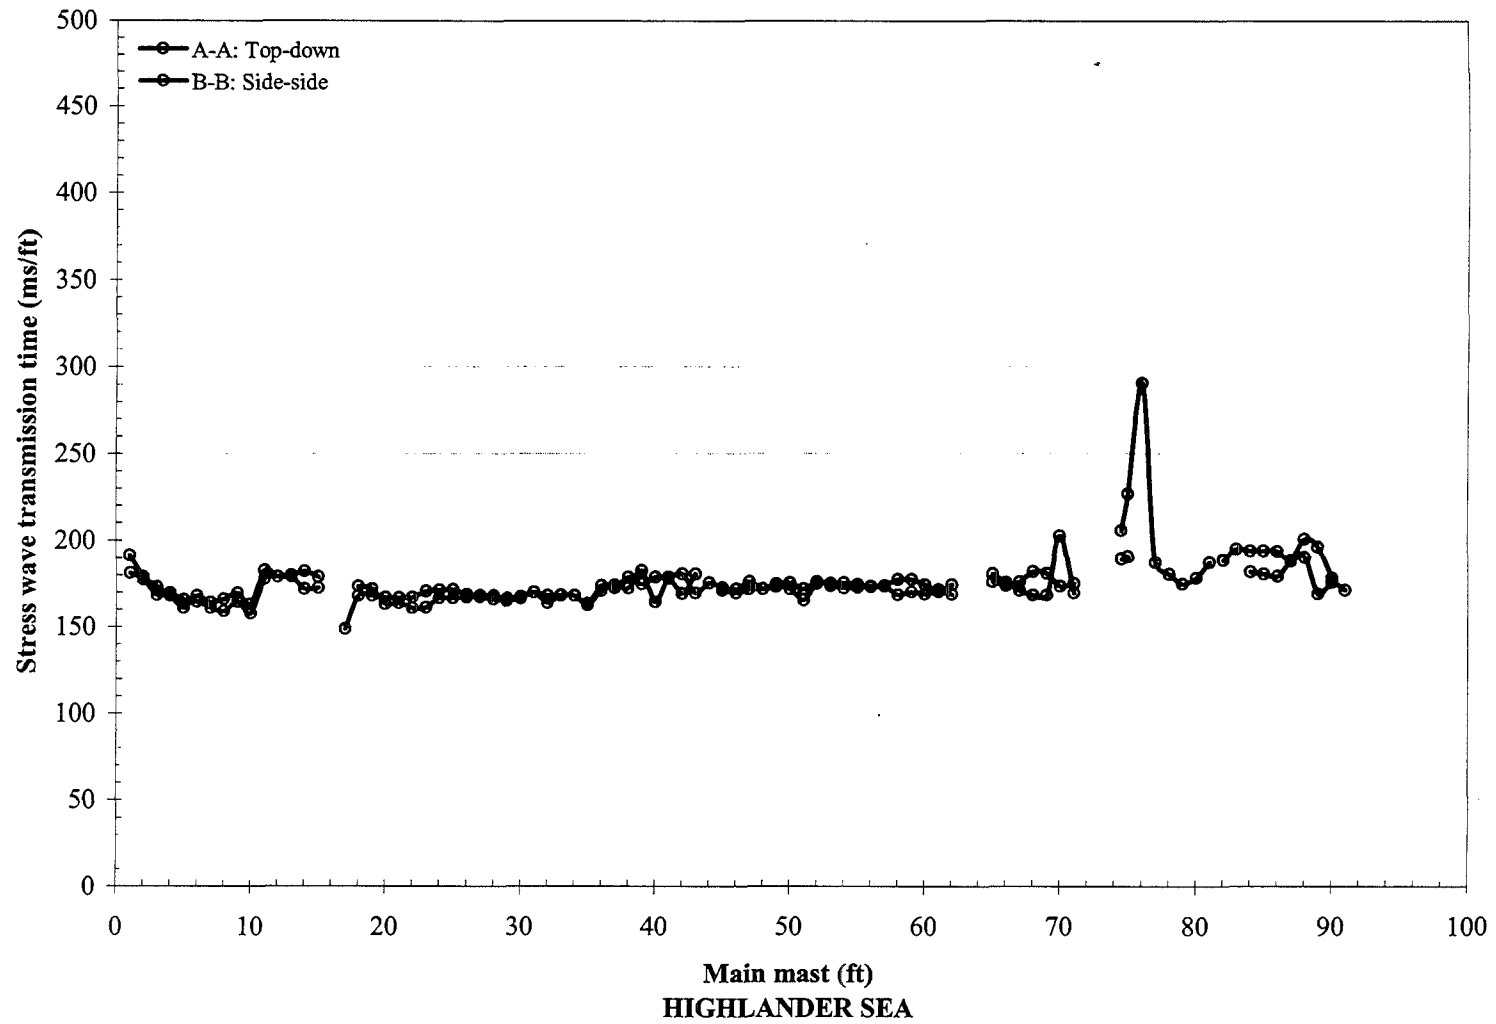
Stress wave scanning results of the main mast revealed areas of moderate deterioration in the lower portion (0 – 2', 11 – 15') and the upper portion (83' – 90') of the mast. Severe decay pockets were found between 75' and 77', which is around the metal mast band as shown in *Appendix A – Photo 4*. This finding has been confirmed by resistance micro-drilling results as shown in *Appendix B*. Moisture measurements at this location indicated a high moisture condition (30 to 50% MC), which is continuously promoting further development of internal decay.

Figure 3. Distribution of stress wave transmission time of main mast.

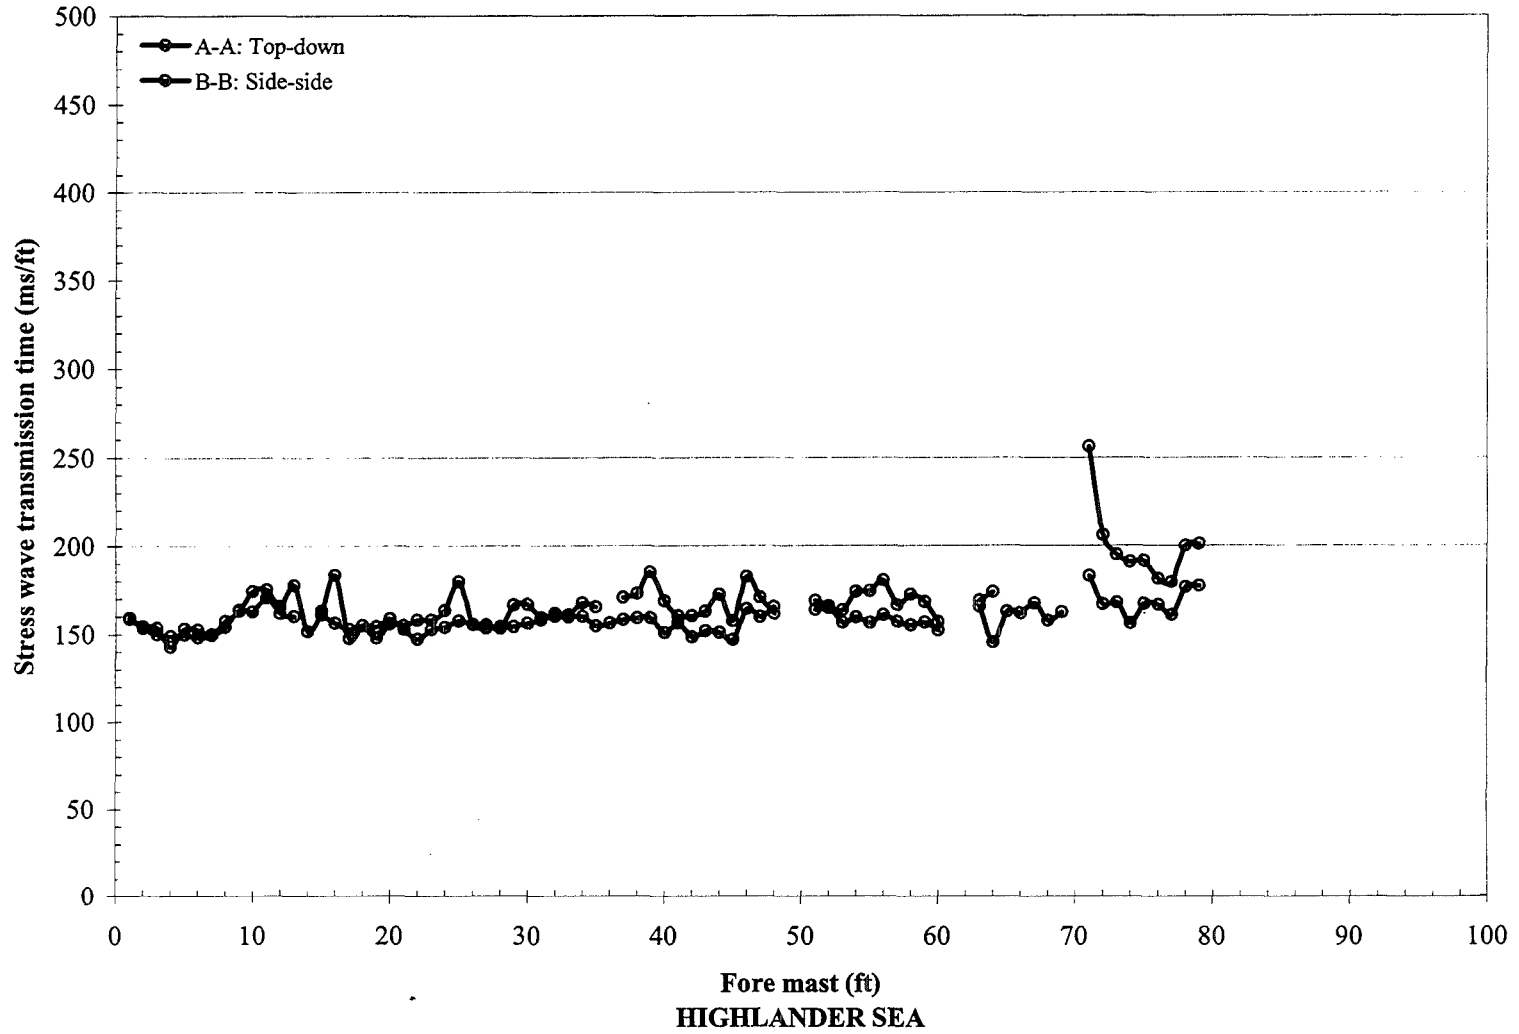
Stress wave scanning results of the fore mast revealed areas of moderate deterioration in the upper portion (between 70' – 80') of the mast. Remaining areas seemed to remain intact, with no significant decayed regions.

Figure 4. Distribution of stress wave transmission time of fore mast.

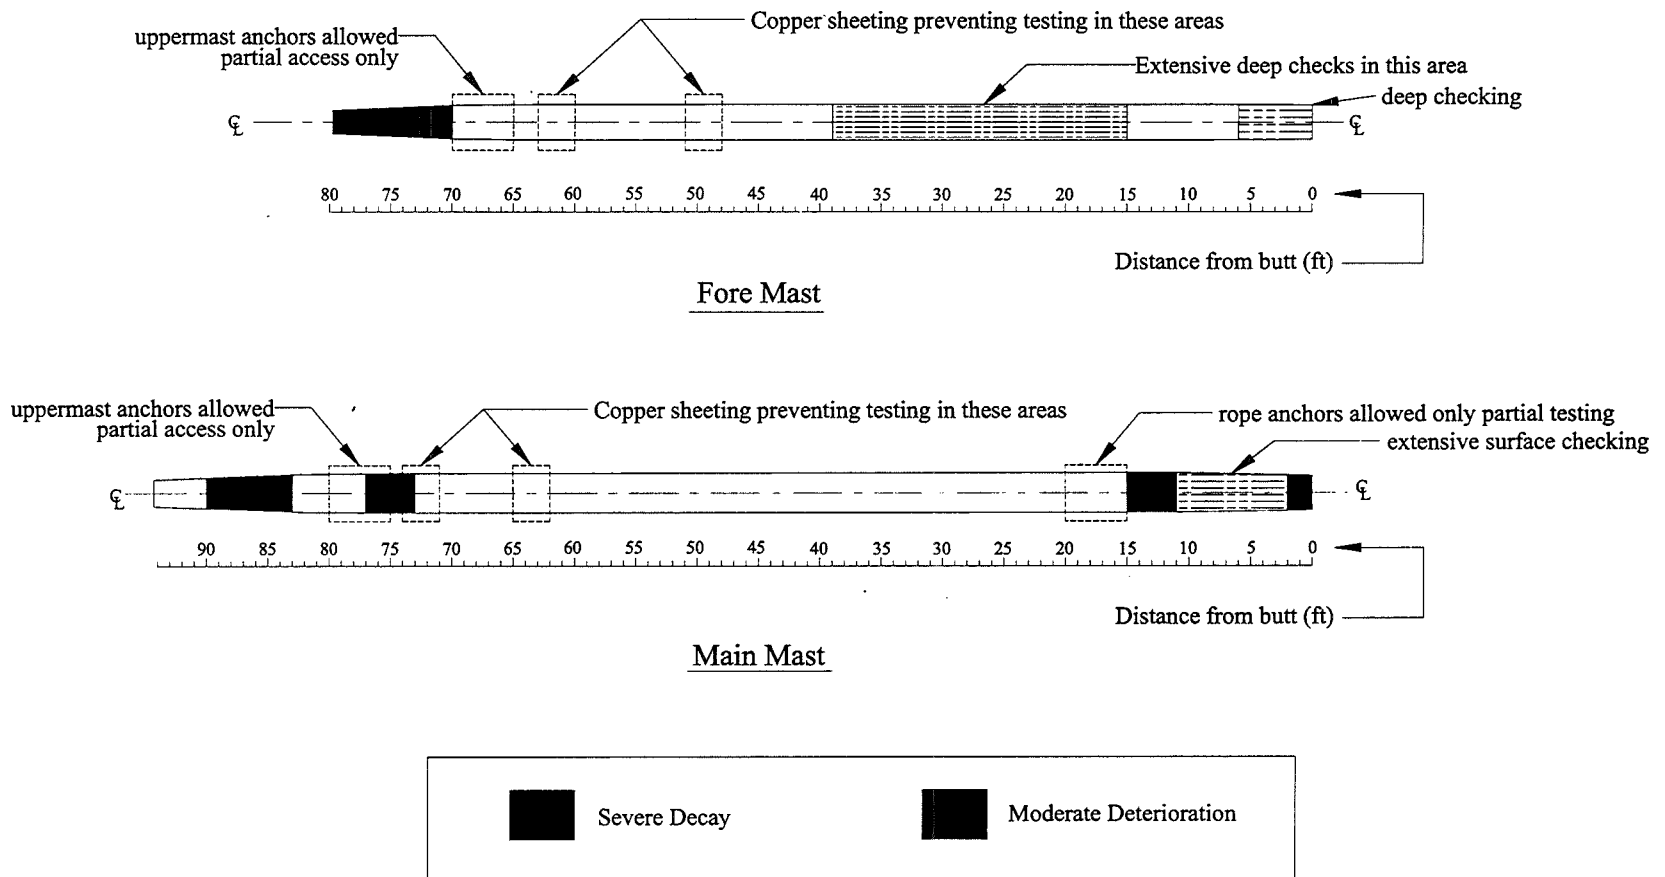
Figure 5. Mapping of the physical conditions of main mast and fore mast of the Highlander Sea.

Based on the findings from this investigation (Figure 5), and the fact that the masts have undergone some significant rehabilitations in the 1990's, we recommend that both main mast and fore mast of the Highlander Sea be removed from service and replaced with new masts.

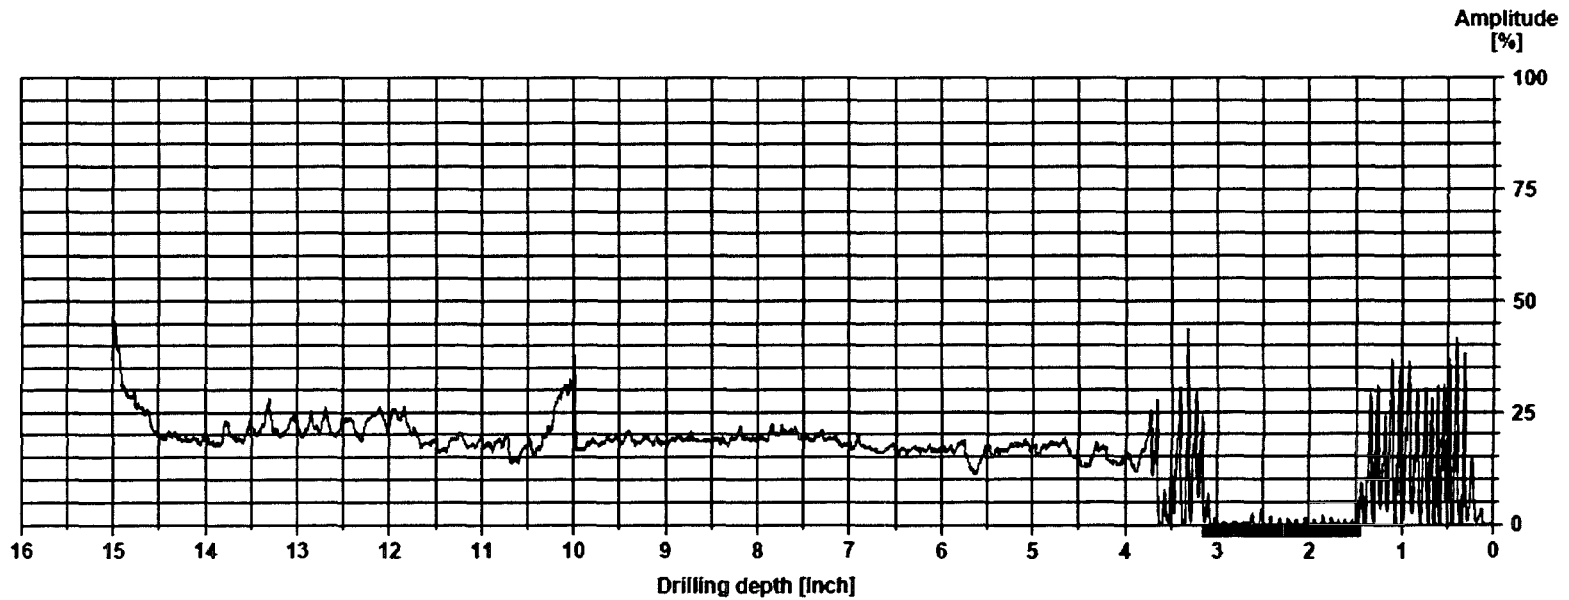
HIGHLANDER SEA
Main Mast
@75 ft +2 in.
Top-down

From 1,45 " to 3,15 " : Severe decay
 From 0,00 " to 0,00 " :
 From 0,00 " to 0,00 " :
 From 0,00 " to 0,00 " :
 From 0,00 " to 0,00 " :
 From 0,00 " to 0,00 " :

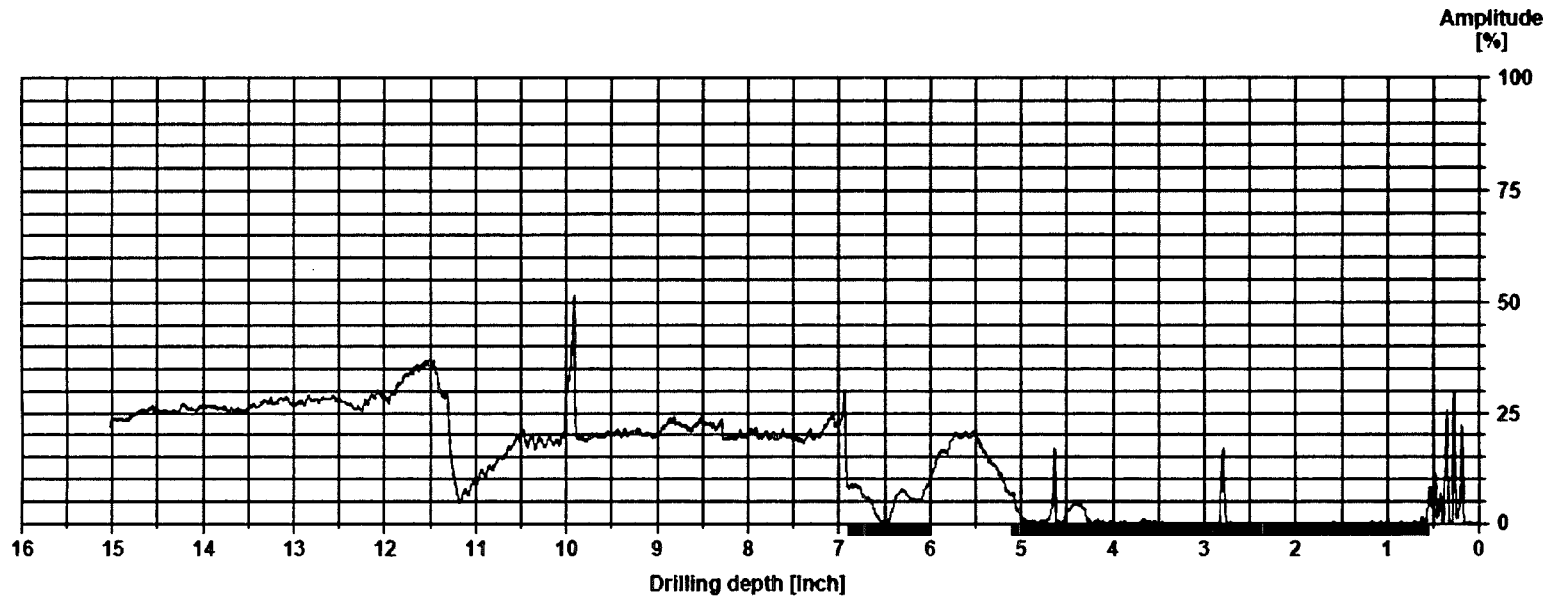
HIGHLANDER SEA
Main Mast
@76 ft Top-down

- From 0,55 " to 5,10 " : Severe decay
- From 6,00 " to 6,90 " : Moderate decay
- From 0,00 " to 0,00 " :
- From 0,00 " to 0,00 " :
- From 0,00 " to 0,00 " :
- From 0,00 " to 0,00 " :

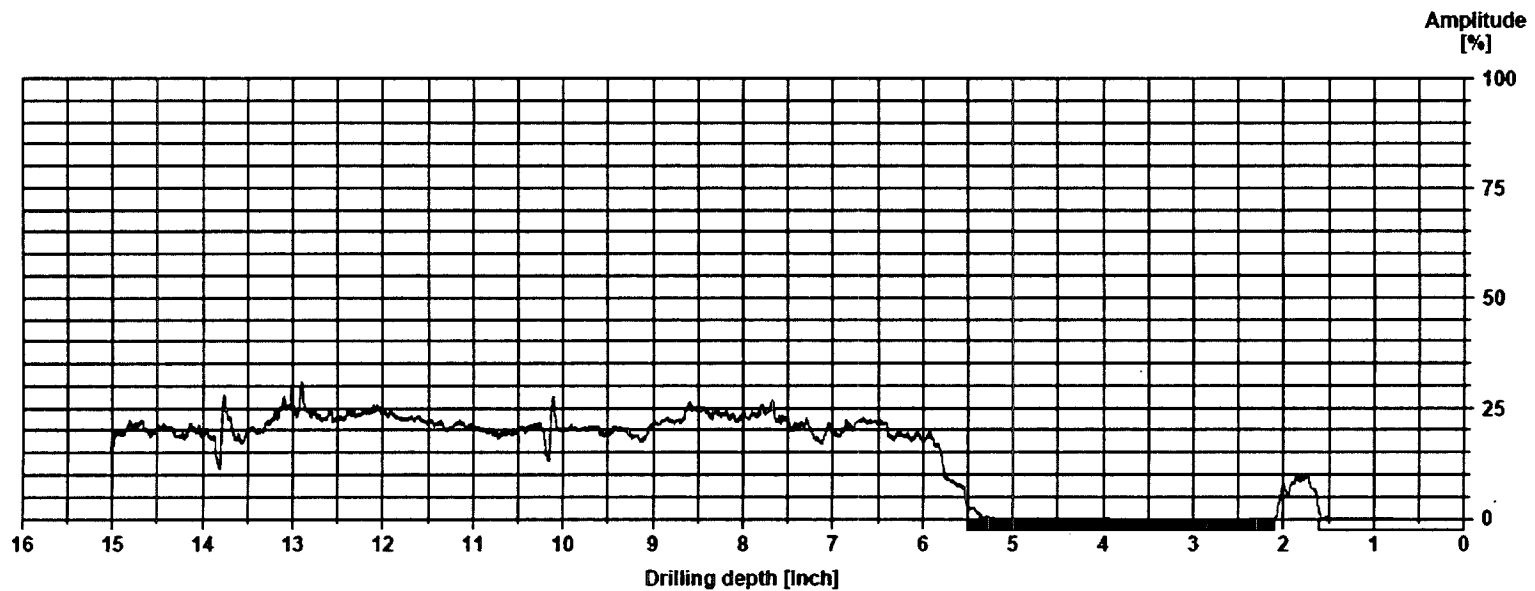
HIGHLANDER SEA
 Main Mast
 @Steel Collar (+76 ft)

- From 0,00 " to 1,60 " : Gap
- From 2,10 " to 5,50 " : Severe decay
- From 0,00 " to 0,00 " :
- From 0,00 " to 0,00 " :
- From 0,00 " to 0,00 " :
- From 0,00 " to 0,00 " :

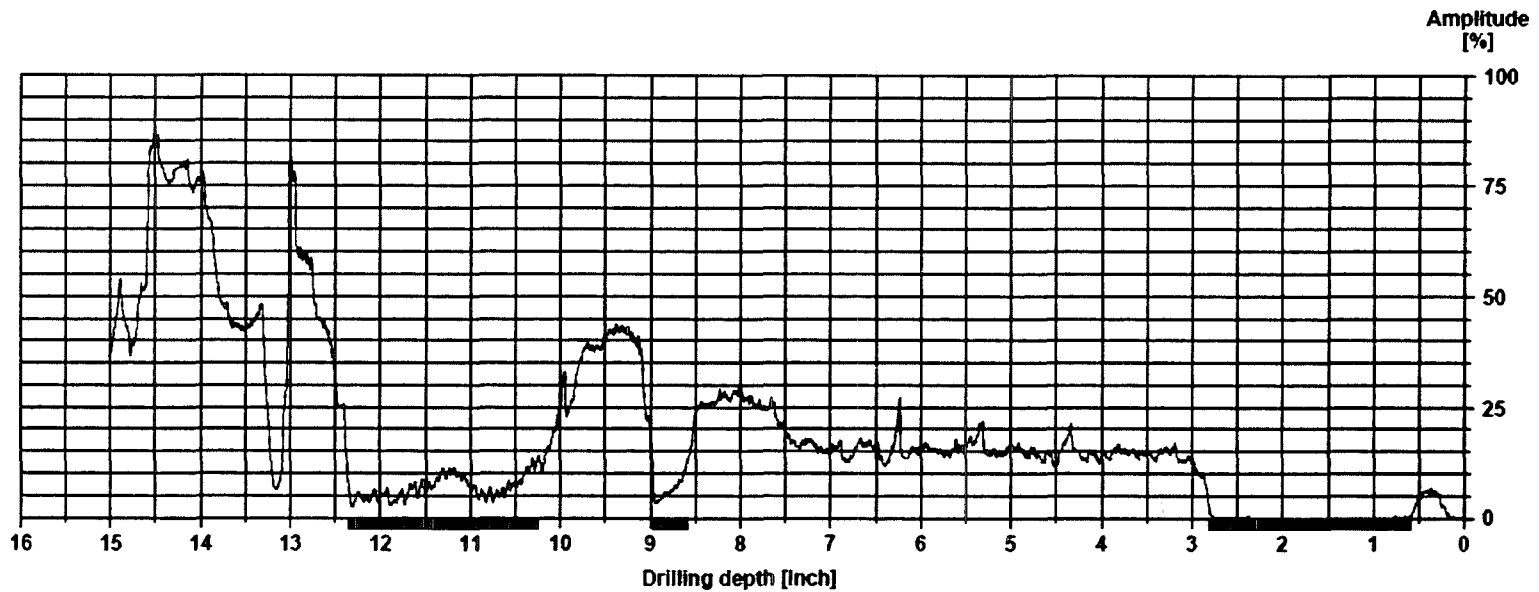
HIGHLANDER SEA
Main Mast
@76.5 ft.

From 0,60 " to 2,80 " : Severe decay

From 10,25 " to 12,35 " : Moderate decay

From 8,60 " to 8,98 " : Moderate decay
