University of Minnesota  
St. Anthony Falls Hydraulic Laboratory

Project Report No. 341

Movable Bed Physical Model  
of Howard Creek

January 1993

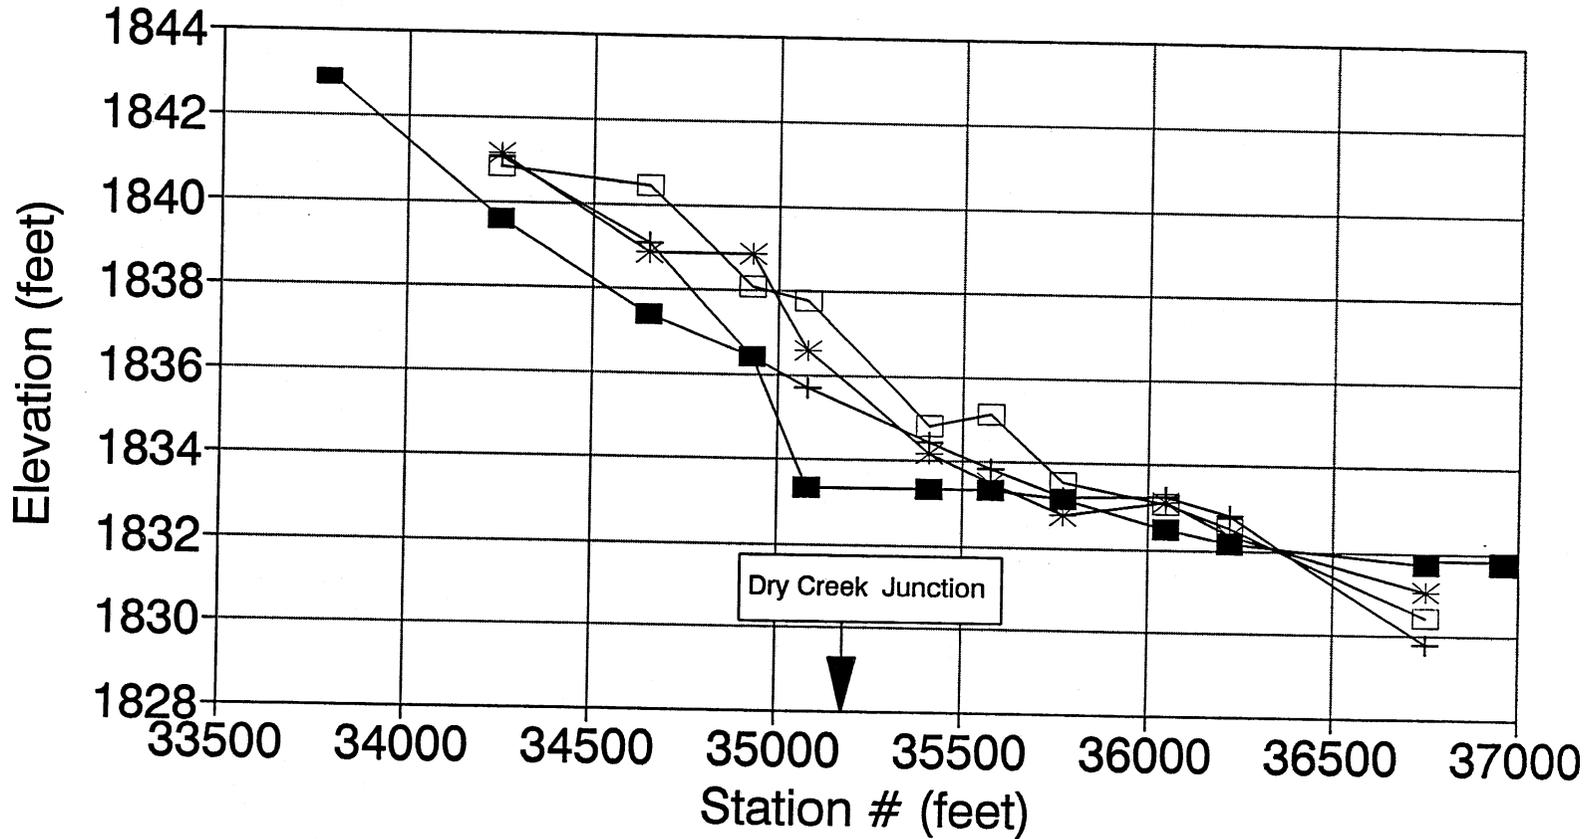
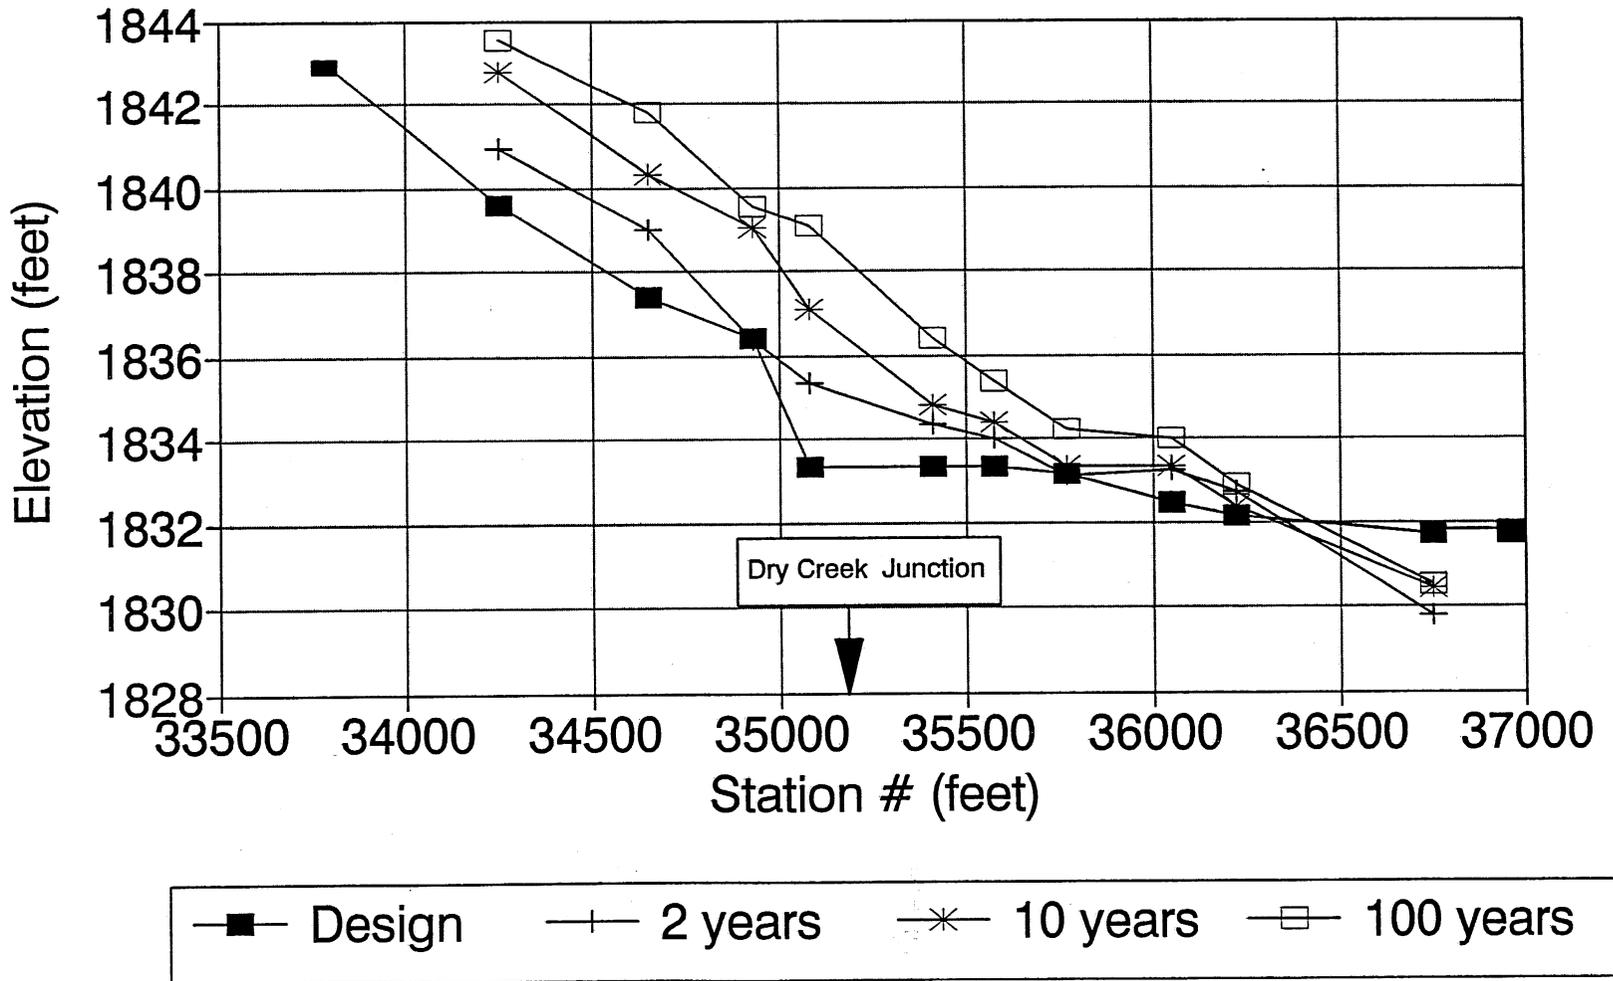
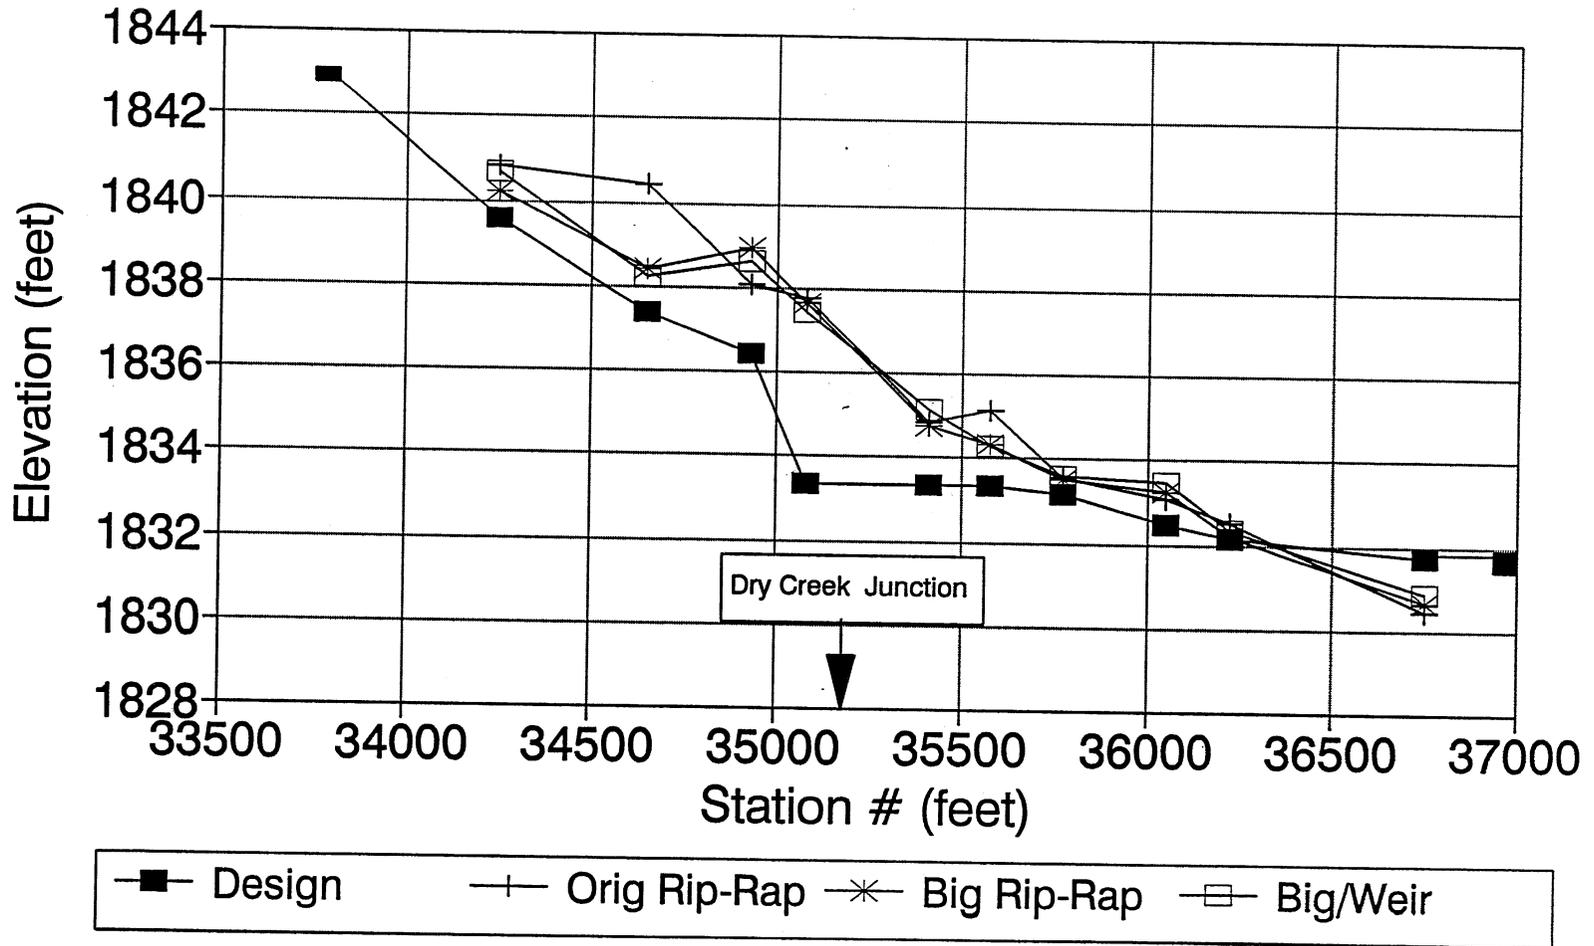
Generally the test runs proceeded as planned and the overall results appear representative. As illustrated in Figures 5, 6, and 7, the bed slope routinely finished slightly steeper than the design slope. As expected, the sediment surplus runs deposited sediment in the upstream reaches of Howard Creek. The sediment starved runs more closely matched the design slope. Occasional anomalies where the bed is higher than normally anticipated are seen in bed topography. This is particularly true for cross sections 2 to 5 and can be explained by the failed riprap mixing with the bedload material thereby creating a relatively immovable bed. These zones are generally described in the following summary of specific test runs.

All cross sections except cross section 10 exhibit some bed aggradation. The degradation of cross section 10 was noted to be on the order of one foot for the sediment-starved 100-year floods. This behavior may not in fact be reflected in the field. This is because cross section 10, being farthest downstream is most strongly affected by the tailgate, which was positioned by trial and error. In addition, the constriction caused by the Greenbrier Street bridge probably contributed to lower bed elevation during floods near this cross section. This notwithstanding, the performance of the model near cross section 10 does not suggest any reason for concern farther downstream.

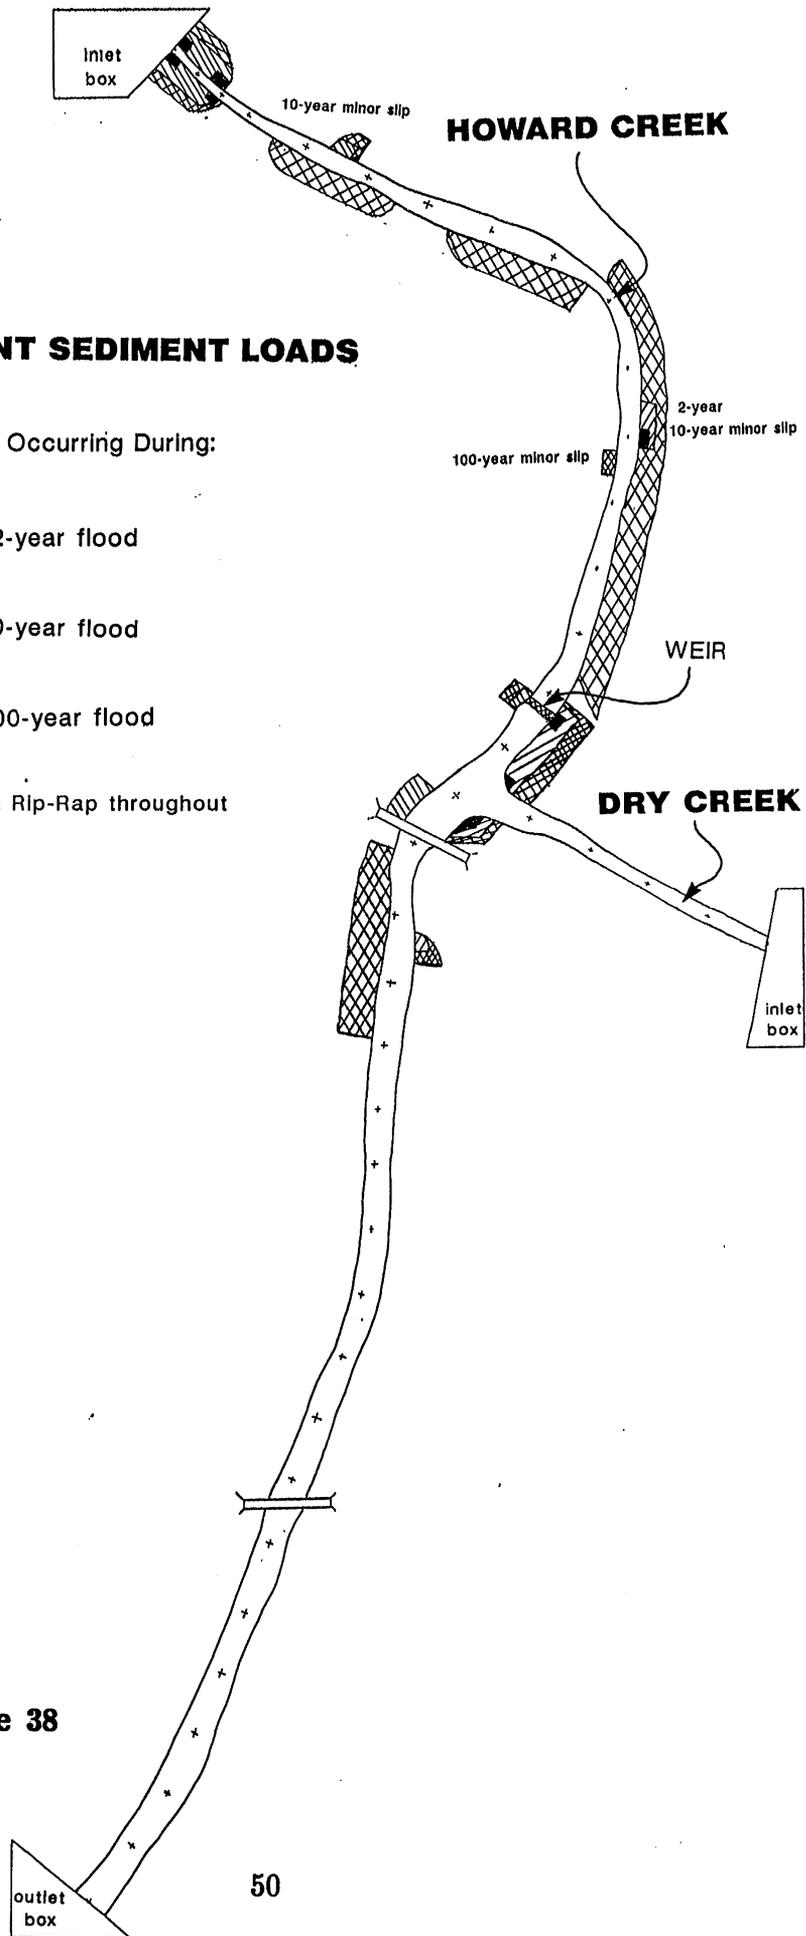
Figure 38

The 10-year runs proved interesting with more obvious changes in bed contour and with several sections of riprap failure. In particular, the riprap at the toe of the rock masonry wall on the outside of the first bend downstream of the Garden Street bridge, hereafter referred to as the main bend (lefthand bank looking downstream), and the riprap on the bank for a reach of approximately 100 ft just downstream of the same wall, experienced failure during the sediment surplus run (Photo 1). Both 10-year tests experienced failure on the left bank just downstream from the weir (Photo 2). Figures 38 to 39 summarize the extent of the failure in plan view drawings.

Areas of Rip-Rap Failure Occurring During:

- 100-year flood

with design 8 to 18 Inch Rip-Rap throughout

As expected, the 100-year flood caused more damage, with riprap failure occurring in isolated areas upstream of the main bend and along the entire left bank from the upstream toe of the wall downstream to the fire house just past the confluence with Dry Creek. Failure also occurred along the righthand bank near Big Draft Road. The reach downstream of about 500 ft from the confluence with Dry Creek performed adequately with little raveling of the riprap. Similar levels of performance were observed with both the sediment deficient and sediment surplus test runs, with slightly worse riprap failure occurring in the case of the sediment deficient run. The reader is again referred to Figures 8 through 27 and 38 and 39. With this in mind, the 100-year sediment deficient run was chosen as the critical test condition to be used in further evaluations.

Upon completion of the first series of test runs (1-6) the bed was reworked to approximate the design bed configuration, and the 8-18" riprap was replaced with 12-30" material in zones of previous failure. The model was then retested (Run 7) for the critical conditions. The revised riprap performed well with the only raveling observed in the short reach between the entrance of Dry Creek into Howard Creek and the Big Draft Road bridge (Photos 3, 4, and 5). This failure may, as mentioned earlier, have been due to model phenomena caused by either the limitation of scour depth as the local scour reached the fixed bed, or the extremely steep side slopes associated with the transition to the vertical wall below the bridge (a reminder that the model is distorted 1.5V to 1.0H).

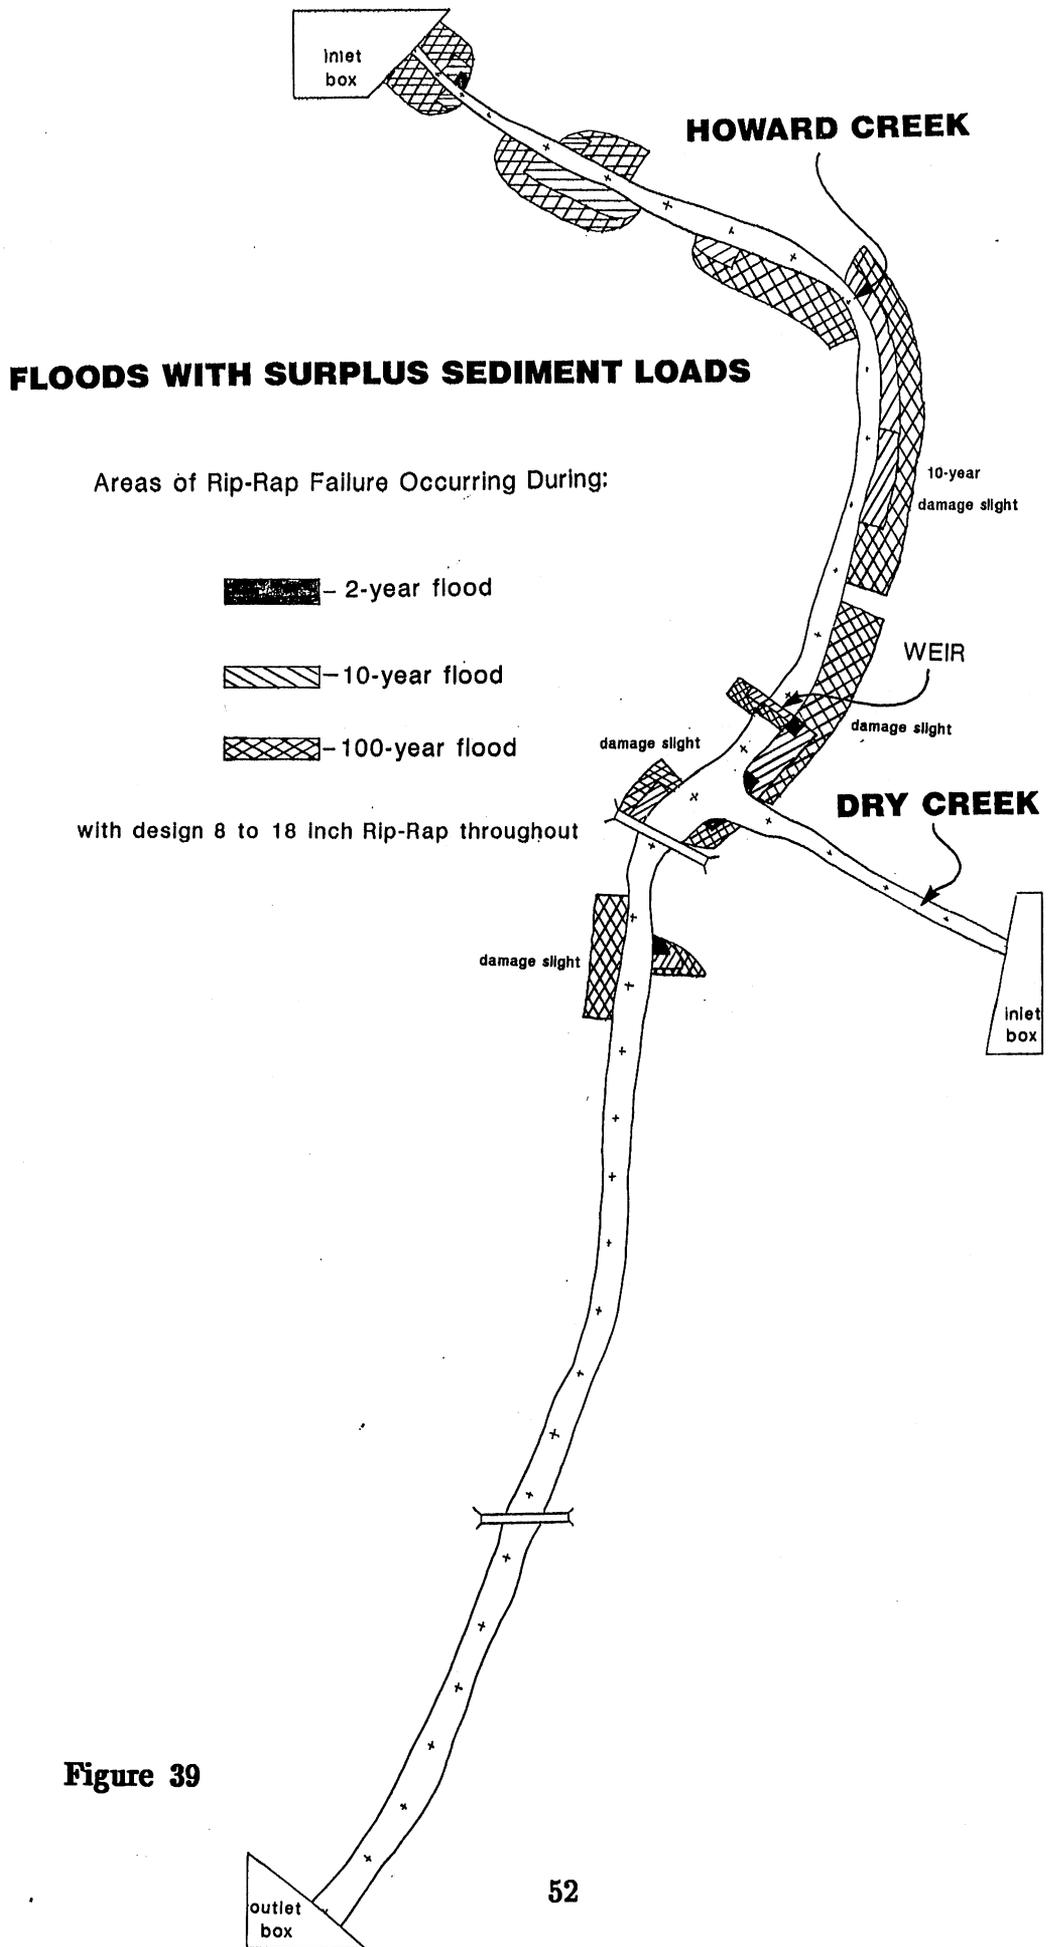
**Figure 39**

For the last run, i.e. run 8, the height of the weir upstream of the confluence with Dry Creek was reduced from 2 ft to 1 ft. Testing was again performed with the 100-year sediment deficient condition. In addition, fish habitat boulders and rock clusters were placed in the two selected reaches as shown on Figure 4, which also shows the data measurement cross sections. Placement of the boulders and clusters was based according to Appendix B. Channel performance differed little from that observed during evaluation of the two-foot weir; the scour hole depth downstream from the weir was similar to that observed with the two-foot weir. Photos 6 and 7 taken before and after testing show the general performance of the boulders and rock clusters in the downstream reach. There was some shifting in the upstream reach, particularly with the smaller rocks subject to movement, while the downstream reach performed well. It was also observed that the clusters in the upstream reach were covered with sediment during the peak discharges, even during sediment deficient conditions, but reappeared near the end of the 100-year hydrograph. The boulders and rock clusters on the stream bed did not induce failure of adjacent bank riprap.

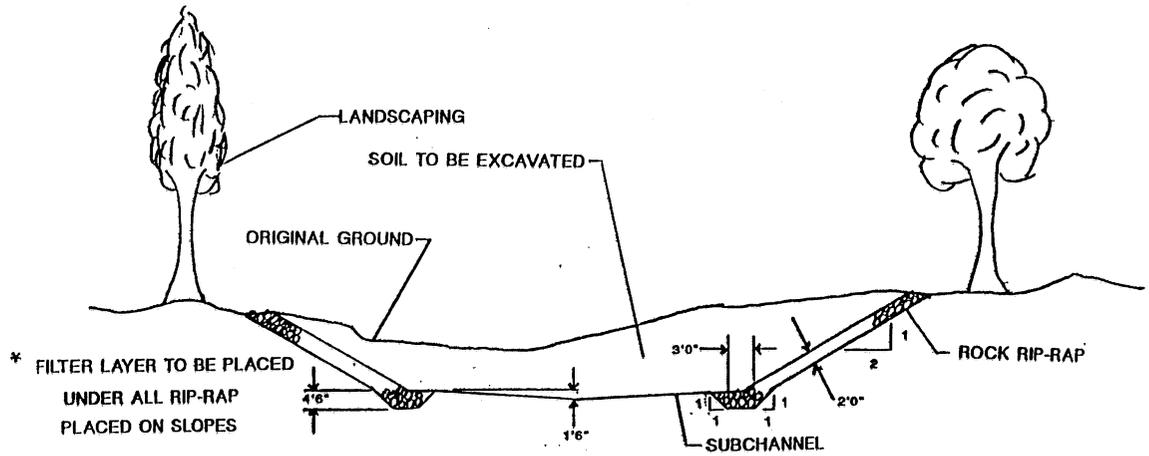
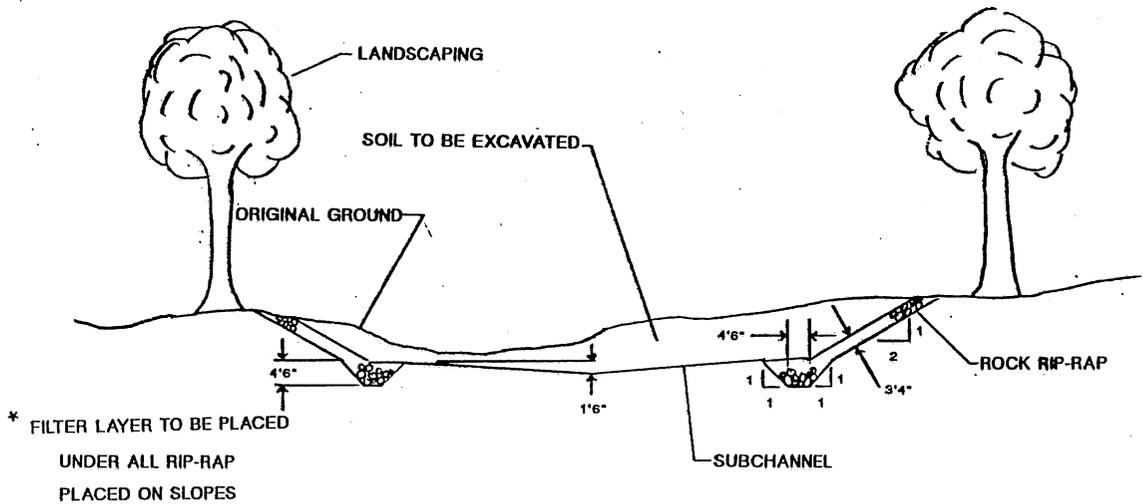
# TYPICAL SECTION CHANNEL WORK

## TYPE I RIP-RAP

8-18 INCHES

## TYPE II RIP-RAP

12-30 INCHES

Suggested riprap modifications are further described by Parker (1993)<sup>2</sup> in his diagnostic study of Howard Creek. Neill (1973)<sup>3</sup> recommends that "the thickness of the stone layer measured normal to the slope should be at least as great as the long dimension of the largest stones in the specified grading." He recommends at least two layers of overlapping stones "so that slight loss of material does not cause massive failure." With this in mind, the 24" thickness originally recommended for the 6" to 18" riprap appears adequate. Where the 18" to 30" riprap is to be used, however, a placement thickness of 35" to 45" is more advisable. This extra thickness should not be attained at the expense of narrowing the resulting channel, but rather by somewhat increased bank excavation.

Figure 41a and 41b illustrate the typical sections for riprap placement. It is expected that with the incorporation of the recommended riprap modifications, the channel will perform as presently designed. It is not realistic to expect a self-formed channel to exactly adhere to design gradelines. As a result, it is necessary to anticipate some local variation within general overall conformance and design, accordingly. The sediment transport rates selected for evaluation during the study are based on very limited field information and subsequent prediction of channel maintenance is difficult. The channel may require occasional dredging in the future after a particular storm event. Fortunately, sediment transport rates on Howard Creek appear to be rather low. The results of the model study did not indicate any serious problems occurring between the Greenbrier Avenue bridge and the Greenbrier Hotel property. This conclusion is somewhat tentative because of tailgate effects at the extreme downstream end of the model.

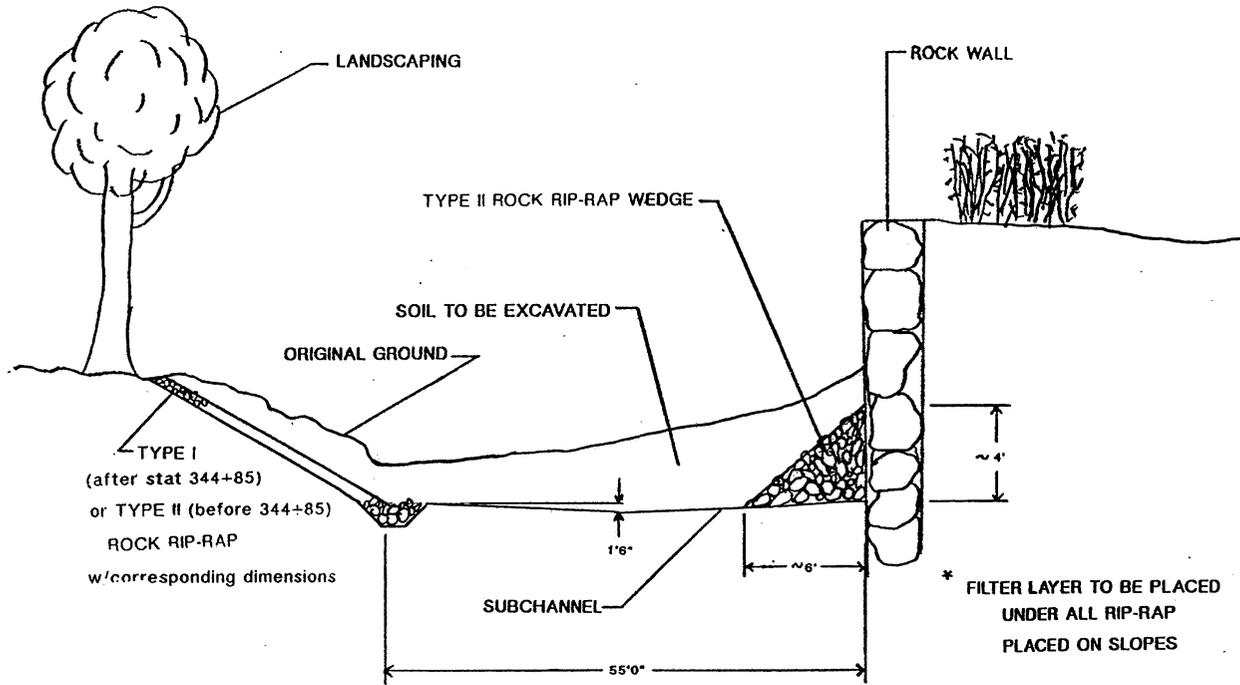
STATION #343+40 TO #345+80

### ROCK WALL

TENTATIVE DESIGN MODIFICATION

(FINAL DESIGN WILL BE BY SCS)

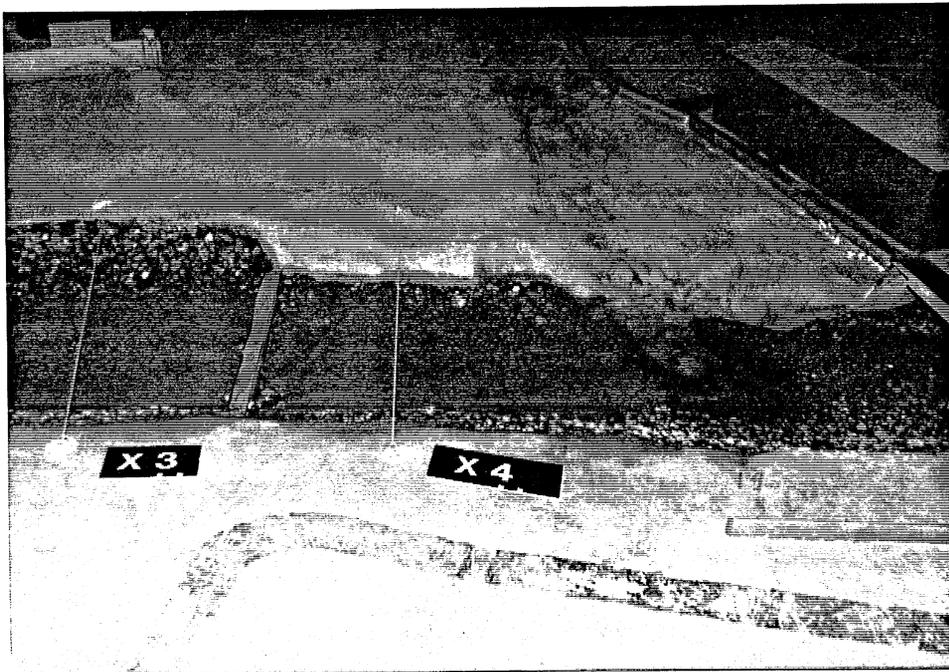
Photo 1.

Main bend and weir to fire house reaches following a 10-year sediment surplus run using Type I (8-18") riprap.

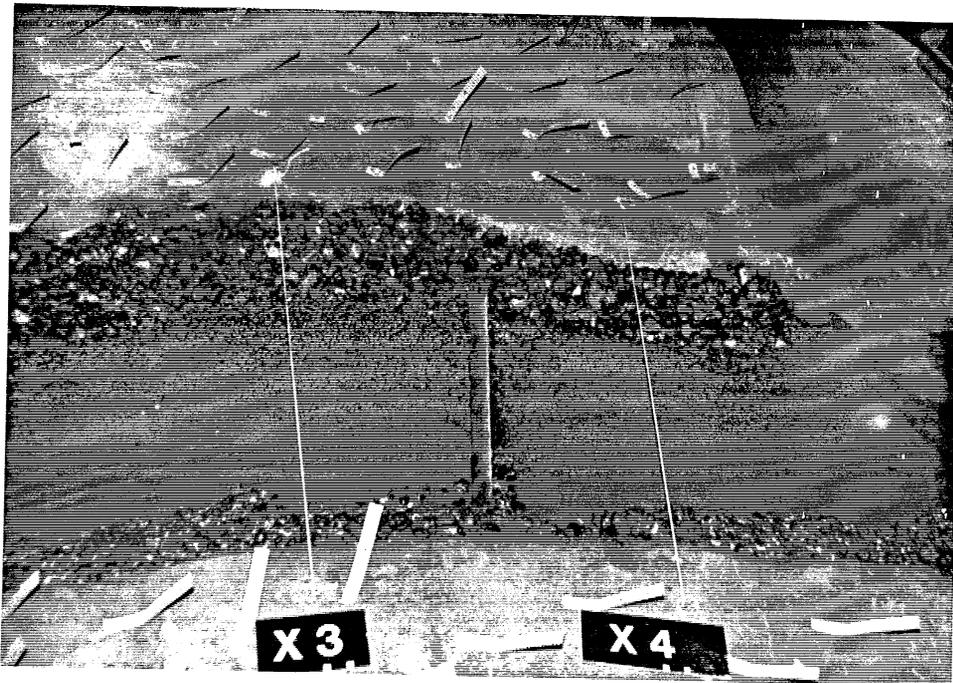
Photo 3

Main bend and weir to Dry Creek reaches following a 100-year sediment starved run using Type II (12-30") riprap.

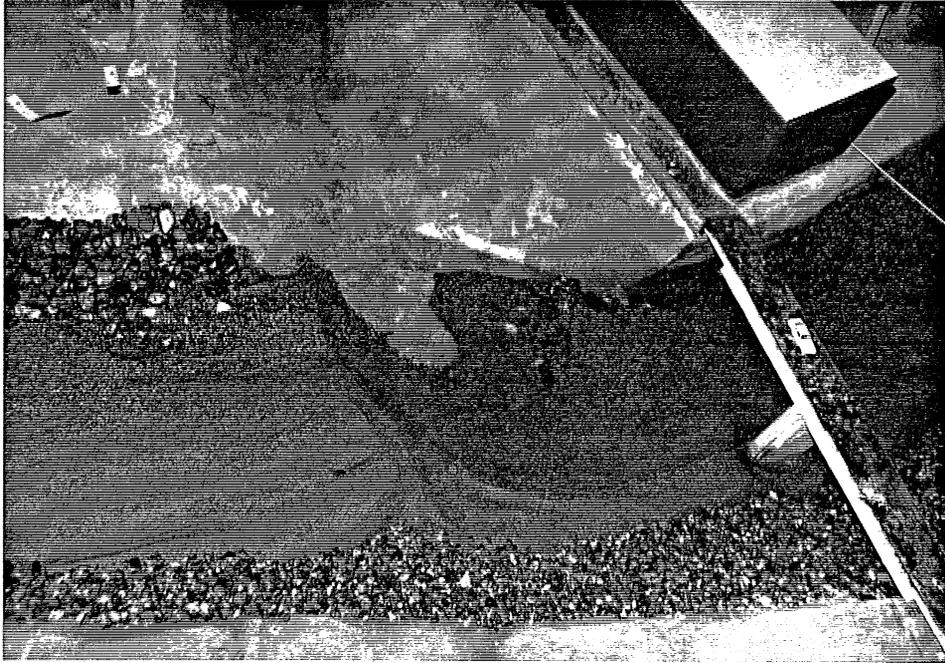
**Photo 5**

Localized failure at juncture of Dry Creek following a 100-year sediment starved run using Type III (12-30") riprap.

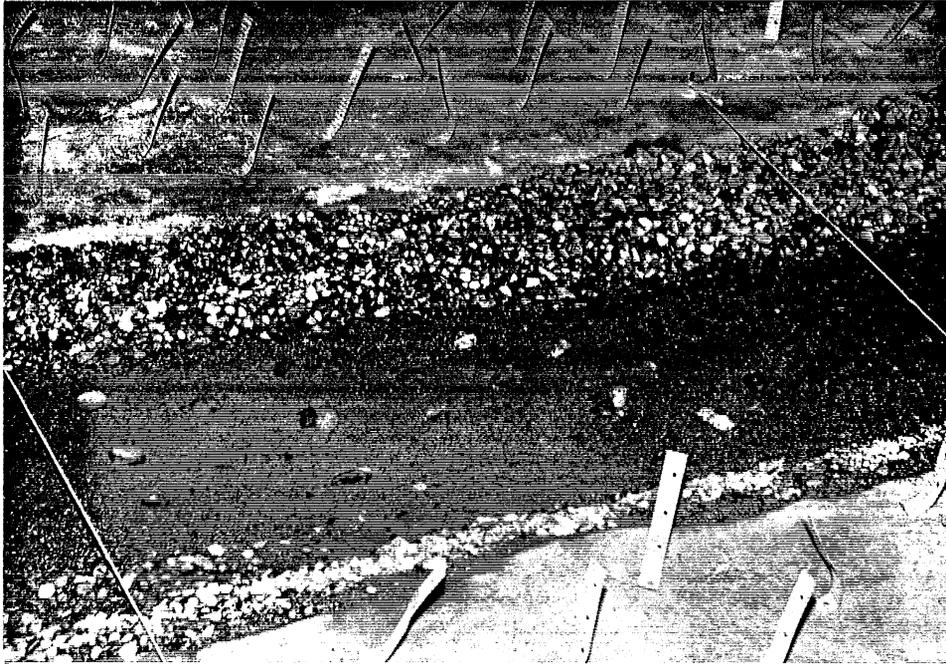
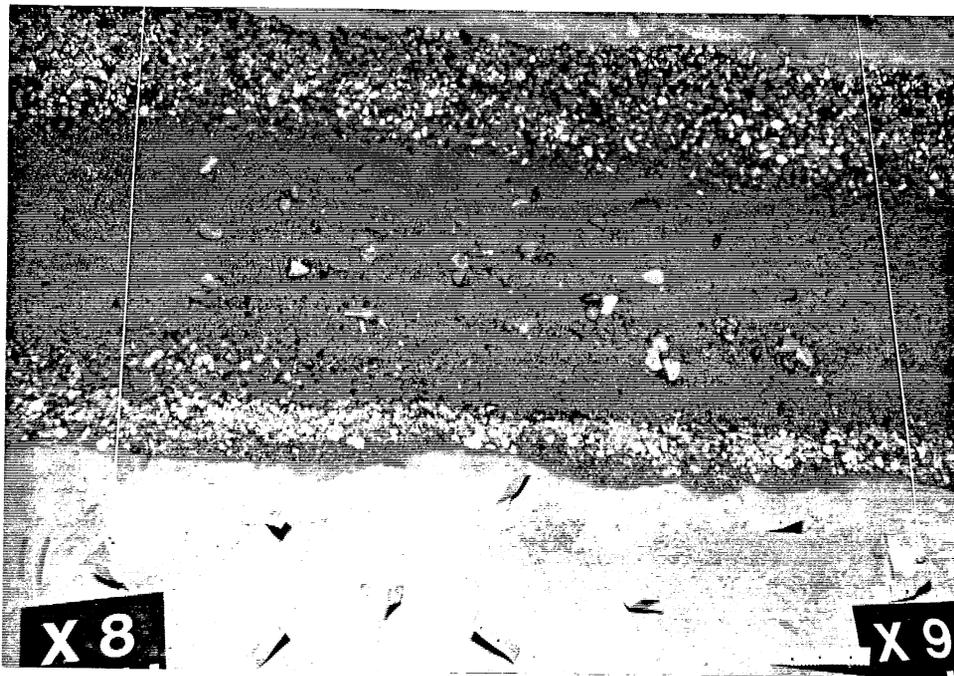
Photo 6

"Fish rocks" before (6) and after (7) for a 100-year sediment starved run.
