Factors influencing roadside erosion and in-stream geomorphic stability
at road-stream crossings for selected watersheds,
North Shore, Minnesota, USA.

A THESIS
SUBMITTED TO THE GRADUATE SCHOOL OF
THE UNIVERSITY OF MINNESOTA
BY

July 2012

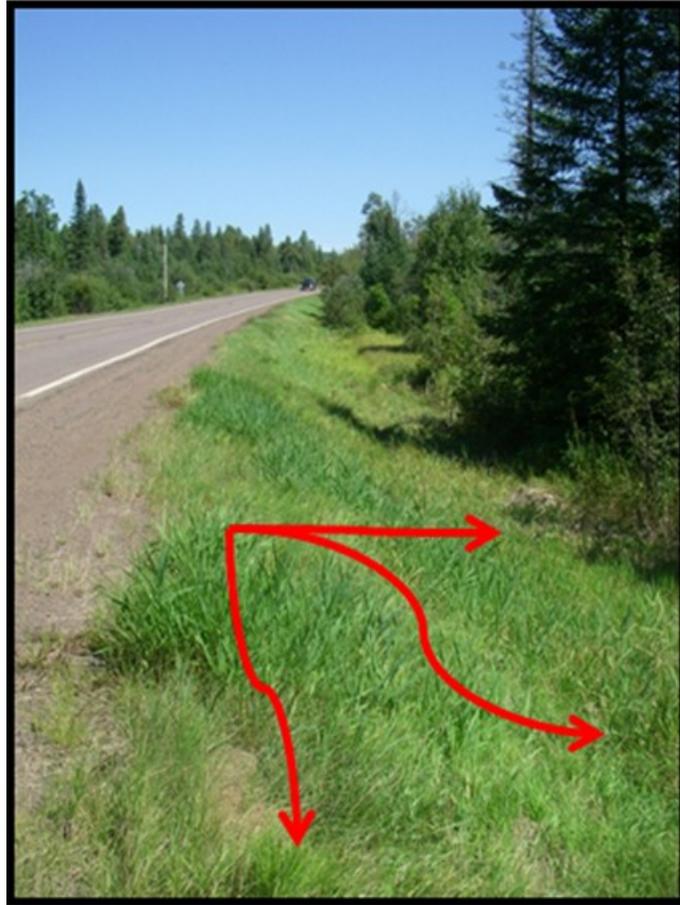
Figure 6. Dispersive flowpath

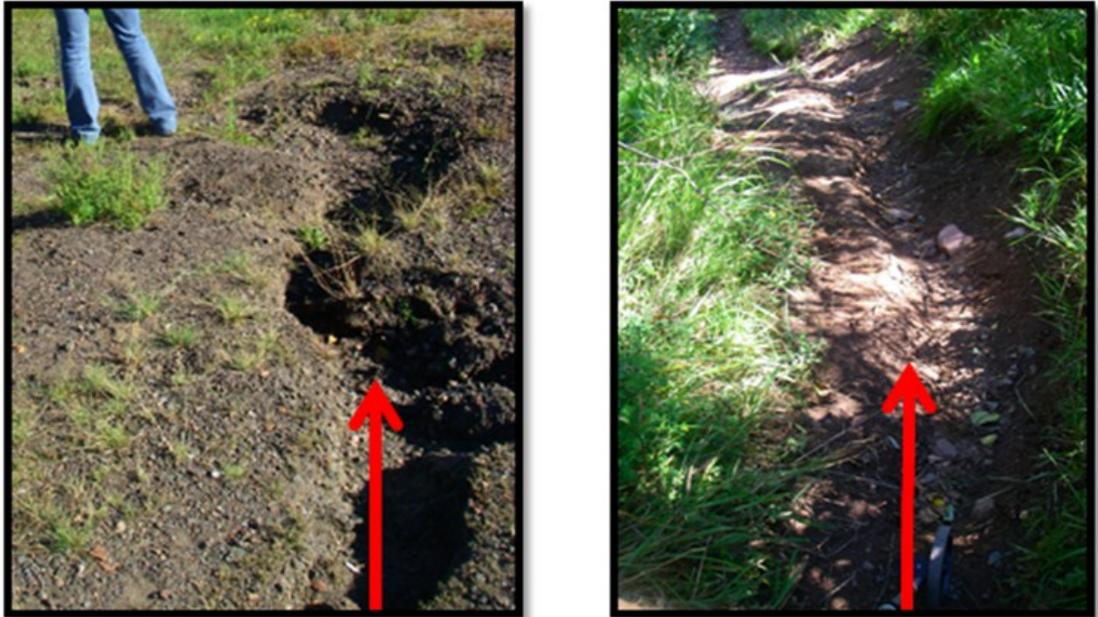
Figure 7. Direct flowpath

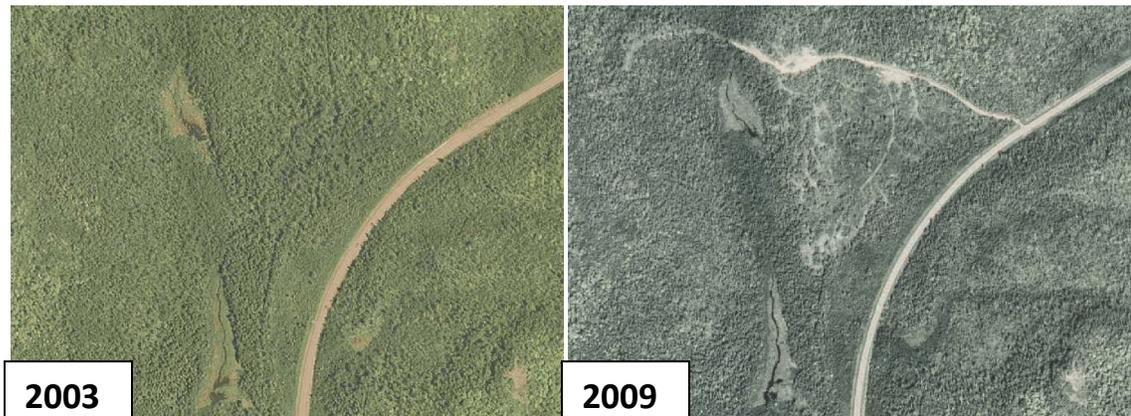
Figure 22. Comparison of land use change detected in Beaver watershed, road survey sites B01-B03 are found on the new road featured in the 2009 photo

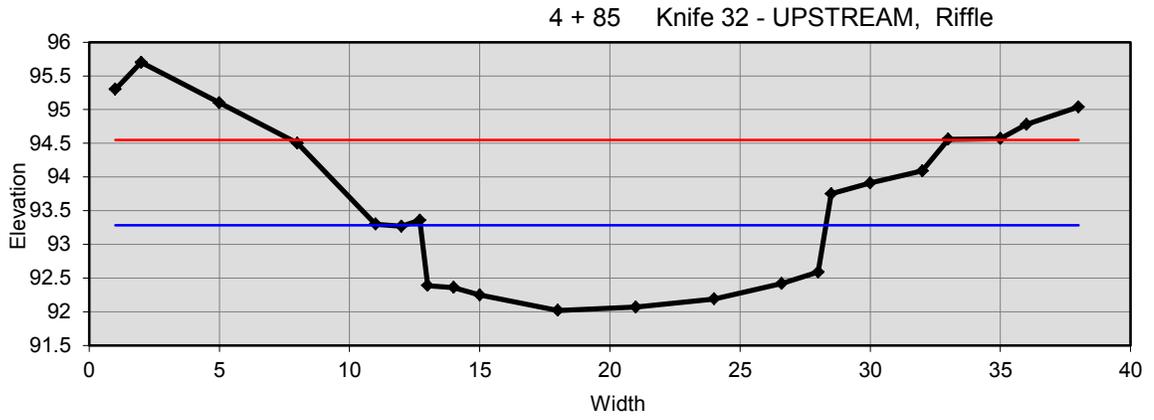
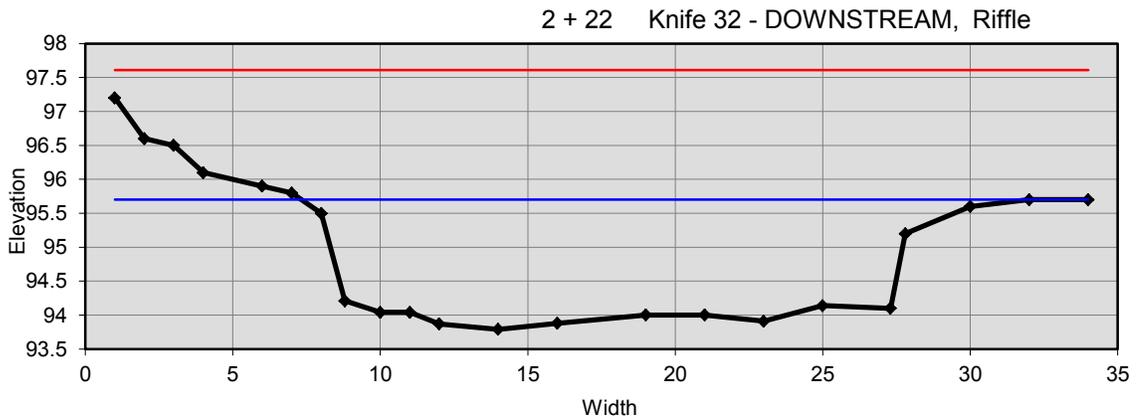
Knife 32 - Cross Sections

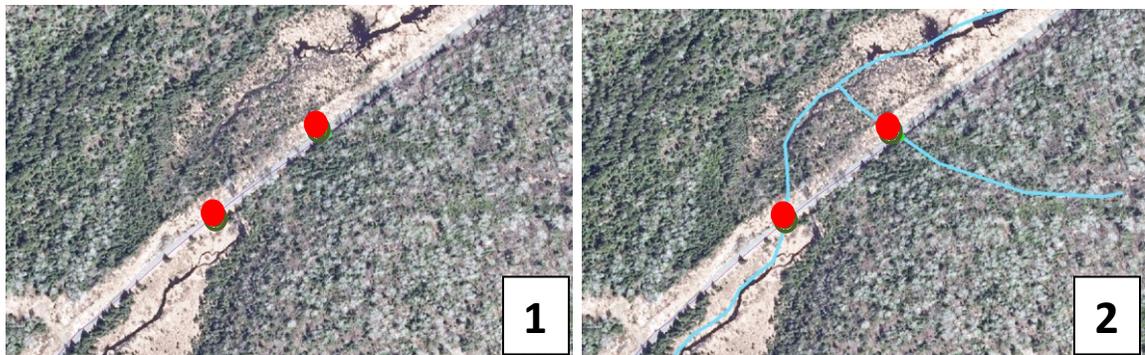
Figure 24. Example of sampling error

Over-estimation of road-stream crossings is probable within this study. This error may have contributed to road survey site sampling error, and errors in estimation of watershed characteristics. The core data layers used are likely to have over/under estimations pertaining to hydrography or the road network. The hydrography data used was developed by the USGS National Hydrography Dataset (NHD) at a 1:24,000-scale; and road network digitized from older aerial photos or USGS quads (the MNDOT layer is current to the date January 1, 2002, with some properties as current as 1979); therefore these layers may not accurately describe the current dimension and path of the existing road and stream network. Figure 25 illustrates possible sampling error when road and stream networks were intersected, a tributary identified within the NHD hydrography layer is unidentified in image 1, but is counted as a road-stream crossing point.
