Technical Paper No. 19, Series B

# Hydraulics of Closed Conduit Spillways

Part VIII. Miscellaneous Laboratory Tests

Part IX. Field Tests

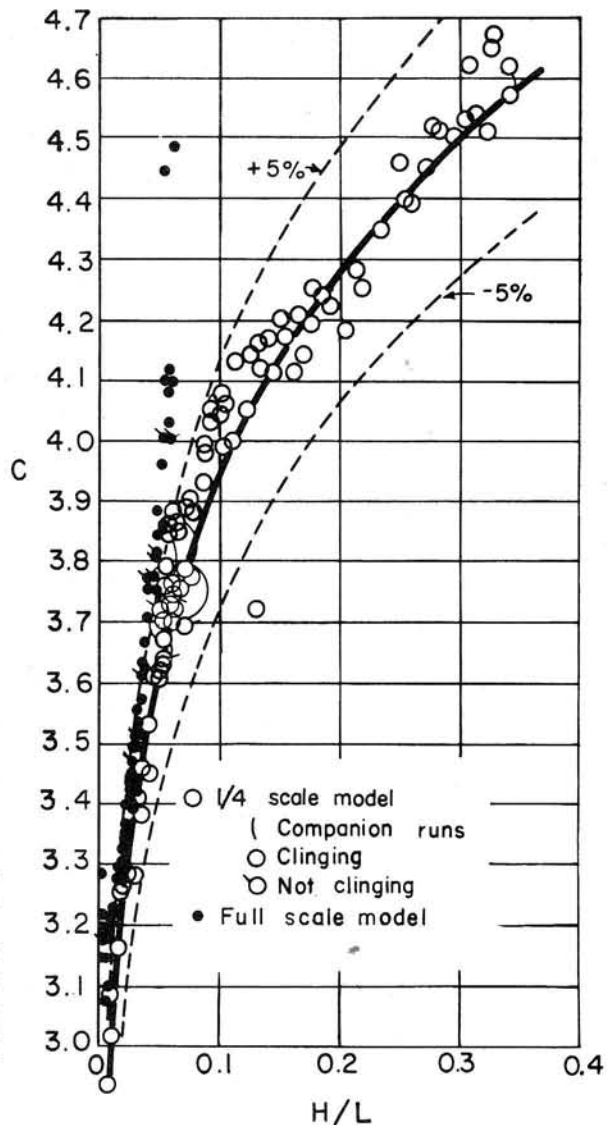
Coefficients of discharge  $C$  for weir flow conditions are plotted in Fig. VIII-8. These are for use in Eq. I-1. The crest length  $L$  is the length taken at the point of horizontal tangency of the crest rounding. It is not the inside length of the crest. Although all full-scale model data are plotted in Fig. VIII-8, the full-scale data obtained at heads  $H/L$  in excess of 0.035 are not considered typical or similar to the one-fourth size model, as is noted below.

Fig. VIII-8 - Head-Weir Coefficient Curve for McCredie, Missouri, Closed Conduit Spillway.

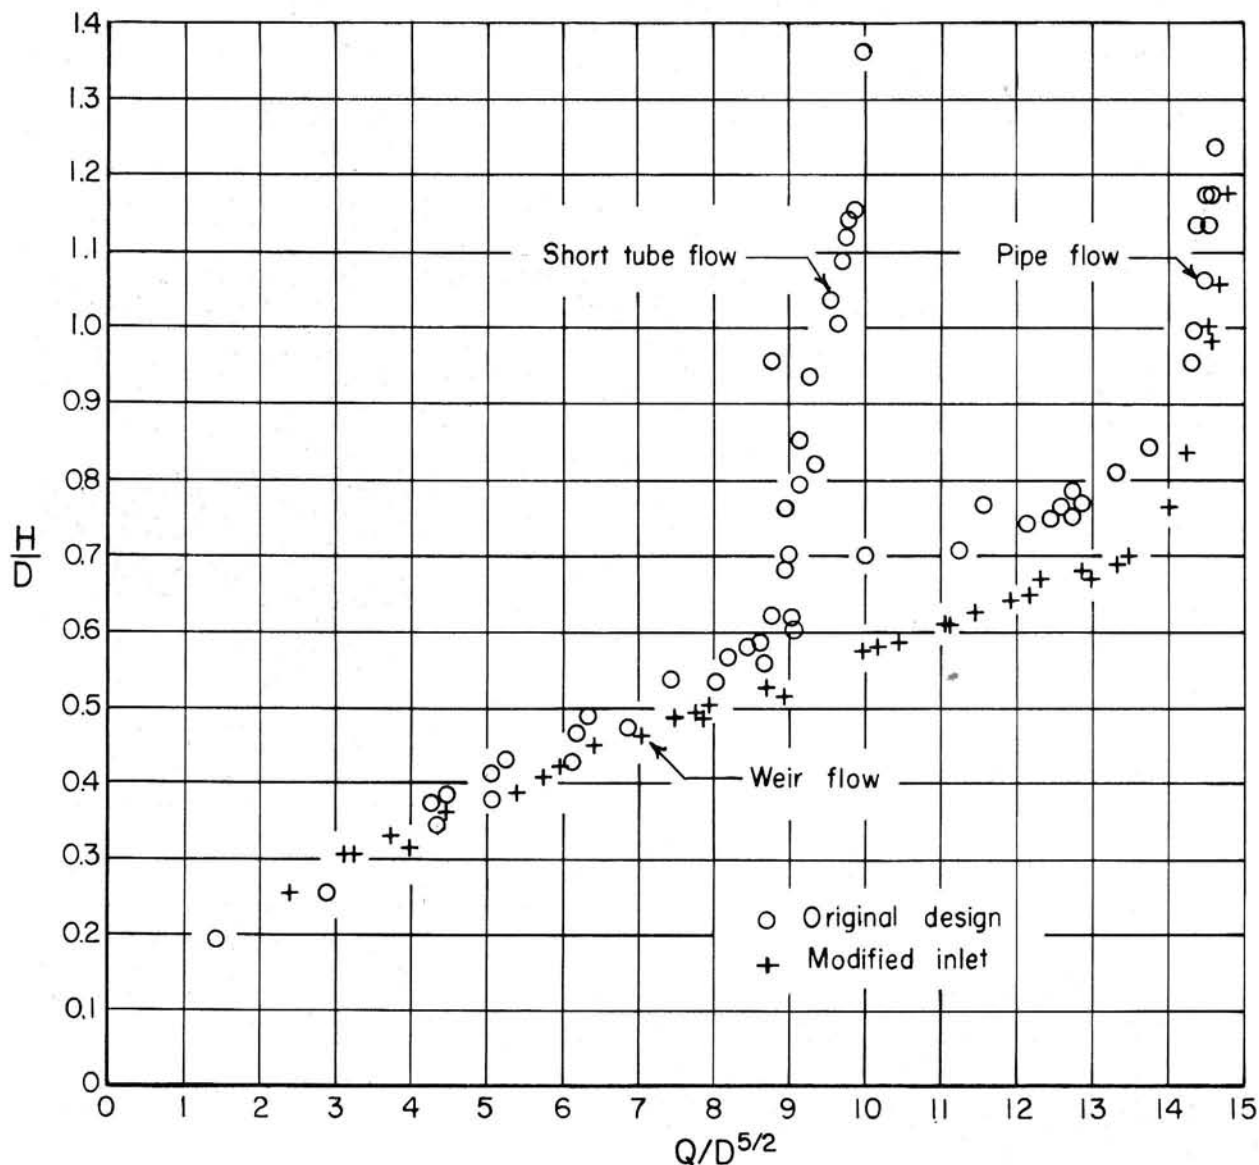
Fig. VIII-13 - Head-Discharge Curve for Crawford County, Iowa, Closed Conduit Spillway.

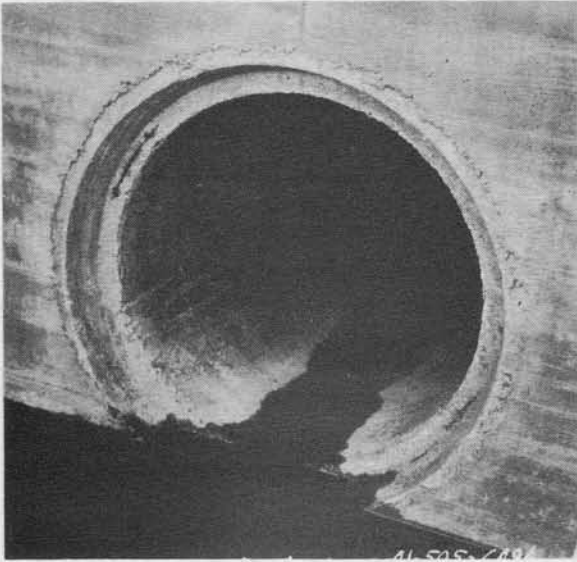
Fig. IX-3 - Concrete Pipe Groove Entrances, Experiment 1, Stillwater, Oklahoma.

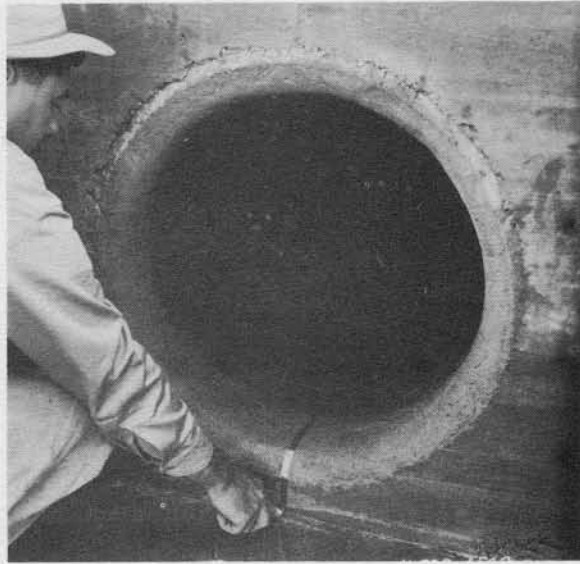
Fig. IX-4 - Rounded Pipe Entrance, Experiments 2, 3, 5 and 6, Stillwater, Oklahoma.

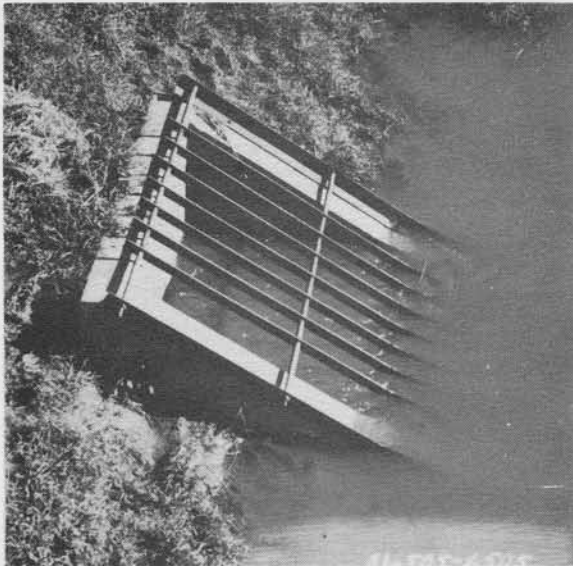
Fig. IX-5 - Debris Guard, Experiment 3, Stillwater, Oklahoma.

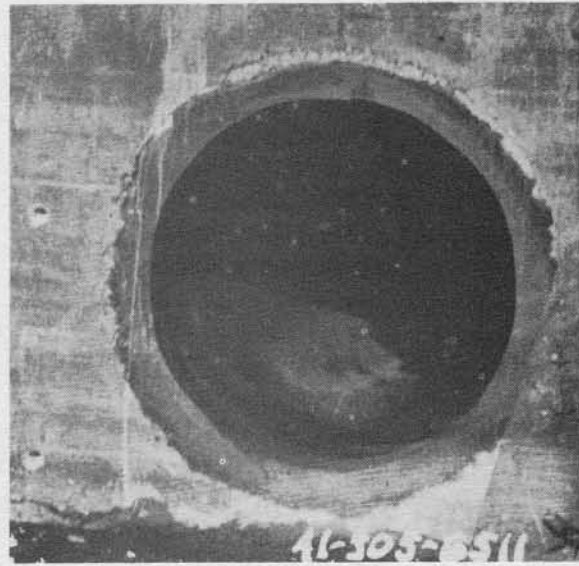
Fig. IX-6 - Square-Edged Pipe Entrance, Experiment 4, Stillwater, Oklahoma.

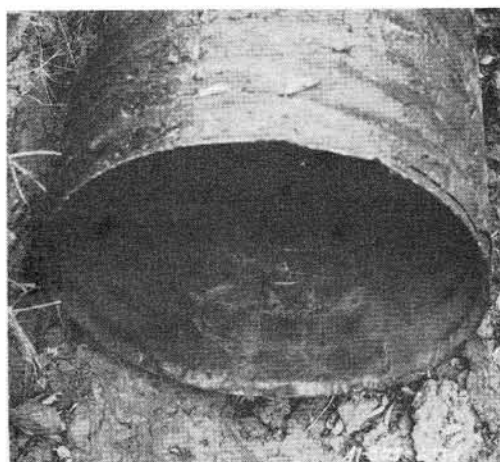
Fig. IX-9 - Cracking of Bituminous Coating of 24-in. Corrugated Metal Pipe, Stillwater, Oklahoma.  $n = 0.0218$ .

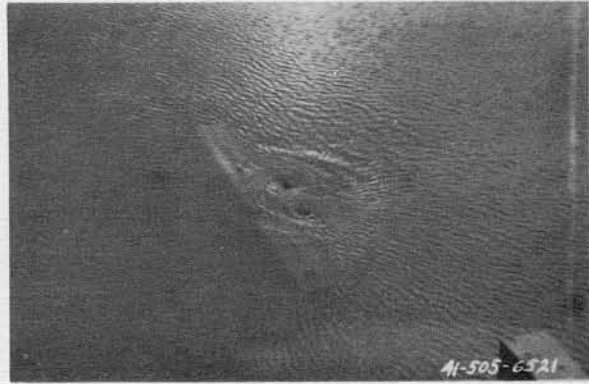
(a) Head on crest is 5.70 ft.  
Pipe flow control.

(b) Head on crest is 2.25 ft.  
Pipe flow control.

(c) Head on crest is 1.95 ft.  
Pipe flow control.

(d) Head on crest is 1.25 ft. Pipe flow  
control or beginning of transition  
from pipe to weir flow control.

(e) Head on crest is 1.00 ft. Weir flow  
control or near end of transition  
from pipe to weir control.

(f) Head on crest is 0.75 ft.  
Weir flow control.

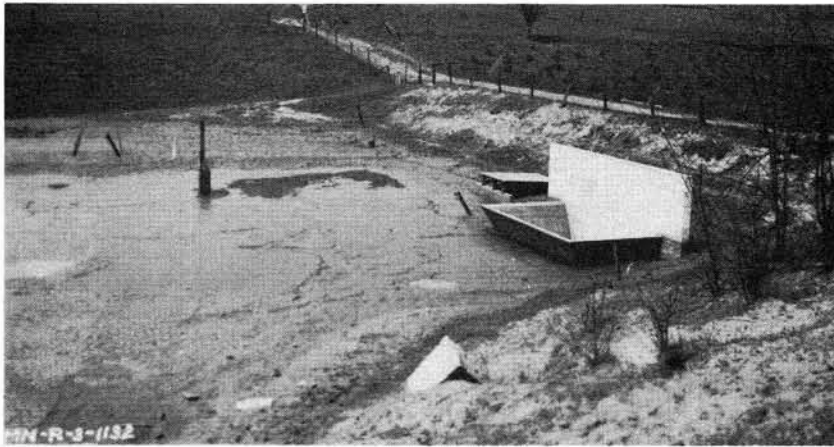
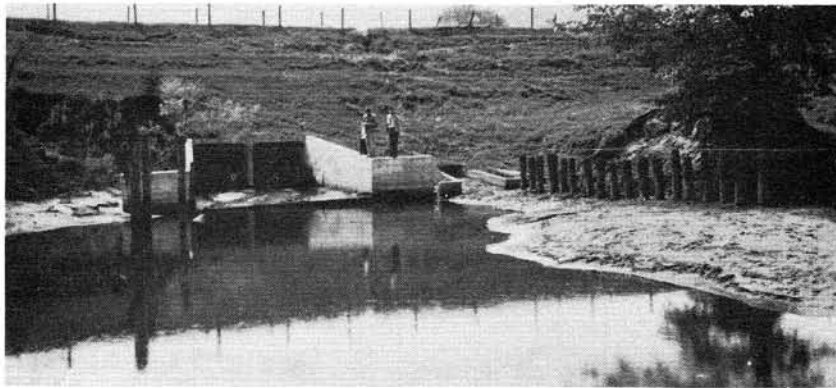
(a) Experimental 2 ft by 2 ft spillway has been capped and only headwall shows beyond twin 6 ft by 6 ft spillway.

(b) Outlet has silted in.

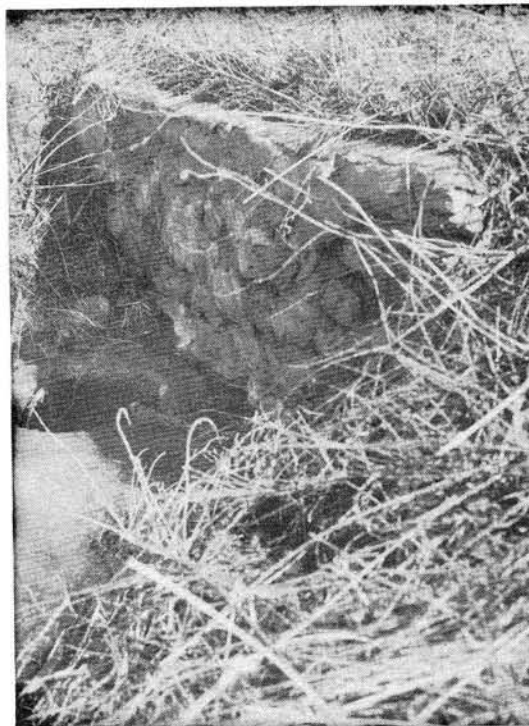
Fig. IX-35 - Entrance to Bethany, Missouri, Closed Conduit Spillway.
