University of Minnesota
St. Anthony Falls Hydraulic Laboratory

Project Report No. 213

MODEL STUDY OF THE MINNESOTA RIVER
NEAR TRUNK HIGHWAY NO. 169 BRIDGE,
MINNESOTA

September, 1982

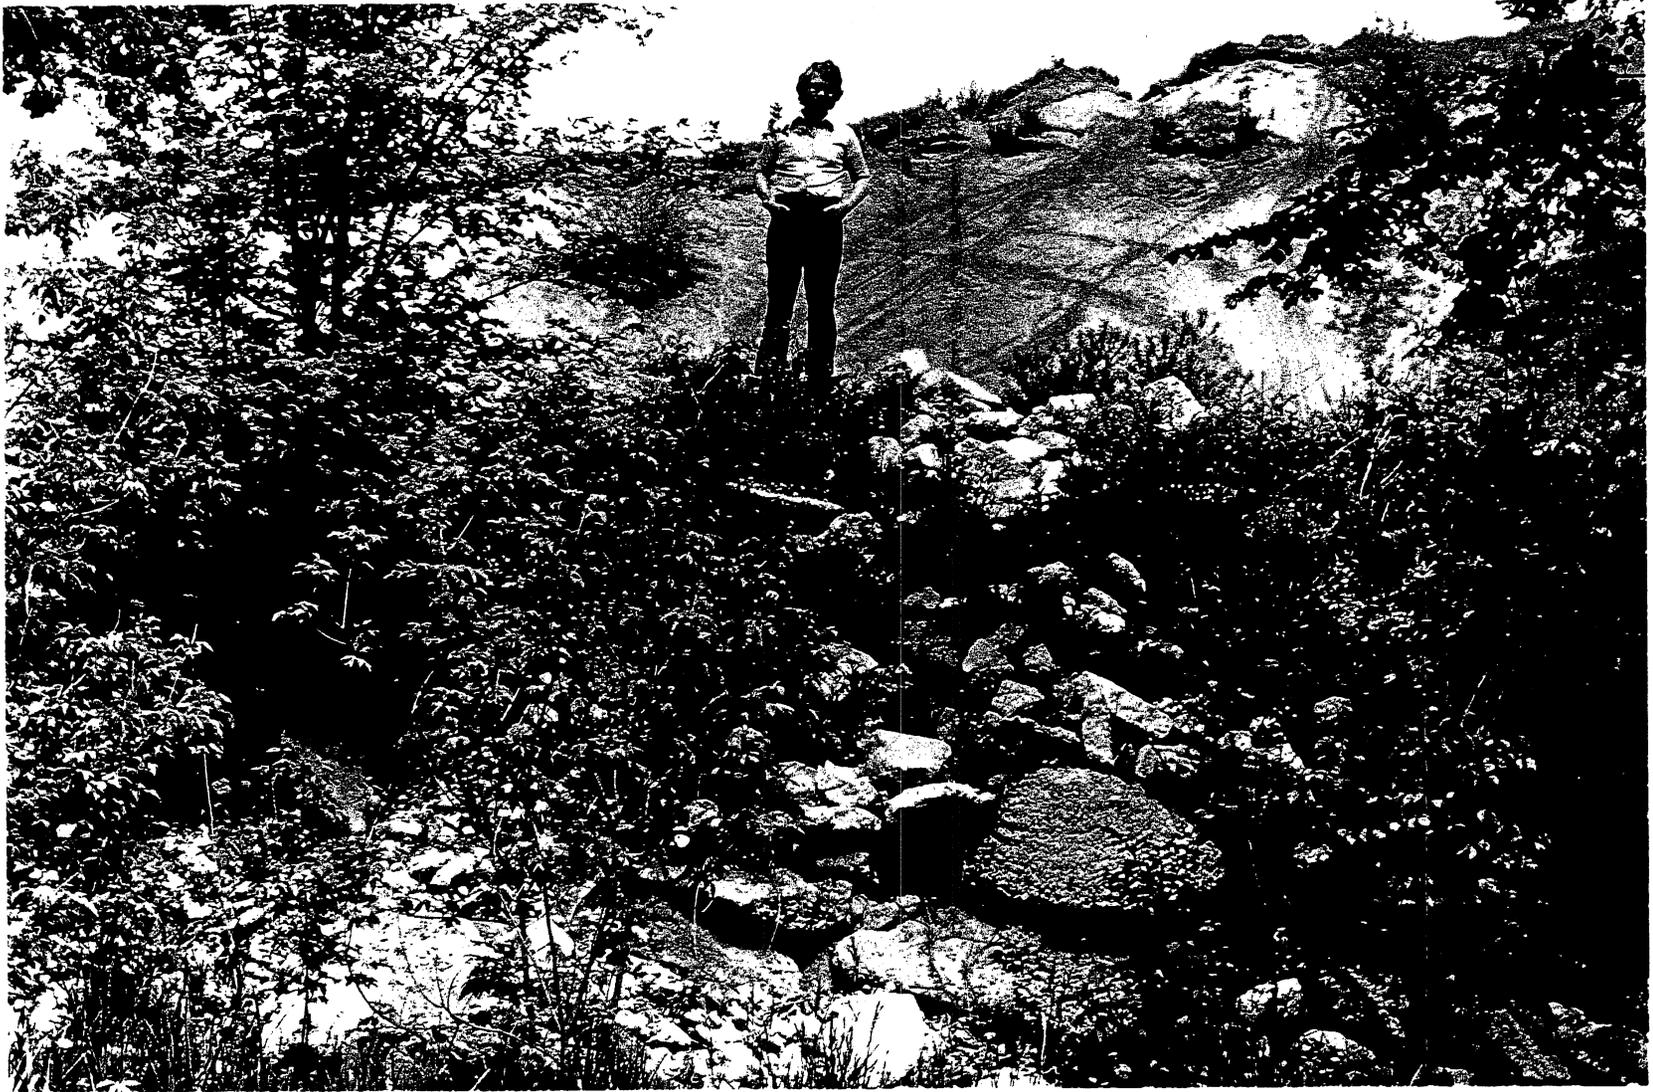
Fig. 8. View of denuded slope of gravel mining operation from Le Sueur Creek. Aquatic grasses at bottom denote margin of creek. The rubble embankment in the foreground does not appear to be more than a decade old.

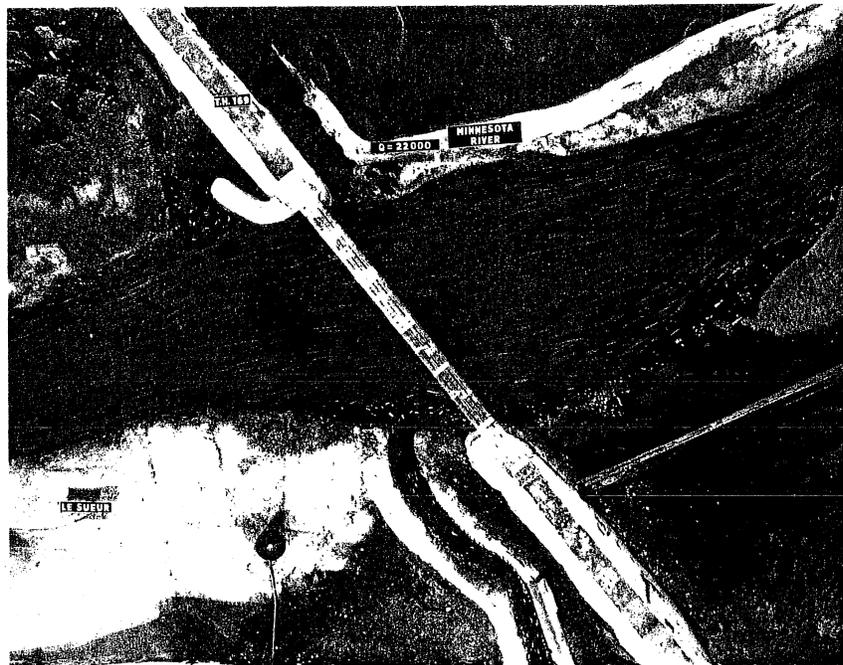
Fig. 22. Streamlines for a mainstem flow of 22,000 cfs and the tributary flow off.

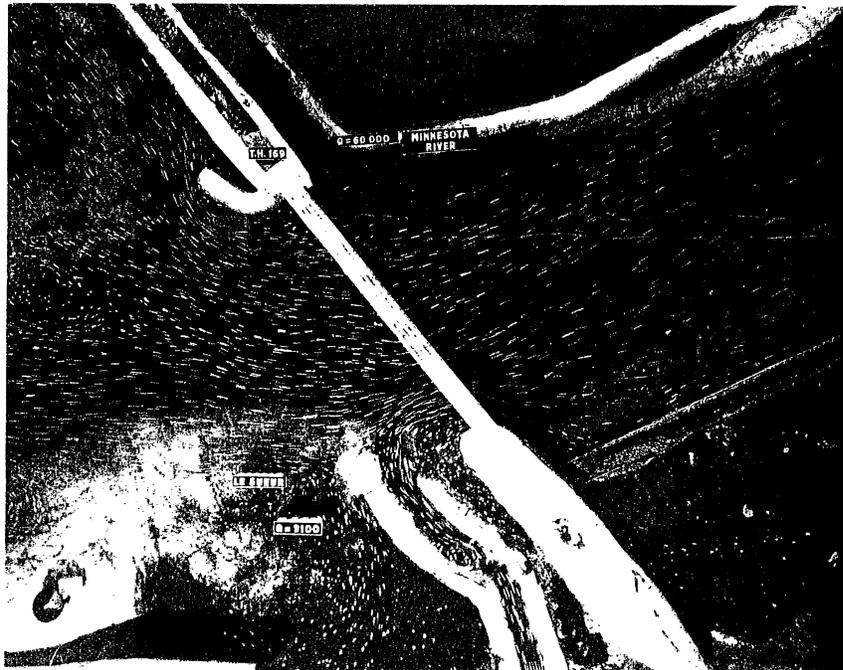
Fig. 24. Streamlines for a mainstem flow of 60,000 cfs and the tributary flow on.

In Figs. 24 and 25, streamlines are shown for runs 6-2a and 6-2b (60,000 cfs), respectively. The effect of tributary flow on the main stem is greatly subdued due to the slack floodplain water through which the tributary must pass. The artificial dikes along Le Sueur Creek, visible in both photographs, tend to exaggerate the effect of the tributary on the main stem, weak as it is even in their presence. It will be recalled that they were installed earlier in order to force formation of a bar at the mouth of Le Sueur Creek; they failed in this purpose due to the slack water. The flow patterns in Figs. 24 and 25 illustrate why a bar cannot form at the mouth of the tributary at flows well overbank; the sediment would first deposit in the slack water of the floodplain.

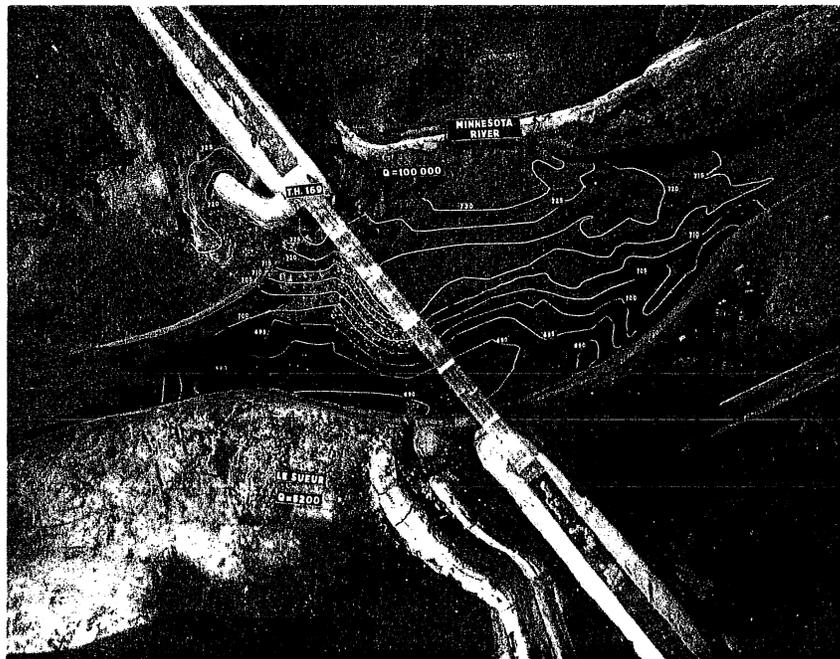
Fig. 28. Bed topography created by a mainstem flow of 100,000 cfs with the tributary flow on.

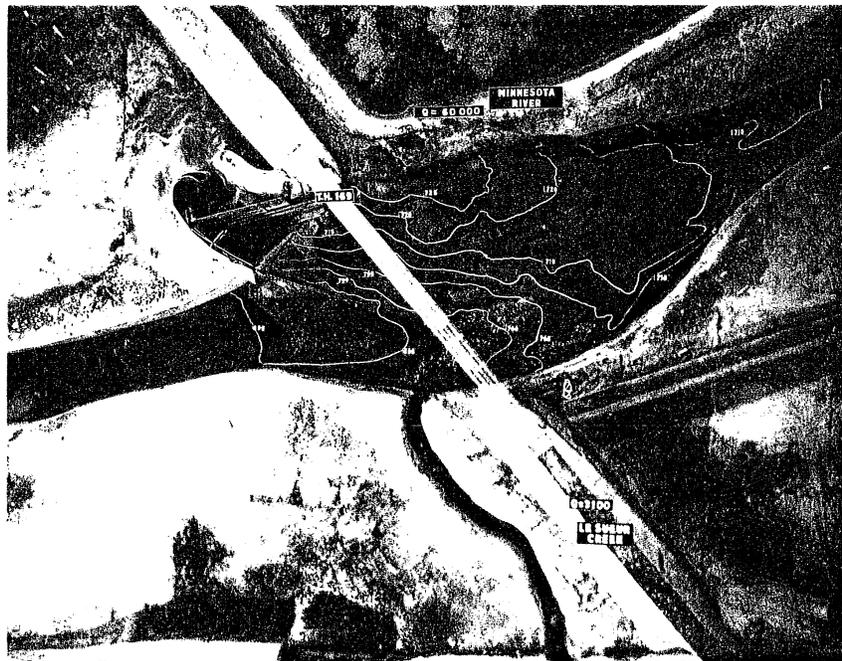
Fig. 31. Bed topography created by a mainstem flow of 60,000 cfs with the sheet metal T-spur dike in place.

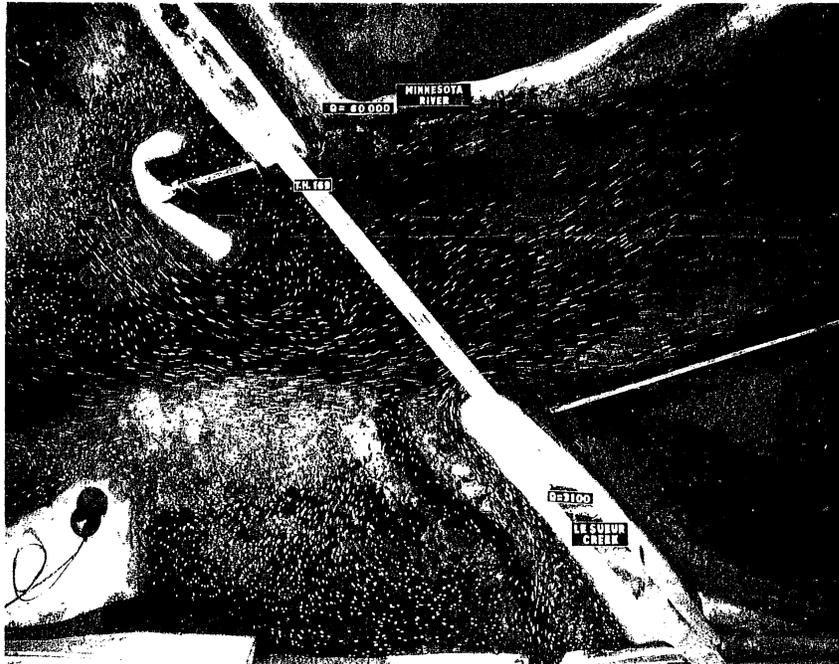
Fig. 33. Flow streamlines at 60,000 cfs associated with the concreted T-spur dike of Fig. 32.

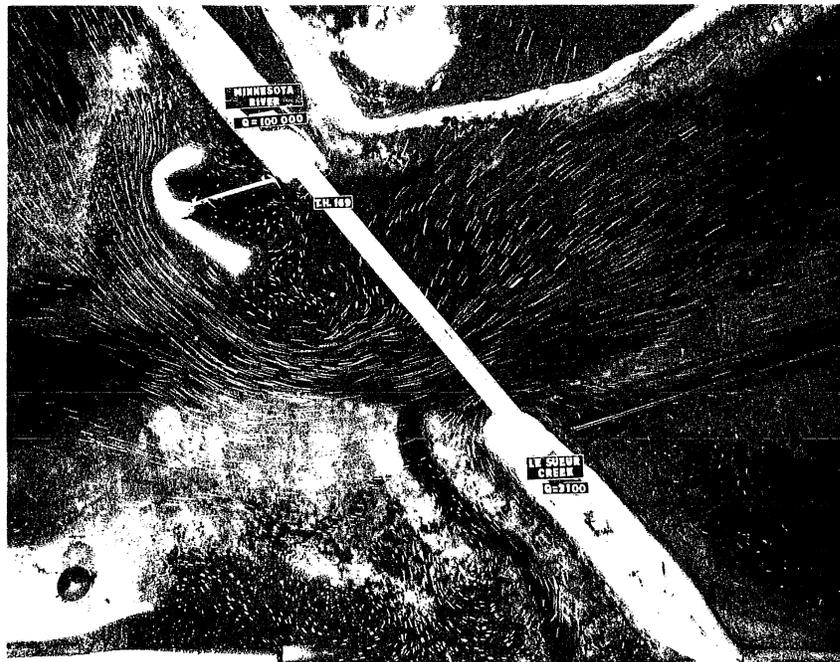
Fig. 34. Flow streamlines at 100,000 cfs with the concreted T-spur dike of Fig. 32 in place.

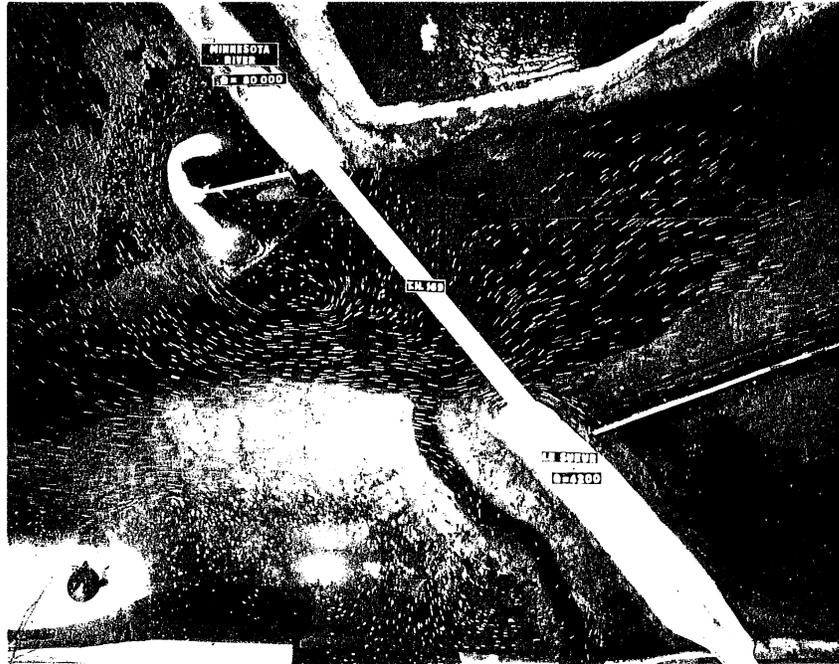
Fig. 36. Flow streamlines at 80,000 cfs, with a shortened version of the T-spur dike. Dike angle has also been modified.

In order to increase conveyance and to divert the flow less intensely to the east, the tip of the T-spur dike was shortened. A test of 80,000 revealed an improved flow pattern (Fig. 36) but again excessive was observed scour at the piers.

To this end, further attempts were made to reduce the eddying and excessive deflection to the east at the highest discharges. It was found that if the area just upstream of the excavation at the downstream tip of the T-spur dike were elevated with riprap, eddying would be avoided. As a result, the spur dike could be angled more nearly downstream without serious separation. These features can be seen by comparing Fig. 37 with Fig. 36.

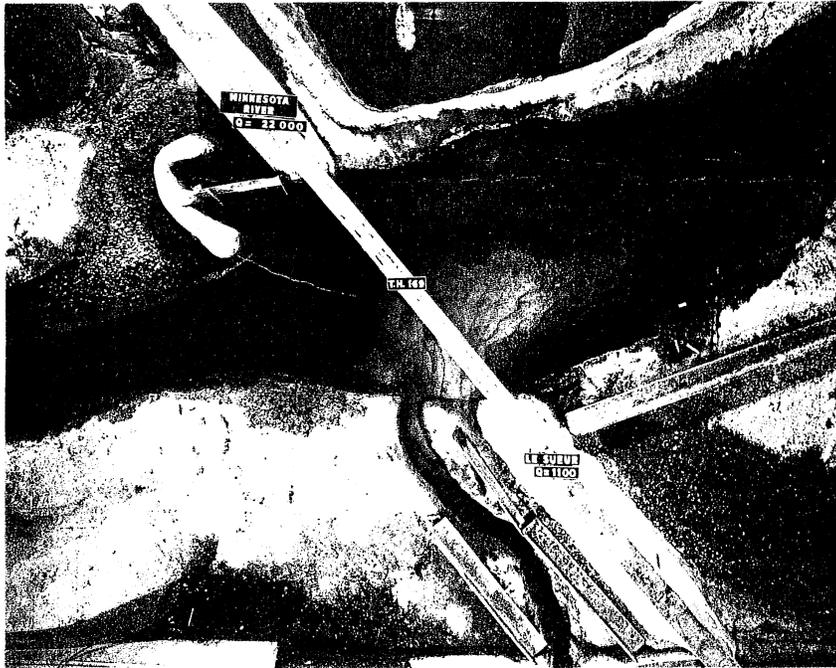
Fig. 38. A view of the bar at the mouth of the tributary created by feeding sediment to the tributary at the rate of 80 grams/minute, or about half the mainstem rate of 165 grams/minutes.

of 80 grams/minute, or about fifty percent of the feed rate to the main stem. As can be seen in Fig. 38, a bar approximating the dimensions of the one observed in the field in 1968 (Fig. 4) formed. In the figure, the bar is rendered visible by the use of new (light) crushed walnut shells in the tributary, and old (dark) crushed walnut shells in the main stem. In fact the deepest part of the channel was observed to be against pier 6, and a weak bar did develop on the west side of the channel behind the spur dike.

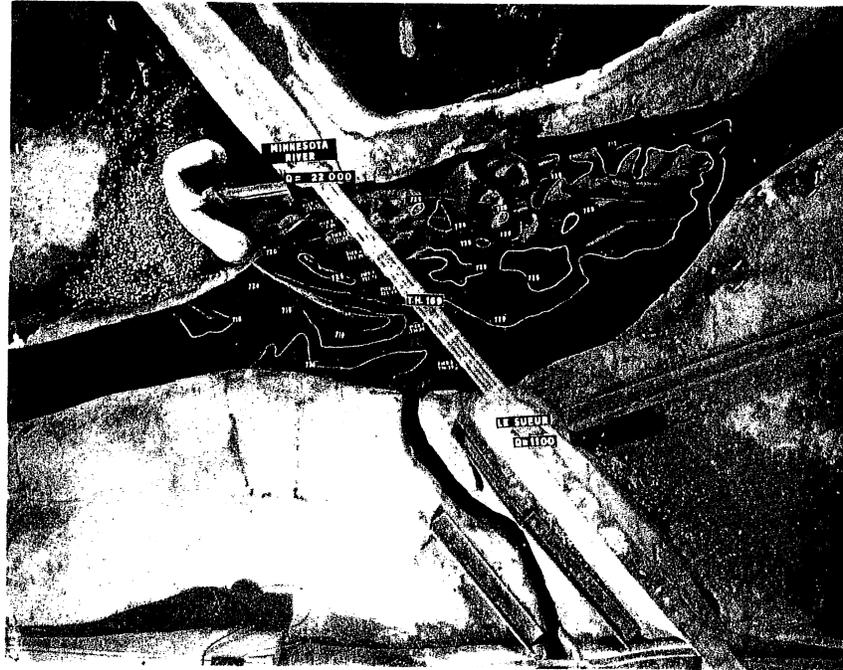
Fig. 40. Top view of the bed topography produced by the flow of Fig. 39.
