Project Report No. 415

**Physical and Numerical Model Study  
of the Little Falls Reservoir,  
Mississippi River at Little Falls, Minnesota**

Tracy Winjum, Richard L. Voigt, Jr., and Gary Parker

March 1998  
**Minneapolis, Minnesota**

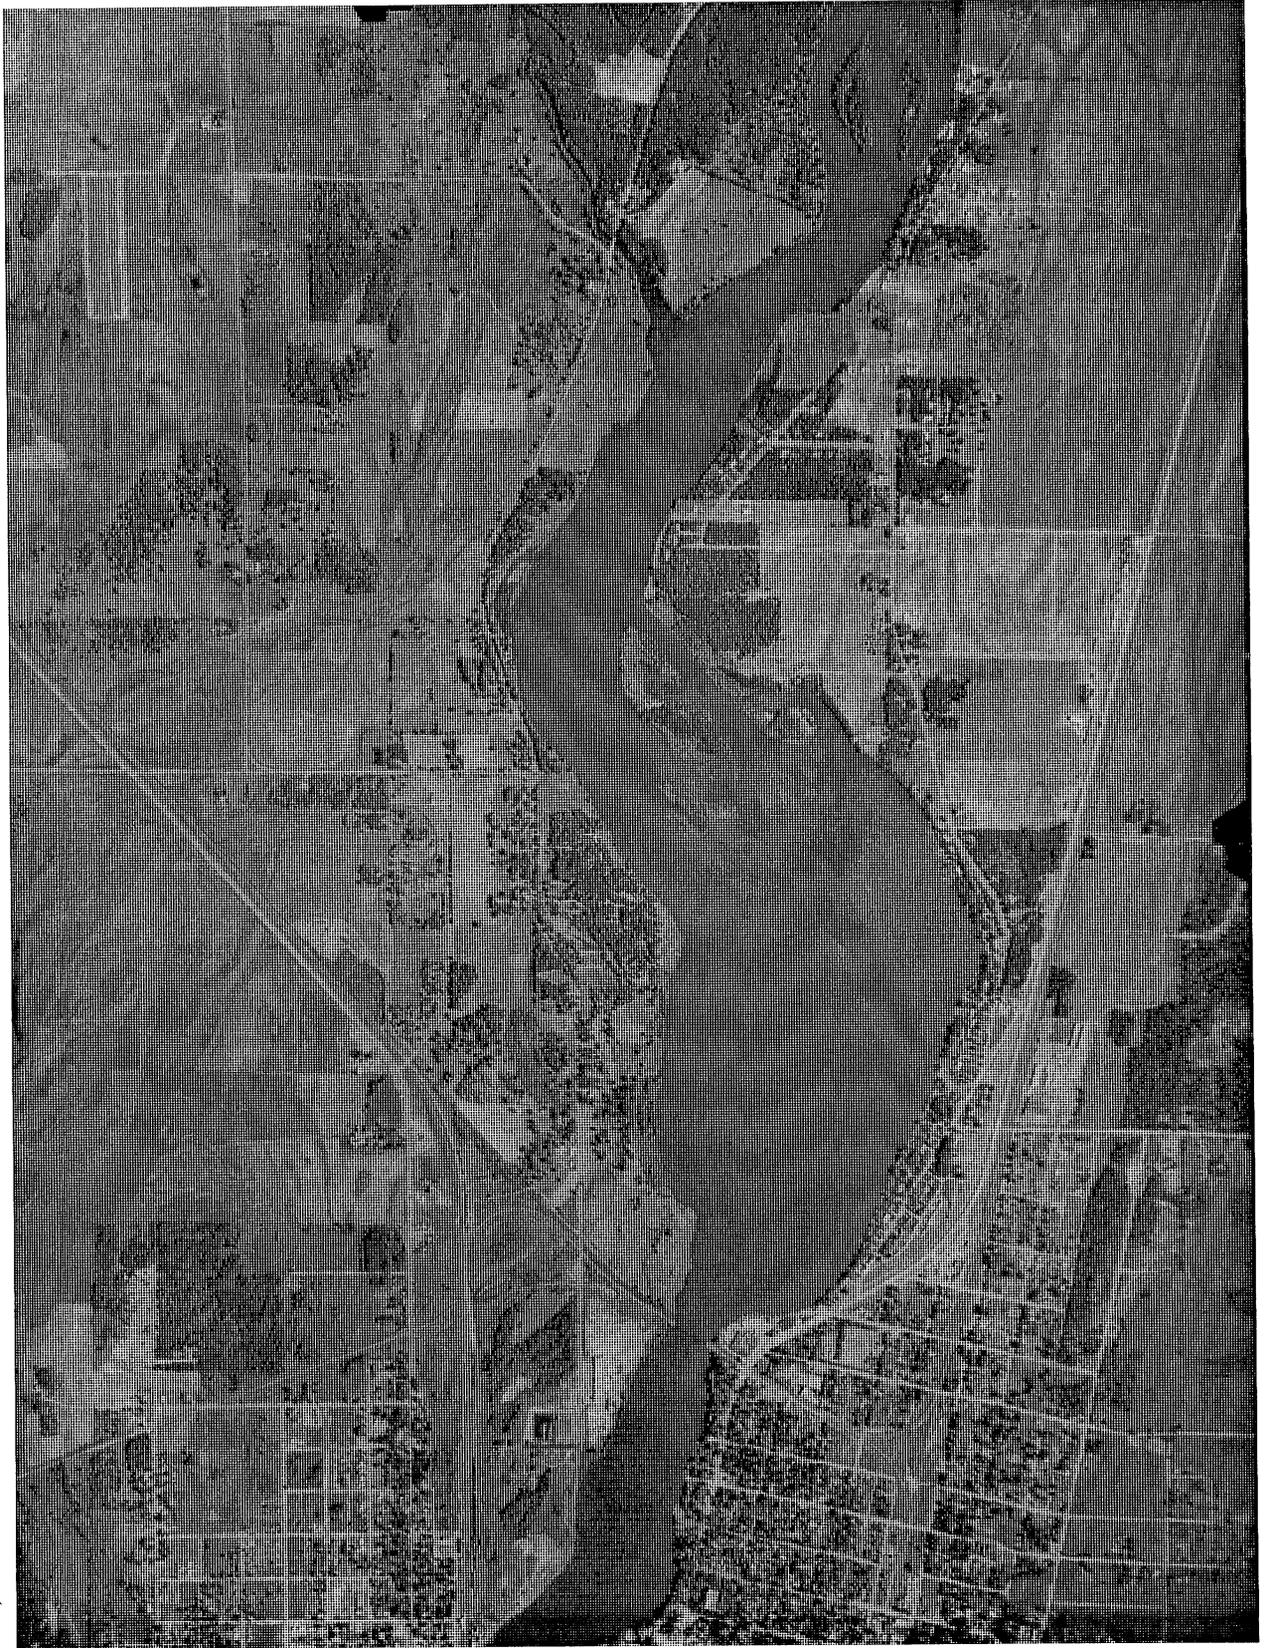
**Fig. 3. Aerial photo of Little Falls Reservoir in 1963.**

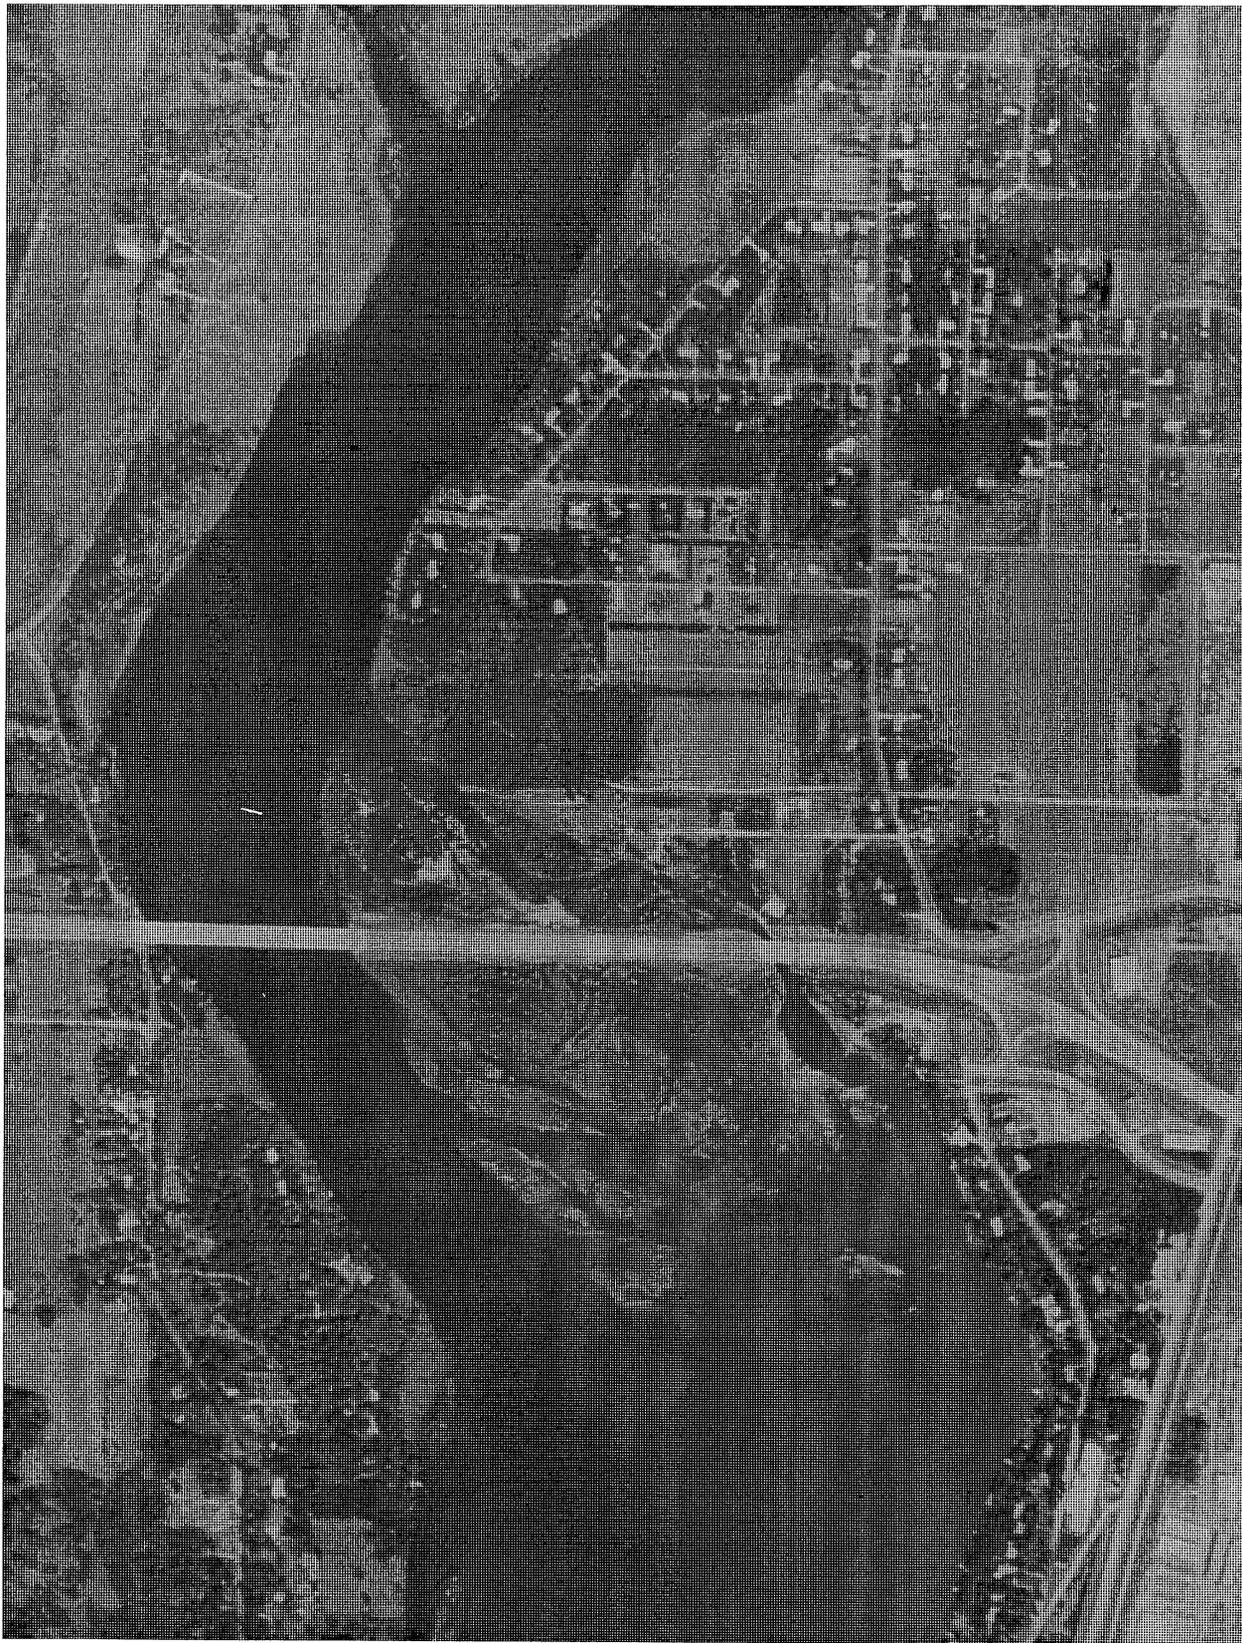
**Fig. 4. Aerial photo of Little Falls Reservoir in 1980.**

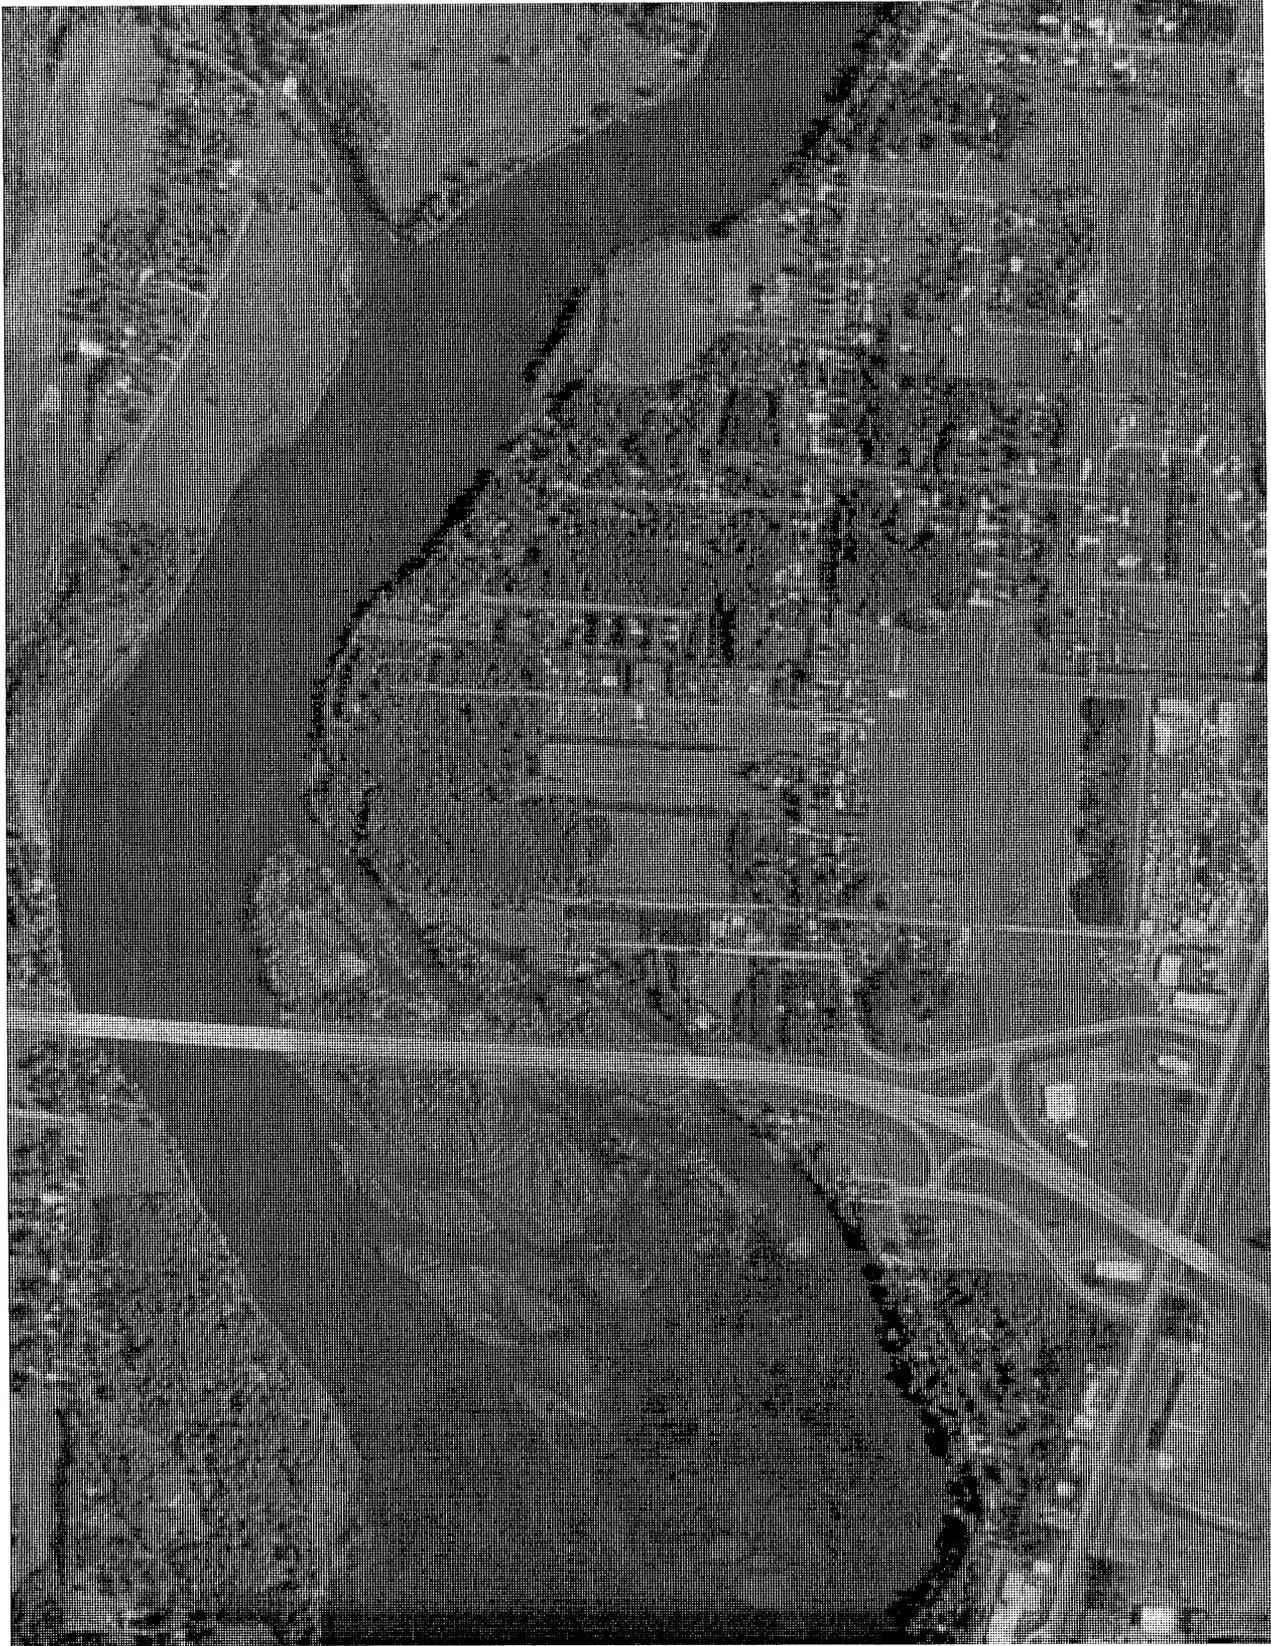
**Fig. 5. Aerial photo of Little Falls Reservoir in 1986.**

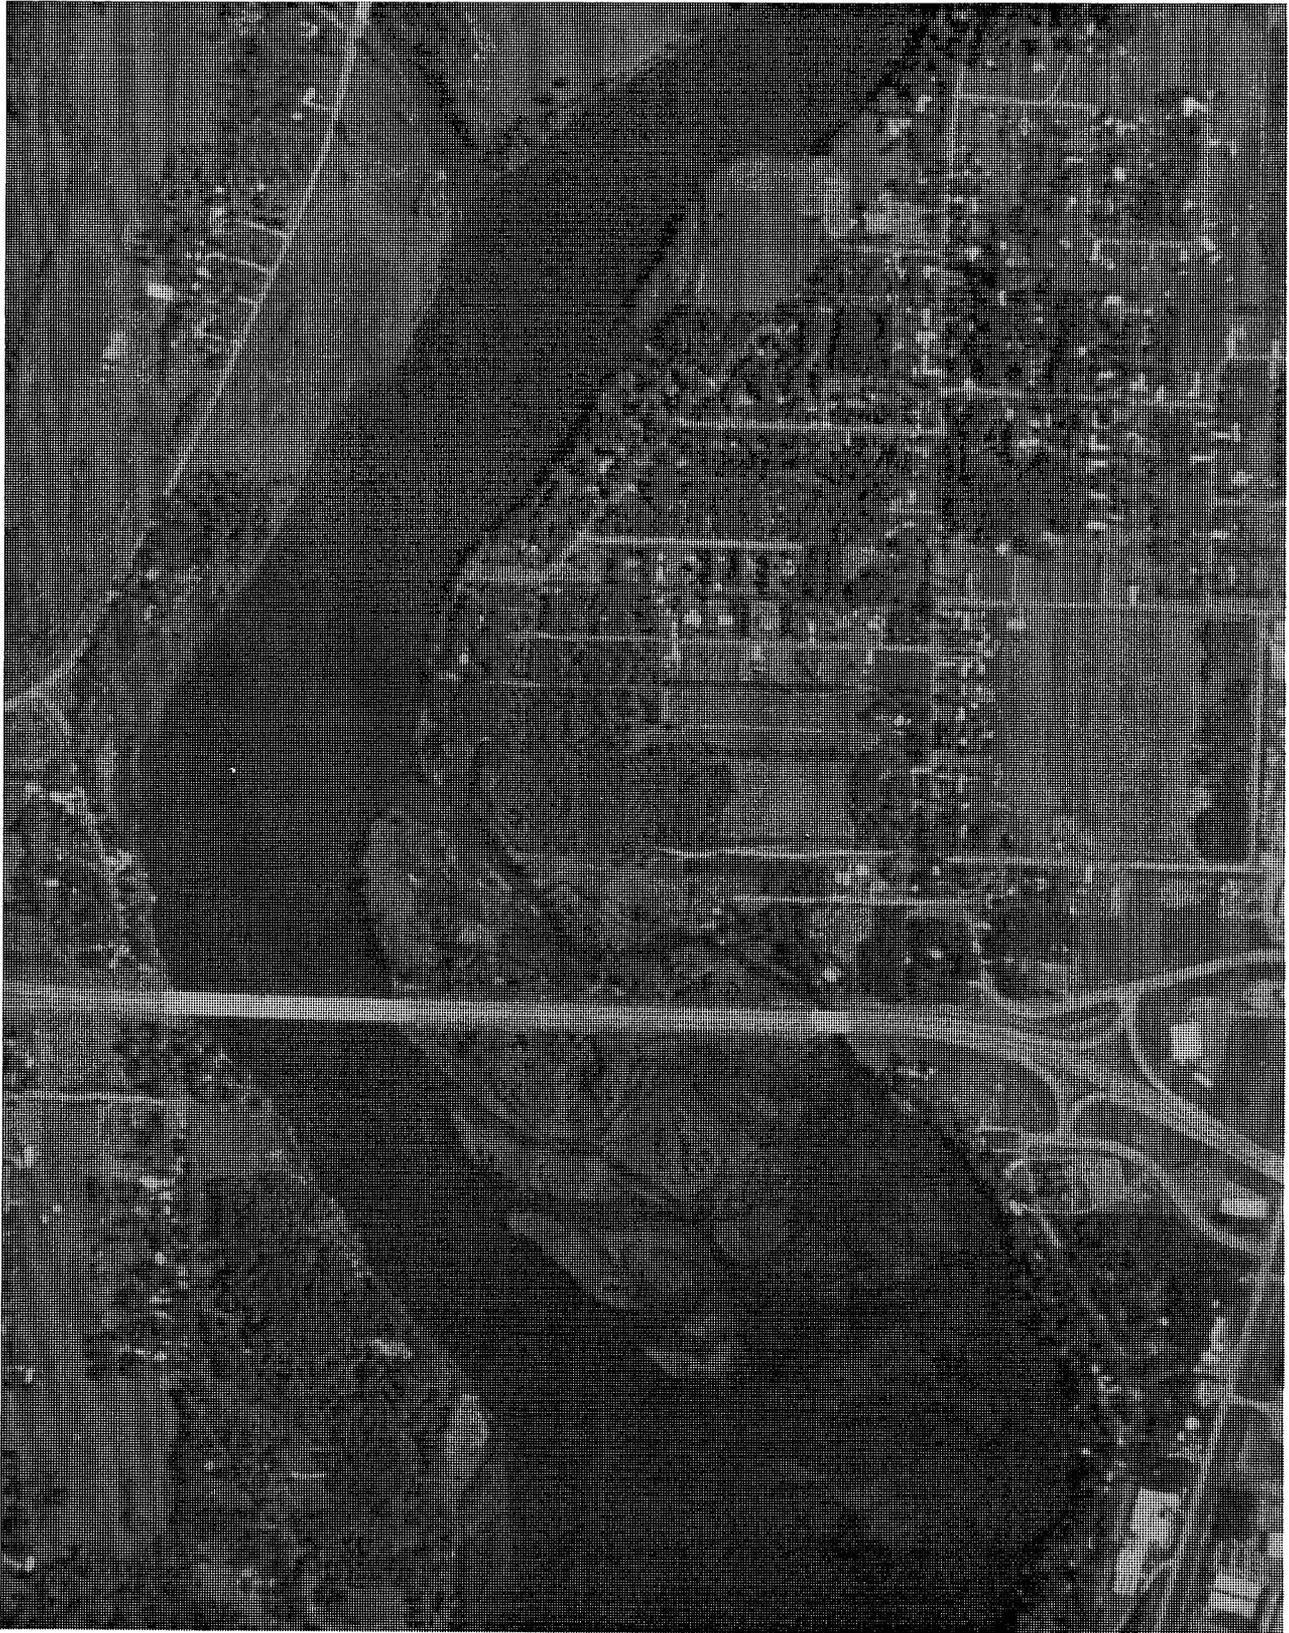
**Fig. 6. Aerial photo of Little Falls Reservoir in 1991.**

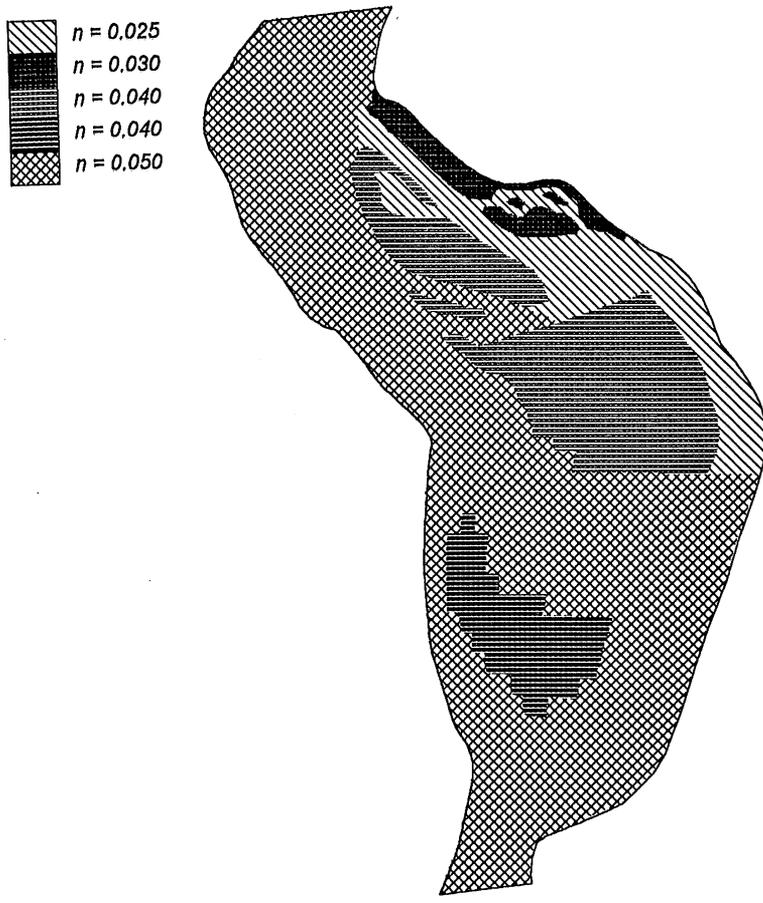
**Figure 11** Numerical model Manning's n values.

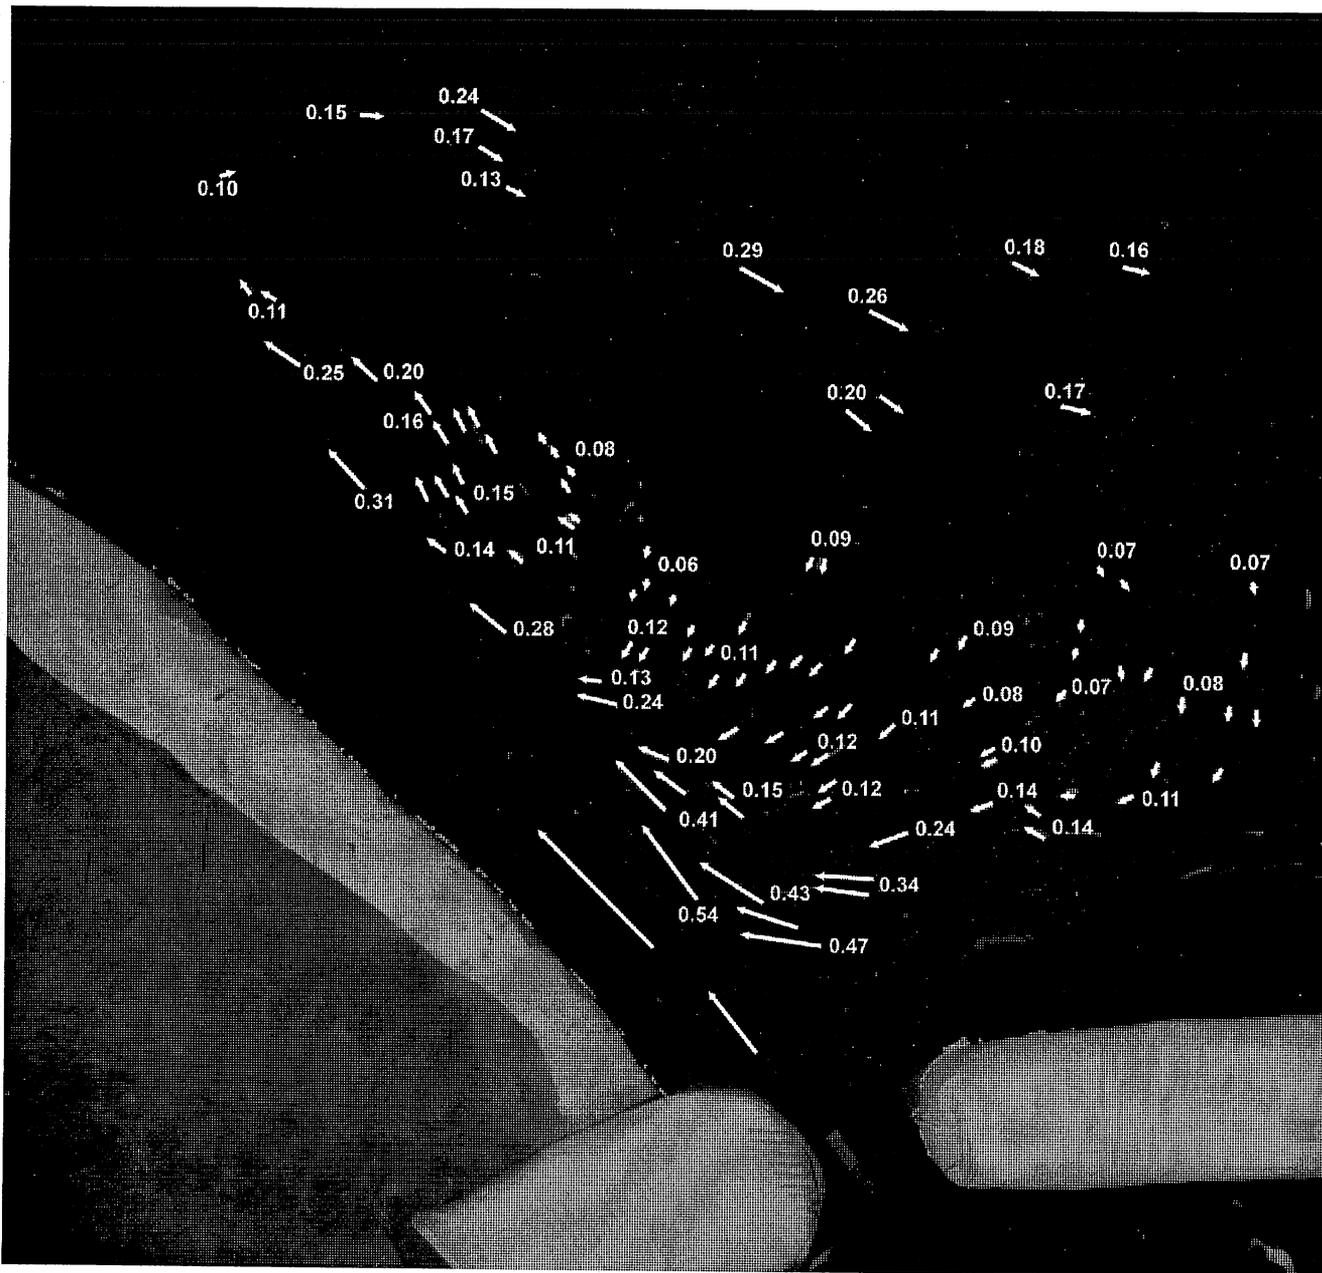
**Figure 22** Surface flow velocities along the east shoreline for a flow of 25,850 cfs with the embankment in place.

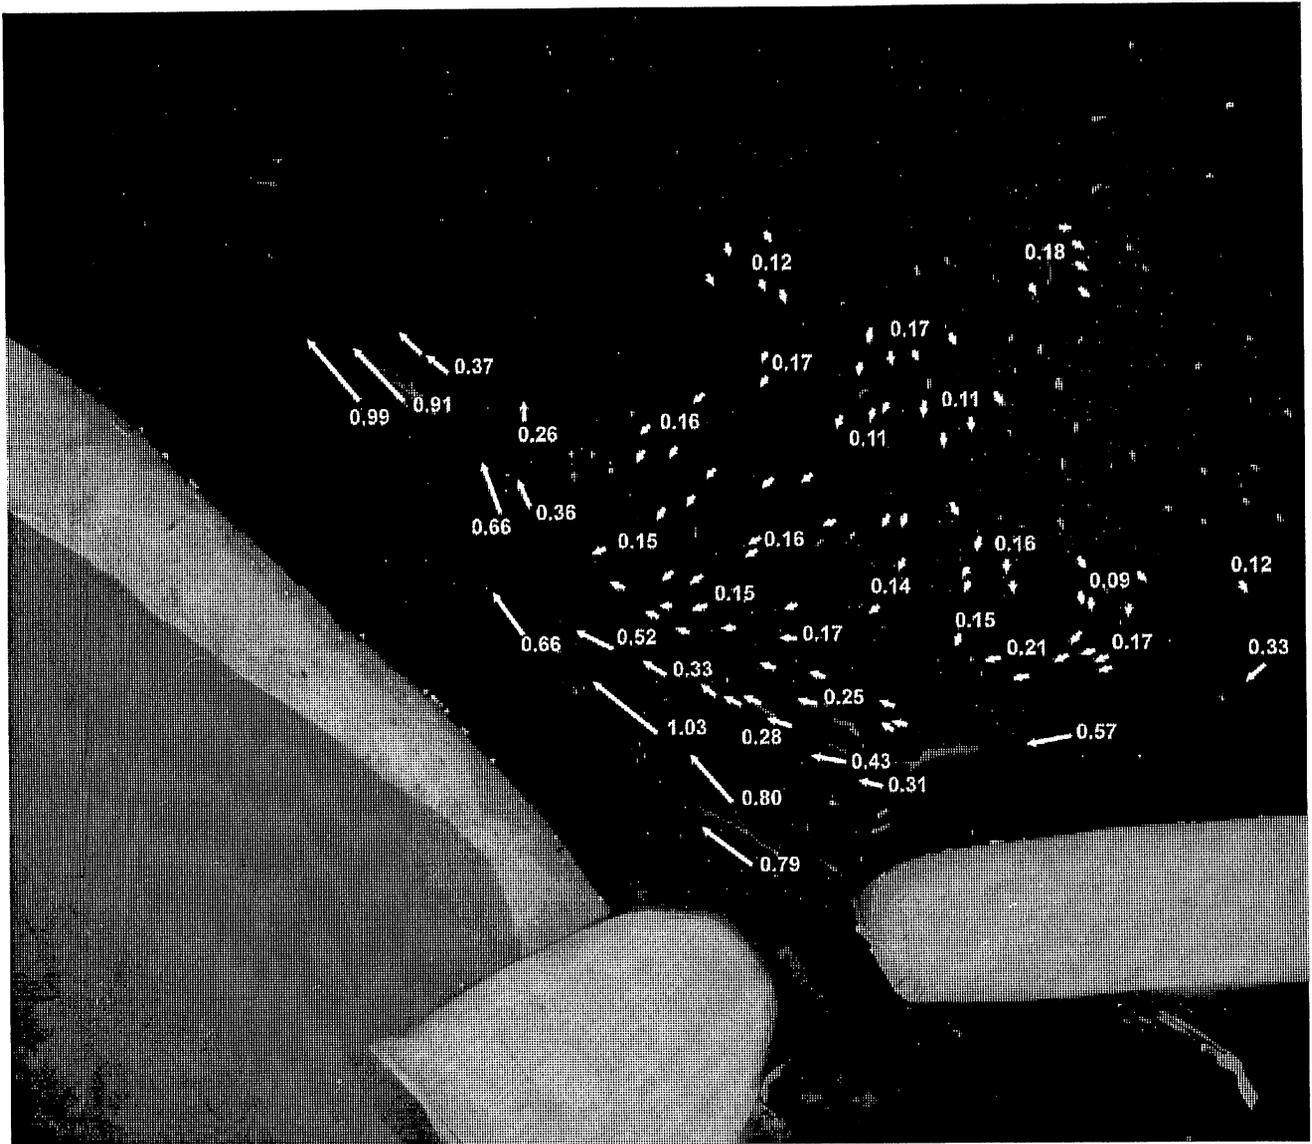
**Figure 25** Surface flow velocities along the east shoreline for a flow of 25,850 cfs with spurdike in place.

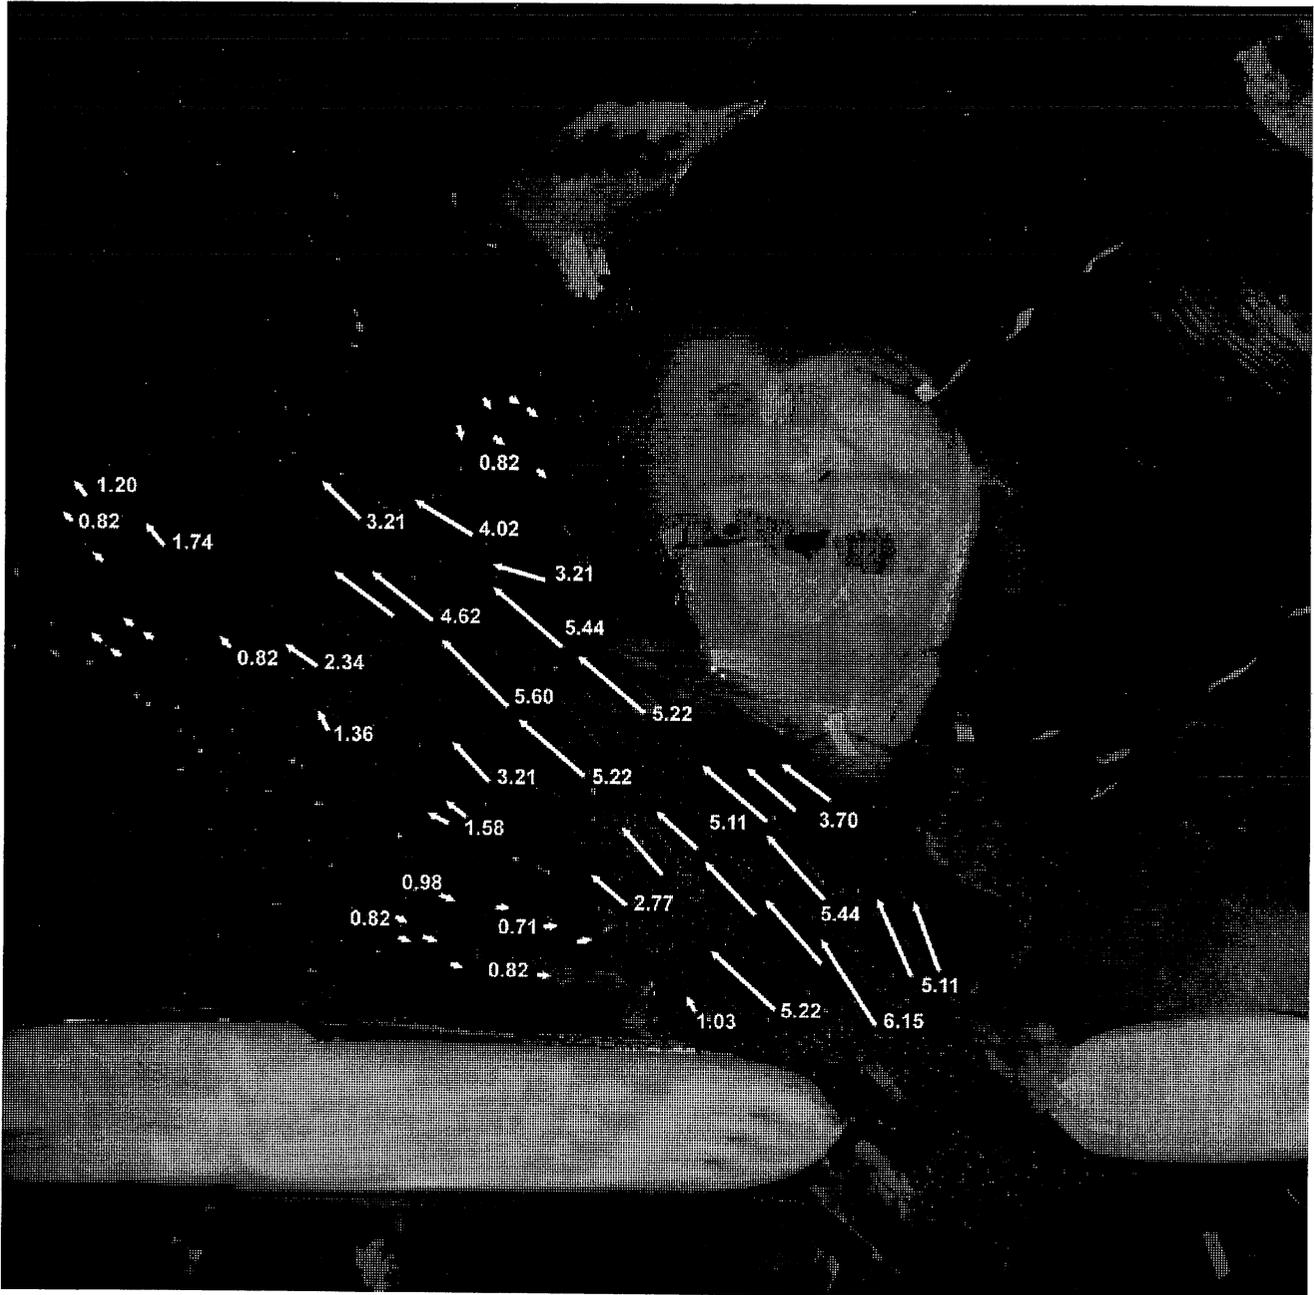
**Figure 32** Surface flow velocities exiting the new opening in the embankment for a flow of 25,850 cfs.

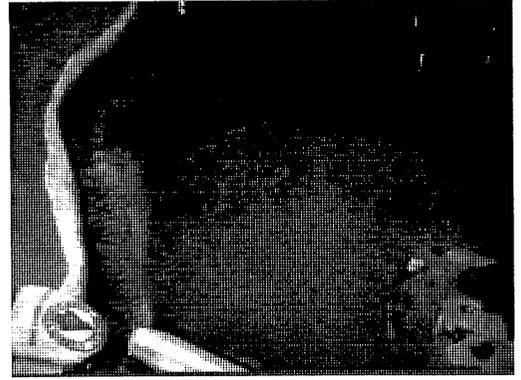
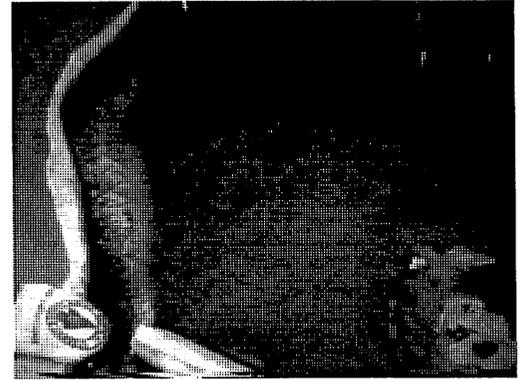
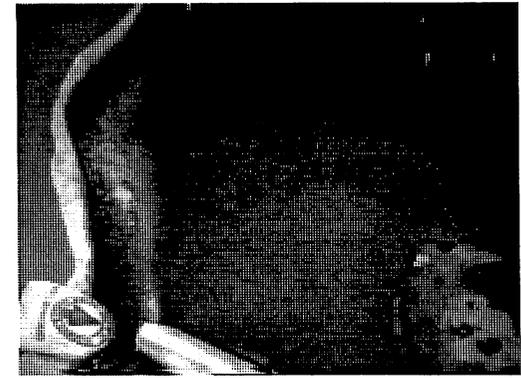
**Fig. 34: Sub-surface sediment deposition without an embankment**

**Fig. 35: Sub-surface sediment deposition with embankment structure in place.**

**Fig. 36: Sub-surface sediment deposition with new opening in embankment.**

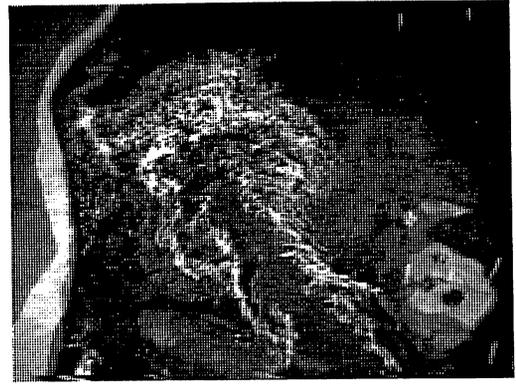
**Fig. 37: Surface flow patterns without embankment structure.**

**Fig. 38: Surface flow patterns with embankment structure.**

**Fig. 39: Surface flow patterns with new opening in embankment structure.**

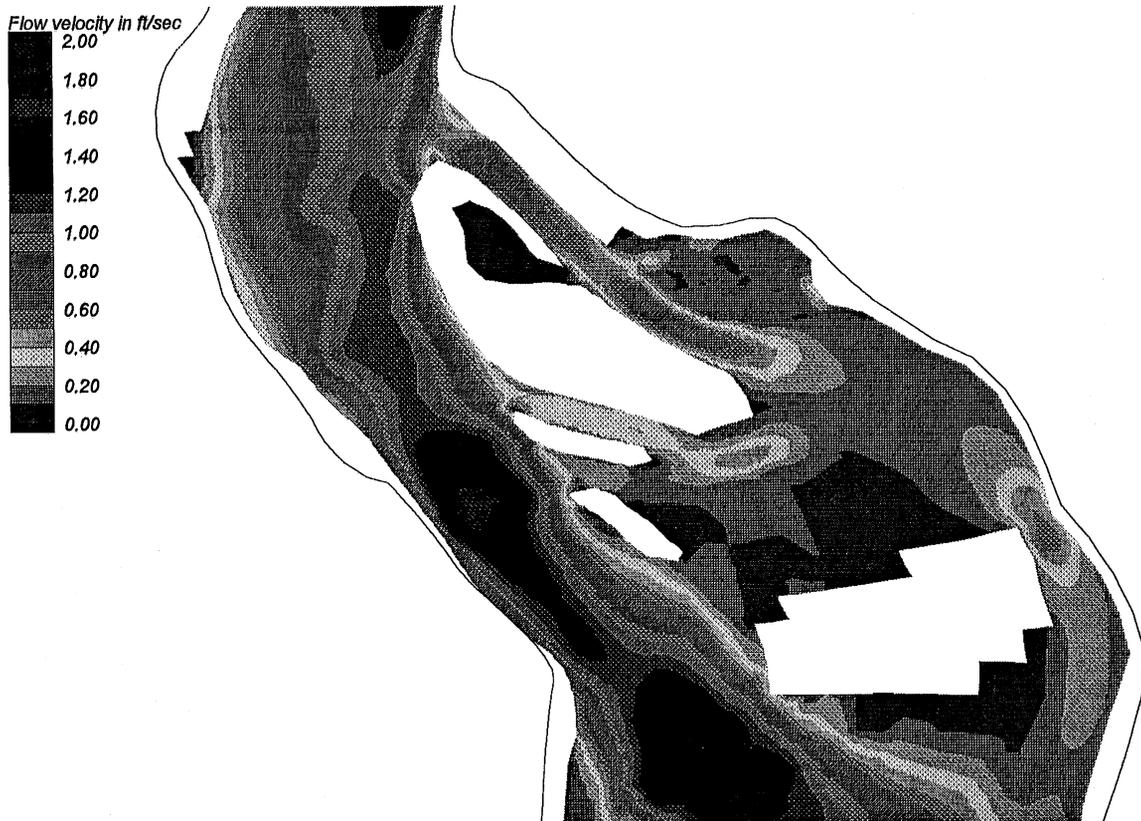
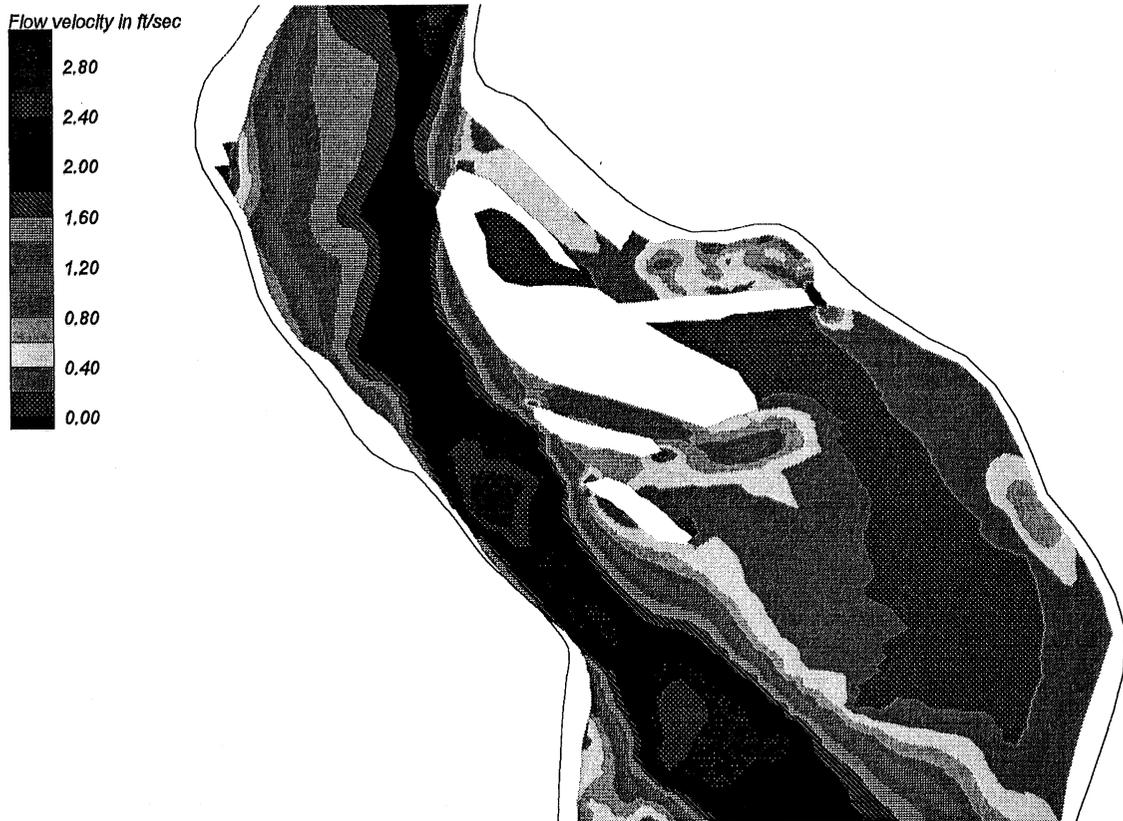
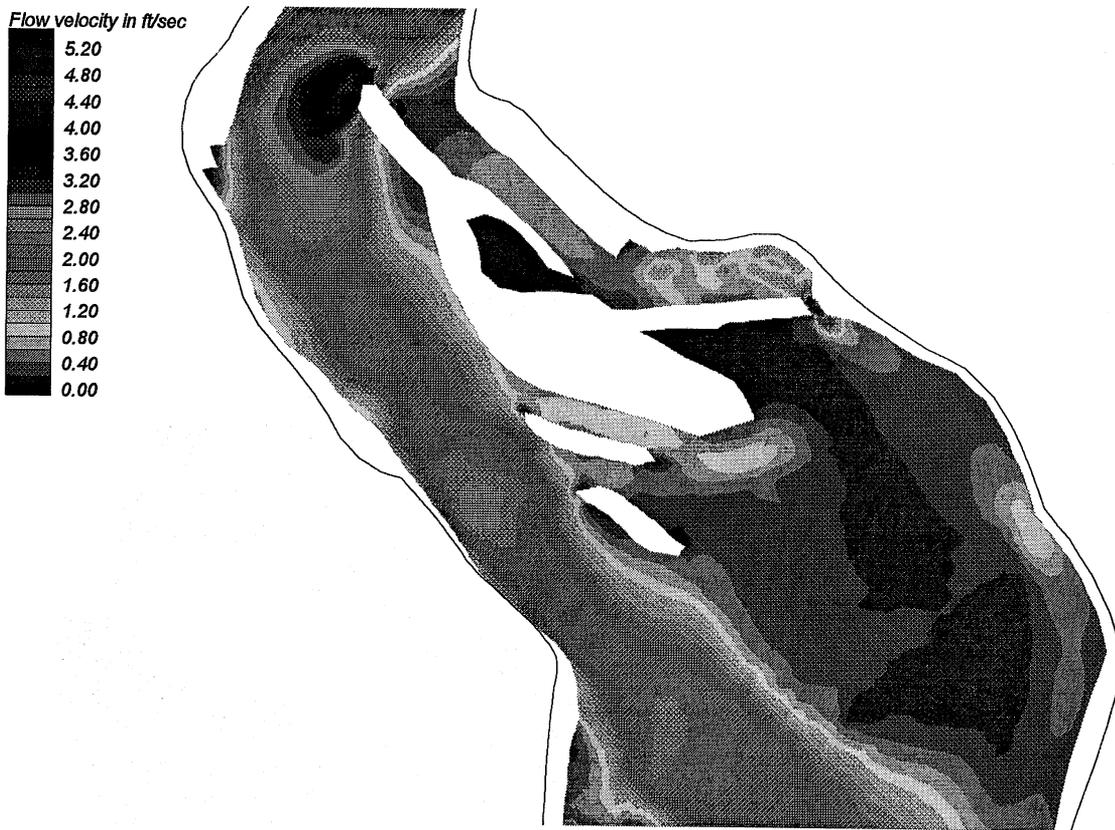
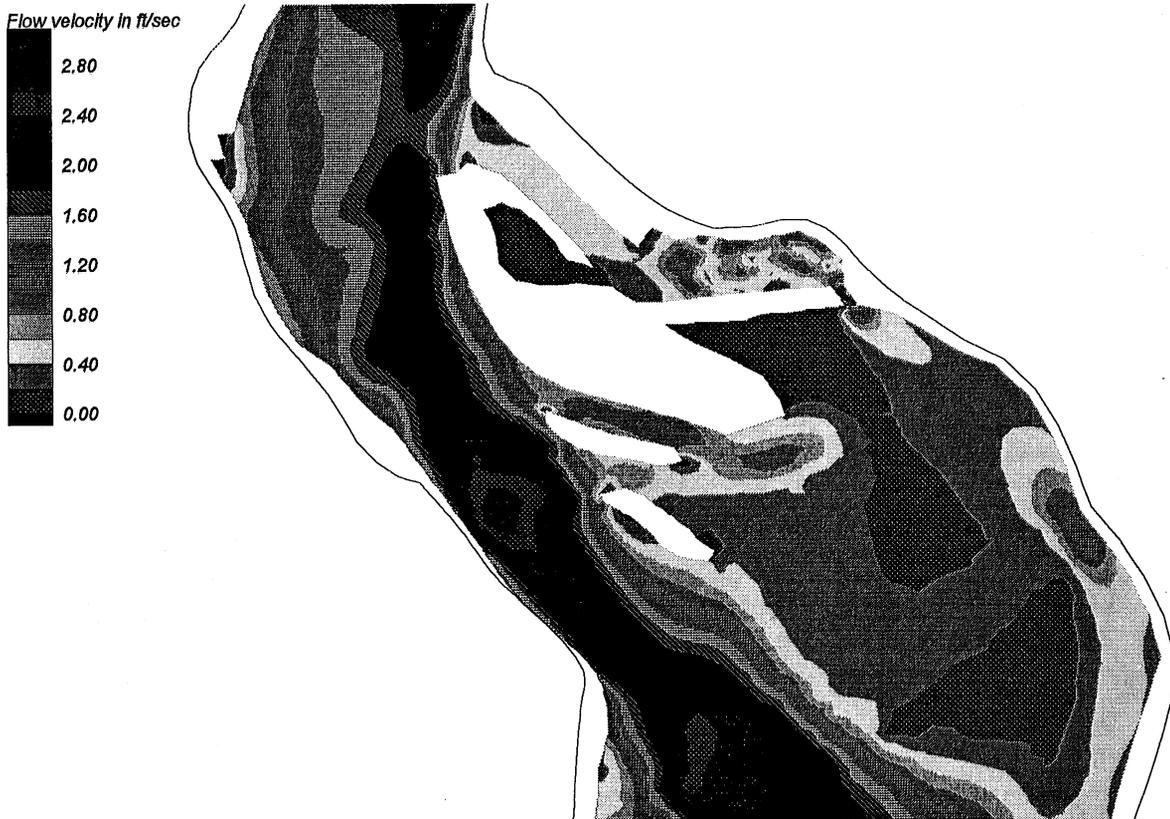
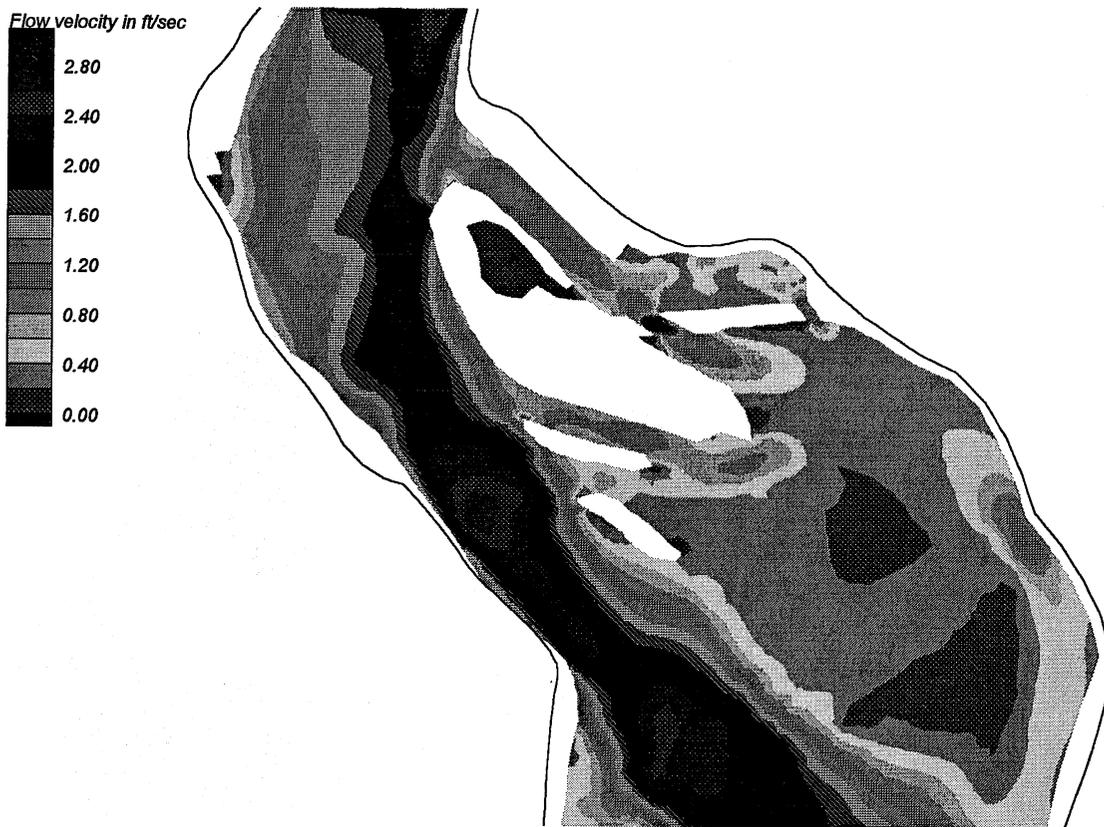
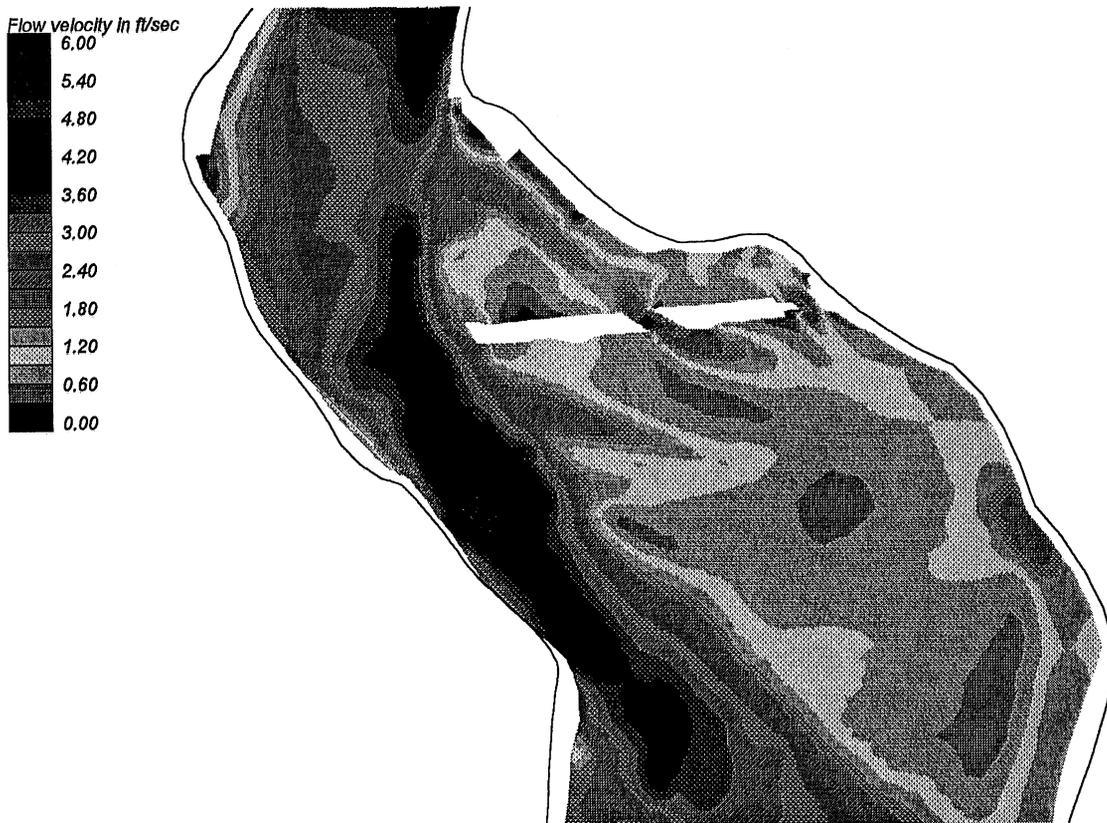
**Figure 41** Velocity contours for a flow of 5285 cfs without the embankment.

**Figure 42** Velocity contours for a flow of 10,200 cfs without the embankment.

**Figure 43** Velocity contours for a flow of 25,850 cfs without the embankment.

**Figure 44** Velocity contours for a flow of 5285 cfs with the embankment.

**Figure 45** Velocity contours for a flow of 10,200 cfs with the embankment.

**Figure 46** Velocity contours for a flow of 25,850 cfs with the embankment.

**Figure 47** Velocity contours for a flow of 5285 cfs with the spurdike option.

**Figure 48** Velocity contours for a flow of 10,200 cfs with the spurdike option.

**Figure 49** Velocity contours for a flow of 25,850 cfs with the spurdike option.

**Figure 50** Velocity contours for a flow of 5285 cfs with 5 ft of dredging in the east channel.

**Figure 51** Velocity contours for a flow of 10,200 cfs with 5 ft of dredging in the east channel.

**Figure 52** Velocity contours for a flow of 25,850 cfs with 5 ft of dredging in the east channel.

**Figure 53** Velocity contours for a flow of 5285 cfs with the new opening option.

**Figure 54** Velocity contours for a flow of 10,200 cfs with the new opening option.

**Figure 55** Velocity contours for a flow of 25,850 cfs with the new opening option.

useful in examining the results of different mitigative options and comparing them to the existing conditions in the reservoir. Numerous examples of these plots can be seen in Figures 41 through 55.

Figures 41 through 55 show velocity contour plots generated by the numerical model for each of the mitigative options. The region focused on in the plots is outlined in Figure 40. It is similar to the region focused on in the physical model photographs. In general, the trends exhibited in the plots are also similar to the trends seen in the physical model. The presence of the embankment causes a significant decrease in the velocities compared to the case with no embankment. This effect can be seen in Figures 41 through 46. The eastern portion of the reservoir immediately downstream of the embankment is largely “low velocity” water. The only significant velocities in the region are in the channel that follows the eastern bank of the river.
