Project Report No. 415

**Physical and Numerical Model Study  
of the Little Falls Reservoir,  
Mississippi River at Little Falls, Minnesota**

Tracy Winjum, Richard L. Voigt, Jr., and Gary Parker

March 1998  
**Minneapolis, Minnesota**

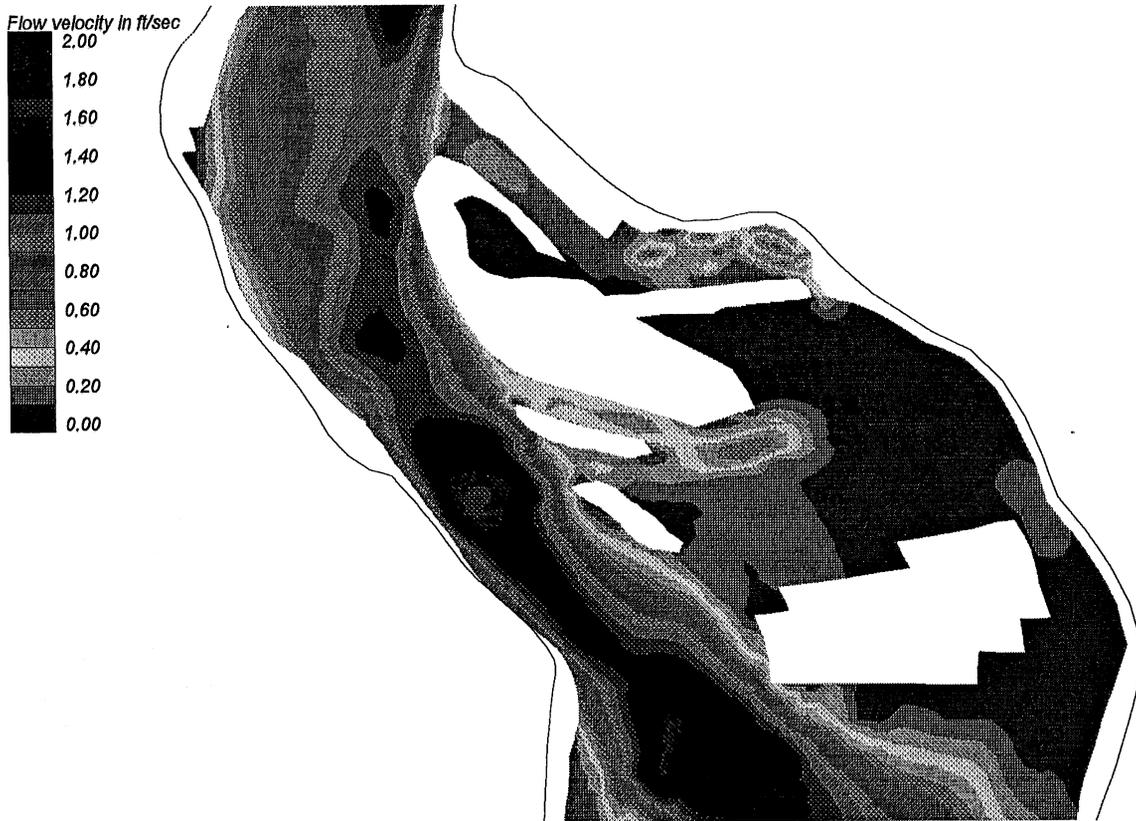
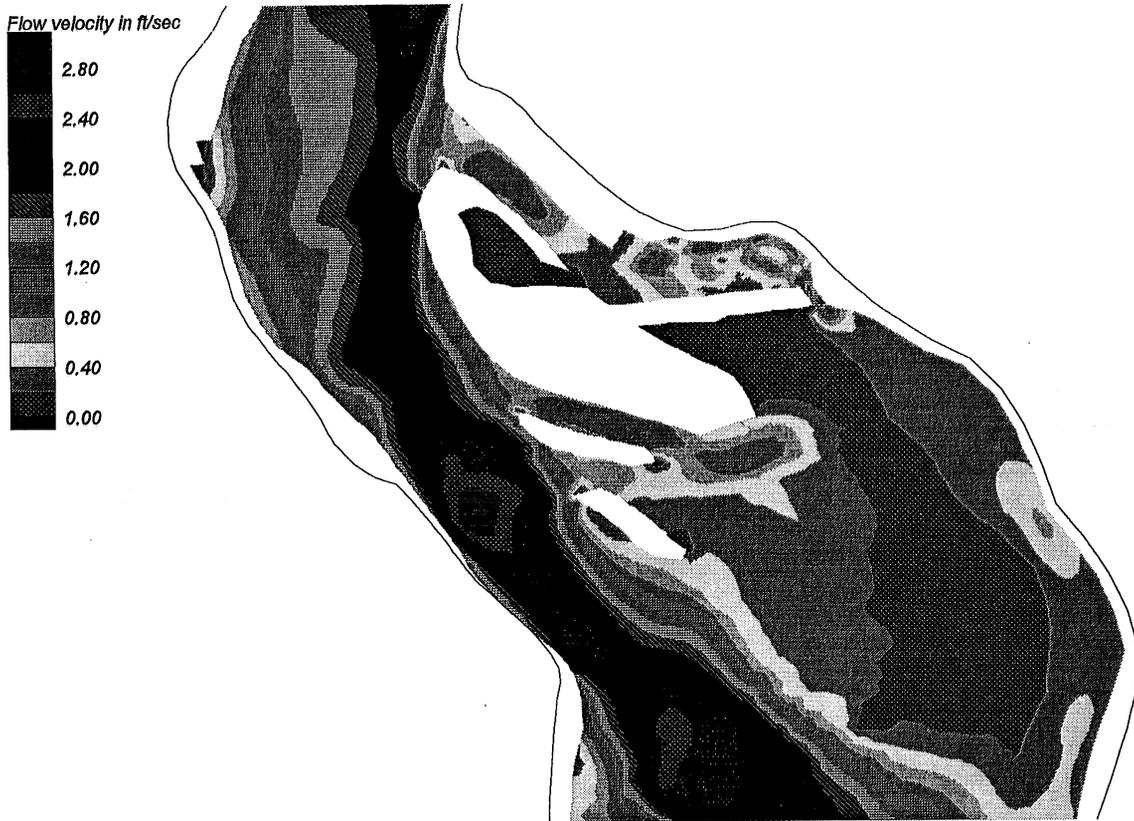
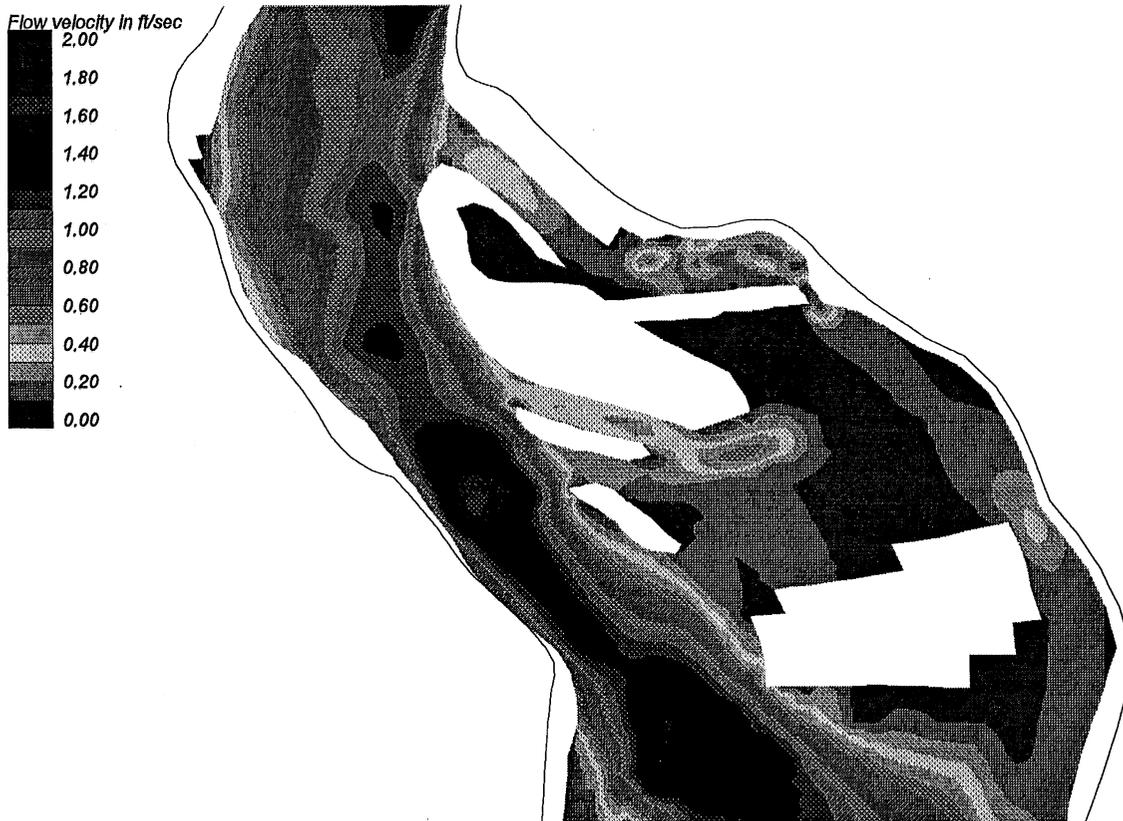
**Figure 59** Velocity contours for a flow of 5285 cfs with additional dredging scenario #1.

**Figure 60** Velocity contours for a flow of 10,200 cfs with additional dredging scenario #1.

**Figure 61** Velocity contours for a flow of 25,850 cfs with additional dredging scenario #1.

**Figure 62** Velocity contours for a flow of 5285 cfs with additional dredging scenario #2.

**Figure 63** Velocity contours for a flow of 10,200 cfs with additional dredging scenario #2.

**Figure 64** Velocity contours for a flow of 25,850 cfs with additional dredging scenario #2.

**Figure 65** Velocity contours for a flow of 5285 cfs with additional dredging scenario #3.

**Figure 66** Velocity contours for a flow of 10,200 cfs with additional dredging scenario #3.

**Figure 67** Velocity contours for a flow of 25,850 cfs with additional dredging scenario #3.

The velocity contour plots for the additional dredging scenarios can be seen in Figures 59 through 67. The differences in predicted velocities between the scenarios is relatively minor. All of the scenarios show a zone of higher velocity flow along the east shoreline with a zone of very low velocity water downstream of the closed channel. Although minor, the velocity plots do show a slight difference along the east shoreline between scenarios. Dredging of only the region along the east shore downstream of the small bridge opening causes the velocities seen in Figures 59 through 61. Dredging of the downstream two-thirds of the east channel and along the east bank downstream of the small bridge shows a slight increase in velocities along the east shoreline as seen in Figures 62 through 64. Dredging of only the downstream two-thirds of the east channel also shows a slight increase in velocity in the channel along the east bank, seen in Figures 65 through 67. The velocity contours for the original dredging scenario, which involved the dredging of five feet of material throughout the entire east channel, are shown in Figures 50 through 52. This scenario caused the highest velocities to occur along the east bank. That is expected since the additional dredging scenarios were examined for dredging depths of approximately four feet compared to five feet in the original. Also, in the original scenario the dredging extended throughout the entire east channel, allowing more water to be drawn into the region at the upstream end.
