UNIVERSITY OF MINNESOTA
ST. ANTHONY FALLS LABORATORY
Engineering, Environmental and Geophysical Fluid Dynamics

Project Report no. 464

**Scoping Study for the Development of Design
Guidelines for Bioengineering in the Upper Midwest**

Prepared for
The Minnesota Department of Transportation
Project No. 81655

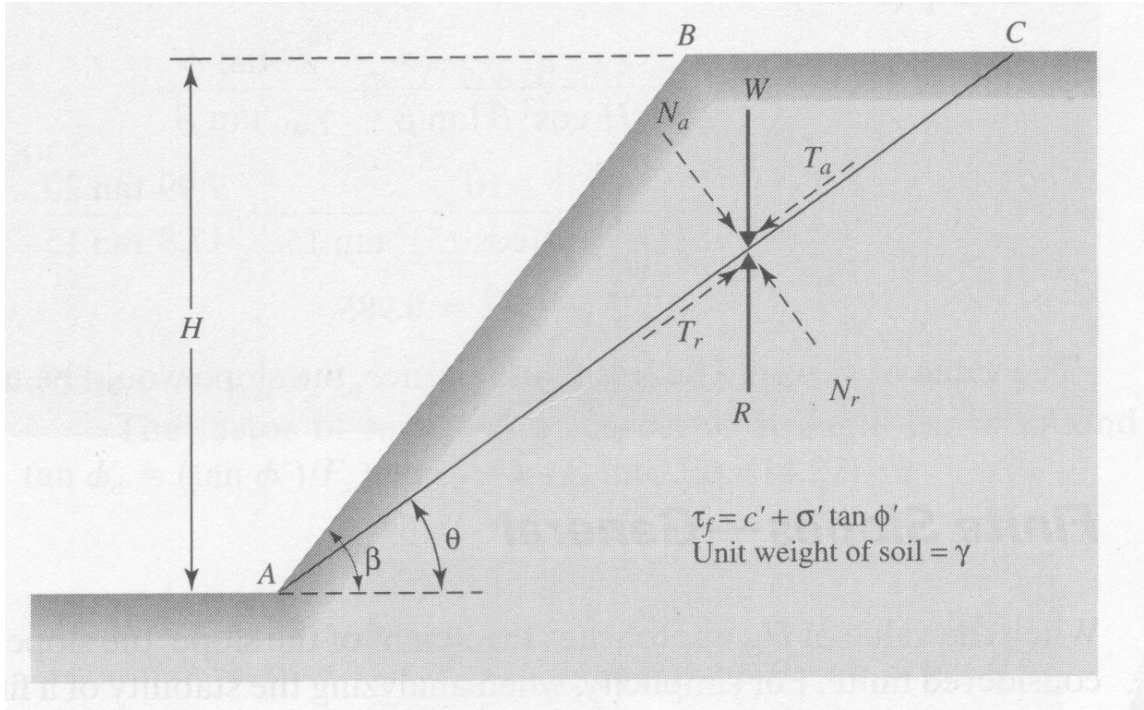
Figure 2.1 Translational failures (from Das, 2002).

There are two main types of failure by mass movement: translational failure and rotational failure (34, 35, 36, 37). Translational slope failures are shallow slides in which the failure plane is roughly parallel to the surface of the ground. Characteristics of translational slope failures include: ground surface, groundwater level, and sliding surface (Figures 2.1 and 2.2). In mathematical analyses of translational slope failures, slip surface assumed to be parallel to ground surface, and the depth to length ratio of the sliding mass is relatively small (13). Furthermore, the types of slopes most susceptible to translational slope failure are as follows:

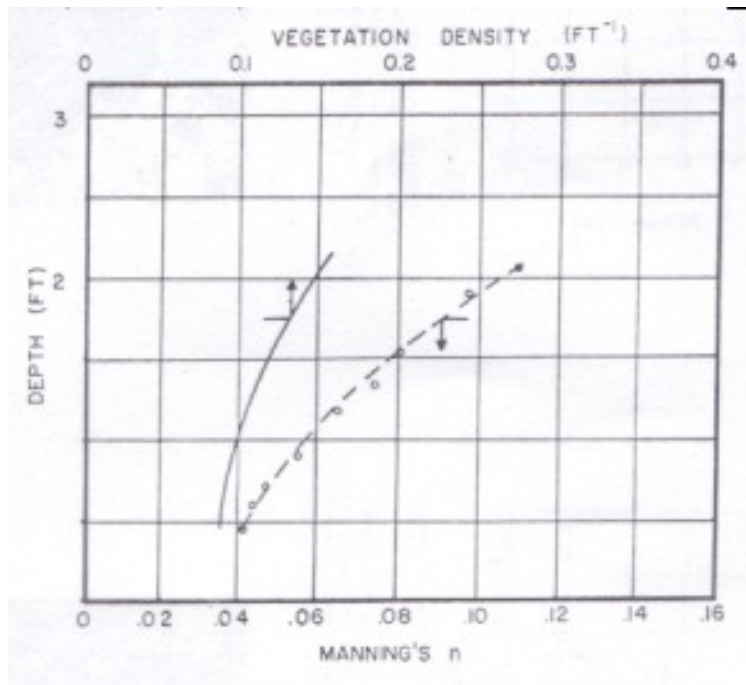
Figure 3.1 The relationships between flow depth, vegetation density (solid line), and Manning's n (dotted line) (from Petryk and Bosmajian, 1975).

Some open-channel flow publications provide general estimates for Manning's n roughness coefficient (19), but they tend to use subjective categories, such as "scattered brush, heavy weeds" or "dense willows." Several researchers have attempted to use more thorough approaches to adjust Manning's n to account for drag. Dudley et al. (1998) compared methods for measuring vegetation density and Fischenich and Dudley (2000) used that information to develop methods to determine drag coefficients that uses the frontal area of the plants (projection of the plant over a plane perpendicular to the flow direction) and the Reynolds number (44, 48). They also acknowledged that the practice of estimating vegetation area, density and their effects on flow is generally new and still being developed, and as more researchers use different methods, the estimates of vegetation density and drag coefficients will become more accurate. Nonetheless, Fischenich (2000) followed this study by providing methods and equations to estimate the Manning's n roughness coefficient based on the drag coefficient and vegetation density, assuming that they are measured accurately (42). These efforts built on the work done by Petryk and Bosmajian (1975), who were able to determine relationships between unit vegetation density (ft^{-1}), flow depth (ft) and Manning's n (49). Typical results (Figure 3.1) show that as vegetation density increases (solid line), Manning's n increases (dotted line).

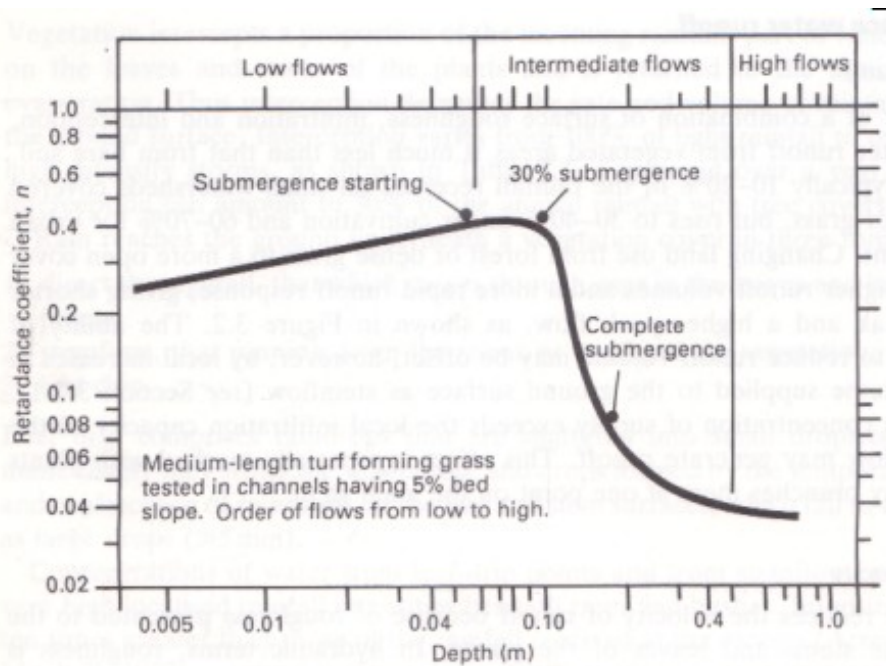
Figure 3.2 Relationships between flow depth and the retardance coefficient (Manning's n) as vegetation is submerged (from Coppin and Richards, 1990).

Riparian vegetation will bend as flow increases, and as it bends, total roughness decreases (43). The amount it bends depends upon the type and age of the vegetation and the flow velocity. It is a difficult task to accurately estimate the channel roughness when vegetation starts bending as flow increases (50). Figure 3.2 shows the relationship between flow depth and Manning's n for flexible vegetation. As the plants become completely submerged, they bend and the effective roughness coefficient decreases.

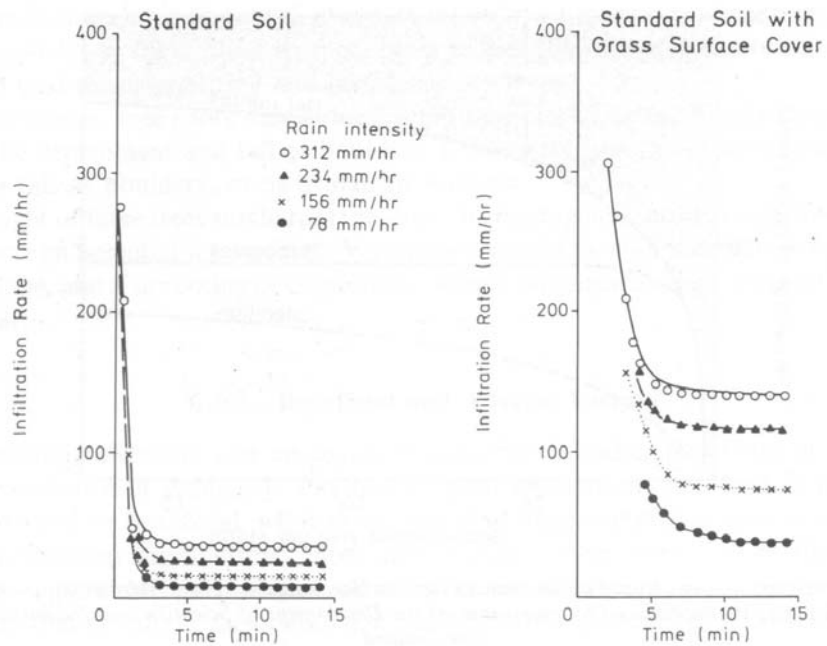
Figure 3.4 Comparison of infiltration rates in vegetated and non-vegetated slopes (from Greenway, 1987).

Sheet, rill or gully erosion occur when there is excess rainfall, which is a function of the infiltration capacity and moisture content of the soil. During a storm event, the vegetation cover not only postpones the onset of runoff due to interception and canopy storage, but it also increases the infiltration rate due to the presence of organic matter, root growth, decaying roots, and earthworms. Vegetation litter may decrease the infiltration rate, but the net effect often results in a greater infiltration rate and reduced runoff (3, 18). Figure 3.4 shows a comparison between infiltration rates of soil with and without vegetation.

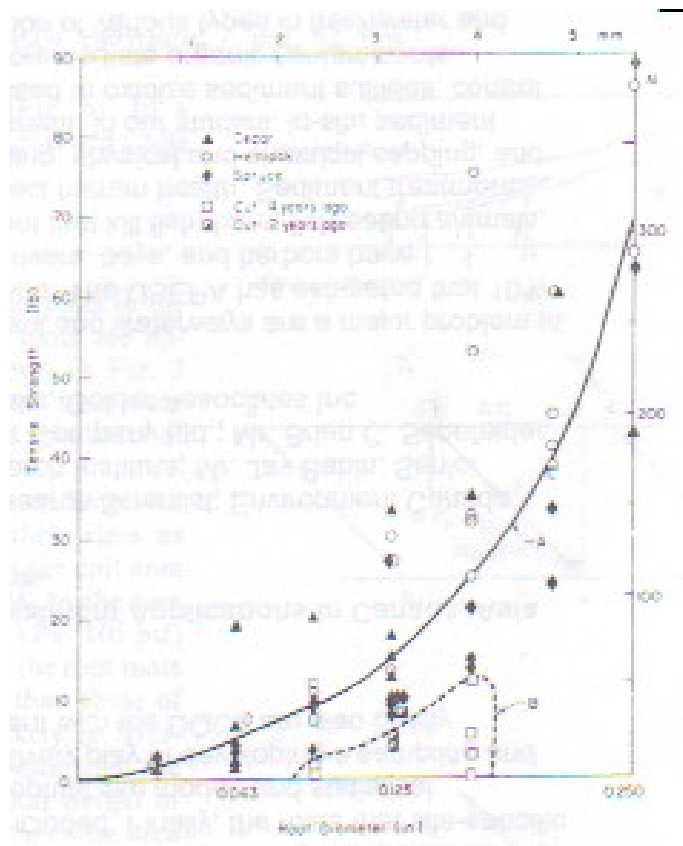
Figure 3.6 The relationship between root diameter and failure load (from Wu et al., 1979).

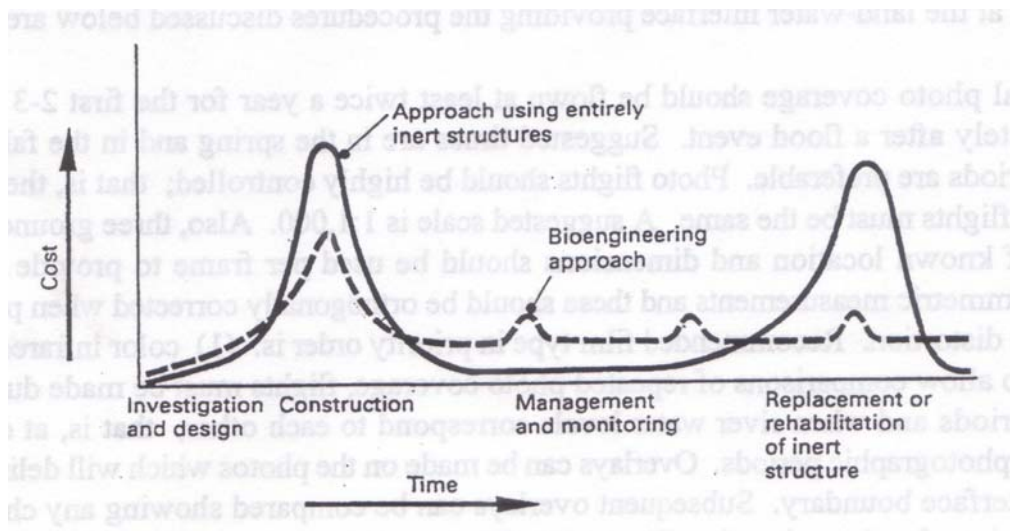
Figure 3.11 Comparison of cost profiles and maintenance of hard armoring and soft armoring techniques (from Coppin and Richards, 1990).

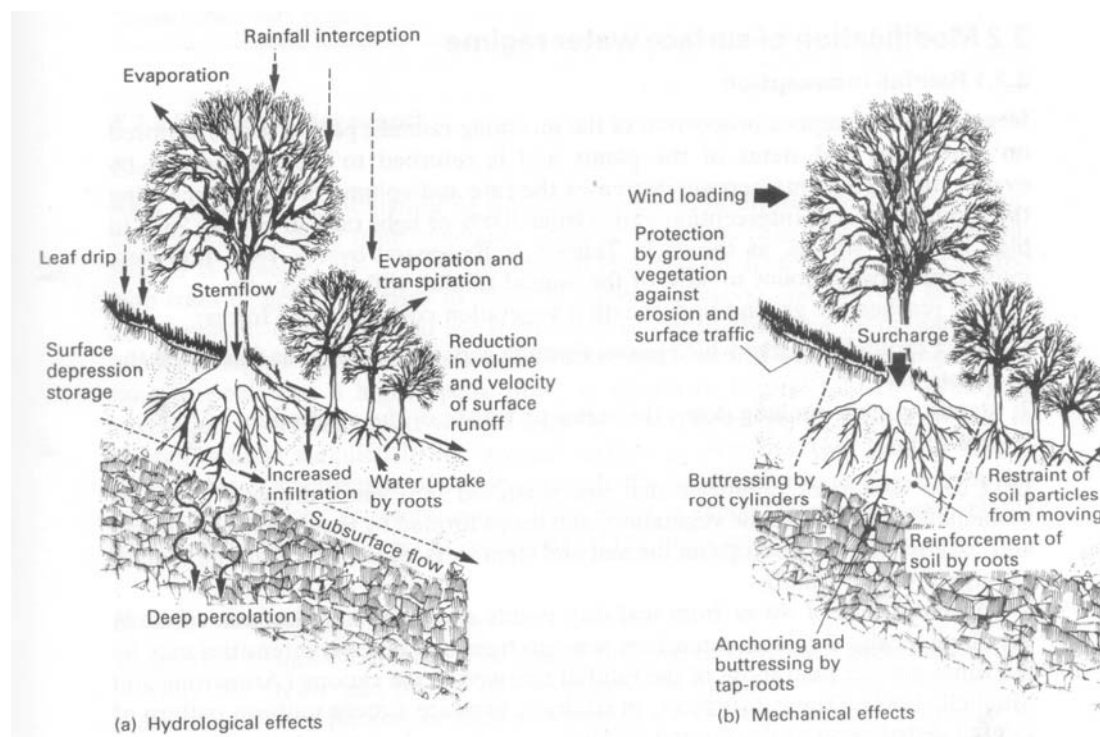
Figure 3.12 Hydrological and mechanical effects of vegetation on slopes (from Coppin and Richards, 1990).

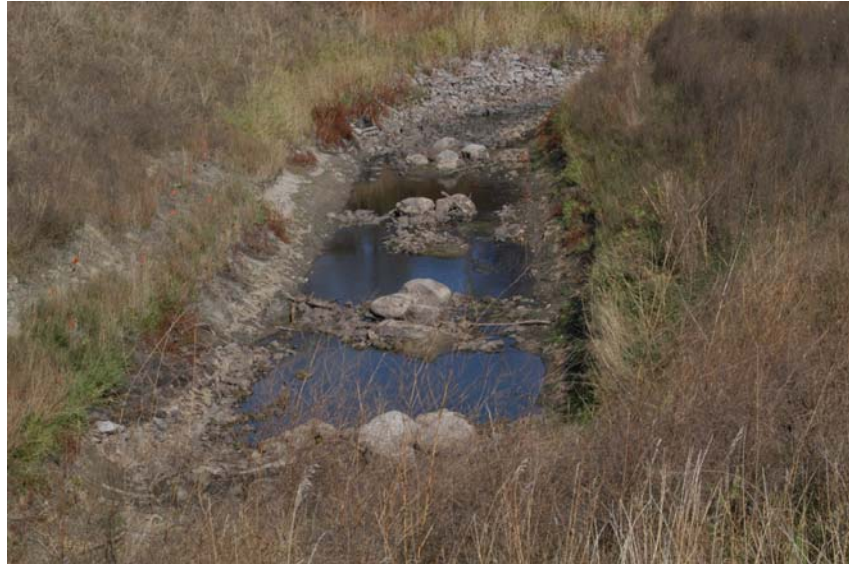
Figure 6.1 The reach initially downstream of the culvert under TH-12. Erosion on the banks can be noted, along in-stream structures that were placed in the stream.

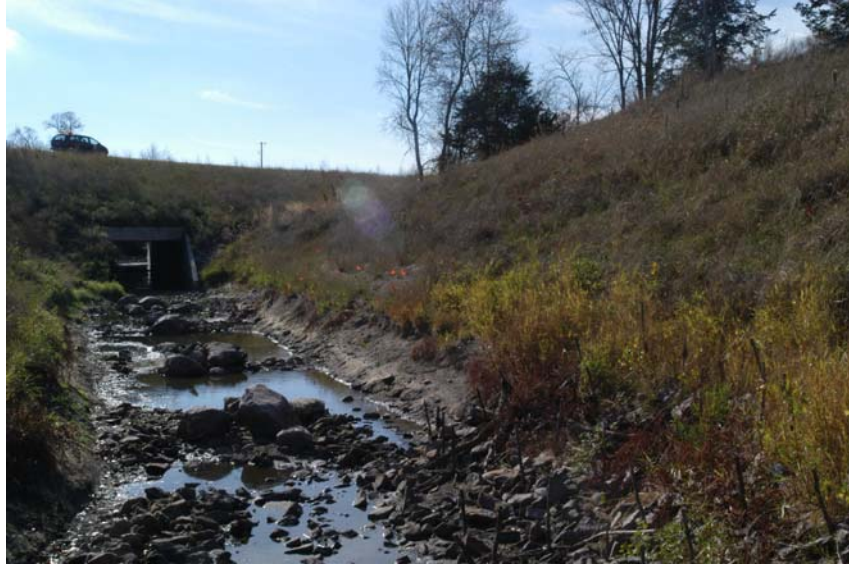
Figure 6.2 Same reach of the stream, but looking back at the culvert. The bank on the right side is showing signs of instability.

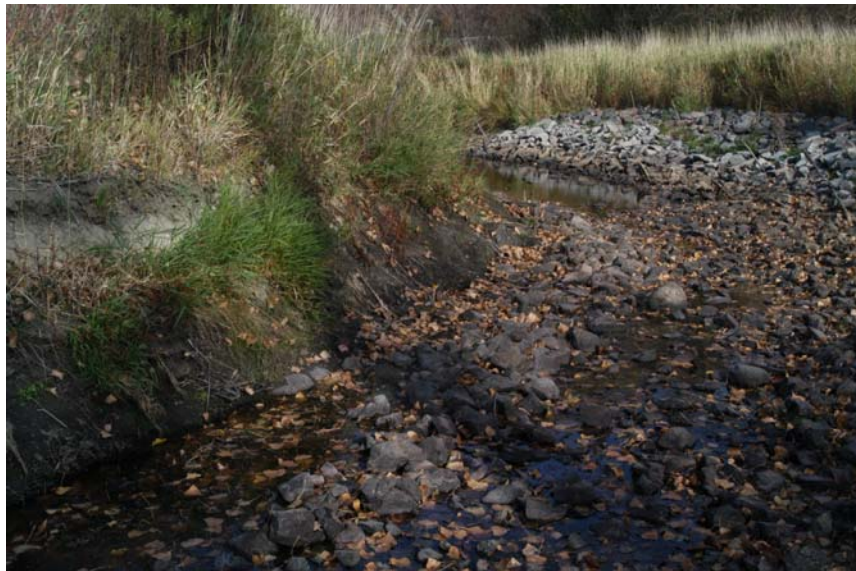
Figure 6.3 A bank where it can be seen that the riprap is no longer on the bank. Either the bank has eroded from behind the riprap or the rocks were carried downstream from the upstream bend where riprap was placed.

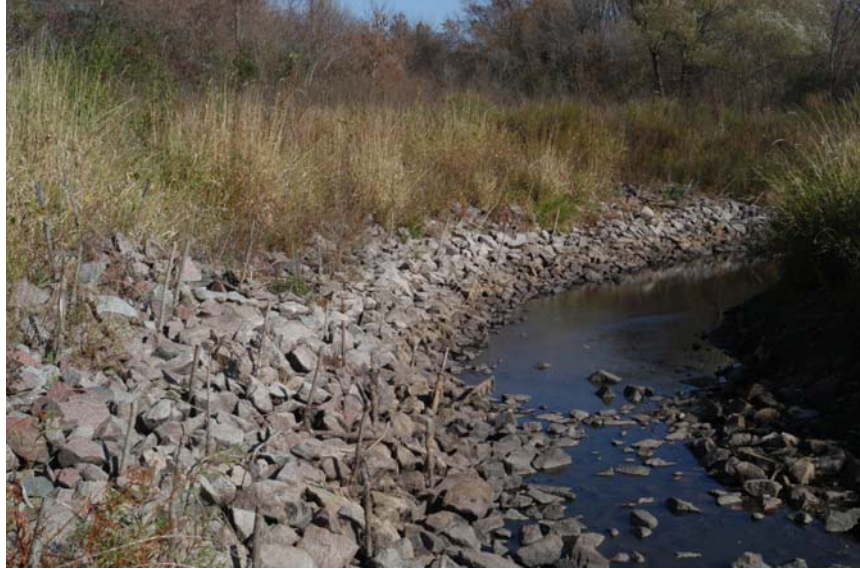
Figure 6.4 Dead willow posts in the riprap.

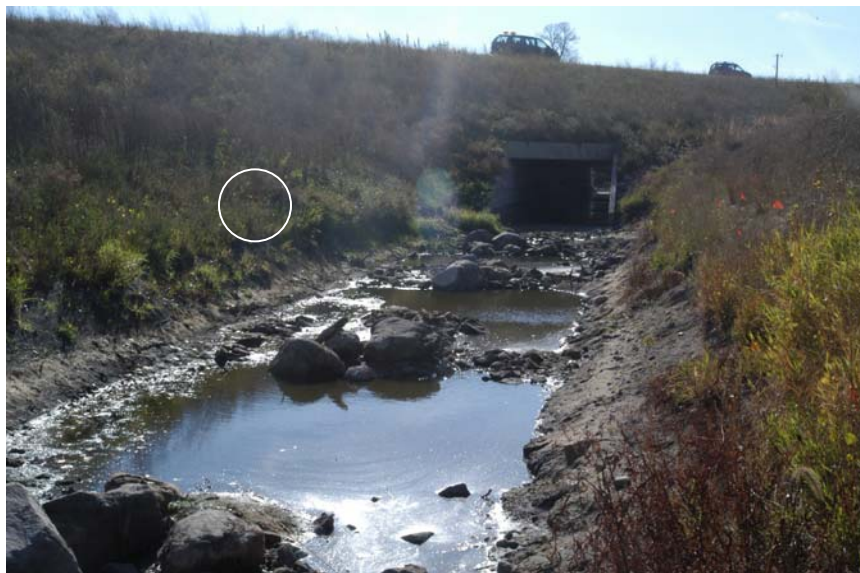
Figure 6.5 Another photo looking upstream. The white circle points out the area where there is a localized slumping of the bank. Runoff from the highway surface is directed into that area.

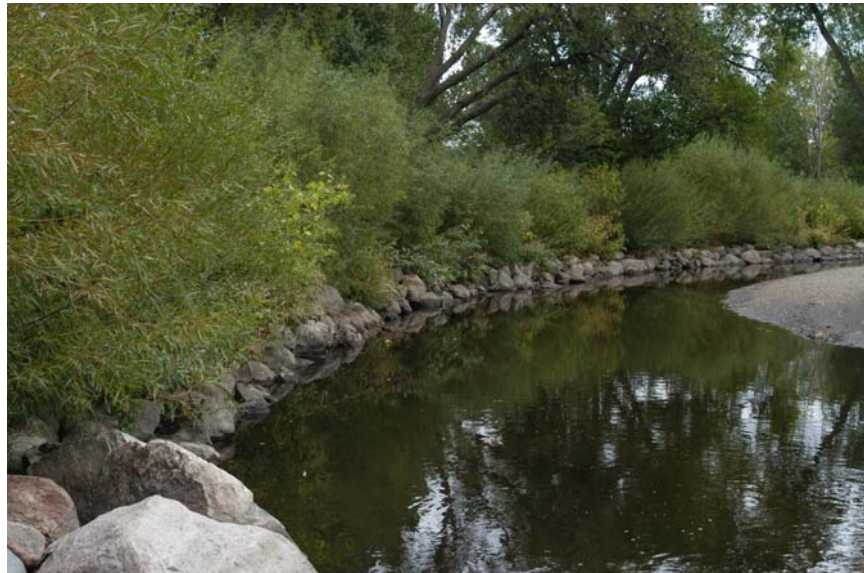
Figure 6.6 MHC site at 18th Ave. S. Boulder cover below, willows on top of bank.

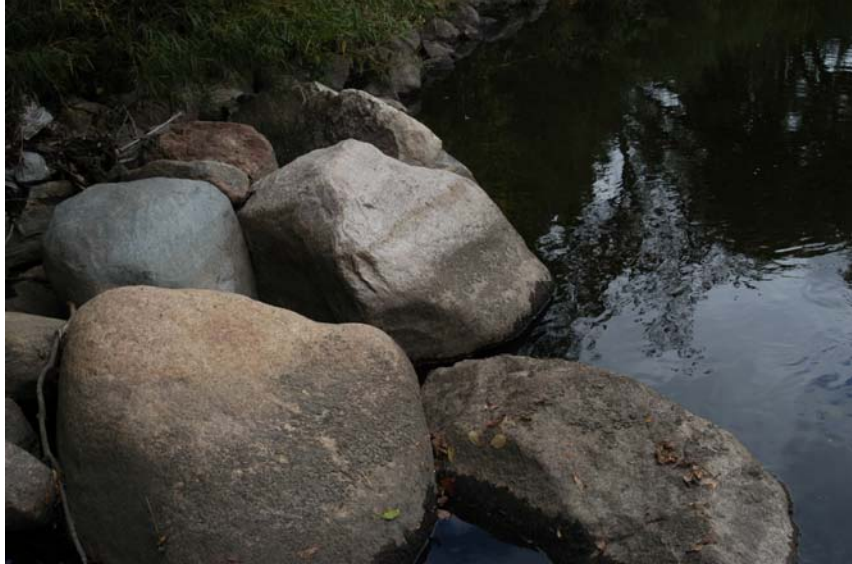
Figure 6.7 Rock vane and eddies in the water.

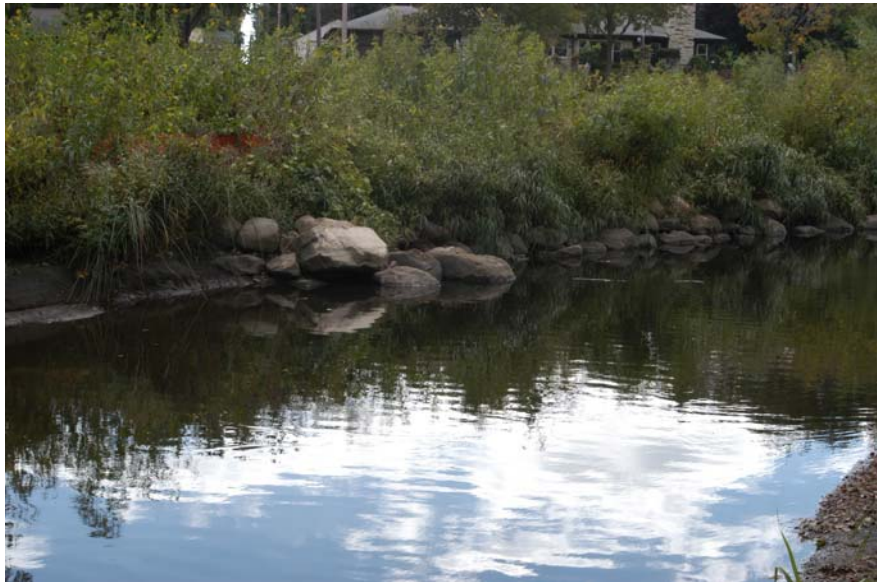
Figure 6.8 Rock vane, boulder toe, and willows.

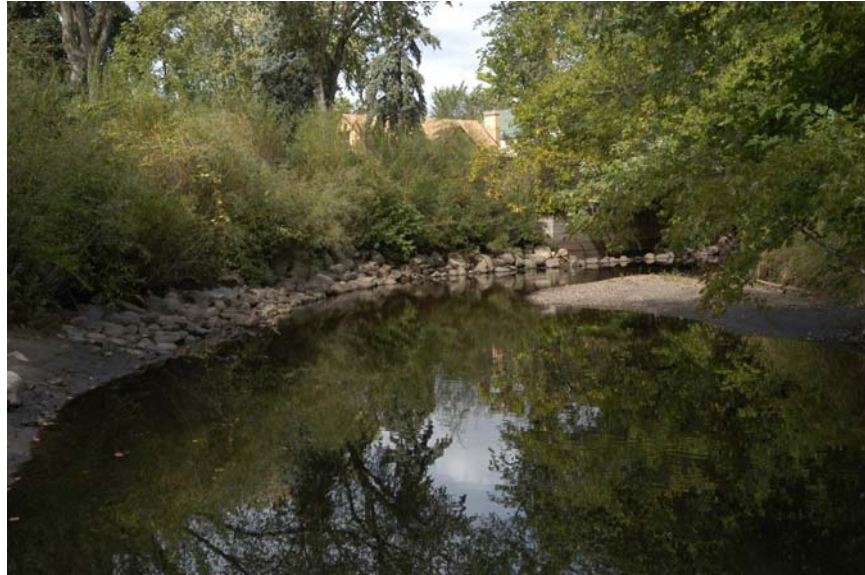
Figure 6.9 Boulder toe and vegetated geogrids at a site slightly upstream of the 18th Ave. S. site.

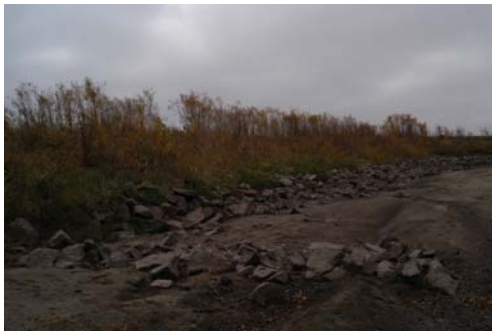
Figure 6.30 Looking upstream. Fascines are in the foreground and brush mattresses are in the background.

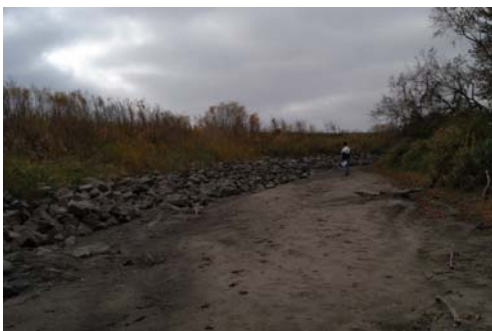
Figure 6.34 Entire channel. Note rocks from riprap in center of channel.

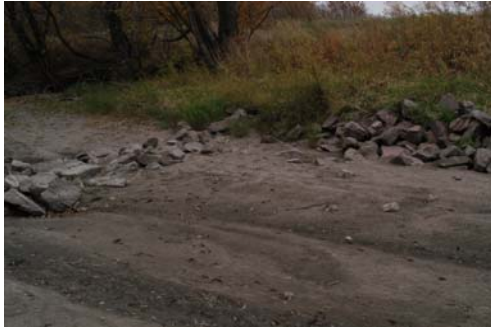
Figure 6.36 Sedimentation behind stream barb.

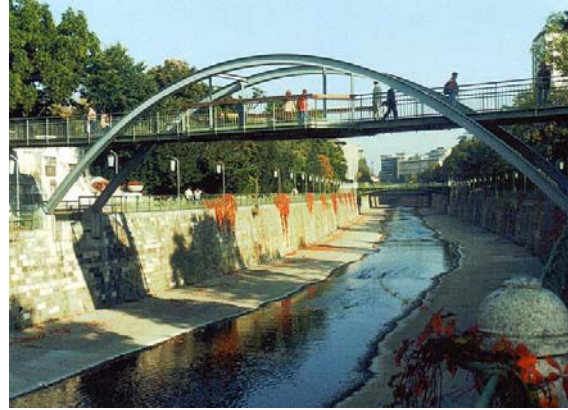
Figure 8.1 Existing and the future design of the Wien River cross section.

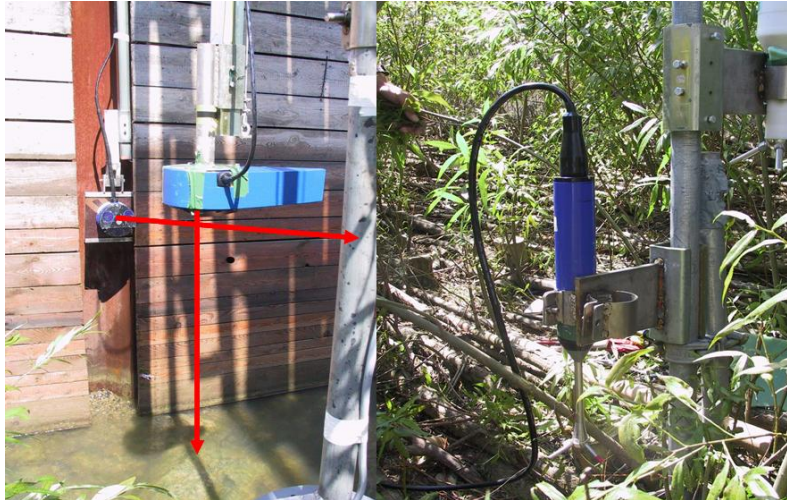
Figure 8.8 Measuring devices: acoustic Doppler profiler (left), acoustic Doppler velocimeter (right).

The research focused on the hydraulic impact of vegetation in successive growth stages. An ADV (Acoustic Doppler Velocimeter) and an ADP (Acoustic Doppler Profilers) were used to acquire local and cross-sectional velocity data (Figure 8.8). Velocity distributions were acquired at a fixed cross-section. Discharge was only measured using the water level in the retention reservoir and the opening of the gate. In addition, water level was measured at five other cross-sections. Figure 8.9 shows the velocity distribution at the fixed cross-section and the influence of the vegetation on the flow conductance.

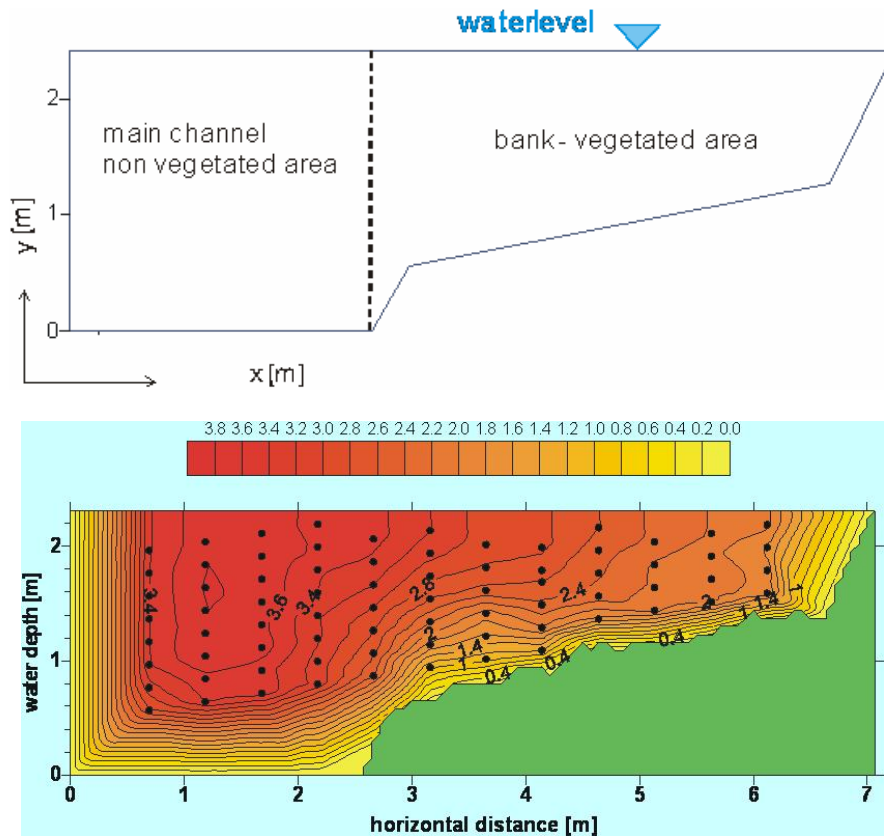
Figure 8.9 Velocity profile along the vegetated and non-vegetated area. Velocities are in m/s (1 m/s = 3.3 fps).

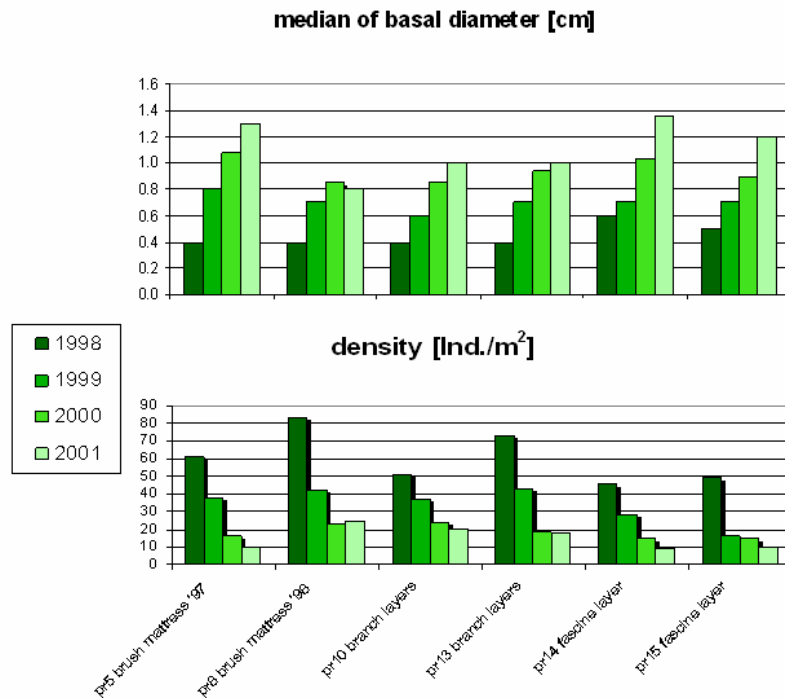
Figure 8.10 Variation in time of median basal diameter and vegetation density in different sections of the flume.

their diameters at a height of 3.3 ft (1 meter), the shoot length, and the shape of the crowns were collected once a year. Analysis of these data on an annual basis provided an overview of vegetation development (Figure 8.10). Typical growth patterns indicated how plants coped with the applied loads. The data in Figure 8.11 show how at a fixed discharge, mature plants increase the water level and decrease the velocity and subsequently the shear stress on the banks.

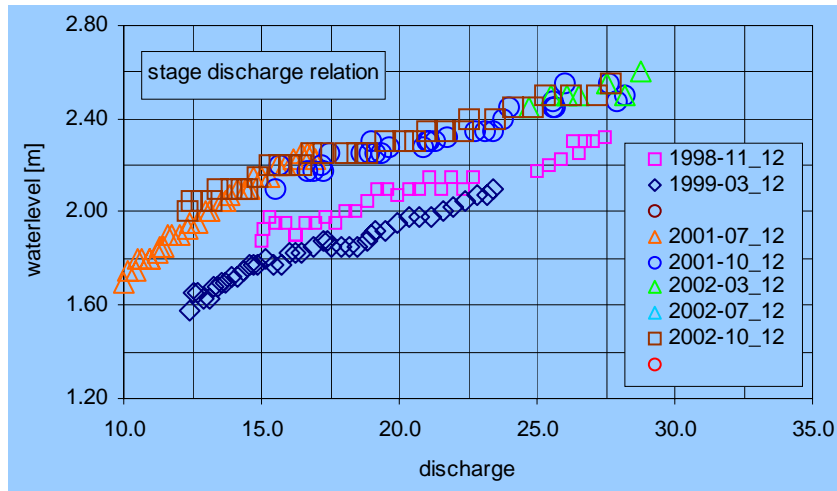
Figure 8.11 Relationship between water level and discharge observed during floods in 1999 and 2001. Velocities are in m/s (1 m/s = 3.3 fps).

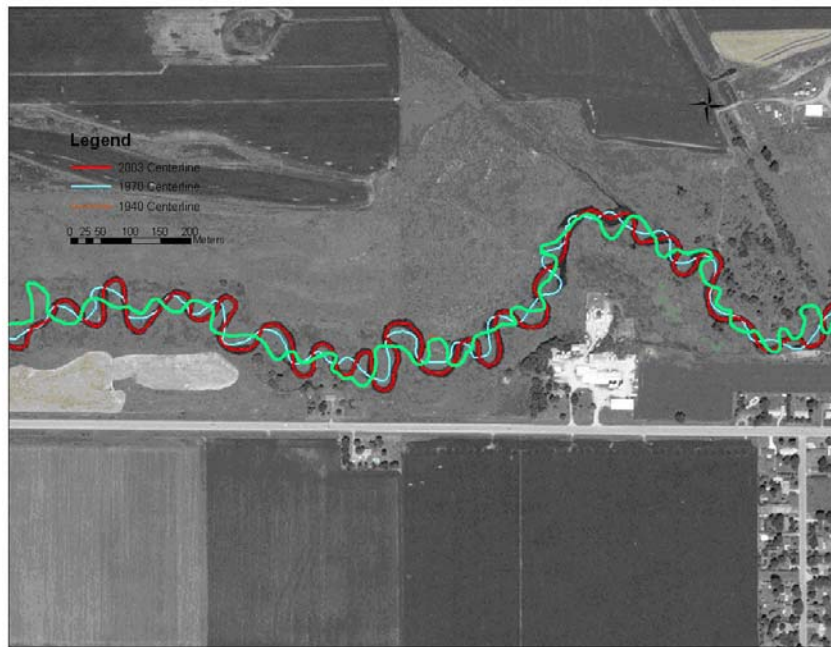
Figure 8.22 Vermillion River: Evolution of the center line.

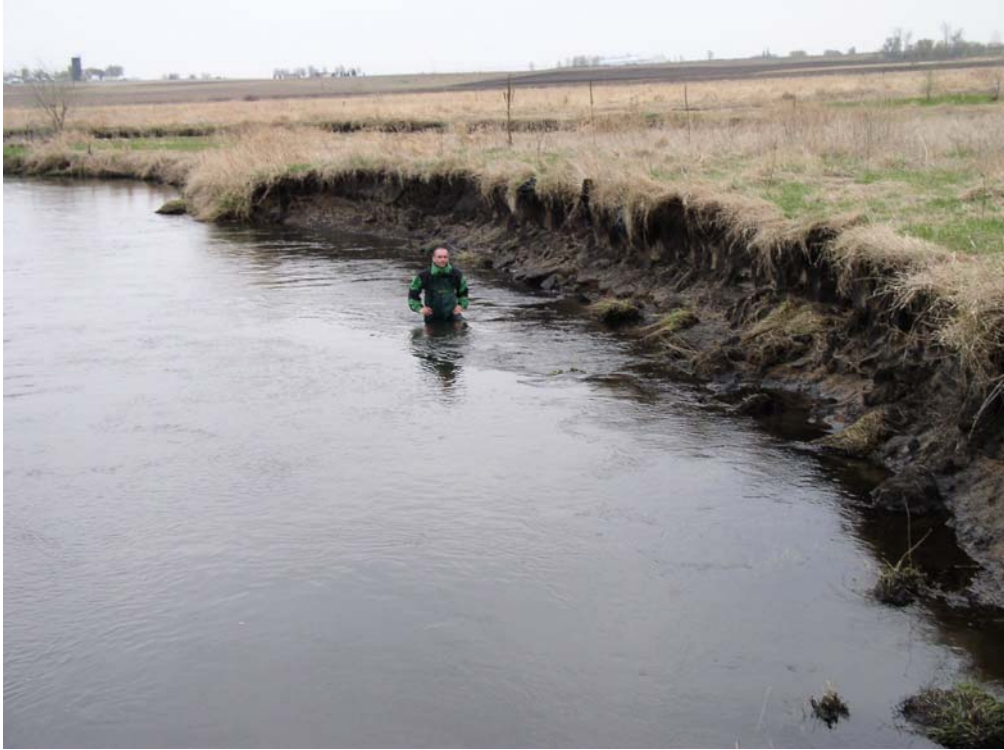
Figure 8.23 Bank erosion along a bend

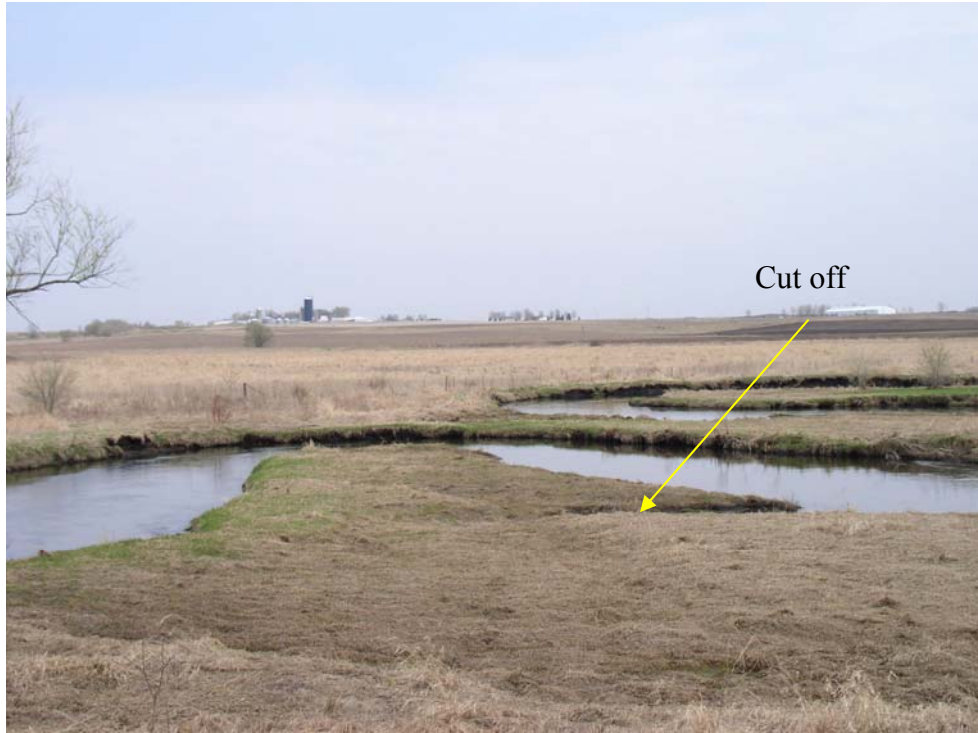
Figure 8.25 Erosion on the flood plane shows a cutoff.

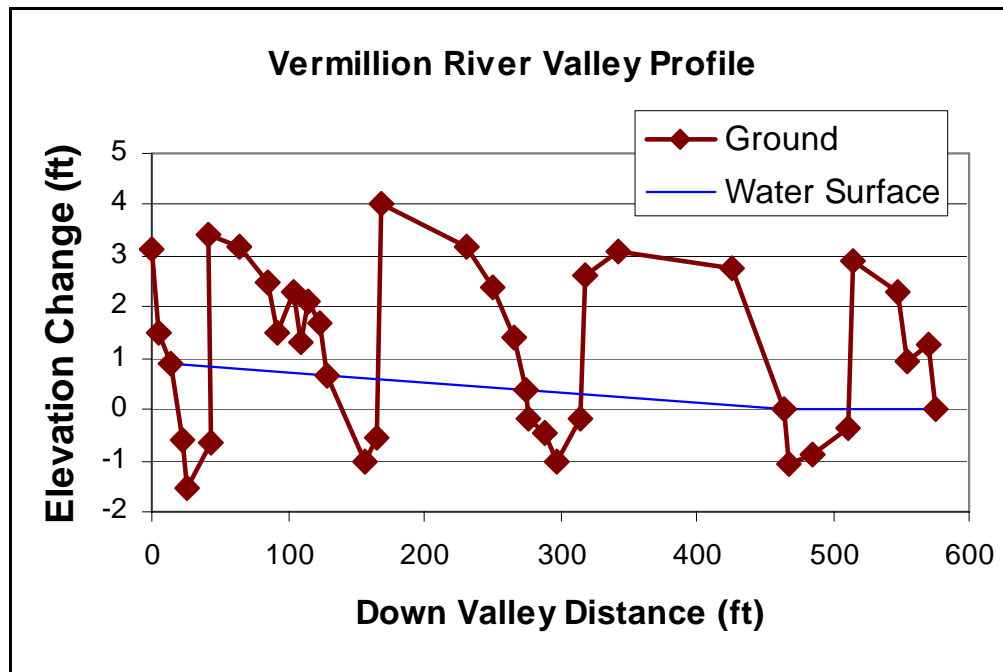
Figure 8.27 Ground and water level profiles along the surveyed section.

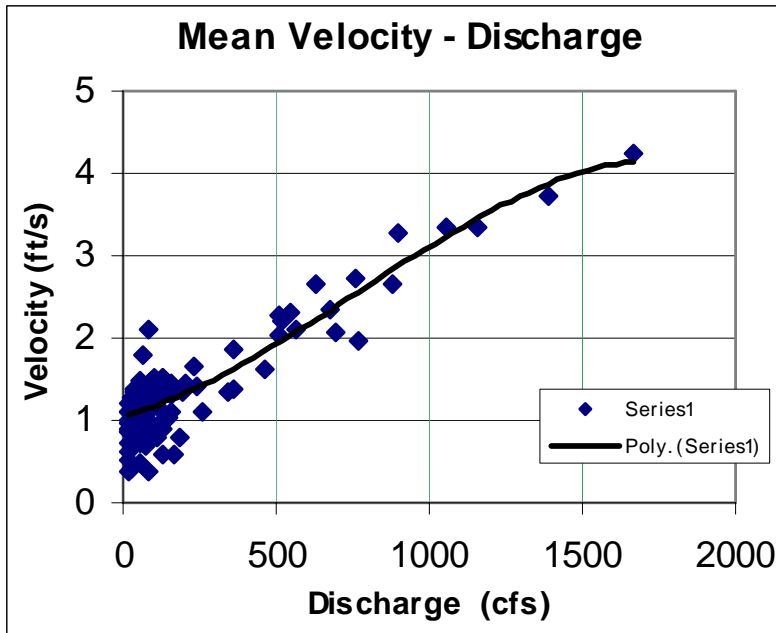
Figure 8.30 Flow and mean velocity relationship of the Vermillion River at the USGS gaging station no. 05345000 near Empire, about one mile upstream of the site.
