University of Minnesota  
ST. ANTHONY FALLS HYDRAULIC LABORATORY

Project Report No. 139

CERRON GRANDE PROJECT

January 1973  
Minneapolis, Minnesota

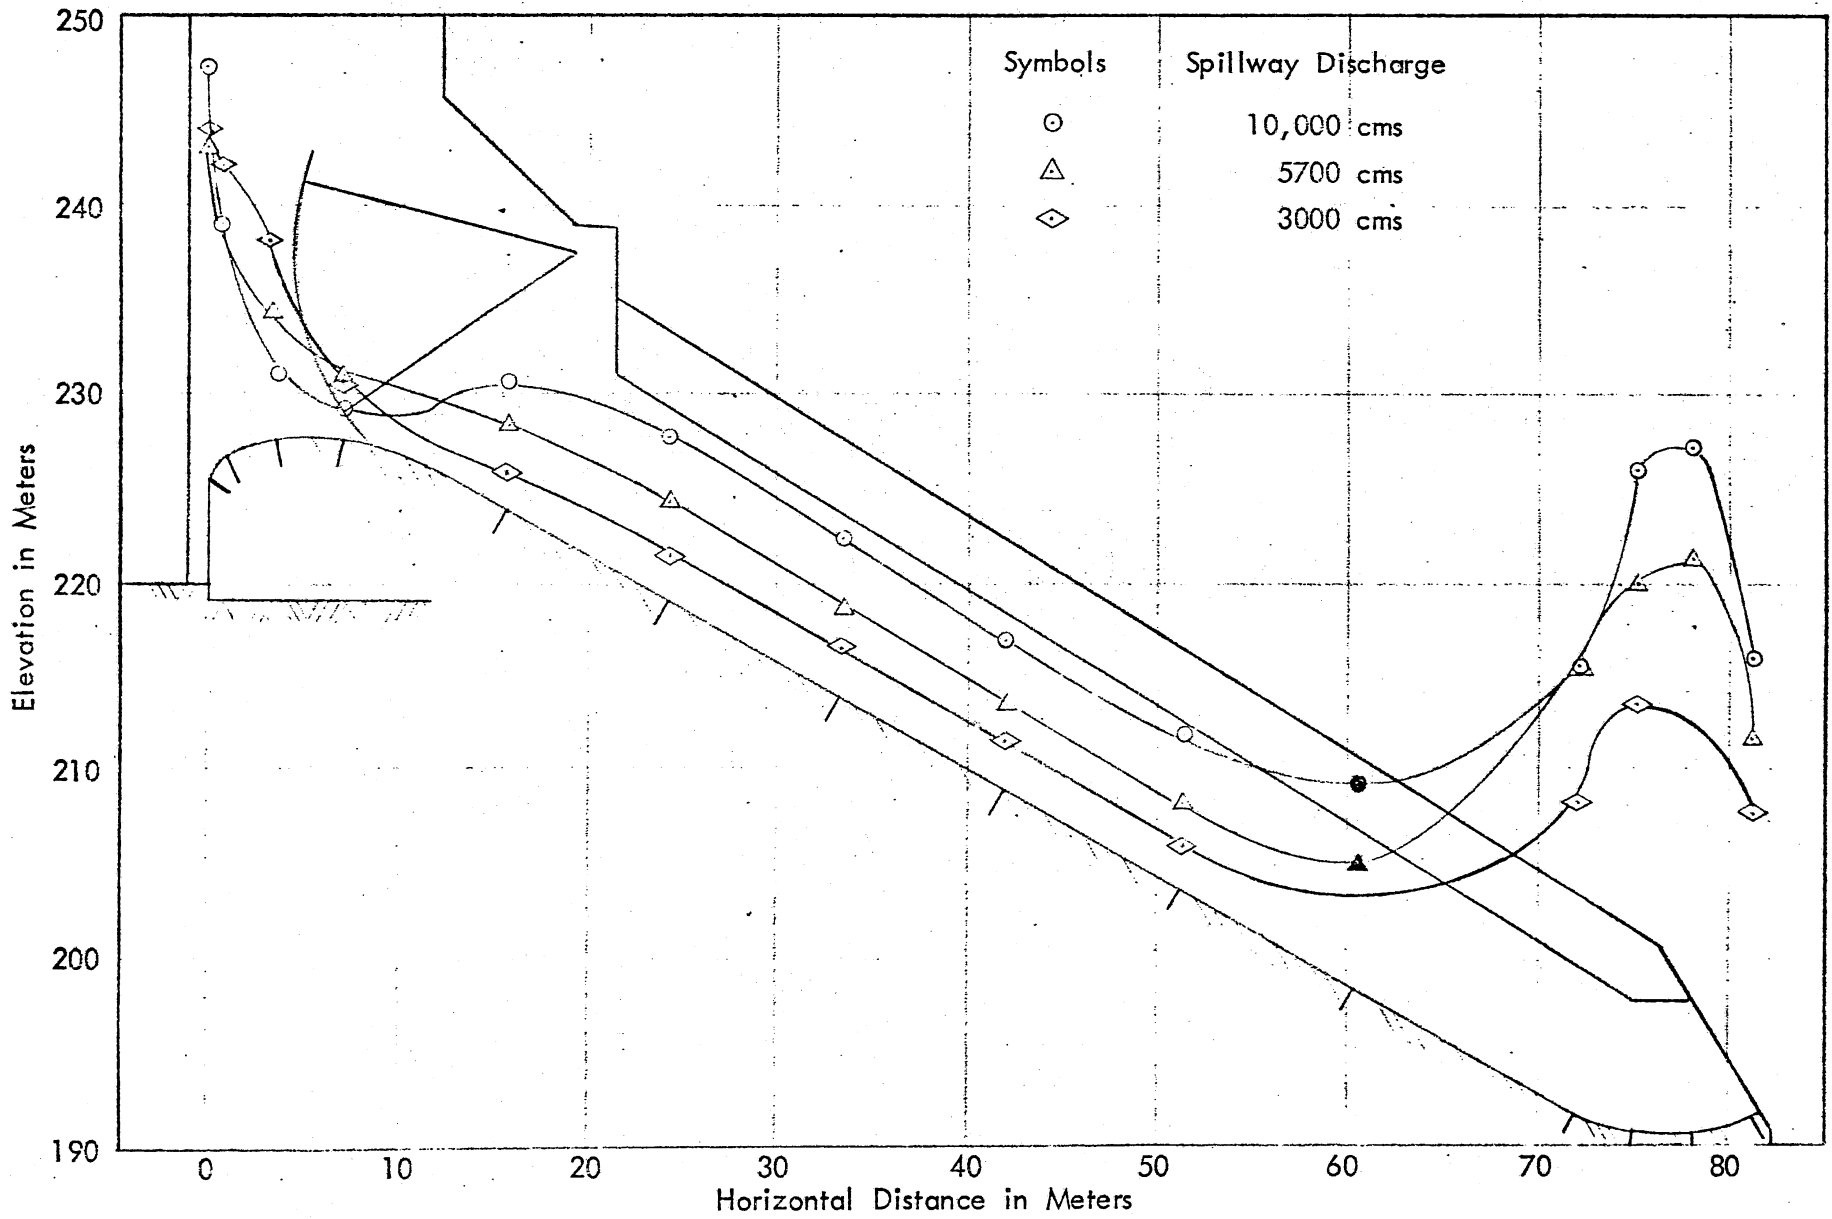
Fig. 15 - PRESSURE DISTRIBUTION ALONG CENTERLINE OF THE SPILLWAY SURFACE

The mean pressure distribution on the ogee and along the centerline of the spillway surface as measured with static pressure taps is plotted in Fig. 15. The pressure distribution on the walls and off the centerline of the spillway surface is shown in Fig. 16. No negative pressure was observed under any of the flow conditions tested. Pressure fluctuations were also measured at the two locations shown in Fig. 4 using pressure transducers which have good frequency response up to 300 Hz. Sample pressure records are shown in Fig. 17. These measurements indicated that a major portion of the fluctuation energy was in a relatively high frequency range in the neighborhood of 100 Hz. Moreover, the amplitude of the fluctuations appeared to be very small, approximately 10 per cent of the static pressure head.

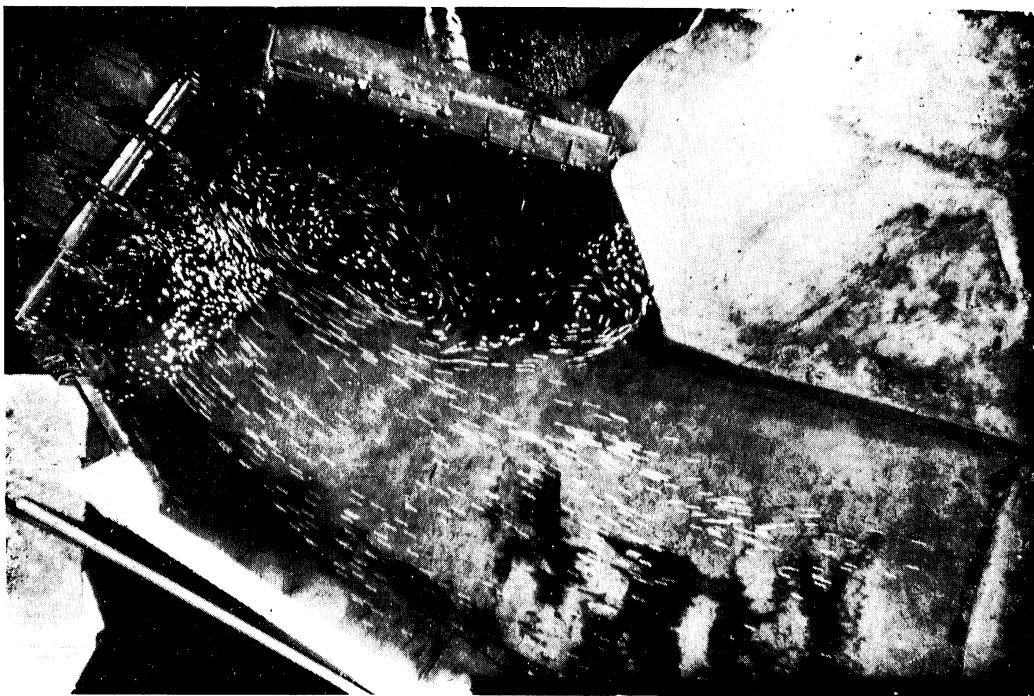
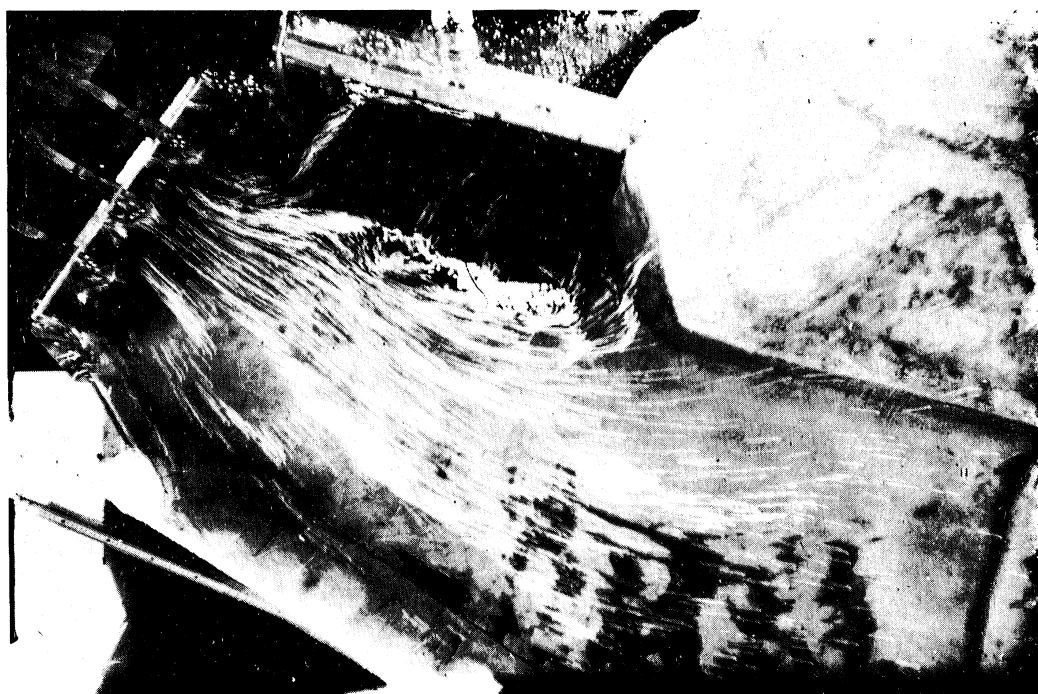
Photo 3 - Surface Flow Pattern in Approach Channel,  $Q = 1000$  cms

Photo 4 - Surface Flow Pattern in Approach Channel,  $Q = 3000$  cms

Photo 5 - Surface Flow Pattern in Approach Channel,  $Q = 5700$  cms

Photo 6 - Surface Flow Pattern in Approach Channel,  $Q = 10,000$  cms

The approach flow patterns were observed for various discharges and gate opening conditions. Photos 3 through 6 show the flow patterns on the water surface made visible by confetti traces. These photographs are arranged in a sequence of increasing discharges, all with uniform gate openings and a powerhouse intake flow of 270 cms. Clearly, in all cases flow separation occurred and eddies formed in front of the powerhouse intake due to the sharp corner in the approach channel. The intensity of the separation eddy increased as the discharge increased. These eddies appear to have been little affected by the powerhouse intake flow and to be strictly products of the flow separation at the sharp corner. No measurements were taken to determine the intensity of the vortex in the flow through the powerhouse intake structure. However, the vortex appears to be localized near the water surface and to have little influence on the flow through the intake structure.

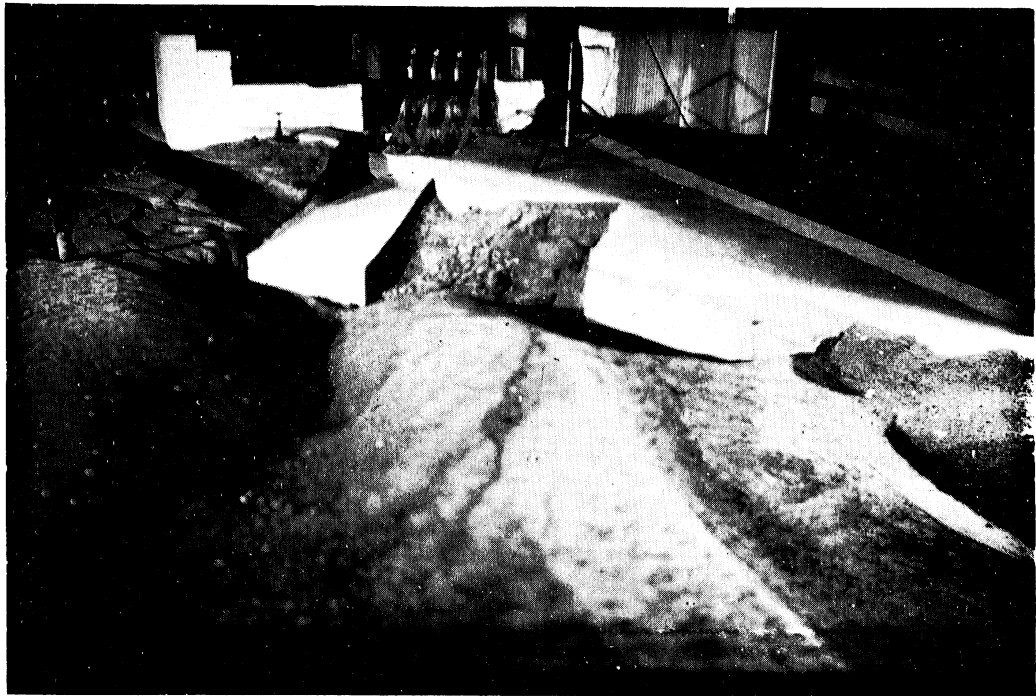
Photo 16 - Scouring Immediately Downstream of Concrete Exit Channel after 90 minutes of discharge at 5700 cms

As was mentioned before, the jet issuing from the concrete exit channel was so intensive that it scoured large quantities of sand and formed a deep trench; this can be seen in Photo 16. This photo, taken looking upstream, also shows severe scouring of the left embankment due to the high-intensity vortex. The velocity of this vortex near the embankment was measured as approximately 3 meters per second in prototype. This erosion of the left bank should be less severe in the prototype, since it is a fairly resistant rock similar to the exit channel. Some of the eroded sand was washed downstream, but much of it was carried upstream toward the powerhouse by the vortex to the right of the mainstream. This upstream movement of the sand took the form of a moving sandbar, as shown in Photo 17. This photograph was taken after 90 minutes of flow time at a discharge of 5700 cms. Although the movement of the sandbar was quite rapid during the first few minutes of flow, it had practically ceased to move upstream by the end of the 90 minute period. As can be noted from the photograph, the sandbar stopped moving short of the powerhouse. The erosion pattern after 90 minutes of flow is shown in Fig. 23 and the change after 90 more minutes of run time in Fig. 24. Very little change is noticeable between these two figures.
