Project Report No. 549

Performance Assessment of an Iron-Enhanced Sand Filtration Trench for Capturing Dissolved Phosphorus

Prepared for
City of Prior Lake
Prior Lake, MN

November 10, 2010
Minneapolis, Minnesota

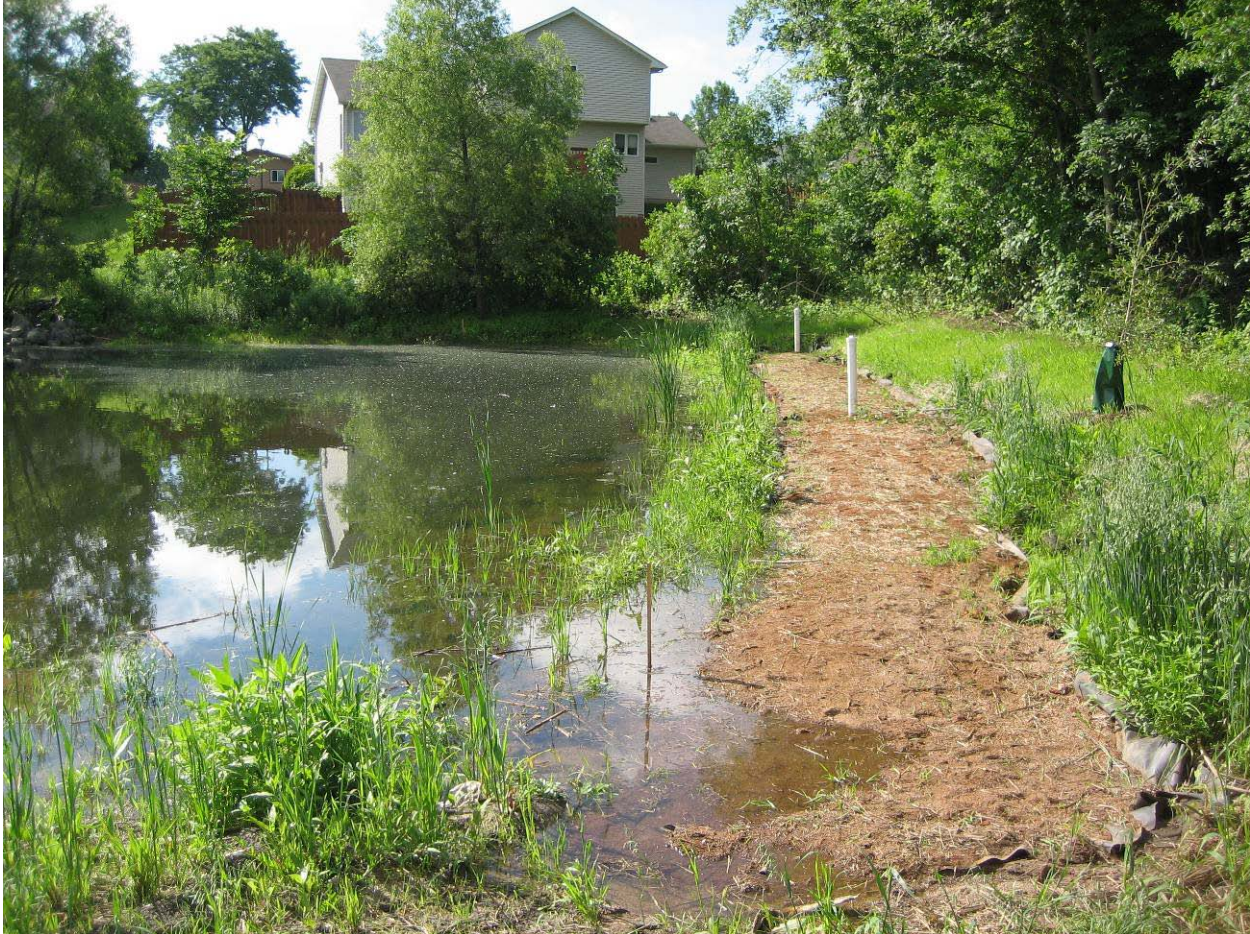
Figure 2: Pond 1 with iron enhanced filtration trenches in Prior Lake, MN

The Minnesota Filter Trenches were installed along the perimeter of two wet detention basins. The first basin, “Pond 1,” is located adjacent to County Road 42 (140th street NE) between Pike Lake Trail NE and Rolling Oaks Circle NE, on the south side of County Road 42, in Prior Lake, MN. Two trenches were installed along the western edge of Pond 1 (Figure 2), one with approximately 7.2% by weight iron filings (the elemental iron) and the other with approximately 10.7% by weight iron filings. The trenches are each approximately 40 feet (12 meters) long, 5 feet (1.5 meters) wide, and 2 feet (0.6 meters) deep. The drainage area for the wet detention basin is approximately 15 acres (6.2 ha) in size and composed of suburban residential land use. The wet detention basin can capture approximately 1.4 ft (0.4 m) of water depth or 0.21 ac-ft (1,300 m³) on top of the pond before overflow occurs. The cost to install the trenches on Pond 1 was approximately \$5,000. Additional costs to retrofit these trenches in other wet detention basins may also include additional pipe, connection to outlet structure, and outlet structure modification.

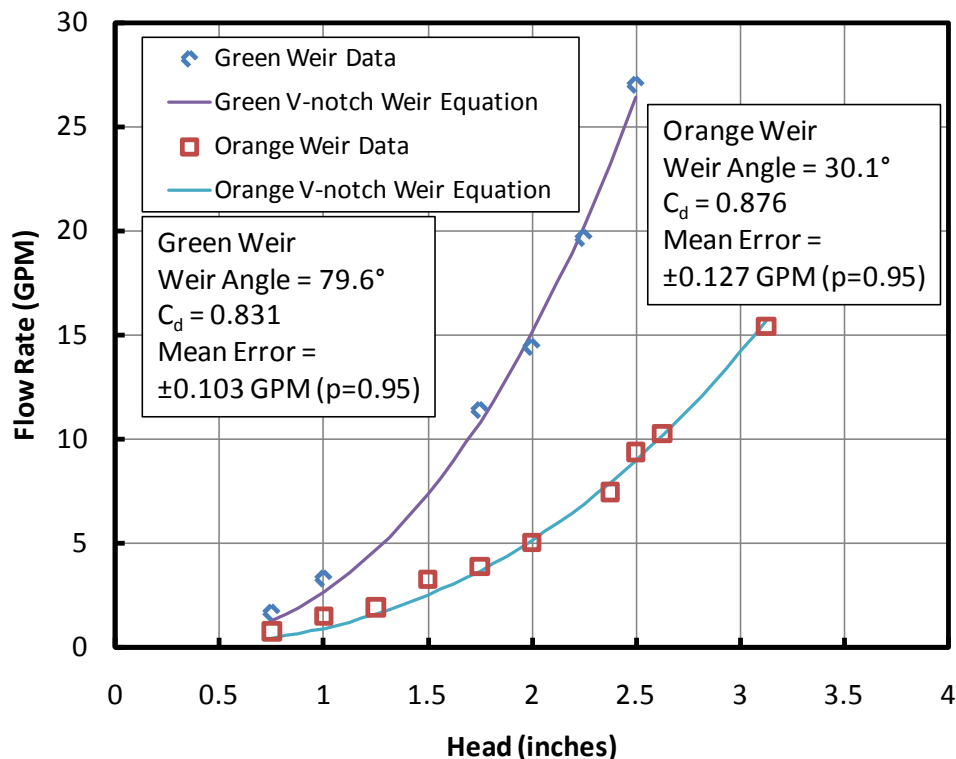
Figure 3: Stage-Discharge relationship for constructed bucket weirs.

The flow rate of stormwater was measured at the outlet of the under-drain systems for each of the trenches. To measure the flow rate, weirs were constructed from plastic five-gallon buckets which were calibrated at the St. Anthony Falls Laboratory. The flow over the weirs was calibrated throughout the range of possible water depths to develop a stage-discharge relationship. Flow rates were measured by measuring the time required to fill a known volume of water. The stage-discharge relationships for the two weirs used in this study are given in Equation 1 and shown in Figure 3.

The bucket weirs were placed in the outlet structure below the under-drains such that the outflow from each under-drain filled one of the bucket weirs. The water then overflowed the weir and the water level was measured at regular intervals and recorded. The flow rate was then calculated from stage-discharge relationship developed for each weir.

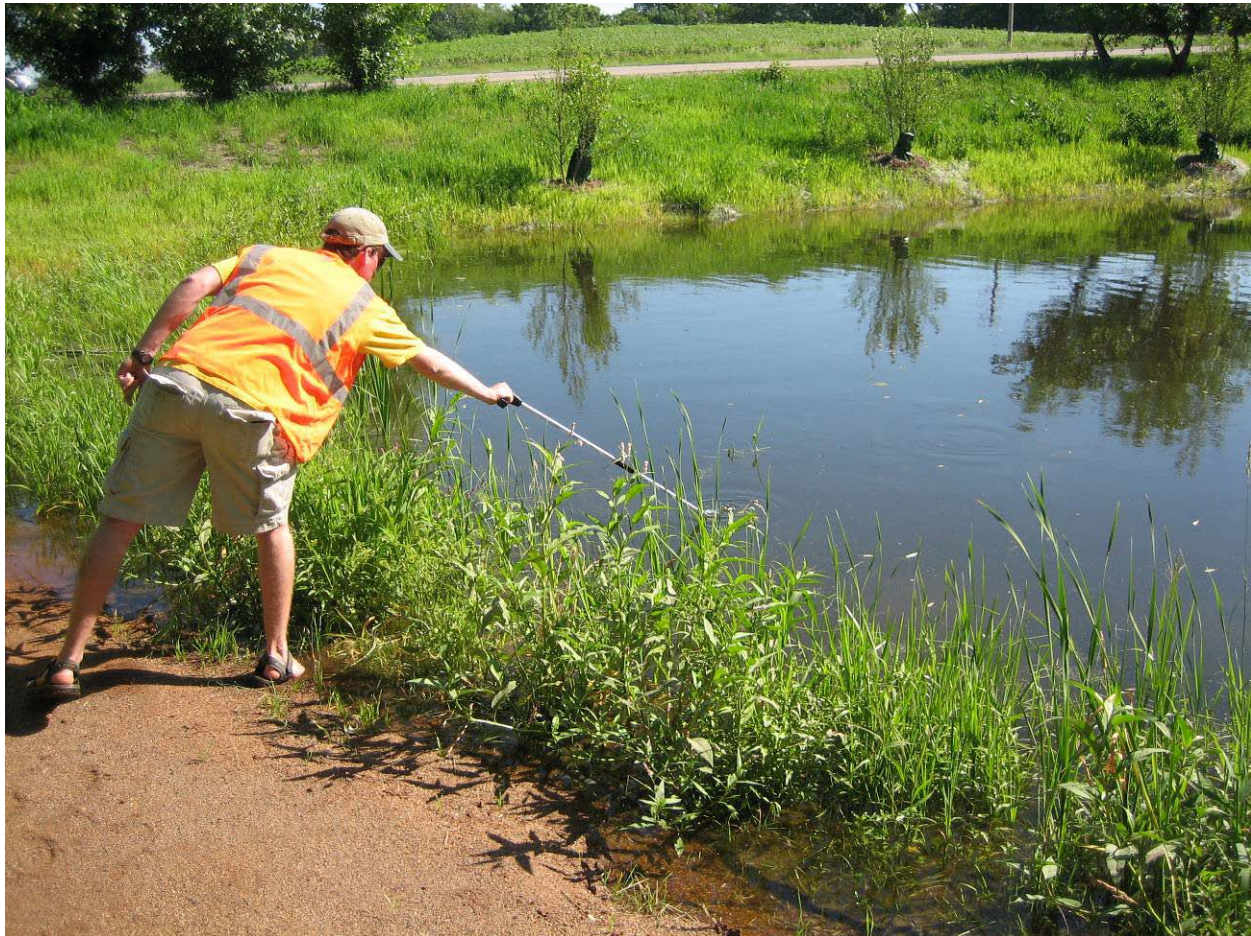
Figure 4: Sampling for phosphorus concentration from within the wet detention basin.

Samples were collected in two locations for each trench: within the wet detention basin as an influent sample (see Figure 4) and from the under-drain system as an effluent sample. Samples were collected using acid-washed glass sample bottles.

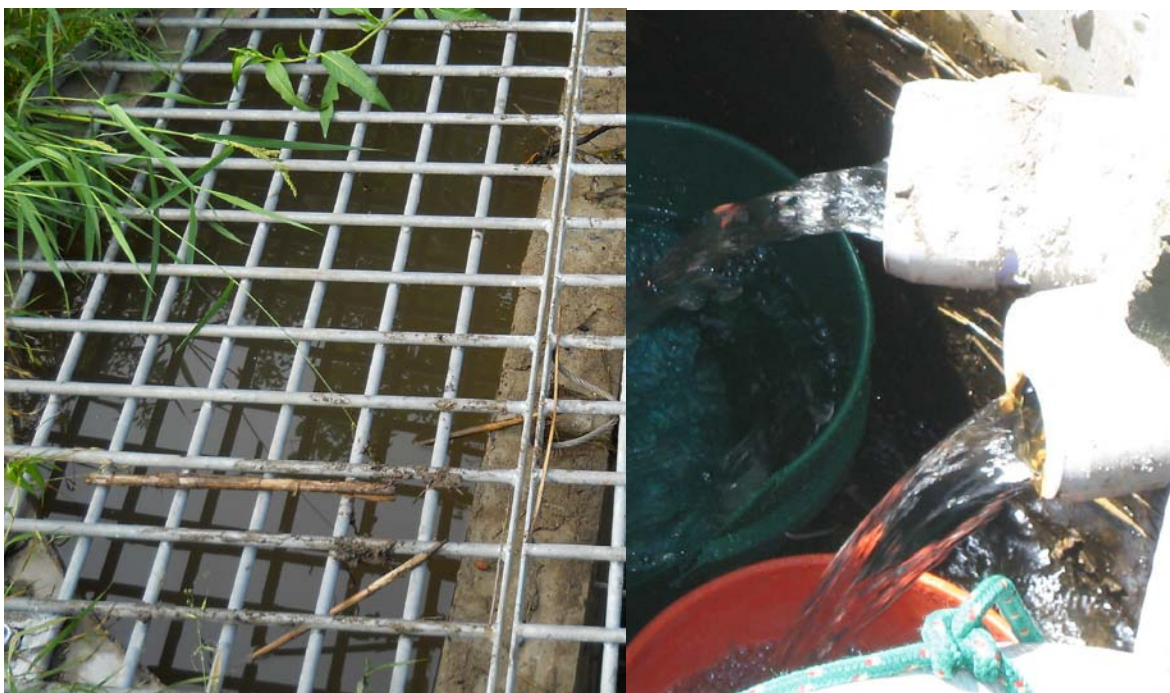
Figure 5: Water clarity within the pond (left, shown in the outlet structure) and after treatment by the iron-enhanced filtration trenches (right, shown at the effluent of the underdrains).

When comparing the influent event mean concentrations (EMCs) in Tables 1 and 2, it is evident that the synthetic stormwater had approximately 50 to 75% less dissolved phosphorus concentration than the natural stormwater events. This is likely due to algae and other biological activity within the basin converting dissolved phosphorus to particulate phosphorus between storm events. Also, all of the influent EMCs, with the exception of the September 24th test, were below the median values of dissolved phosphorus concentration in stormwater, 0.12 mg P/L (Pitt et al., 2005). No dissolved phosphorus was added to the synthetic discharge, but there is roughly 0.395 ± 0.017 mg P/L (average \pm 95% confidence interval, $n = 4$) in the domestic water supply to reduce pipe corrosion. A comparison of the water quality upstream (within the pond) and downstream (outflow from the underdrains) is provided in Figure 5.

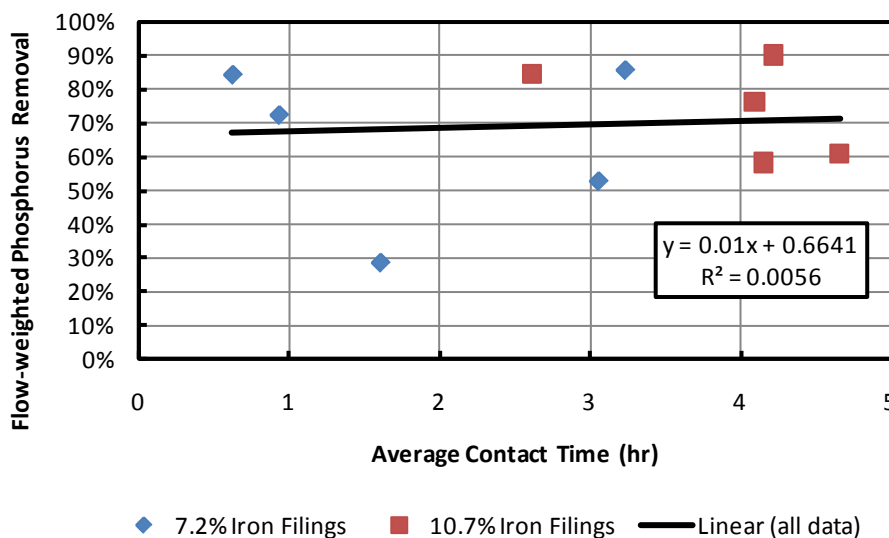
Figure 6: Relationship between flow-weighted phosphorus removal and average contact time with iron-enhanced filter media (assumes media depth = 1.4 feet).

The filtration rates reported in Tables 1 and 2 can be used to estimate the contact time between the phosphorus in the water and the iron-enhanced filter media (contact time = bed depth / filtration rate). Assuming an iron-enhanced media bed depth of 1.4 feet (0.4 m), phosphorus removal as a function of contact time for the 7 % iron filings and 11% iron filings trenches is shown in Figure 6.

Laboratory experiments with steel wool or elemental iron has shown a strong relationship between contact time and phosphorus capture (Erickson et al., 2007), but no such relationship is apparent from the data collected during these tests (Figure 6). As mentioned previously, several measurements during these tests were below detection limits (which affects percent removal) and therefore these results may not be accurate enough to determine a relationship between contact time and phosphorus capture.

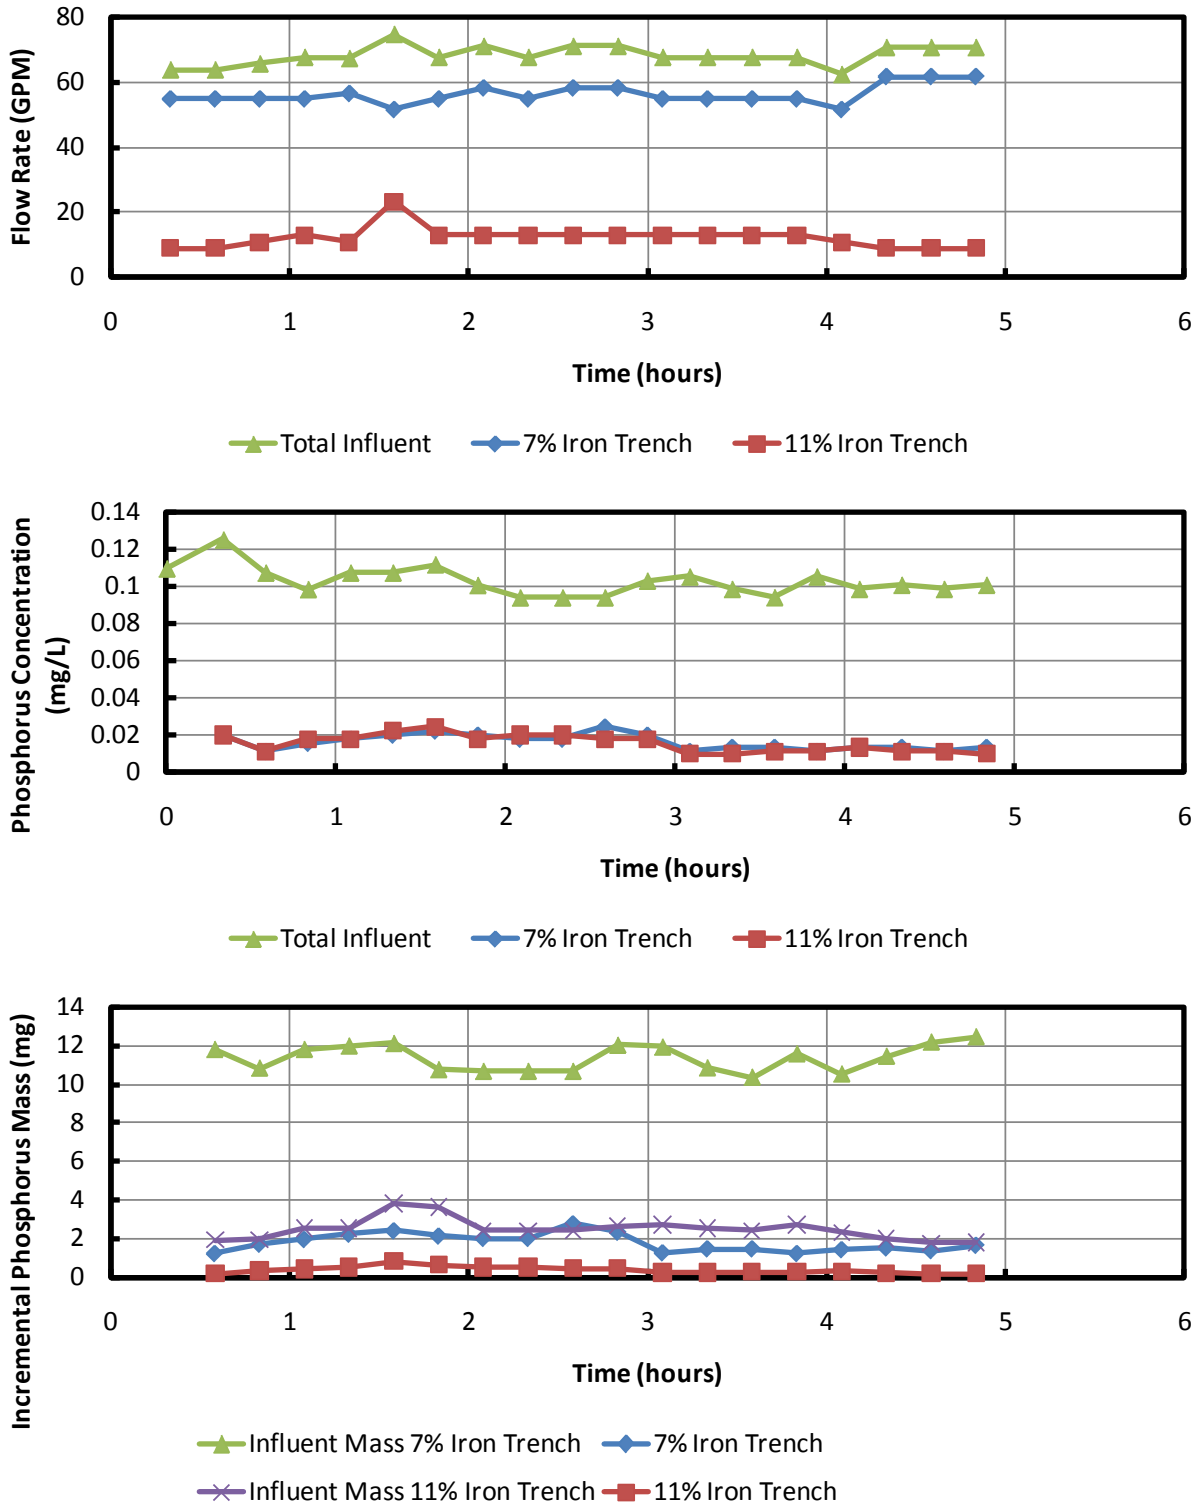
Figure 9: Detailed test results for August 11, 2010 at Pond 1.

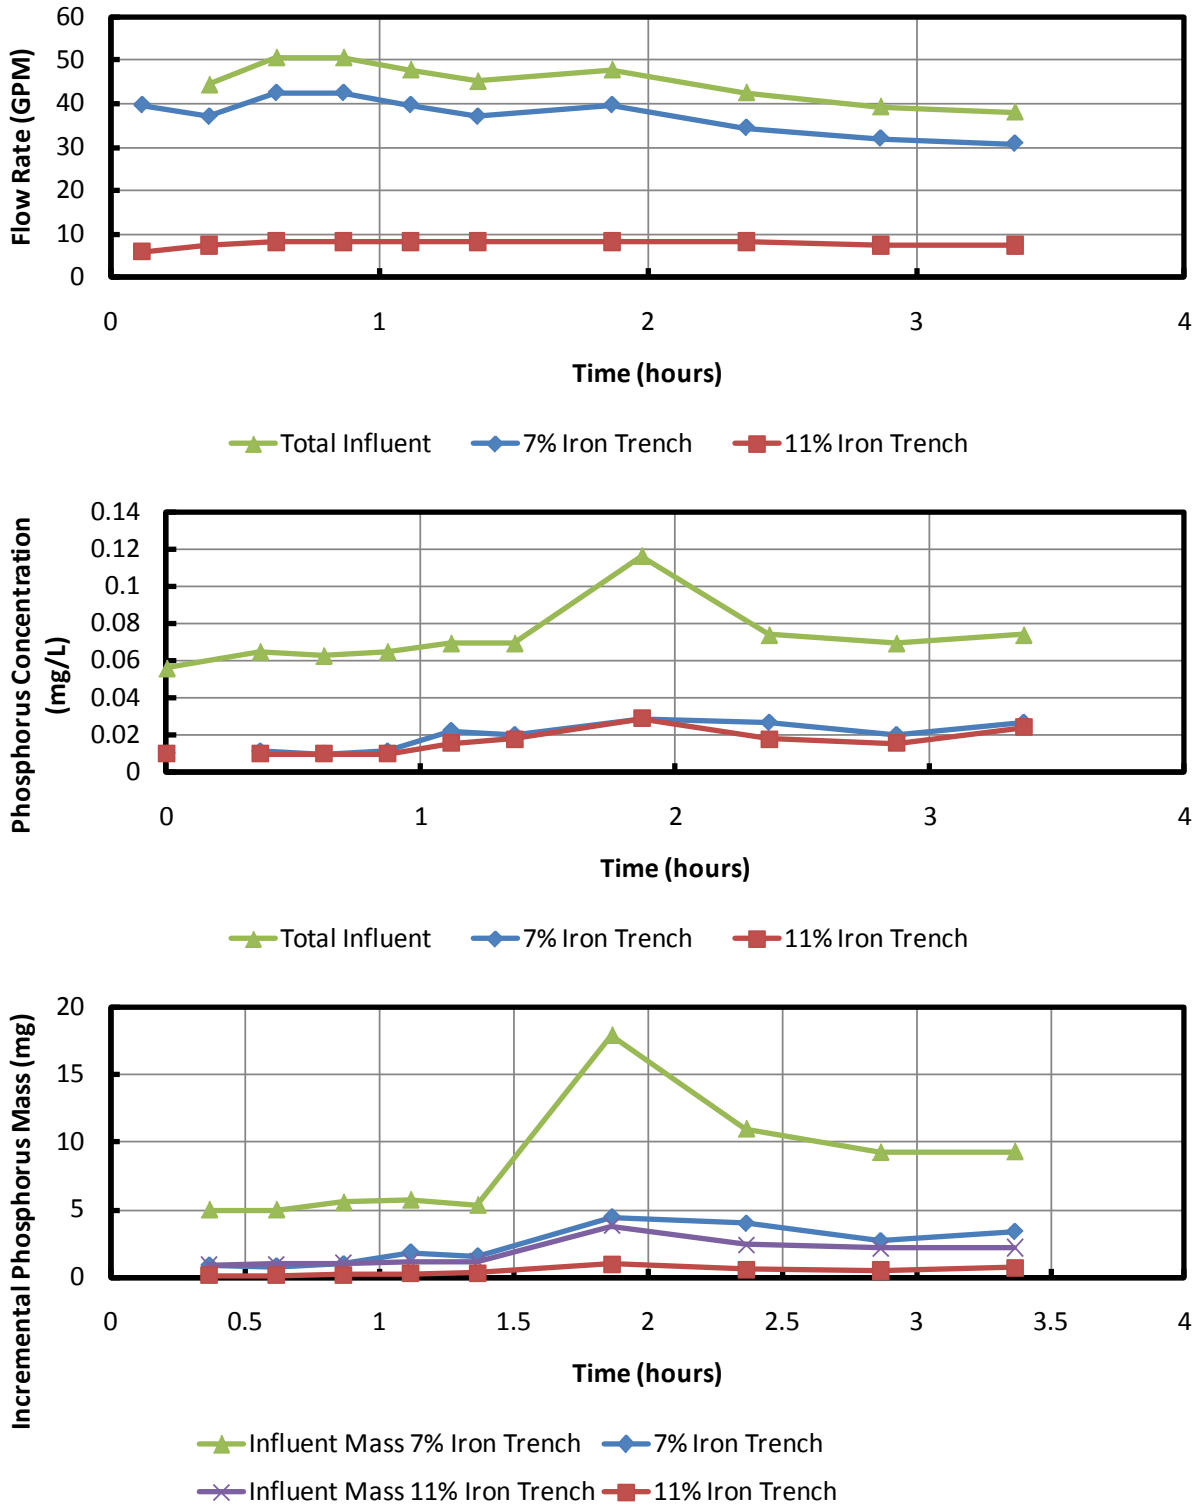
Figure 10: Detailed test results for August 12, 2010 at Pond 1.

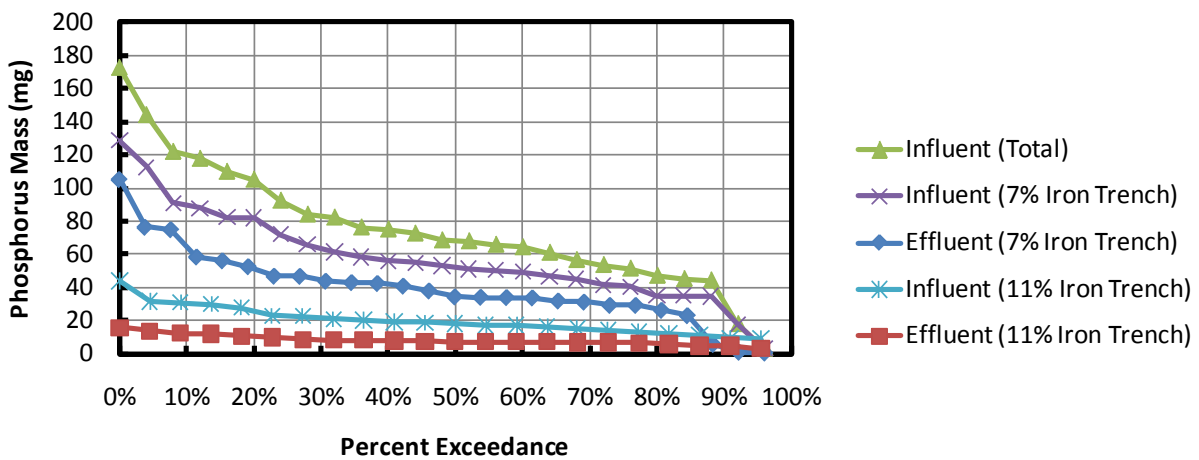
Figure 12: Percent Exceedance for July 1, 2010 at Pond 1.

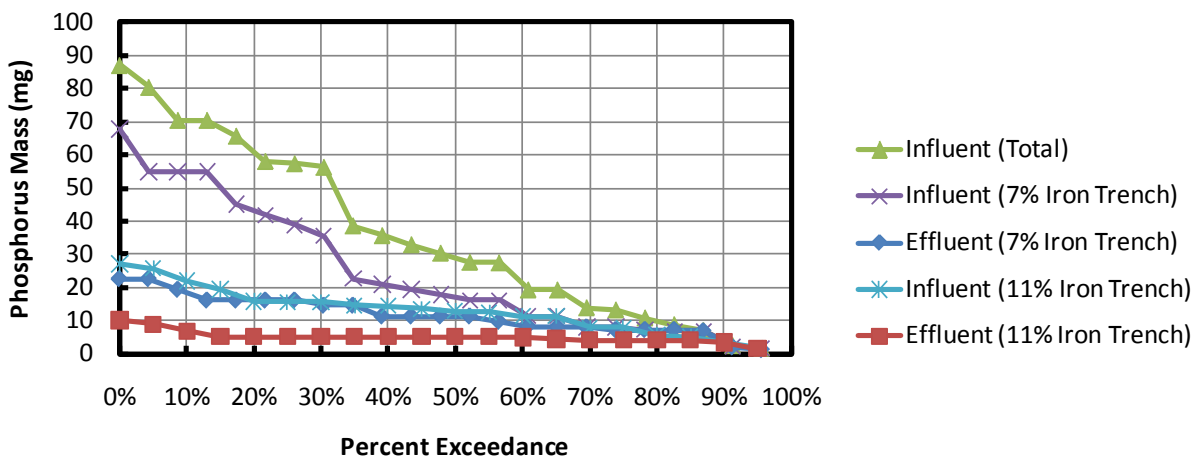
Figure 13: Percent Exceedance for July 13, 2010 at Pond 1.

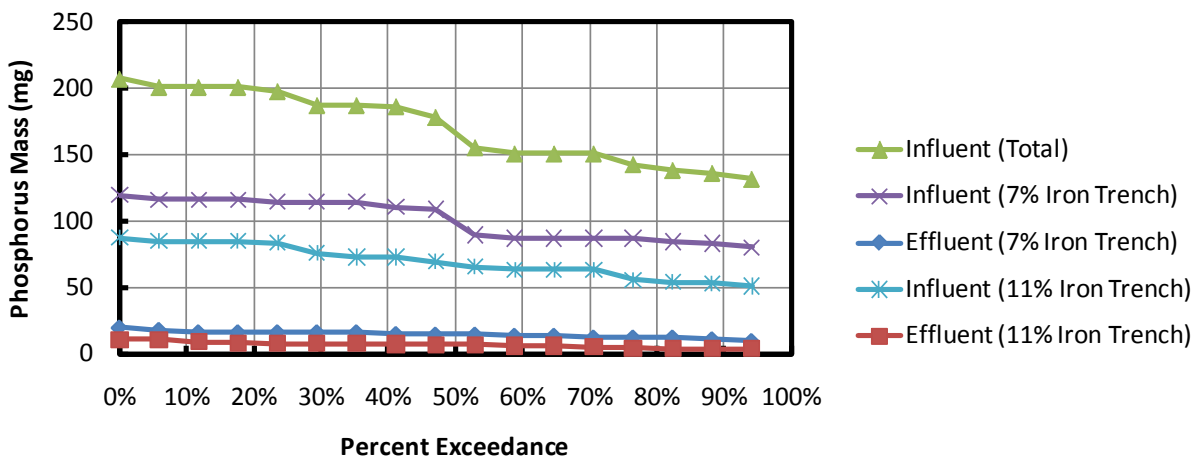
Figure 16: Percent Exceedance for September 24, 2010 at Pond 1.
