Design, Construction, and Assessment of a Self-Sustaining Drainage Ditch

A THESIS

IN PARTIAL FULFILLMENT OF THE REQUIREMENTS
FOR THE DEGREE OF MASTER OF SCIENCE IN
BIOSYSTEMS AND AGRICULTURAL ENGINEERING

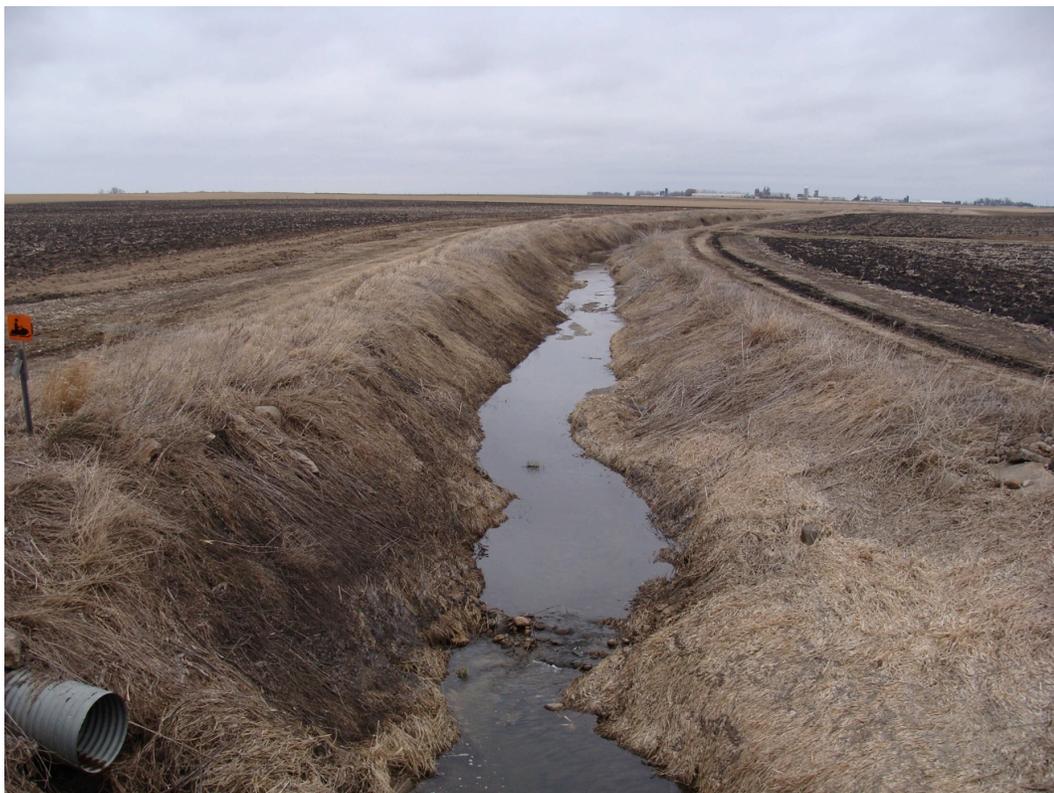
Figure 2. A Typical Agricultural Drainage Ditch in Minnesota – the Mullenbach Drainage Ditch, March 2009. Photo taken by Brad Hansen.

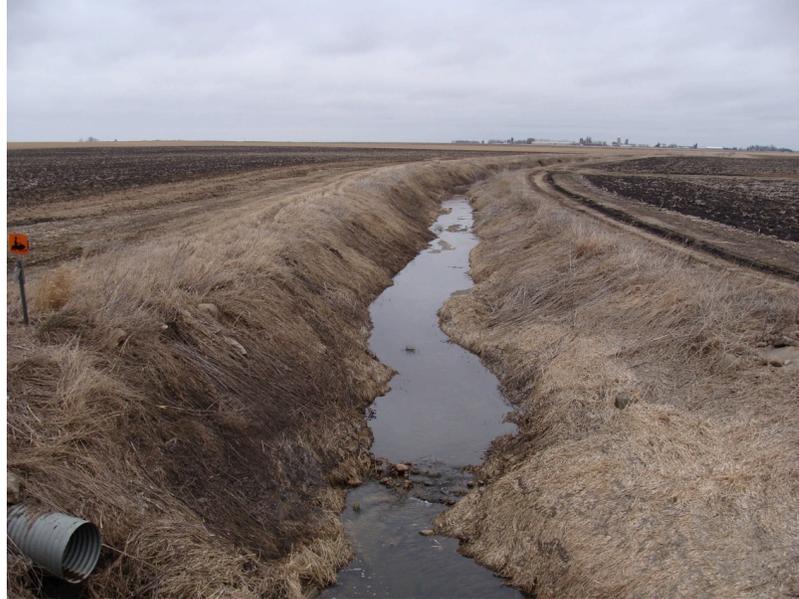
Figure 37. Looking North from Mower County Road 6: A View Upstream from the Downstream End of the Project Reach. March 31st, 2009. Photo by Brad Hansen.

Pictures of the pre-existing Mullenbach trapezoidal ditch are included in the Appendix (Figure 37- Figure 42). These pictures highlight issues related to the ditch condition prior to the construction of the two-stage channel.

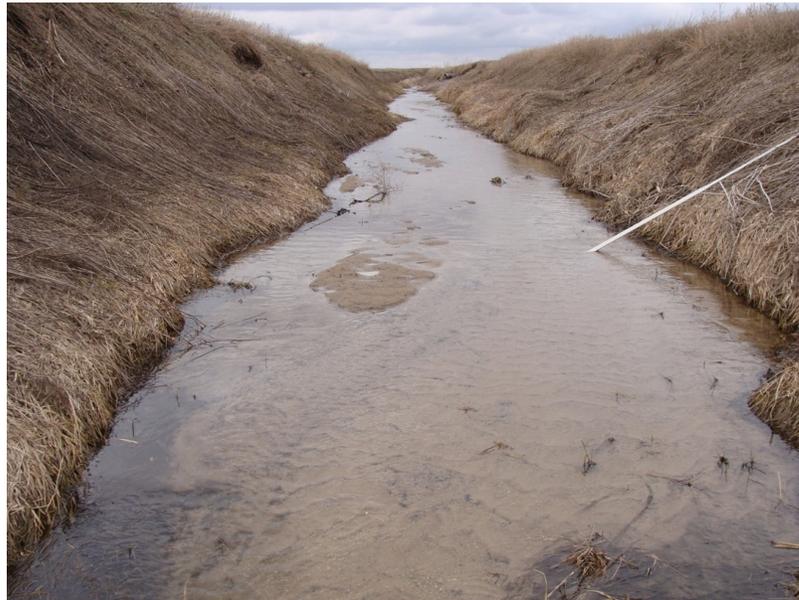
Figure 38. A Section of the Reach with a Continuous Sand Bed. March 31st, 2009. Photo by Brad Hansen.

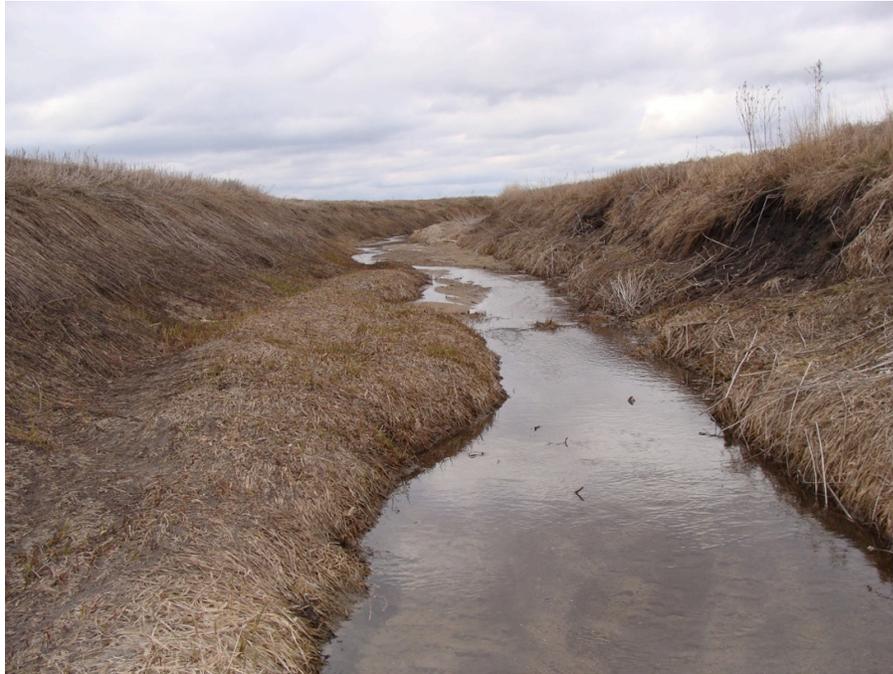
Figure 39. A View of Sand Deposits and a Bench Near 52+00. Photo Taken Looking Upstream. March 31st, 2009. Photo by Brad Hansen.

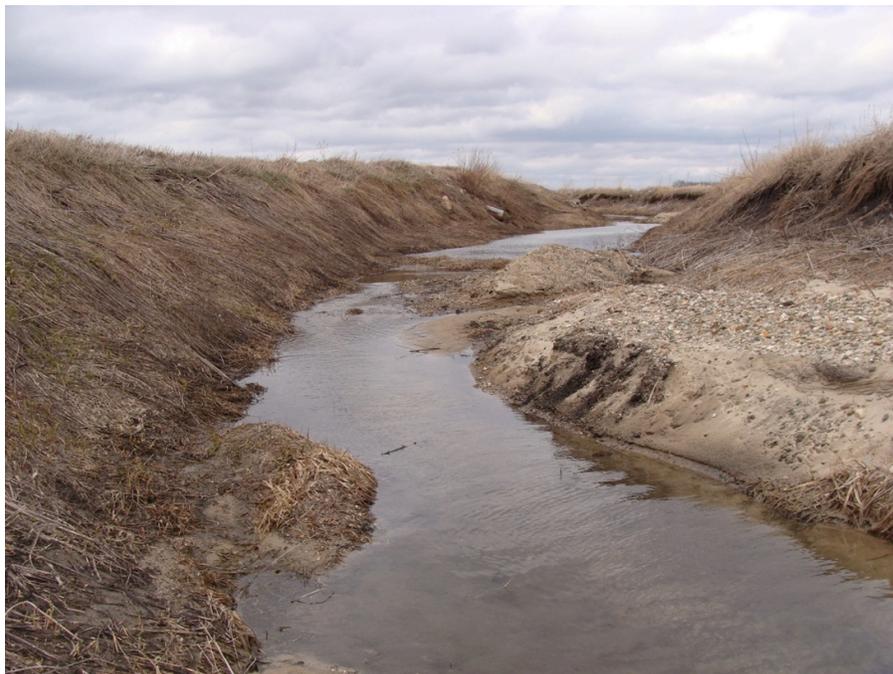
Figure 40. Large Sand and Gravel Deposits on the Left Bank (Right in the Photo) at the Bend Near 50+00. Photo Taken Looking Upstream. March 31st, 2009. Photo by Brad Hansen.

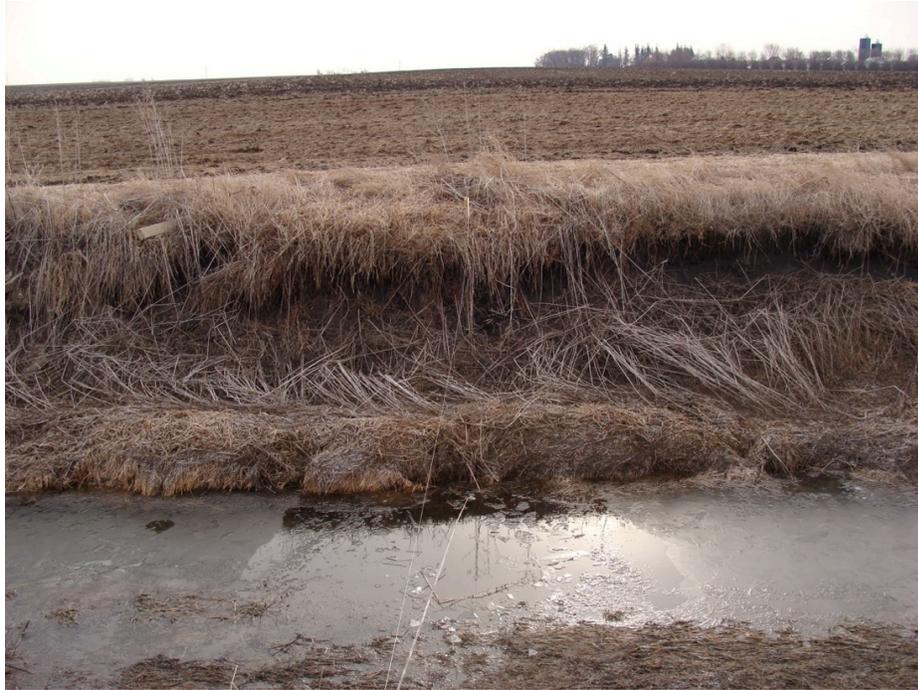
Figure 41. Bank Undercutting and Overhang with a Bench Feature at the 46+54 Cross-Section. March 31st, 2009. Photo by Brad Hansen.

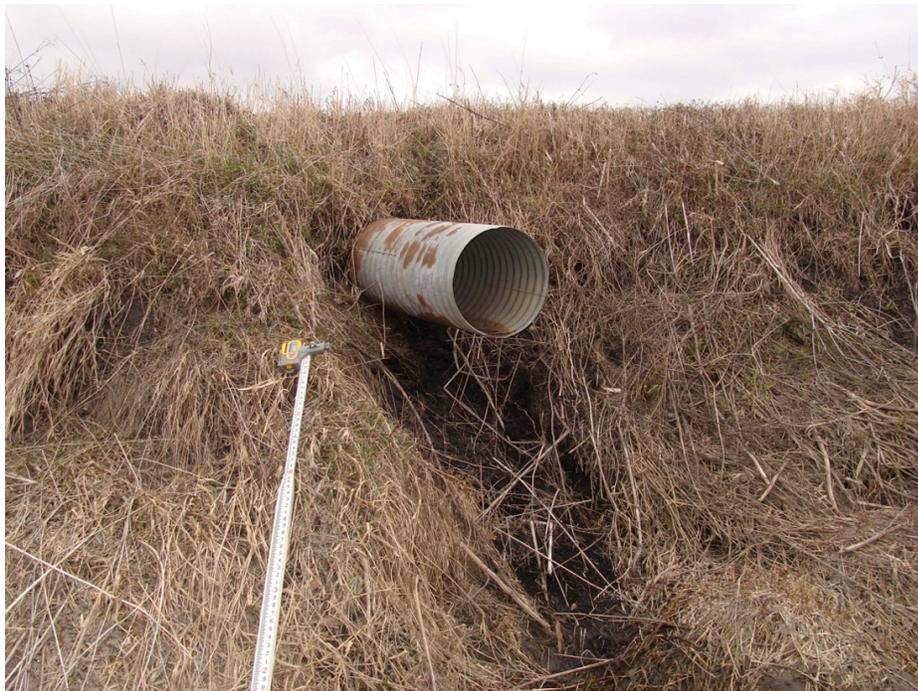
Figure 42. The Side Inlet on the Left Bank at 52+00. March 31st, 2009. Photo by Brad Hansen.

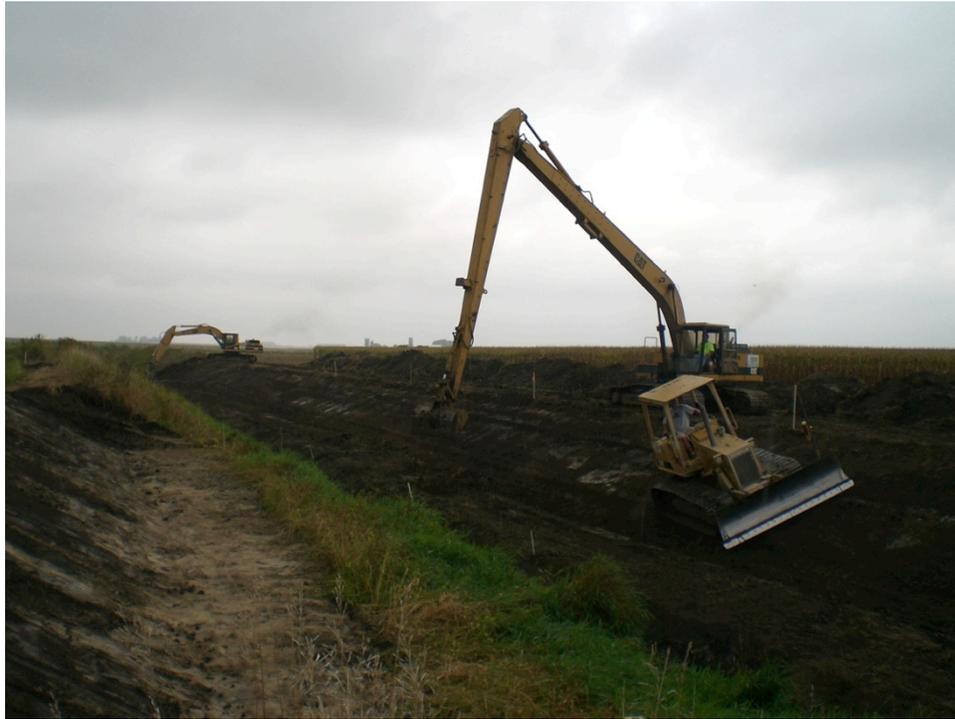
Figure 43. Beginning of Excavation at the Upstream (North) End of the Ditch Reach. Two Backhoes are Excavating the Ditch Benches while the Other Machine is Leveling the Bench and Bank Slope. September 23rd, 2009.

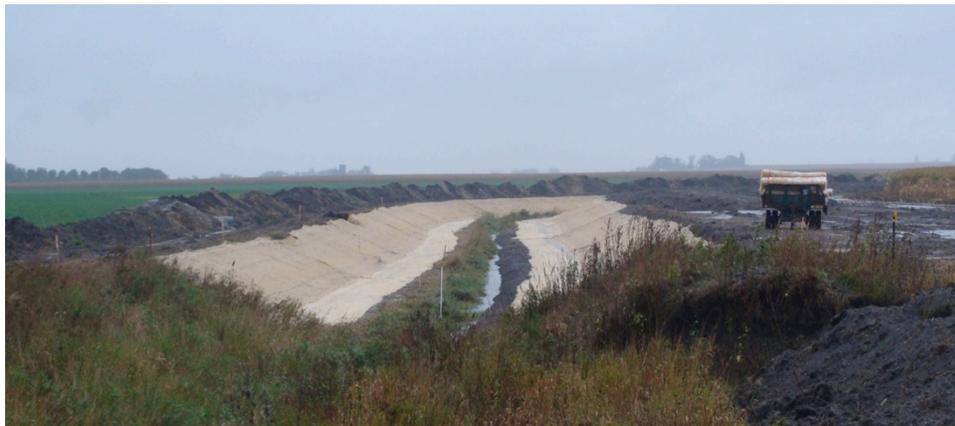
Figure 44. A View of the Completed 2-Stage Channel Form at the Upstream (North) End of the Ditch. Photo Taken Looking Downstream from 120th Street. October 1st, 2009. Photo by Brad Hansen.

Construction was completed in early November 2009. Pictures from the two-stage construction are included in the Appendix (Figure 43 - Figure 56).

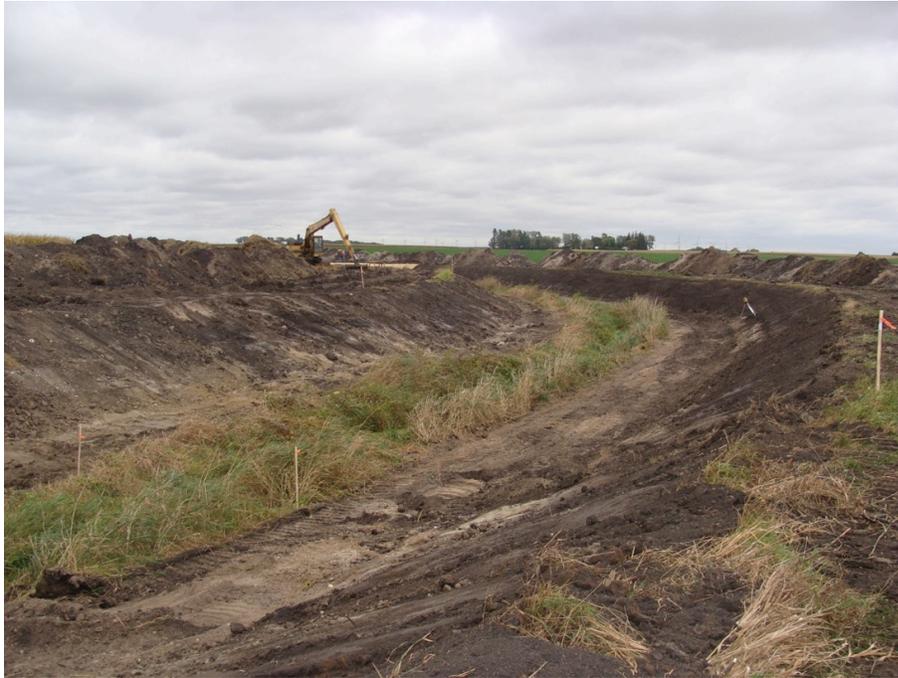
Figure 45. Excavation Continues Through the Bend Near 12+00. Photo Taken Looking Upstream. September 28th, 2009. Photo by Brad Hansen.

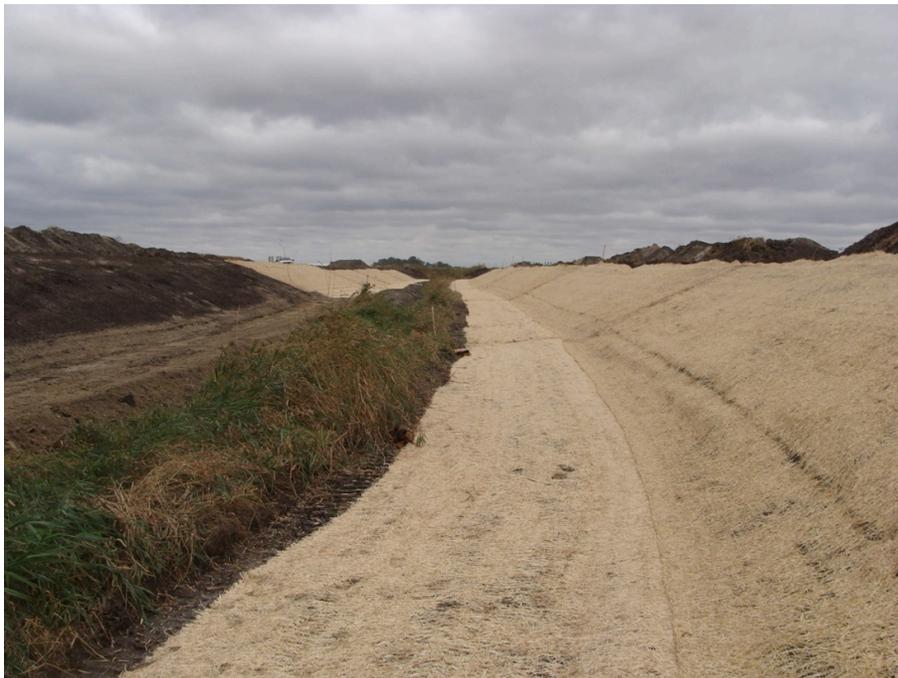
Figure 46. Erosion Control Mat Covering the Ditch Benches and Banks at the Upstream End. Photo Taken Looking Upstream from Approximately 10+00. September 28th, 2009. Photo by Brad Hansen.

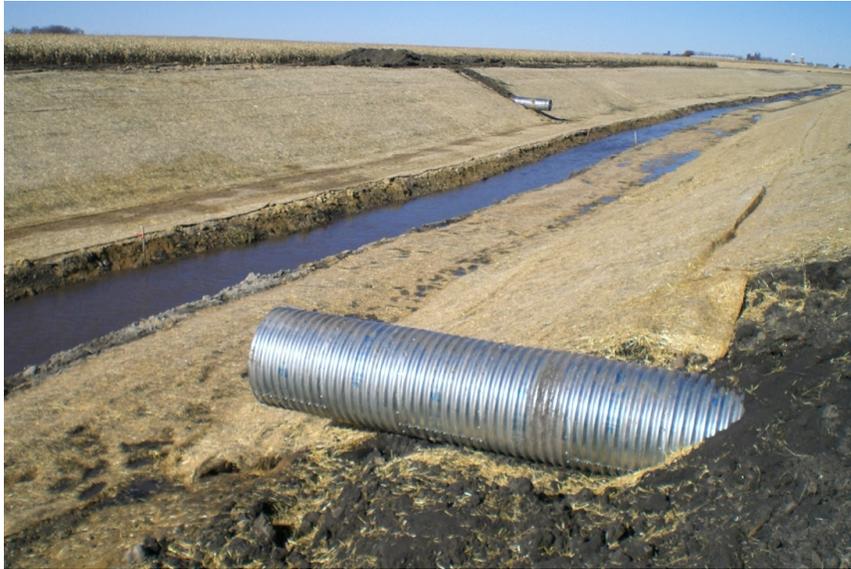
Figure 47. Photo Showing the Side Inlets at 58+28 (Foreground) and 57+00 Following Construction. Note that This Photo was Taken Before Riprap Armoring Was Placed at the Outlets of These Structures. Photo Taken Looking Upstream. November 2nd, 2009.

There are 12 side inlets, which are designed to convey surface water from the surrounding landscape into the ditch, in the study reach. All of the side inlets were replaced during construction, and each was sized according to the area from which it receives surface runoff. Riprap was also used to protect the ditch benches from water discharging into the ditch from side inlets. A view of two completed side inlets (before riprap reinforcement was placed) can be seen in Figure 47 in the Appendix. The locations of all side inlets are shown in Figure 7.

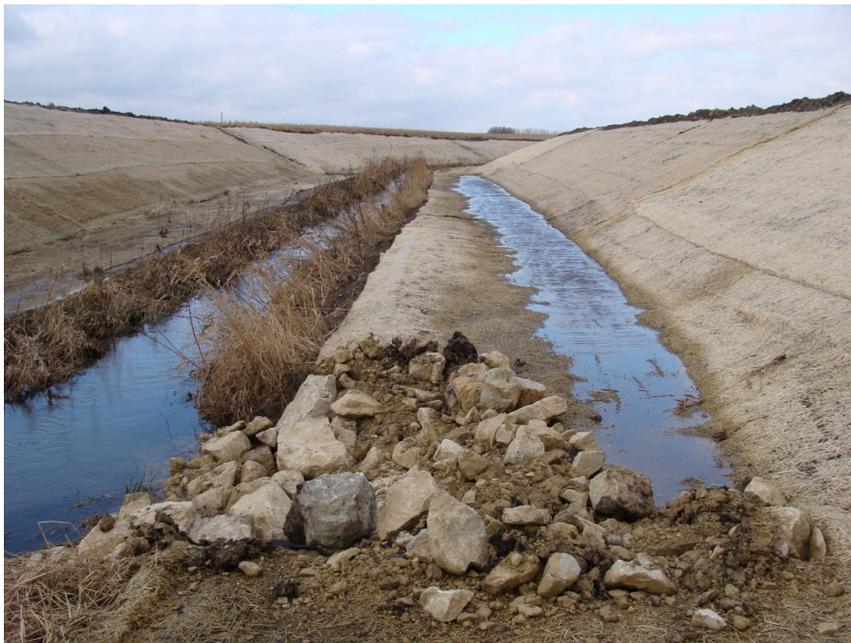
Figure 48. A View of the Linear Treatment System Along the Left Bank at 28+00. The Tile Outlet is Approximately 200 ft Upstream (61 m) (in Background), while the Outlet from the Linear Treatment System to the Channel is in the Foreground. Photo Taken Looking Upstream. November 4th, 2009. Photo by Brad Hansen.

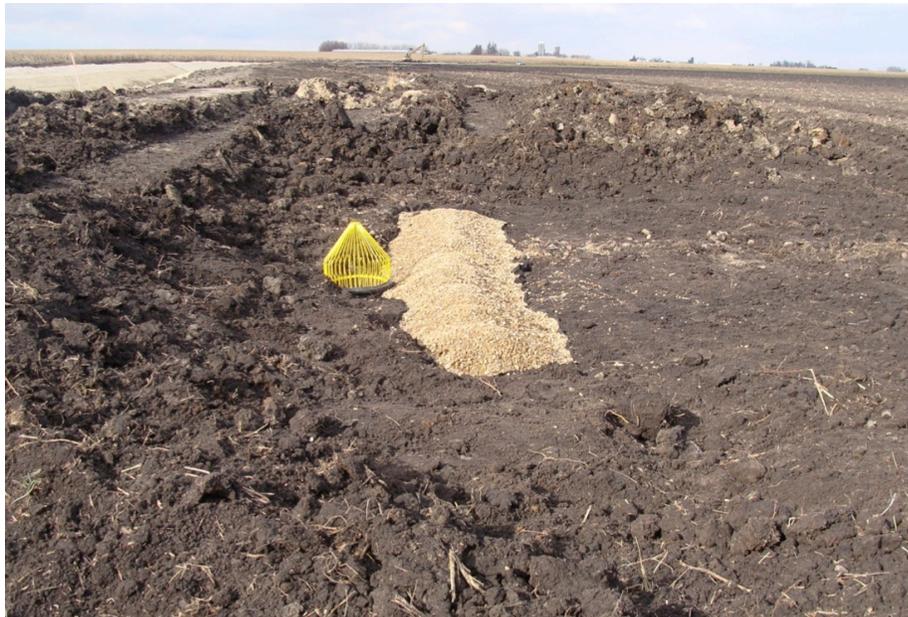
Figure 50. The Rock Trench Side Inlet Intake Structure. Note the Mounded Pea Gravel, which Routes Water Downward into the Rock Trench. The Auxiliary Inlet is to the Left of the Mounded Rock, and Includes a Trash Rack to Prevent Plugging of the System. November 4th, 2009. Photo by Brad Hansen.

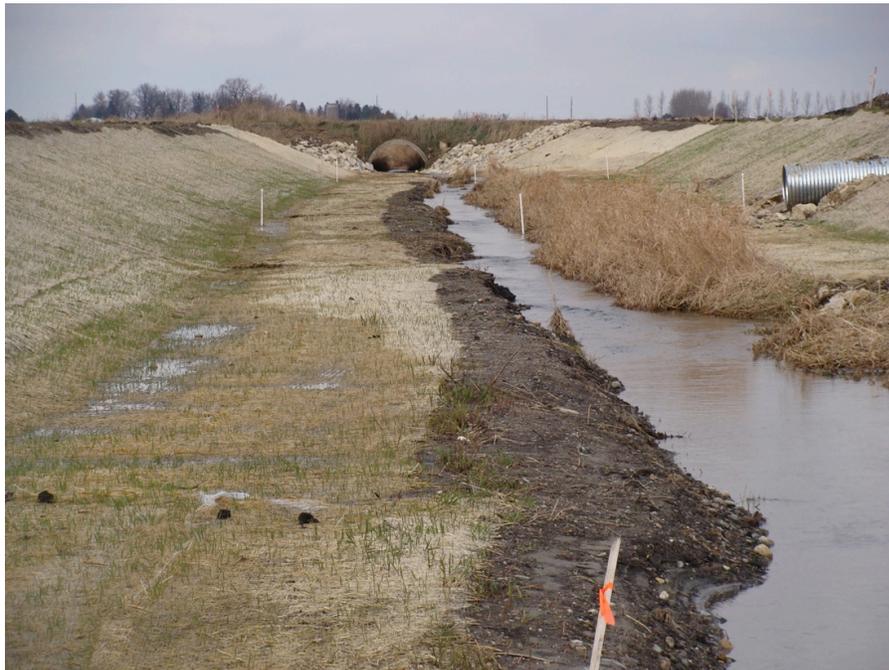
Figure 52. A View of the Upstream End of the Ditch, Taken Looking Upstream from 6+00. The Vegetation Emerging Through the Erosion Control Mat Shows the Approximate Extent to which Vegetation Emerged in 2009. November 4th, 2009. Photo by Brad Hansen.

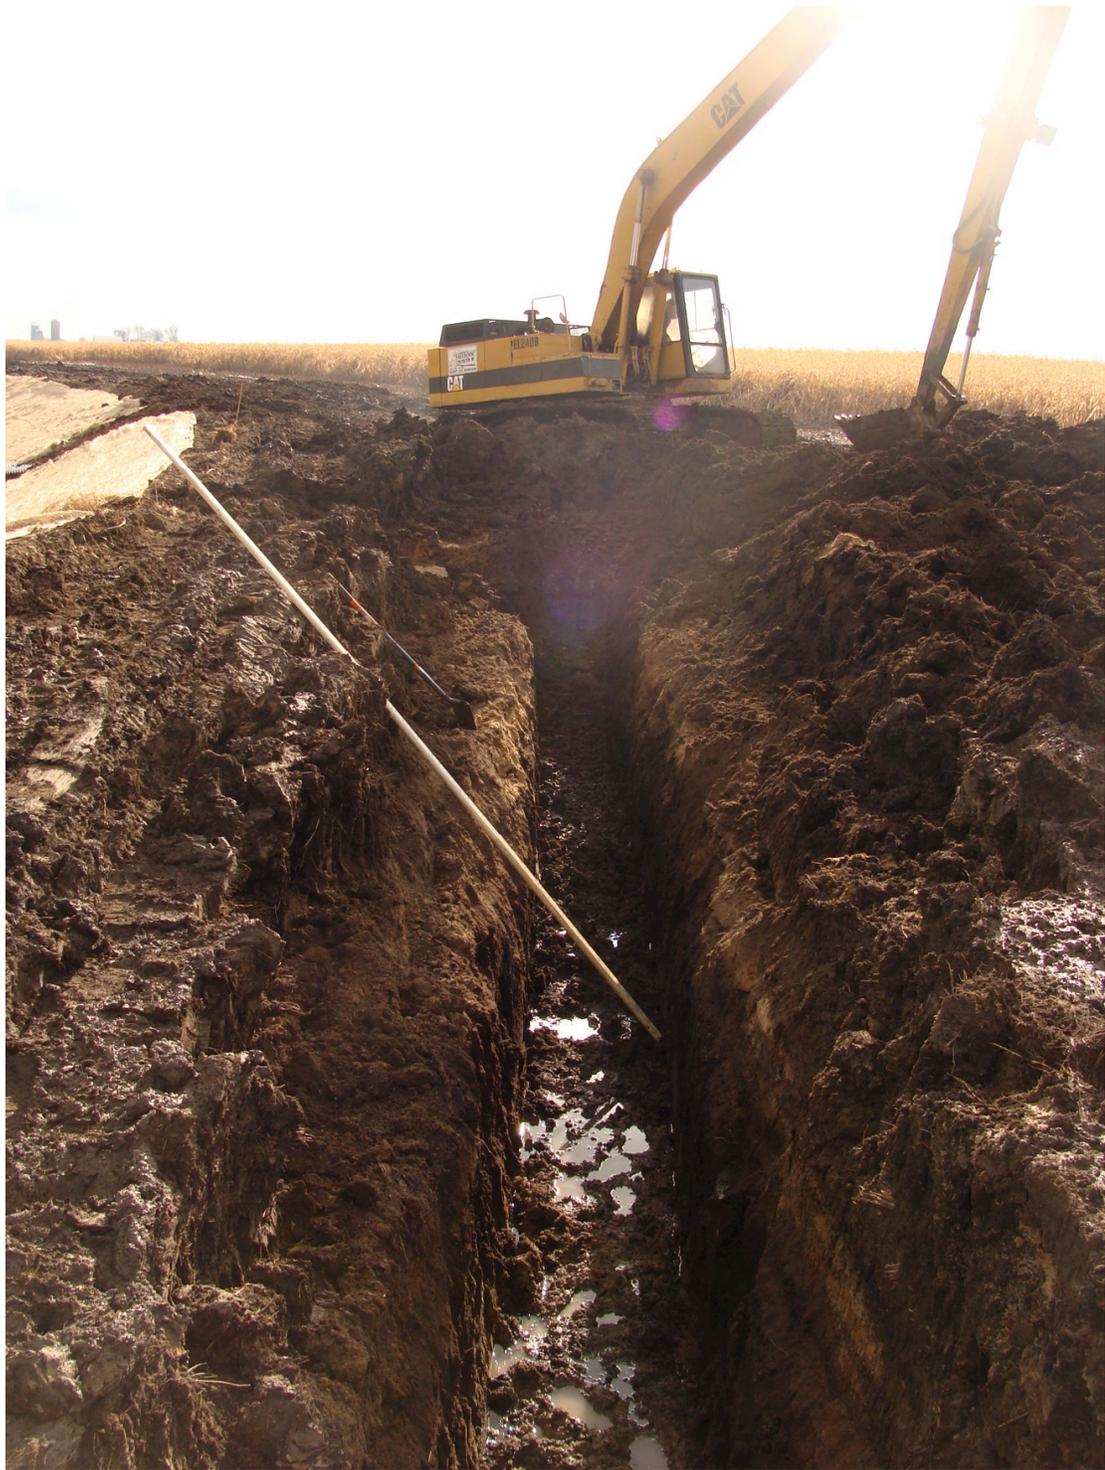
Figure 53. The Excavated Seepage Trench in the Right Bank at 22+00 Before Being Filled. November 4th, 2009. Photo by Brad Hansen.

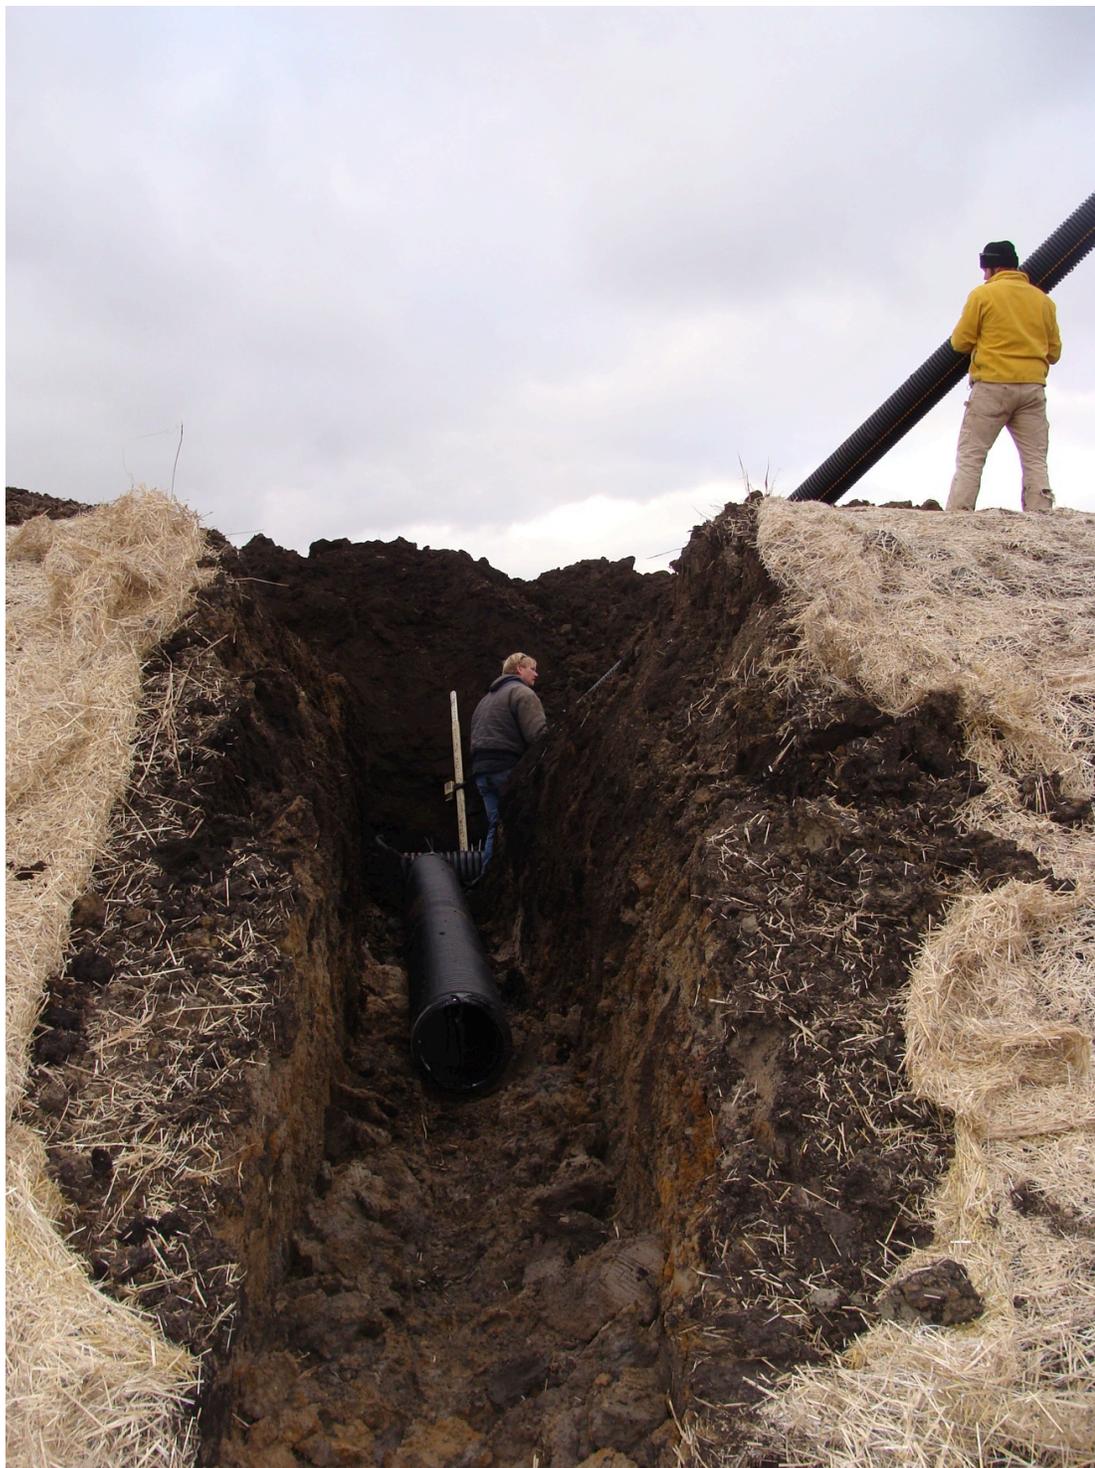
Figure 54. The First Section of Seepage Trench Outlet Pipe (12" Plastic) Exiting the Seepage Trench Toward the Channel. November 4th, 2009. Photo by Brad Hansen.

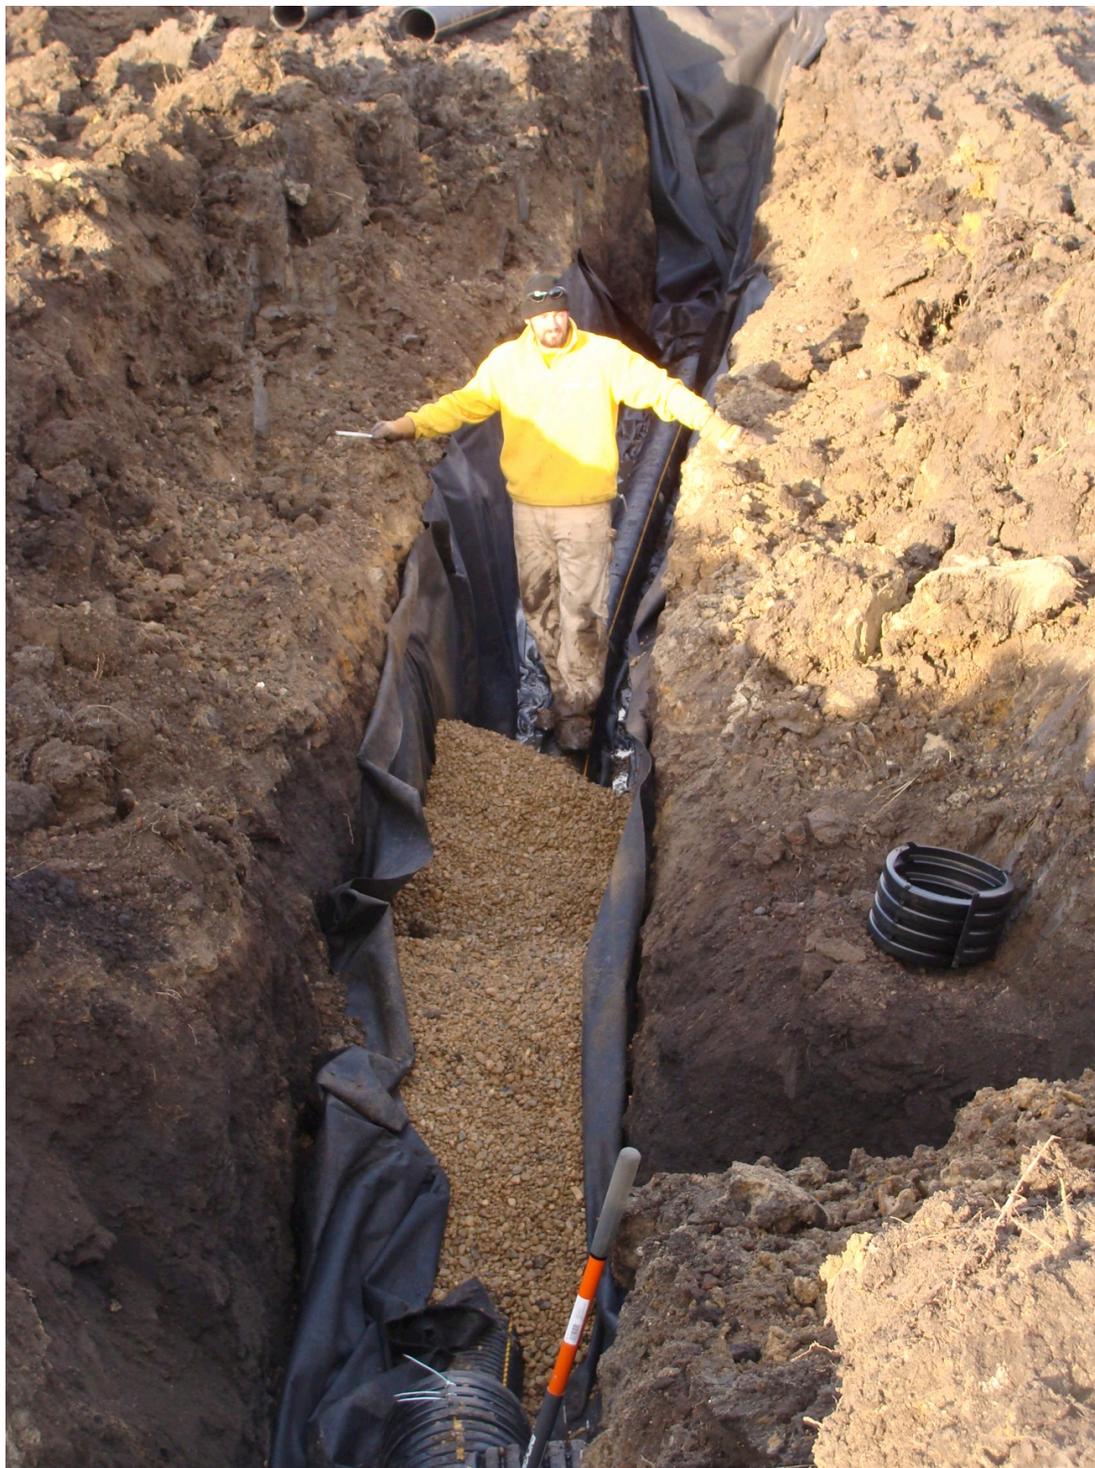
Figure 55. The Seepage Trench Being Filled with Pea Gravel (Note the Liner to Maintain the Gravel Within the Trench). November 4th, 2009. Photo by Brad Hansen.

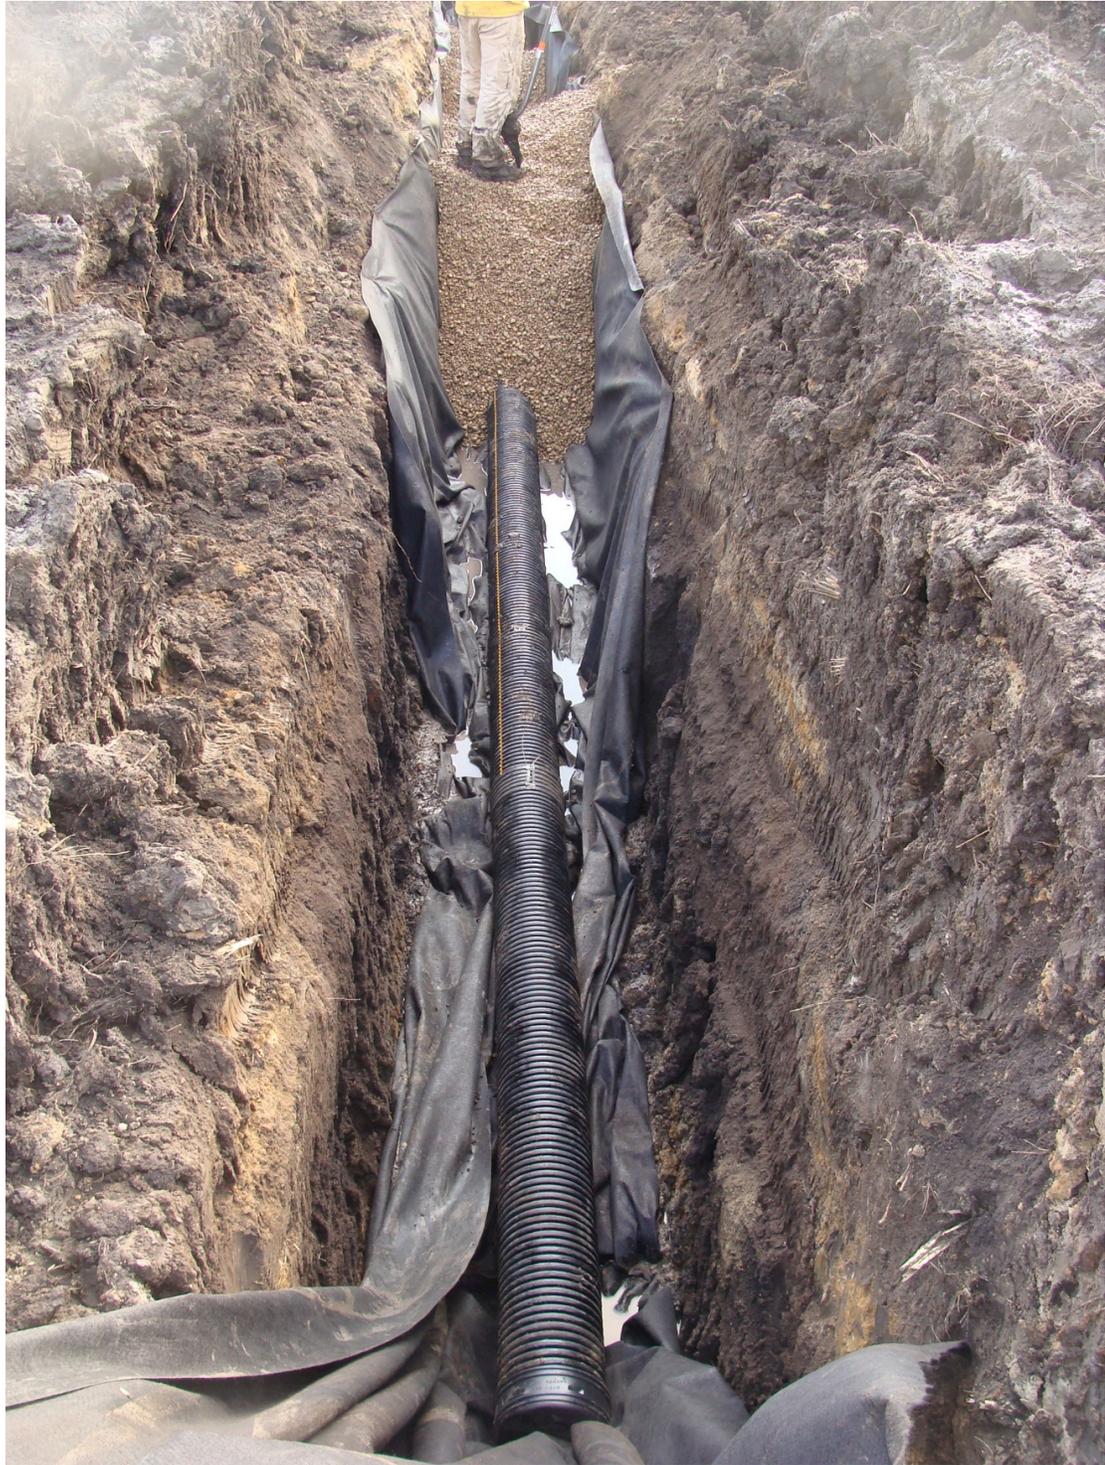
Figure 56. A View of the Longitudinal Drainage Pipe (8" plastic) Installed at the Bottom of the Seepage Trench to Collect Water and Carry it to the Seepage Trench Outlet Pipe. November 4th, 2009. Photo by Brad Hansen.

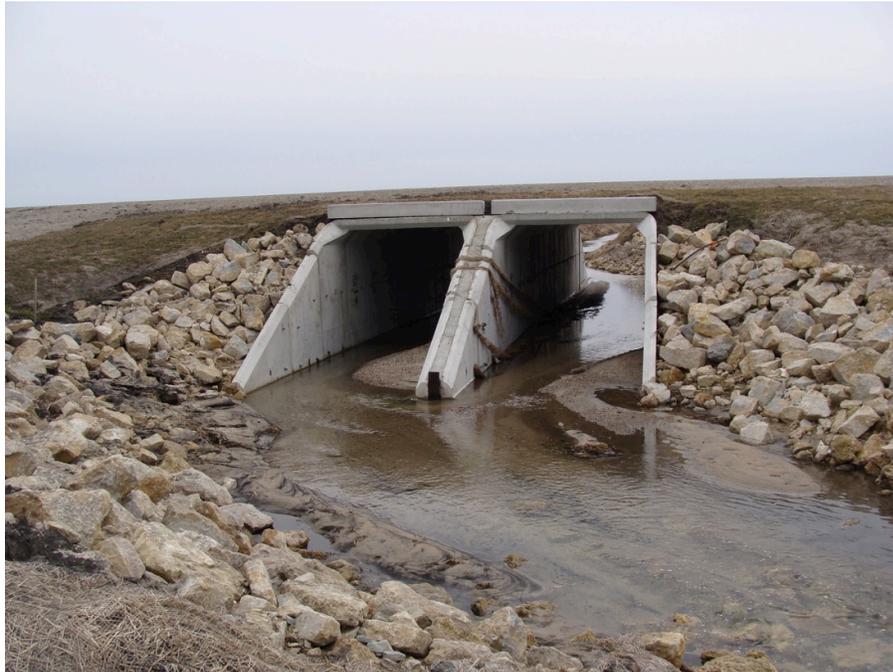
Figure 57. View of the Double-Box Culvert Beneath Mower County Highway 6 (Looking Downstream). March 24th, 2010.

when the culvert beneath Mower County Highway 6 was replaced (the new double-box culvert can be seen in Figure 57 in Appendix A.3). The top of the culvert beneath 120th Street was selected as a new benchmark, as its elevation had been measured as part of the initial site survey, and was therefore tied to the original project datum of 100 ft (30.48 m). For clarification, the current benchmark on top of the culvert is the top of the lower lip (the most downstream extent of the culvert), and the elevation is 109.63 (33.42 m). No attempt has thus far been made to tie the current or former project benchmarks to sea level.

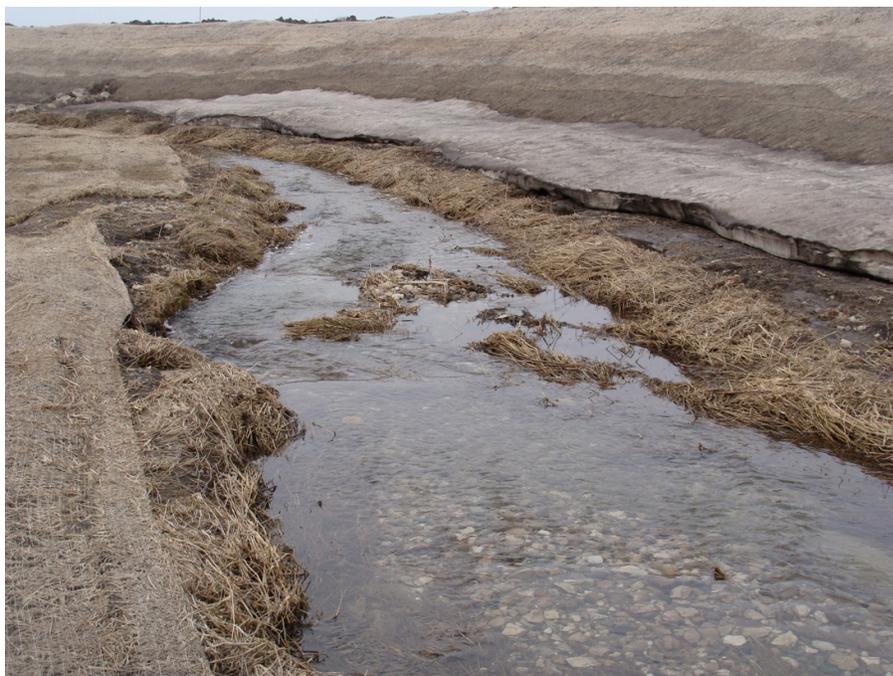
Figure 58. View of a Riffle Section Near Station 18+00. March 24th, 2010.

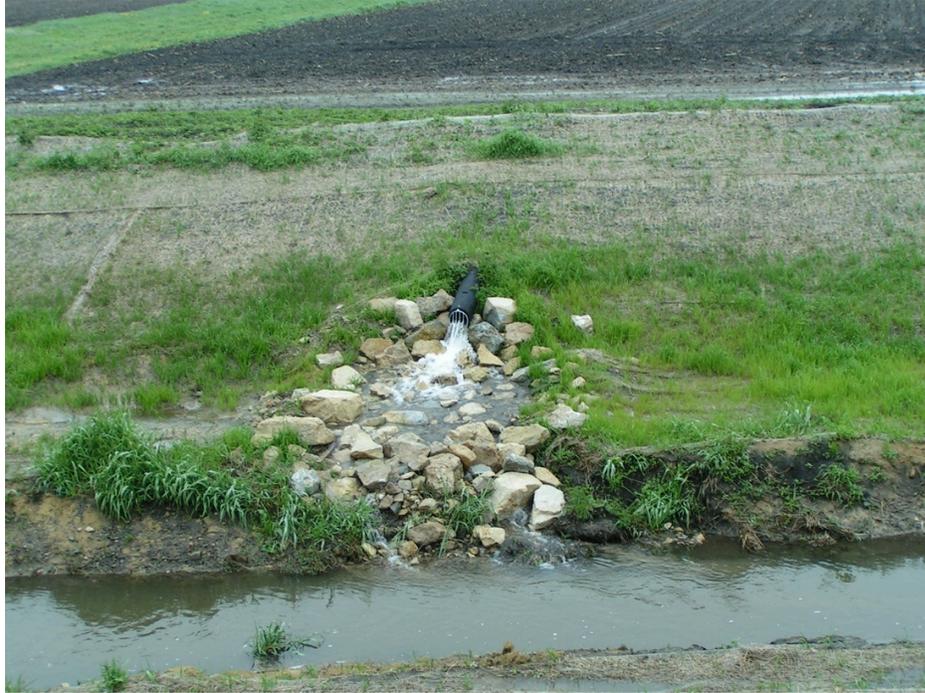
Figure 61. The Tile Outlet at 5+88, with Vegetation Emerging on the Bench and Bank. May 2010.

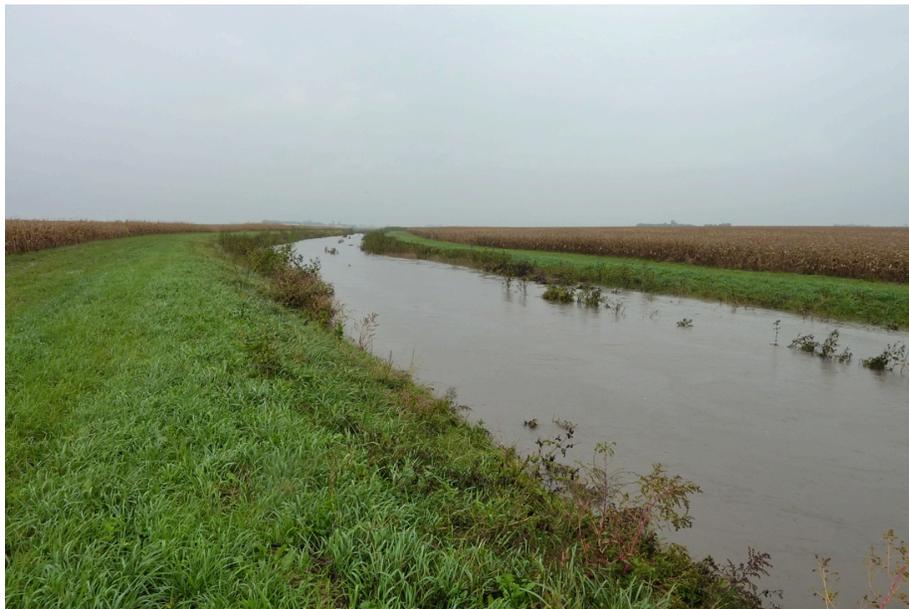
Figure 63. View of the Mullenbach Two-Stage Drainage Ditch During a High-Flow Event on September 23rd, 2010. Picture Taken Looking North from Just North of Mower County Highway 6.

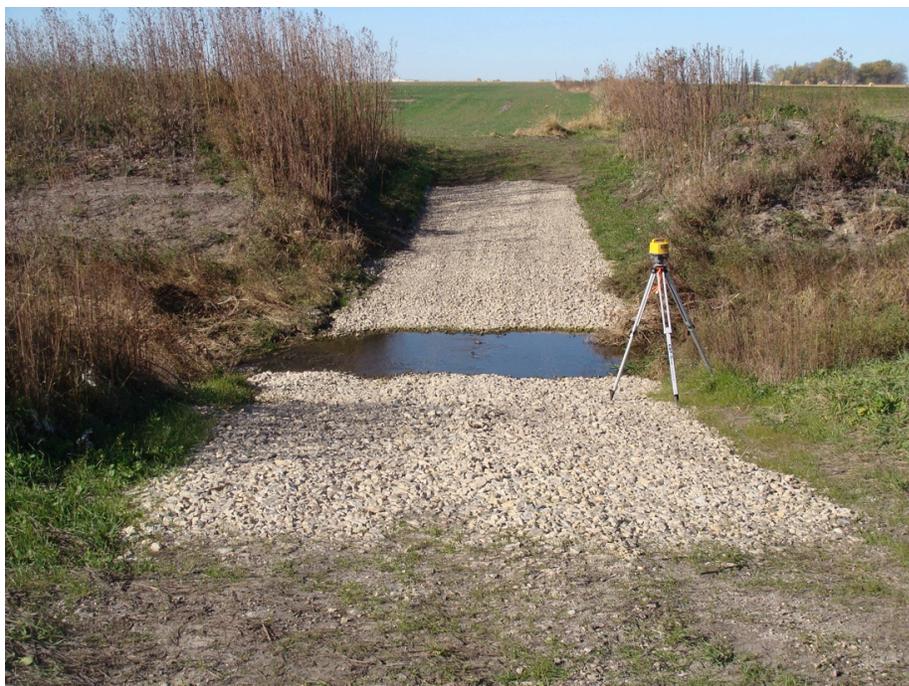
Figure 64. A View of the Field Road Crossing, Looking West (Streamflow is from Right to Left). October 21st, 2010. Photo by Brad Hansen.

ditch channel at that location. The field road crossing consisted of a rock base before construction, and the replacement crossing was designed similarly, with a new layer of rock (approximately 3-4 inches in diameter) making up the surface. A picture of the completed field road crossing is included in the Appendix (Figure 64).

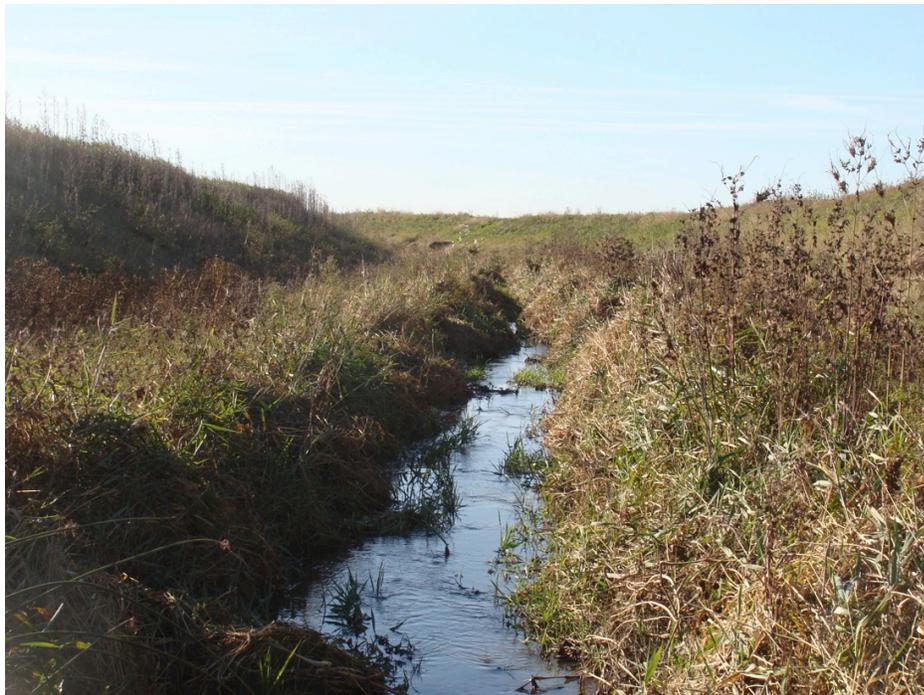
Figure 65. A View of the Channel Looking Downstream from 120th Street. October 21st, 2010. Photo by Brad Hansen.

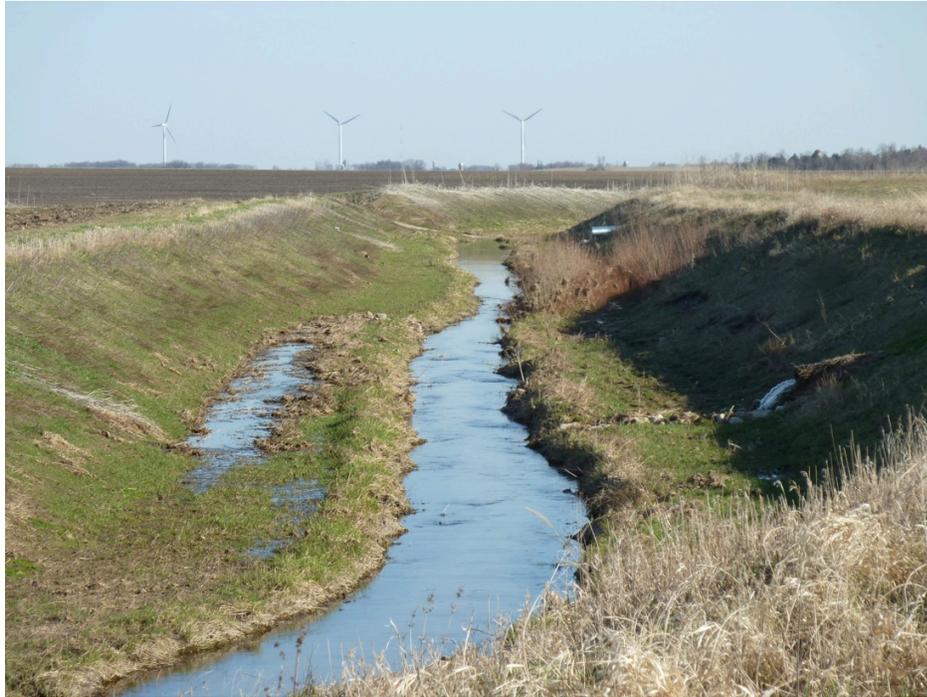
Figure 67. A View of the Channel Looking Downstream from 26+00. The Tile Outlets at 28+00 (Left and Right Banks) Are in the Picture. The Left Bench Includes a Linear Treatment Structure. April 12th, 2011.

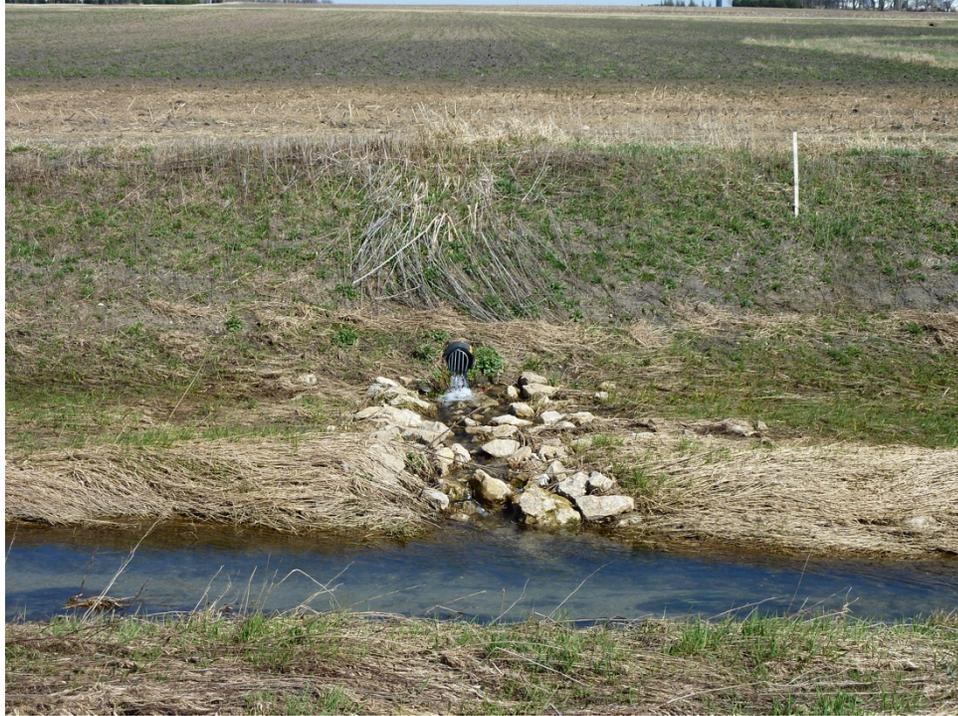
Figure 69. A Tile Outlet and Riprap Reinforcement. April 12th, 2011.
