Bulletin of the University of Minnesota

BULLETIN NO. 18

CONDENSATION OF MOISTURE AND ITS RELATION TO BUILDING CONSTRUCTION AND OPERATION

FRANK B. ROWLEY, M.E.

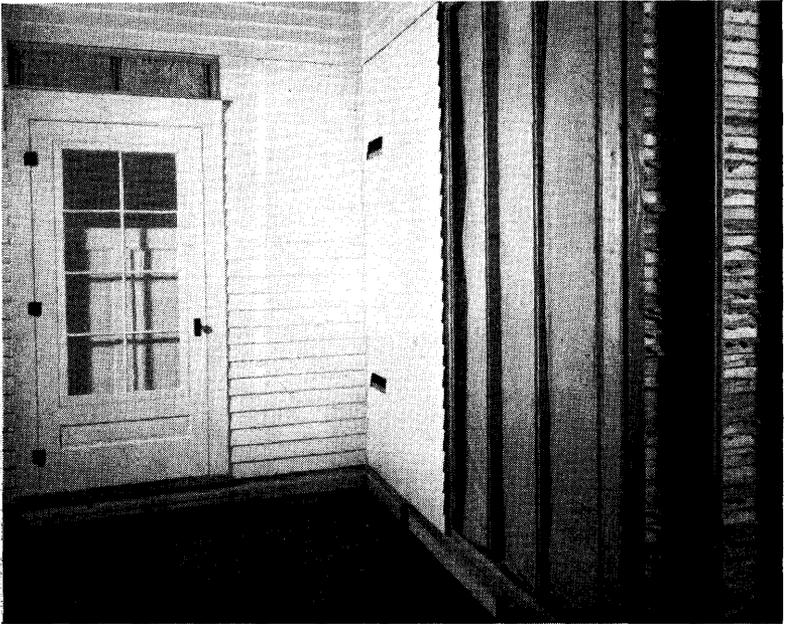
FIGURE 8. VIEW OF ENTRANCE TO BUNGALOW, WITH PART OF EXTERIOR WALL SECTIONS REMOVED SHOWING METHODS OF INSULATION AND CONSTRUCTION.

Figure 8 shows the exterior view of the 1-inch blanket application and also the $3\frac{5}{8}$ -inch bat material applied above the doors. Figure 10 shows the exterior view of two different makes of $3\frac{5}{8}$ -inch bat insulation at right of window and below window. Figures 12, 13, and 14 show interior views of the insulated walls before plaster base was applied. Figure 12 shows the construction of Wall A with $3\frac{5}{8}$ -inch mineral wool bats without barriers; Wall B with $3\frac{5}{8}$ -inch mineral wool bats with barriers attached; and Wall C with $3\frac{5}{8}$ -inch mineral wool bats with a continuous barrier applied over the warm surface of the insulation. Figure

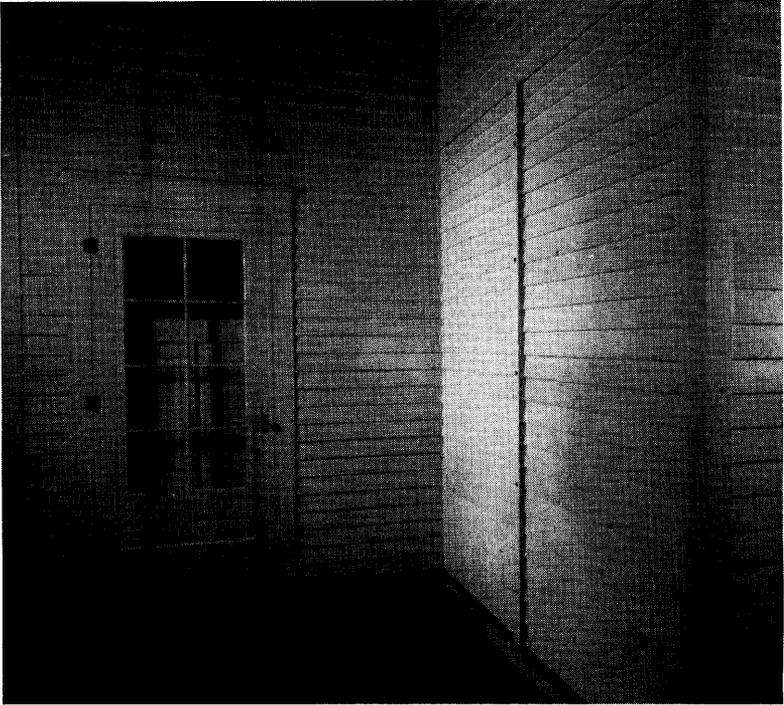
method of constructing the exterior wall section, the grooves in the studs to receive the nailing strips, and the removable sheathing panels are shown in Figure 10. Figure 8 shows the application of two types of insulating materials and removable siding panels with an exterior wall section removed. Figure 9 shows the same wall with the exterior walls assembled.

FIGURE 9. VIEW OF ENTRANCE TO BUNGALOW SHOWING THE EXTERIOR WALLS COMPLETELY ASSEMBLED.

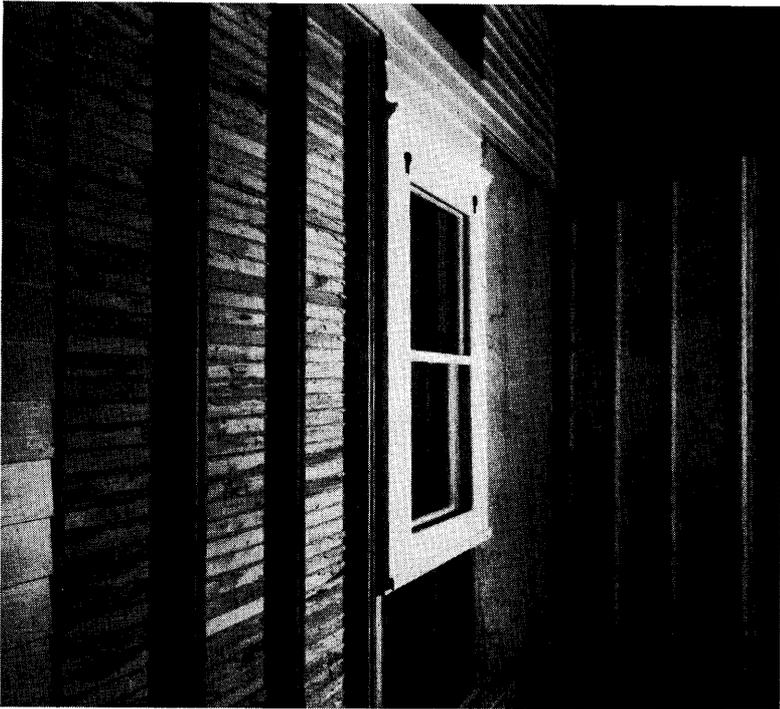
FIGURE 10. VIEW OF EXTERIOR WALL WITH OUTER WALL SECTION REMOVED SHOWING DIFFERENT TYPES OF INSULATION, WINDOW INSTALLATION, AND OUTER WALL SECTION WITH REMOVABLE SHEATHING PANELS.

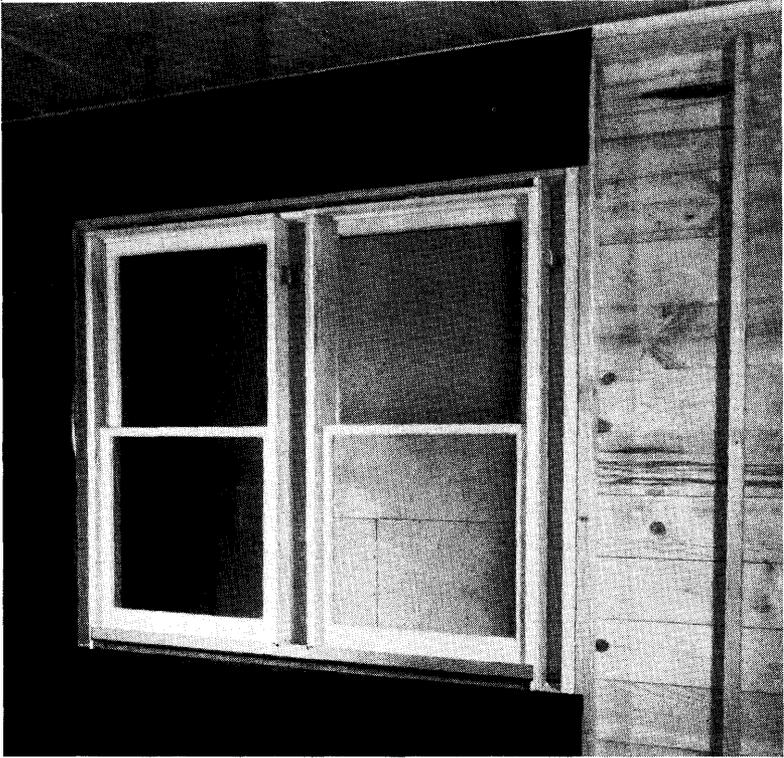
FIGURE 14. VIEW OF INTERIOR SURFACES OF WALL BEFORE LATH AND PLASTER WERE APPLIED SHOWING INSTALLATION OF CONTINUOUS BARRIER, WALL WITHOUT INSULATION, AND DOUBLE WINDOW WITH INTERIOR TRIM REMOVED.

13 shows, at the left, Wall P with 1-inch blanket insulation, and at the right, Wall R with 2-inch blanket insulation. Figure 14 shows at the left, Wall E with $3\frac{5}{8}$ -inch mineral wool insulation and a continuous barrier, and, at the right, Wall F with no insulation and no barrier. The method of attaching the barriers by lapping the edges over the studs for the blanket and bat/bak barriers will be noted in Figures 12 and 13.
