# Advanced LED Warning Signs for Rural Intersections Powered by Renewable Energy

Minnesota  
Department of  
Transportation

Taek Mu Kwon, Principal Investigator  
Department of Electrical and Computer Engineering  
University of Minnesota Duluth

Research Project  
Final Report 2011-04

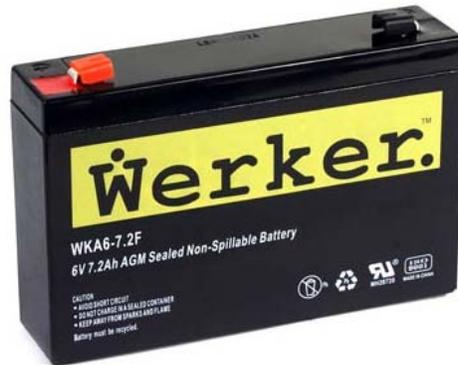
**Figure 7: Werker 6 V, 7.2 Ah (43.2 Wh) AGM lead-acid battery.**

The battery selected to support the PIR detector is the Werker 6 V, 7.2 Ah (43.2 Wh) AGM lead-acid battery (Figure 7). This battery is available at Batteries Plus for \$19.79. The dimensions of this battery are 6.0" x 3.75" x 1.25" and it weighs 2.8 lbs. In order to support the 7-day power supply requirement with low voltage protection, two batteries are needed. These two batteries are connected in series to produce 12 V, 7.2 Ah equaling 86.4 Wh.

The PIR detector is powered by Absorbed Glass Mat (AGM) lead-acid batteries (Figure 7). Typically, AGM batteries allow around 400 cycles of 100 percent discharges in its lifetime. Although AGM lead-acid plates are designed thicker for a longer lifespan, the plates tend to wear out when more than 50 percent of the battery capacity is discharged. To insure a long battery life, a limit of 50 percent discharge level is used for this design. This would extend the AGM battery lifetime to many years. Adding this limit to the energy requirement gives:

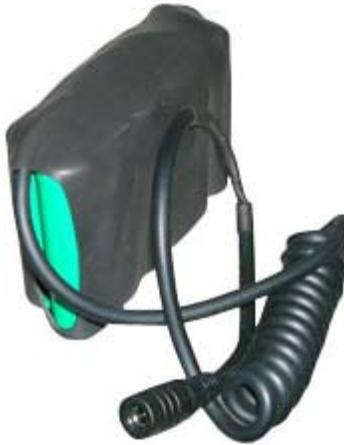
**Figure 8: Powerizer 11.1 V, 9.6 Ah (106.5 Wh) Li-ion battery.**

Since a radar detector uses six times as much power as a PIR detector, a larger capacity battery is used. A radar detector is powered by Li-ion batteries. The Li-ion battery pack selected to power a radar detector is an 11.1 V, 9.6 Ah (106.5 Wh) battery (Figure 8). In order to support the 7-day power supply requirement with low voltage protection, two batteries are needed. These two batteries are connected in parallel to produce 11.1V, 19.2 Ah equaling 213.1 Wh. This is sufficient to supply power for the 7-day power supply requirement but not sufficient for low voltage protection.

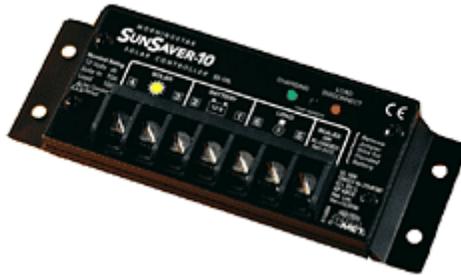
**Figure 9: Morningstar SunSaver-20L solar charge controller.**

This charge controller is used for charging AGM sealed lead-acid batteries. The SunSaver-20 uses an advanced series Pulse Width Modulation (PWM) charge control for constant voltage battery charging. A sensor next to the green LED measures ambient temperature conditions. The SunSaver-20L is rated for 12 V systems. The maximum solar array open circuit voltage is 25 V. The maximum short circuit current rating for the SunSaver-20 is 25 A. The operating power consumption is 10 mA. Use of copper wires between 10 AWG and 14 AWG are

recommended. The Low Voltage Disconnect (LVD) is set at 11.5 V and the LVD reconnect is set at 12.6 V.

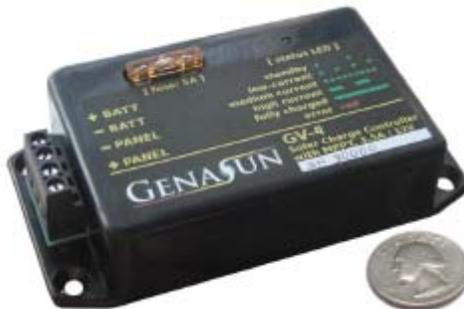
**Figure 10: Genasun GV-4 solar charge controller**

This charge controller is used for charging Li-ion batteries. GV-4 uses Maximum Power Point Tracking (MPPT) for charging. The GV-4 is rated for a 12 V battery up to 45 W. The maximum load current is 4 A. The solar panel open circuit voltage must be between 0–27 V. The operating power consumption is 0.125 mA. Cooper wire between 12 AWG and 24 AWG are recommended. The Genasun GV-4 has LVD set at 7.2 V.

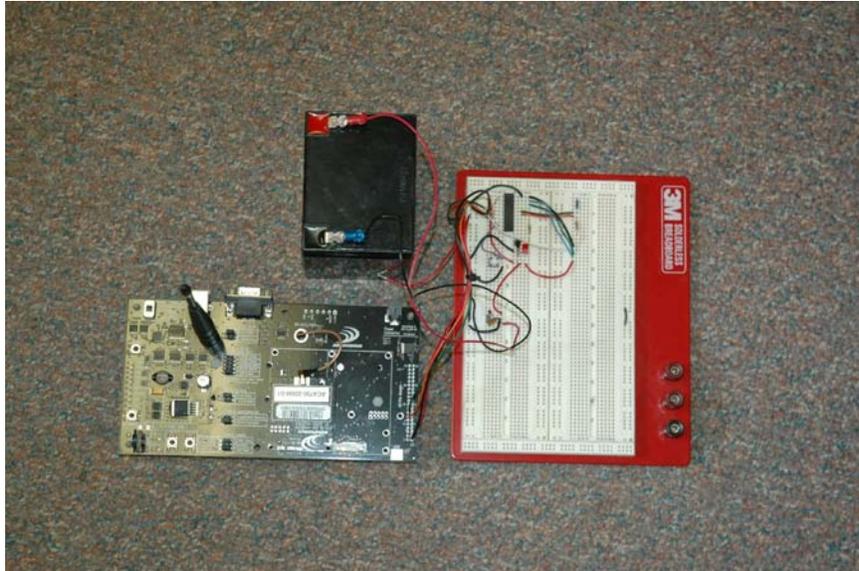
**Figure 22: Testing of the AeroComm AC4790 SDK.**

In order to test the AC4790 wireless module, an AeroComm Software Developer Kit (SDK) was purchased. The SDK includes two development boards which contain AC4790 wireless transceivers, MMCX antenna, power adapter, RS-232 cable, USB cable, software, and documentation. Using a development board, the AC4790 was interfaced with the PIC16F690 microcontroller, a 5 V regulator, LEDs, and a pushbutton. The whole system was powered by a 12 V battery. This initial configuration is shown in Figure 22.

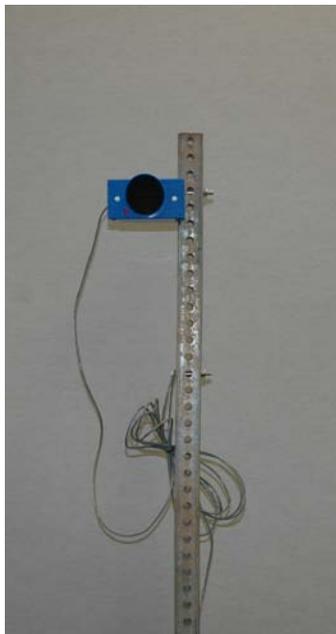
**Figure 25: SonaSwitch ultrasonic test circuit.**

A more powerful ultrasonic sensor was purchased, the SonaSwitch 1400 ultrasonic sensor. This sensor was designed for industrial applications such as proximity detection and vehicle detection at drive-ups. The SonaSwitch 1400 ultrasonic sensor has a range of 1.5 ft (0.46 m) to 35 ft (10.7 m) and provides one Normally Open (NO) relay contact output along with power and ground connections. This NO contact was connected to a buzzer tied to a 3.7V battery. The sensor was powered by a 12 V battery and draws about 50 mA. When detection occurs, the relay will close causing the buzzer to sound. The maximum detection distance is adjusted by a “Range Control” potentiometer. This sensor was housed in a single gang electrical box. The SonaSwitch sensor was mounted on a free-standing square channel pole shown in Figure 25.

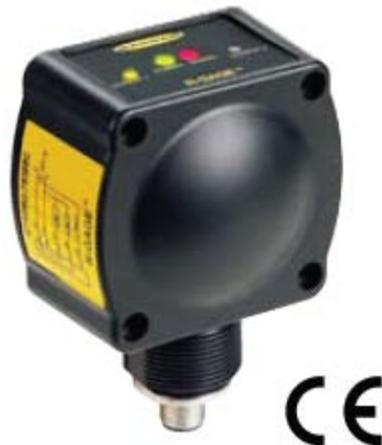
**Figure 26: Banner R-Gage QT50RAF sensor.**

The radar sensor tested is the Banner R-Gage QT50RAF Sensor. This radar sensor uses Frequency Modulated Continuous-wave (FMCW) radar. FMCW radar transmits a frequency sweep, often called a chirp. The signal is reflected from distant targets and detected by the receiver. By measuring the frequency of the return signal, the time delay between transmission and reception can be measured and therefore the range is determined. Advantages of this sensor are that it can detect both moving and stationary objects. Also, using the R-Gage radar sensor allows a detection zone to be present at each stop sign. Vehicles are detected as they enter the detection zone and remain detected until they leave the detection zone. This allows for only one sensor to be used at each stop sign instead of the previously mentioned sensor configuration of one PIR sensor and one ultrasonic sensor per stop sign. Figure 26 shows the Banner R-Gage Radar sensor.

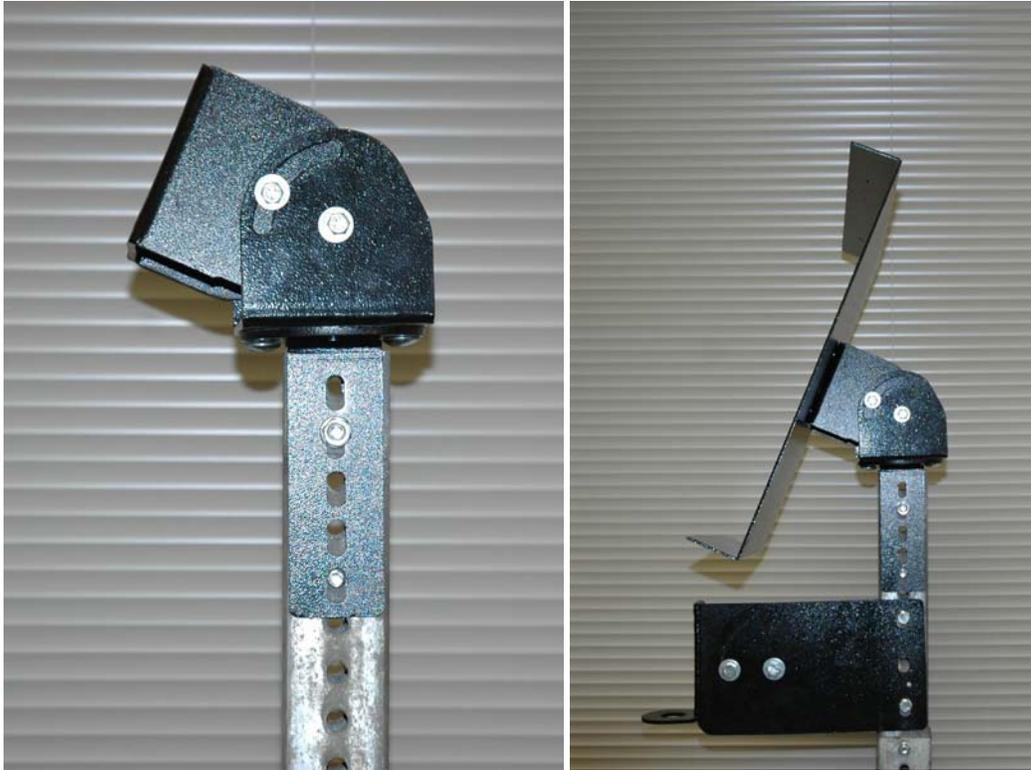
**Figure 38: Solar panel mounting bracket (left) and attached solar panel housing (right).**

Each assembled solar panel and housing is attached to a solar panel mounting bracket. This bracket, also built by Povolny Specialties, is designed to mount to a u-channel sign post. Figure 38 shows an image of the solar panel mounting bracket (left) and the mounted solar panel housing (right). Also shown in the figure is the mounting bracket for the radar sensor. This mounting bracket, built by Povolny Specialties, allows the radar sensor to be adjusted both vertically and horizontally.

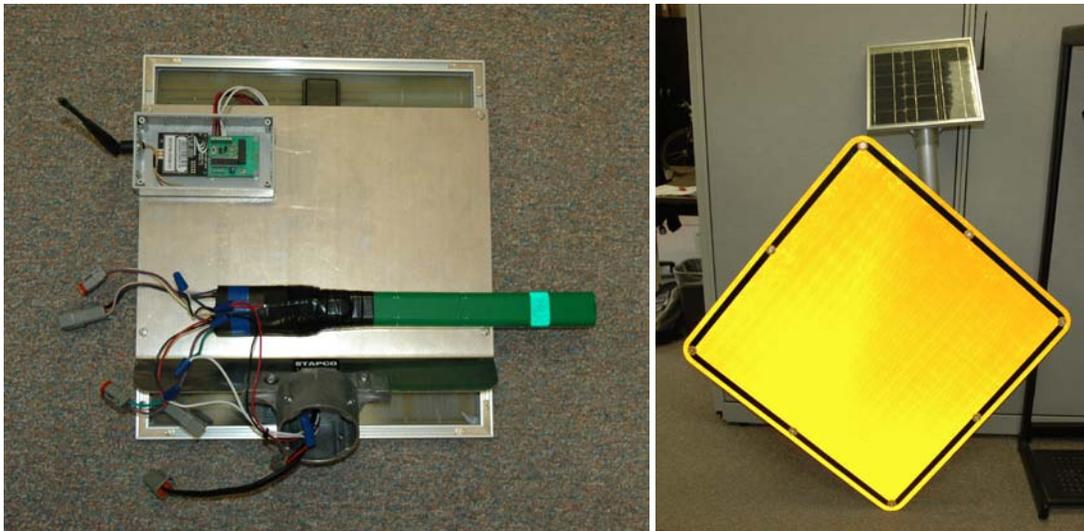
Figure 40: Modified Tapco circuitry (left) and complete blinker sign.

The wireless circuitry for the blinker signs is mounted in a small plastic enclosure screwed to the back of the supplied Tapco solar panel. The wireless antenna is mounted on the outside of this enclosure. The Tapco battery must be charged for 24 hours prior to installation. The battery bank slides into a metal tube mounted on the back of the warning sign. Connections are made to for the LEDs and solar panel. The solar panel then mounts on top of the metal tube and is locked in place with three hex nuts. Complete Tapco installation instructions can be found in Appendix B. Figure 40 shows the back of the Tapco solar panel with the additional wireless and relay circuitry (left) and a complete blinker sign without any lettering (right).

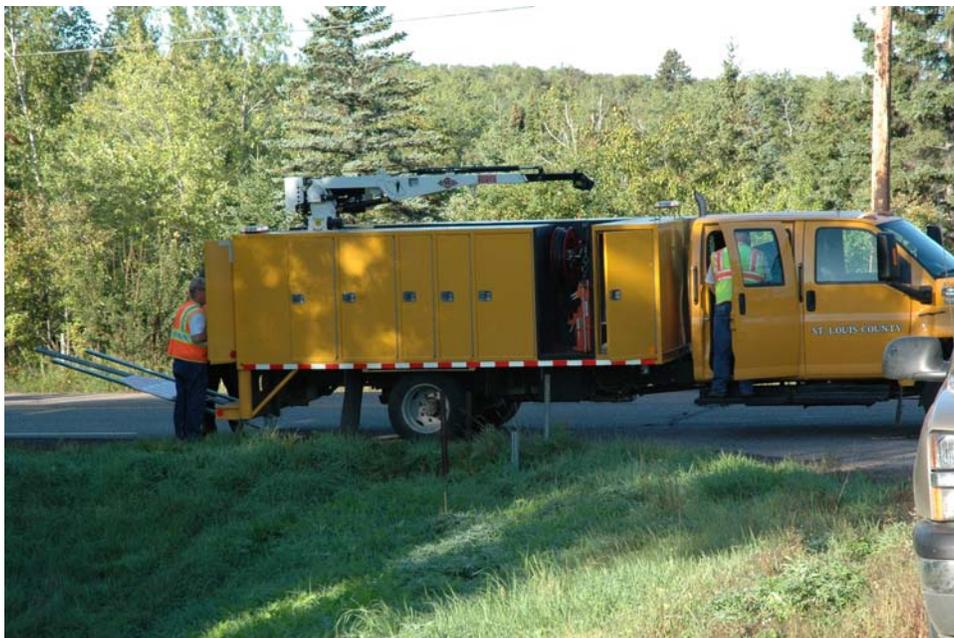
**Figure 41: Utility truck holding the first radar detector stop sign.**

The first component that was installed was the radar detector (D3) located in the southeast quadrant of the intersection. Originally, the stop signs at Eagle Lake Road were mounted between two 8 ft (2.4 m) u-channel sign posts. These two posts are bolted to two 8 ft (2.4 m) u-channel sign posts buried 6 ft (1.8 m) in the ground. In order to compensate for the extra weight being added to the stop sign by the radar detector, another u-channel sign post was needed. This sign post acted as a brace and was attached at a 45° on the back of the stop sign and to another post buried in the ground. A utility truck was used to hold the stop sign while the radar detector components were being installed on the sign. Figure 41 shows an image of the utility truck holding the stop sign.

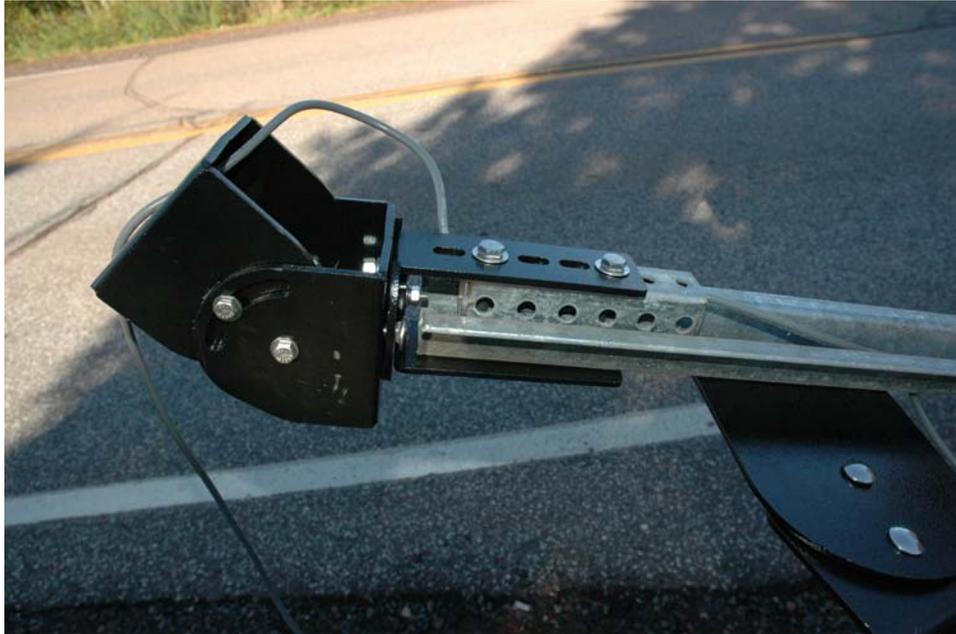
**Figure 42: Mounted solar panel and radar sensor brackets.**

below the solar panel bracket. Figure 42 shows an image of the solar panel and radar sensor brackets.

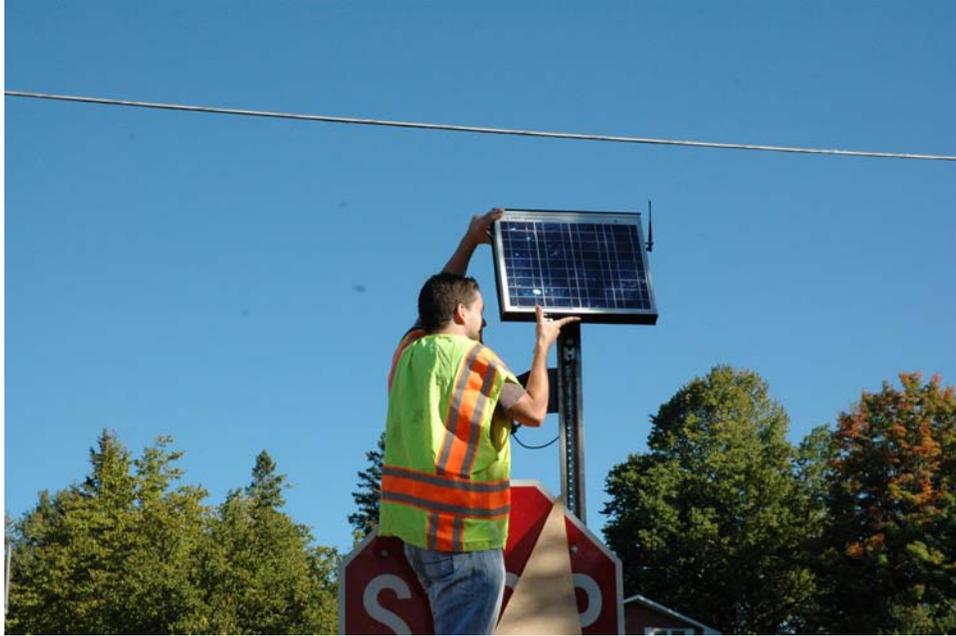
**Figure 43: Adjusting the solar panel tilt angle.**

The solar panel housing was then attached to the solar panel bracket. The sign was lifted into place and bolted to the three u-channel posts buried in the ground. Once the sign is in position, the solar panel needed to be adjusted to face south and tilt vertically at an angle of  $66.8^\circ$ . A compass was used to face the solar panels south and a cardboard cut-out was used to adjust the tilt angle. Figure 43 shows the adjusting of the solar panel tilt angle using the cardboard cut-out.

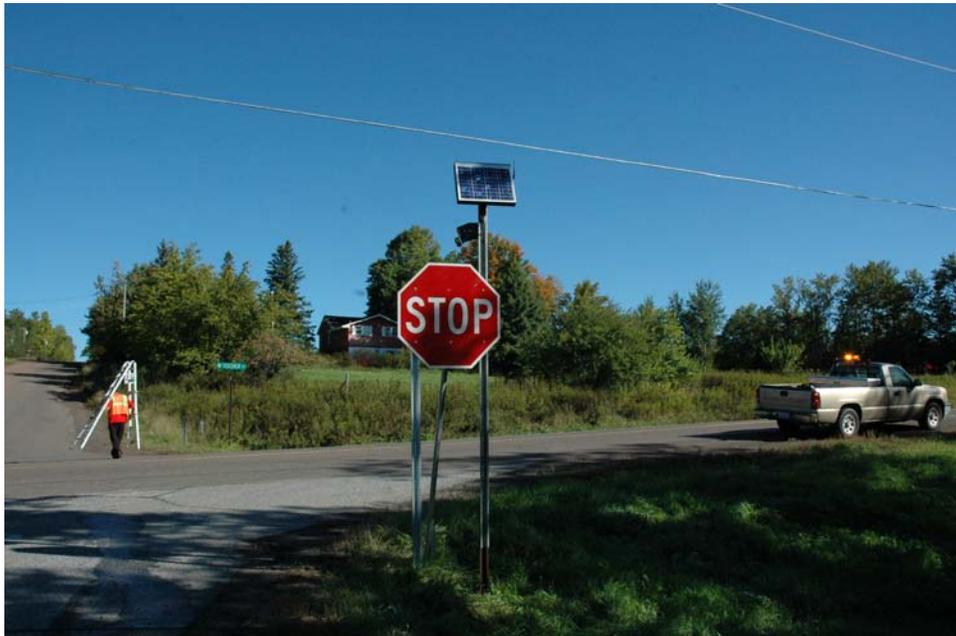
**Figure 44: Installed radar detector.**

Finally, the position of the radar sensor was adjusted and the installation of the first radar detector was complete. Figure 44 shows an image of the installed radar detector (D3). The second radar detector (D2) was installed in the same fashion.

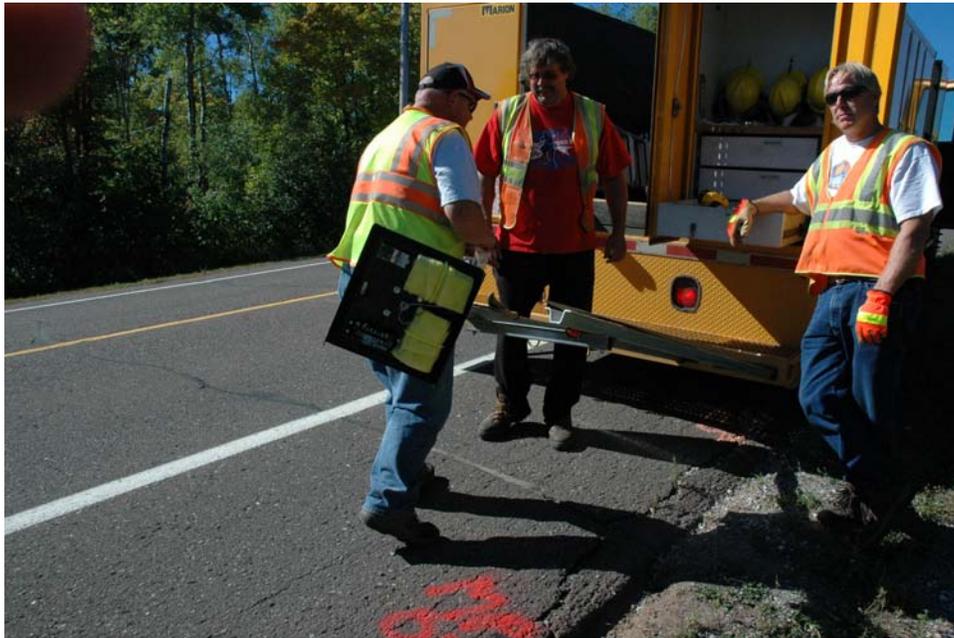
**Figure 45: Utility truck holding the PIR detector.**

The second component installed was the PIR detector (D1) which detects vehicles traveling westbound on West Tischer Road. A PIR detector is not mounted on existing structure like the radar detector so a dual 8 ft (2.4 m) u-channel sign post configuration was used. The solar panel is mounted on the top the outer u-channel sign post. Again, the utility truck was used to hold the sign posts while the solar panel bracket, solar panel housing, and PIR sensor were mounted. The PIR sensor is mounted below the solar panel on the inner u-channel sign post. It is slightly tilted in order to only detect vehicles traveling in the westbound lane. Figure 45 shows an image of the utility truck holding the completed PIR detector.

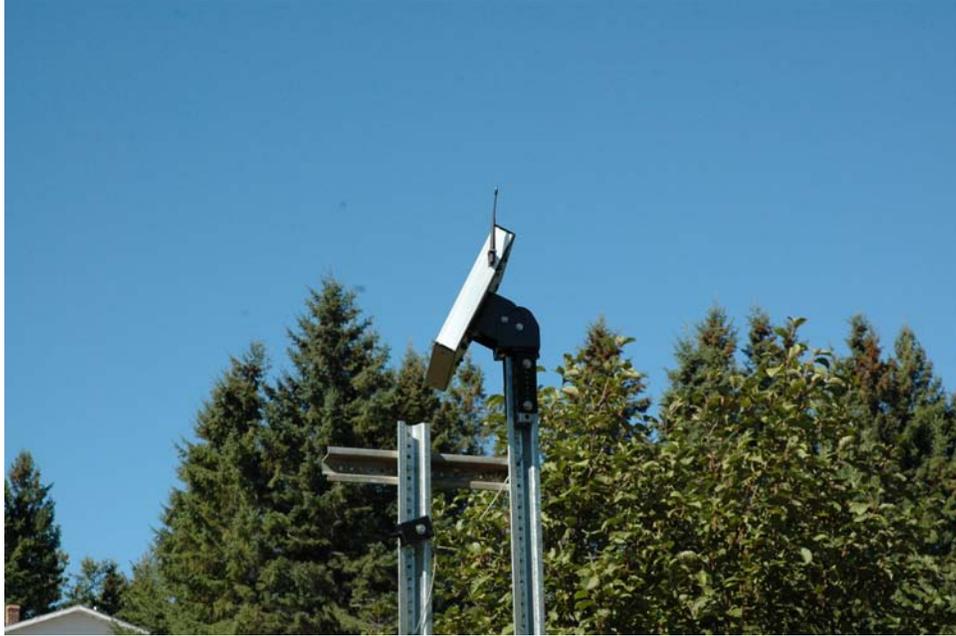
**Figure 46: Installed PIR detector.**

The completed PIR detector was mounted on previously buried 8 ft (2.4 m) u-channel sign posts. Figure 46 shows an image of the installed PIR detector (D1). The second PIR detector (D4) was installed in a similar fashion.

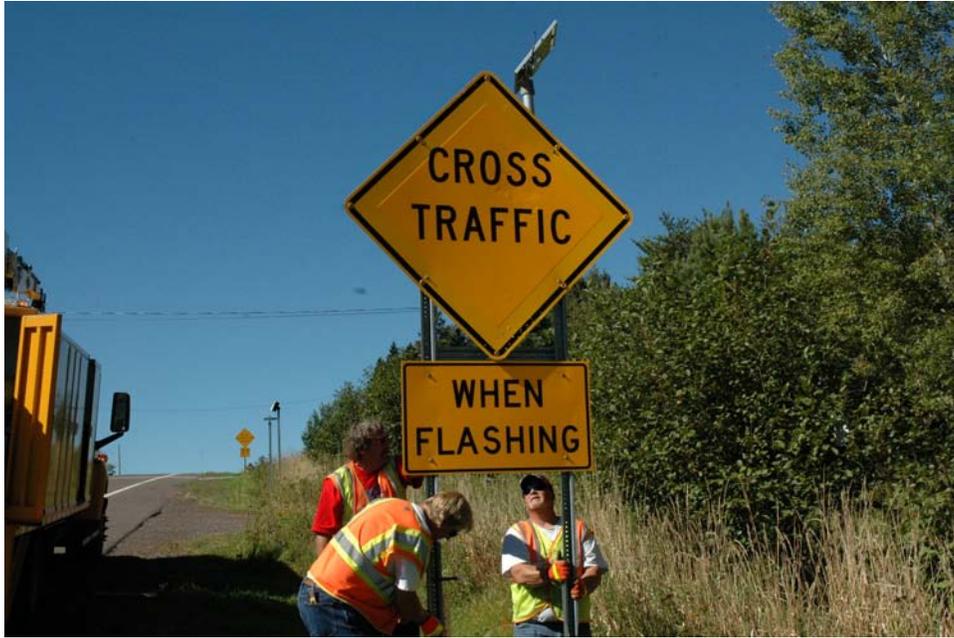
**Figure 47: Installed “CROSS TRAFFIC WHEN FLASHING” blinker sign.**

The last components installed were the three blinker signs. The first blinker sign installed was the “CROSS TRAFFIC WHEN FLASHING” blinker sign (S1) located on West Tischer Road. This is a 48 in (121.9 cm) warning sign. This is the largest of the three blinker signs so a three u-channel support system similar to the radar detectors was used. Installation of the blinker sign components was quite simple. Three connections from the solar panel to the sign had to be made: power, solar panel charging, and blinker control. The solar panel was then mounted to the top of the battery bank tube and adjusted to face south. Tapco does not provide an adjustable tilt angle on their solar panels. The lettering of the sign was done by the St. Louis County Sign Shop. Figure 47 shows the installed “CROSS TRAFFIC WHEN FLASHING” blinker sign.

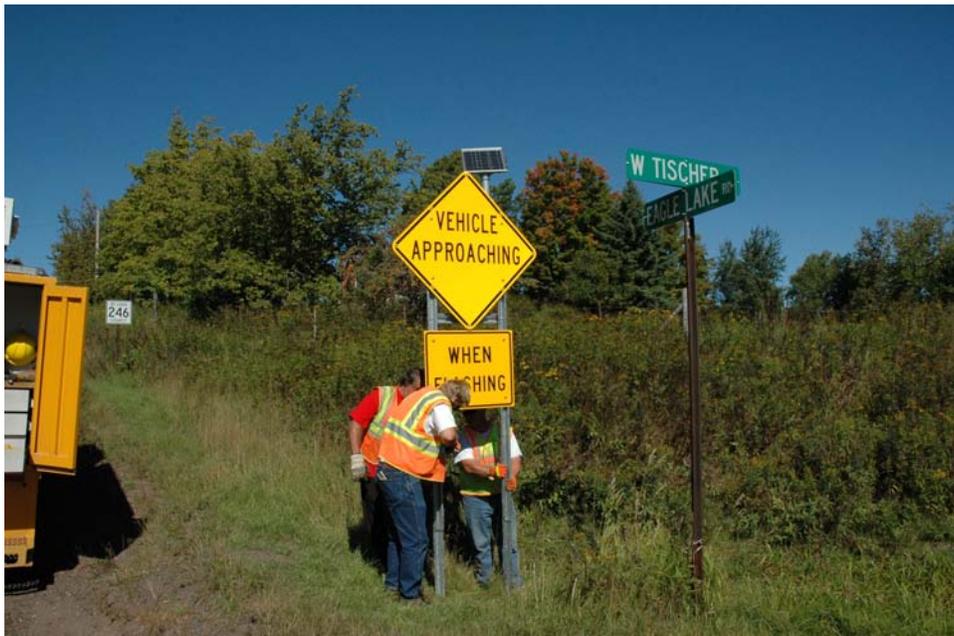
**Figure 48: Installed “VEHICLE APPROACHING WHEN FLASHING” blinker sign.**

Next, the two “VEHICLE APPROACHING WHEN FLASHING” blinker signs (S2 and S3) were installed on Eagle Lake Road. These two signs are 36 in (91.4 cm) warning signs and only need to be supported by two u-channel sign posts. Figure 48 shows the installed “VEHICLE APPROACHING WHEN FLASHING” blinker sign.

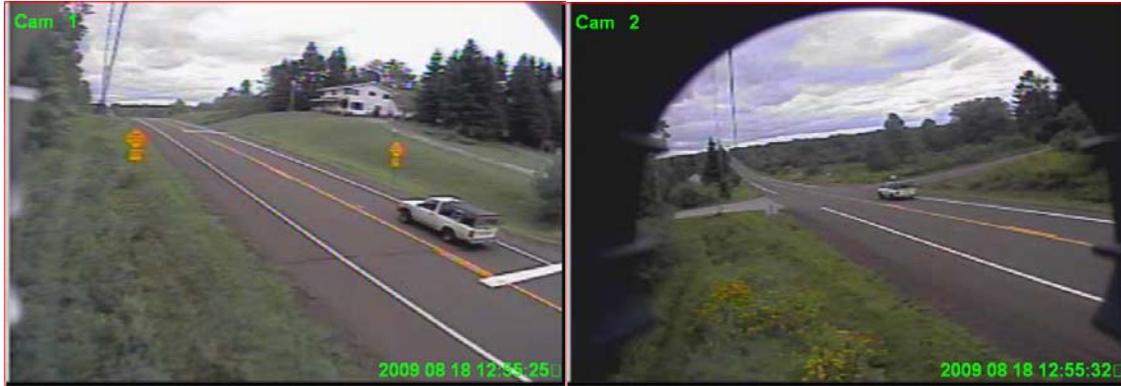
The DVR is mounted in front of the utility pole which C1 is attached to. This is because this pole contains a transformer. A custom DVR cabinet was built by Povolny Specialties. This cabinet is suspended between two u-channel poles in order to raise it above the ground. The cabinet is constructed from aluminum and is NEMA 3R rated which is intended for outdoor use primarily to provide a degree of protection against windblown dust, rain, and sleet; undamaged by ice which forms on the enclosure. The cabinet was modified to contain ventilation holes in order for air to circulate throughout the cabinet. The cabinet is attached to the u-channel poles using sealable screws. The cabinet has a front door that is lockable. Figure 50 displays sample images from both Camera 1 and Camera 2 at the intersection.

Figure 50: Images of a vehicle traveling towards (left) and through (right) the intersection.

An important part of the data collected at the intersection is the speed of vehicles traveling westbound towards the intersection on West Tischer Road. Two transverse white lines, referred to as speed markers, and separated by a distance of 150 feet (45.7 m) were installed on the pavement surface on July 9, 2009. The first speed marker is 425 ft (129.5 m) from the intersection. The second speed marker is 575 ft (175.3 m) from the intersection. Speed markers are visible in Figure 50 (left).

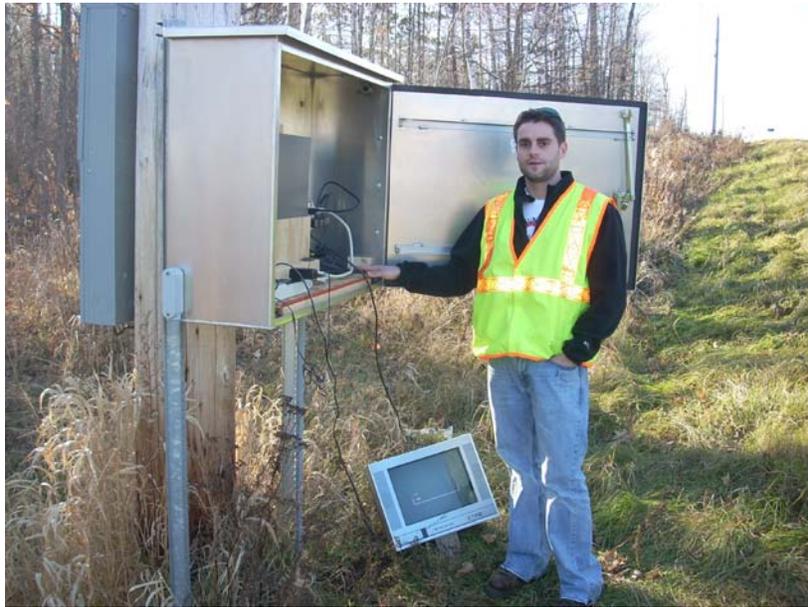
**Figure 51: On-site data collection.**

During the summer and fall, data collection was done on-site. A TV monitor was connected to the DVR using an s-video cable in order to navigate the file system on the DVR. A 750 GB external hard drive connected to the DVR via a USB cable was used to download the data. Figure 51 shows an image of on-site data collection set-up. During the winter months, it was found that it was easier to disconnect the DVR from the system and download the data in lab.

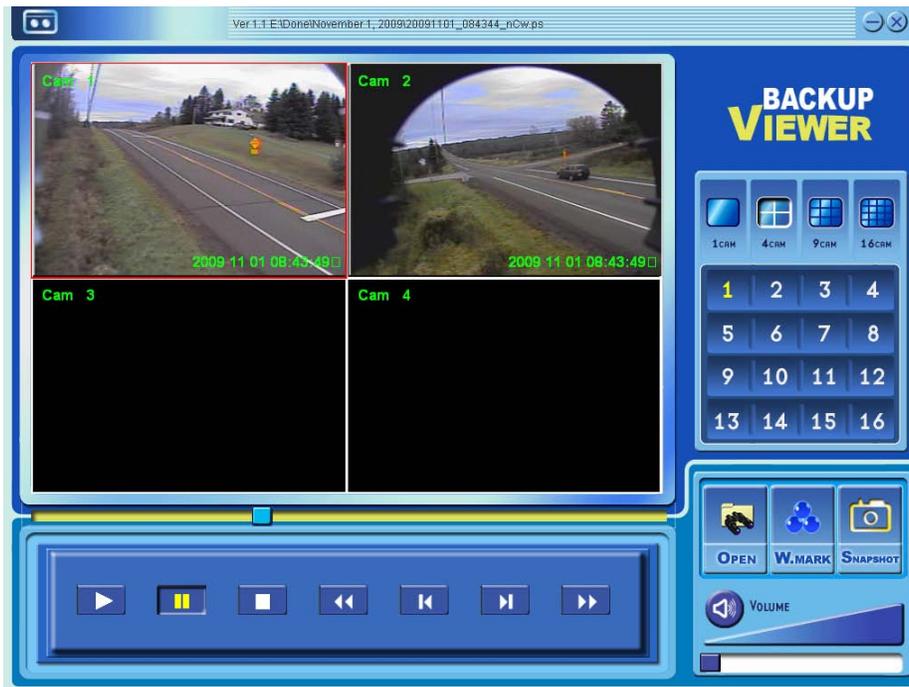
Figure 52: Supplied video viewer.

The video files collected from the on-site video monitoring system are encoded in a proprietary file format. This means that only the supplied video viewer (Figure 52) can be used to view the video files. This makes analysis of the video files using software very difficult. A vehicle speed software program was developed using Microsoft Visual Studio .NET Visual Basic and LEADTOOLS Document Imaging add-on. The vehicle speed GUI is shown in Figure 53.
