A Computational Study of the I-35W Bridge Collapse

CTS 09-29

Final Report

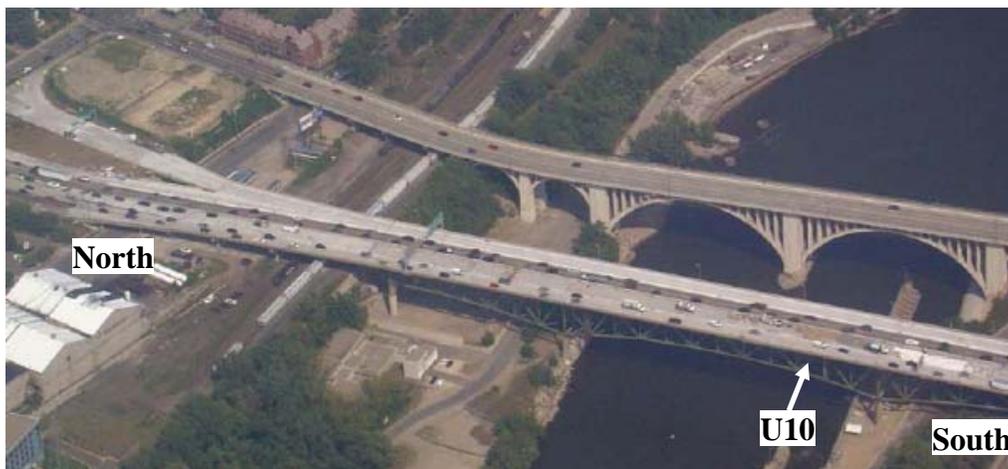
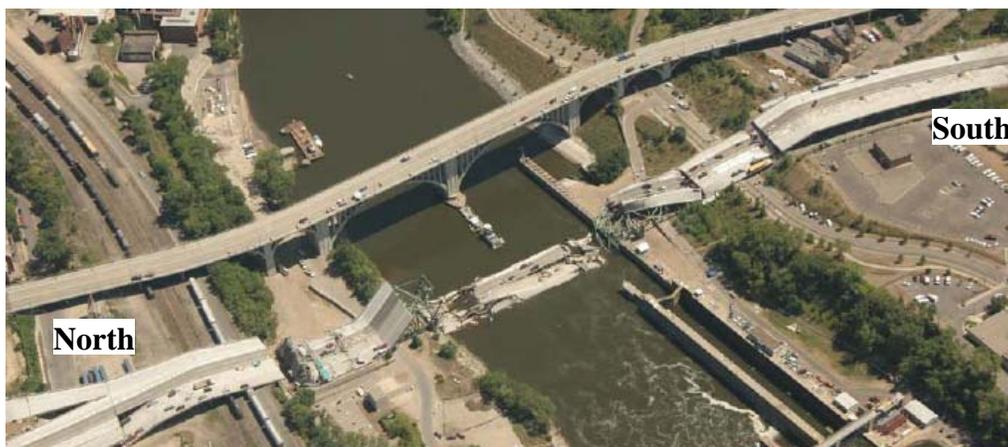
Figure 1.1 Photographs of I-35W Bridge (from NTSB 2008a).

On Wednesday, August 1, 2007, about 6:05 p.m. central daylight time, the bridge carrying Interstate Highway 35W (I-35W, National Bridge Inventory Structure No. 9340) over the Mississippi River in Minneapolis, Minnesota, suffered a tragic collapse within a matter of seconds. Figure 1.1 shows a comparison of the bridge before and after the collapse. The photographs are from a report by the National Transportation Safety Board (NTSB 2008a). The 456-foot-long center span of the deck truss portion of the bridge fell into the Mississippi River. According to a post-accident investigation by the NTSB (NTSB 2008b), at the time of the collapse, a total of 111 vehicles were on the collapsed portion, and of these, 17 vehicles fell into the water. Thirteen people died, and 145 people were injured because of the collapse.

(a) Before collapse

(b) After collapse

Figure 6.3 shows the elastic deflection of the bridge model when the strength of the diagonal member L9/U10W was set to zero and loading Case 4 was applied. The deflection shown in the figure is enhanced in order to make the deformation visible. The center span of the bridge severely deflected downwards, and the model was distorted and twisted in the region close to panel point U10W. Although material and geometrical nonlinearity were not considered in the model, the distortion and twisting in Figure 6.3 correlates with the photograph of the collapsed bridge shown in Figure 1.1(b).

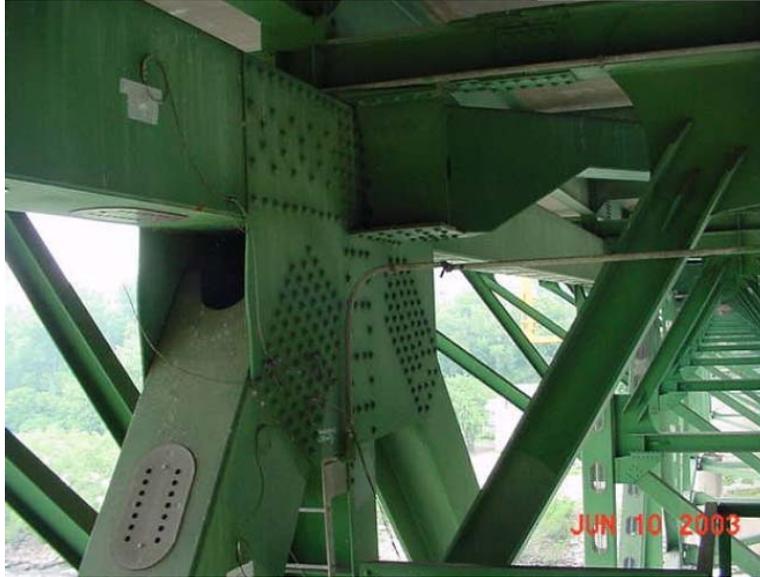
Figure 2.4 Panel point U10.

After the bridge collapsed, field investigation was conducted by the Mn/DOT and the NTSB. Reported observations (Hill et al. 2008; NTSB 2008a; NTSB 2008b), summarized in the following, indicate that the failure initiated at panel point U10. Figure 2.4(a) is a photograph taken prior to the collapse (NTSB 2008a), showing a pair of gusset plates connecting five truss members at the panel point U10 of the west main truss (U10W). Figure 2.4(b) identifies the five truss members: upper chords U9/U10 and U10/U11, diagonals L9/U10 and U10/L11, and a vertical U10/L10. The five truss members were connected through a pair of 0.5-inch-thick gusset plates of ASTM A441 grade 50 steel (Beshah et al. 2008) and using 1-inch diameter rivets (Mn/DOT 2008). The upper chords U9/U10 and U10/U11 and compression diagonal L9/U10 were box sections, while the tension diagonal U10/L11 and vertical U10/L10 were W-sections. All members were welded built-up sections.

(a) Photograph of U10W before collapse (from NTSB 2008a)

(b) Member designation

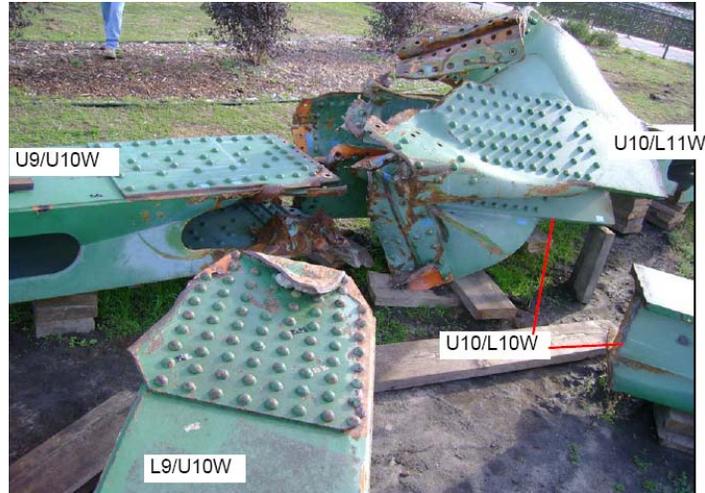
Figure 2.5(a) shows a photograph of panel point U10W taken after the collapse (NTSB 2008a), while Figure 2.5(b) illustrates the three primary fractures seen in Figure 2.5(a) and that were commonly observed in all four U10W and U10E gusset plates (NTSB 2008c). These fractures are listed below:

- (A) Diagonal fracture along rivet holes connecting the gusset plate to the compression diagonal L9/U10. The fracture occurred along the perimeter holes of the rivet group adjacent to U10/L10.
- (B) Horizontal fracture below the lower edge of upper chord U9/U10.
- (C) Vertical fracture near the separation between the upper chords U9/U10 and U10/U11.

(a) Photograph of U10W (from NTSB 2008a)

(b) Reported locations of fracture

Fracture of gusset plates was uniquely observed in panel point U10. This observation combined with the fact that the design strength of the U10 gusset plates was insufficient to carry the design forces (Holt and Hartmann 2008) strongly suggests that failure of the I-35W Bridge initiated in the U10 gusset plates.

The primary objective of the gusset plate connection model analysis was to examine the stress and strain condition that may have led to the failure shown in Figure 2.5. Therefore, the rivet connection was explicitly modeled only between the compression diagonal L9/U10 and the gusset plates. Unlike the other four truss members, which were merged to the gusset plates, the diagonal L9/U10 was modeled as an independent element. Force transfer between the flange plate of L9/U10 and the gusset plates was permitted only in the direction normal to the surface (In other words, friction was neglected). As shown in Figure 5.2, rivets were modeled as rigid cylindrical shells interacting with the periphery of the rivet holes, either in the flange plate of L9/U10 or the gusset plate. A uniform pressure of 8.2 ksi was applied at both sides of the riveted joint within an annular region of 0.3 inches from the edge of holes to produce a pre-tension of 10 kips. This pre-tension is equivalent to the minimum bolt-pretension specified by the Research Council on Structural Connections (RCSC 2004). The pressure was also needed to prevent separation between the diagonal L9/U10 and the gusset plates during analysis.

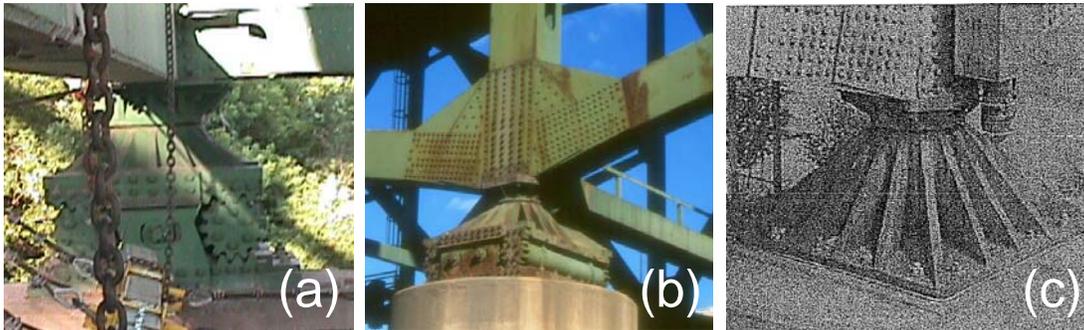
The main trusses were supported by a roller bearing at Piers 5, 6, and 8, and by a hinge bearing at Pier 7. Figure A.3 shows photographs of the roller and hinge bearings. Based on field inspection, URS (2006) reports “relatively poor” conditions of bearings at Pier 6 and 7, which were directly underneath the expansion joints, and also states that “[all] the roller bearings seem to have thick coating of paint and did not appear to be functioning as intended under live load.”

Judging from the mechanism of the bearings, out-of-plane motion (perpendicular to the primary plane of the main trusses) was restrained at the support points.

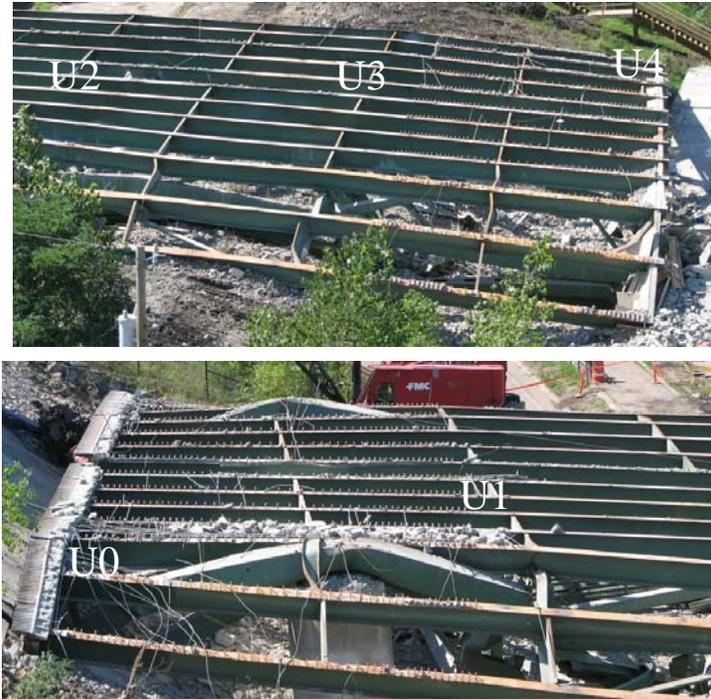
Figure A.11 Shear studs in stringers placed only in the first span of the continuous span (from Prof. Taichiro Okazaki).

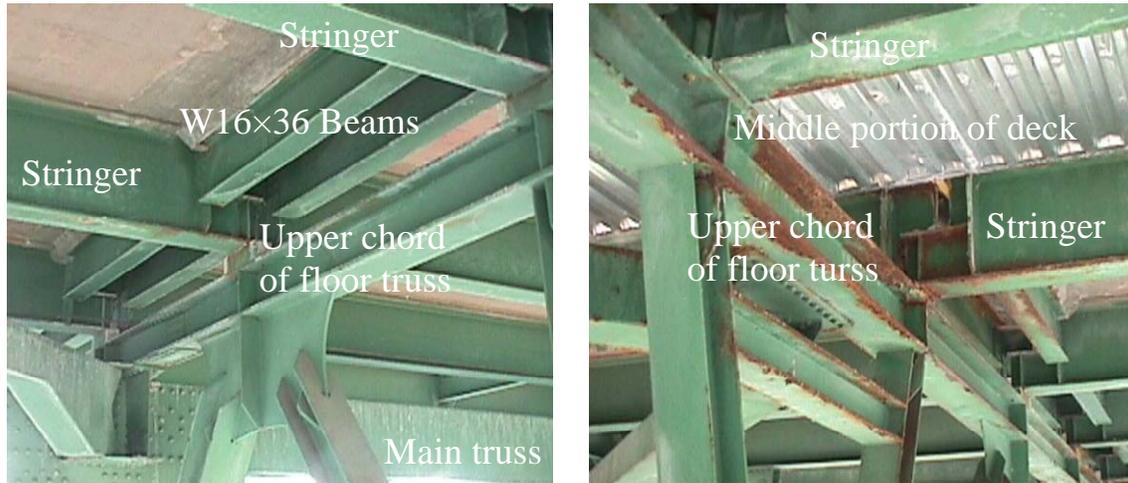
Figure A.13 Photographs of stringer expansions viewed from below (from Prof. Robert Dexter).
