Evaluating Roadway Subsurface Drainage Practices

1. Report No. MN/RC 2009-08	2.	3. Recipients Accession No.	
4. Title and Subtitle Evaluating Roadway Subsurface Drainage Practices		5. Report Date January 2009

Final Report

Minnesota Department of Transportation
Research Services Section
395 John Ireland Boulevard, MS 330
St. Paul, Minnesota 55155-1899

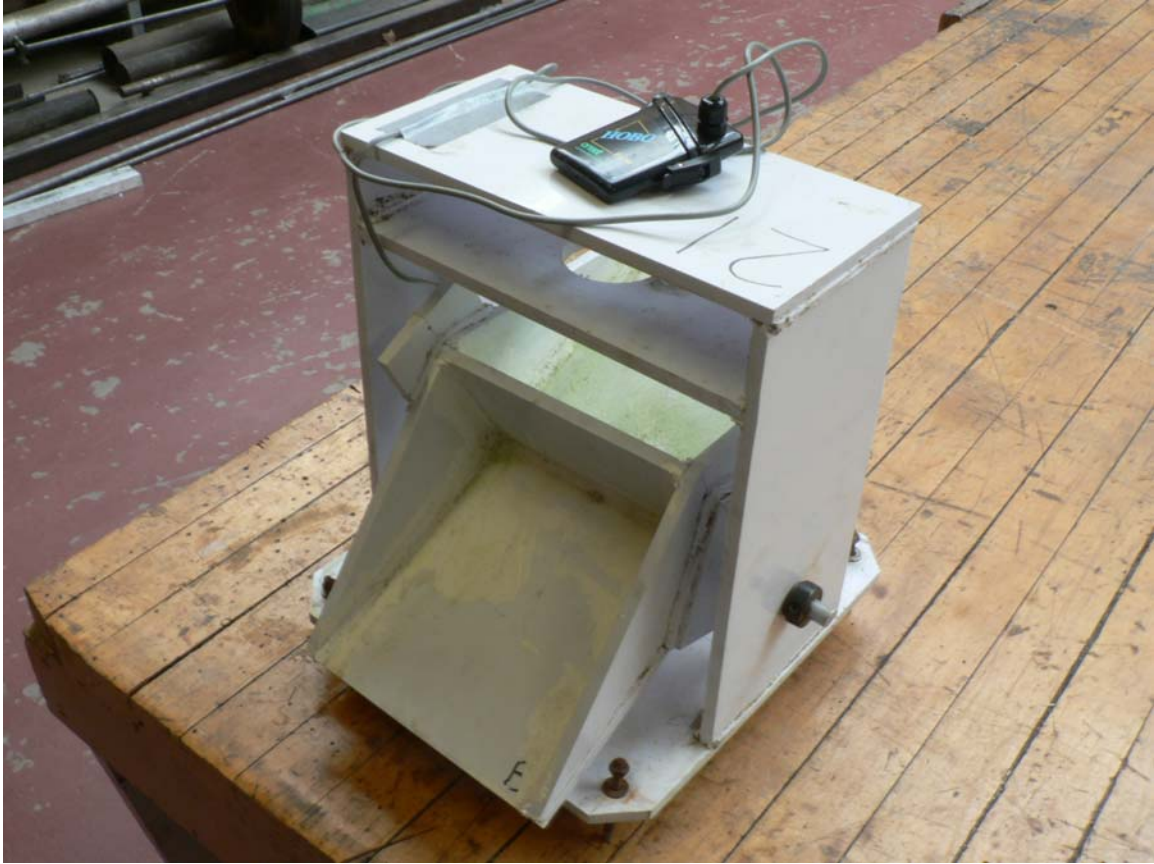
Figure 2.2 A constructed tipping bucket, with a data logger on top of the meter

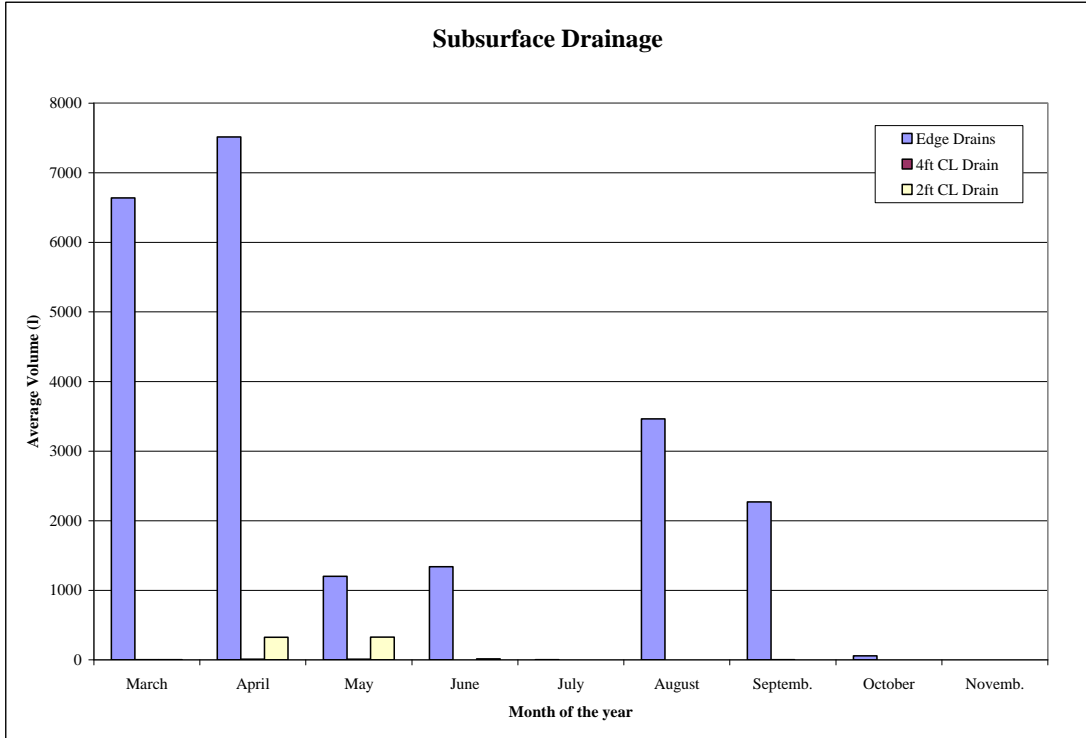
Figure 3.1 Average drained volumes for edge/centerline drains (l) – 2006

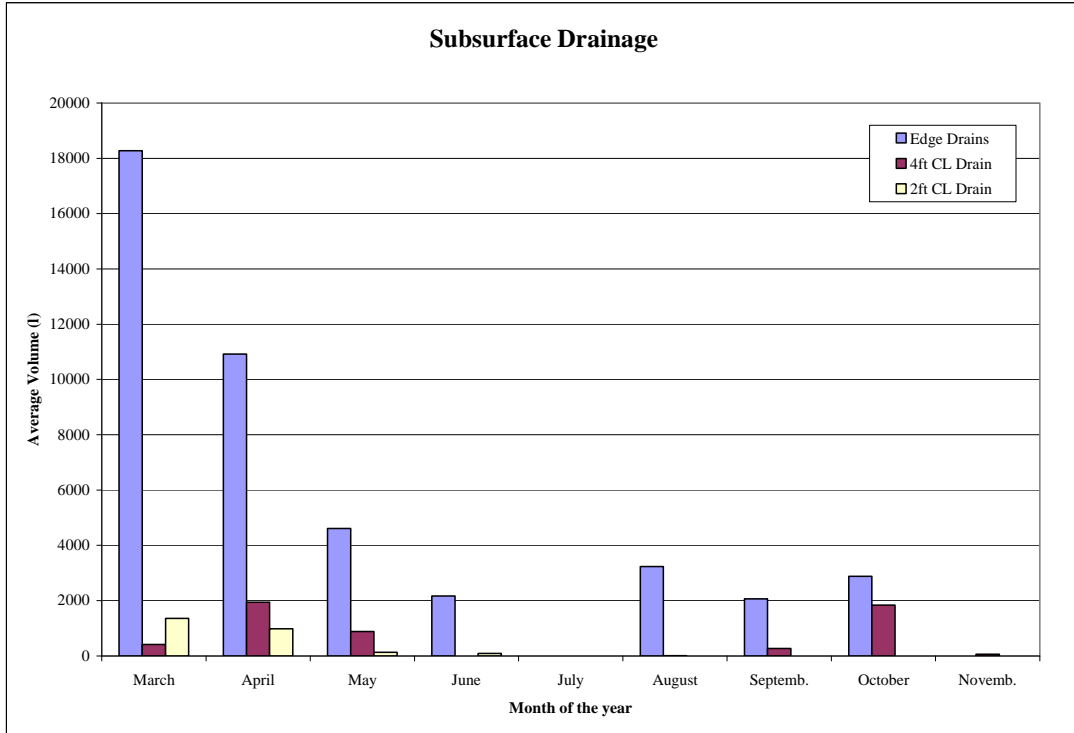
Figure 3.2 Average drained volumes from edge/centerline drains (l) – 2007

Figure 3.2 shows the monthly average volume of water drained from the three treatments during the 2007 monitoring period. In a behavior similar to that of the 2006 year, edgedrains collected much more water than the other two treatments combined during the entire year. Likewise, volumes collected during both March and April were considerably higher than those of the other months. With the exception of only March, the 4ft centerline drains collected more water than the 2ft centerline drains.

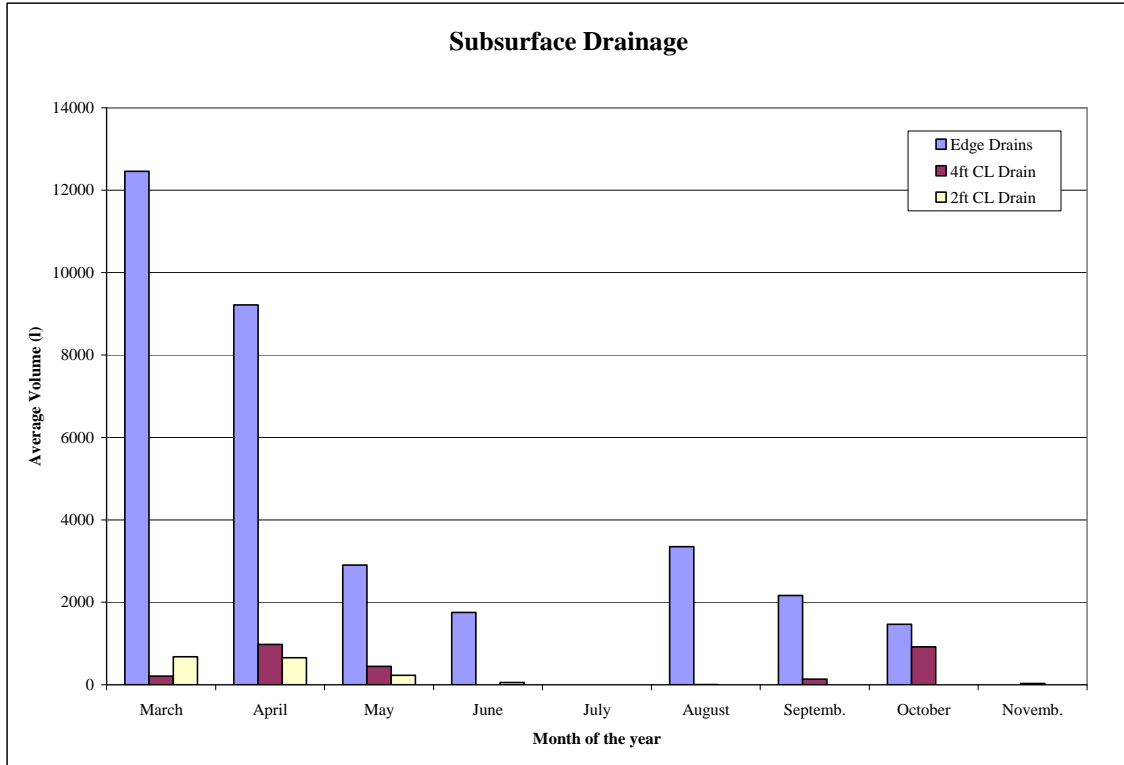
Figure 3.3 Average drained volumes from edge/centerline drains (l) – 2006/2007

Figure 3.3 shows the monthly average volume of water drained from the three treatments during the 2006-2007 years. As expected, water collected from both the 2ft centerline drains and the 4ft centerline drains were exceeded by the volume collected from edgedrains. With the exception of only March, the 4ft centerline drains collected more water than the 2ft centerline drains.

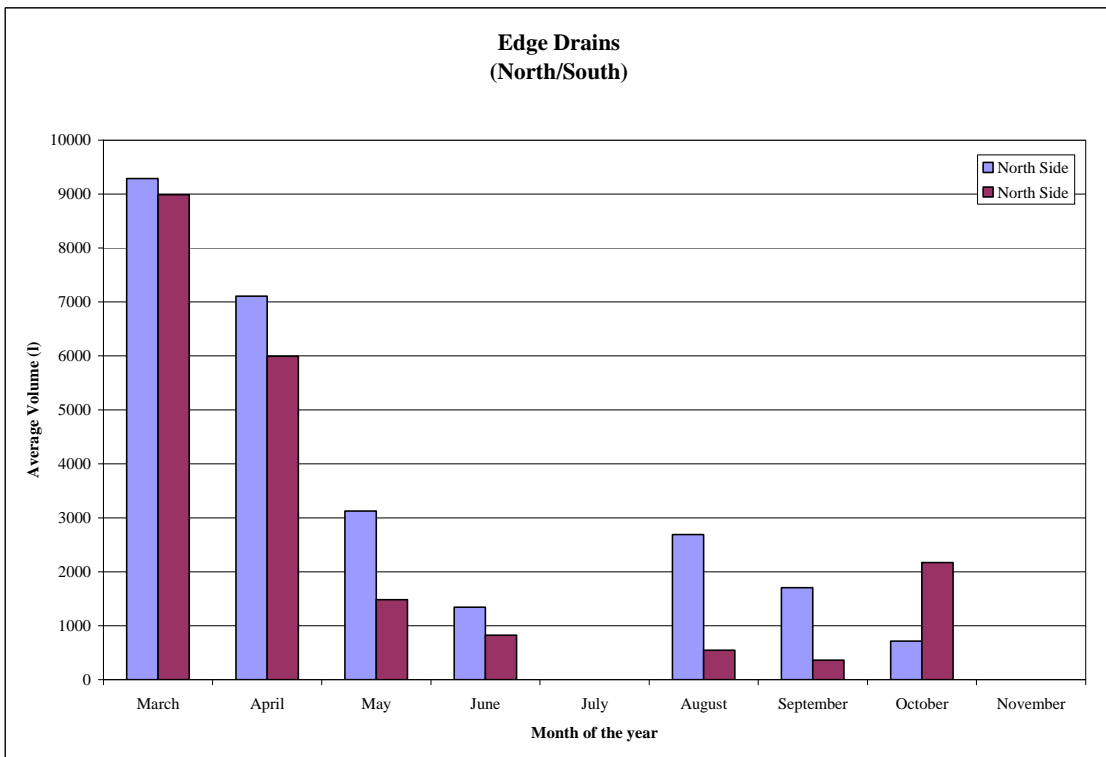
Figure 3.5 Average drained volumes from north/south edgedrains (l) - 2007

Figure 3.5 presents the monthly average volume of water drained during 2007 from edgedrains located on either side of the road. In contrast to the results obtained for the 2006 monitoring

period, for the 2007 monitoring period the drains on both sides of the road had similar behavior for March, April, July and November, but in May, August and September the north side drains had higher drainage volumes than the south side drains. Both drains showed significant volumes drained for October in contrast to that observed for the 2006 monitoring period.

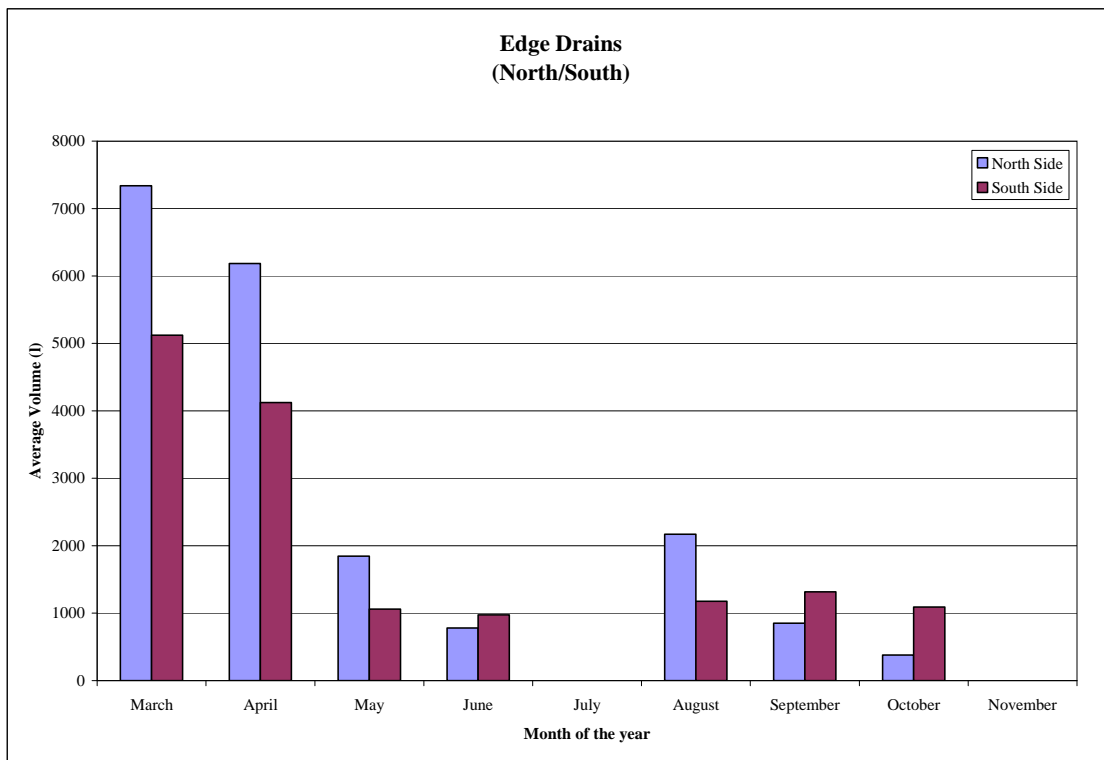
Figure 3.6 Average drained volumes from north/south edgedrains (l) – 2006-2007

Figure 3.6 presents the monthly average volume of water drained during 2006-2007 from edgedrains located at either side of the road. Again, there is not a clear difference in behavior due to the locations of drains: during March, April, May, and August, volumes coming from the north drains exceed the ones coming from the south drains; however, during June, September, and October, the results, although close, show an opposite behavior.

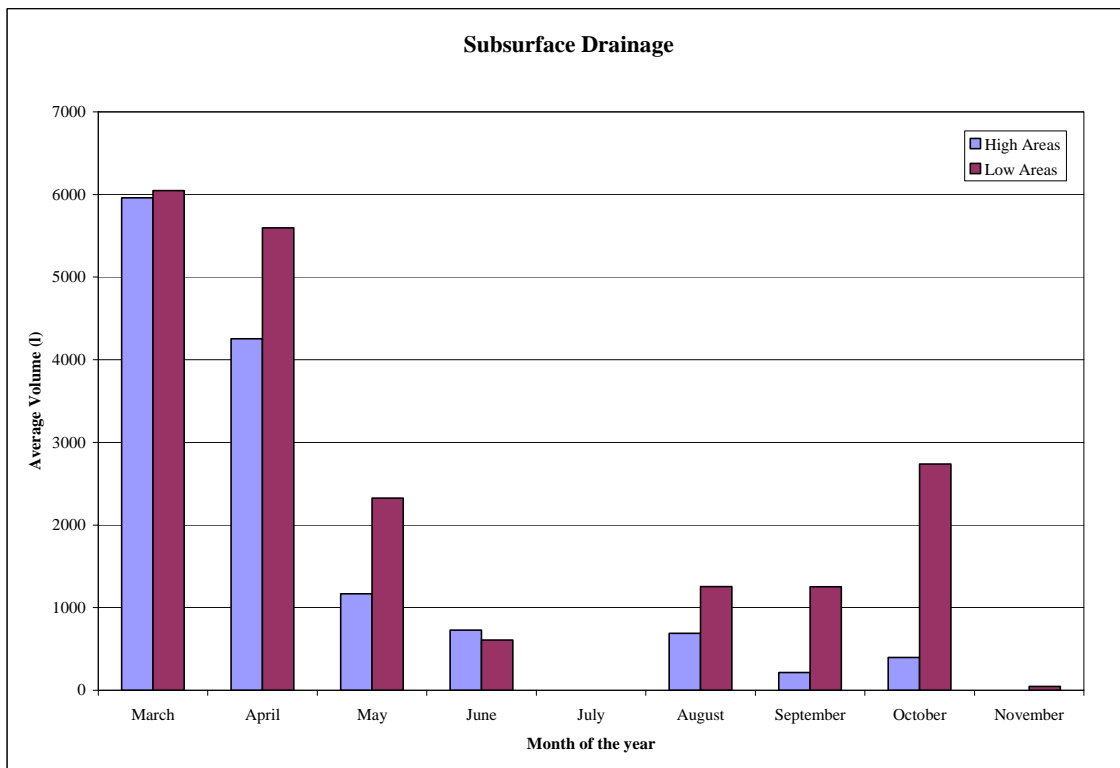
Figure 3.9 Average drained volumes from high/low areas (I) – 2007

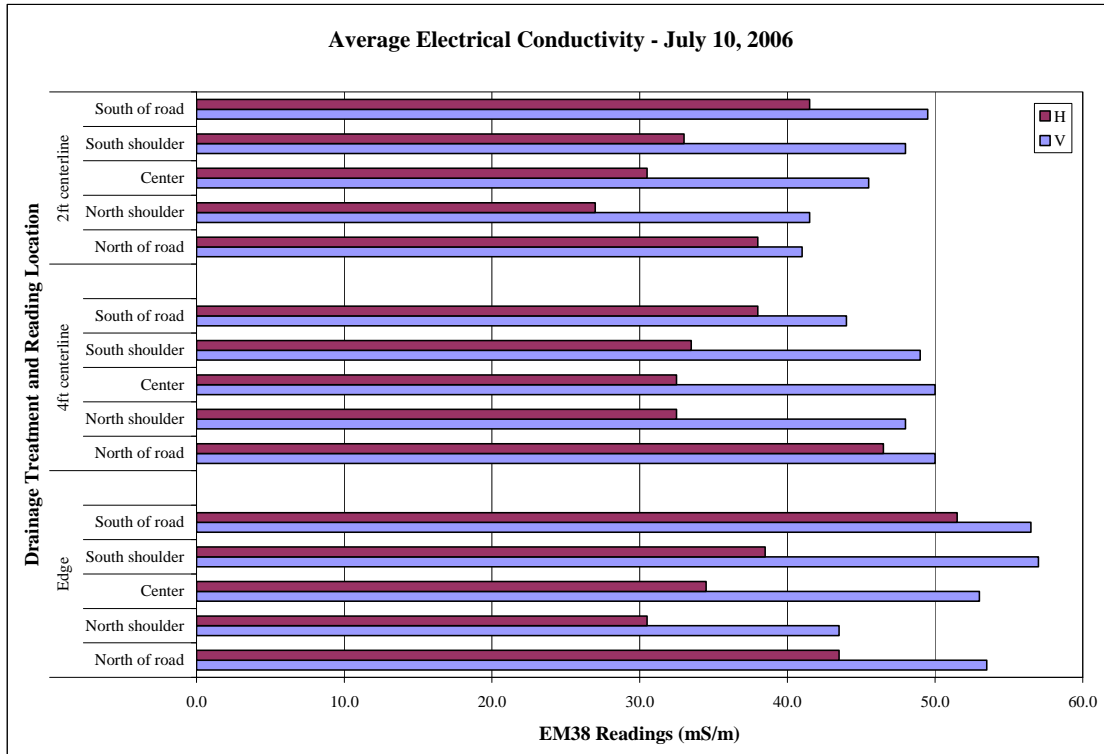
Figure 4.3 Average E.C. (mS/m) by treatment and location – July 10, 2006

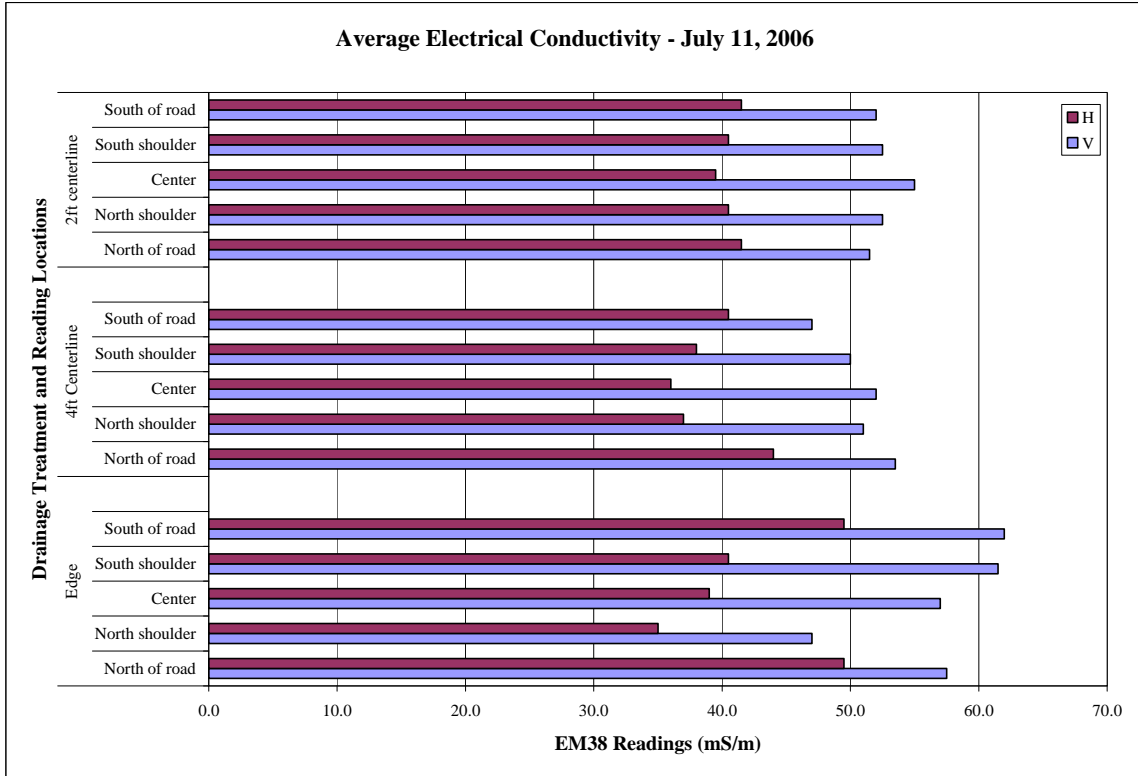
Figure 4.5 Average E.C. (mS/m) by treatment and location – July 11, 2006

Similar to the measurements from the previous day, results show that, for all cases, vertical measurements are higher than horizontal ones; this day, however, measurements are, in general, a little higher. Edgedrain and 4ft centerline measurements are higher in the southern locations, while 2ft centerline drain measurements are higher for the center and northern locations.

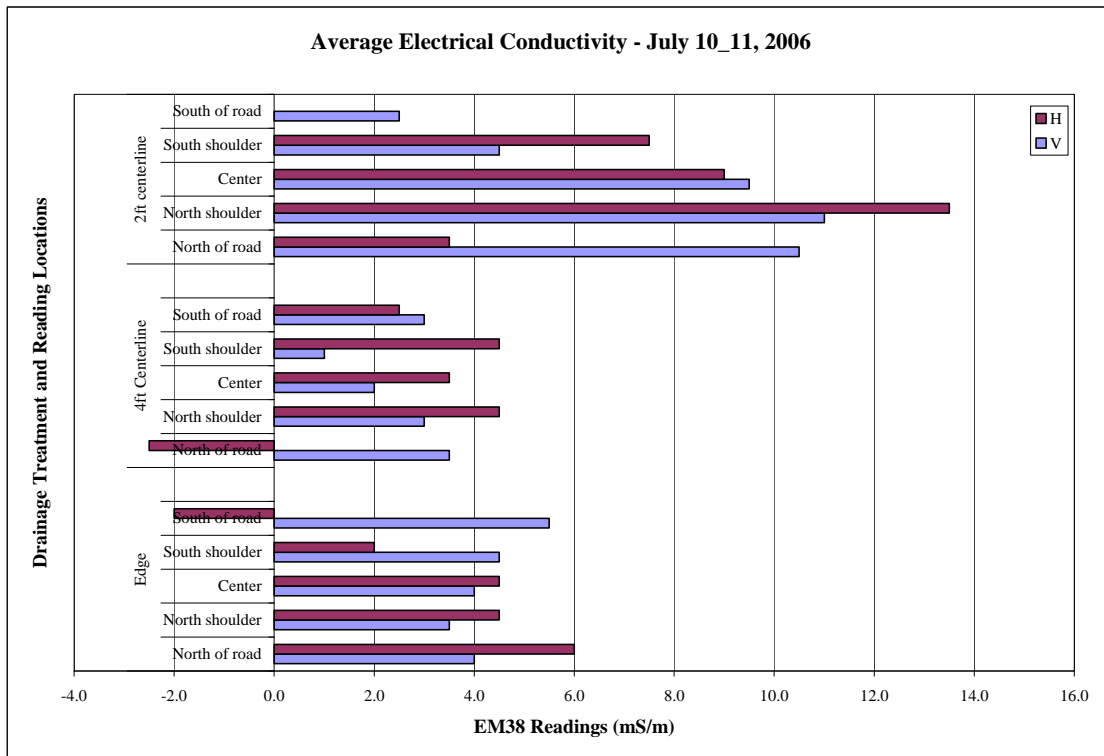
Figure 4.7 Differences in average E.C. (mS/m) by treatment and location – July 10-11, 2006

Figure 4.7 shows the differences in EM38 measurements from the three drainage treatments and the five measurement locations devised in two consecutive days. Figure 4.8 shows the difference in EM38 measurements from the drainage treatments only, regardless of measurement locations, for the same period of time. Results are presented for both the horizontal and vertical orientation of the EM38 instrument.

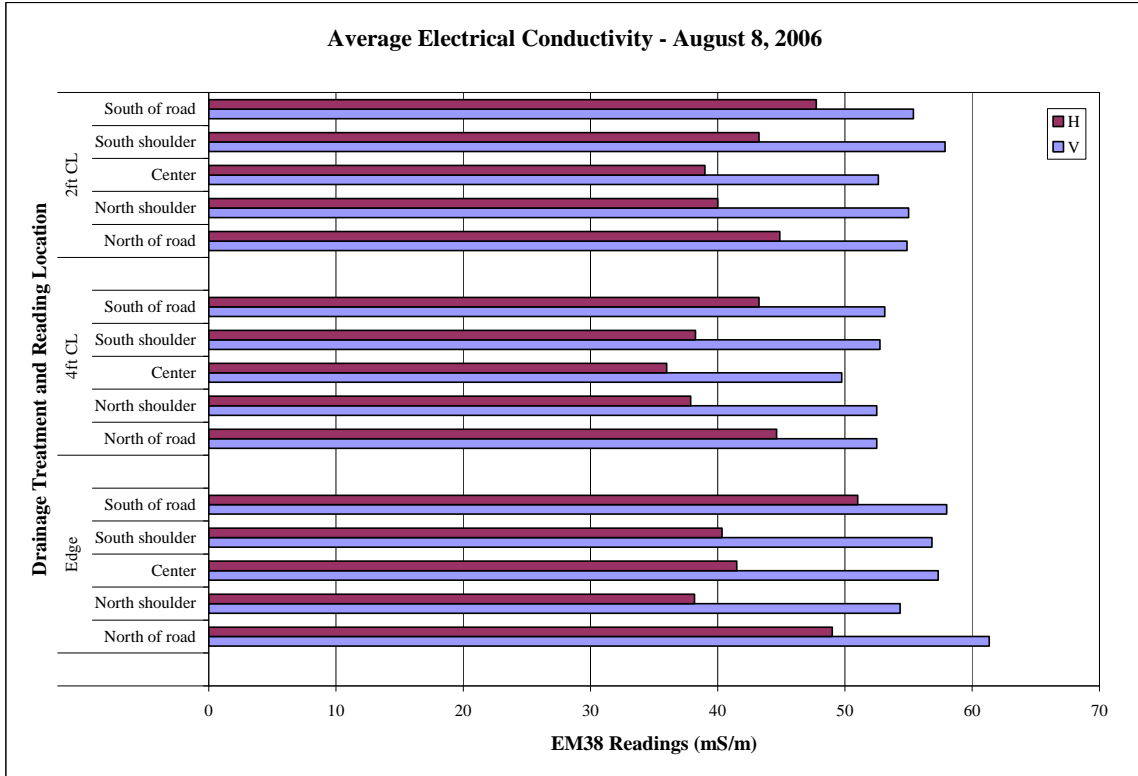
Figure 4.9 Average E.C. (mS/m) by treatment and location – August 8, 2006

Results show that, for all cases, the vertical measurements are higher than the horizontal ones. The measurement locations are similar for the three drainage treatments, showing higher values in locations away from the center of the road. When locations are combined, measurements from

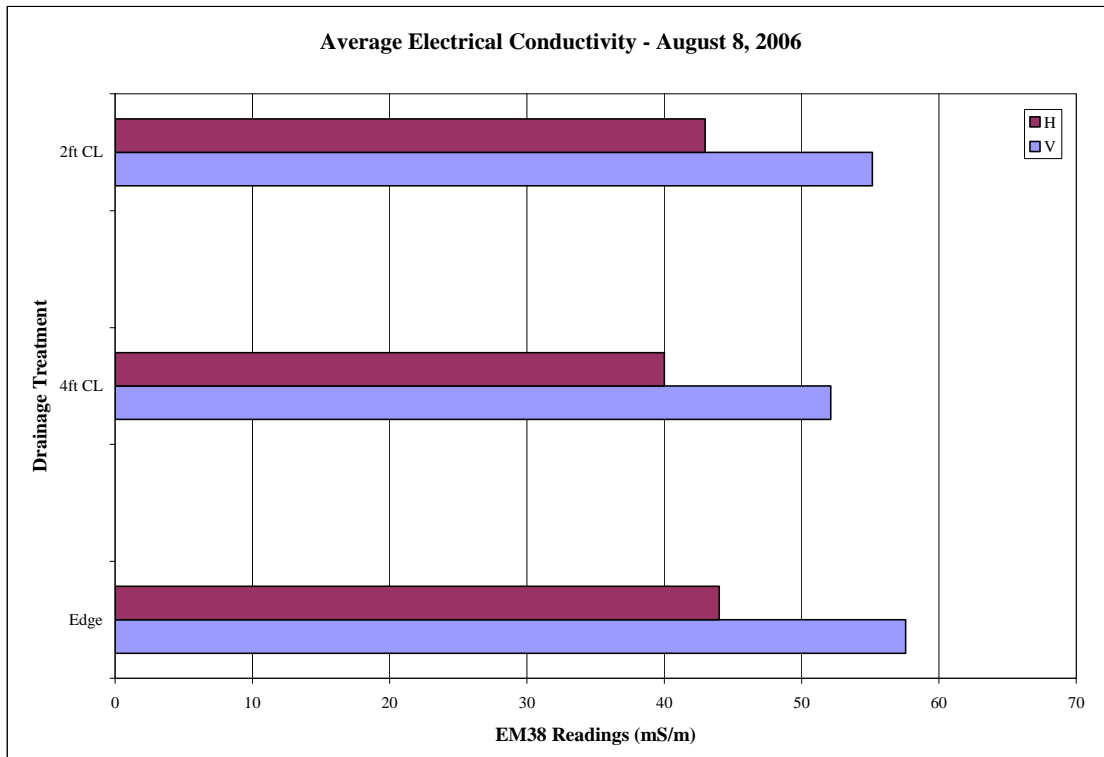
Figure 4.10 Average E.C. (mS/m) by location only – August 8, 2006

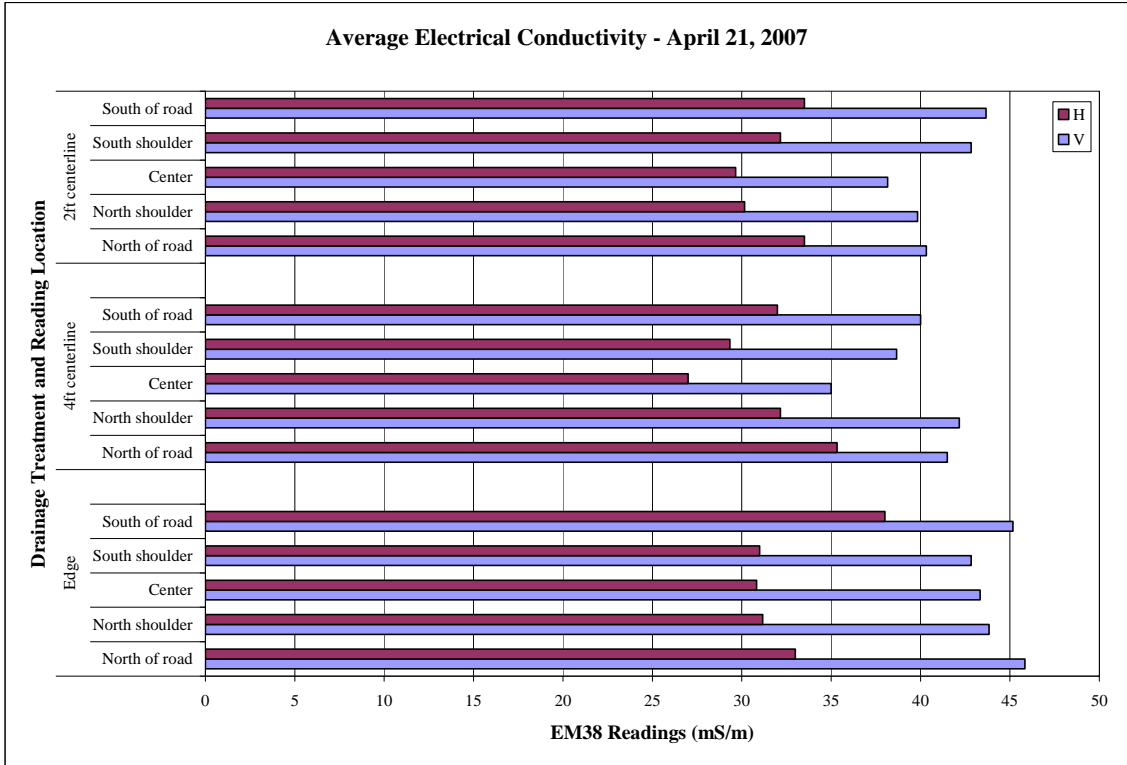
Figure 4.11 Average E.C. (mS/m) by treatment and location – April 21, 2007

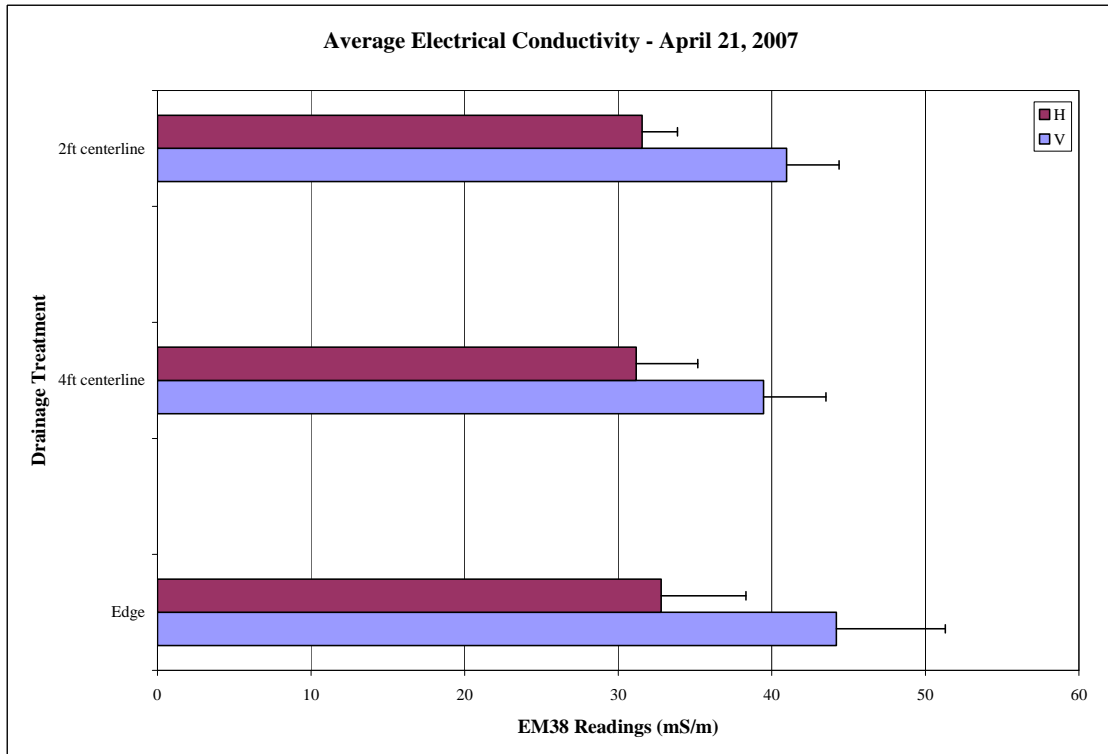
Figure 4.12 Average E.C. (mS/m) by treatment only – April 21, 2007

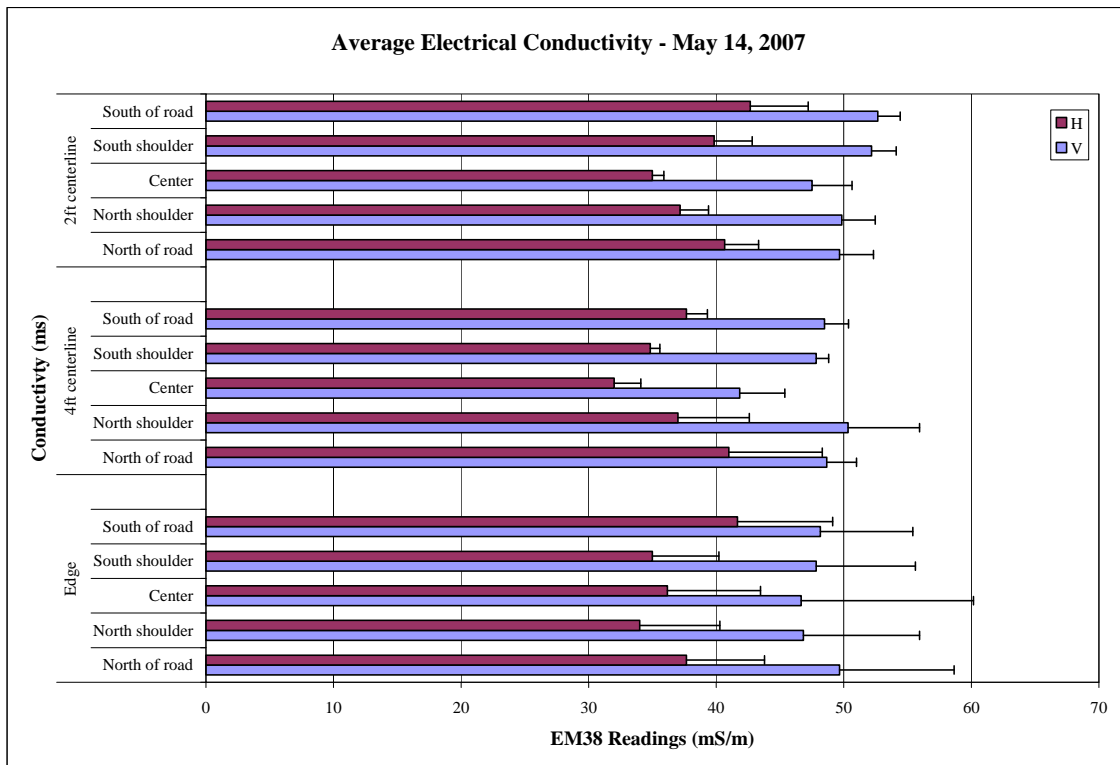
Figure 4.13 Average E.C. (mS/m) by treatment and location – May 14, 2007

Figure 4.13 shows the EM38 measurements from the three drainage treatments and the five measurement locations devised, while Figure 4.14 shows the EM38 measurements from the drainage treatments only, regardless of measurement locations. Results are presented for both the horizontal and vertical orientation of the EM38 instrument.

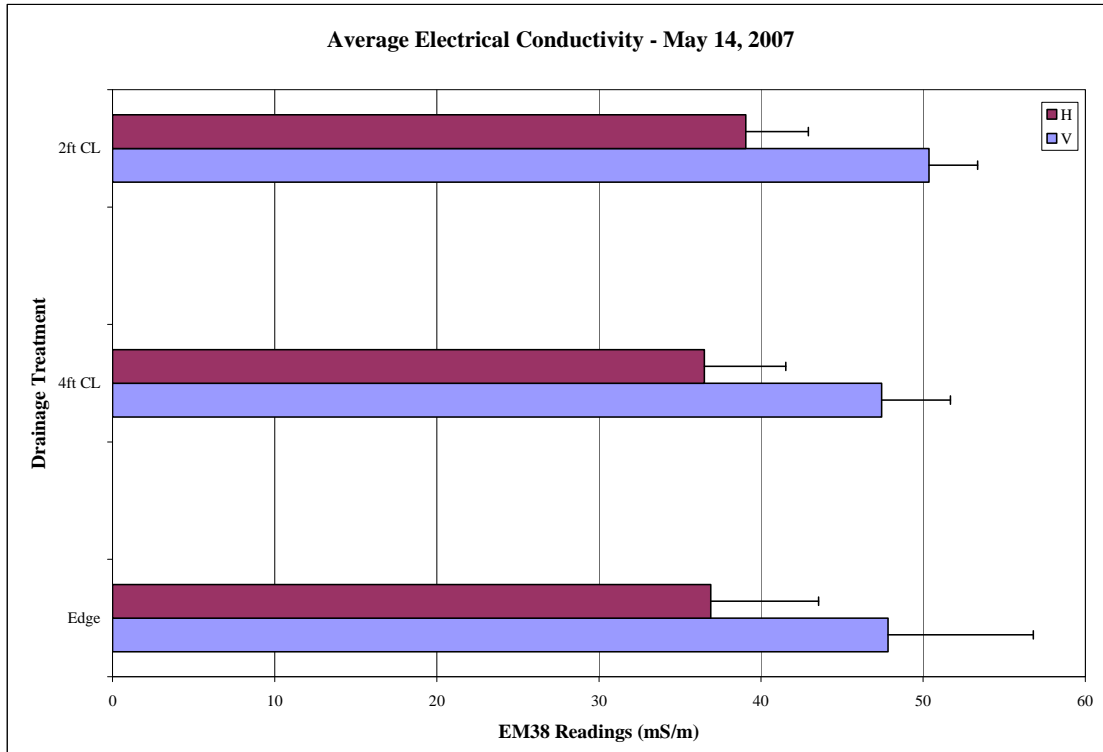
Figure 4.14 Average E.C. (mS/m) by treatment only – May 14, 2007

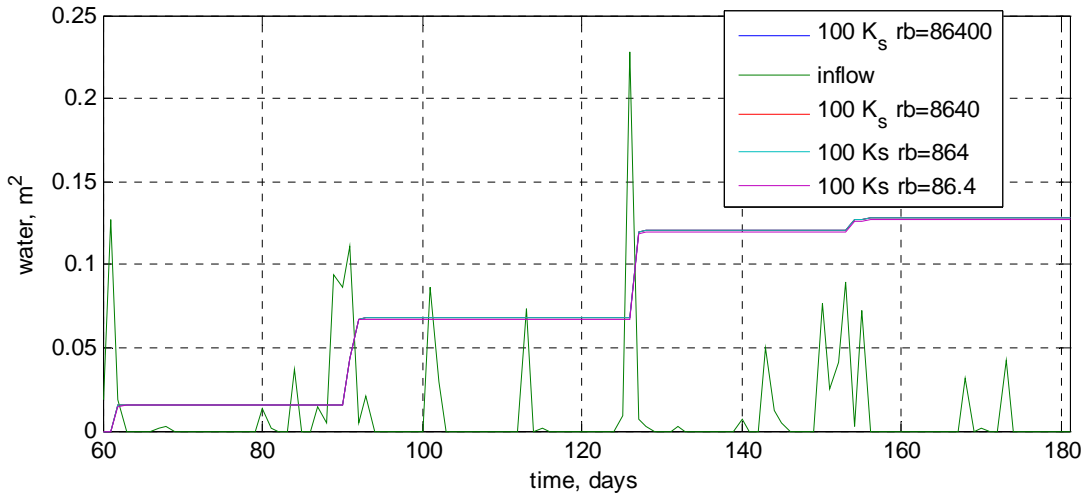
Figure 6.5 Simulation results for different values of empirical conductance parameter

The higher the value of R_b implies the more permeable the interface is. From numerical experiments it was found that if R_b is greater than some value it virtually does not influence the result. Figure 6.5 shows one of the simulation results for different values of R_b parameter. For values exceeding $R_b = 86.4/day$ there is hardly any visible difference. In this study $R_b = 864/day$ was used.

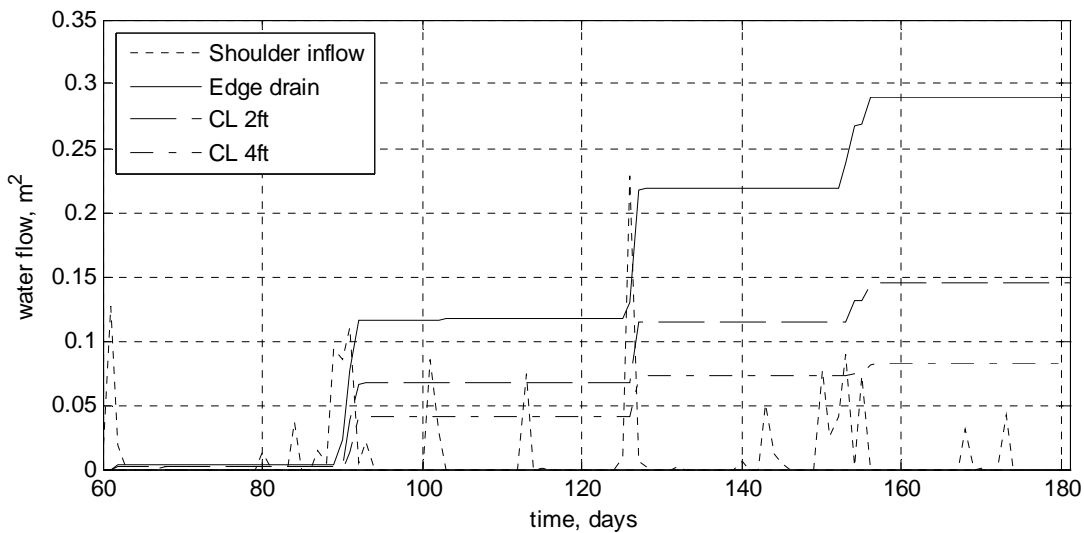
Figure 6.6 Cumulative water outflow (m³ water /m roadway) from the three drain configurations for the case where the pressure is fixed at the bottom of the soil profile for the Prinsberg silty clay loam soil

Several treatments were modeled for *Prinsburg silty clay loam* soil type which is found near the bucket located at 100 hundred feet along the test road from Rushmore to Worthington. Modeled treatments include edgedrain and centerline drains at 2 feet and 4 feet beneath the pavement. Two boundary conditions for the bottom of the domain were considered: pressure head $h = -0.5m$ and the impermeable condition. Simulation results corresponding to constant pressure head are shown in Figure 6.6. Both centerline drains yielded less outflow compared to the edgedrain configuration. The centerline drain at 4 feet is the least efficient for this case.

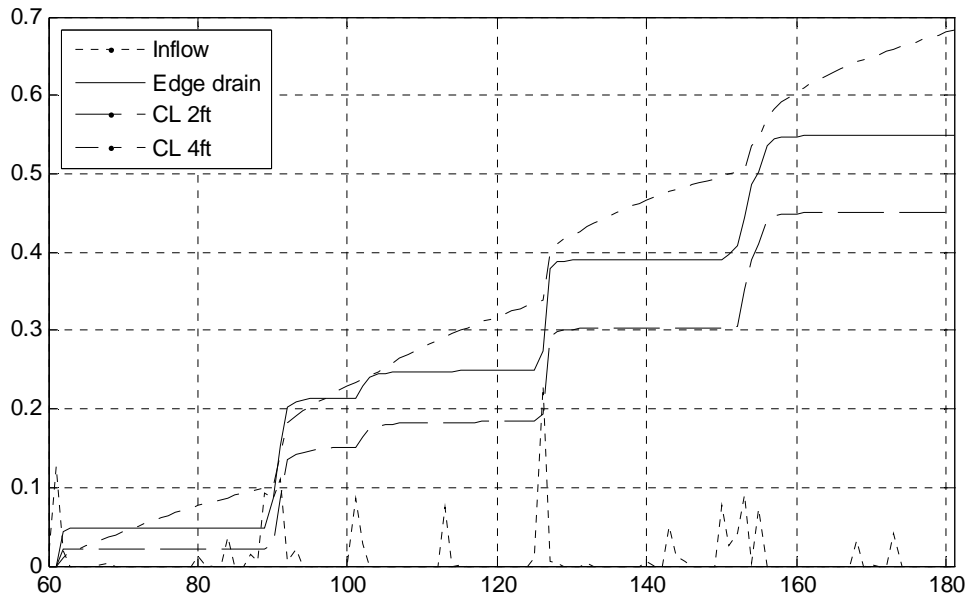
Figure 6.7 Cumulative water flux (m^3 water / m roadway) from the three drain configurations for the case where the bottom of the soil profile is an impermeable boundary for the Prinsberg silty clay loam soil

The infiltration into the shoulder is also shown in Figure 6.7, but is given as a daily water flux m^3 water / m roadway.

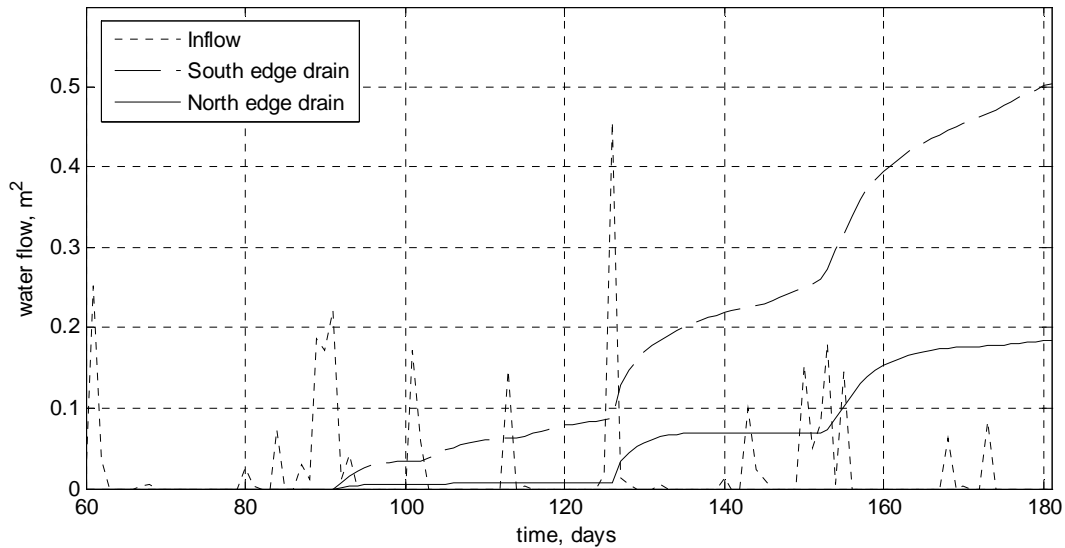
Figure 6.9 Cumulative water flux (m^3 water /m roadway) from the edgedrain configuration for the north and south side edgedrains

Simulation results for this case are shown in Figure 6.9. From the plot it is observed that the cumulative discharge is higher for the south edgedrain than for the north edgedrain. This is the result of there being a higher reference water pressure on the south side of the road, than on the north side of the road. The reference pressure is manifested directly by the elevation of the landscape on the side of the road. Figure 6.8 shows that at this location the elevation is much higher on the south side of the road.

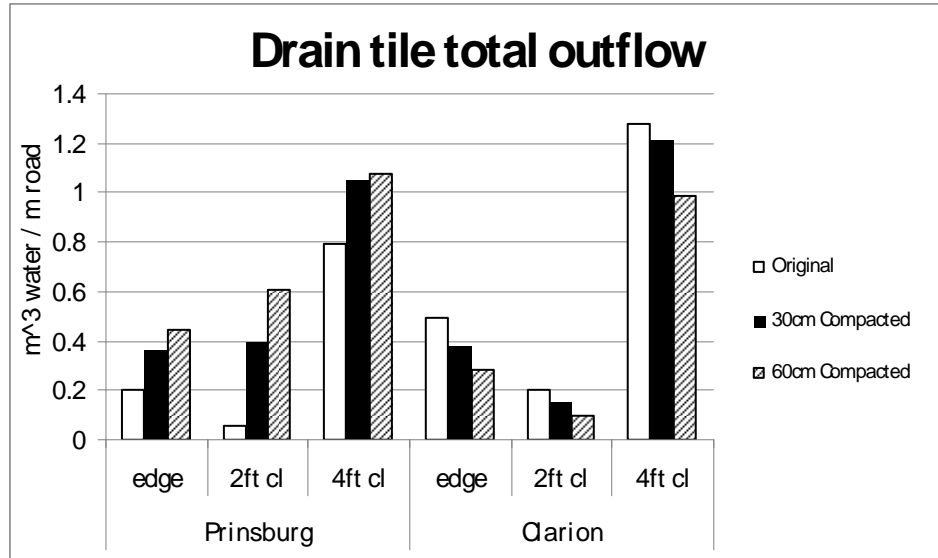
Figure 6.11 Effect of compaction on total drain outflow for different subgrade materials and compaction conditions

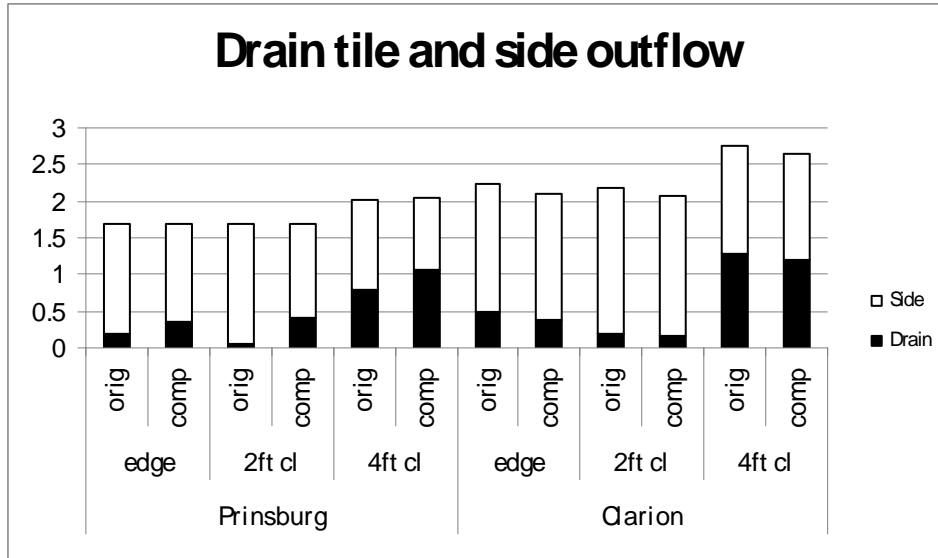
Figure 6.12 Total water outflow through drain tile and side of the domain for the various configurations

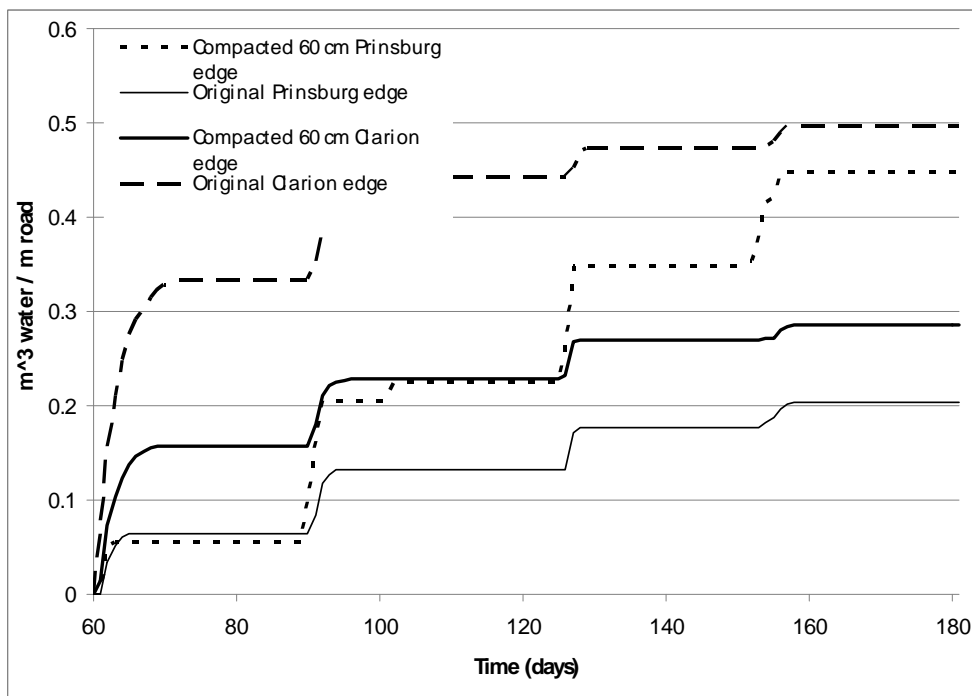
Figure 6.13 Cumulative drainage outflow for the two soil types and the two compaction conditions

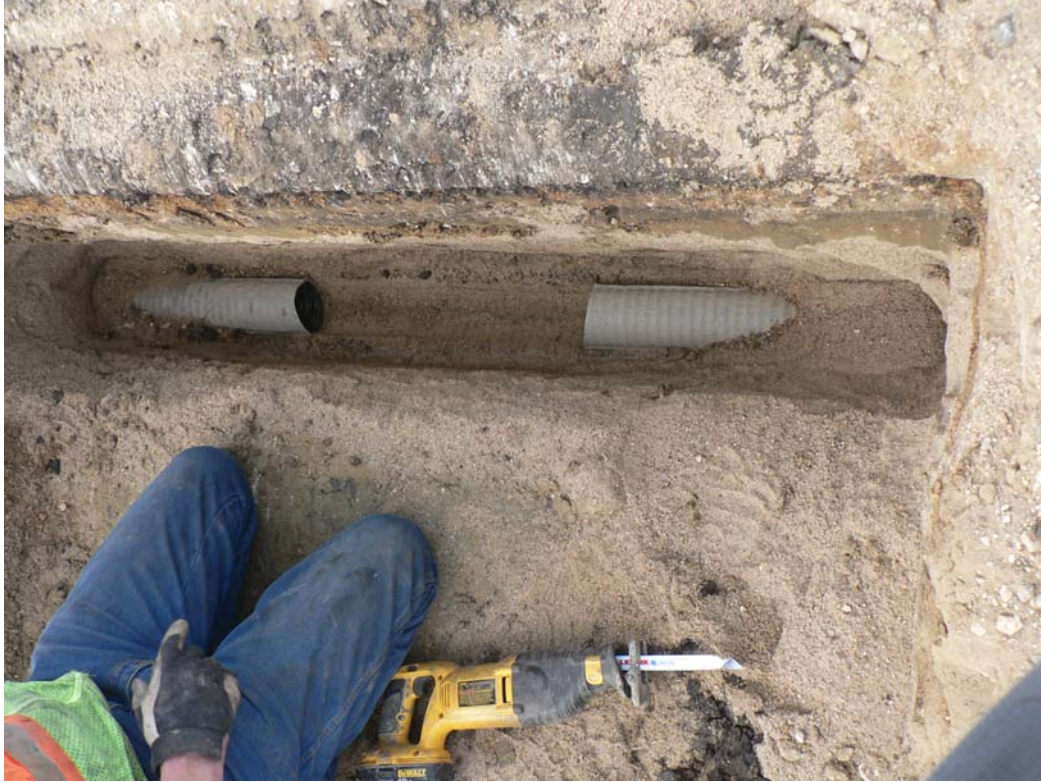
Figure 7.5 Edgeline with tile sample removed

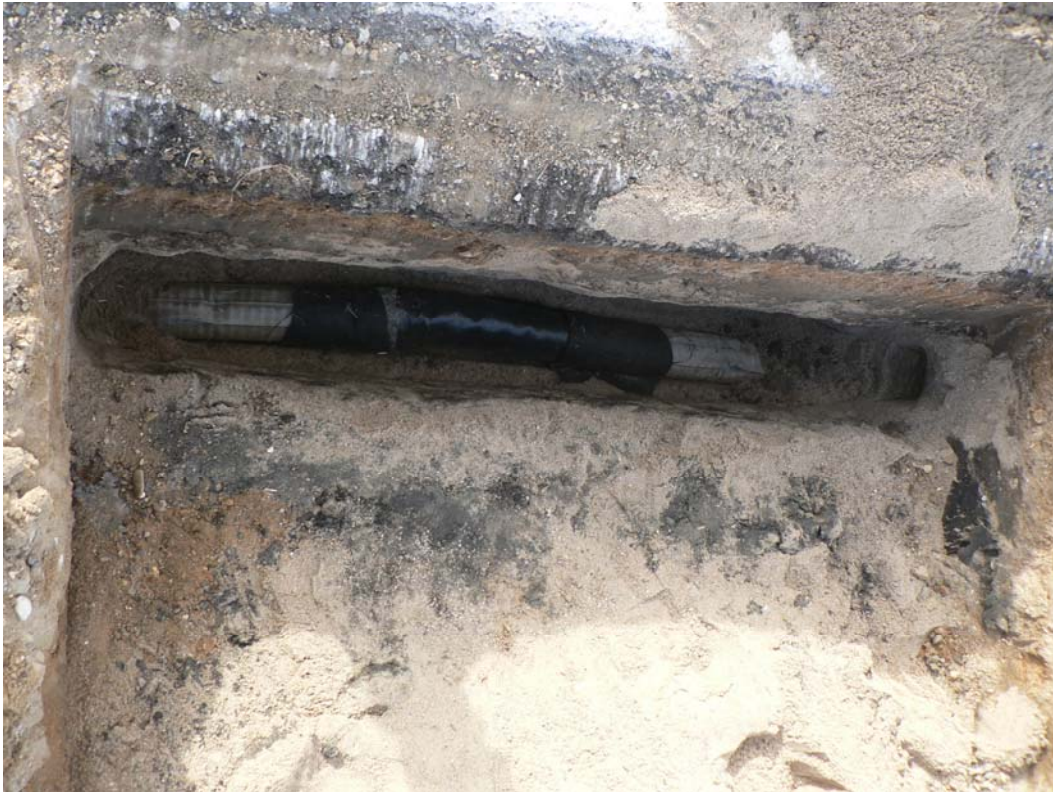
Figure 7.6 The edgeline with the splice in place

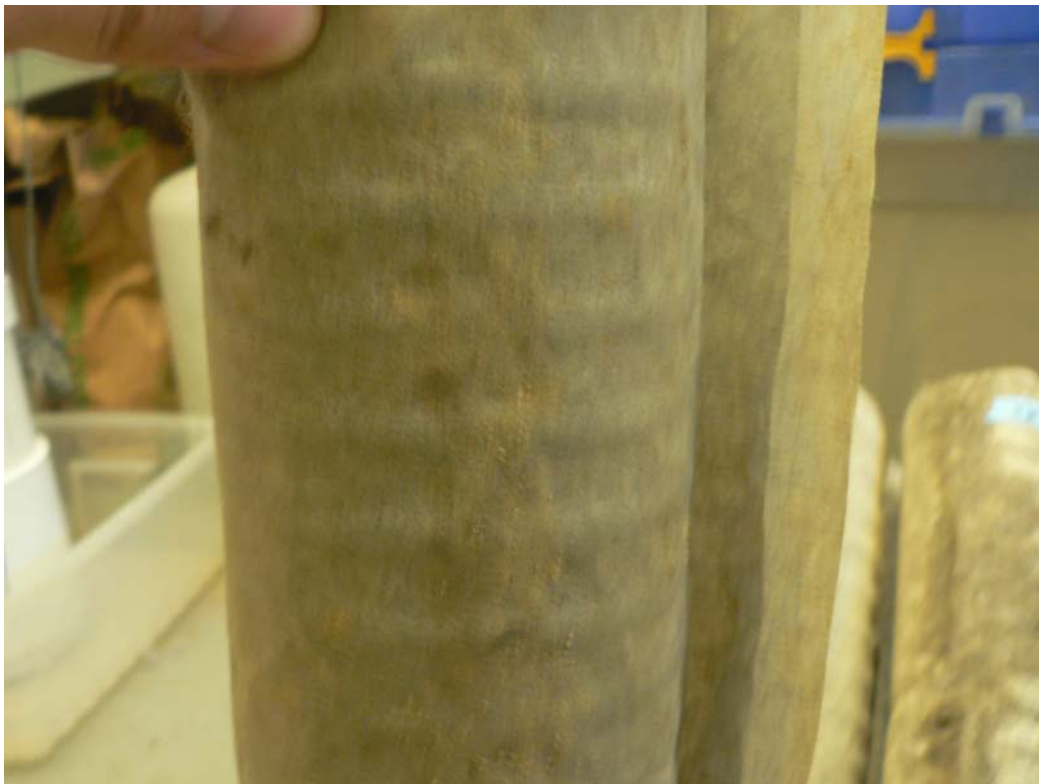
Figure 7.7 The geofabric of the edgedrain at site A on CR 32

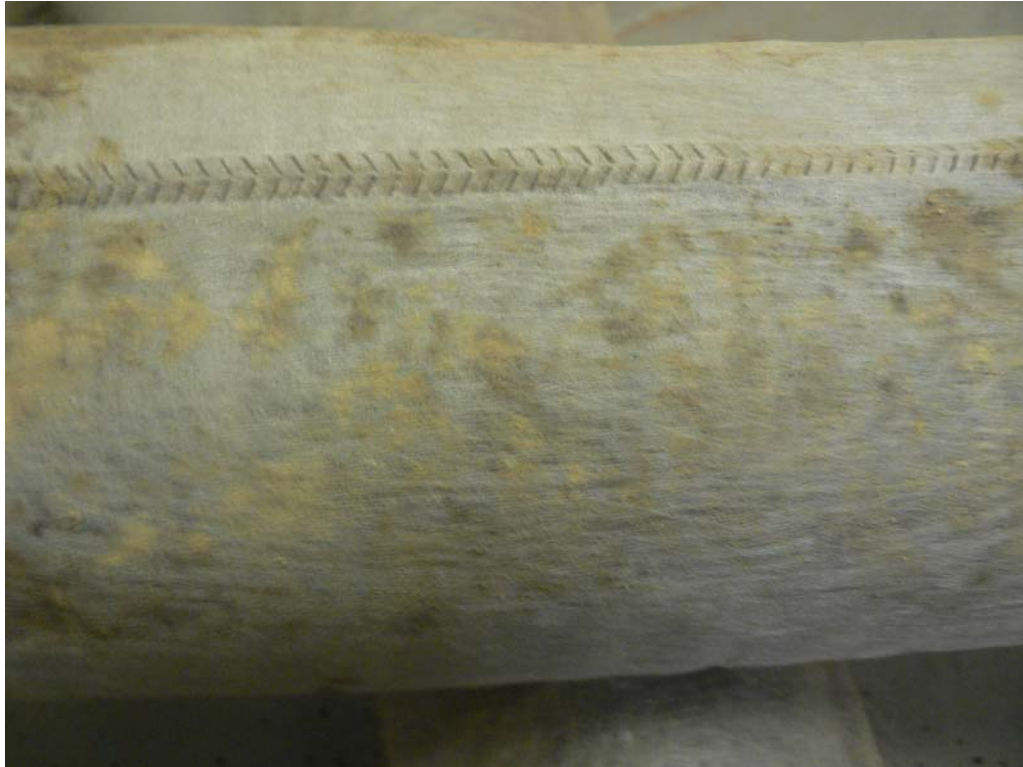
Figure 7.15 The geofabric of the edgedrain at site B on CR 35
