Evaluating Roadway Subsurface Drainage Practices

1. Report No. MN/RC 2009-08	2.	3. Recipients Accession No.	
4. Title and Subtitle Evaluating Roadway Subsurface Drainage Practices		5. Report Date January 2009

Final Report

Minnesota Department of Transportation
Research Services Section
395 John Ireland Boulevard, MS 330
St. Paul, Minnesota 55155-1899

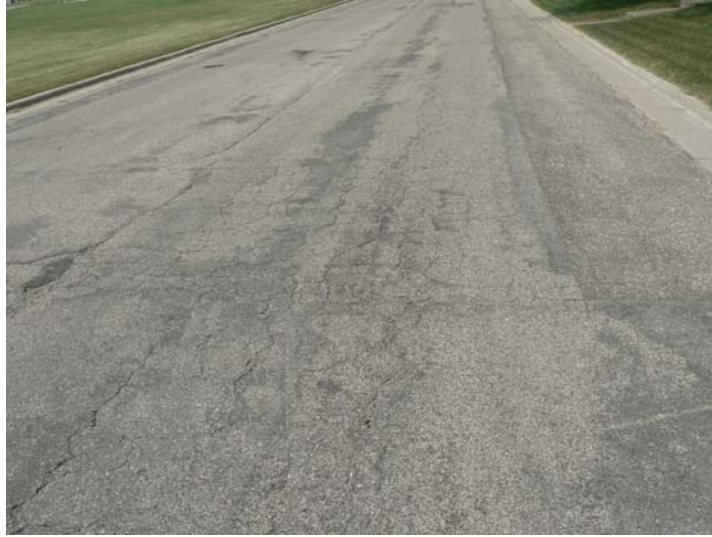
Figure 8.4 View of pavement of Pleasant Street showing the cracking pattern in the street

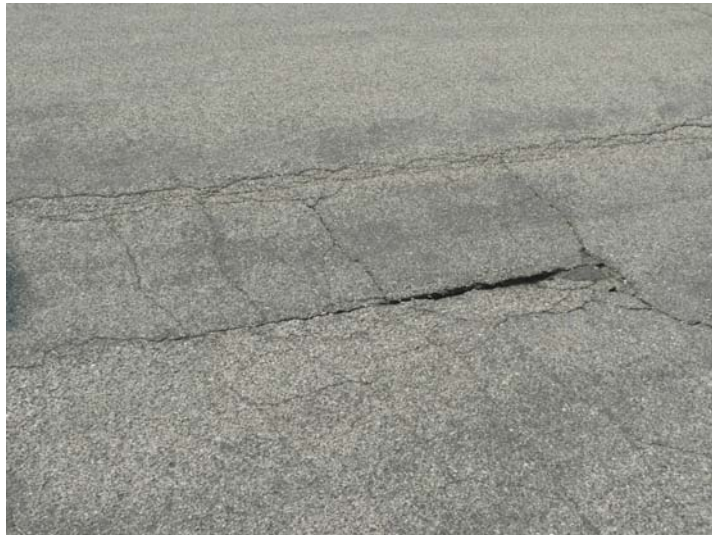
Figure 8.5 Closeup view of cracking on Pleasant Street

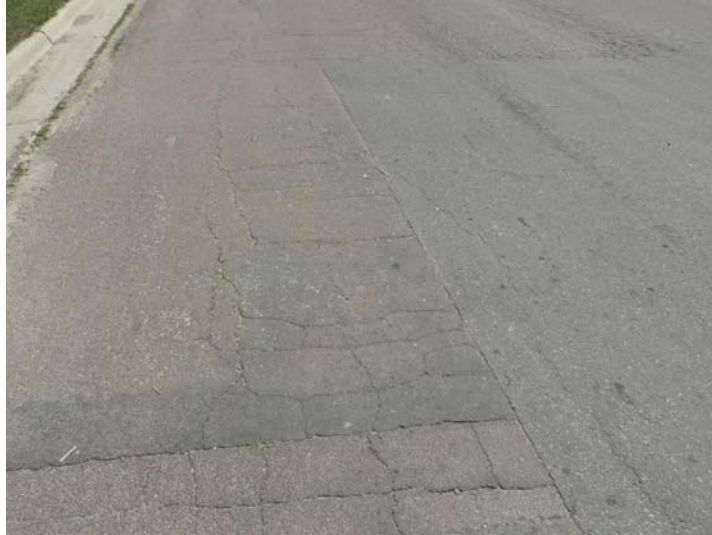
Figure 8.8 View of pavement of N. Spring Avenue, looking south of the intersection with Cecillee Street, showing the cracking pattern in the street

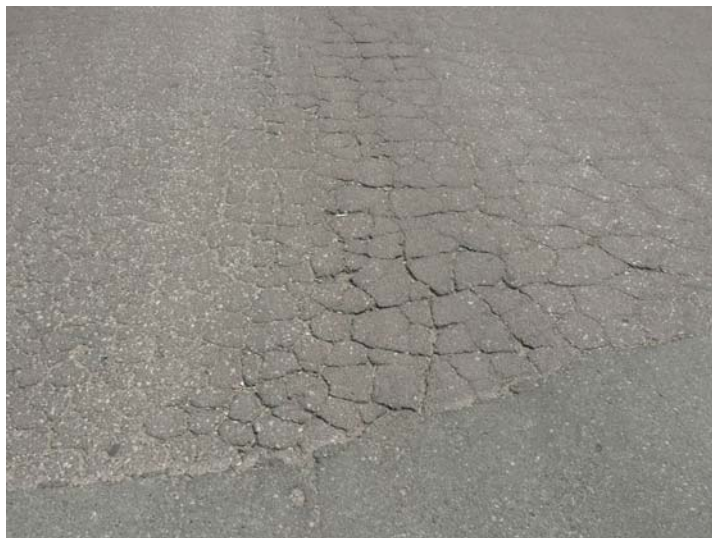
Figure 8.9 Cracking pattern in pavement on N. Spring Ave

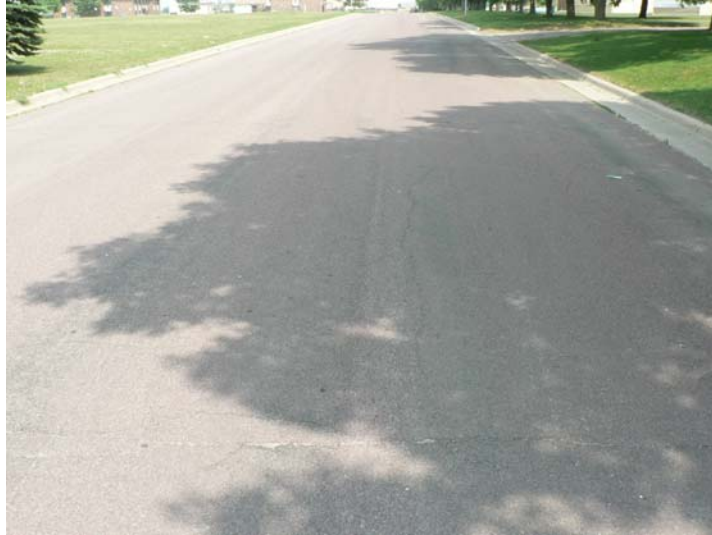
Figure 8.10 View of pavement of Cecillee Street looking east of the intersection with Spring Avenue, showing the presence of some longitudinal and transverse cracks

Alligator cracking was not present.

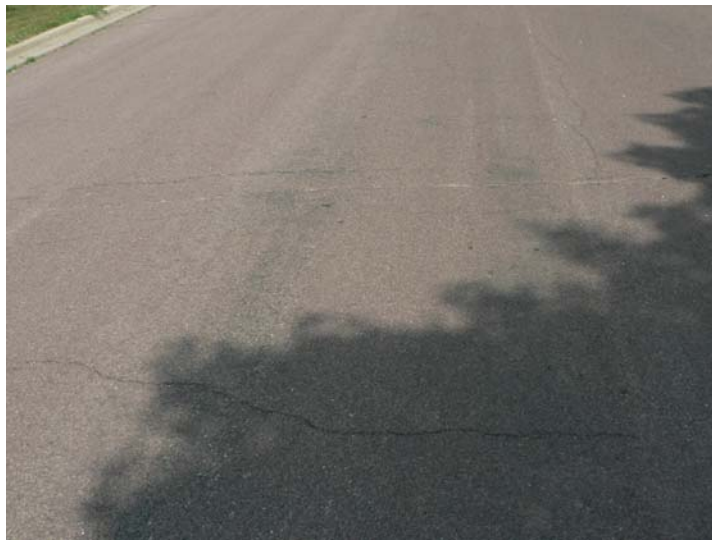
Figure 8.11 View of pavement of Cecillee Street looking west of the intersection with Spring Avenue, showing the cracking pattern in the street

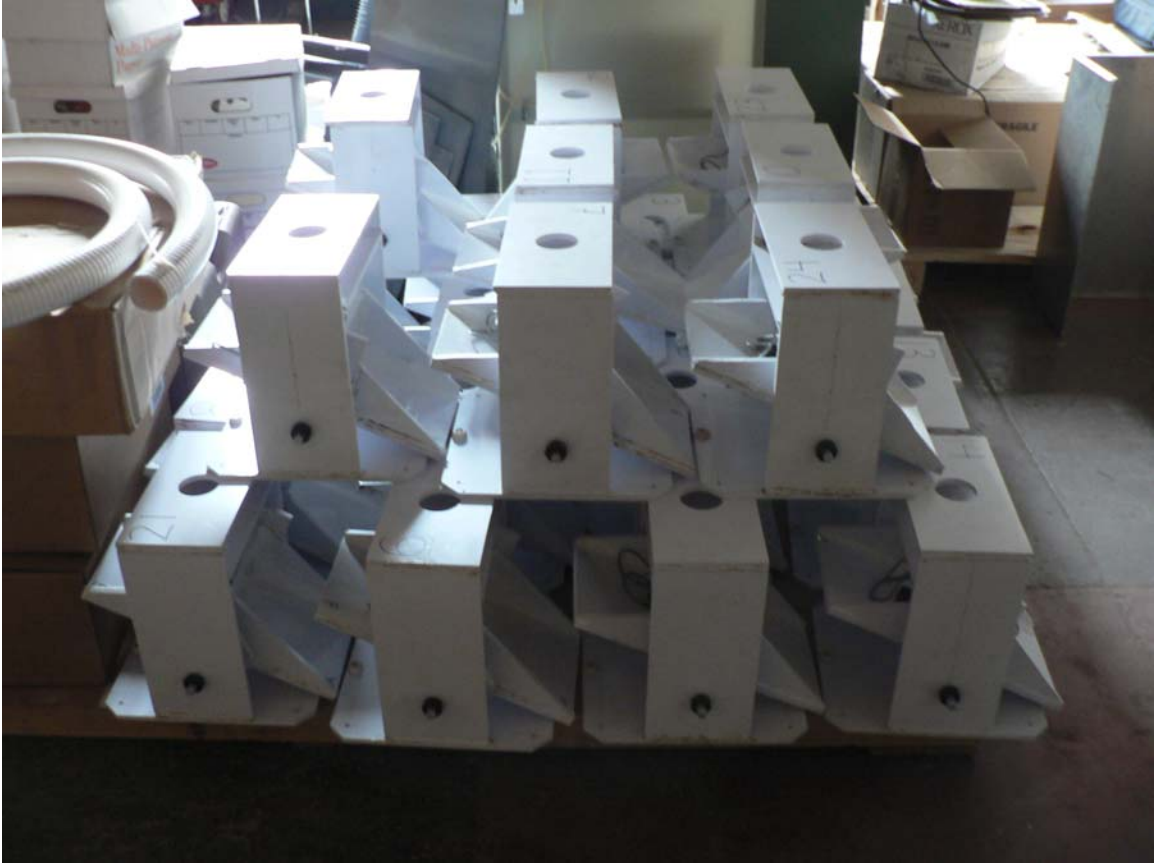
Figure A.1 The inventory of tipping buckets constructed for the project

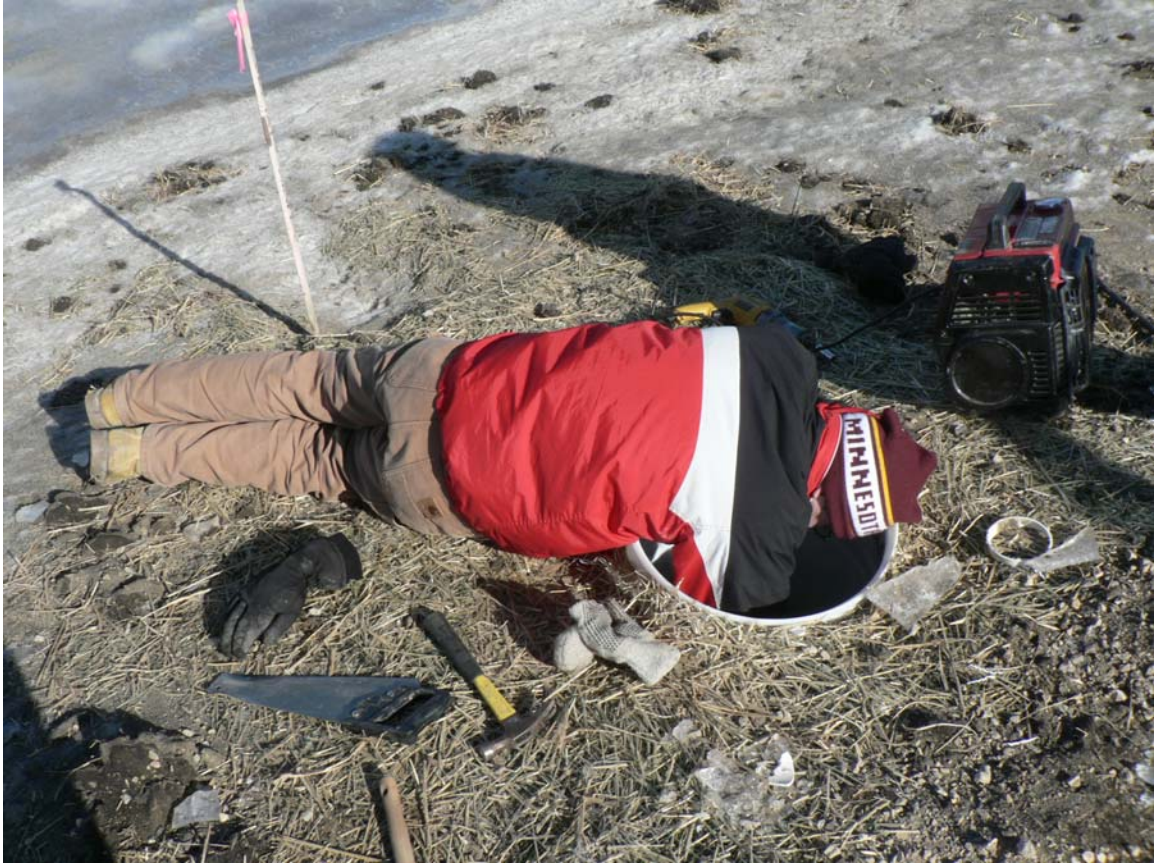
Figure A.3 Preparing the tipping bucket housing and placement of tipping bucket into the housing. Preparation of the tipping bucket in the housing includes the leveling of the tipping bucket

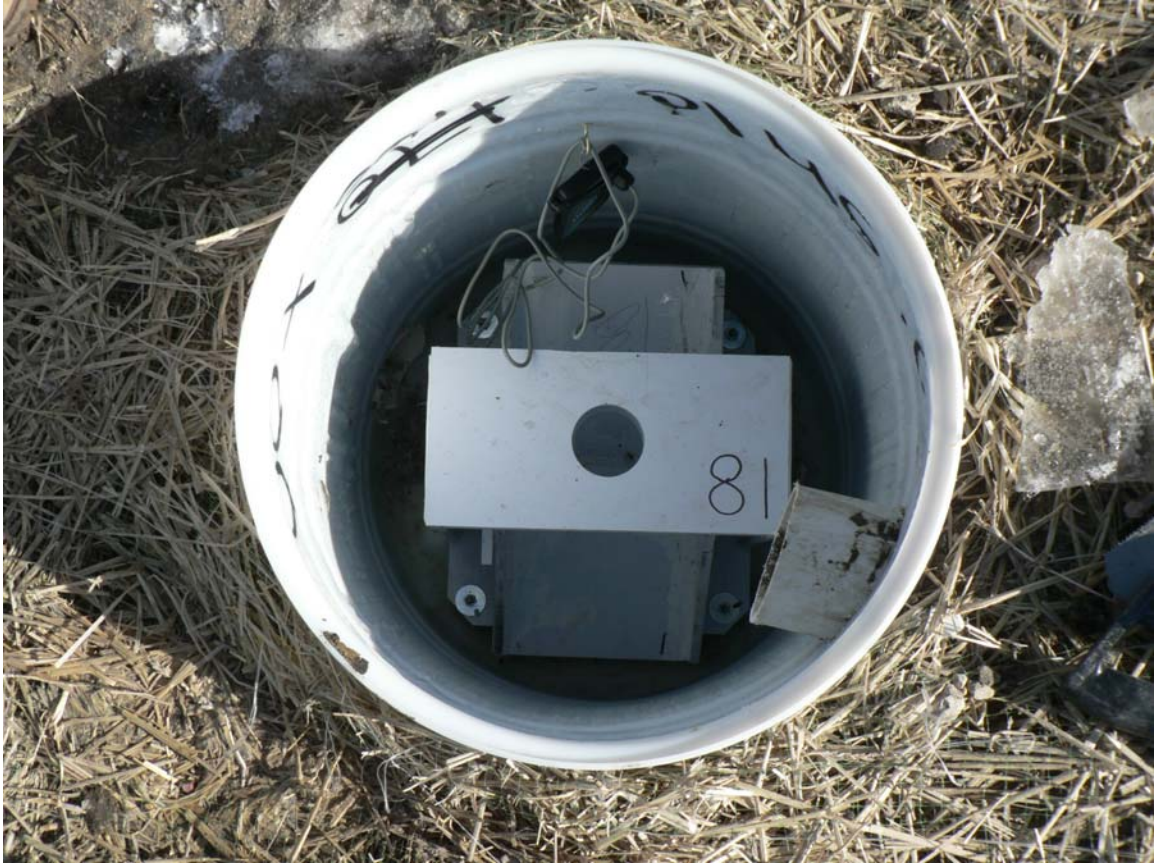
Figure A.4 Levelled tipping bucket ready for connection to the drain outlet from the pavement

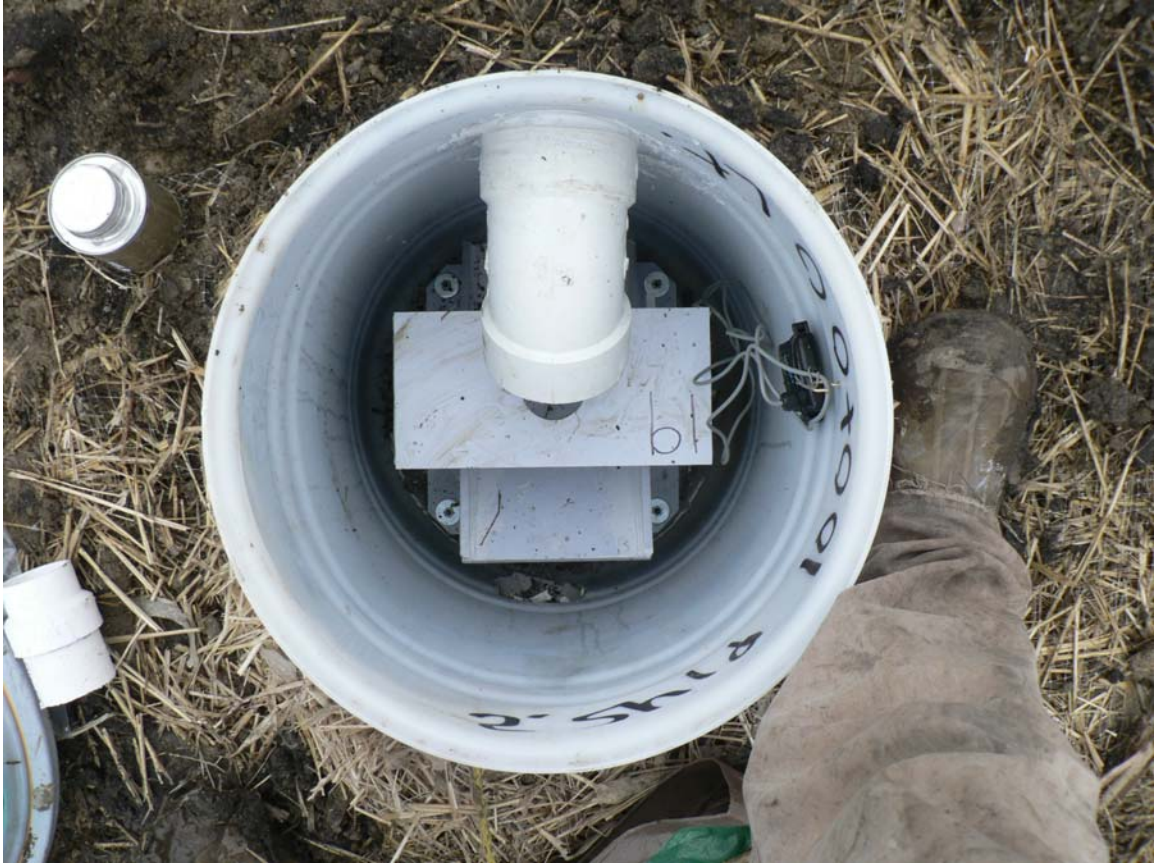
Figure A.5 Tipping bucket after connection to the drain

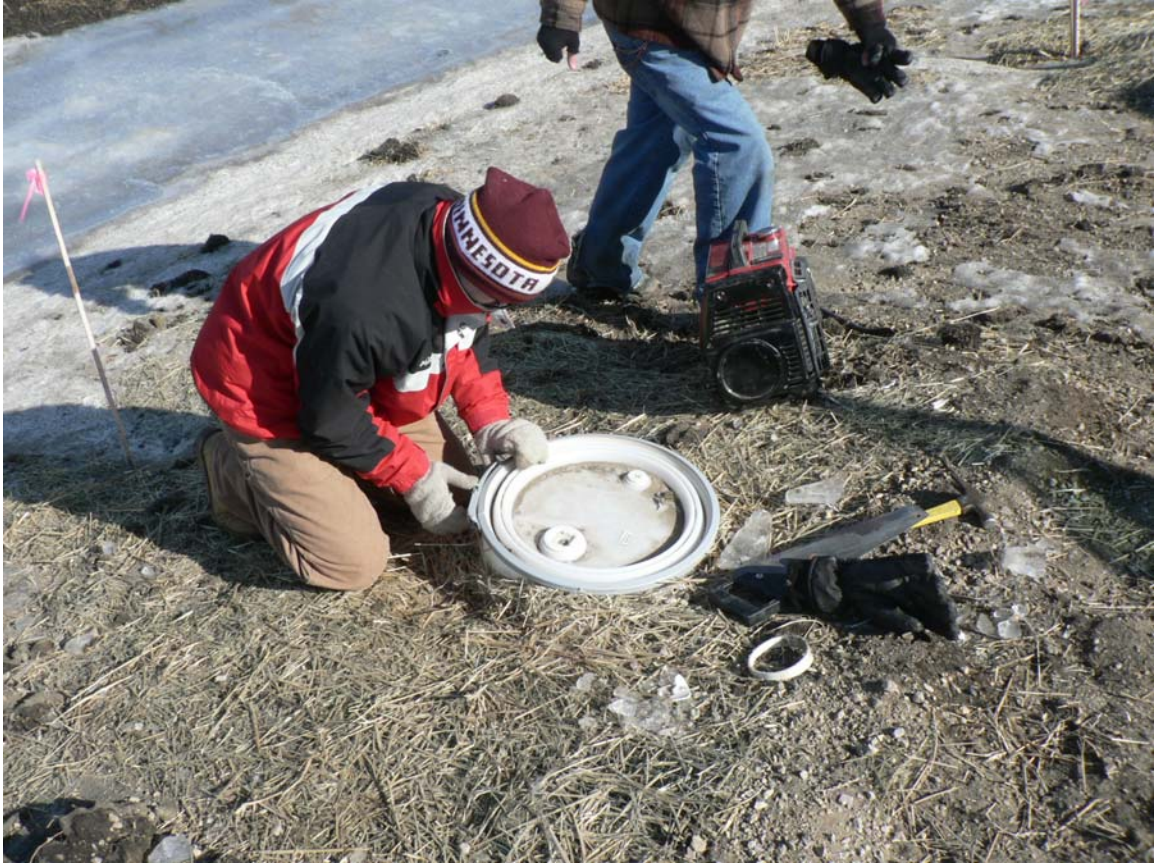
Figure A.6 Closing and the tipping bucket housing. The housing cover is locked to deter vandalism

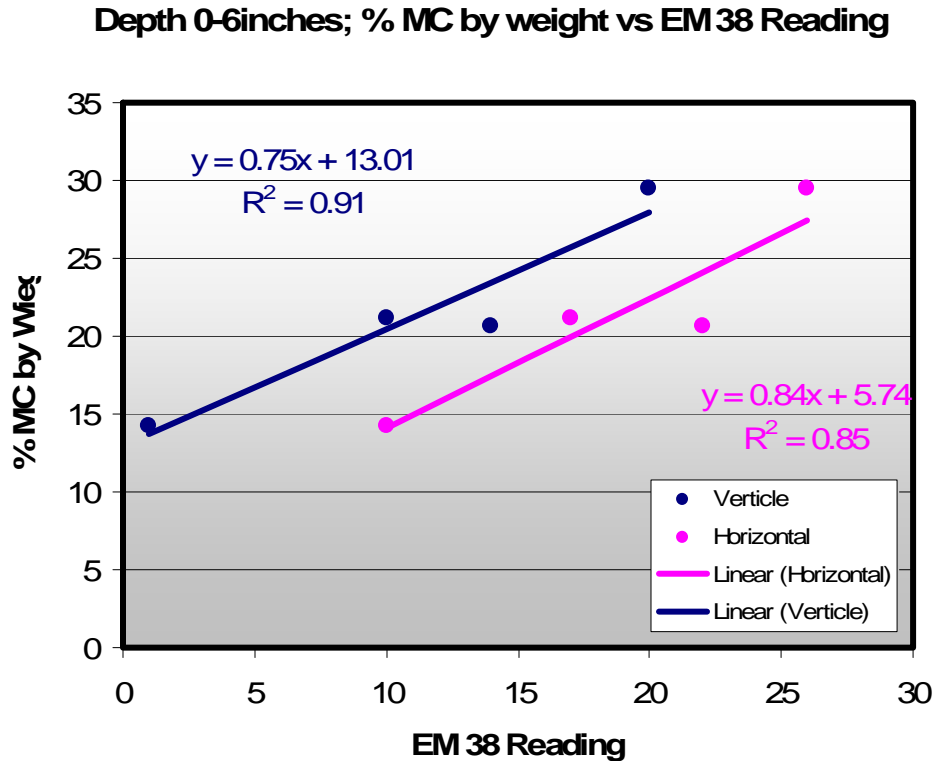
Figure A.11 EM38 reading for vertical and horizontal orientation of the instrument and the moisture content taken from the 0-6 inch depth increment

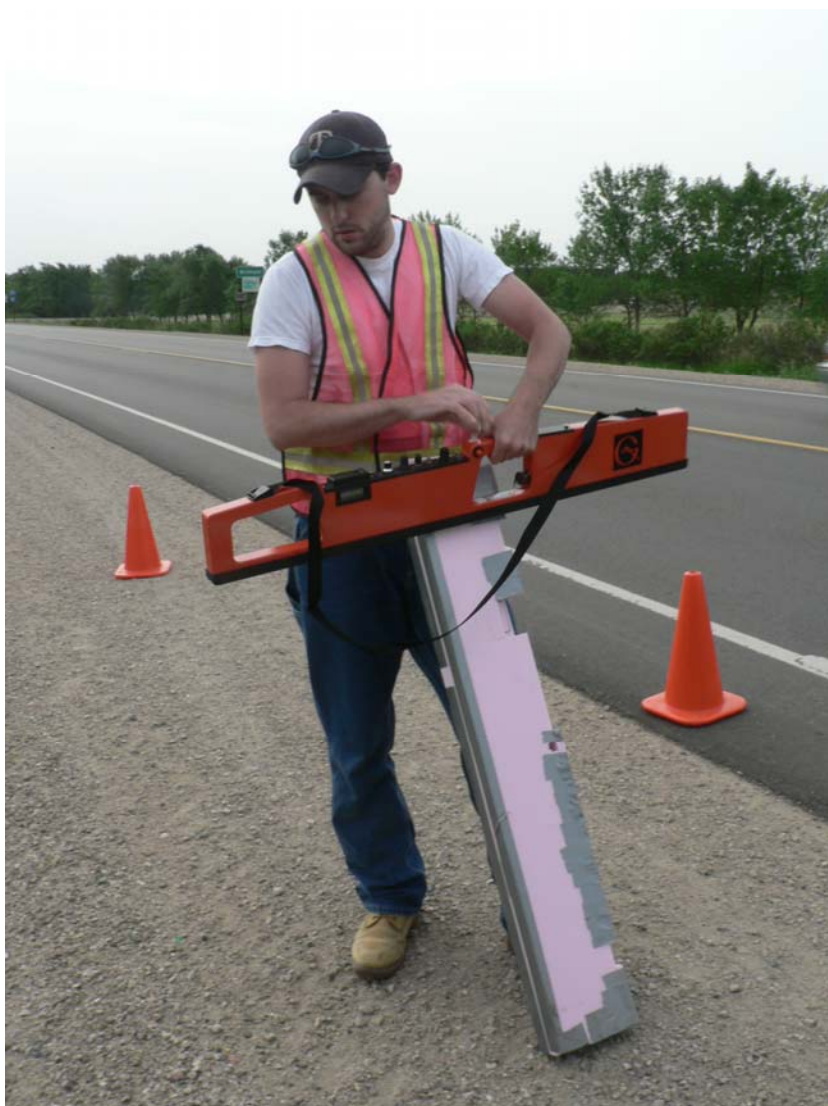
Figure A.13 The EM38 instrument and the insulation enclosure made for the instrument to shield it from environmental temperature fluctuations

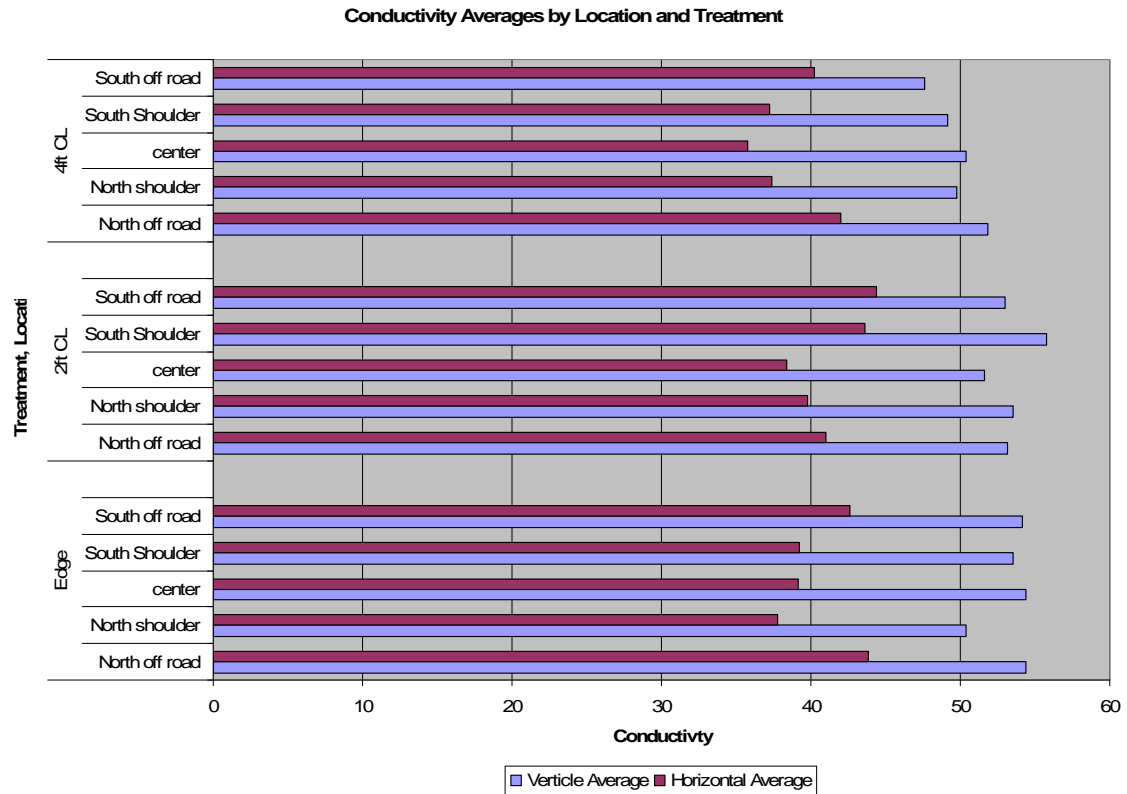
Figure A.15 Electrical conductivity readings from the EM38 for the various drainage treatments for both vertical and horizontal configuration

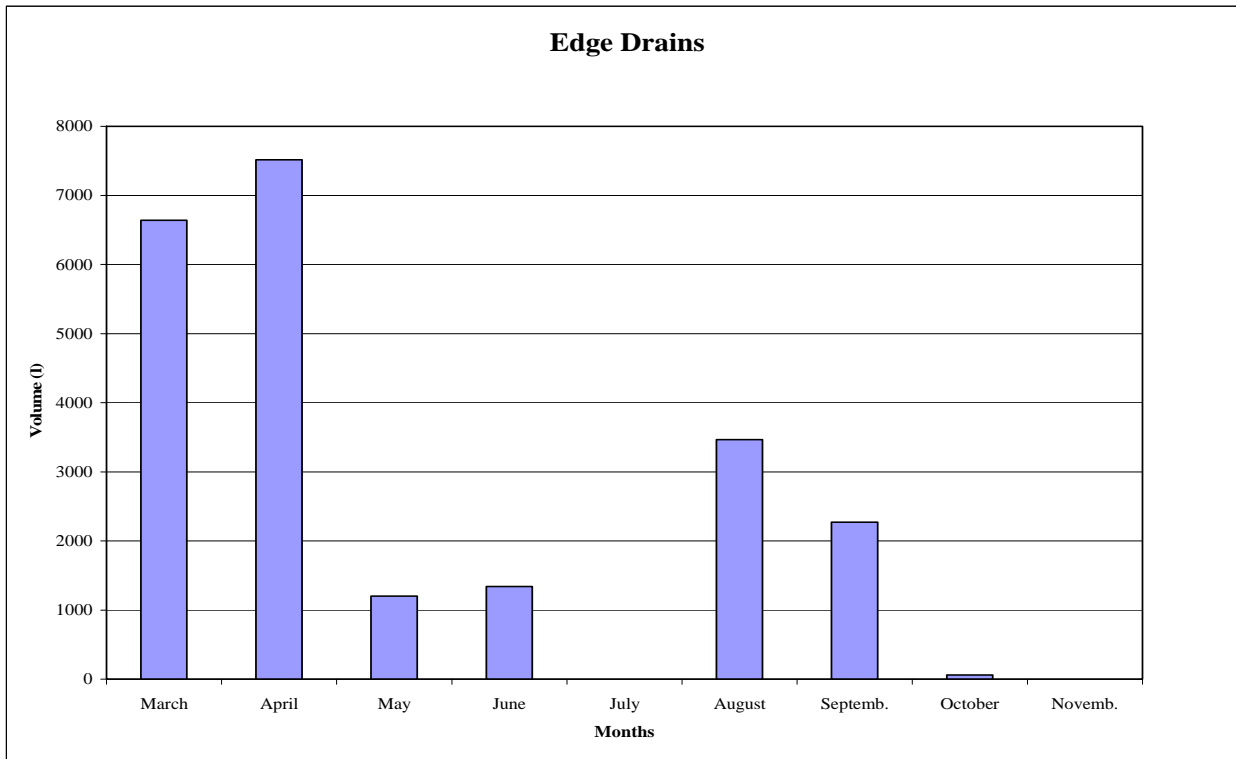
Figure B.1 Average volume drained from edgedrains (l) - 2006

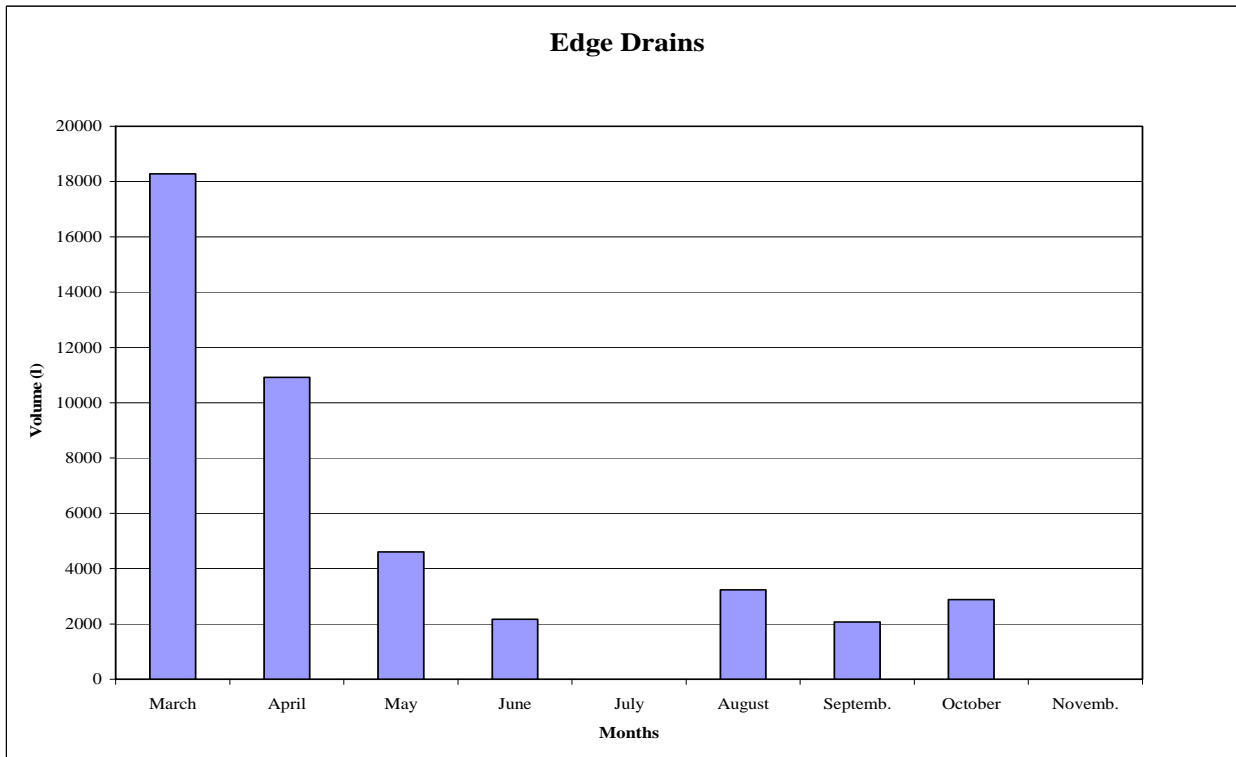
Figure B.4 Average volume drained from edgedrains (l) – 2007

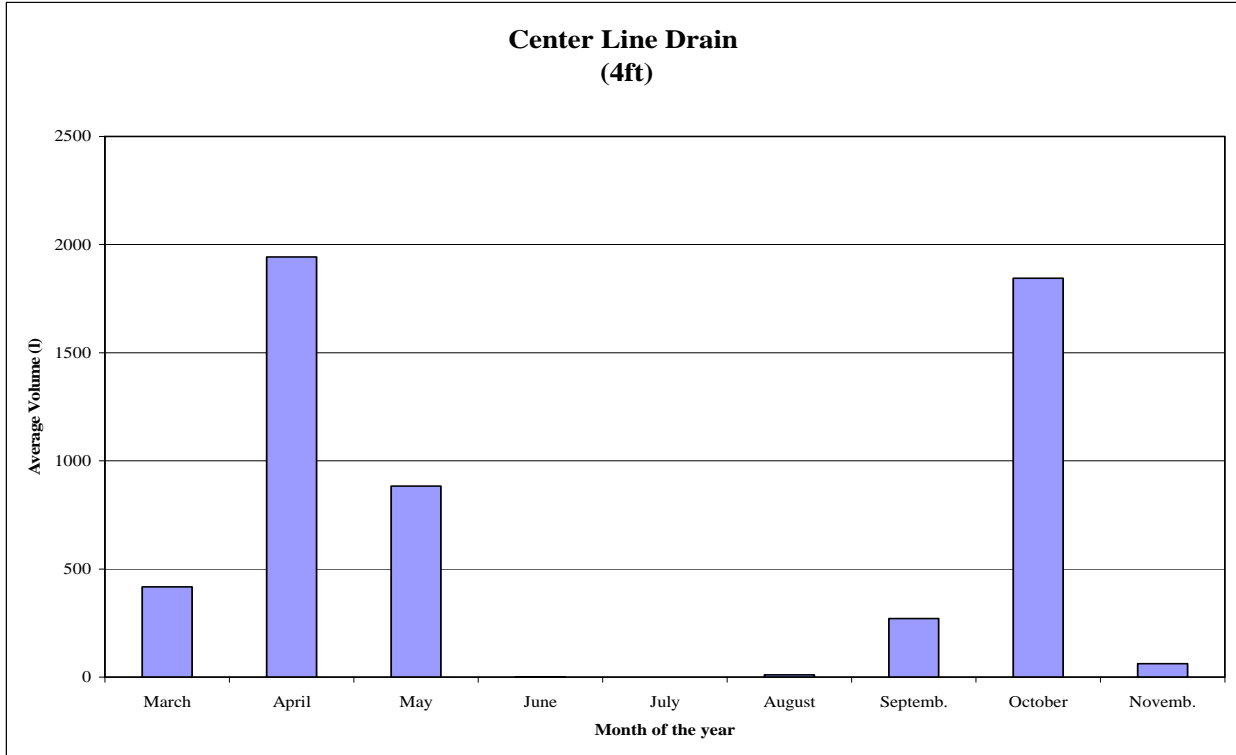
Figure B.5 Average volume drained from 4-ft centerline drains (l) – 2007

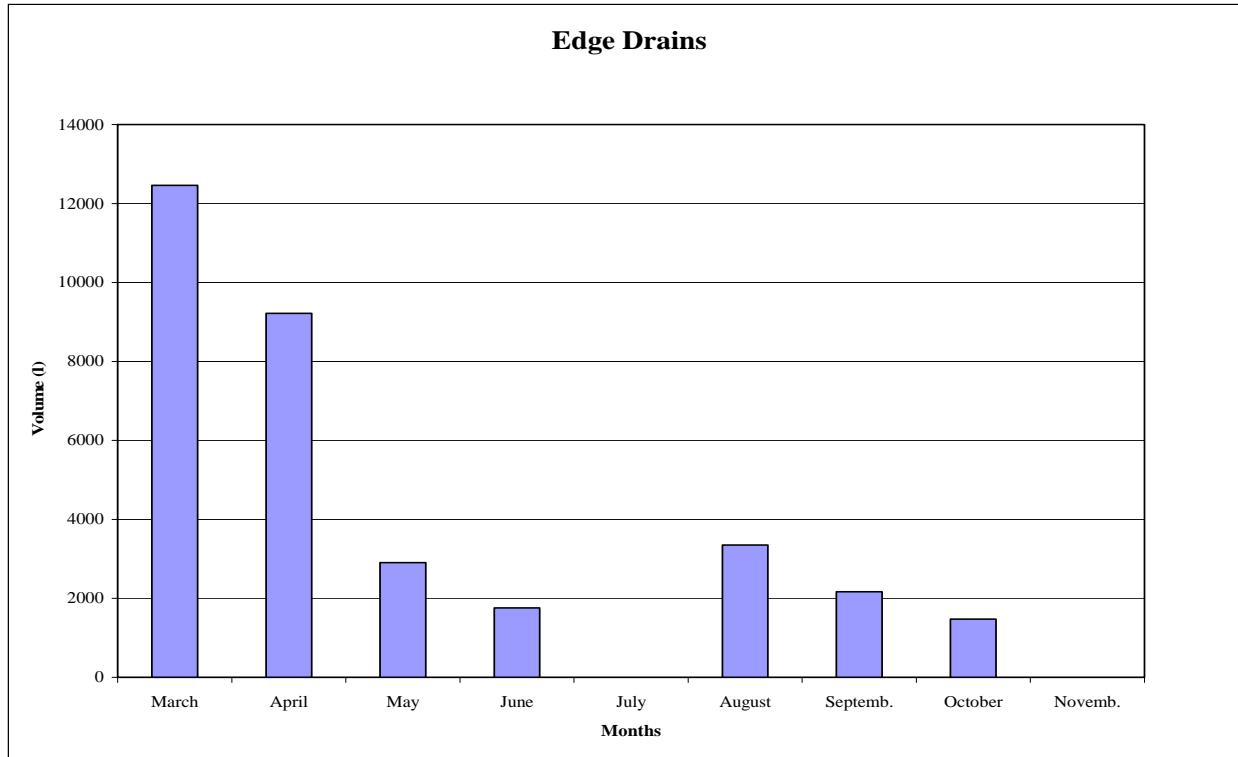
Figure B.7 Average volume drained from edgedrains (l) – 2006-07

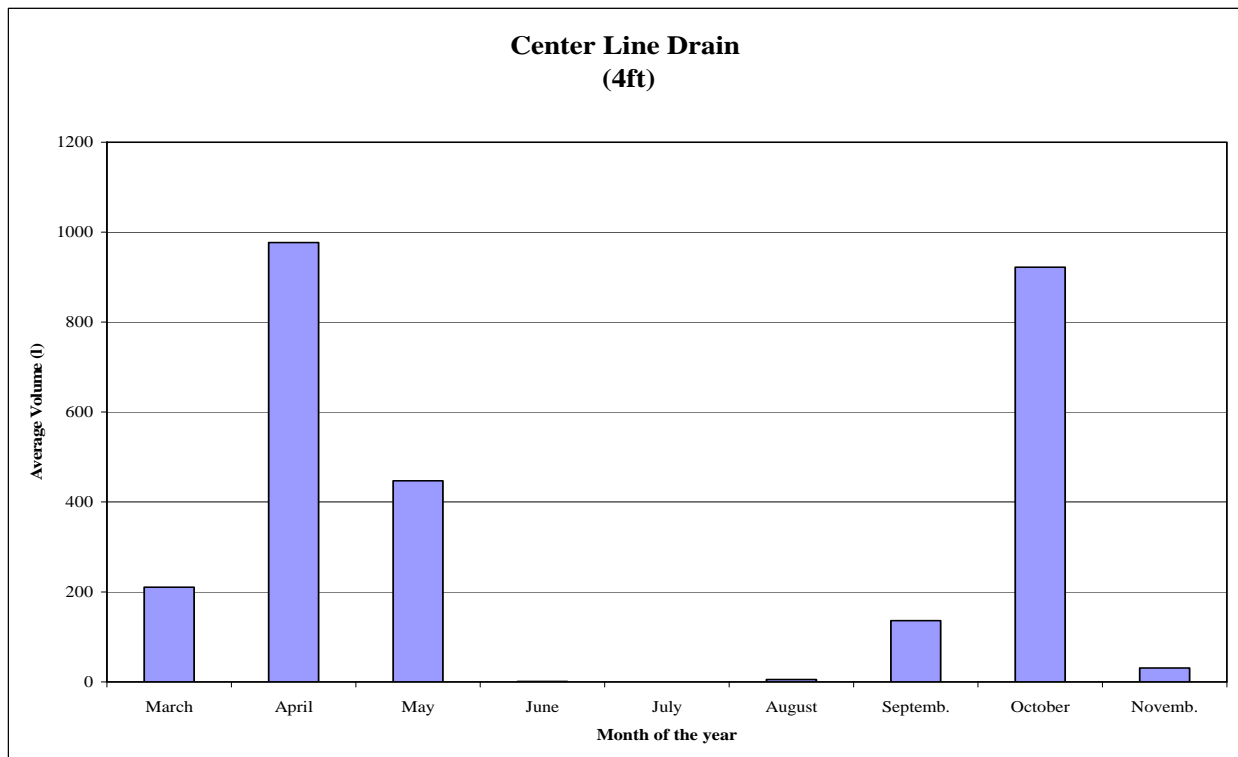
Figure B.8 Average volume drained from 4-ft centerline drains (l) – 2006-07
