**PRIORITIZING STREAM RESTORATION:
A DECISION SUPPORT TOOL FOR USE IN RESTORING
WATERS IMPAIRED BY EXCESS SEDIMENT IN THE
BLUE EARTH RIVER BASIN OF MINNESOTA**

A THESIS SUBMITTED TO THE FACULTY OF THE GRADUATE
SCHOOL OF THE UNIVERSITY OF MINNESOTA

June, 2013

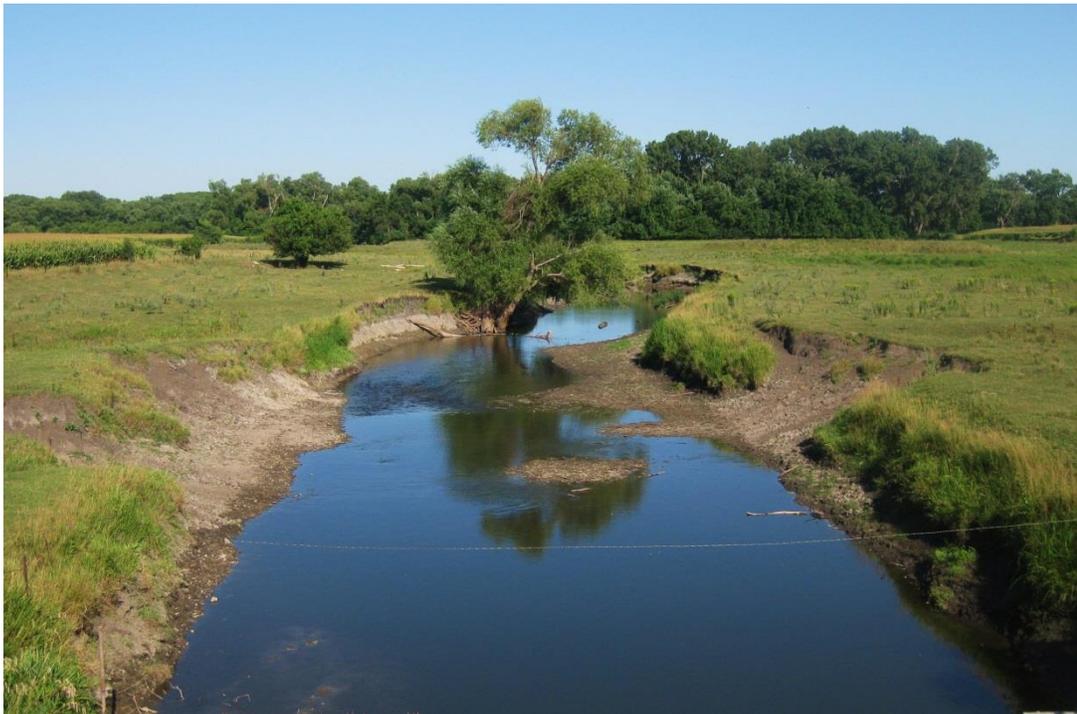
Figure 2.2a: Loss of Forested Riparian Habitat in the BERB. Grazing has also accelerated the amount of erosion. Photo: Center Creek: 2011 by Presnail.

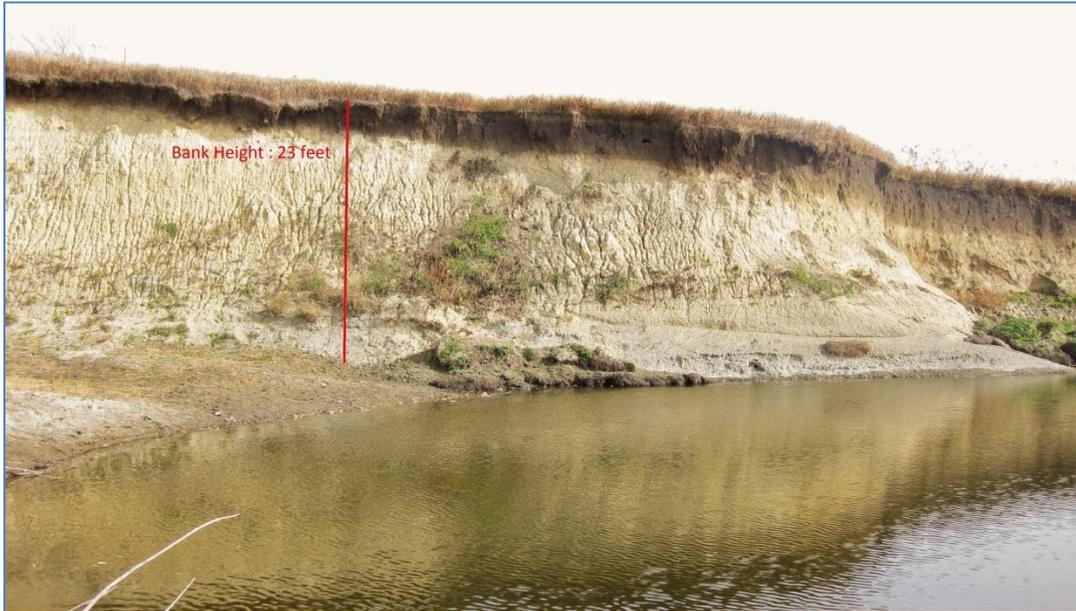
Figure 2.3 Actively eroding streambank on Elm Creek, a tributary to the BER. Photo by Presnail, taken fall, 2011.

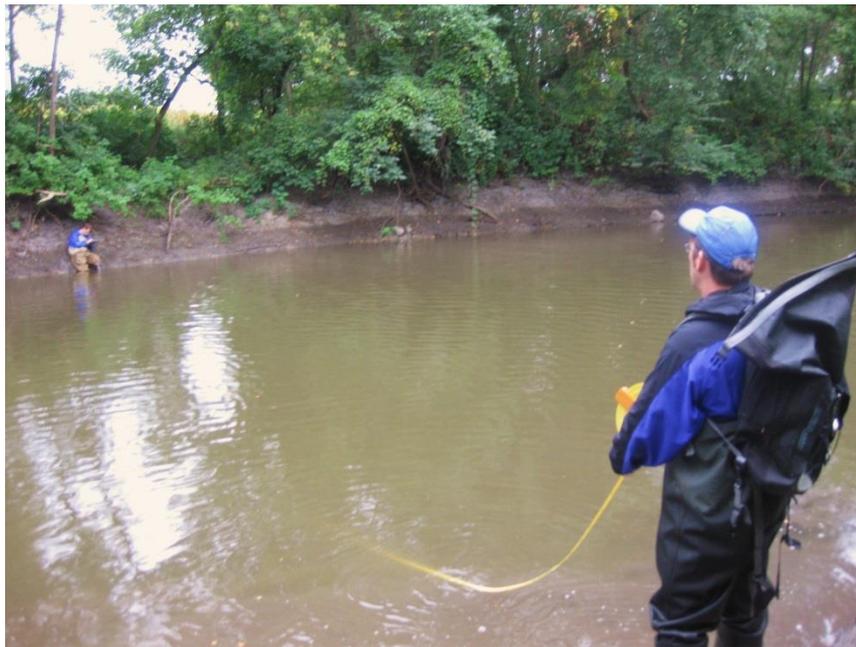
Image 4.3.4 Researchers gathering measurements. Photo by M. Presnail, Fall, 2011.

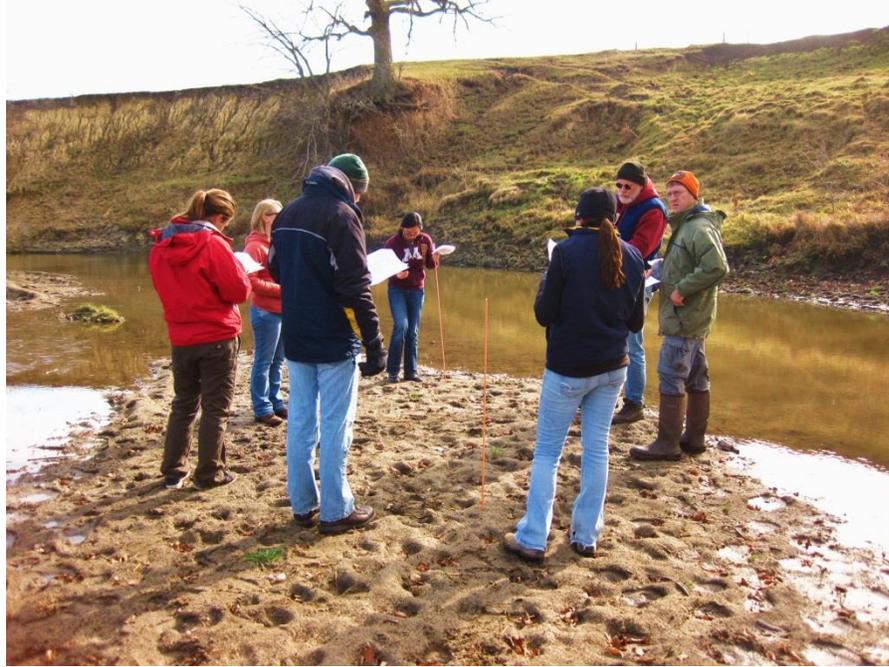
Image: 4.3.7 Researchers filling out the SRPSS on a site on Elm Creek. Photo by M. Presnail, Fall, 2012.

Once the watershed assessments were complete, the next step was to fill out the, “Stream Restoration Prioritization Score Sheet.” As stated in Chapter 3, this score sheet uses 13 metrics that will help to prioritize the need, ease and cost for restoration. The “Guidance Manual for the Stream Restoration Prioritization Score Sheet” was used as a step by step guide to determine score sheet rankings. See score sheet results in Chapter 5 Results and Discussion.
