IMPACT RESISTANCE OF FILLED CONCRETE BOX SECTIONS

A THESIS
SUBMITTED TO THE FACULTY OF THE GRADUATE SCHOOL
OF THE UNIVERSITY OF MINNESOTA
BY

CHRISTOPHER MICHAEL BRUHN

August 2013

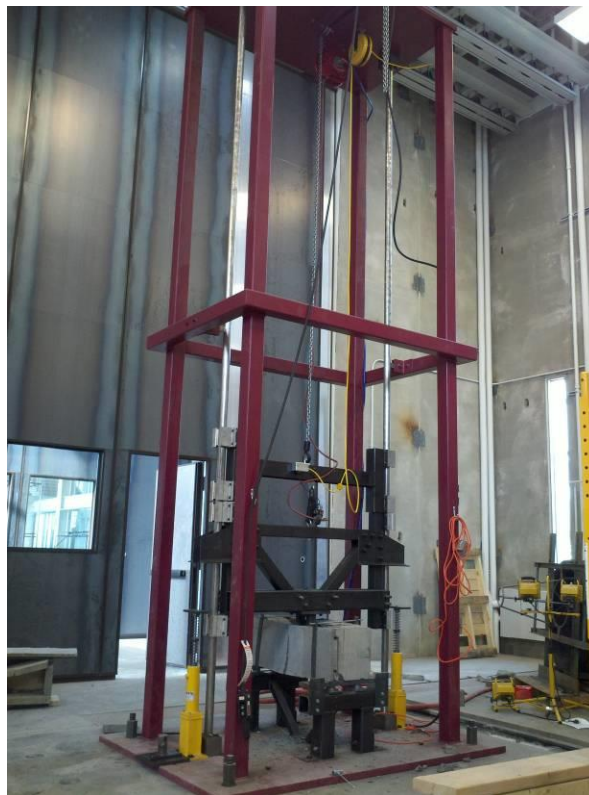
Fig 3-1
Impact testing machine with concrete box section in testing bay

Before any concrete specimens could be tested, a machine capable of producing the loading needed to be designed and constructed. The author produced a set of structural drawings, computer models, and calculations for the impact testing machine (Fig 3-1). The machine is capable of producing over 50,000 lbs of force (according to a classical mechanics approach) and can be equipped with various impacting tips or shapes. The machine relies solely on gravity for means of energy.

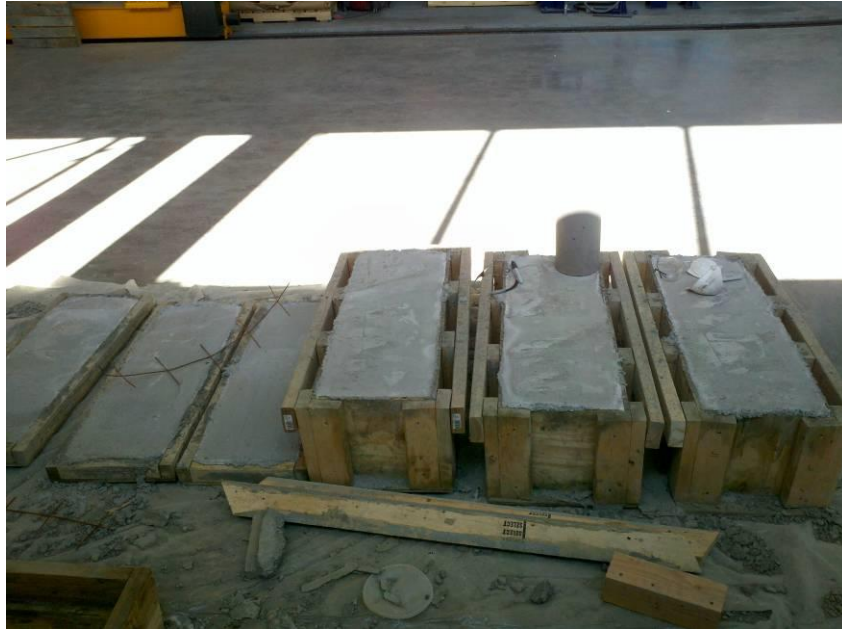
Fig 3-6
Concrete box sections and lids in forms

Three wooden forms were built for both the lid section and the main box section. The casting process consisted of rebuilding the forms after the previous cast first. Then the forms were oiled then the welded wire was placed. The concrete was mixed and poured/shoveled into the forms. A vibrating tool was used to consolidate the mix. The specimens were then covered with a plastic and moist cured for at least 24 hours before removal. It should be noted that all box sections have a sacrificial strip of plywood left in them after the casting process. This piece is located in the bottom of the fill material bay. The reason for this is that the forms were built to be the easiest to assemble and pull out and the bottom piece of plywood was virtually impossible to remove.

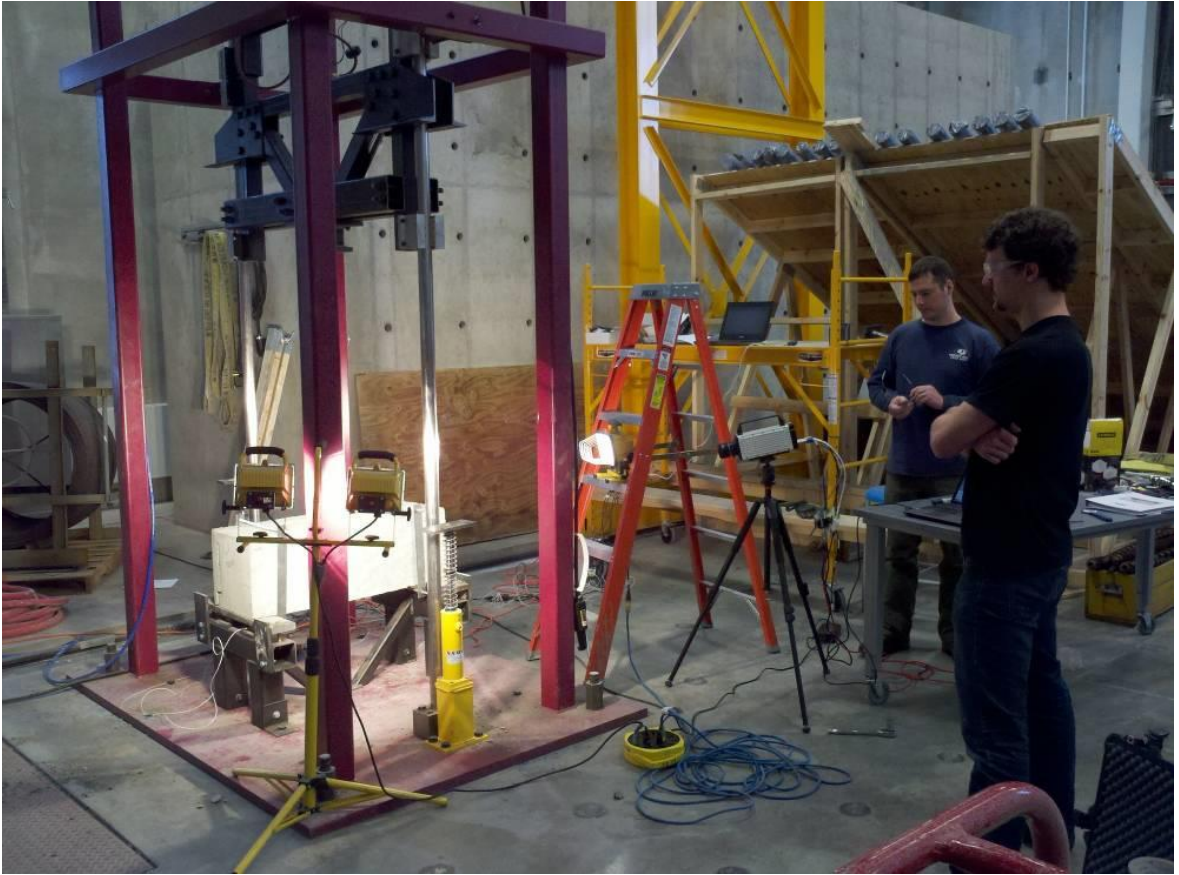
Fig 3-8
Test setup

For round impacting head use, the drop height was 5 ft and velocity before impact was around 90 in/sec. For rectangular plate drops, the height was increased to 6 ft and velocity was around 95 in/sec. The drop heights were determined by means of trial and error on sample, empty boxes. Impacting heads were dropped from various heights until the level of damage became satisfactory. For the round impacting head, a punching shear failure was desired. The plate impactor was used to generate a flexural failure in the box.

After determining the height and fill of the test and that the data acquisition was working, it was time to conduct the test. The safety pin could then be removed from the quick release, the carriages would be raised, and the weight would be released.

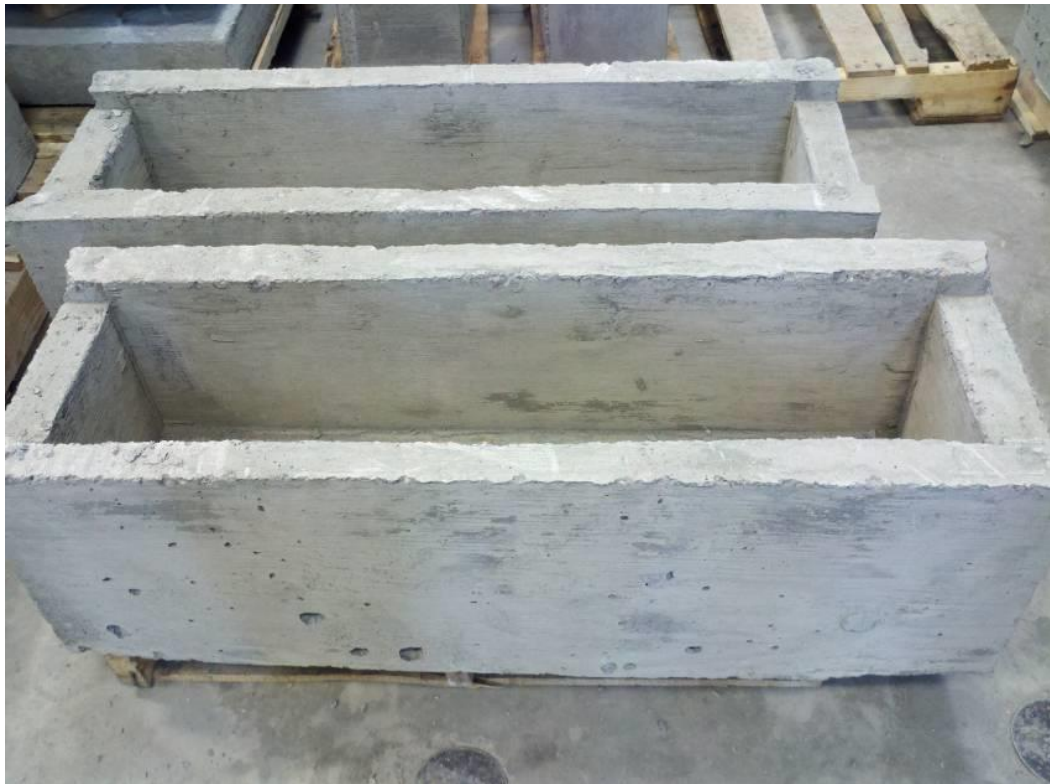
Fig 4-1
Unfilled box sections

In this section a visual analysis will be presented of each test specimen. The pictures of the aftermath of the impact test may present the most compelling data for arguments of a certain fill material. Below is a picture of a typical, finished box section prior to fill material.

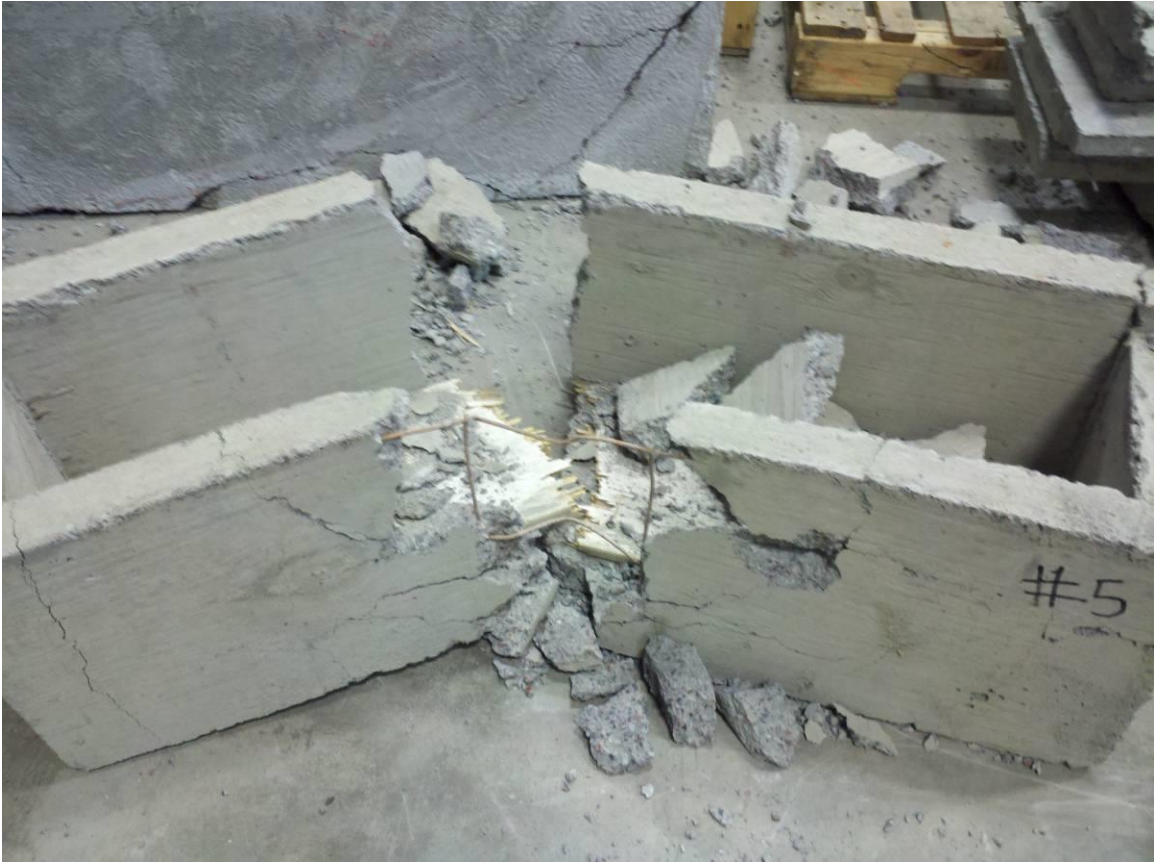
Fig 4-3
Test 5 - Round Control II Post Impact

The round control specimens showed the importance of having a fill material immediately. Without the fill material, the impactor was able to penetrate fully on both tests thus letting the broad part of the impacting carriage contact the box producing a second wave of damage. The slow motion footage of the test shows only a modest amount of cracking from the impactor penetration but very large amounts of flexural damage from the carriage. As force traveled through the box into the simple supports, there was considerable damage to the ends which responded poorly to the impulse and

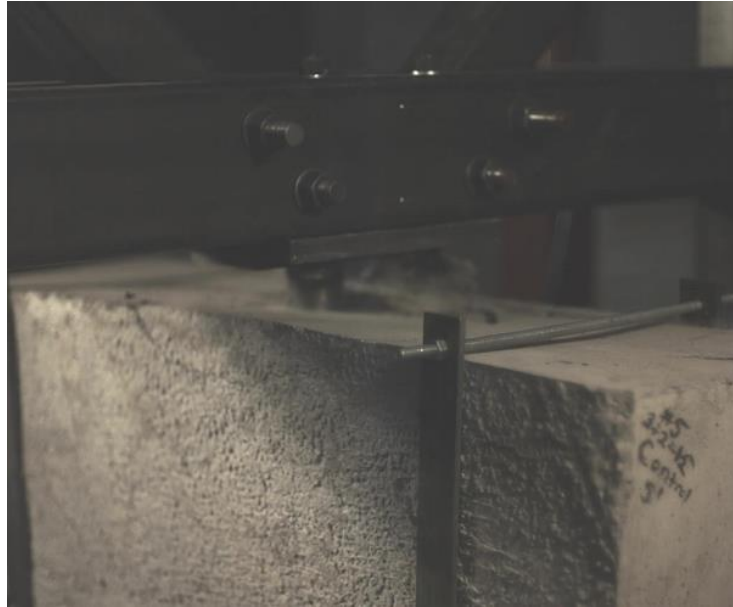
Fig 4-3.1
Test 5 – Impactor penetration from high speed footage

cracked. Fig 4-3.1 and fig 4-3.2 show the progression of damage of specimen #5 from the impactor.

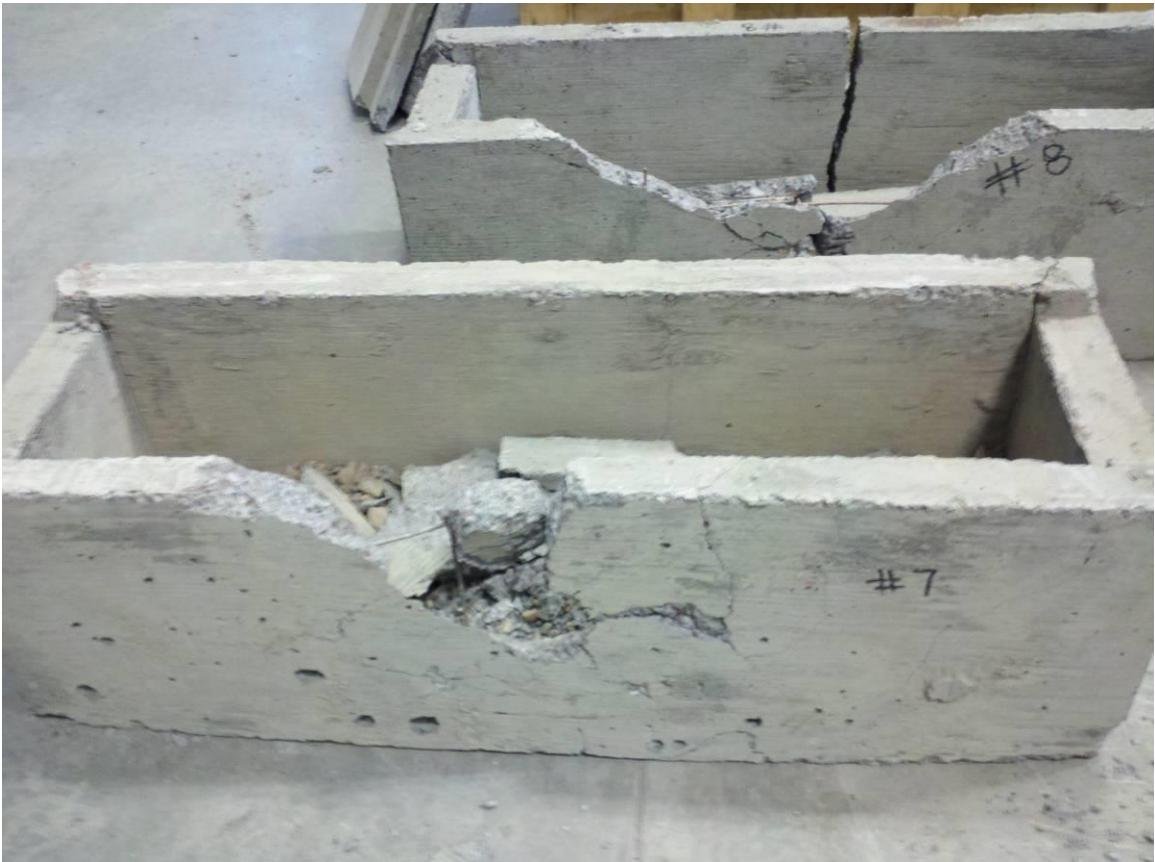
Fig 4-6
Test 7 - Round Coarse Aggregate 2 Post Impact

As expected, a fill material improved the response of the box from the impact. However, just as with the control specimen, full penetration of the impactor occurred causing considerable flexural cracking after the carriage impact. Response at the ends improved and less damage occurred as the coarse aggregate mass was able to absorb more energy. Both coarse aggregate tests seemed comparable and consistent in results.

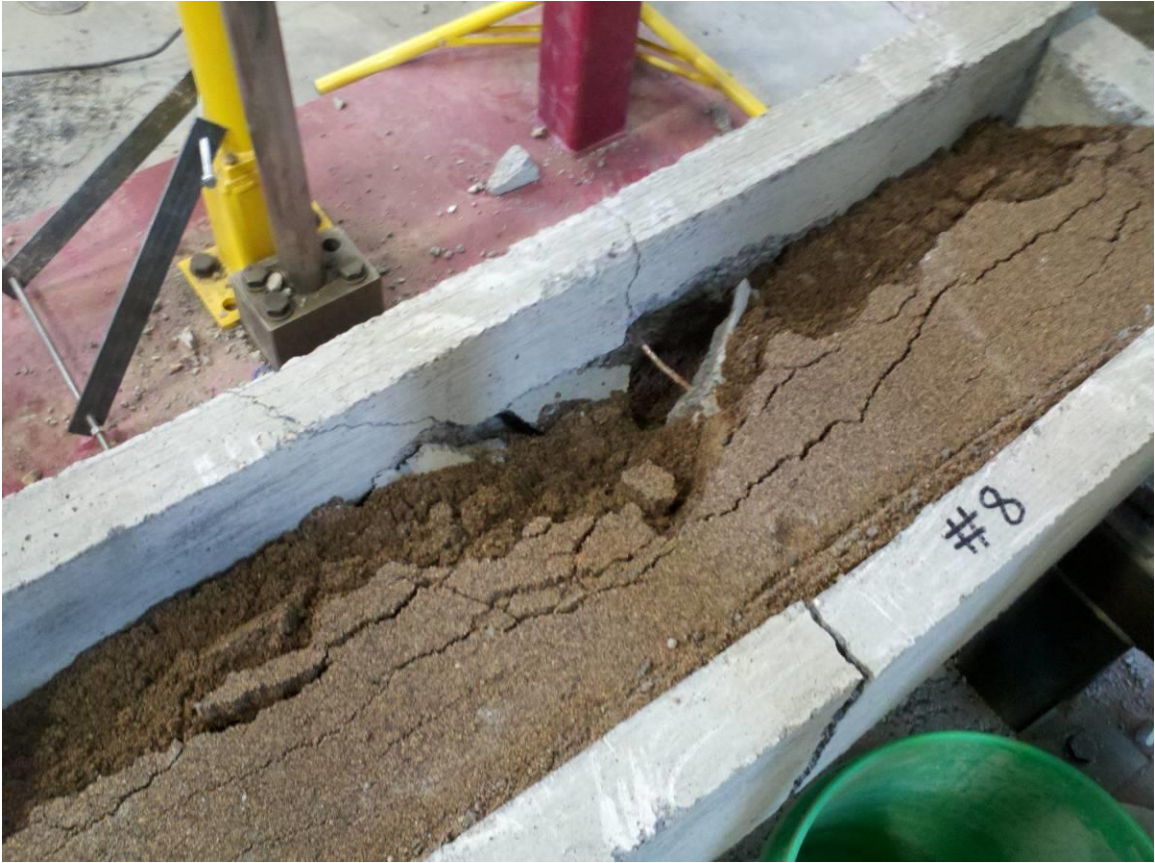
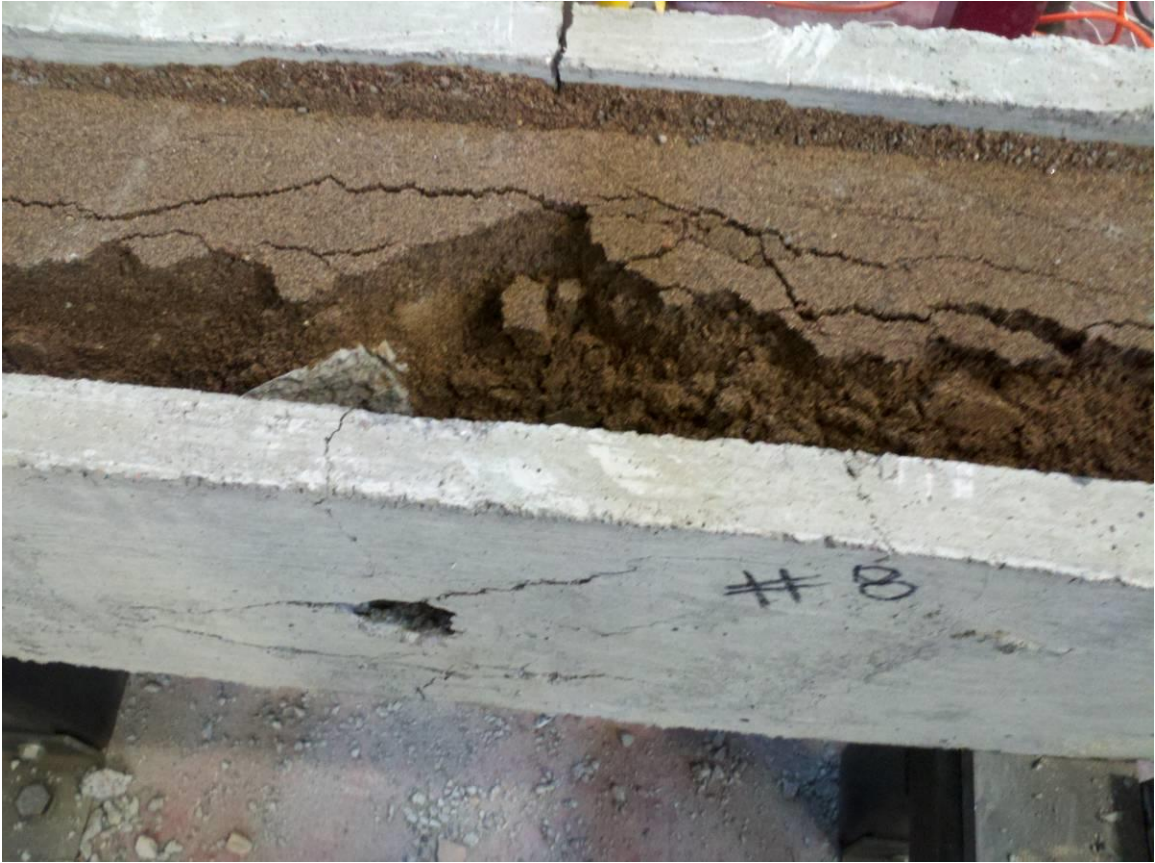
Fig 4-9
Test 8 – Round Sand Uncompacted I Post Impact

Again, just as in the control and coarse aggregate tests, the round impactor fully penetrated and caused significant flexural cracking. However, this seemed to be the most critical damage in the specimen and rigidity was maintained after the test. Little to no end cracking or damage was observed and the impacted side was limited to just the punching shear hole caused by the impactor. Both specimens appeared to respond very similarly. Upon impact, the uncompacted sand was settled by the impact and a reduction of volume can be seen in Fig 4-9 and 4-10.

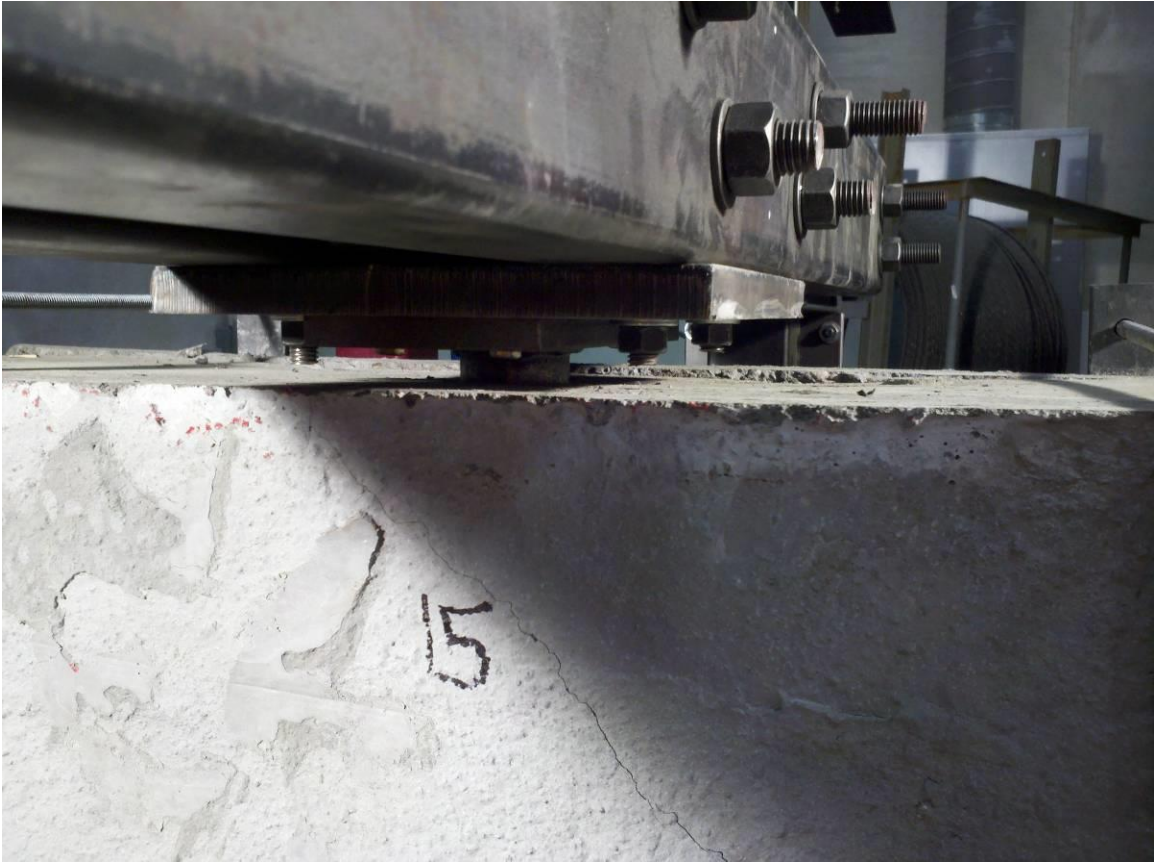
Fig 4-15
Test 15 – Round Sand Compacted Impactor Penetration

The compacted sand performed very well as the impactor was not able to fully penetrate for the first test (Fig 4-15). The second specimen did penetrate fully but was evidently slowed by the compacted sand and produced little extra damage upon carriage impact. Interestingly, no evidence of flexural cracking was produced on either specimen. True shear cracking showed up most prevalently in the first test in one crack and none in the second test. Ends of the boxes were preserved very well.

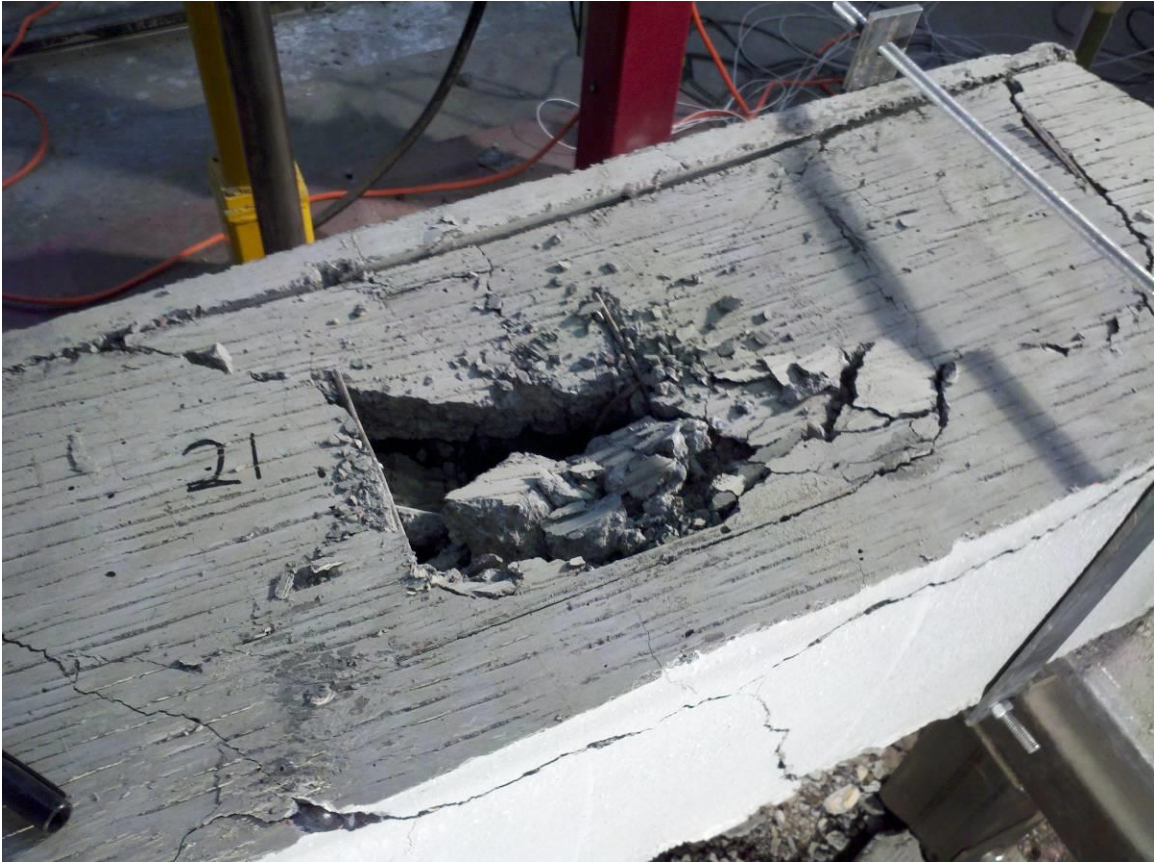
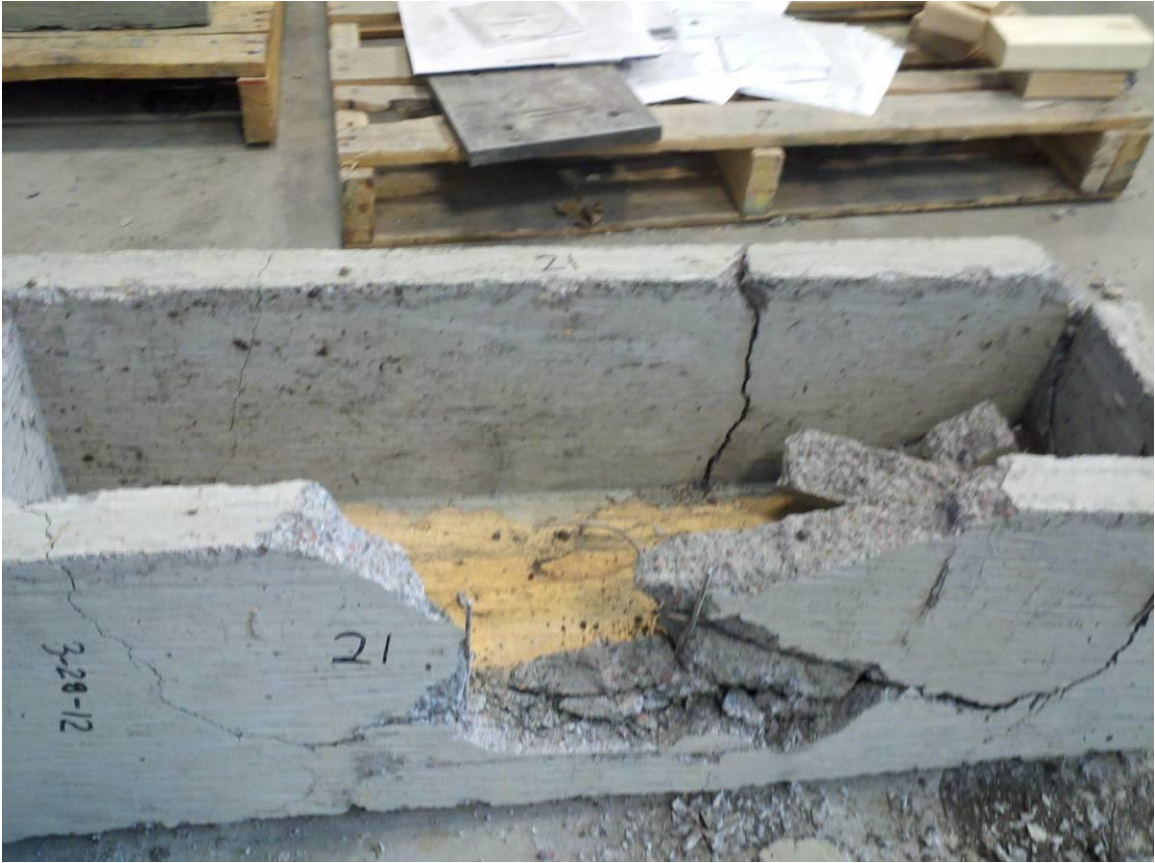
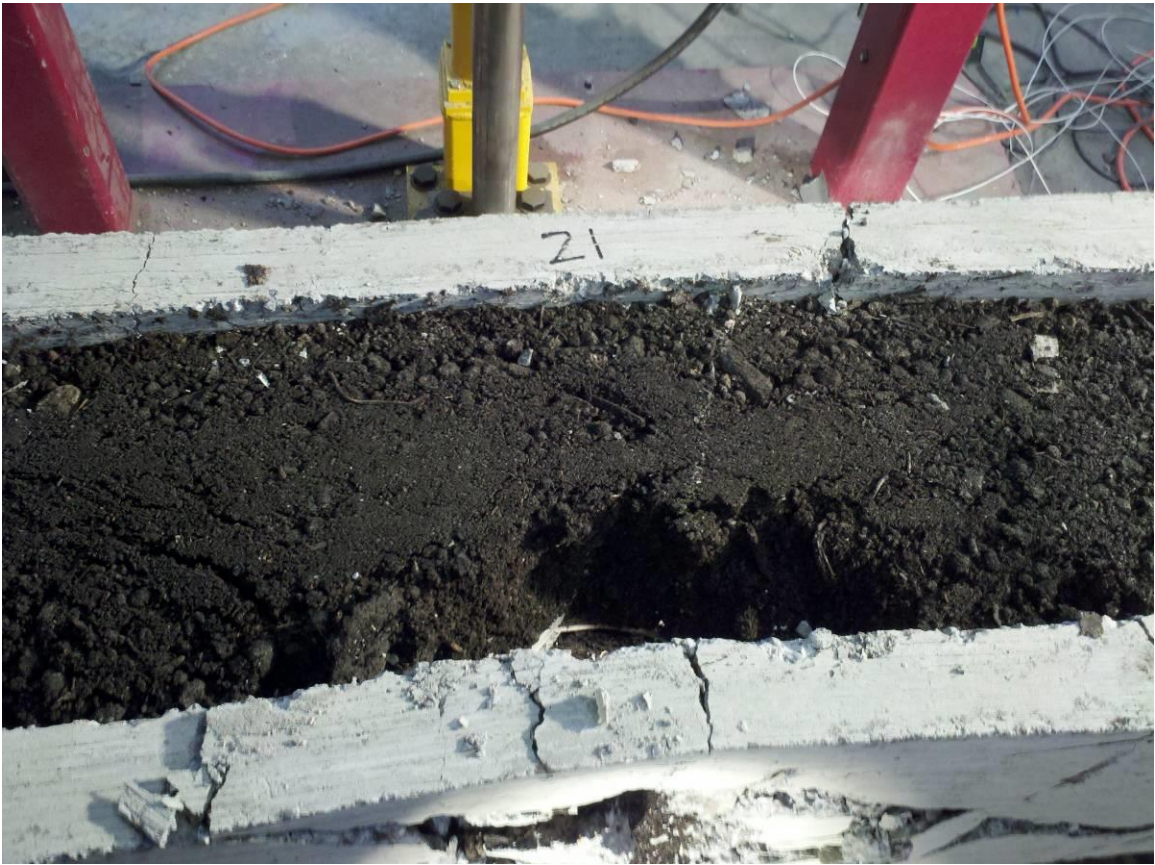
Fig 4-23
Test 21 – Round Soil Uncompacted II Post Impact

Both uncompacted soil specimens performed relatively poorly. Full penetration of the impactor caused extended flexural damage that failed the reinforcement considerably. The soil used has the lowest unit weight of any fill material in the study. The ends of the sections held up surprisingly well consider the amounts of flexural and shear damage in both specimens.

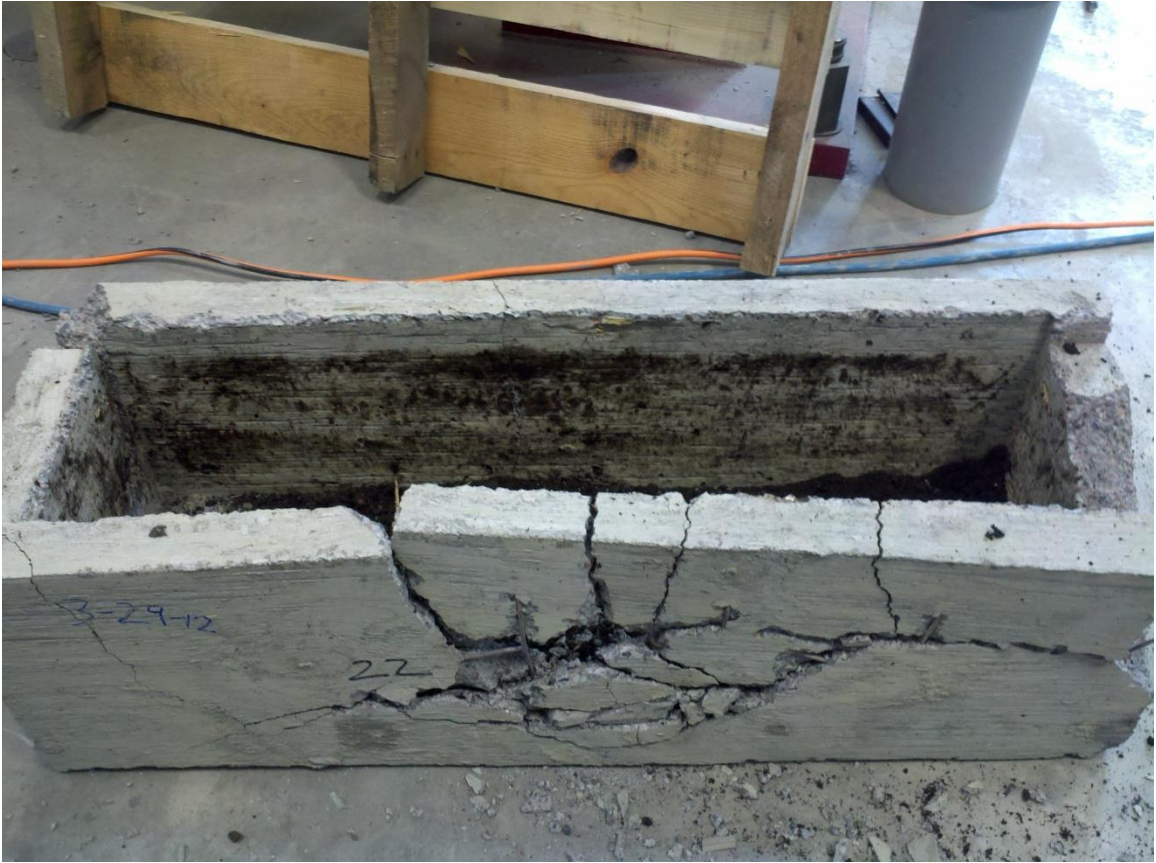
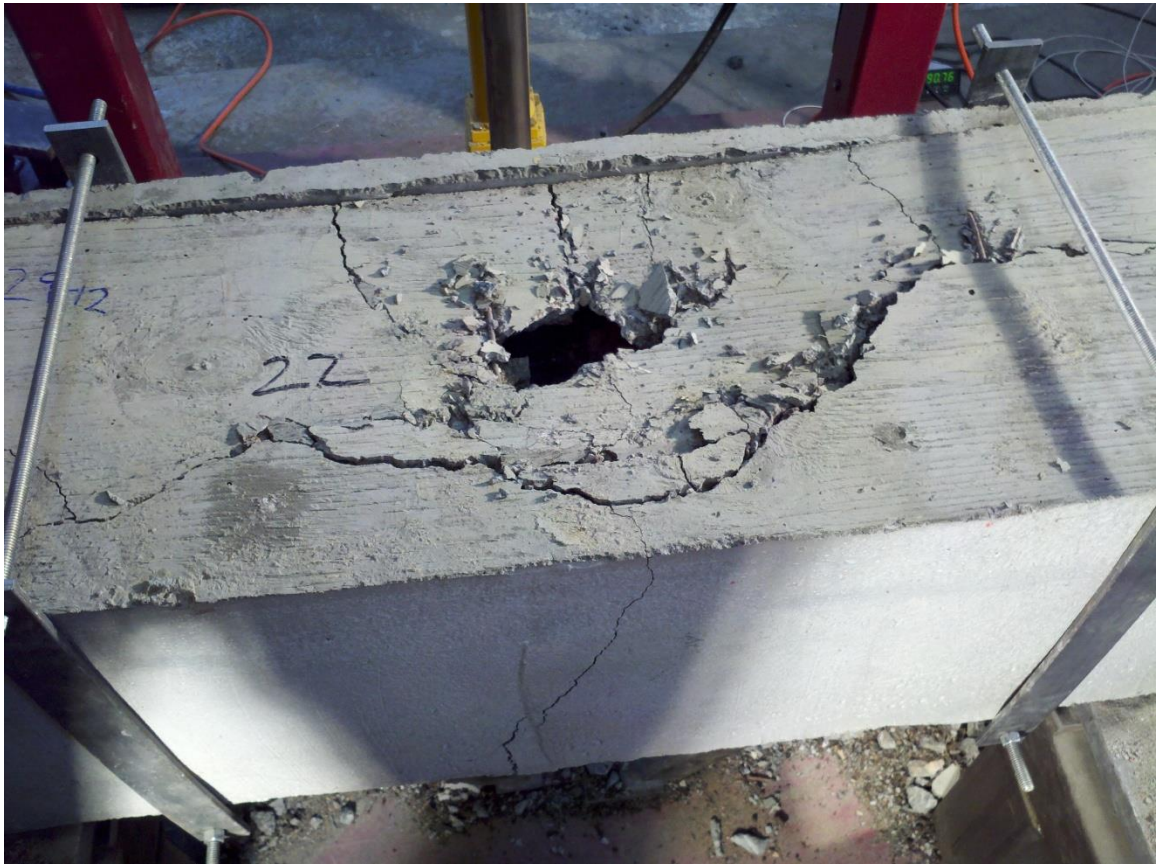
Fig 4-29
Test 22 – Round Soil Compacted 2 Post Impact

Compacted soil performed better than uncompacted soil but could not match performance of sand. Full penetration of the impactor caused extended flexural damage from carriage impact. Flexural cracks propagated slower than in the uncompacted test. The ends showed damage after fill material was extracted as corners fell off completely.

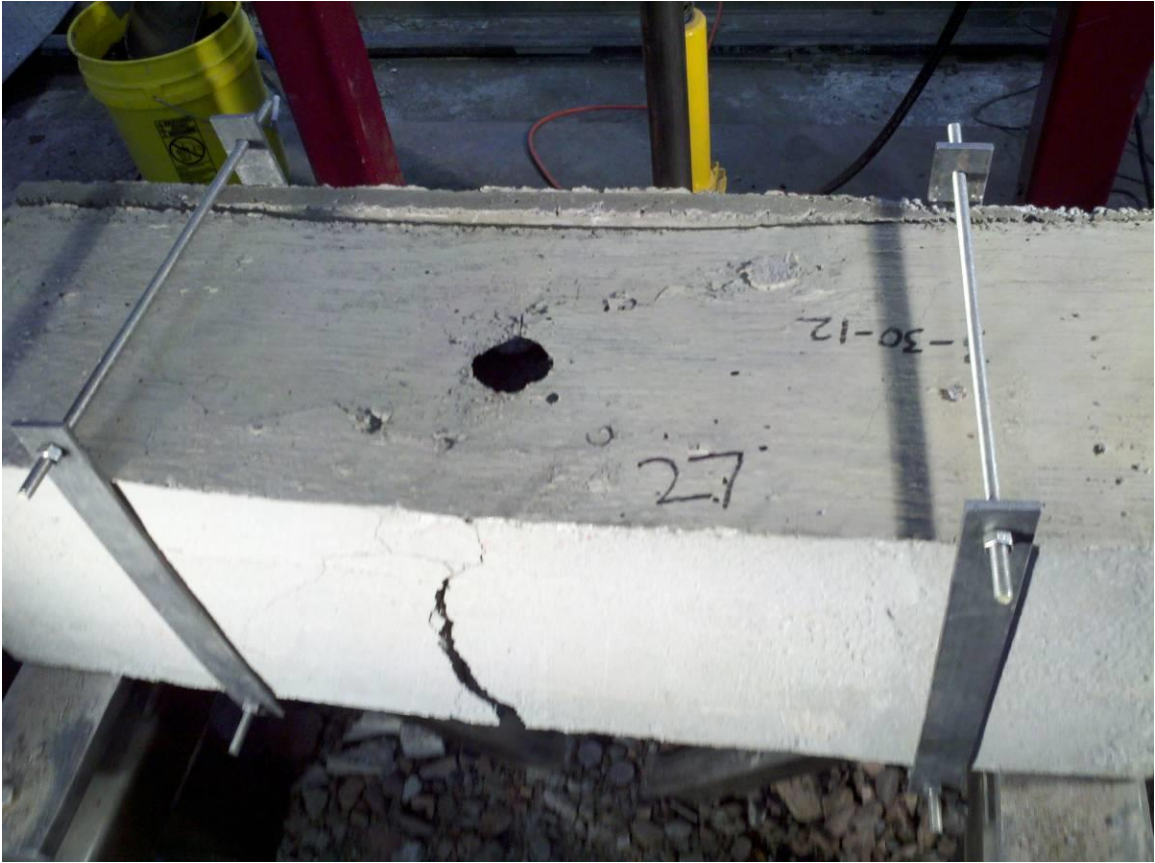
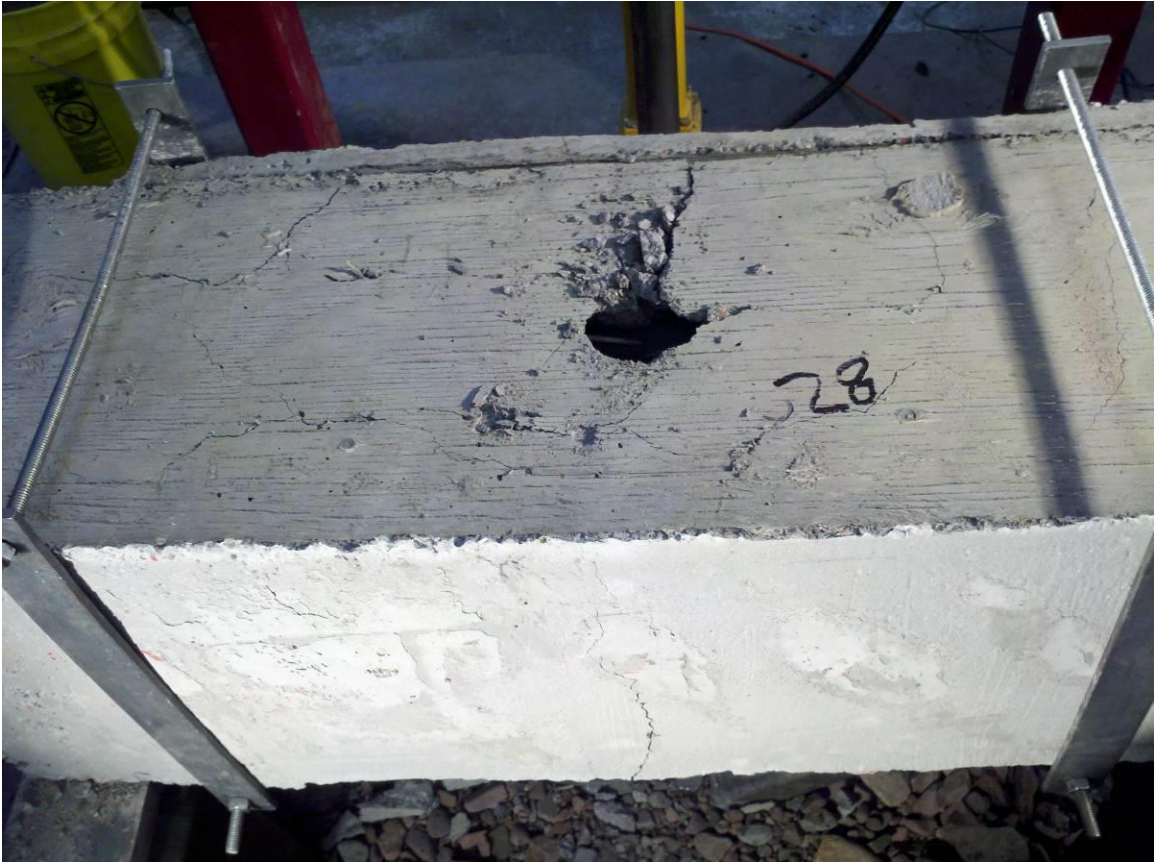
Fig 4-31
Test 27 – Round River Gravel I Post Impact

The round river gravel fill performed somewhat similarly to the angular coarse aggregate fill. Most of the failure was localized around a main flexural crack with a few shear cracks nearby. Ends were mostly preserved in both tests. Both tests showed full penetration of the impactor causing extended damage from the carriage impact.

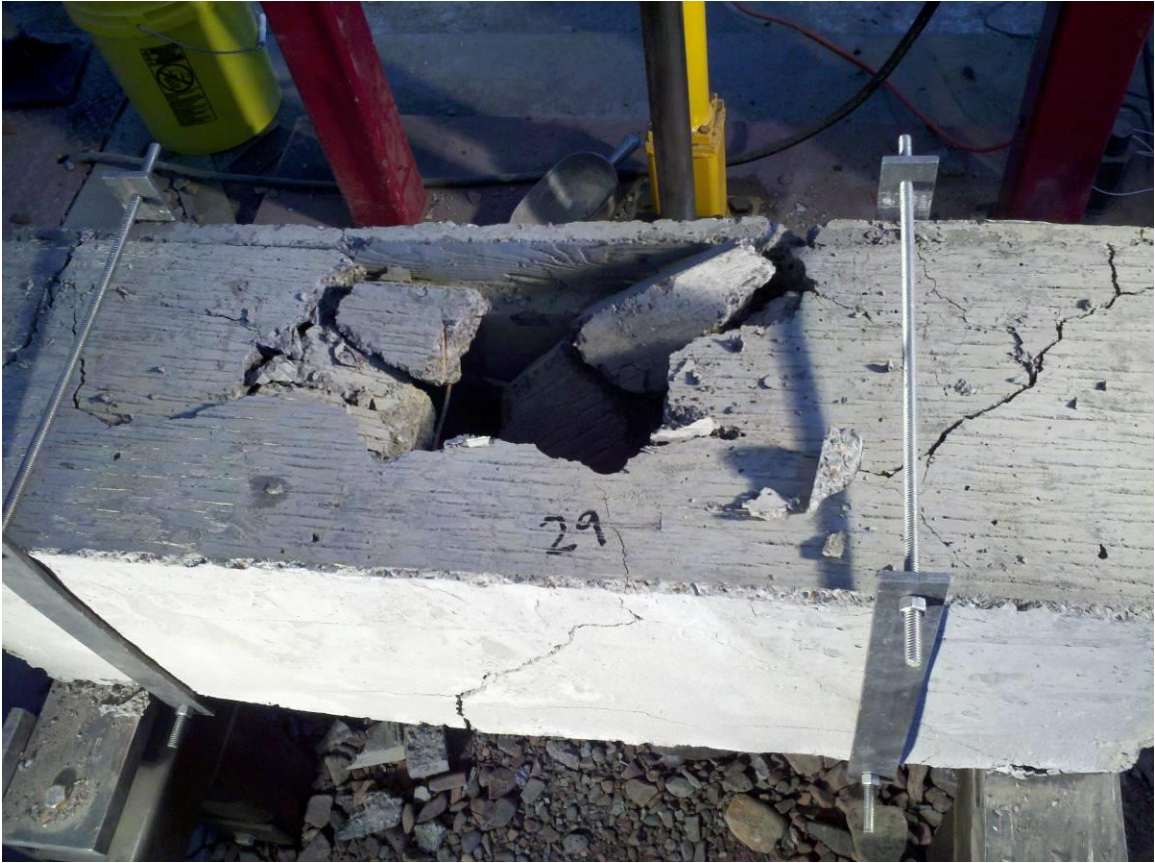
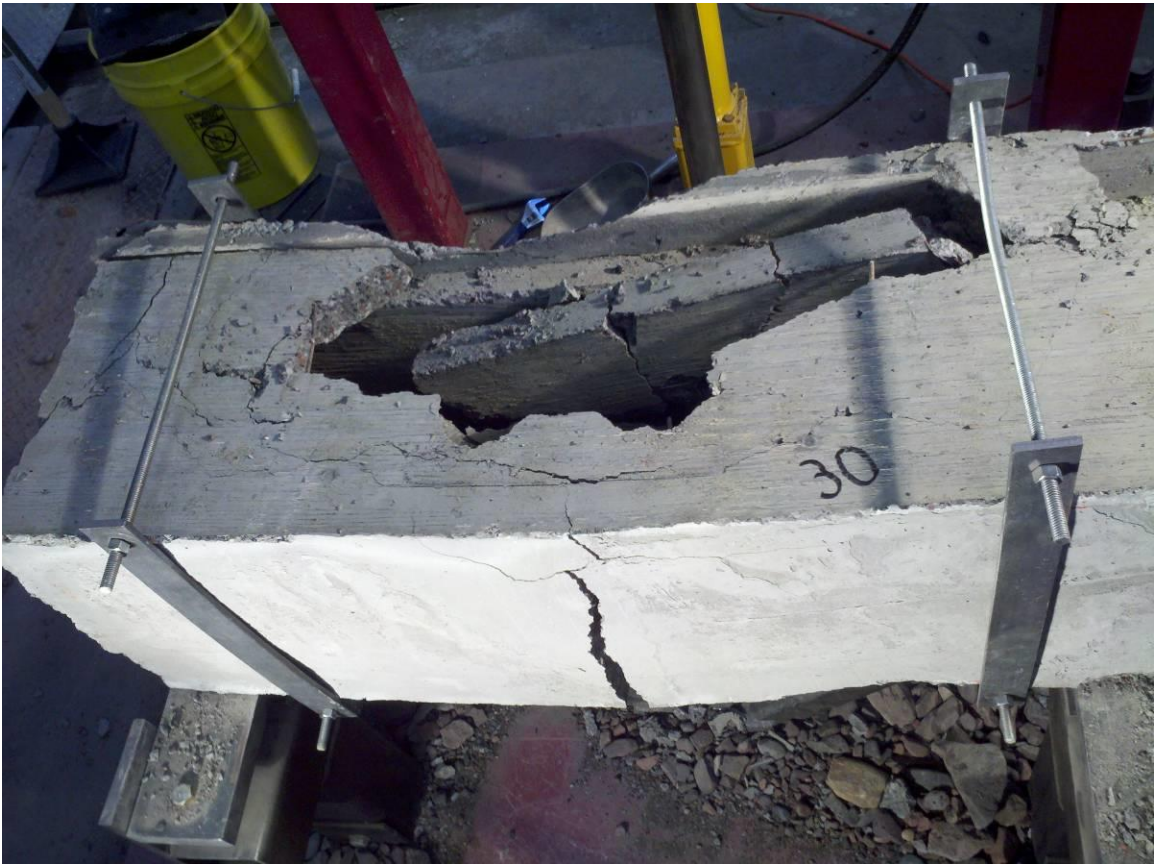
Fig 4-32
Test 29 – Plate Control III Post Impact

The plate control specimens all exhibited similar behavior. Upon impact, a small flexural crack, if any, would form. But just as with the round controls and other tests, the impactor fully penetrated causing the carriage to impact. At this point the plate had already cause a considerable amount of damage to the face of the specimen. Upon carriage impact, a flexural crack would evidently propagate along with shear cracking. Fig 4-33.1 and 4-33.2 shows the differences before and after impactor penetration. Aside from test #1, ends stayed intact during testing and fill extraction, but were cracked

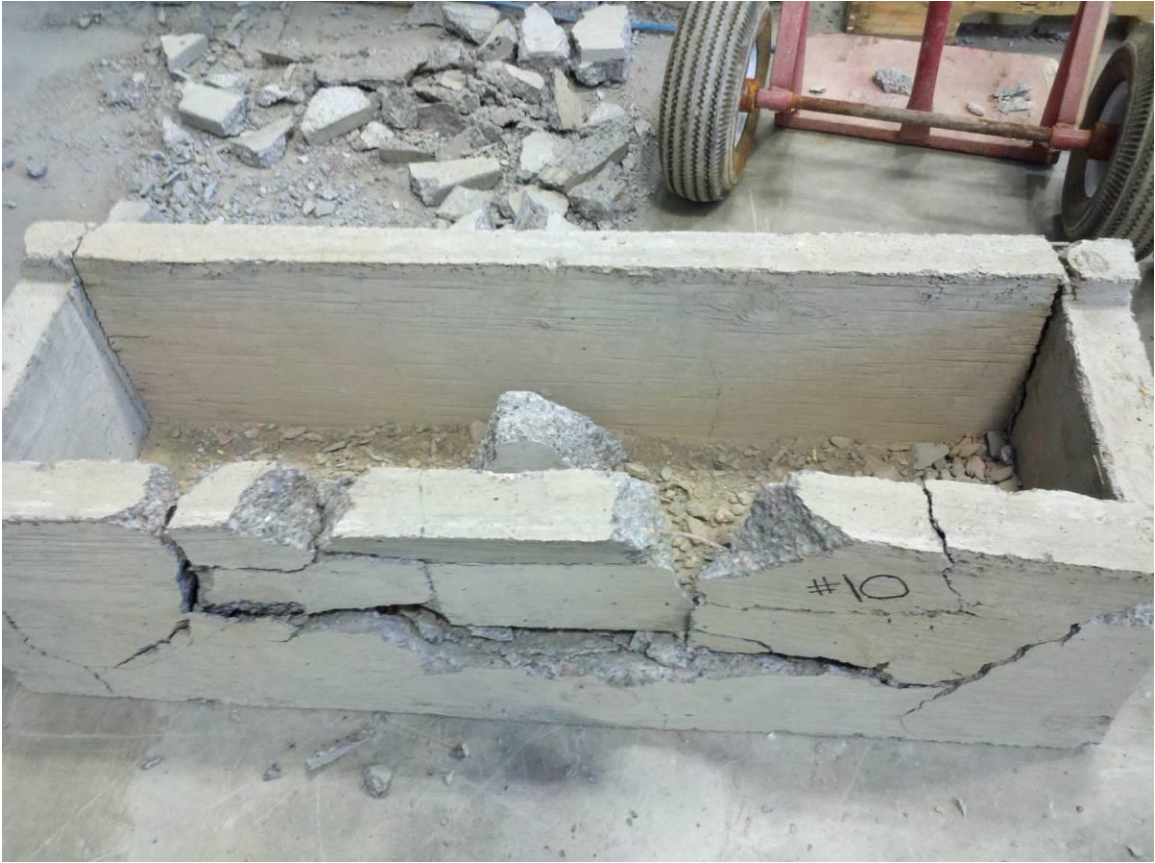
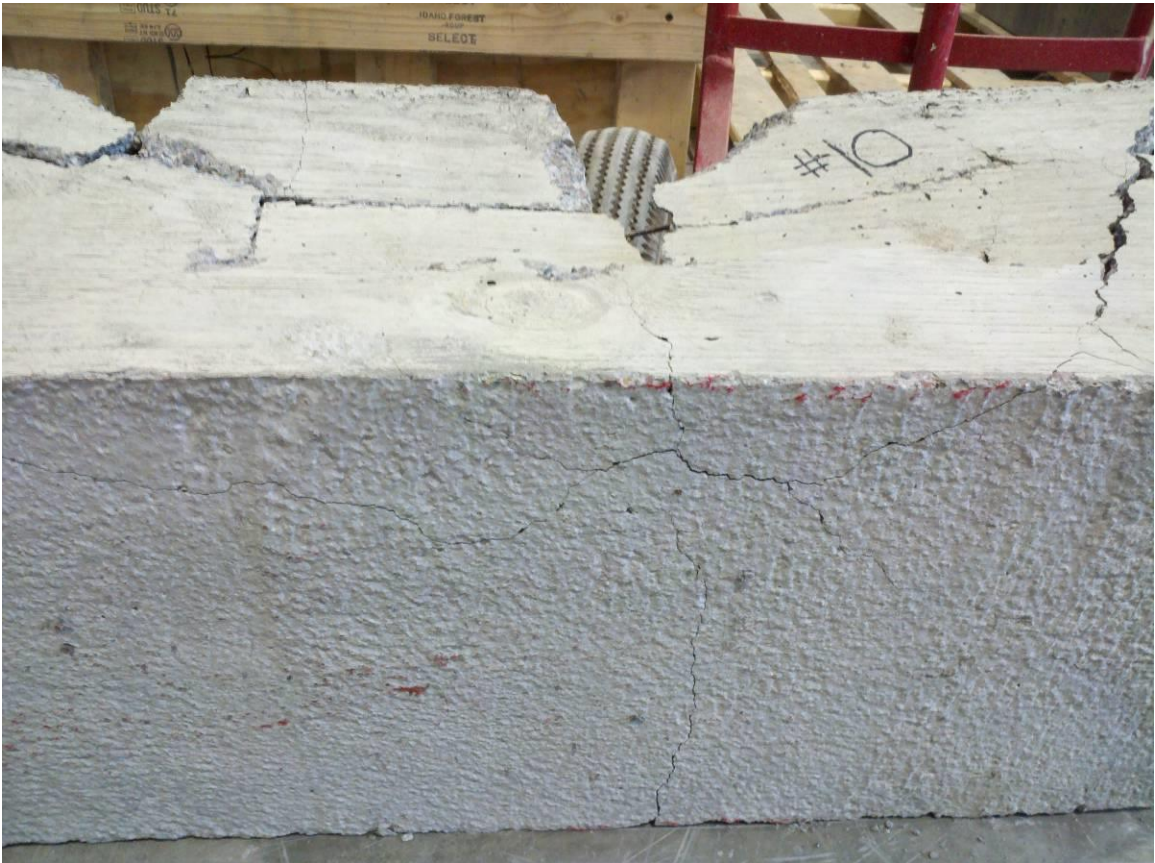
Fig 4-35
Test 10 – Plate Coarse Aggregate II Post Impact

For both coarse aggregate tests, the impactor was stopped from fully penetrating by approximately one inch. Flexural and shear cracking were significantly reduced from that of the control specimens. However, considerable damage to the ends of the specimen occurred causing chunks of concrete to barely be held on by the welded wire reinforcement after fill extraction.

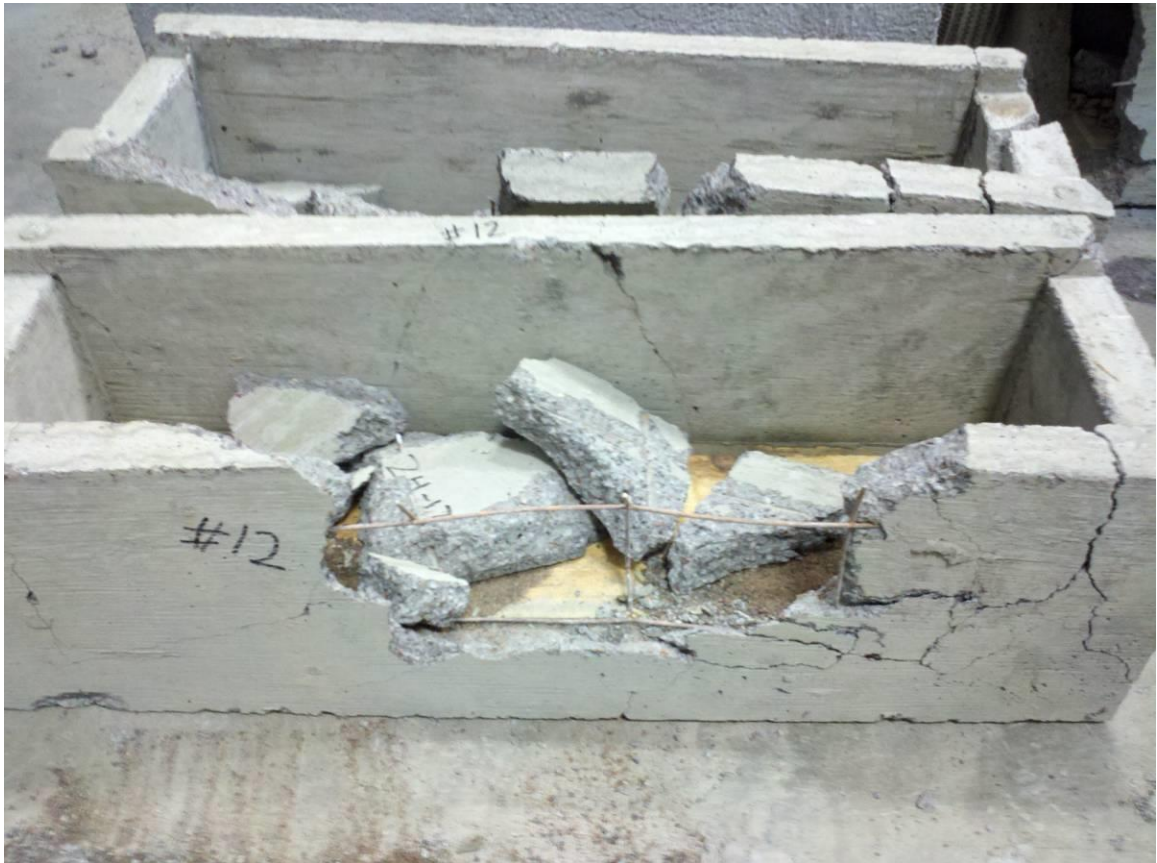
Fig 4-40
Test 12 – Plate Sand Uncompacted II Post Impact

The first uncompacted sand test, #11, showed no signs of flexural or shears cracking upon impact. The second test did crack both in flexure and shear but the cracks did not cause nearly the amount of damage of the controls. The impacting head did not fully penetrate on either test and ends were reasonably well preserved. On both tests, the damage was confined mostly to the impacted face of the box section.
