IMPACT RESISTANCE OF FILLED CONCRETE BOX SECTIONS

A THESIS
SUBMITTED TO THE FACULTY OF THE GRADUATE SCHOOL
OF THE UNIVERSITY OF MINNESOTA
BY

CHRISTOPHER MICHAEL BRUHN

August 2013

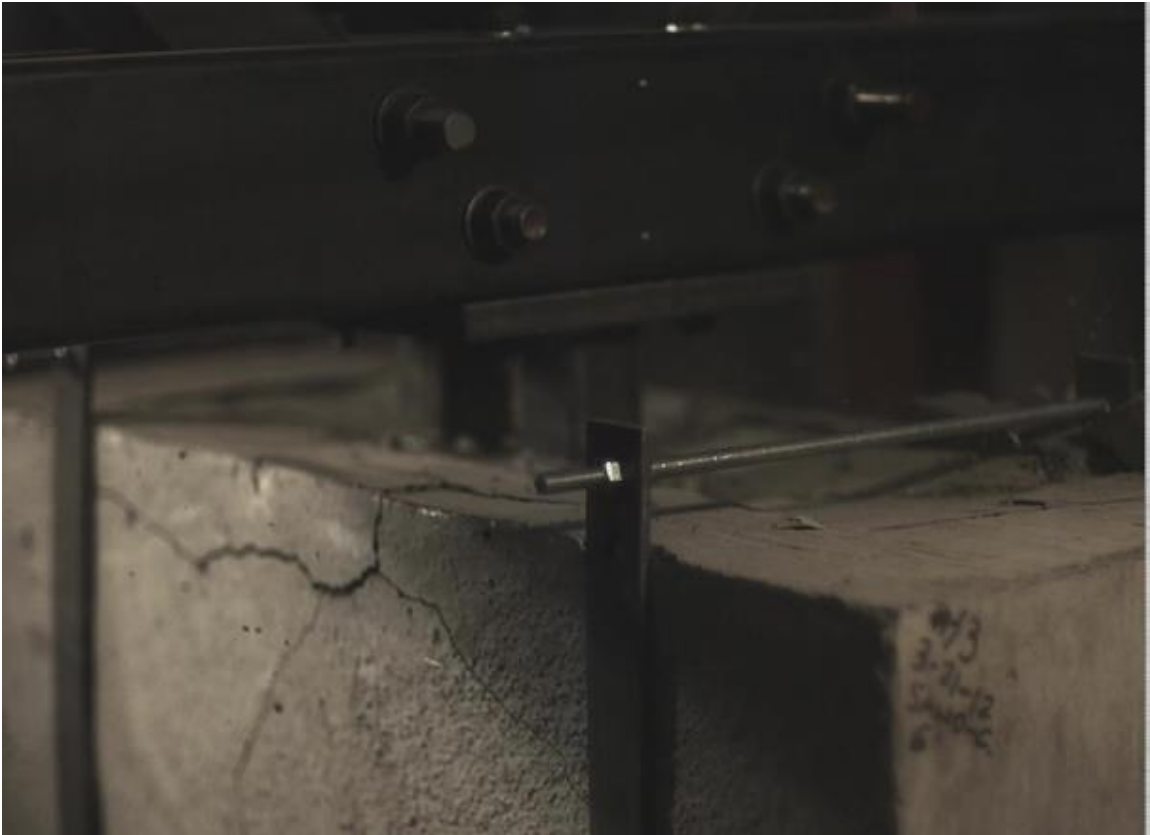
Fig 4-49.1
Test 13 – Plate Sand Compacted Bottom cracking

Plate impact on compacted sand fill showed some flexural and shear cracking. This was more evident on the first test, #13 where the impact created significant bursting forces. Ends were preserved but again, #13 shows a significant crack on one side. The boxes were well intact. An interesting behavior noticed here was the significant cracking about one inch down from the face. After looking at the compaction of each specimen, #14 seems to have had a more thorough compacting. The cracking shown above did not occur in #14. It appears that the lack of good compaction caused a fixed end moment failure but the sand prevented a further total flexural failure.

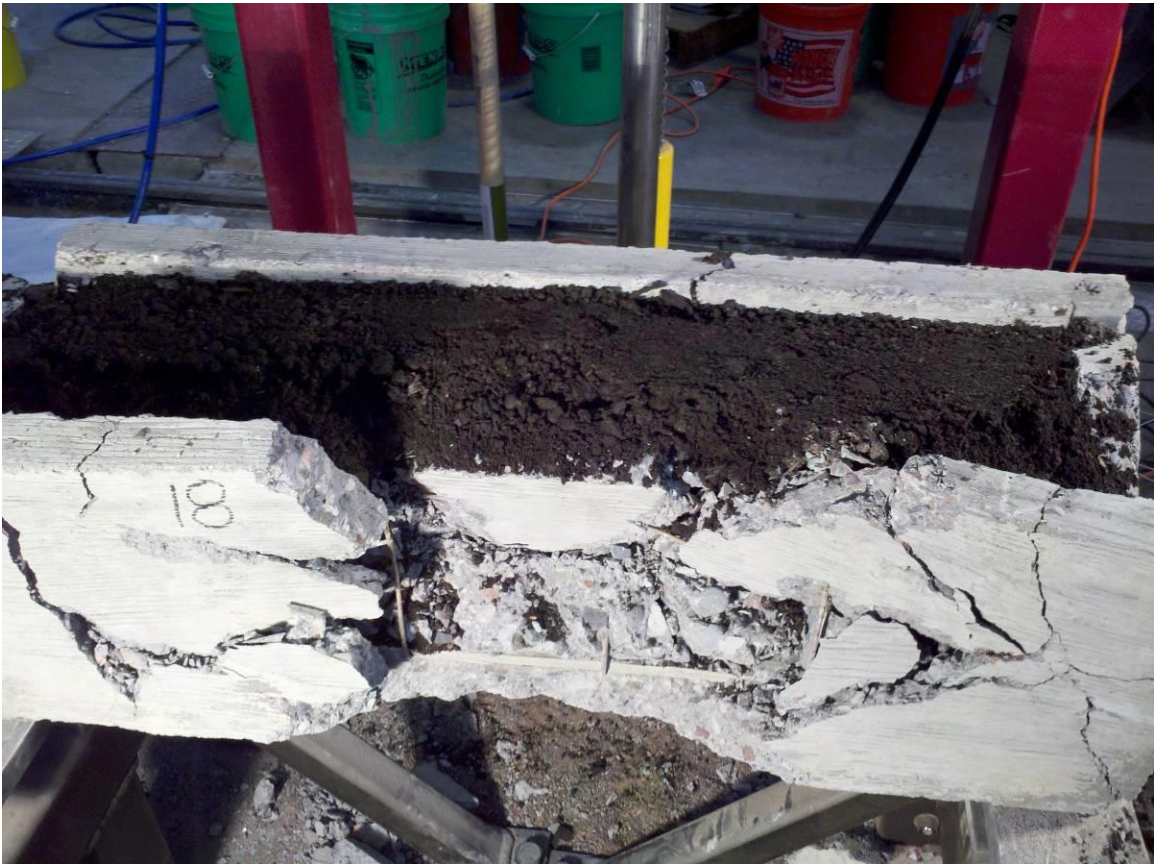
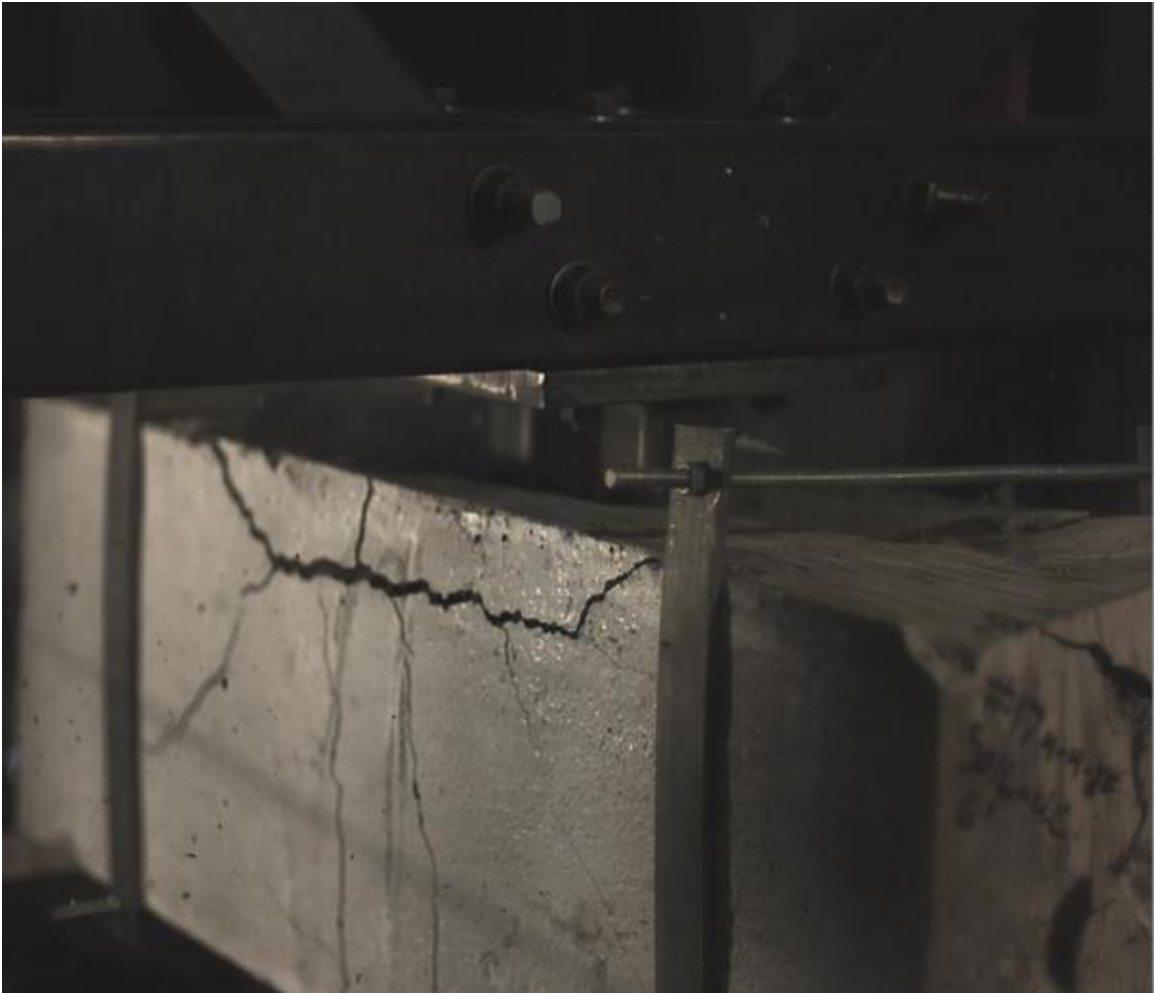
Fig 4-54
Test 17 – Plate Soil Uncompacted I Bottom Cracking

The plate soil uncompacted performed poorly as expected. The damage to the impacted side was significant as well as end damage. Interestingly, the same fixed end moment failure as seen with compacted sand occurred. The first test, #17, did not have full impactor penetration but still exhibited significant flexural cracking. The second specimen did allow full impactor penetration which led to carriage impact. The carriage impact caused a very significant flexural crack to form and propagate .

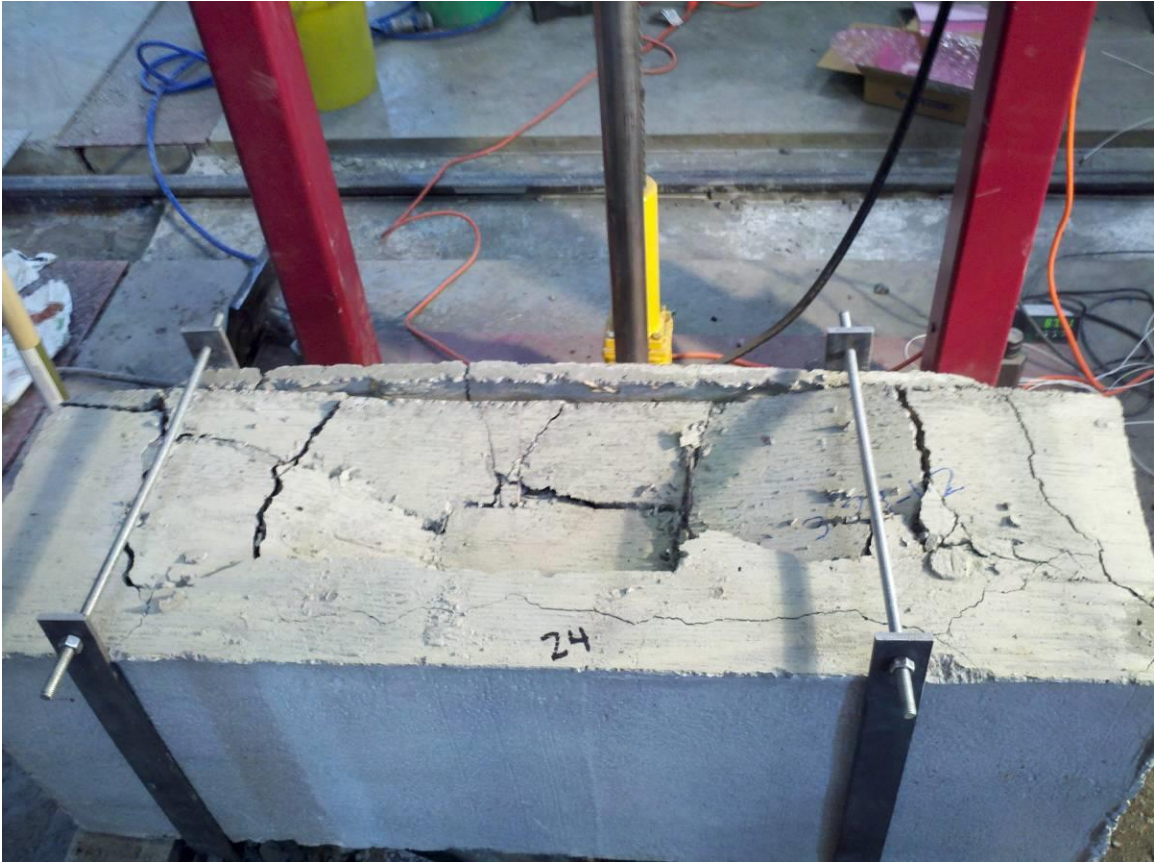
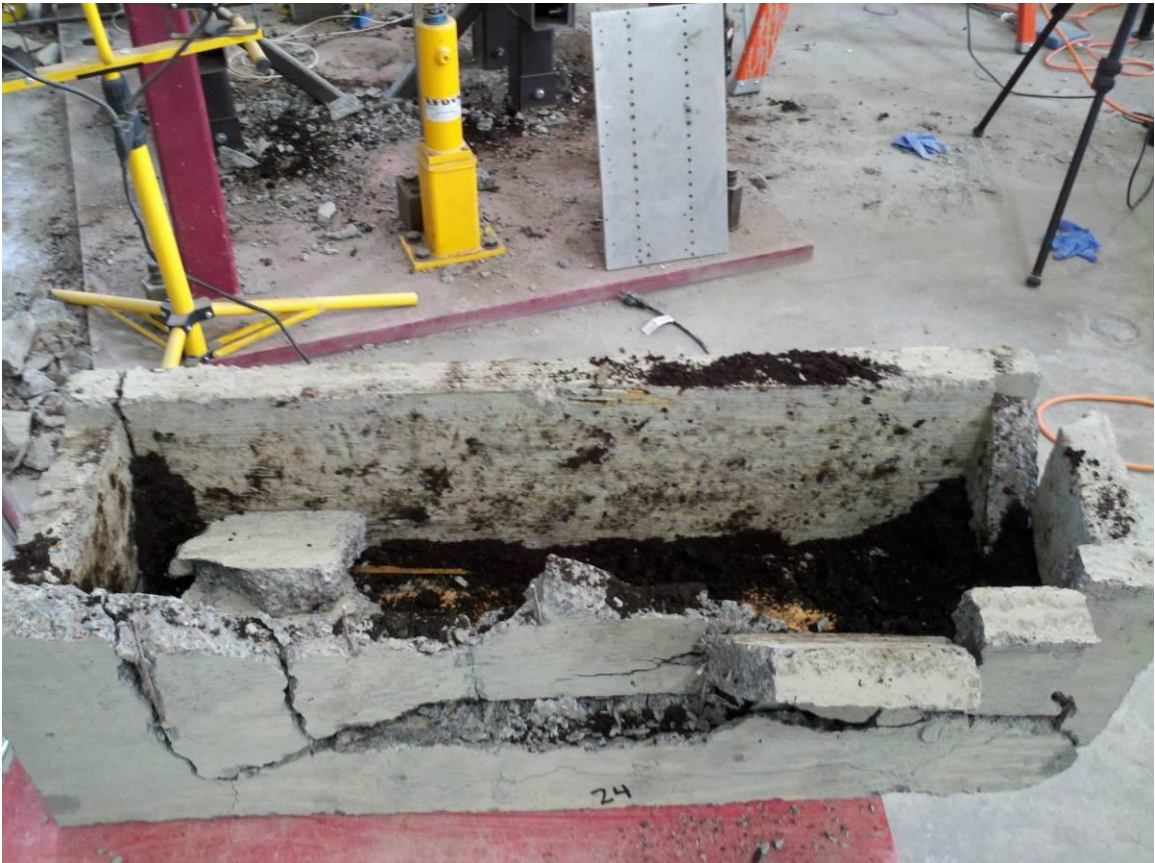
Fig 4-57
Test 24 – Plate Soil Compacted II Post Impact

The two tests showed the most variability among duplicates. The first specimen, #23, saw the same fixed end moment failure as before but concrete was spalled from this location. Flexural and shear cracks appeared and propagated down the side. Ends were split at the joint of the side and the ends on both sides. The second specimen did not appear to have any flexural or shear cracks but did sustain significant end damage and total loss of concrete in some areas of the corners.

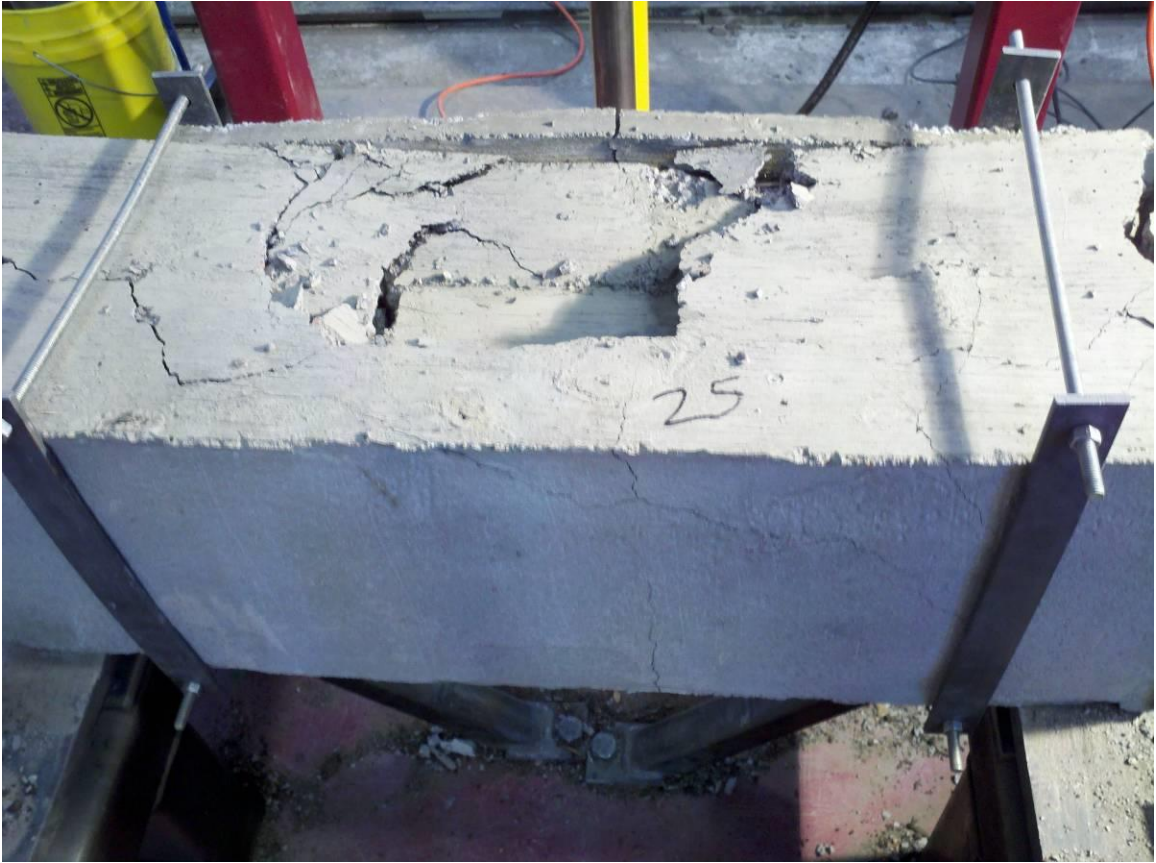
Fig 4-61
Test 26 – Plate River Gravel II Post Impact

The second specimen shown above showed more significant flexural and shear damage than the first specimen. Ends were damaged in both tests but more severely in the first test. The first specimen saw a large crack propagate from the impact right through the middle of the end causing the end to fall off. The second specimen also lost concrete off the ends from the impact but not as severely.

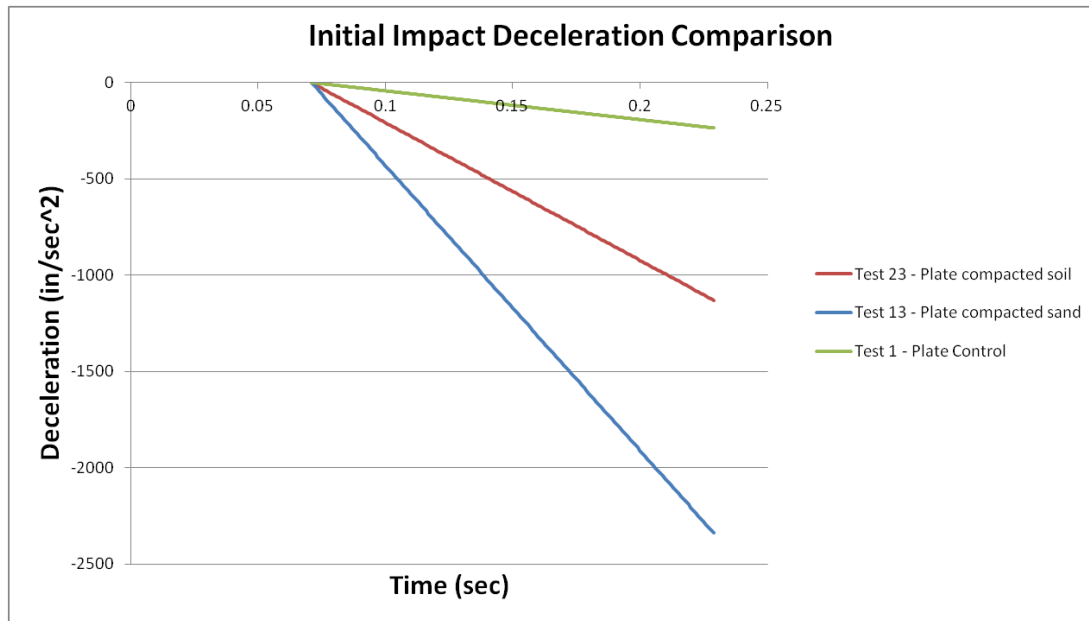
Fig 5-17
Initial impact comparison of tests, 1, 13, and 23

The plate impacting head did not typically experience a multiple impact event meaning that anytime an impact occurred, it was only the impactor head. The load cell graphs pictured in the appendix for the plate impactor reinforce this as no double-spikes are typically seen for the exception of the control. Since load cell data is not available to analyze directly with a control specimen, acceleration can be used instead. Below, the acceleration plots of the best numerically-performing fill materials, compacted soil and compacted sand are compared with a control specimen.

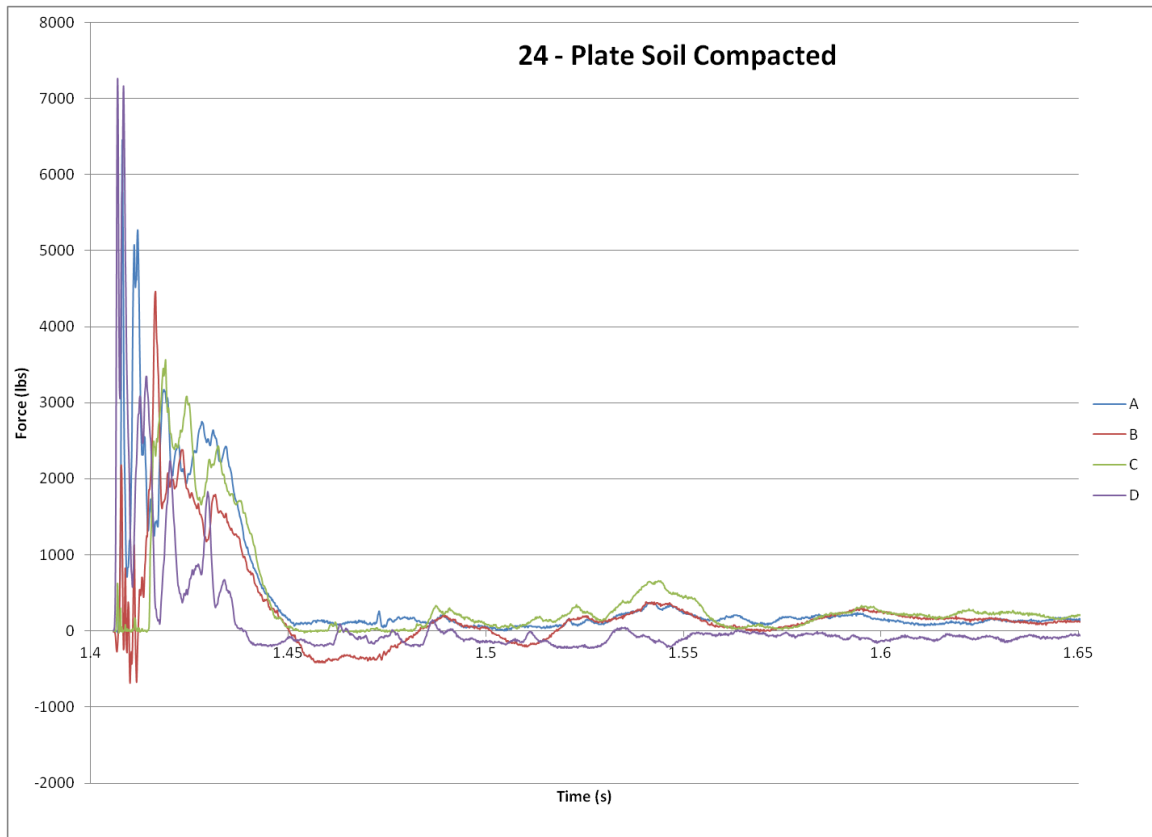
A.2.14 Plate Soil Compacted II

Below, two sets of acceleration and velocity graphs are given for test #24. Two tracking dots were put on the impact carriage. The reason for this is to calibrate the tracking software. The dots were placed 3 inches apart. Looking at the graphs, it shows that consistency was achieved and either tracking dot produces very similar results.
