**historic buildings inventory
st. paul campus
university of minnesota**

office of physical planning

30aug72

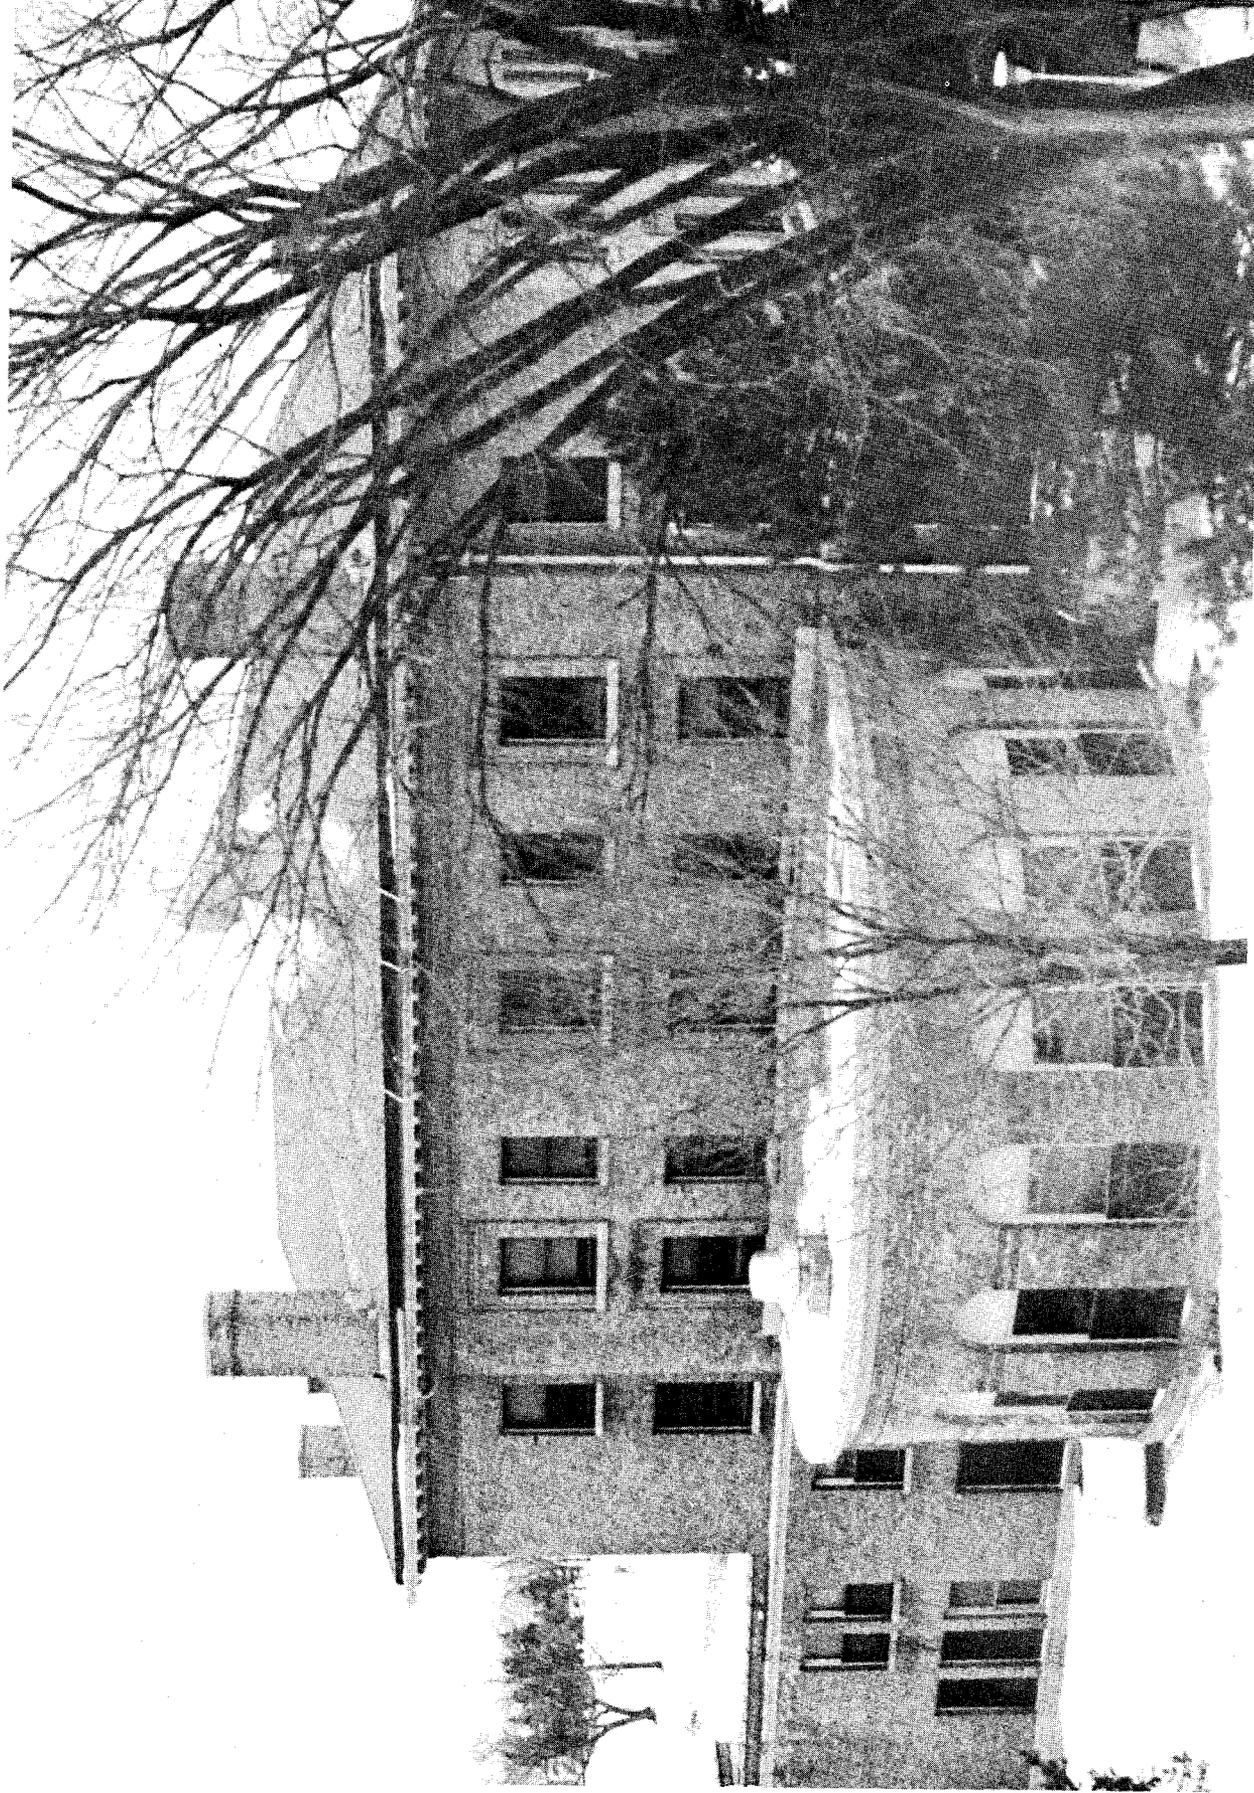
north hall

At present, the building suffers from the afflictions of old age. The oak floors ripple, and the woodwork is either painted or completely destroyed by remodeling. The large dining area has been made into a theatre on one end and a photographic supply room on the other. The dormitory rooms have retained their configuration along axial corridors but the beds have been replaced by desks and file cabinets. The Photo Lab, the University Police, the College of Agriculture, CLA Sociology and Statistics Departments and the I.T. Math Department, presently share the building.

1. Year constructed: 1895.
2. Floor area: Gross area 56,495 square feet.
3. Exterior walls: Brick requires cleaning and some tuckpointing.
4. Structural frame: Wood beam and post.
5. Roof: Major areas are sloped, asphalt shingles -- needs extensive repair or replacement.
6. Heating system: Steam, needs replacing.
7. Plumbing: Needs replacing.
8. Ventilation: Inadequate, needs replacing.
9. Exterior windows and doors: Wood, needs replacing.
10. Room lighting inadequate: Needs replacing.
11. Emergency lighting and fire alarm system: None existing. New system should be installed.

REMARKS: This building would require gutting of all interior walls and floor systems and total rebuilding of all systems to bring it up to present day codes and standards. The cost of remodeling would likely exceed the cost of total replacement.

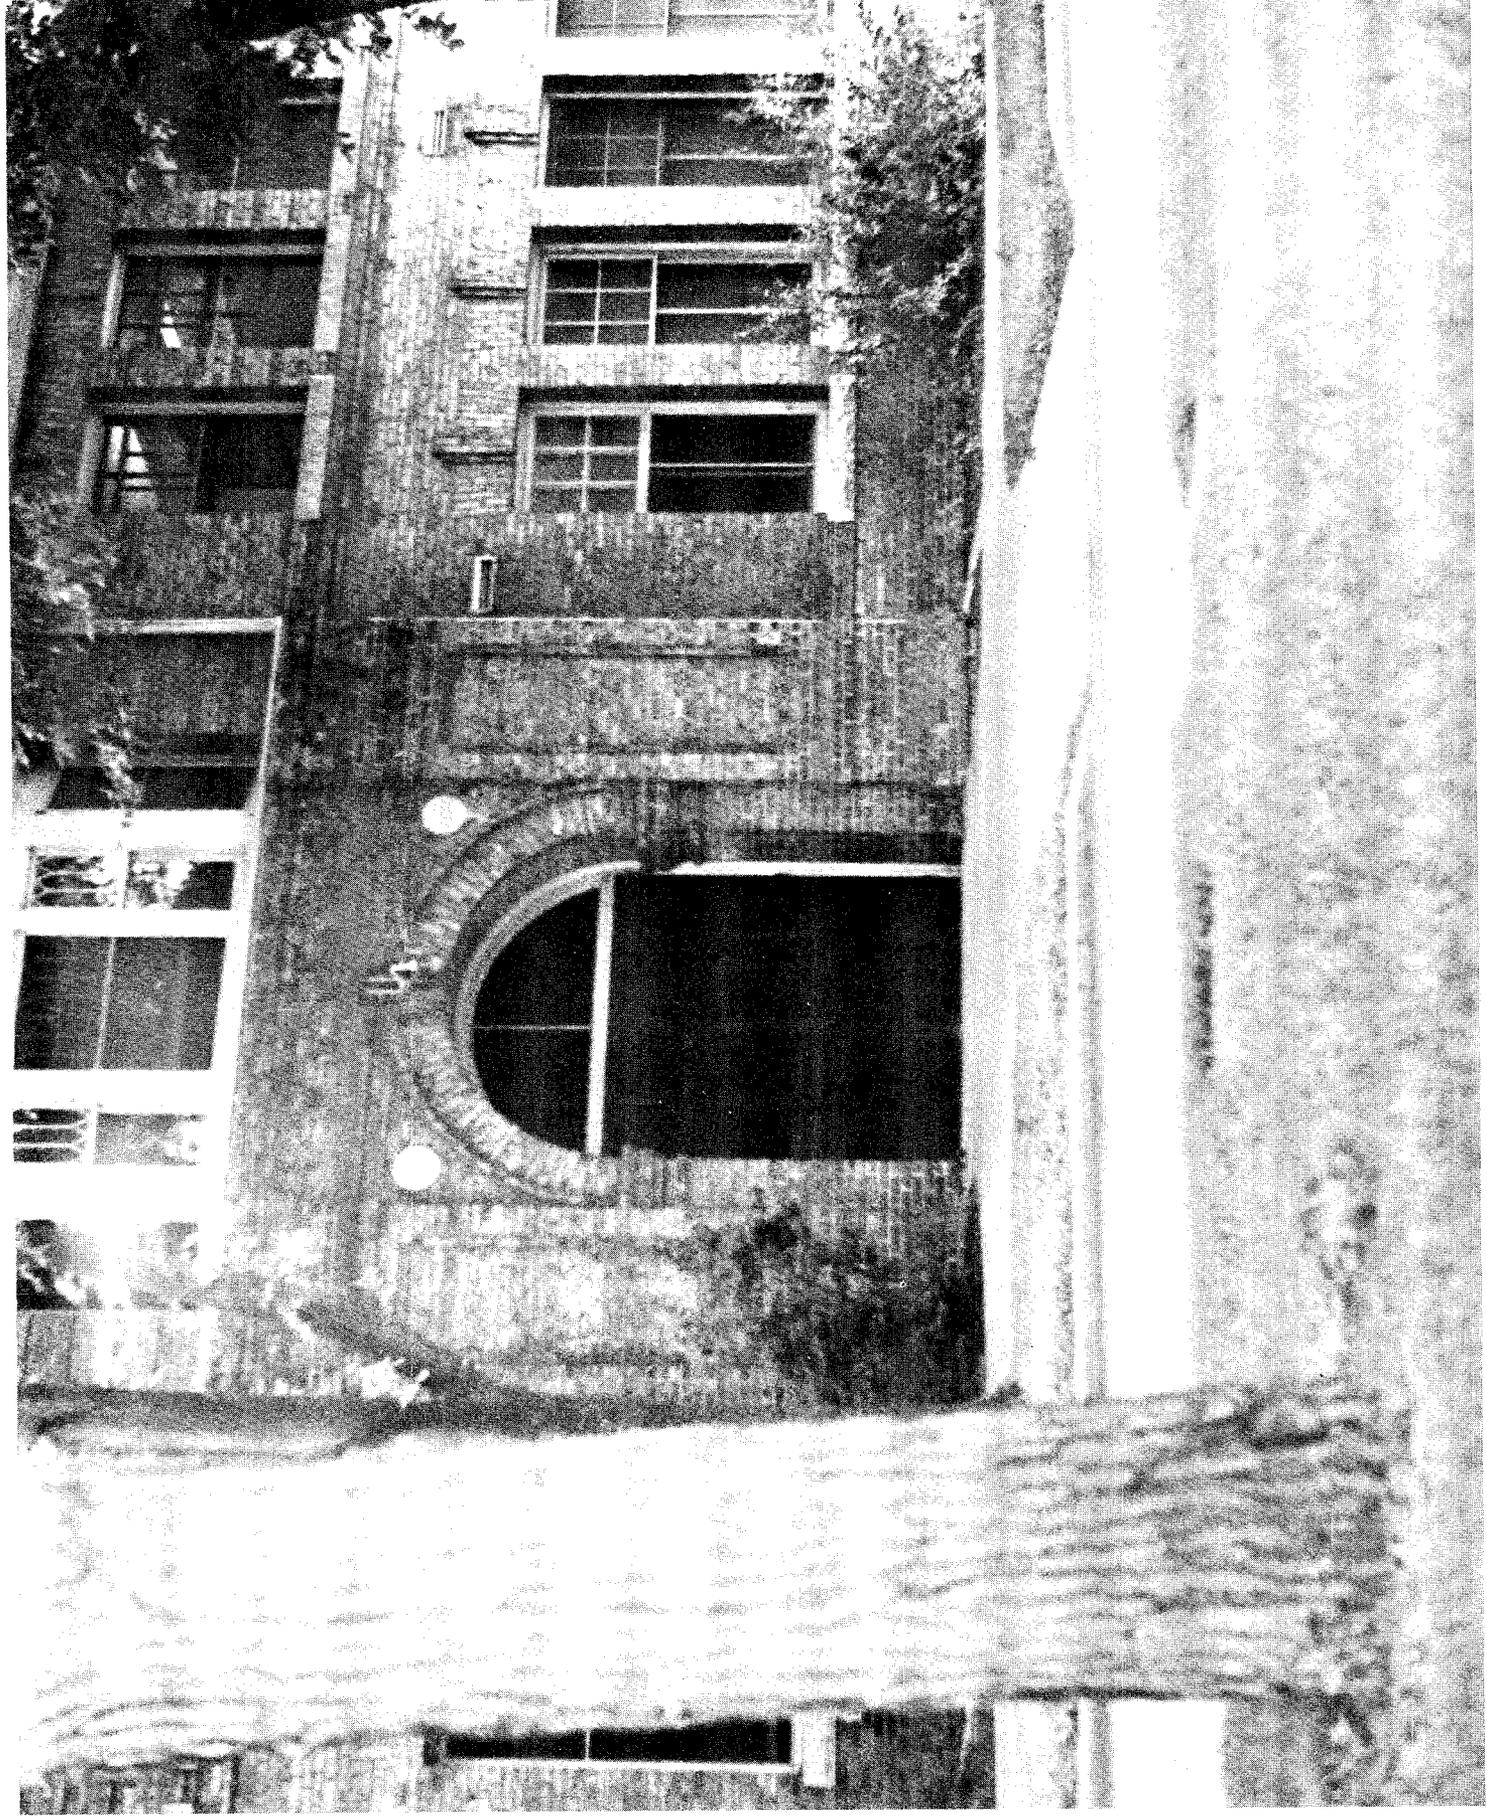
VETERINARY ANATOMY

Before the completion of the Veterinary Anatomy Building in 1901, the Department of Veterinary Science was housed in an old barn with a roof that was "ready to fall in".¹⁹ Since that time Veterinary Anatomy has faithfully provided classroom, laboratory and office space for the study of Veterinary Science. Its future may hold a surprising change: The Andrews Development Plan has scheduled it to become part of a projected fine arts complex.

1. Year constructed: 1901.
2. Floor area: Gross area 16,521 square feet.
3. Exterior walls: Brick, fair condition.

4. Structural frame: Wood beam and post.
5. Roof: Sloped, asphalt shingles, needs replacing.
6. Heating system: Steam, needs replacing.
7. Plumbing: Needs replacing.
8. Ventilation: Inadequate, needs replacing.
9. Exterior windows and doors: Wood, needs replacing.
10. Room lighting: Most areas inadequate, needs replacing.
11. Emergency lighting and fire alarm system: Inadequate, new system should be installed.

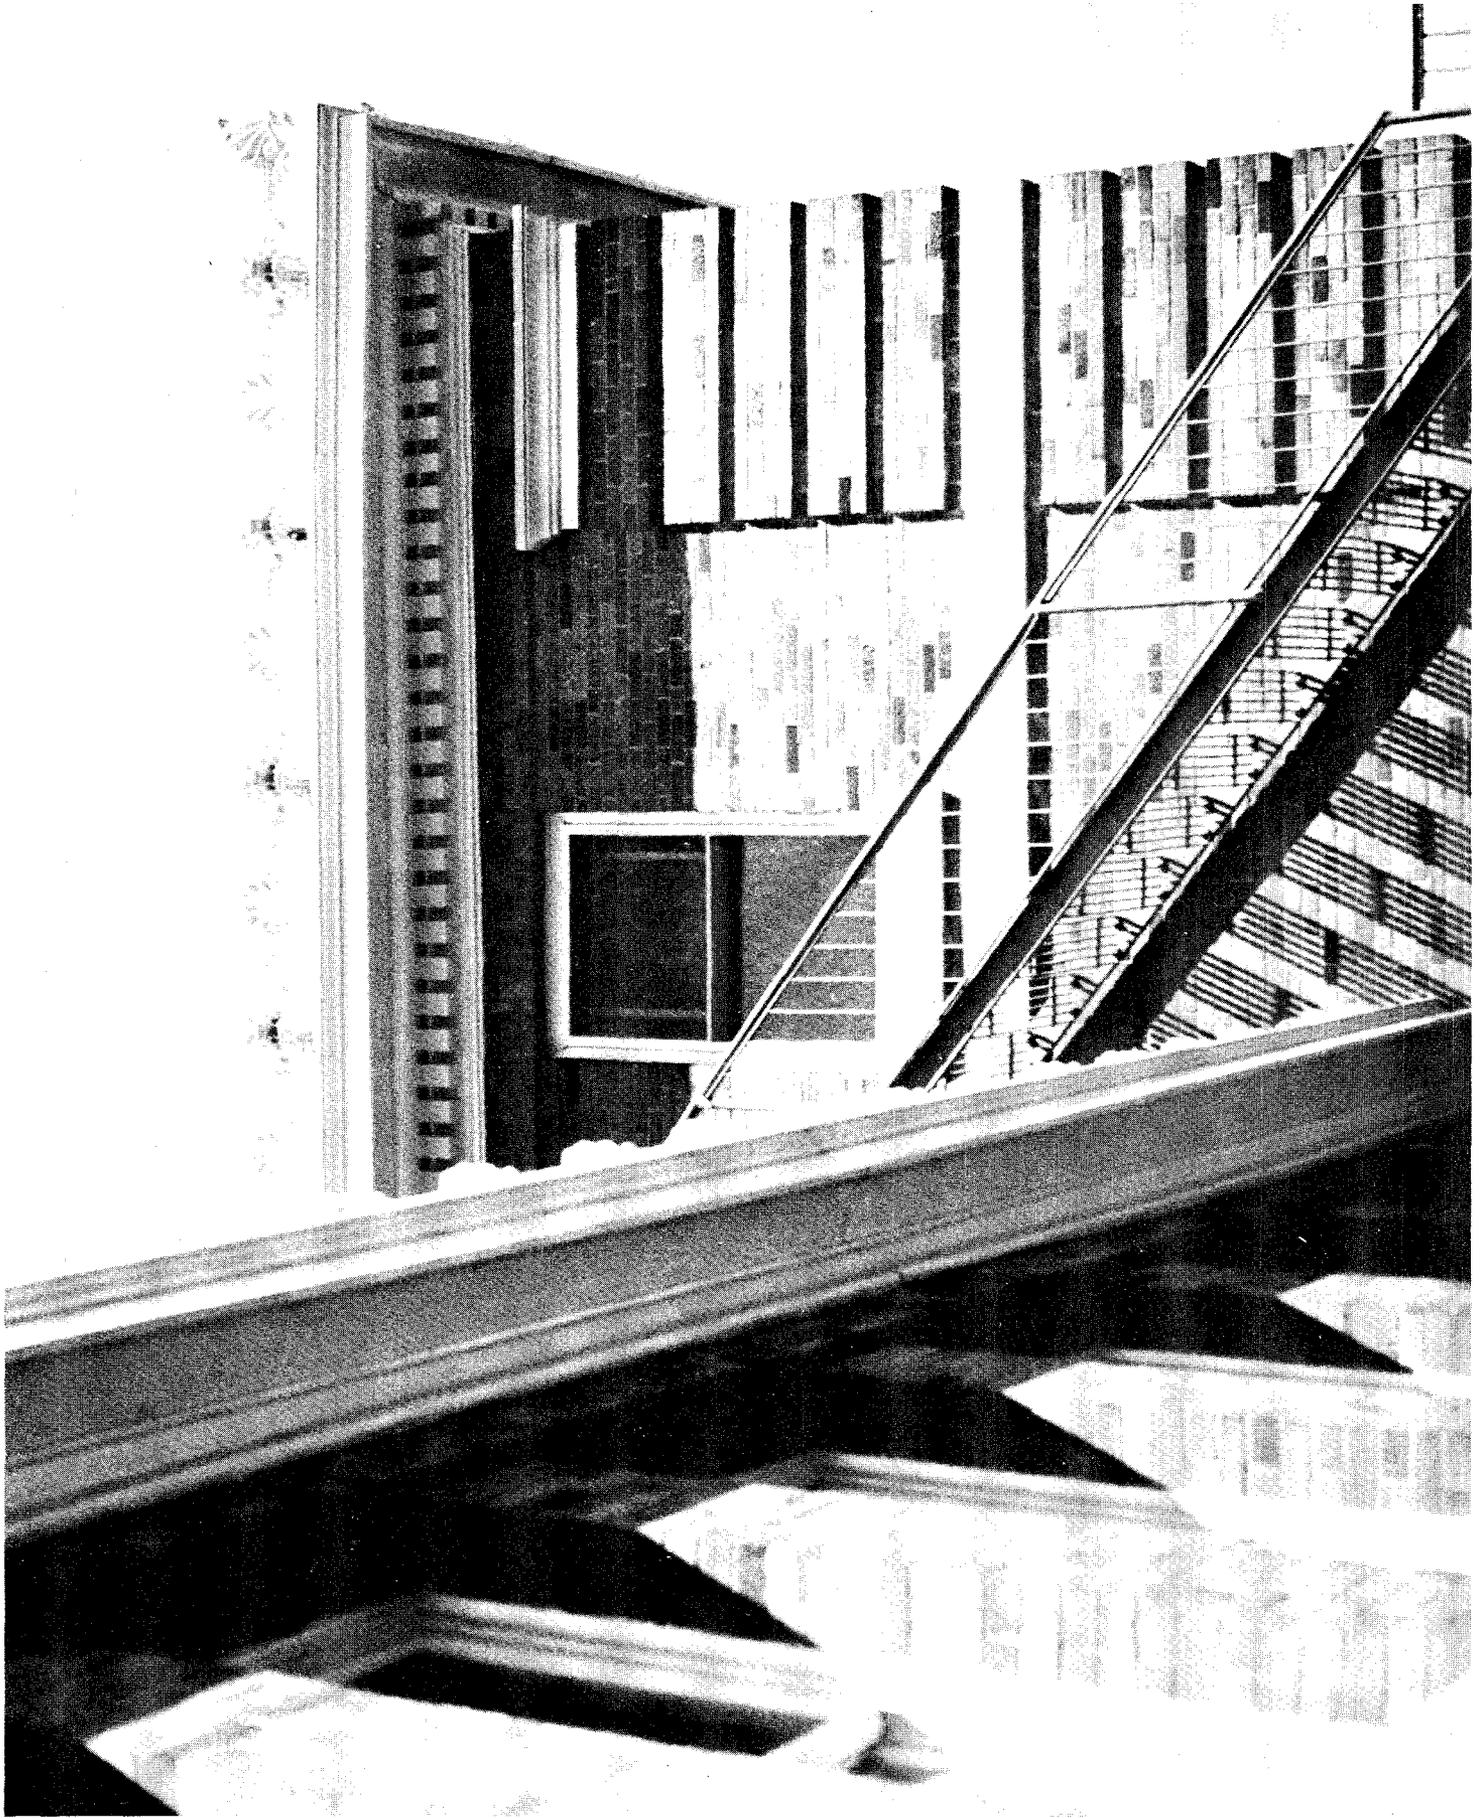
LIVESTOCK PAVILION

The Livestock Pavilion, constructed in 1904, has traditionally served as a livestock amphitheatre. The dirt floor in the show area and the barn-like quality of the east wing have prevented a significant change of function. The second level over the show room has been occupied by the Interior Design Department of the School of Home Economics, and the original Andrews Development Plan suggested that the building become part of the Home Economics Complex. Further consideration, however, has changed the original recommendation, and the future of the building is presently uncertain.

The Minnesota Historical Society classified the Livestock Pavilion as "a weak attempt at Greek revival architecture." It has subtly expressed traces of columns and lintels and a strong statement of the architrave. Inside, the amphitheatre takes the shape of a carriage house with three subdivisions and a large central doorway.

The building seems to offer a good deal of usable space, but in this case the floor plans are deceptive. Low ceilings, dirt or irregular concrete floors, inadequate insulation and poor access tend to reduce the desirability of much of the usable space.

1. Year constructed: 1904.
2. Floor area: Gross area 27,169 square feet.
3. Exterior walls: Brick -- good condition.
4. Structural Frame: Wood beam and post.
5. Roof: South wing-sloped, asphalt shingles -- fair to good condition. Main part of building - flat, pitch and gravel -- fair to good condition.
6. Heating system: Steam - needs replacing.
7. Plumbing: Needs replacing.
8. Ventilation: Inadequate - needs replacing.
9. Exterior windows and doors: Wood - needs replacing.
10. Room lighting: Inadequate - needs replacing.
11. Emergency lighting and fire alarm system: Inadequate - should be replaced.

REMARKS: This building should be totally gutted and structural system along with other building systems should be replaced.

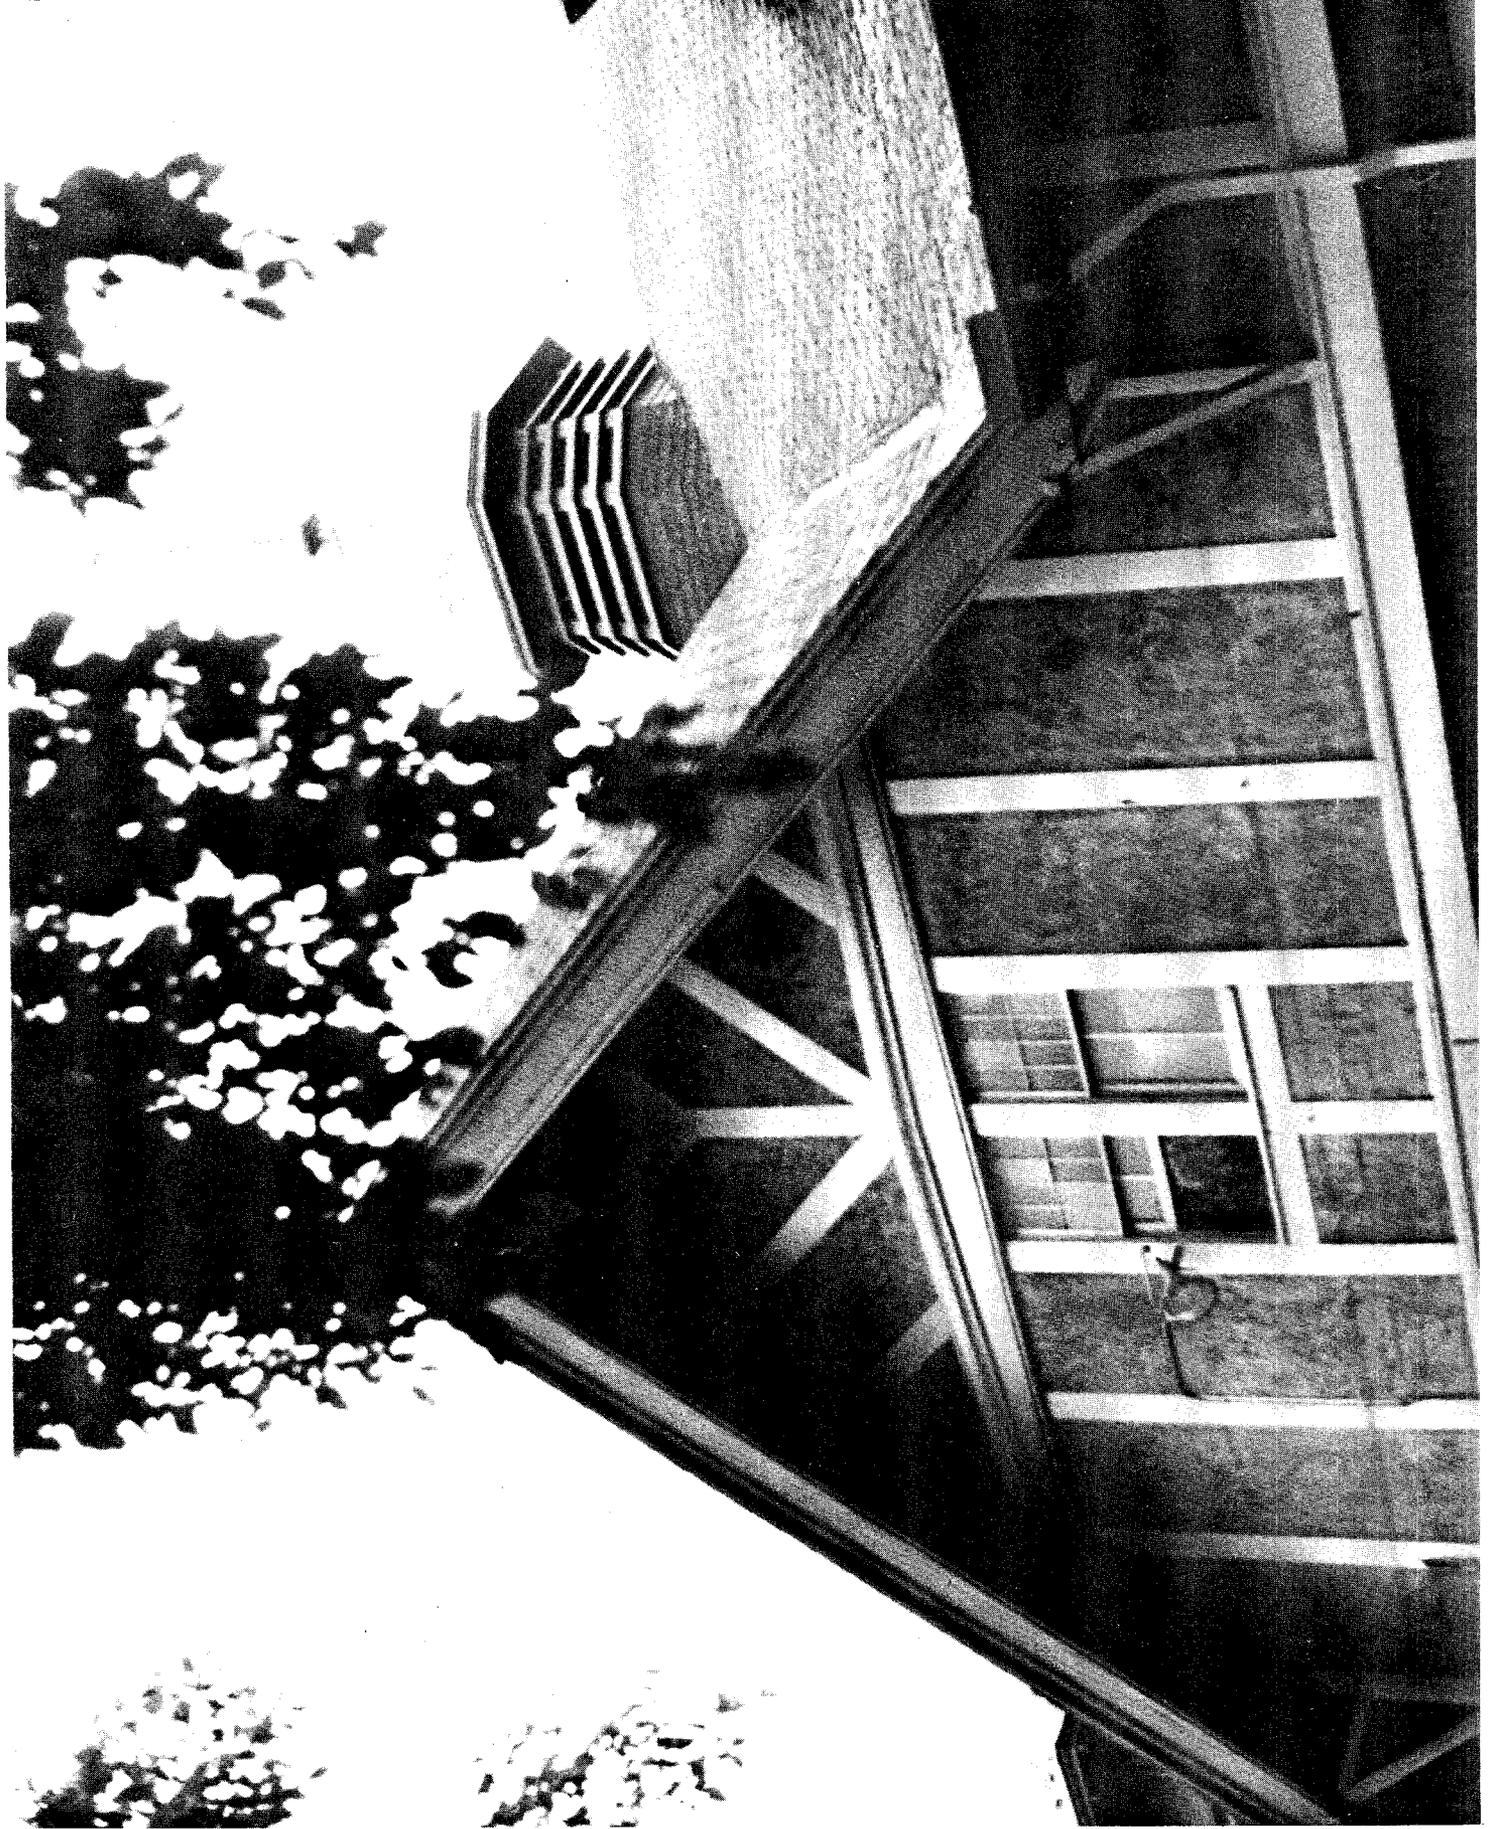
DAIRY NUTRITION

The Dairy Nutrition Barn was built in 1907 to facilitate innovative dairy research being conducted by Avant-Garde Agriculture Professor Haeker. He was one of the first scientists in the country to investigate the relationship between milk production and the rearing and feeding process. The building has accepted various additions since that time but never a major change of function.

1. Year constructed: 1907.
2. Floor area: Gross area 16,784 square feet.
3. Exterior walls: Wood stud and siding -- stucco above clay tile to a four foot height.
4. Structural frame: Wood -- fair to poor condition.
5. Roof: Sloped (Gambrel), asphalt shingles -- fair condition.
6. Heating system: None.

7. Plumbing: None.
8. Ventilation: For barn usage only.
9. Exterior windows and doors: Wood -- fair to poor condition.
10. Room lighting: Barn usage only - should be upgraded.
11. Emergency lighting and fire alarm system: None existing.

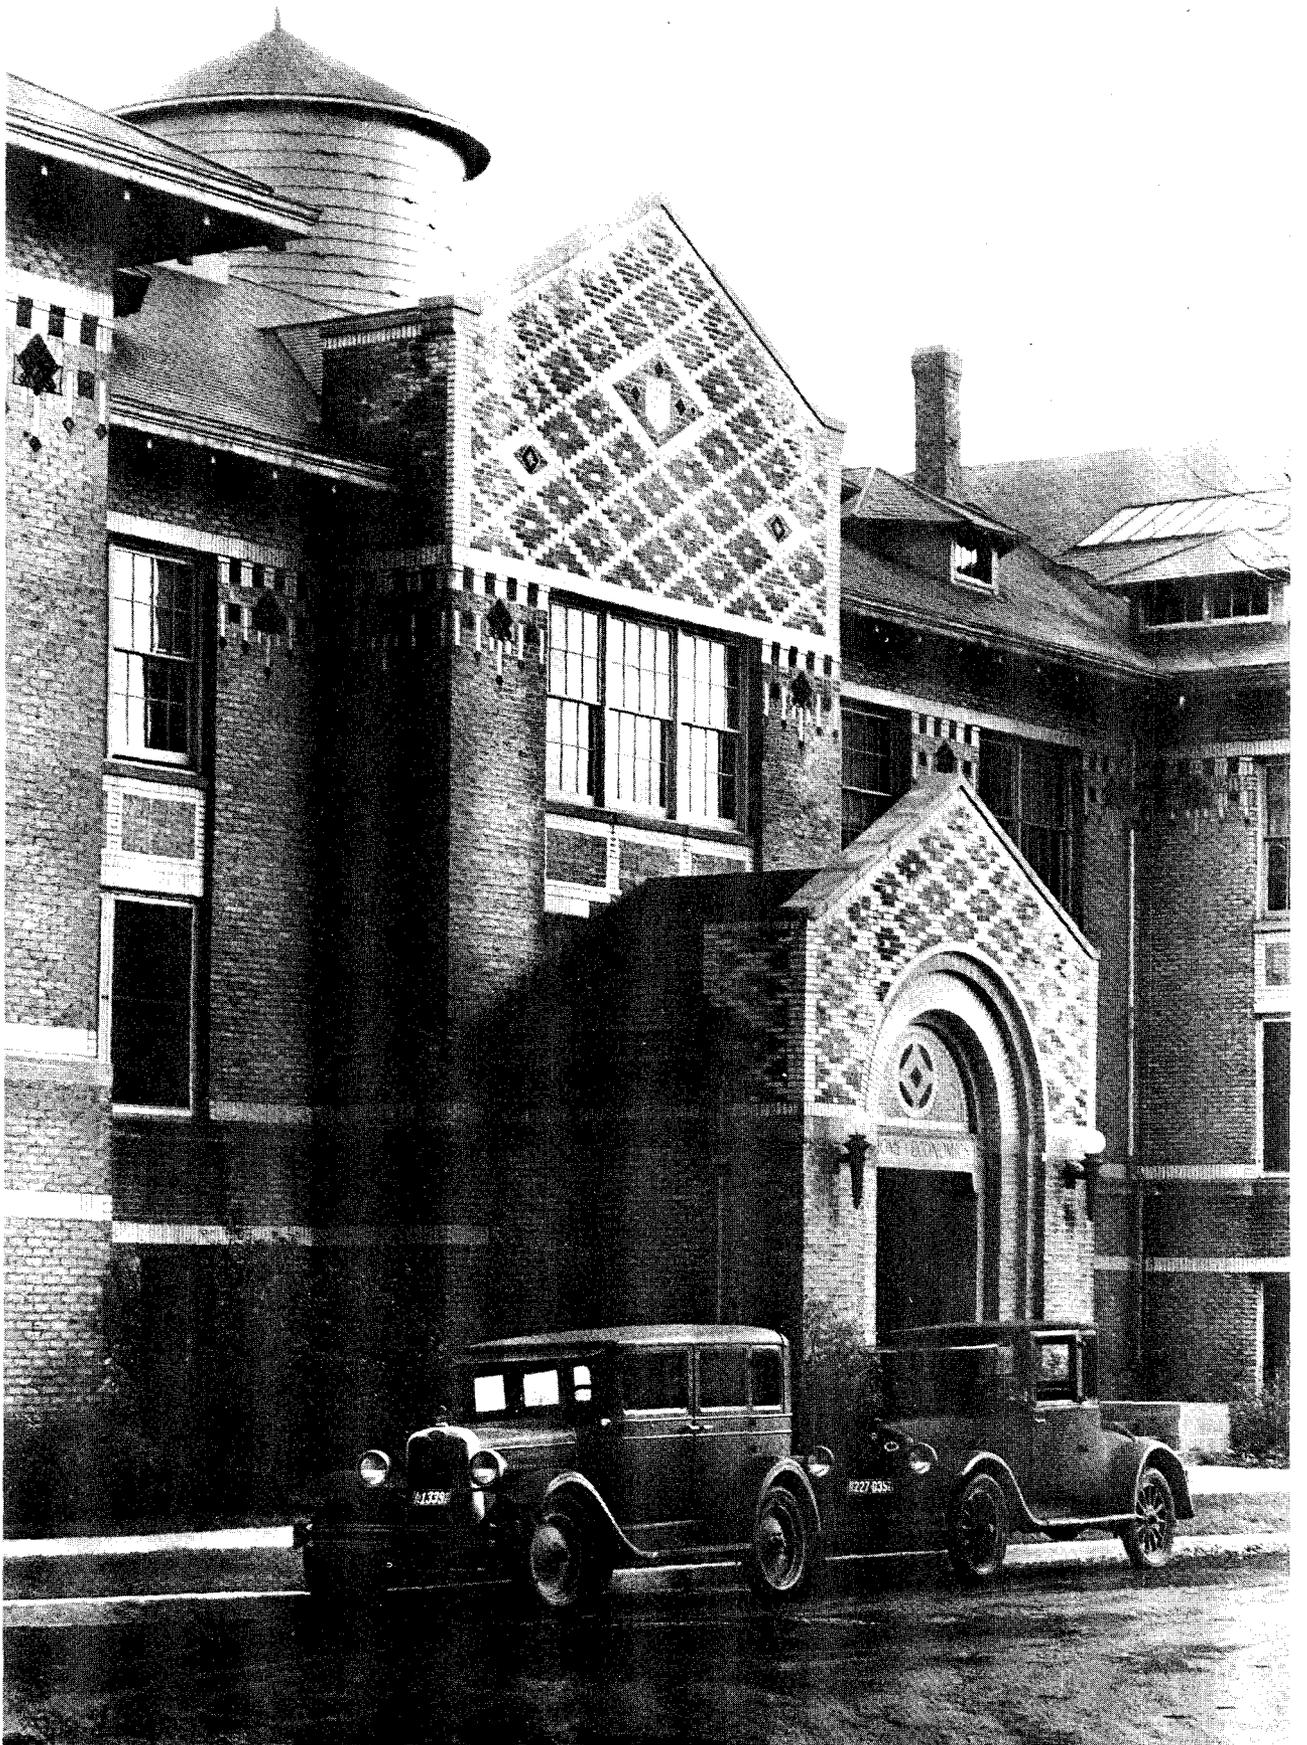
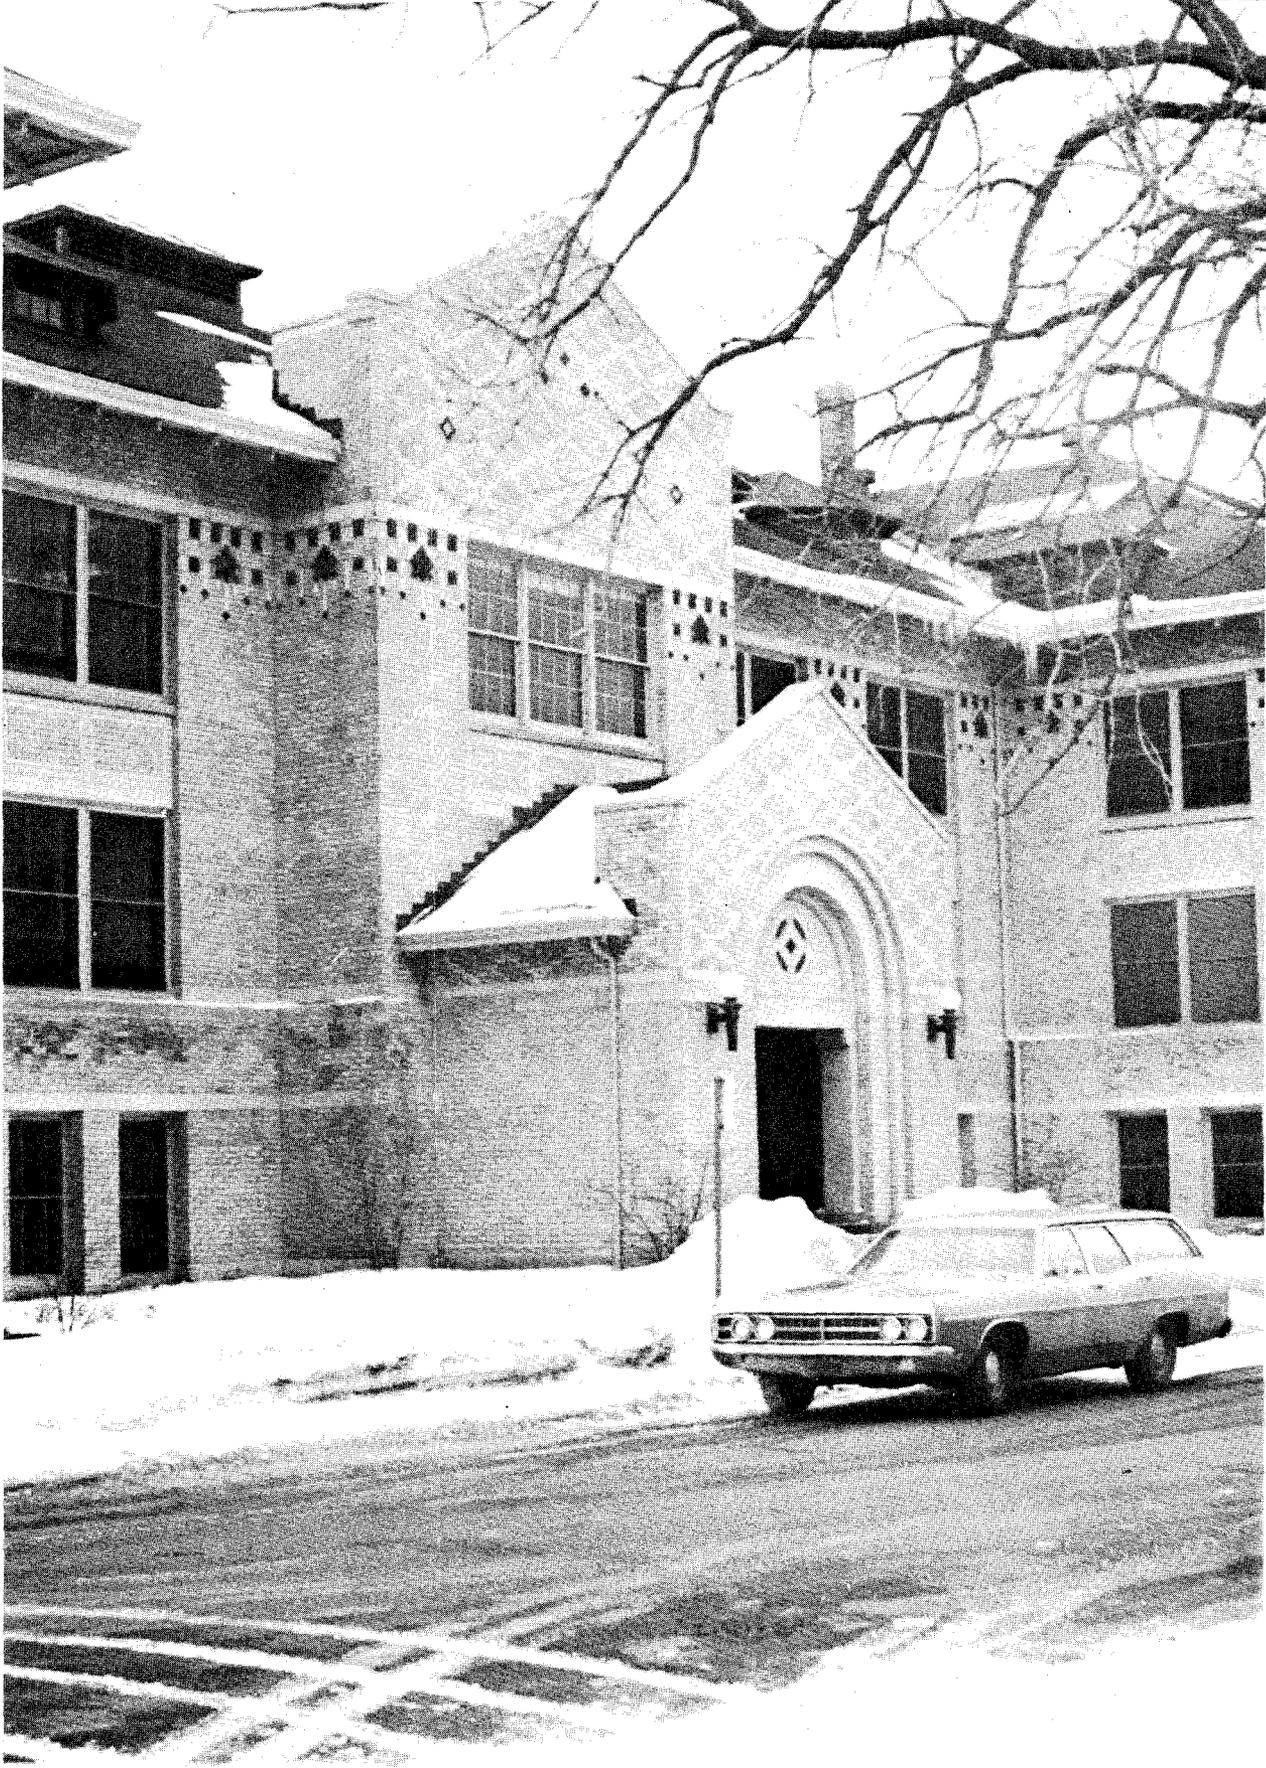
home economics

Old Home Economics has been remodeled and up-dated regularly and is in very good condition. Plans for its future use as part of the Home Economics Complex are now in their final stages.

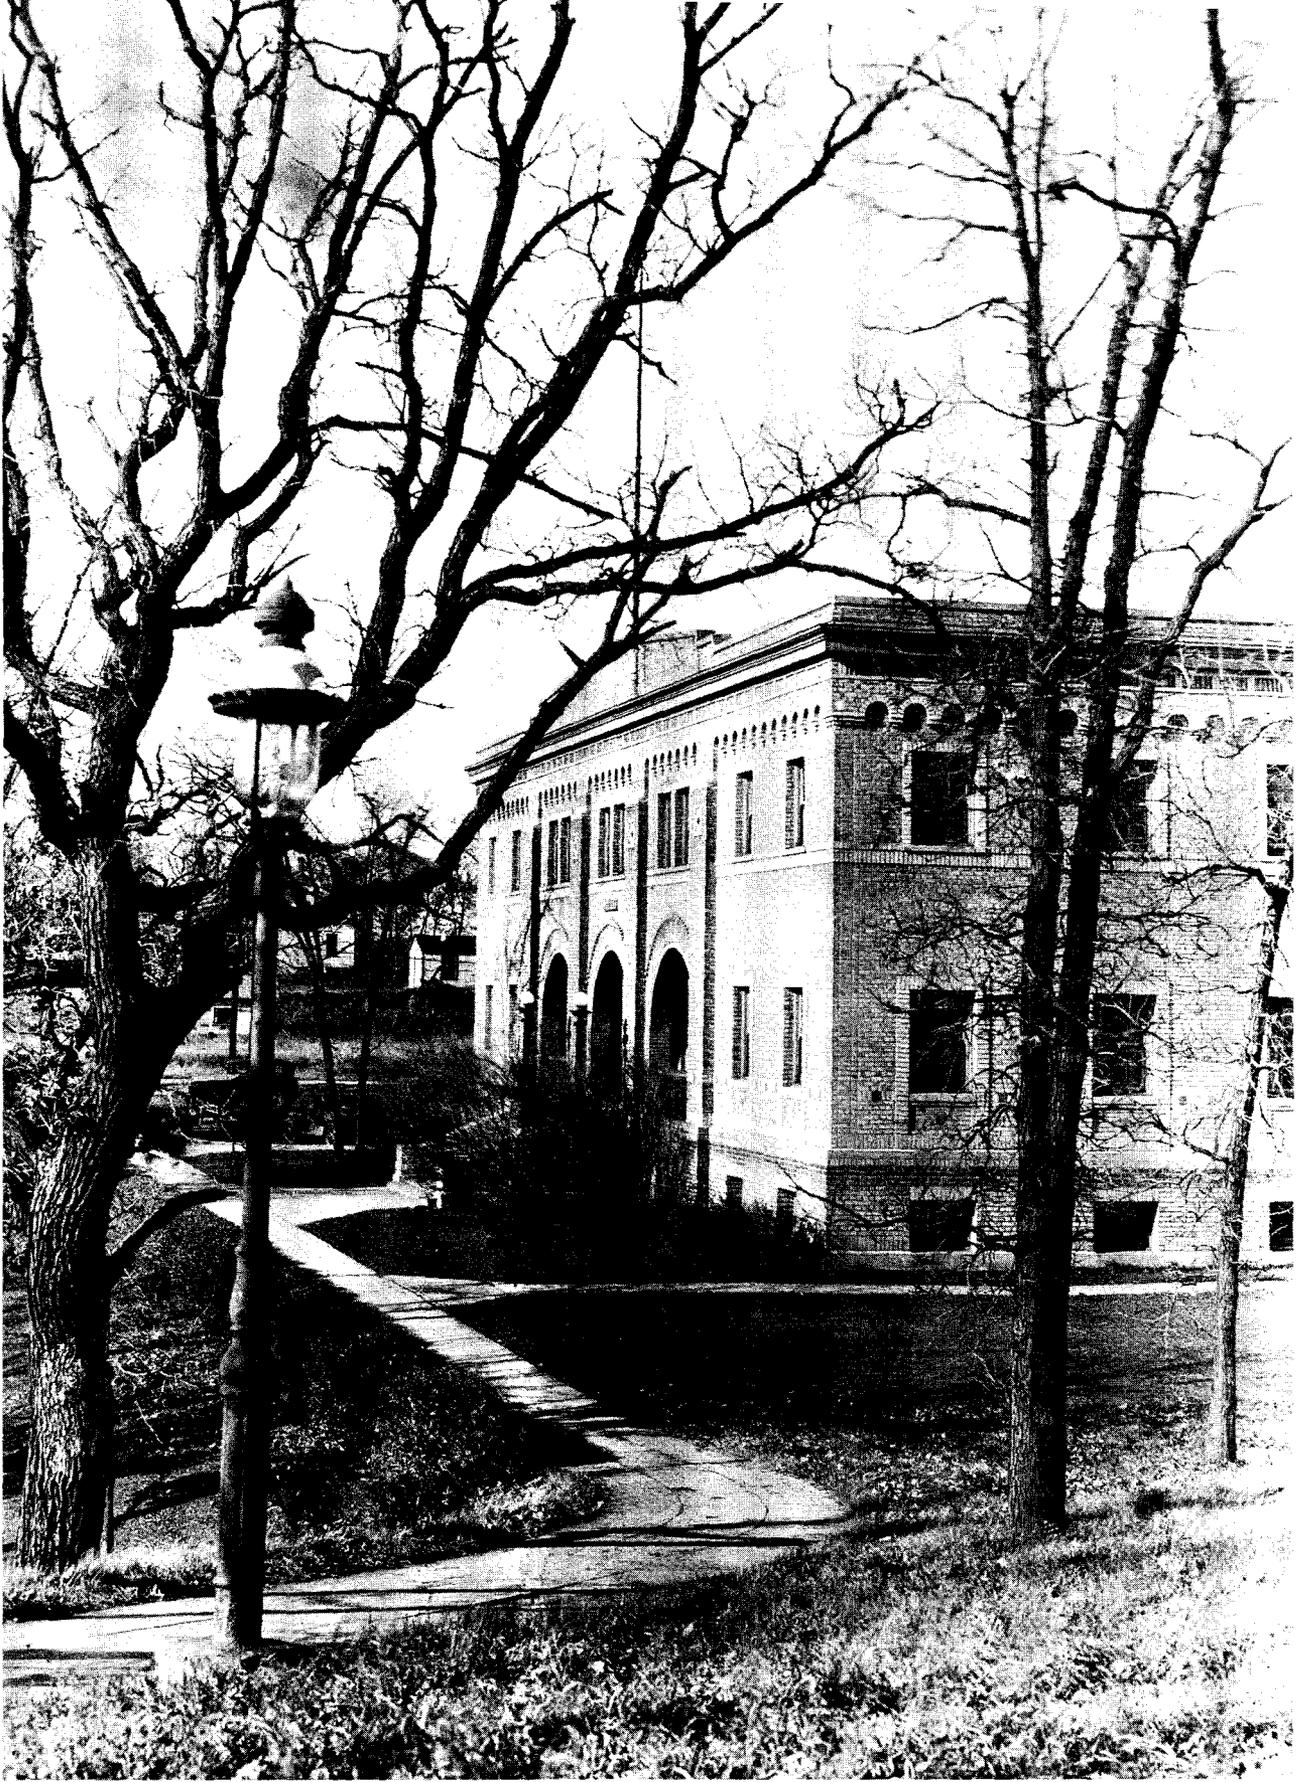
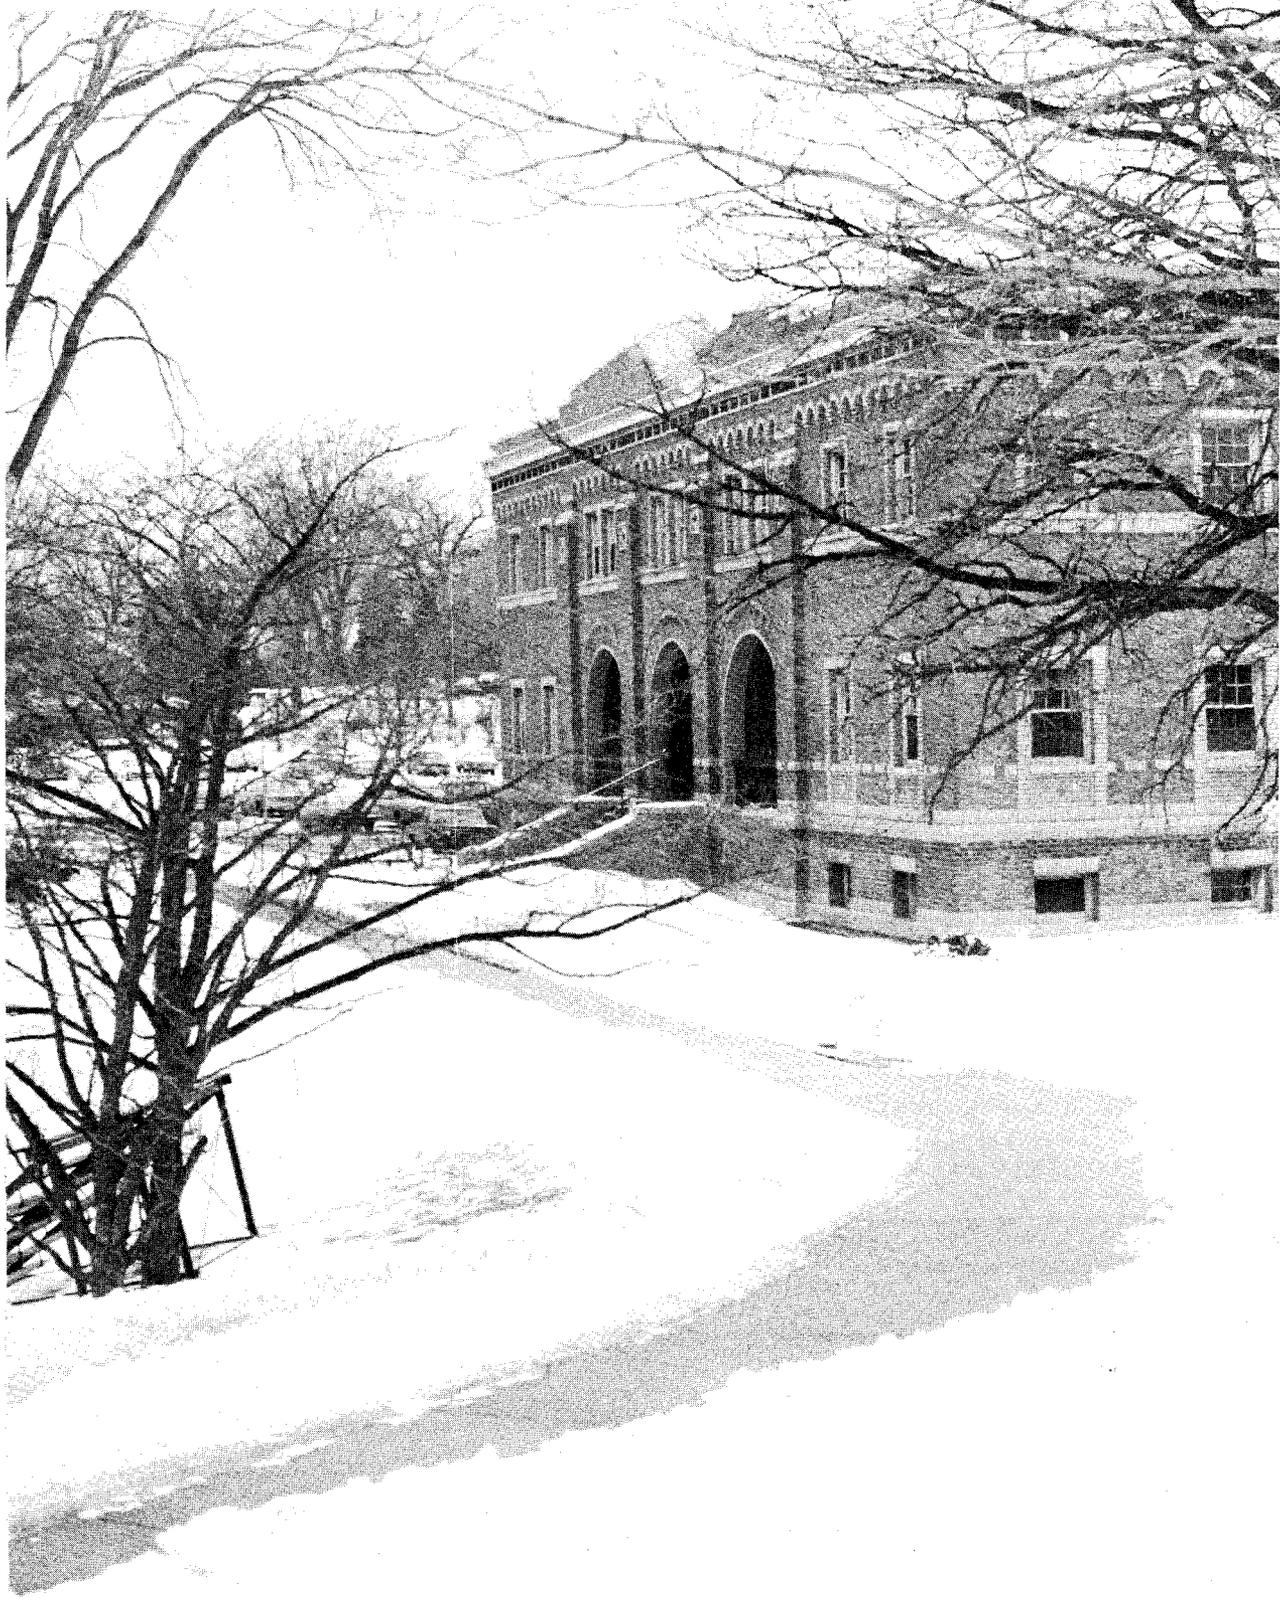
The gym was built in 1915. Leaving very little recorded history in its wake, it has quietly served as a physical education and recreation center for St. Paul Campus and will probably continue to do so in the future. It is in good physical condition and the Long Range Development Plan has scheduled it to be part of the Health Sciences Facilities on the St. Paul Campus.
