Hygrothermal Performance of Residential Cantilevered Floors

A Thesis
SUBMITTED TO THE FACULTY OF
UNIVERSITY OF MINNESOTA
BY

This field investigation was designed to compare three insulation strategies commonly used in residential cantilevered floors. The first objective is to determine floor surface temperatures above insulated cantilever cavities, with respect to occupant thermal comfort. The second objective is to determine moisture behavior within insulated cantilever cavities, with respect to durability.

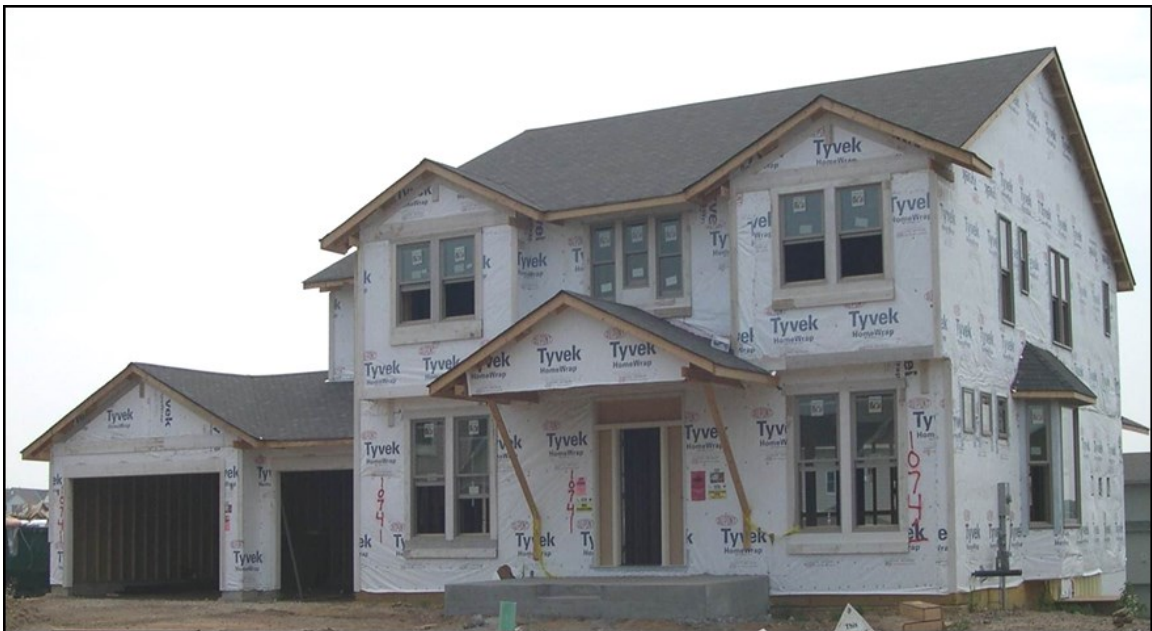
The cantilevered floor is an architectural feature where the floor extends a short distance beyond an exterior wall that supports it from below. The extended floor supports an exterior wall at its outer edge. The cantilevered floor has also been identified by other names such as a floor over unconditioned space, overhang, garrison style floor, cantilevered overhang, extended rim joist, jettied floor, and overhanging floor. This type of overhanging floor is commonly used in the design of homes to give a residential building greater curb appeal, extend the size of a room, or provide extra space extending beyond the main part of a room for a bay window, closet, or gas fireplace. *(Figure 1)*

Figure 1. Cantilevered second story floors and cantilevered bay window

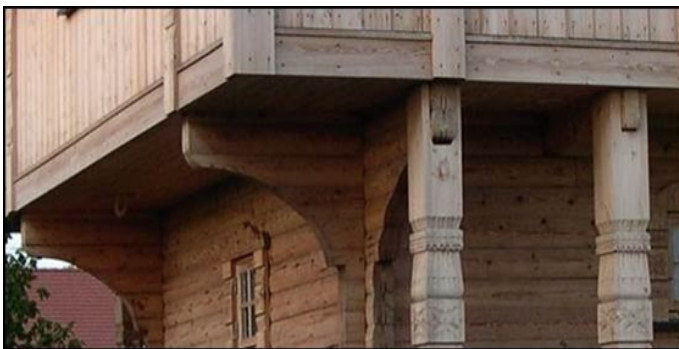
While timber construction created strong, durable structures, the solid wood provided minimal resistance to heat loss, resulting in cold floors. (Figure 6)

Figure 6. Uninsulated timber floor in Green Lake, WI

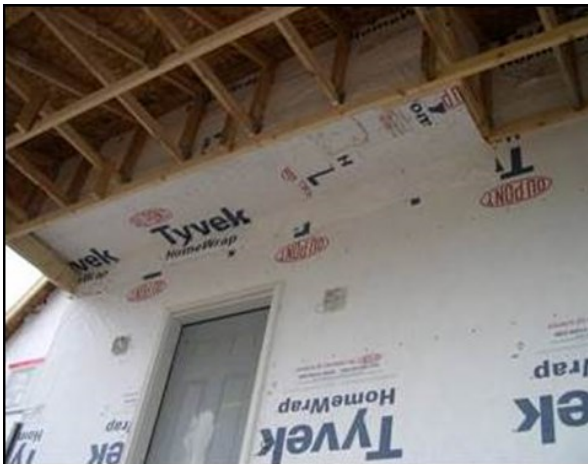
Figure 7. Exterior view of cantilevered floor during construction

A cantilevered floor, projecting over unconditioned or ambient space also adds more exterior surface area to the heating and cooling load of the conditioned room above it. (Figure 7) The method selected

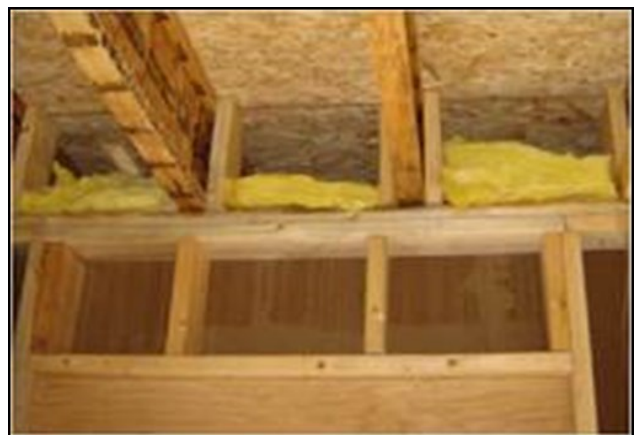
1. All joints and seams of the cantilever overhang are air-sealed. The framed cantilever cavity is filled partially with a fiberglass batt at the bottom and rim joist, but without blocking installed between the insulated

Figure 8. Cavities partially filled with batts

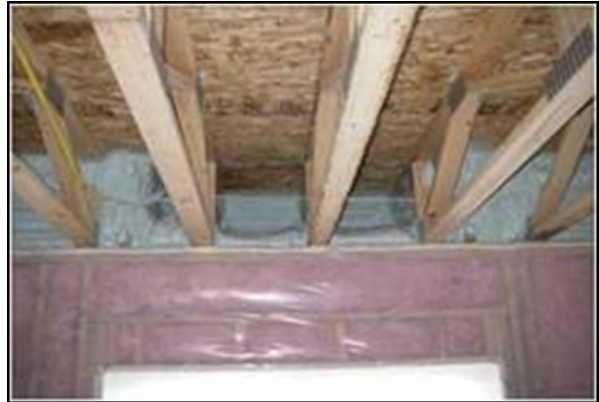
2. Closed cell foam insulation is spray-applied against the exterior cantilever rim joist and across the bottom of the cantilever cavity. The foam insulation extends fully over the top of the exterior wall that supports the cantilever and air-seals all joints and seams in the framed cantilever overhang cavity. (Figure 9)

Figure 9. Spray applied polyurethane foam

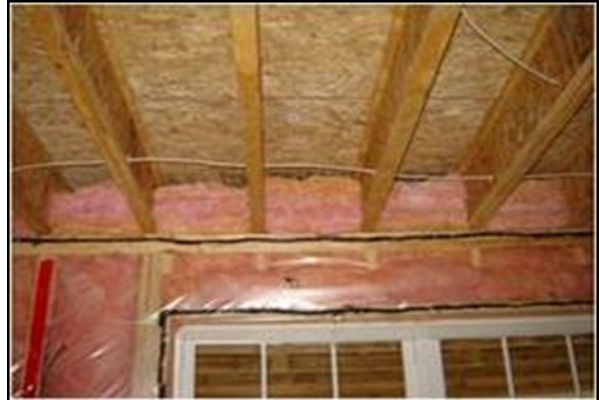
3. All joints and seams of the cantilever overhang are air-sealed. The framed cantilever cavity is filled completely with fiberglass batts (Figure 10) and solid blocking is then air-sealed in place between the insulated cantilever assembly and the uninsulated floor from which it extends. (Figure 11)

Figure 10. Cavities filled completely with batts

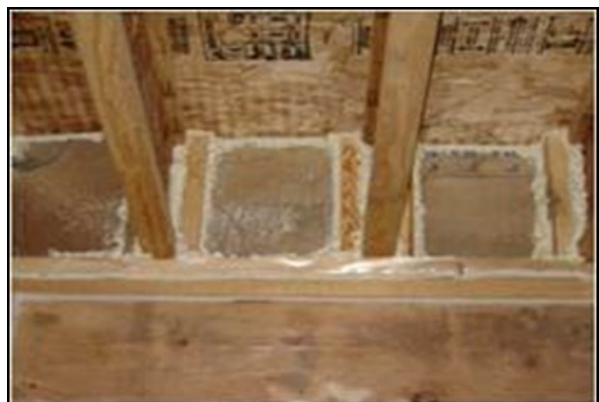
Figure 11. Cavities blocked and air-sealed

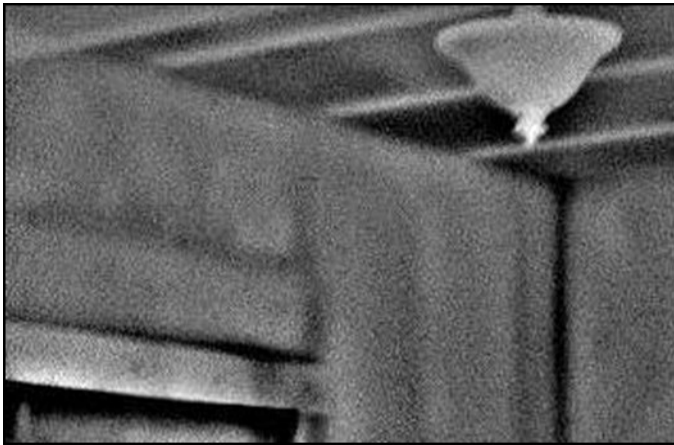
(previously shown from the exterior in *Figure 7*) identified ceiling surfaces below this particular cantilever floor assembly that appear much colder than adjacent wall surfaces

Figure 12. Thermograph of cold ceiling surfaces below the cantilevered floor

While infra-red inspection provides a snapshot of the surface temperatures of materials surrounding a cantilever floor assembly, it does not provide the detailed information about cantilever cavity interior temperature and moisture conditions and boundary conditions that are needed to see a more complete picture of the hygrothermal performance of cantilevered floors.

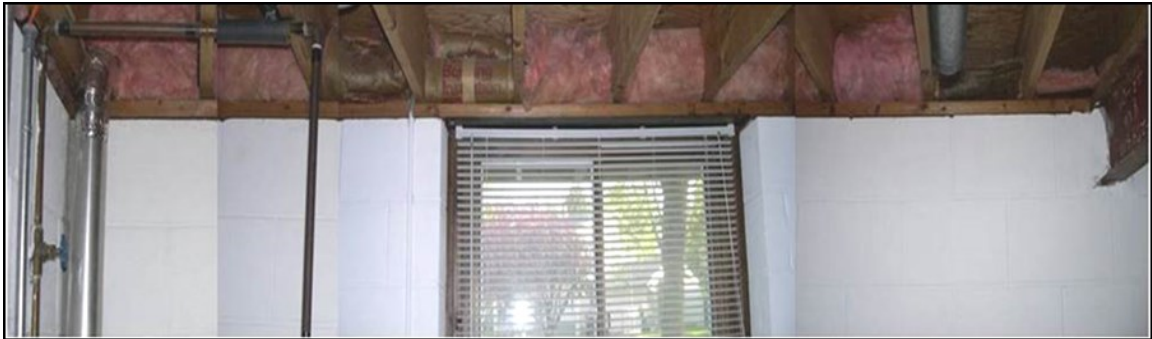
there was no blocking or air-sealing where the cantilever floor cavities meet the uninsulated floor above the basement wall (*Figure 17*)

Figure 17. Interior of the cantilever in 'as found' condition (west side)

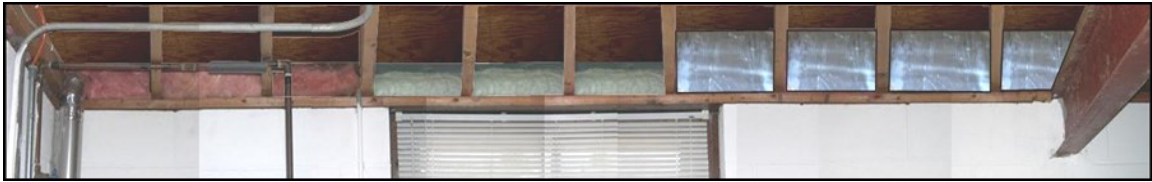
insulation), #8 (R-30 batt, blocked and sealed), #11 (R-30 batt, blocked and sealed), #14 (Foam insulation), and #17 (R-19 batt open to the basement). (Figure 18)

Figure 18. Proposed insulation type locations (west side)

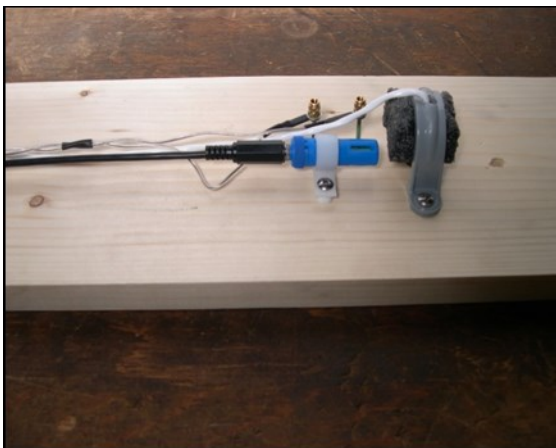
A mounting bracket with a closed cell foam insulation block was fabricated for the material temperature probe and a sheet metal template (*Figure 20*) was created to mark the sensor group layout consistently in every location. A mock-up (*Figure 21*) of

Figure 21. Sensor group mock-up

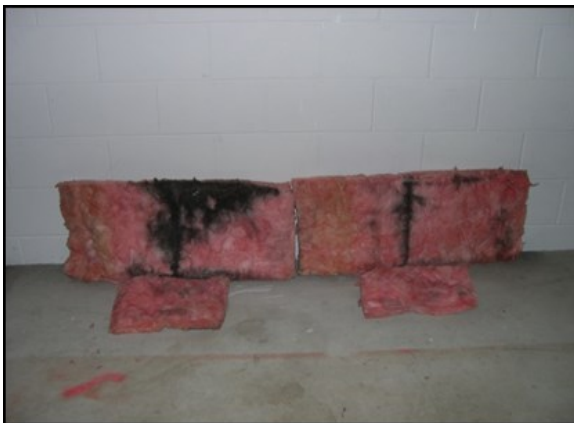
While the bench test of the data acquisition system was in progress, modifications were made to the existing cantilever floor to create the most uniform conditions possible from cavity to cavity. The Kraft-faced fiberglass insulation batts that were in the cantilever cavities were removed, along with the accumulated dust and dirt of forty years, from all eighteen of the accessible cavities. Several of the removed fiberglass batts had staining

Figure 23. Evidence of infiltration through the cantilever assembly

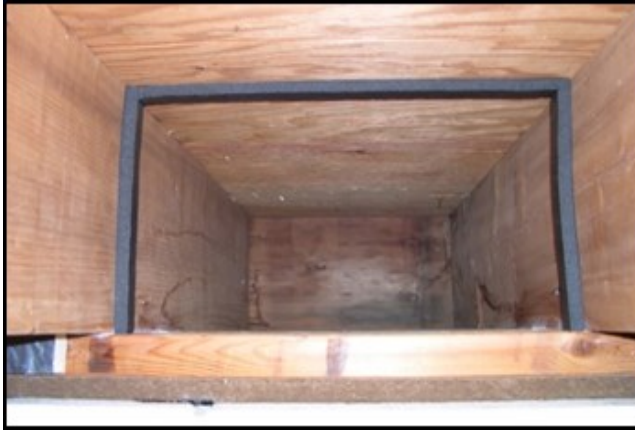
conditions while the soffit was open. On the cavity side of a line above the inside edge of the 2x6 sill plate, three quarter inch by seven sixteenths inch closed cell foam tape

Figure 24. Temporary foam tape seal

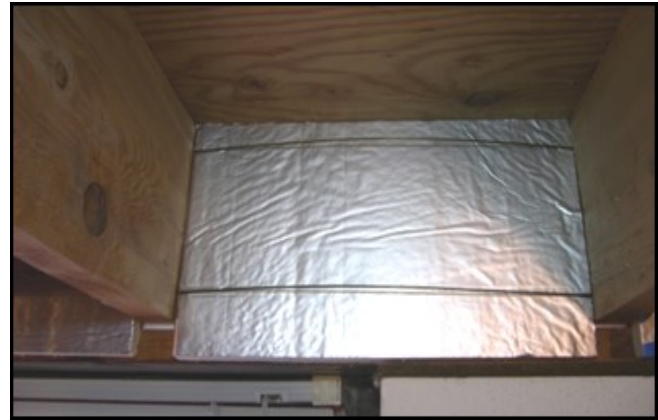
Figure 25. Temporary foam board blocking

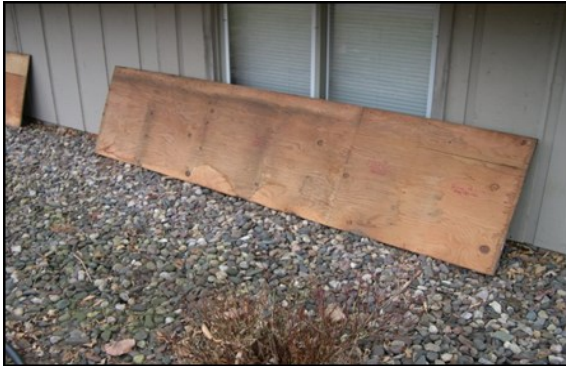
Figure 26. Moisture stains on soffit plywood

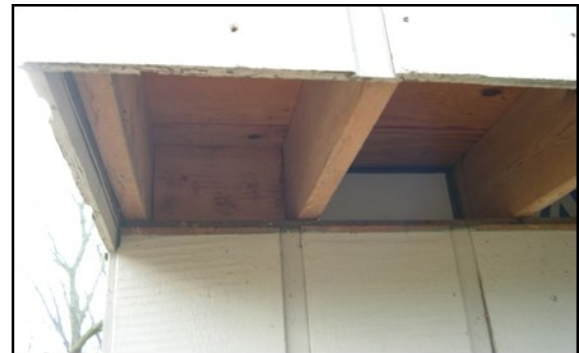
and fiberboard (*Figure 27*) both showed evidence of repeated exposure to moisture. Staining was also visible on the exposed framing of the cantilever floor cavities, but did not include any evidence of decay. (*Figure 28*)

Figure 28. Exposed cantilevered floor framing

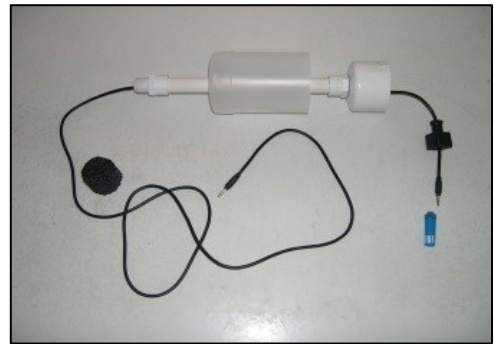
After the work space was completed, two outdoor boundary condition sensor housings (*Figure 31*) were fabricated and installed between cavities 6 and 7 and between cavities 12 and 13. Two holes had been drilled a few inches vertically up into the outer 2x10 of the double

Figure 31. Sensor and housing assembly

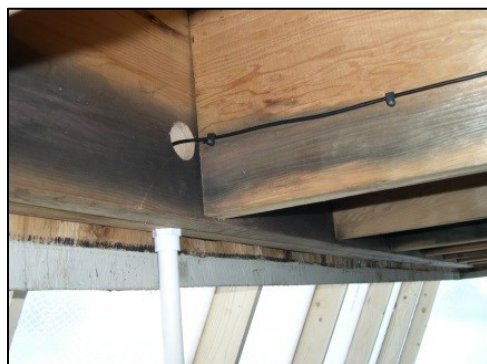
rim joist and from inside cavities 7 and 12 to intersect with the vertical holes. (*Figure 32*) Cables were run through both sets of holes into the housings. The sensors were mounted

Figure 32. Housing and cable installed

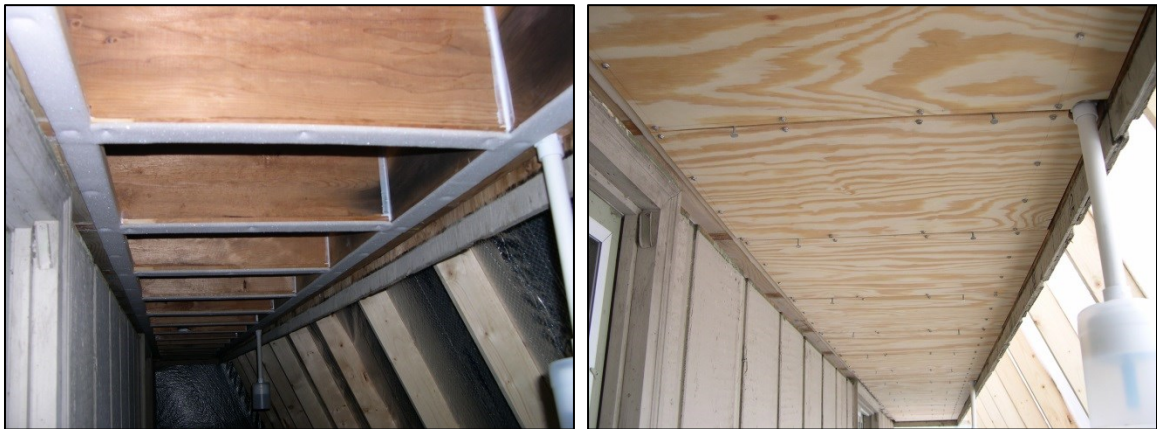
Figure 33. Shimmed, sealed, and gasketed

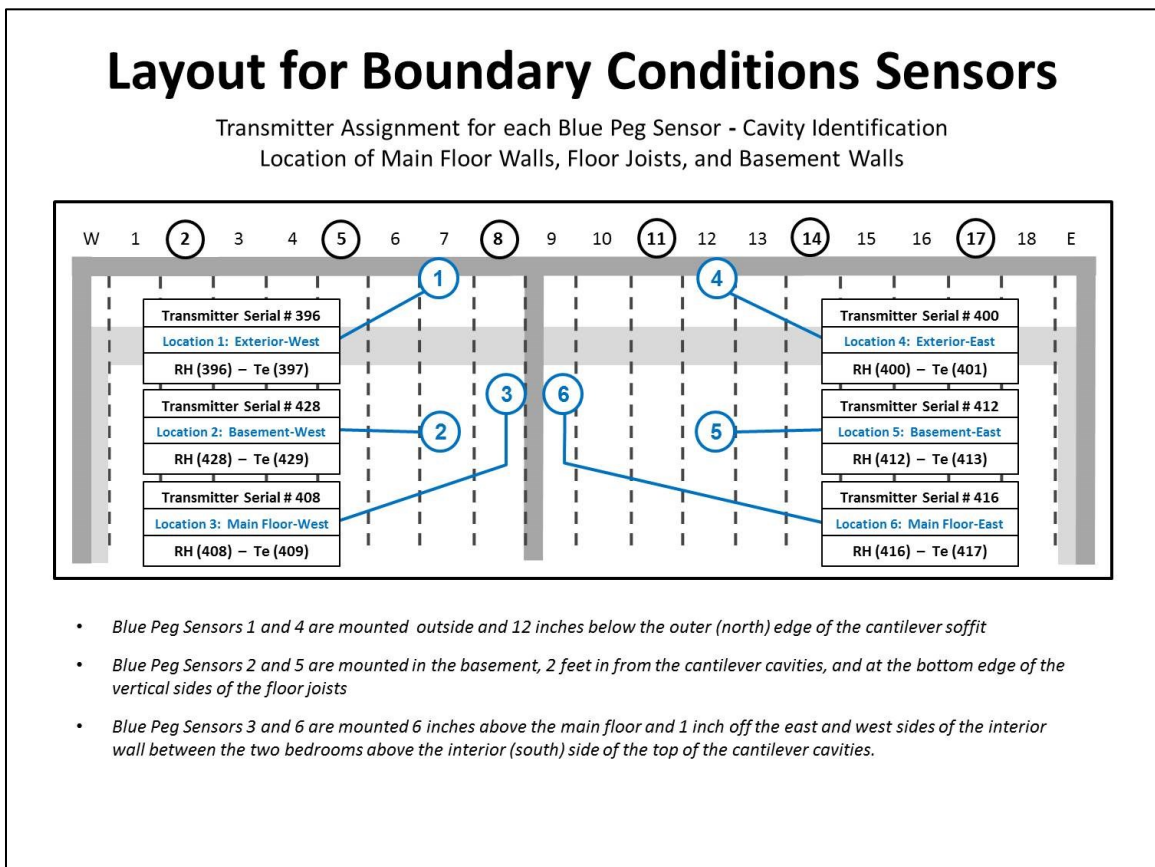
The layout of the six boundary sensors was mapped with reference to the cantilever assembly. Sensors would measure air temperature and relative humidity at the locations shown and described on the Boundary Conditions layout map. (Figure 35) Relative

Figure 35. Boundary Conditions layout map

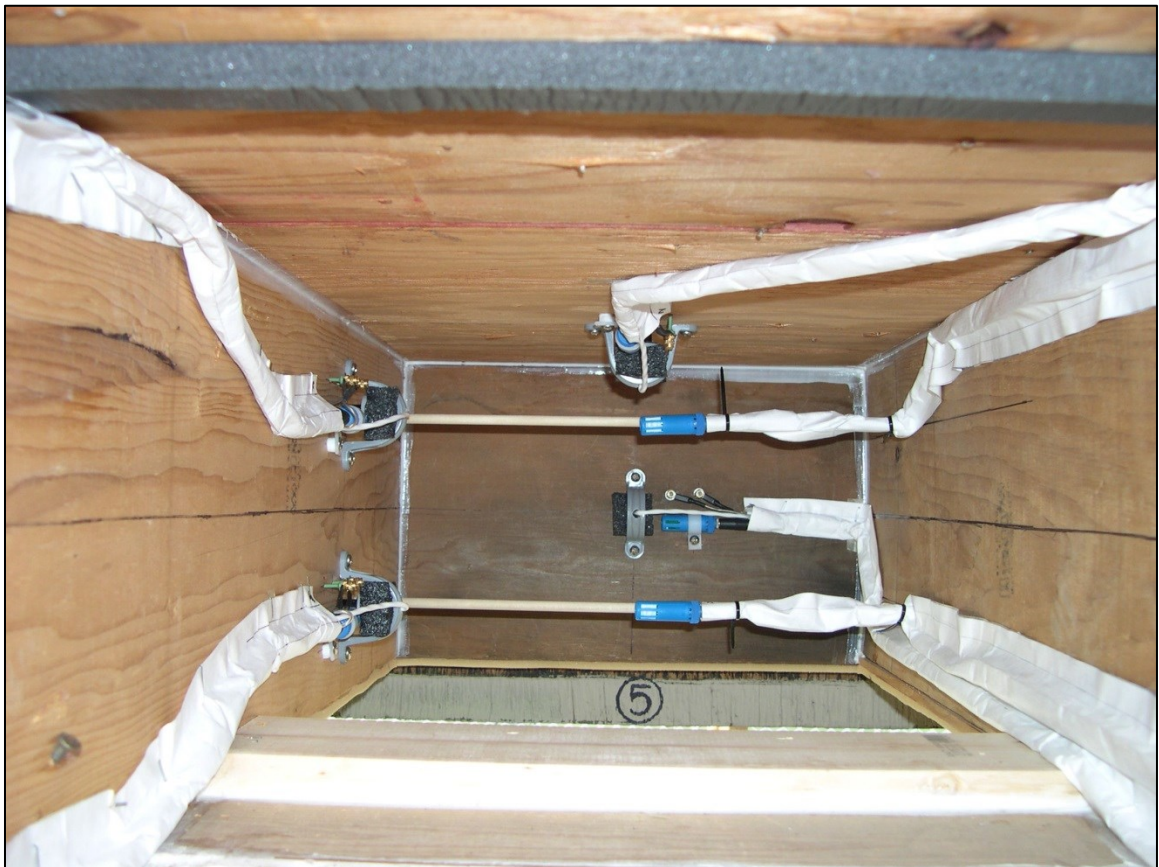
At each sensor group location, following the pattern marked by the template and the example of the sensor group mock-up, pilot holes were drilled for mounting brackets, wood moisture pins, and dowels to mount the center-of-cavity RH-Te sensors. Using pre-set drill bit stops, the pilot holes for mounting brackets and the holes for the birch dowels were drilled to one quarter of an inch deep. Pre-set stops were set at one eighth of an inch deep for the moisture content pins and they were set at one quarter inch deep to the tip of the pins using a spacer block to stop the cable mounting shoulder of the pins. All sensors and cables were mounted following the Test Cavity layout map. (Figure 37)

Figure 37. Sensor groups and suspended sensors installed in a test cavity

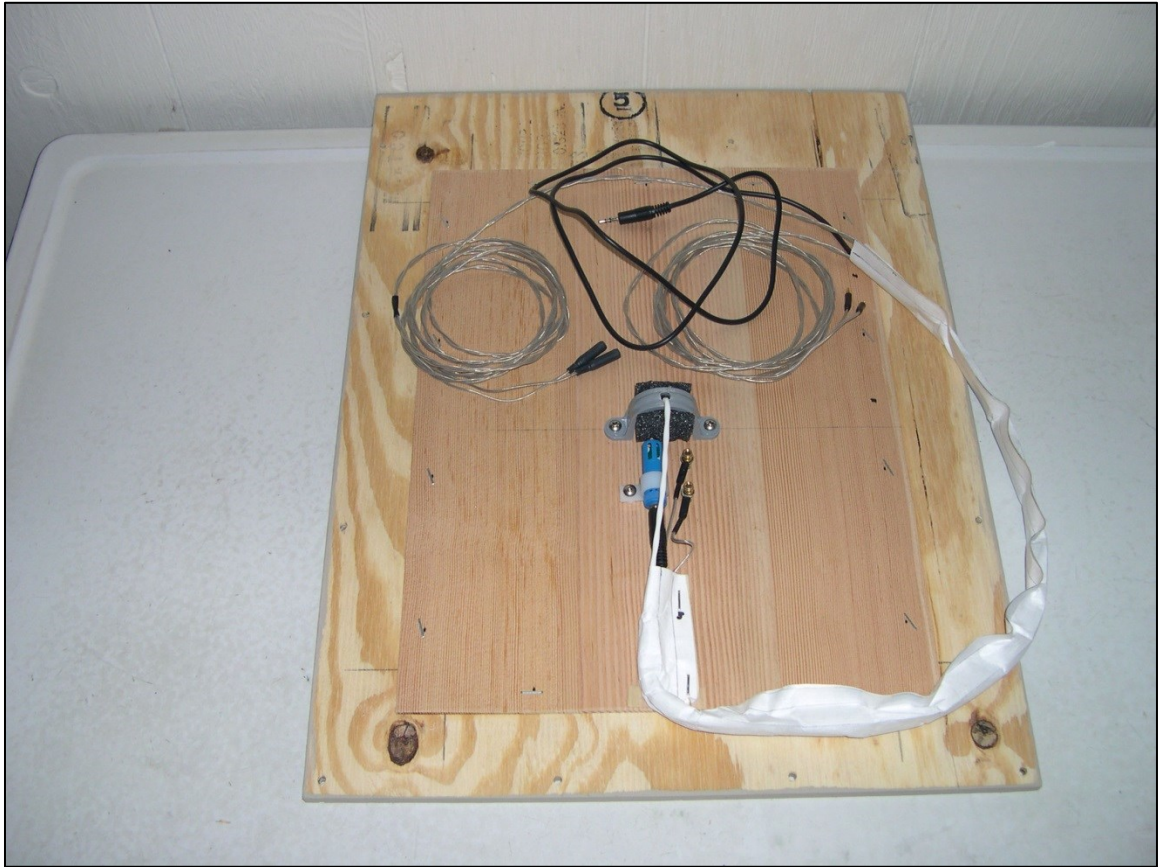
After the sensor groups at the top and sides of each cavity were installed, the sensor group was installed on the Douglas Fir panel at the center of the soffit cover. (Figure 38)

Figure 38. Soffit cover sensor group on inset Douglas Fir panel

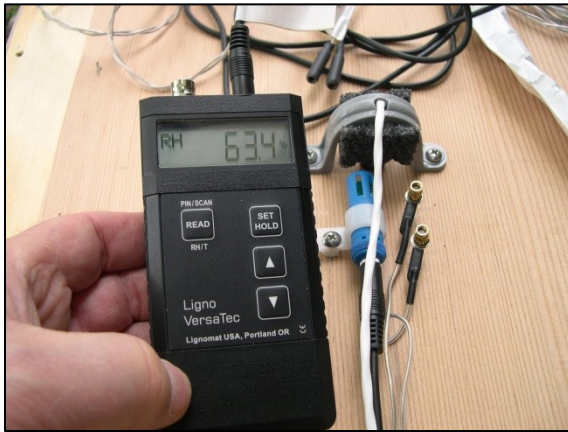
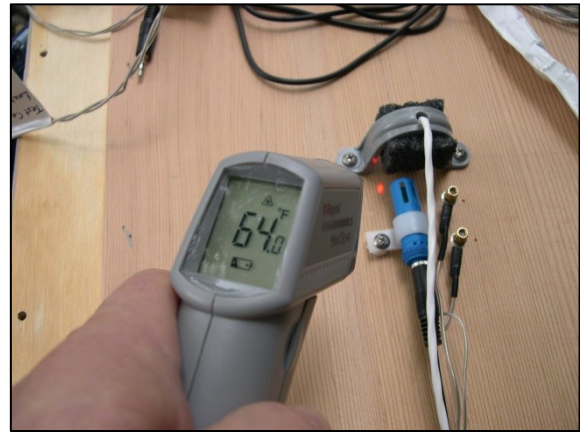
allowed to stabilize before comparing the readings with those taken from the mounted temperature-relative humidity sensor and the Ligno-VersaTec handheld meter. (Figure 39) The temperature was taken at the surface next to each material temperature probe using a Raytek MiniTemp MT4 Infrared Laser Thermometer (Figure 40) and compared

Figure 39. Checking RH reading from sensor Figure 40. Checking material temperature with readings from the server after all the sensors in the cavity were brought back online.

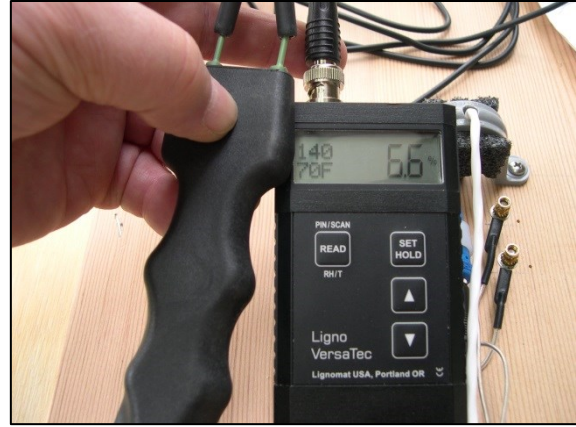
Figure 42. Checking MC at cable ends

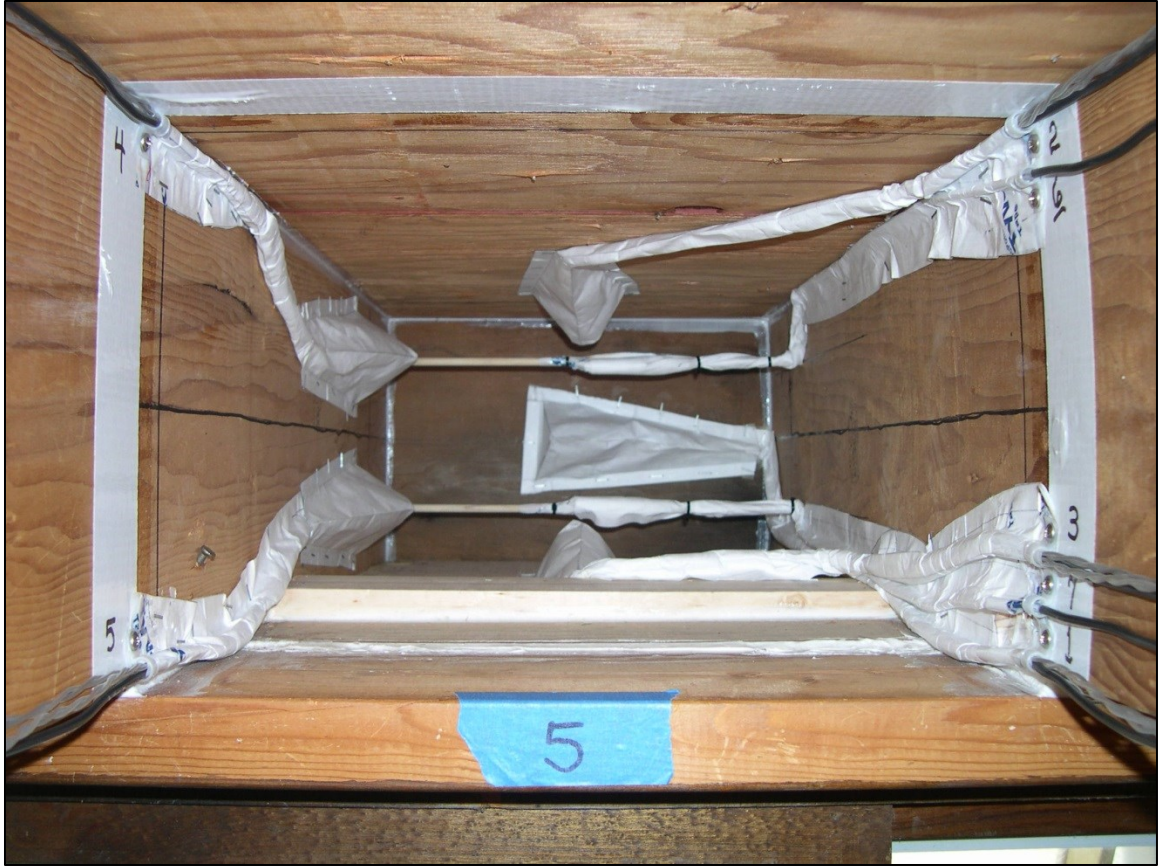
Figure 43. Soffit cover installed. Sensor group enclosures and cable covers attached

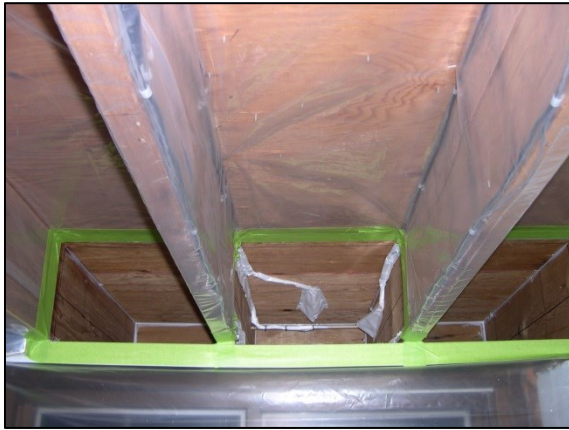
Figure 44. Masking for foam installation

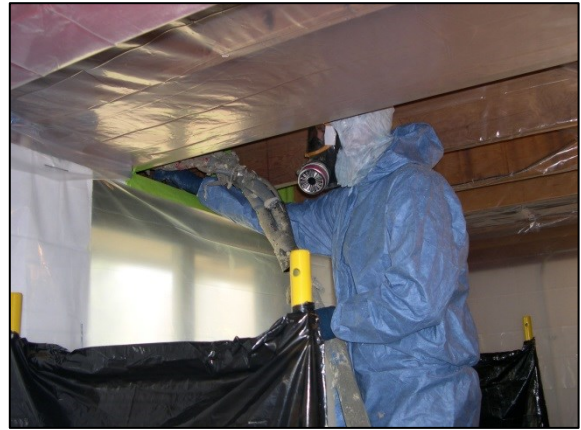
Figure 45. Foam installation

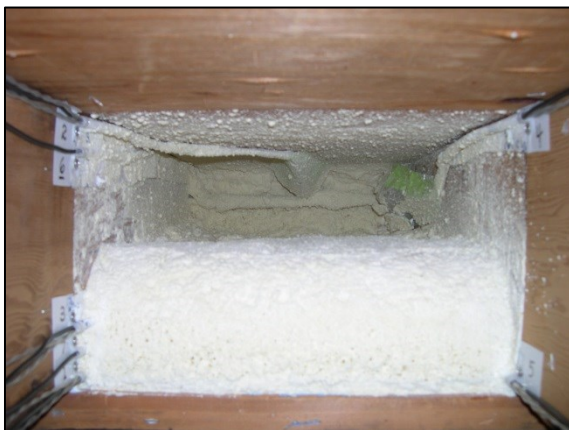
Figure 46. Enclosures masked outside foam fill

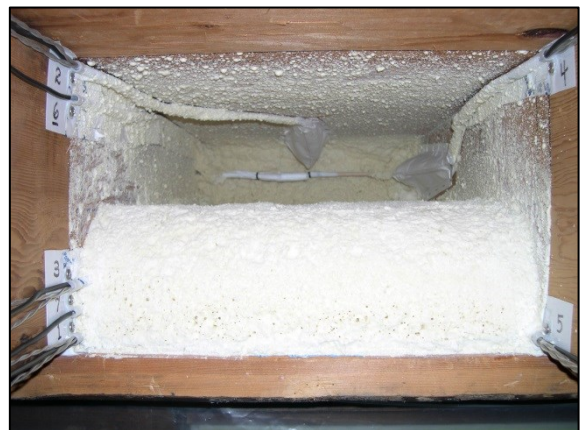
Figure 47. Masking removed from enclosures

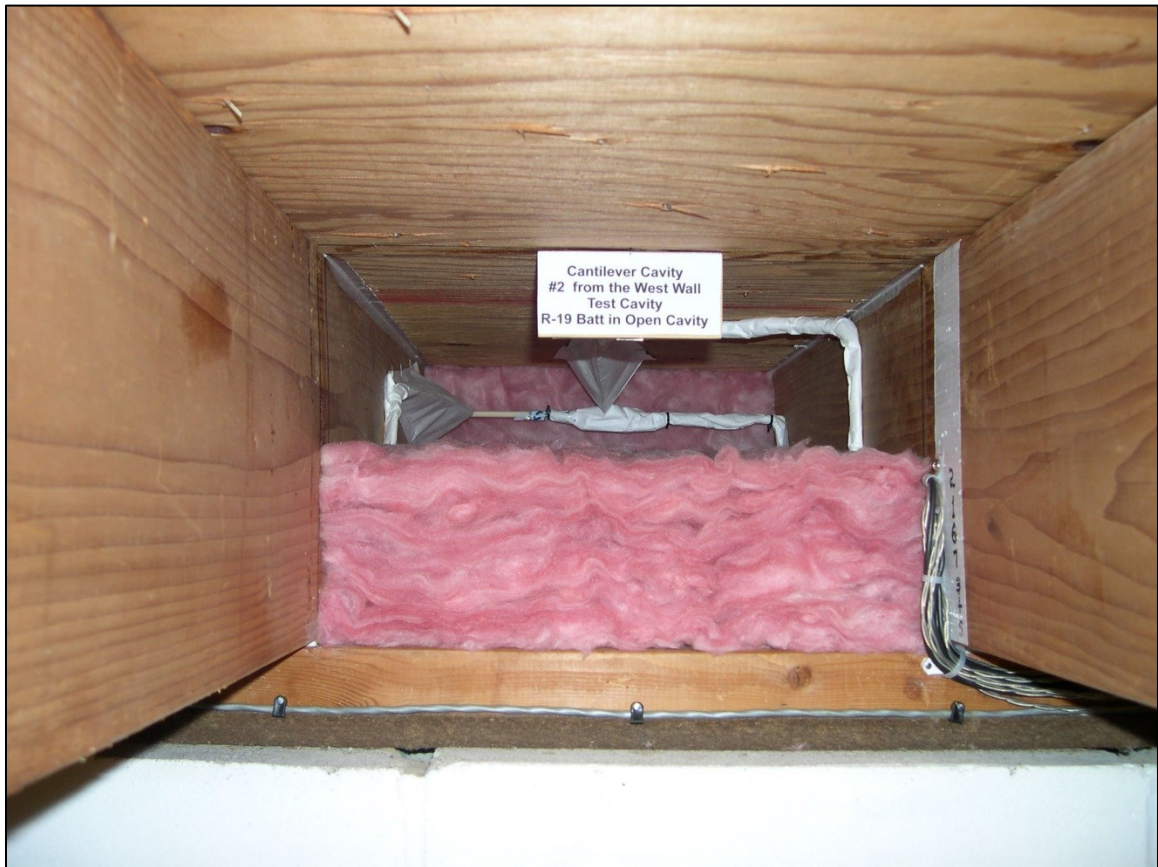
checked for proper function after cavity completion. (Figure 48)

Figure 48. Completed R-19 test cavity

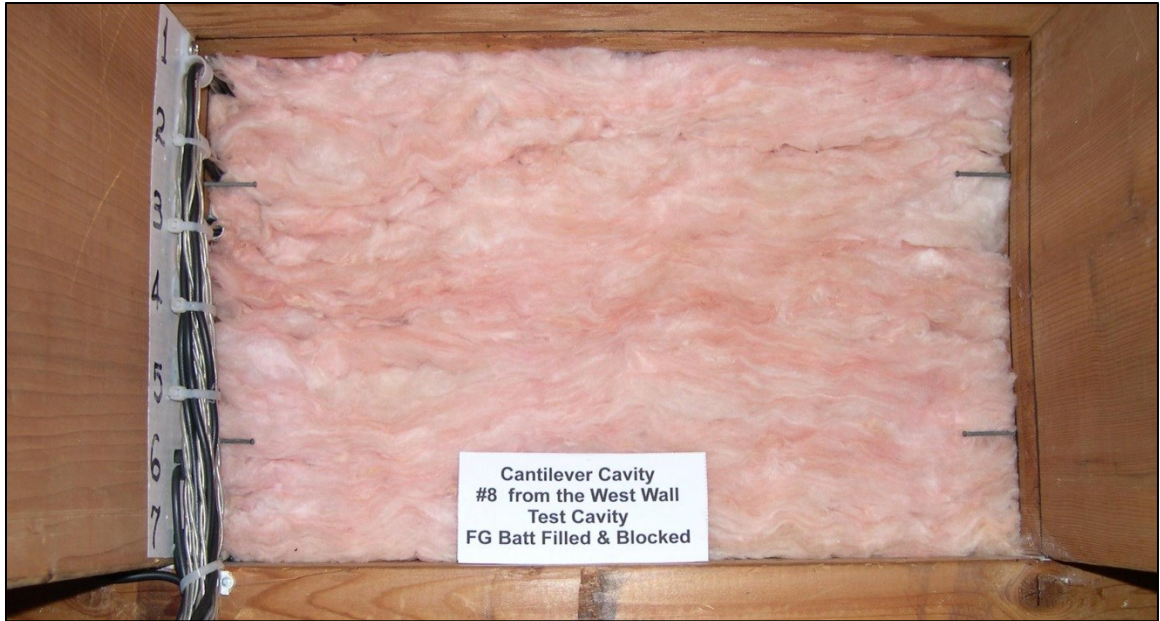
Figure 49. R-30 insulation fill completed

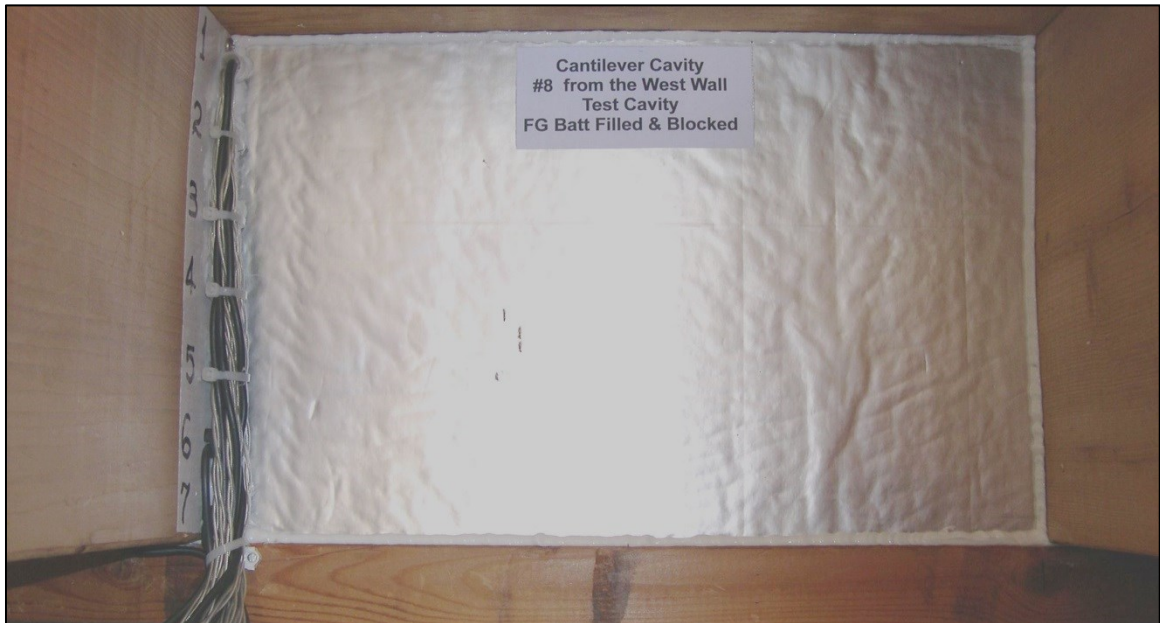
Figure 50. Rigid foam blocking and air-seal completed

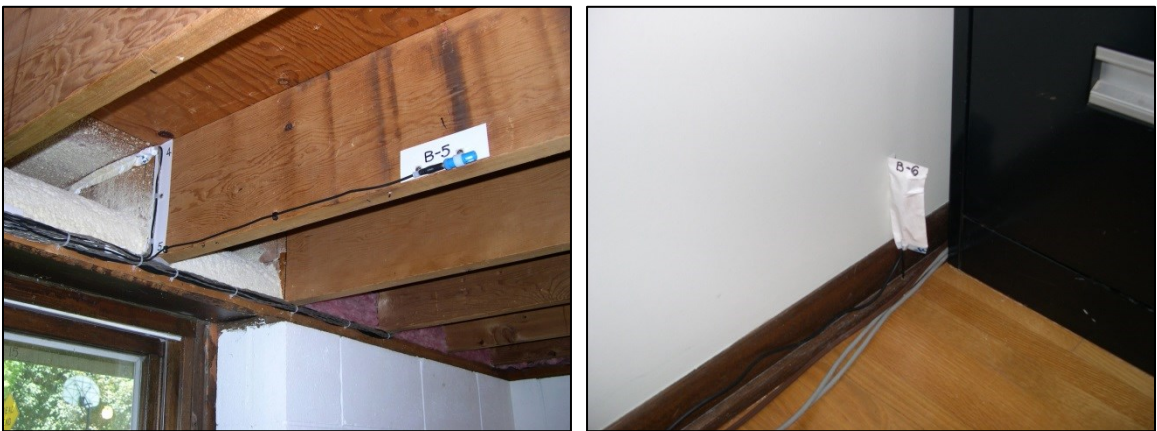
Figure 51. Boundary sensor-basement location Figure 52. Boundary sensor-main floor-west

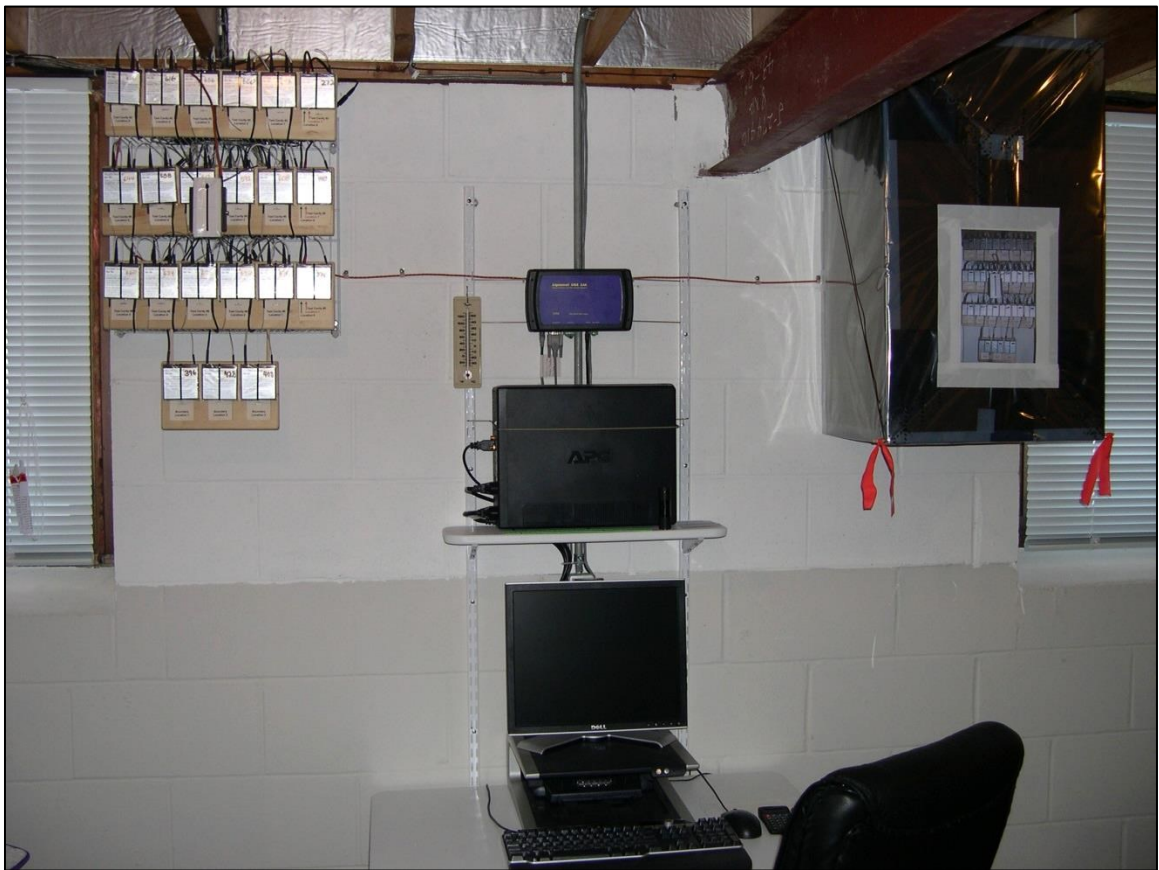
Figure 53. Transmitter-receiver arrays and data-logger set-up

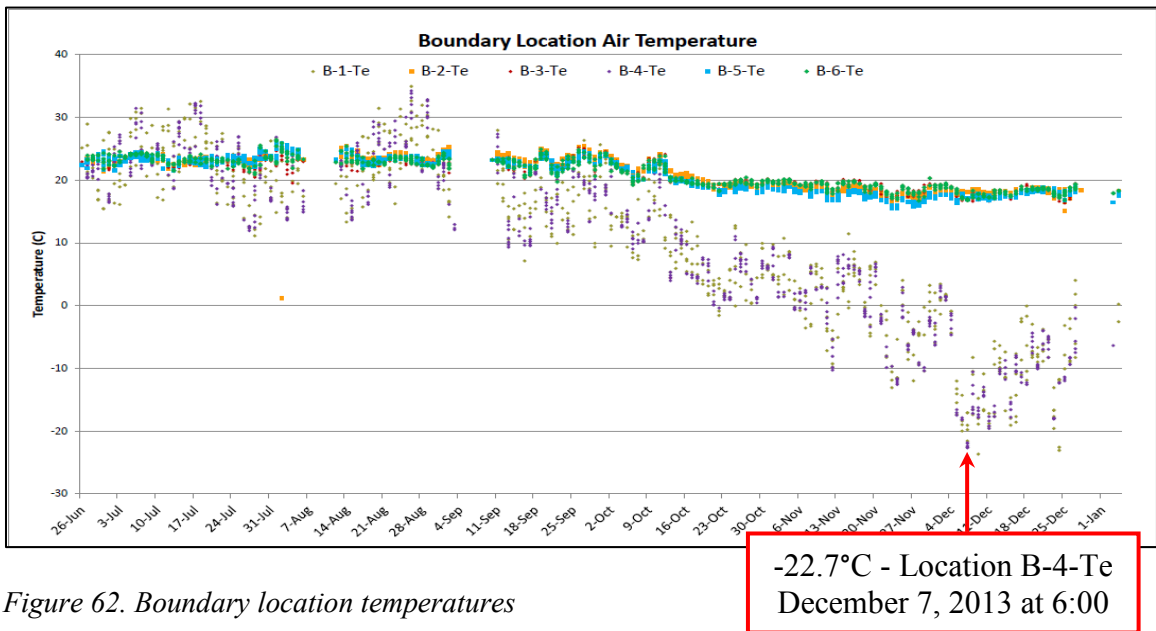
Figure 62. Boundary location temperatures

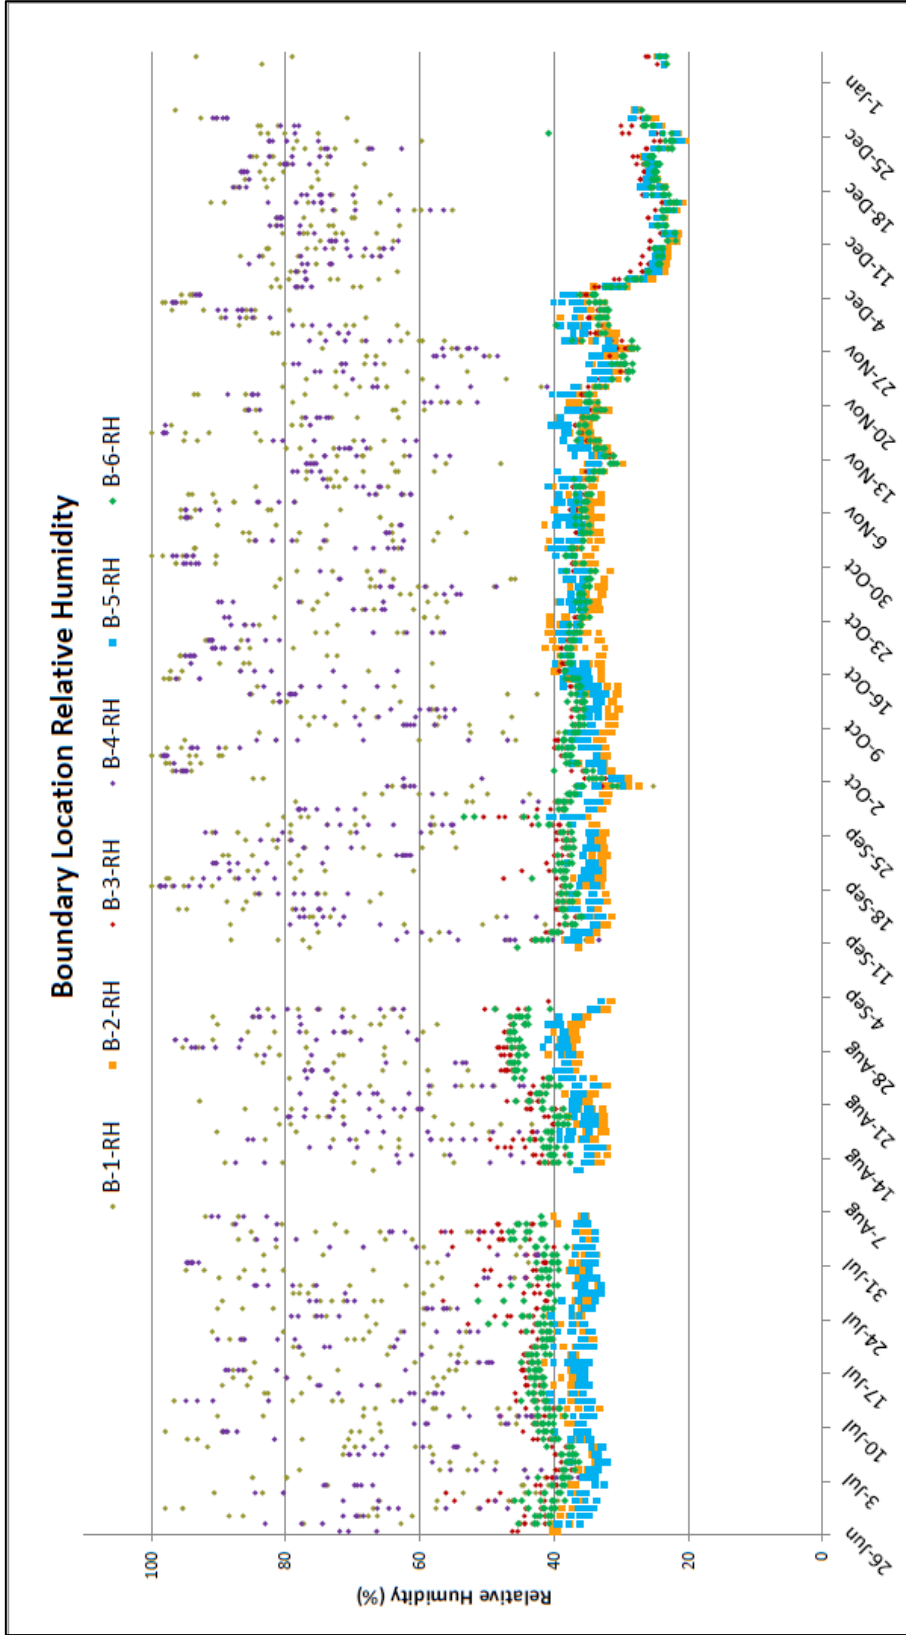
Figure 64. Relative humidity – Boundary locations

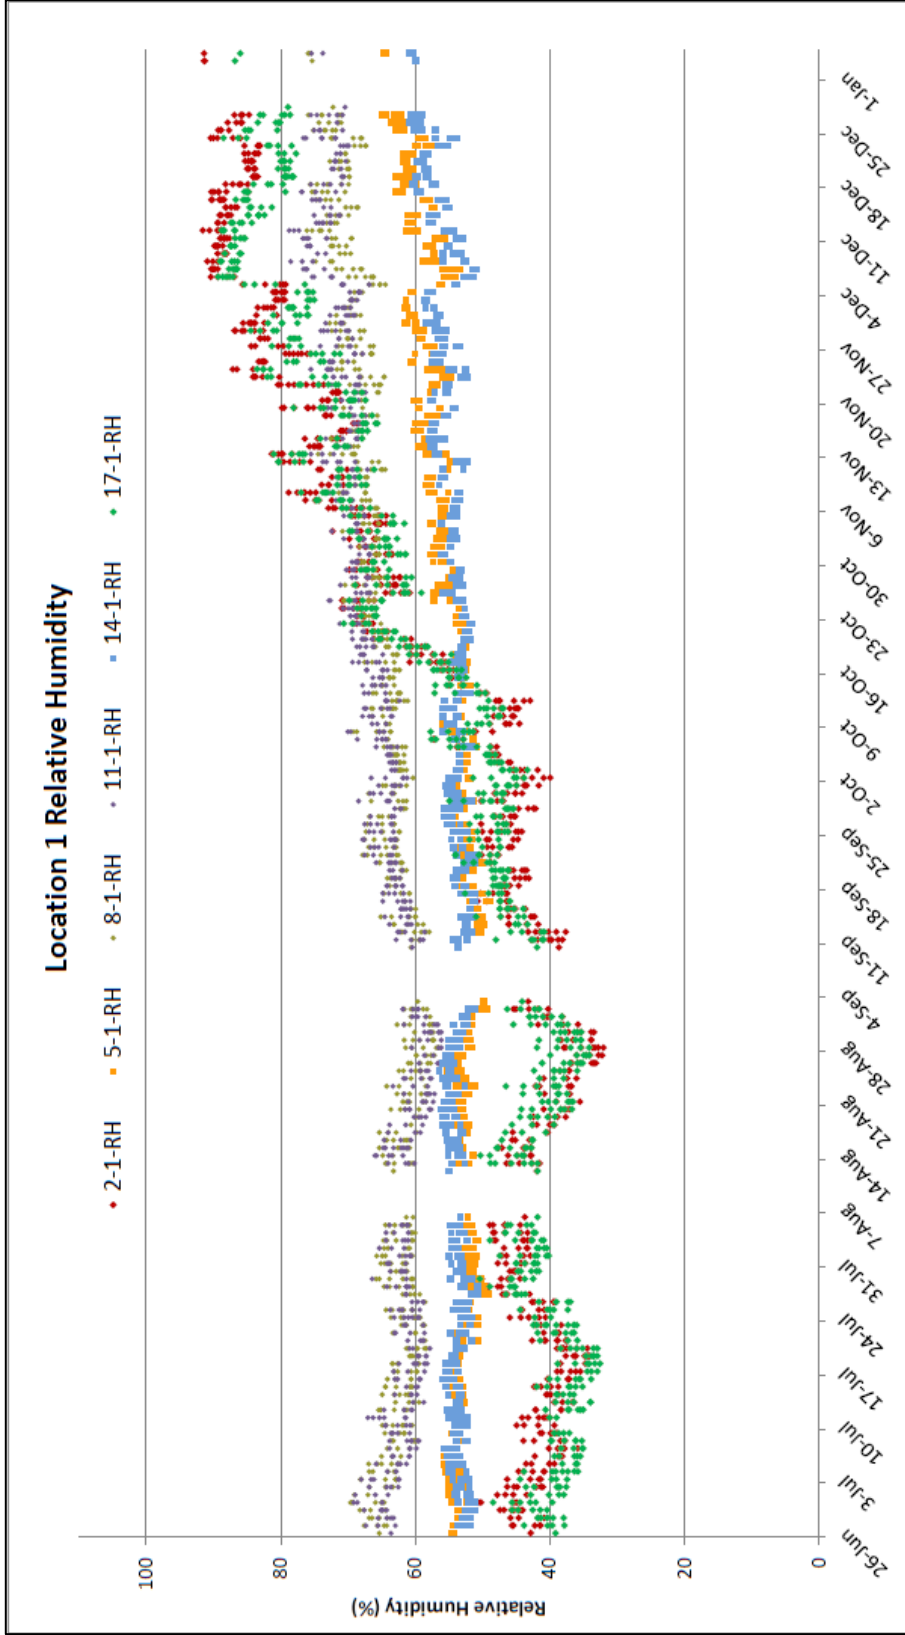
Figure 65. Relative humidity inside rim joist – Test cavities
