Permeable Pavements in Cold Climates: State of the Art and Cold Climate Case Studies

John S. Gulliver, Principal Investigator
Department of Civil, Environmental, and Geo- Engineering
University of Minnesota

Research Project
Final Report 2015-30

Minnesota
Department of
Transportation

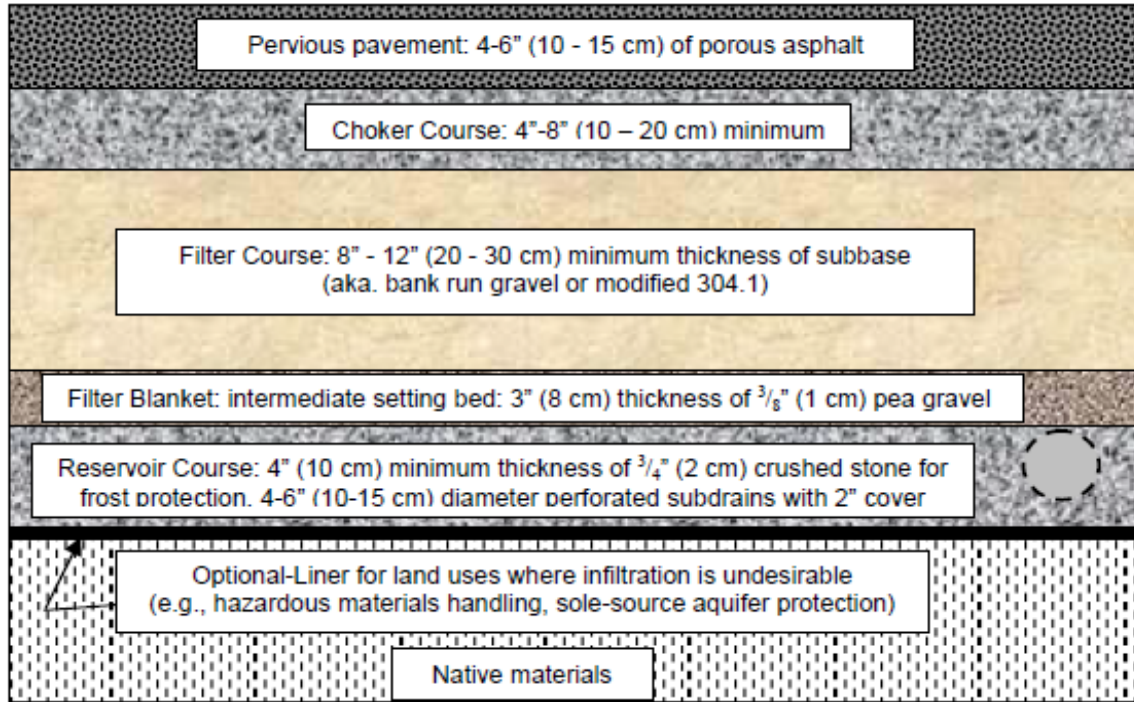
Figure 2.1. Possible porous asphalt pavement cross-section as proposed by UNHSC (2009).

A study conducted by the University of New Hampshire Stormwater Center (UNHSC 2009) included a discussion of the structural layers in the pavement system. UNHSC recommended that below the porous asphalt layer there should be a 4 to 8 inch choker layer of crushed stone (8 inches is preferred due to compaction issues with the porous asphalt), an 8 to 12 inch filter course layer of poorly graded sand, a 3 inch (minimum thickness) filter blanket (i.e. pea gravel), and a reservoir of course, crushed stone. This layering is shown schematically in Figure 2-1. The

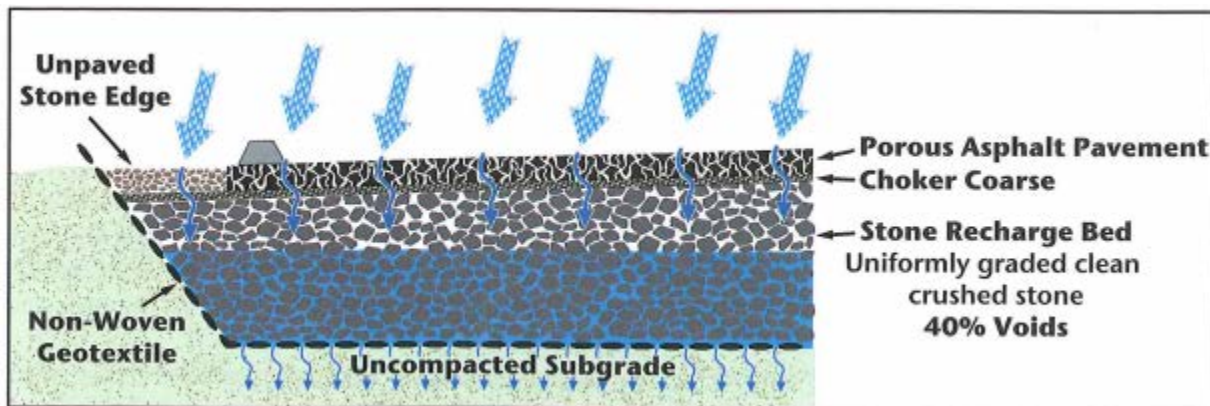
Figure 2.2. Porous asphalt pavement cross-section presented by NAPA (2008).

optional bottom liner is recommended only for aquifer protection or to eliminate infiltration. A simpler cross-section that has been recommended by NAPA (2008) is shown in Figure 2-2.

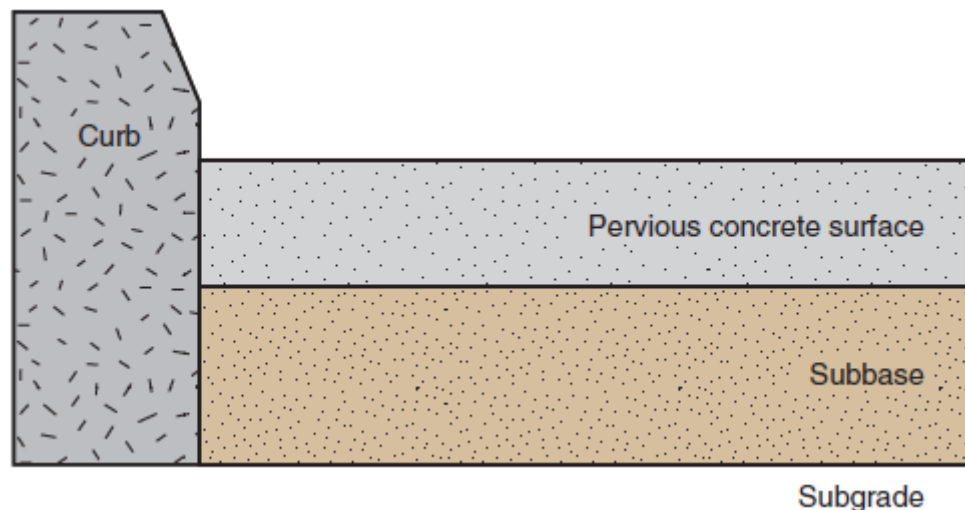
Figure 2.3. Typical cross-section of pervious concrete pavement. Concrete surface layer is 15-25% voids, subbase is 20-40% voids, and subgrade is 5-20% voids (ACPA 2009).

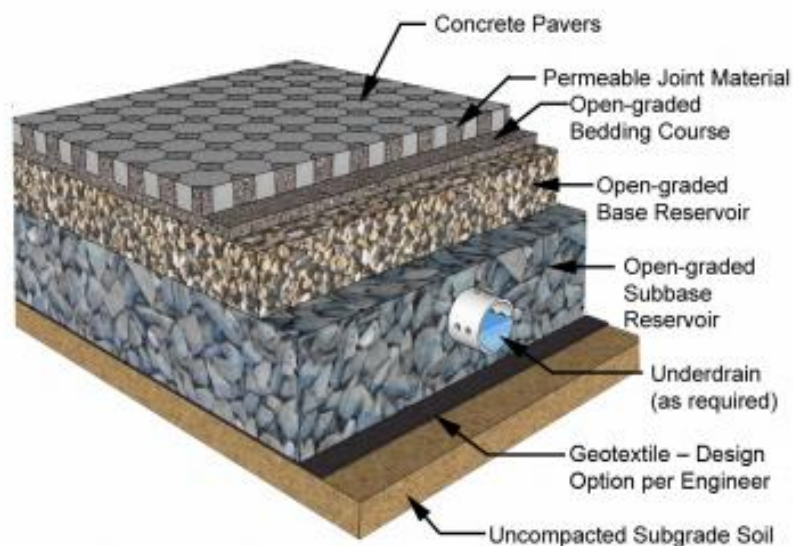
Figure 2.4. Typical cross-section of a permeable interlocking concrete paver system (Smith 2011).

The Interlocking Concrete Pavement Institute (ICPI) presented design advice for permeable, interlocking, concrete pavements (PICP) (Smith 2011). These pavers have joints or openings that are filled with permeable material that allows water to infiltrate across the pavement surface and can reduce runoff volume and improve water quality. The joints and/or openings typically cover about 5% to 15% of the total pavement surface area. A typical cross-section of a PICP system is shown in Figure 2-4.

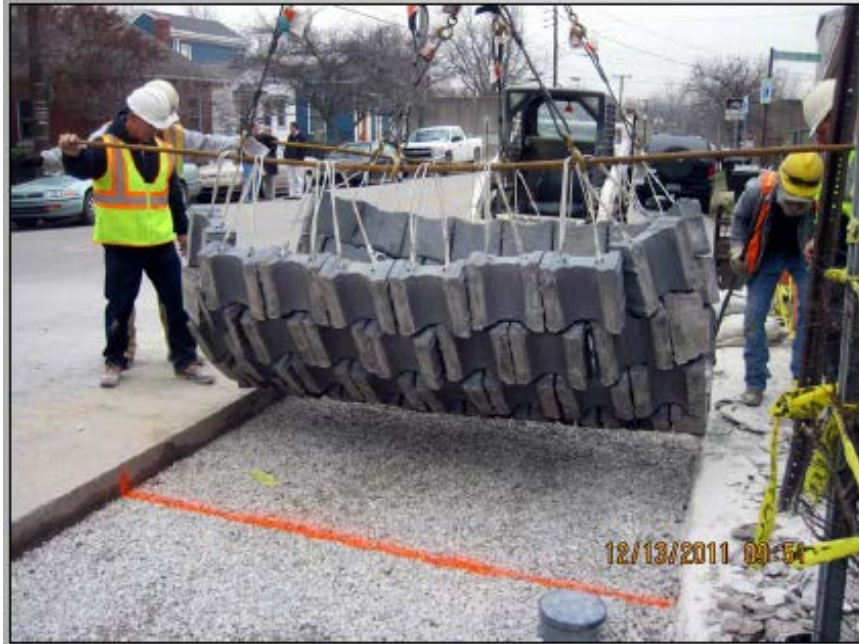
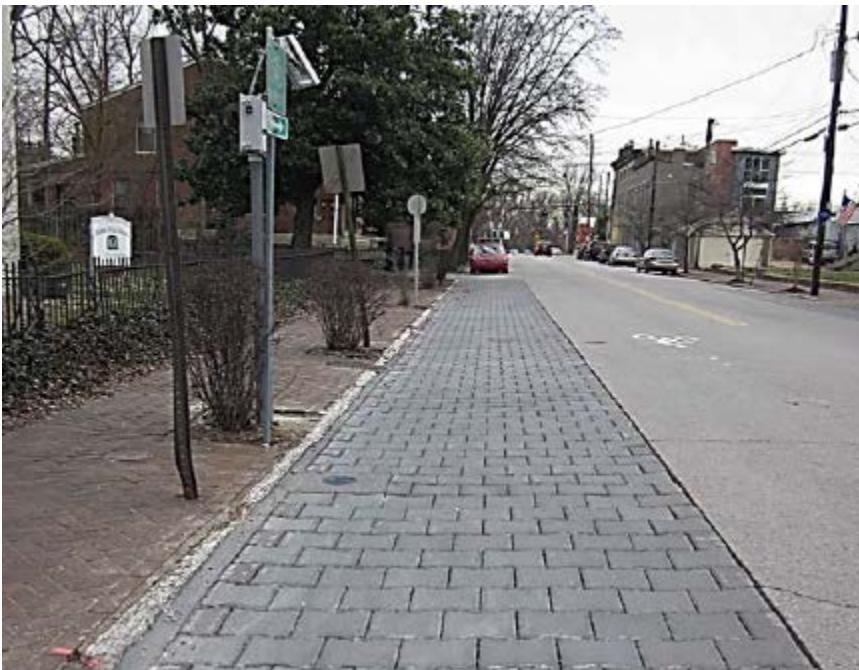
Figure 2.5. Permeable articulated concrete block/mat A) installation and, B) completed project (Photos courtesy of University of Louisville and D. Buch, Pavedrain, LLC.).

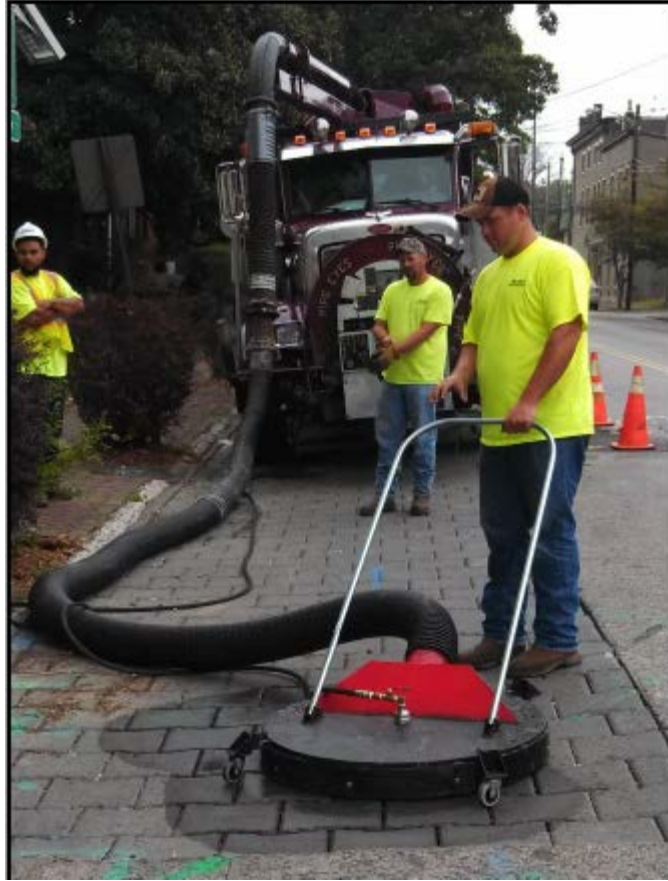
Figure 2.6. Maintenance of permeable-articulated concrete block/mats with a Vac Head (Photo courtesy of University of Louisville and D. Buch, PaveDrain LLC.).

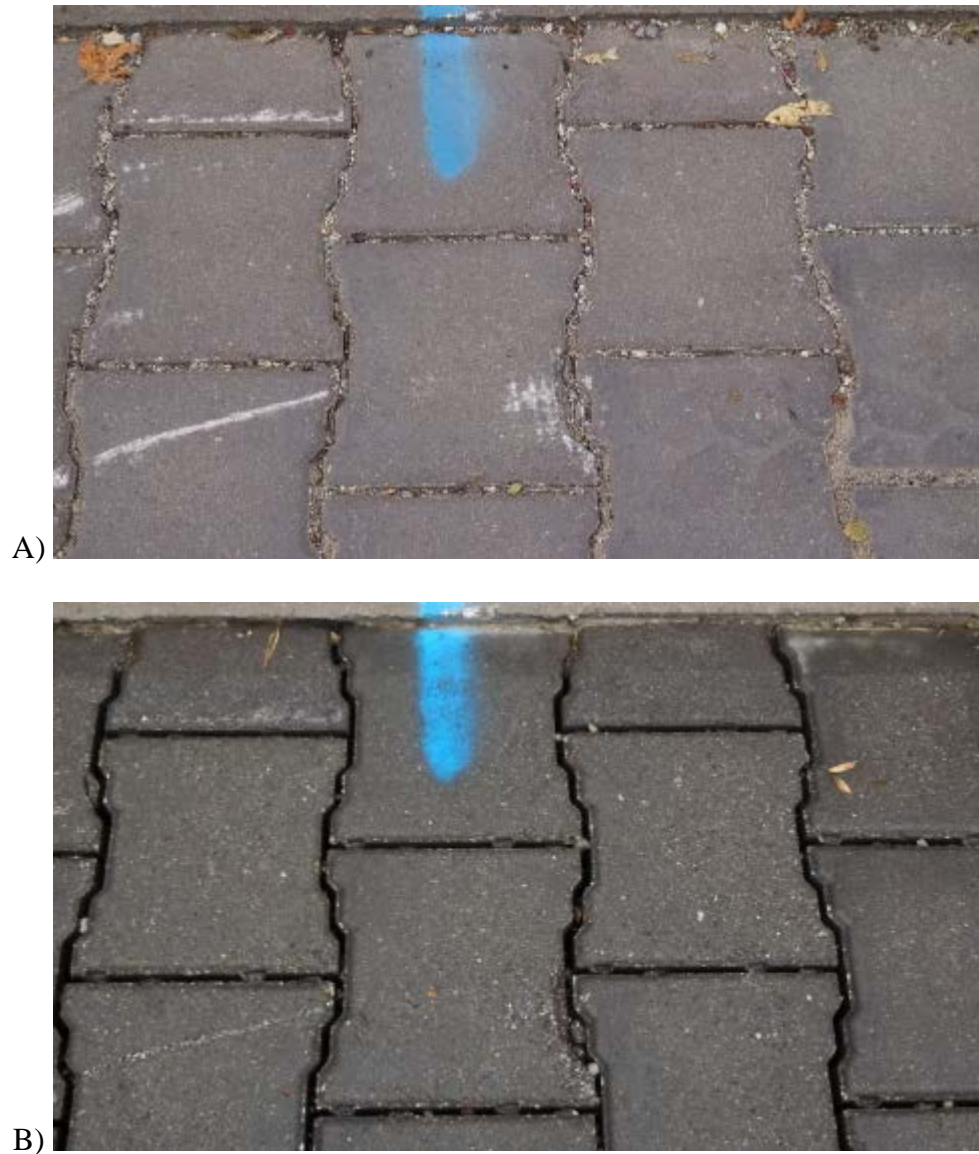
Figure 2.7. Permeable articulated concrete blocks/mats before (A) and after (B) cleaning with a Vac Head (Photo courtesy of University of Louisville and D. Buch, PaveDrain, LLC).

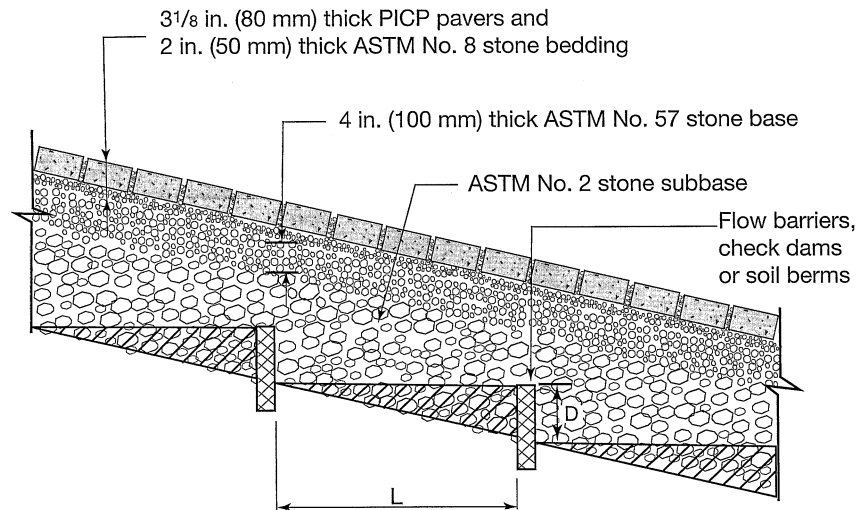
Figure 3.1. One available design for using concrete pavers on sloped surfaces (ICPI 2011).

For PICP applications on slopes greater than 2%, designs should include flow barriers that retain water in the open-graded subbase (ICPI 2011). One typical design is shown in Figure 3-1. The volume available for water storage, which is shown as the hatched area, can be estimated from the geometry of the site.

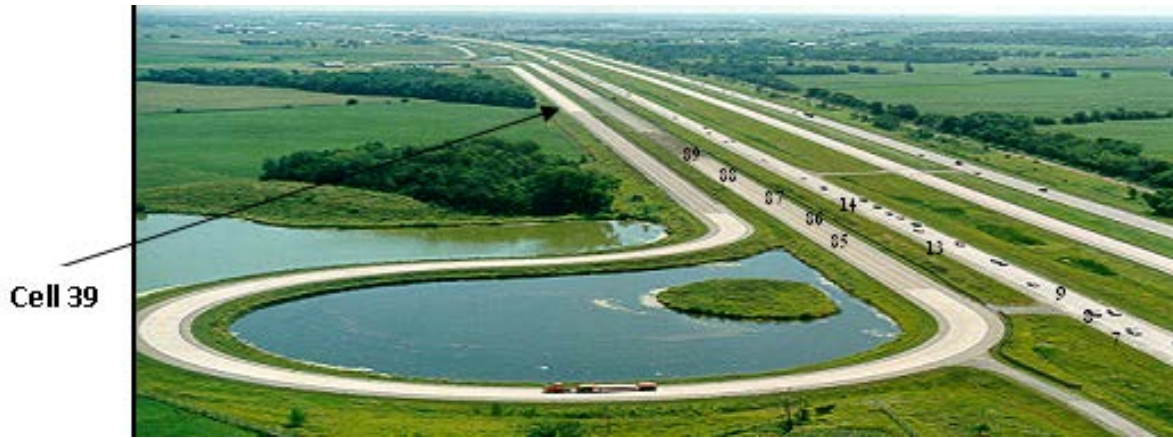
Figure 9.1. MnROAD test facility and cell locations. Cell 85 = pervious concrete on sand, cell 86 = porous asphalt on sand, , cell 87 = pervious controls, cell 88 = porous asphalt on clay, cell 89 = pervious concrete on clay, cell 39 = pervious concrete overlay. (Izevbekhai and Akkari 2011).

Cell 85 is a pervious concrete pavement over non-compacted sand and cell 89 is a pervious concrete pavement over non-compacted clayey soil. Cell 86 is a porous (PA) asphalt cell over sand and cell 88 is a porous asphalt cell over clay. For reference, cell 87 is a standard, non-porous asphalt pavement. The pervious concrete test cells (and other test cells) are shown in the aerial photograph of Figure 9-1 (note that the location of each cell is indicated by the number on the pavement).

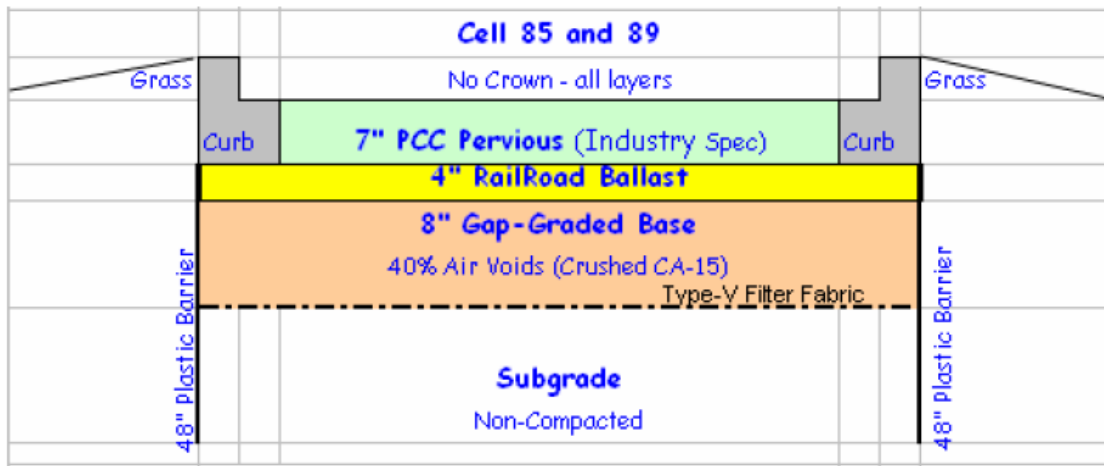
Figure 9.2. Cross-section of pervious concrete test cells (Izevbekhai and Akkari (2011)).

Cells 85 and 89 are seven inch thick, full-depth pervious concrete constructed to industry standards. Beneath the pervious concrete pavement layer each cell has, from top to bottom, 4 inches of railroad ballast, 8 inches of gap-graded aggregate, and a geotextile fabric (Type V) on top of the underlying soil. The cells are identical except for the underlying natural soil; cell 85 was constructed on granular soil and cell 89 on clayey soil. A cross-section of the pervious concrete pavement is shown in Figure 9-2.

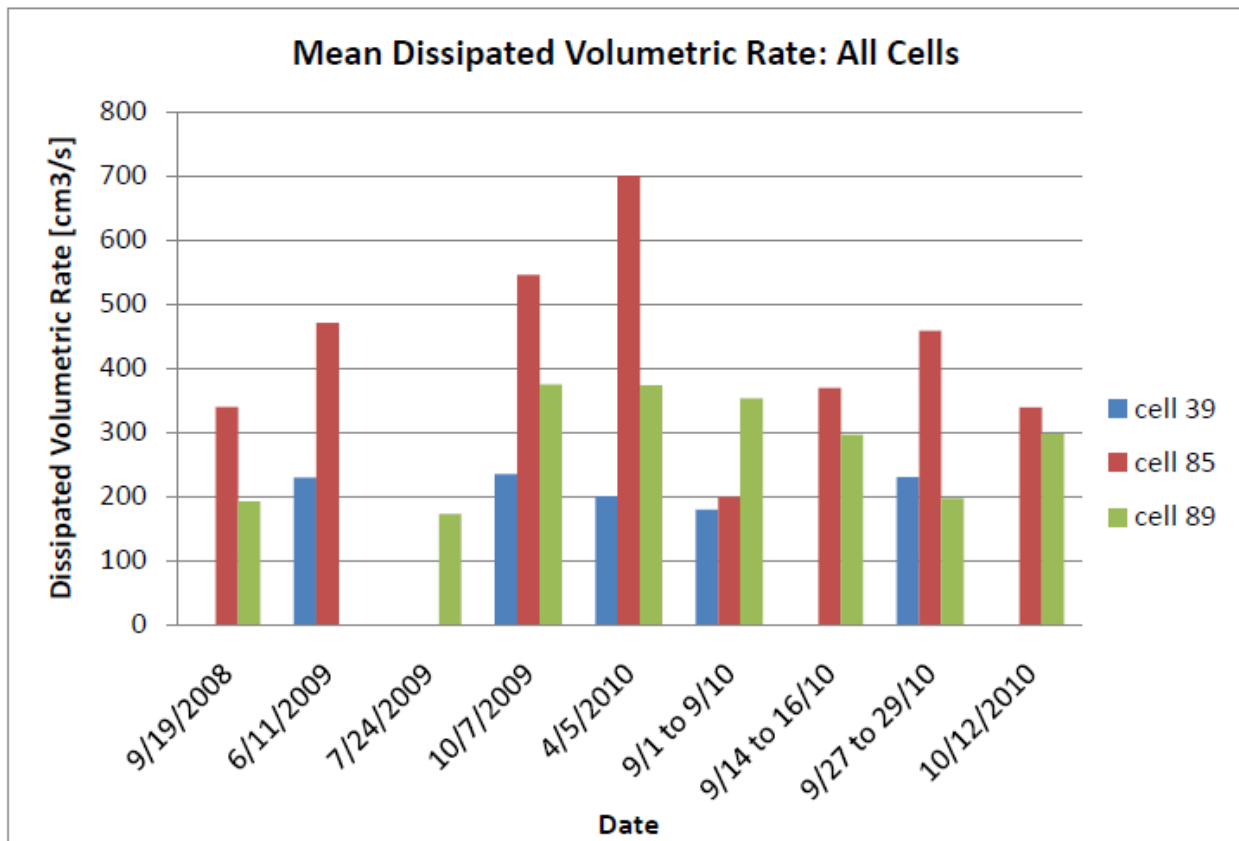
Figure 9.3. Average dissipated volumetric rates for pervious concrete cells over sand (cell 85) and clay (cell 89). Note: cell 39 is a porous overlay and not related to this review.

Values of DVR varied greatly from location to location, even on the same test cell. Thus, average values were computed for each cell. As may be expected and as shown in Figure 9-3, on all test dates the pervious cell over sand (cell 85) had a greater average DVR than the pervious concrete cell over clay (cell 87).

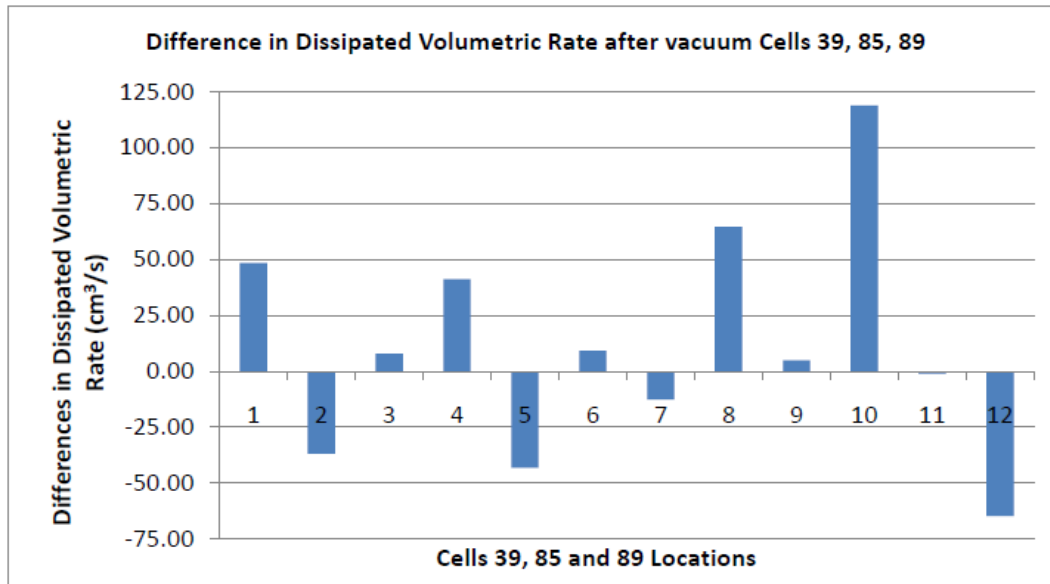
Figure 9.4. Change in dissipated volumetric rate (before and after second vacuuming) (Izevbekhai and Akkari (2011)).

For the second cleaning, the DVR at some locations increased but others decreased after vacuuming. Figure 9-4 shows the change in DVR at each of the 12 test locations.

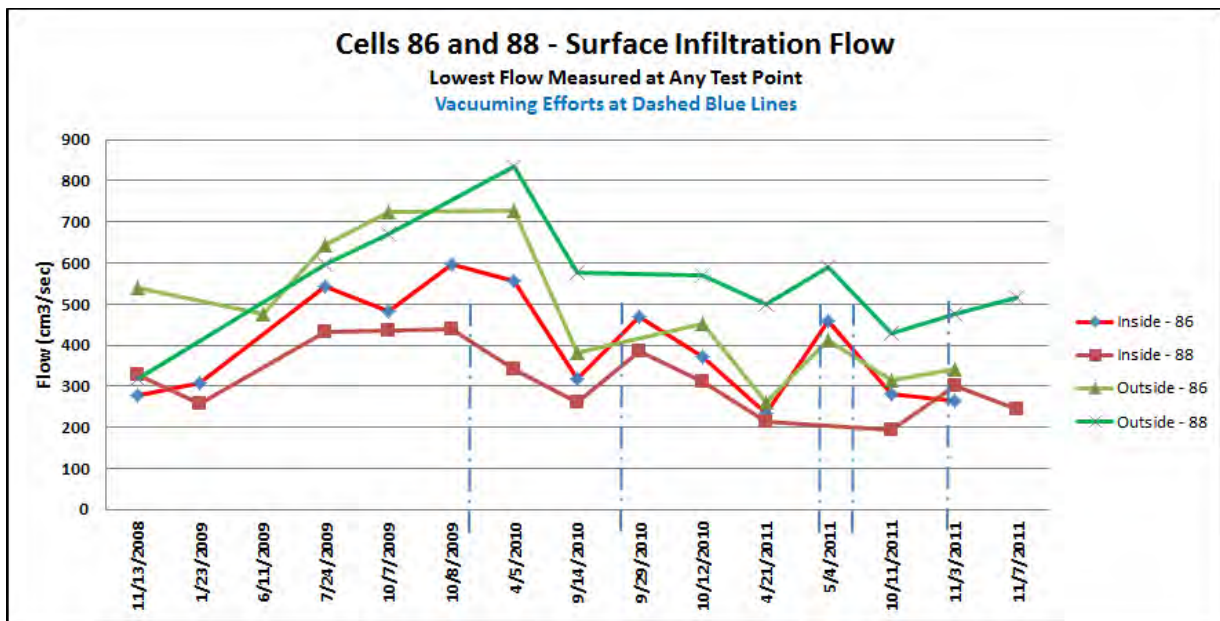
Figure 9.6. Lowest flow measured at any porous asphalt test location (Lebens and Troyer 2012). Dashed, vertical lines correspond to dates the pavement surface was vacuumed.

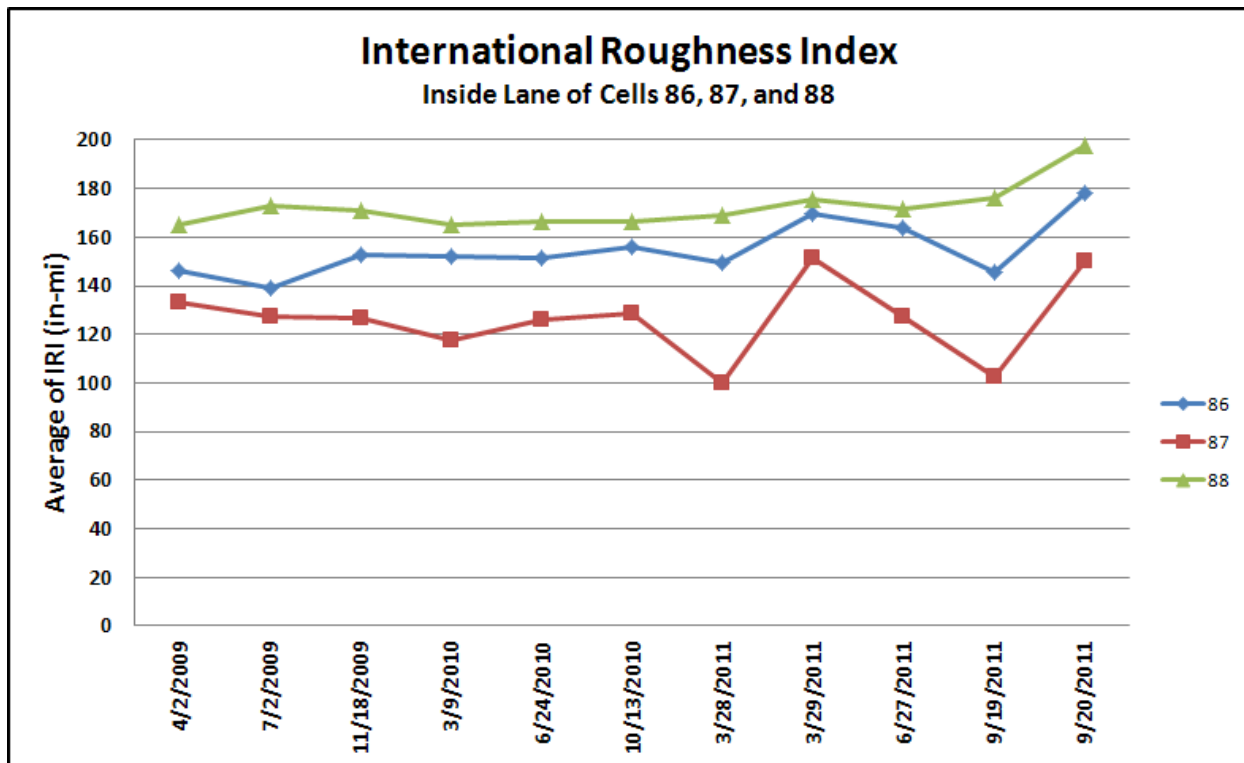
Figure 9.7. Typical International Roughness Index values (Lebens and Troyer 2012).

Similar to the pervious concrete test cells, the porous asphalt test cells were evaluated based on several measurements including: IRI, SR, skid resistance, density, deflection and temperature. Over the course of the study the IRI values for all three asphalt cells changed very little (Figure 9-7). The porous asphalt cells were consistently rougher than the standard dense-graded asphalt cell and cell 88 (clay) was always slightly rougher than cell 86 (sand). It was thought that roller marks put in the pavement of cell 88 during construction resulted in it being rougher than cell 86.

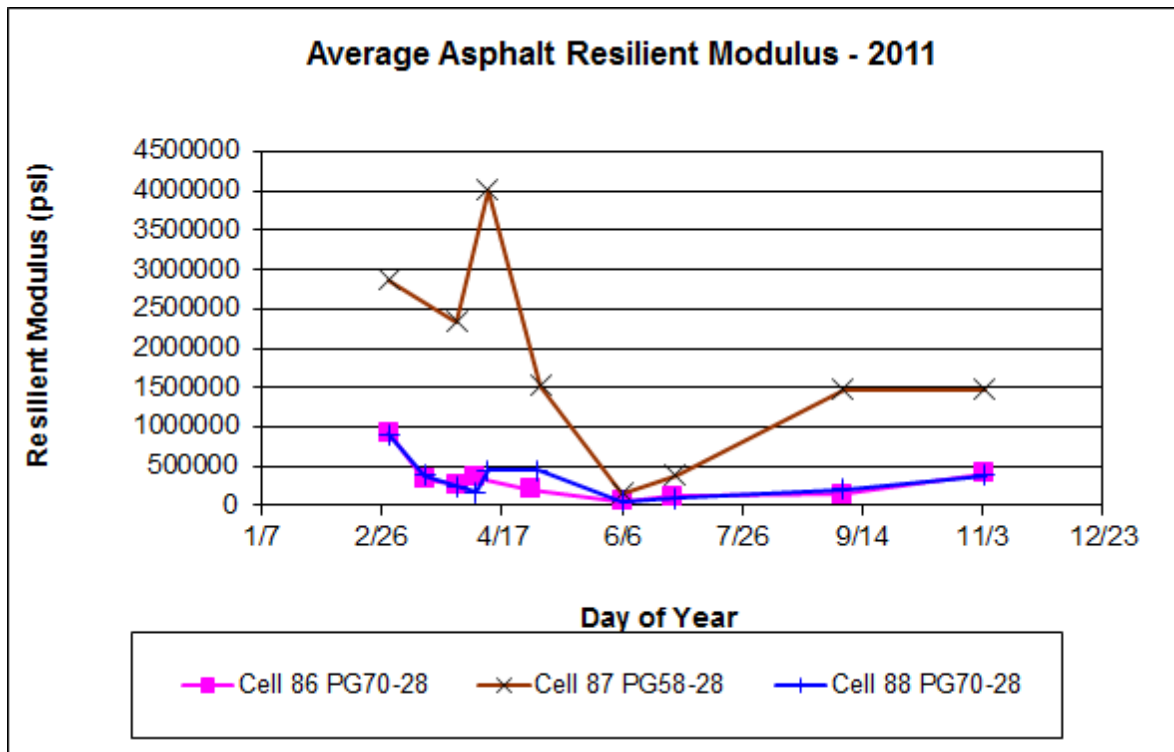
Figure 9.8. Average resilient moduli for final year of testing (Lebens and Troyer 2012).

Falling weight deflectometer (FWD) data was collected from 2009 through 2011 on cells 86 and 88 and used to back calculate the resilient moduli of the pavement. The average results for the final year, 2011, are shown in Figure 9-8.

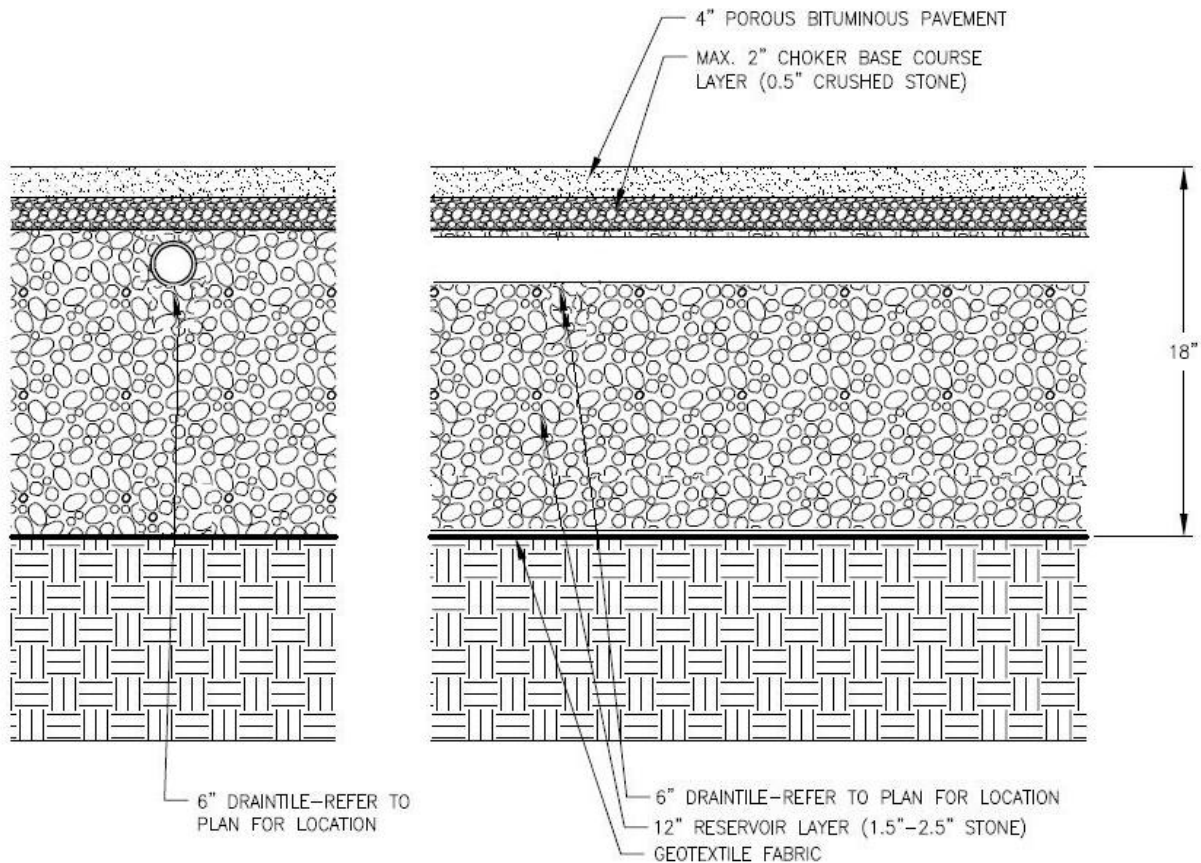
Figure 9.11. Porous asphalt pavement cross-section (Wenck 2014).

The porous asphalt sections were designed to store the 2 year return period rainfall in the underlying reservoir layer. The cross-section of the permeable pavement consisted of, from top to bottom, a four inch thick, full-depth porous asphalt layer, a two inch thick choker course consisting of 0.5 inch crushed stone, a 12 inch thick reservoir layer of 1.5 to 2.5 inch granitic stones with a porosity of 35 to 40%, and a geotextile fabric on top of the subgrade. An overflow drain pipe that conveyed water to a nearby catch basin was also placed near the top of the reservoir layer. The cross-section is shown in Figure 9-11.

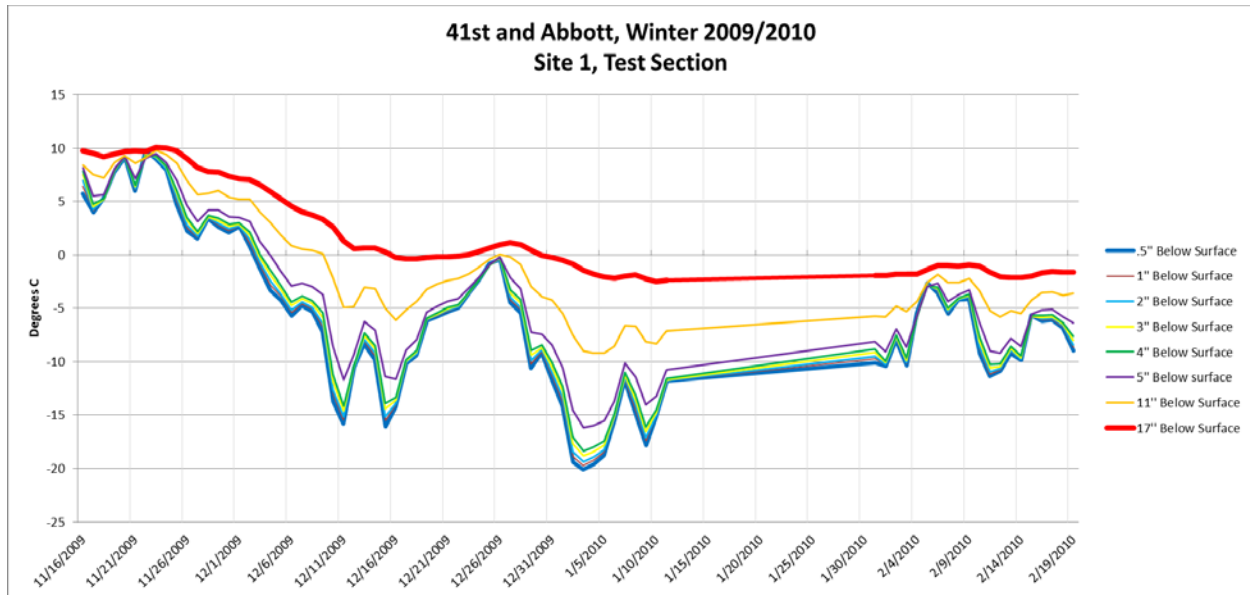
Figure 9.12. Temperatures in porous pavement system at Site 1 (Wenck 2014).

The trend of the reservoir temperature being warmer than the air and pavement temperatures during the winter and cooler during the spring was attributed to the air within the voids of the reservoir layer. During the winter, that air tends to insulate the reservoir and minimize freezing while in the spring it tends to keep reservoir temperatures cooler than air temperatures. The insulating effect may also be, in part, due to the air within voids of the sand subgrade. The warmer temperatures within the reservoir during the winter occur because subgrade soils are warmer than the surface temperatures throughout most of the winter. This suggests that throughout much of the winter the subgrade may be able to infiltrate snowmelt and rainfall runoff and hence preventing the runoff to be discharged into receiving waters and will help to reduce the chloride mass loading. In addition, the surface of the traditional pavements tended to be slushier and the slush would refreeze later in the day when the sun lowered (Figure 9-13). On the porous asphalt sections, however, slush tended to infiltrate and not refreeze on the pavement (Figure 9-14). Overall, this tended to make the amount of bare pavement on the porous test sections comparable to the amount on the conventional asphalt sections, even though the porous test sections were not salted.

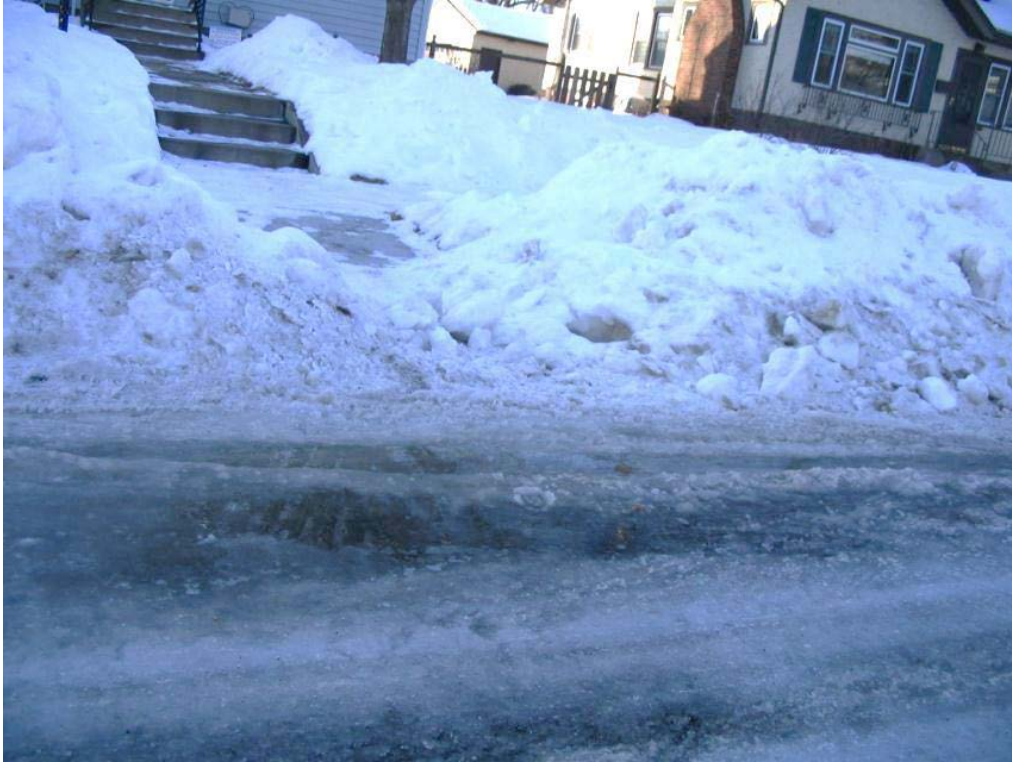
Figure 9.13. Slush gathering and refreezing on the traditional asphalt at Site 1 on January 17, 2010 (Wenck 2014).

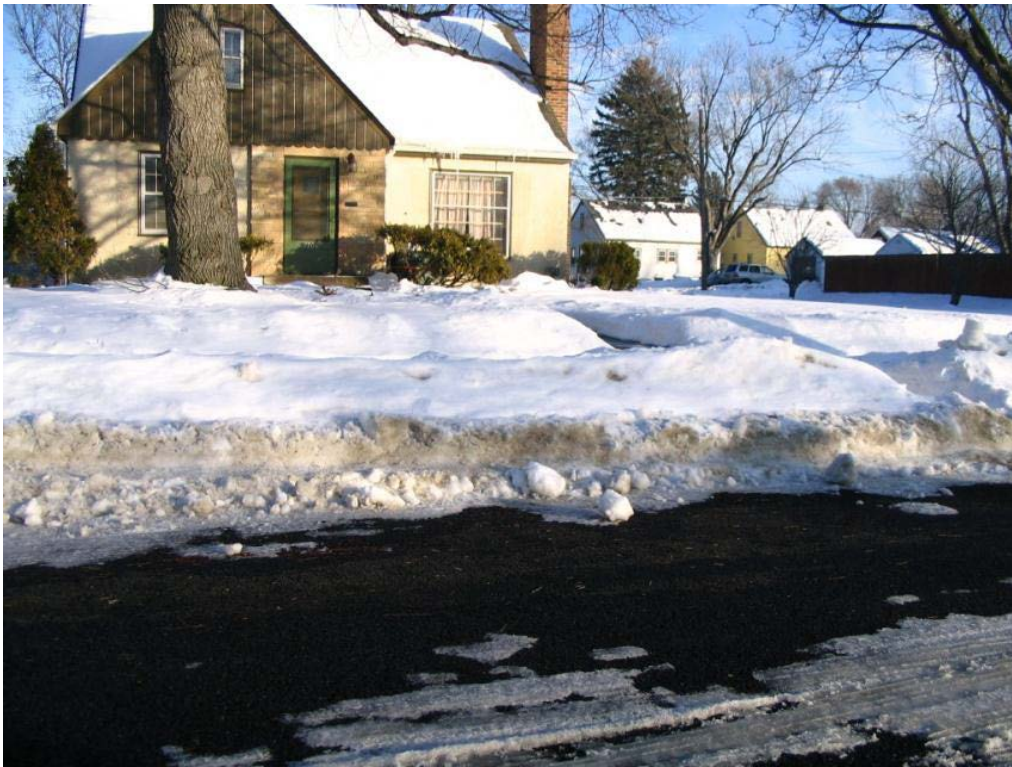
Figure 9.14. Slush free porous asphalt on January 17, 2010 (Wenck 2014).

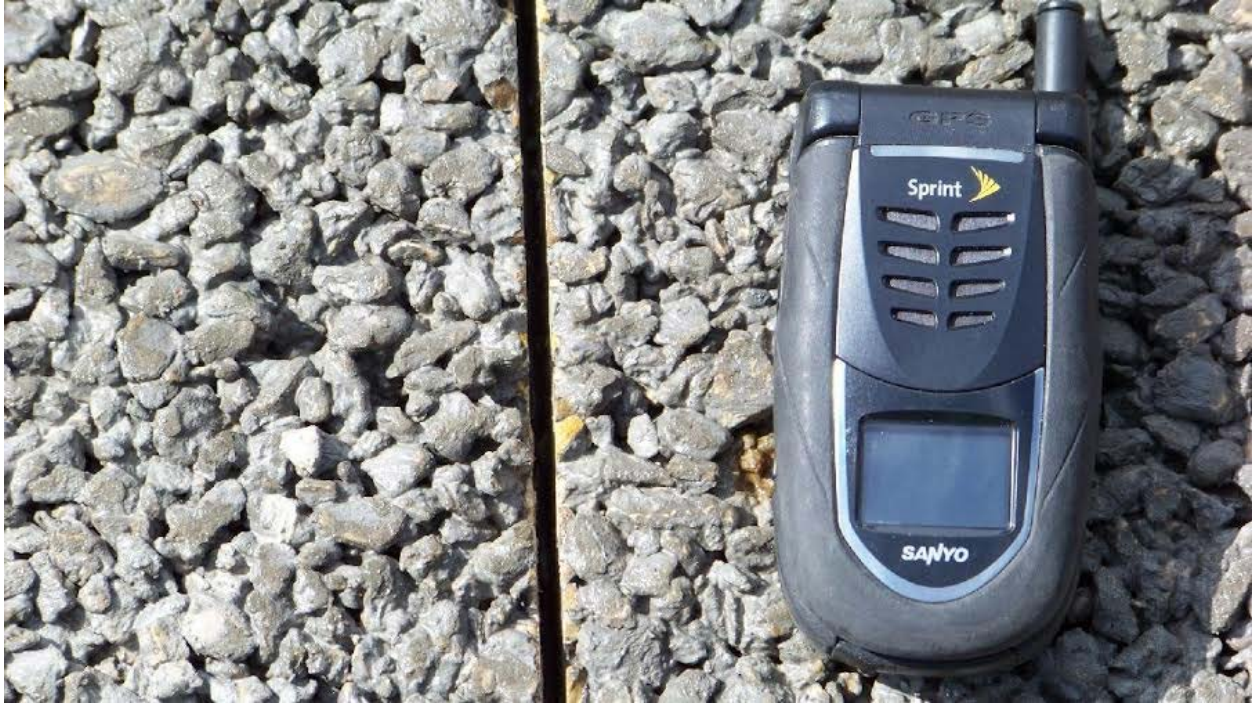
Figure 9.15. Saw cut joint in pervious concrete at Woodbridge neighborhood, Shoreview, MN (photo courtesy of M. Maloney, City of Shoreview).

One to two days after pouring, joints were cut into the pervious concrete with a diamond tip blade. No raveling or spalling of the concrete near the sawn joints has been observed. Saw cut joints are recommended for two reasons, 1) rolling joints deforms the pervious concrete and increases the surface area of the pervious concrete at the joint, which may cause more evaporation and affect the curing process, and 2) rolling joints has the potential to create a lip or obstruction that may be damaged by a snow plow blade. Figure 9-15 shows a close-up picture of a saw cut joint.

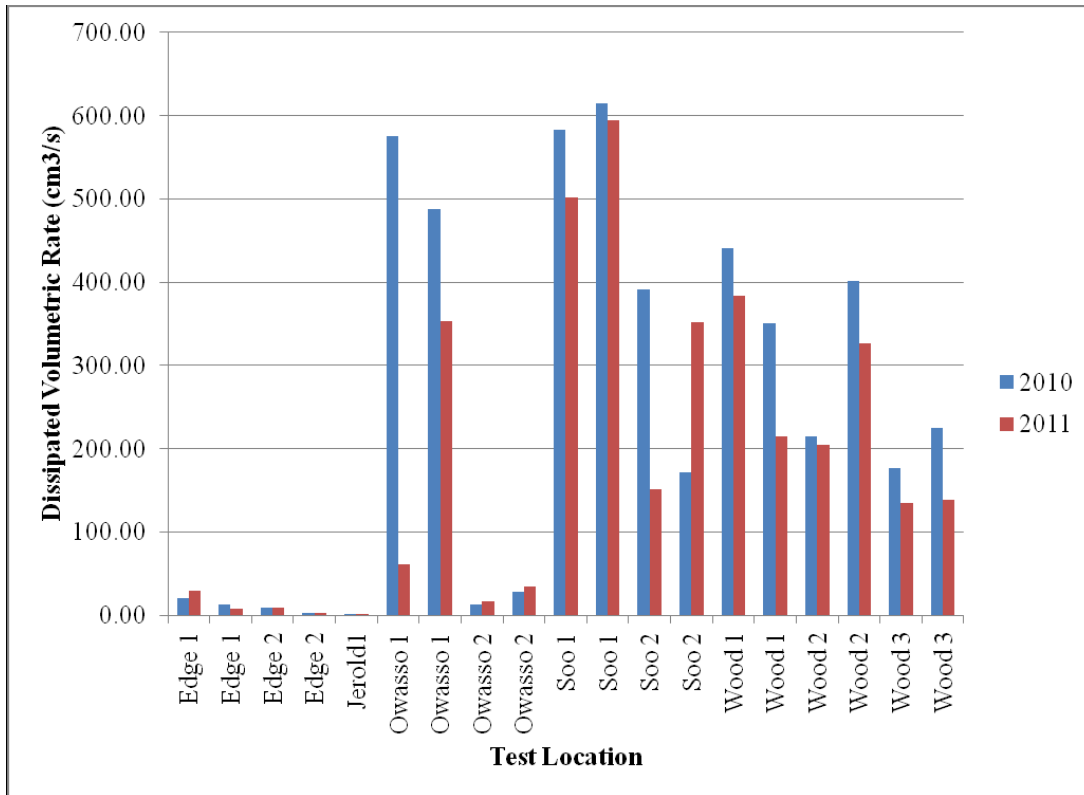
Figure 9.16. Dissipated volumetric rates of Shoreview, MN pervious concrete at various locations (Izevbekhai and Akkari 2011).

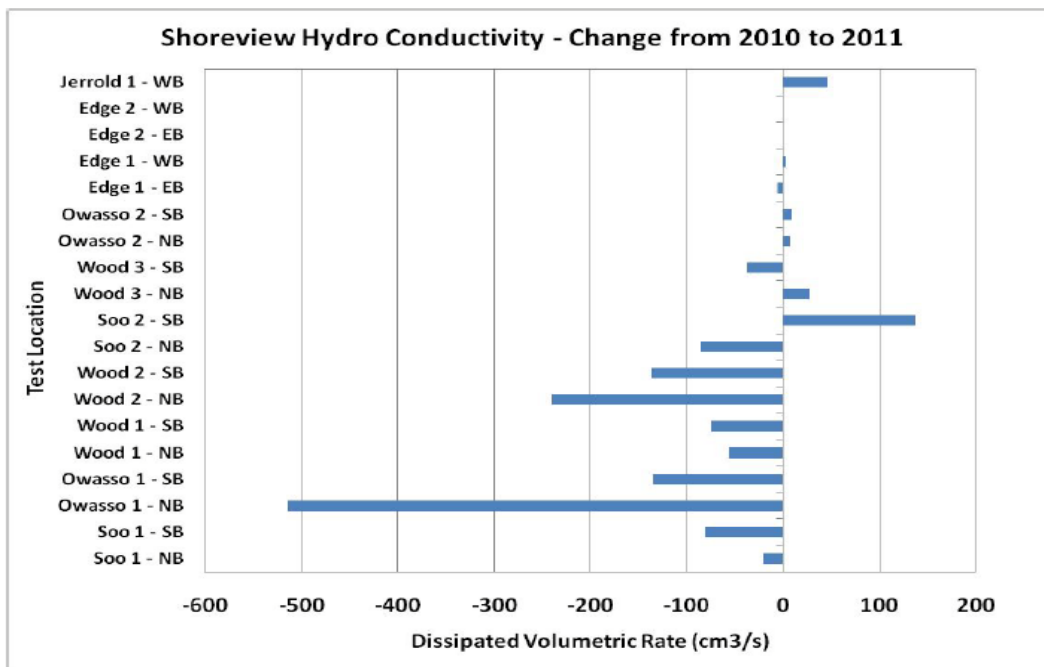
Figure 9.17. Change in dissipated volumetric rate of Shoreview, MN pervious concrete (Izevbekhai and Akkari 2011).

Figure 9-17 shows the change in DVR at each test location from 2010 to 2011. Izevbekhai and Akkari (2011) suggested that the drop in DVR was due to clogging of the pore structure, which may have been due to raveling at the surface or other debris entering the pavement.

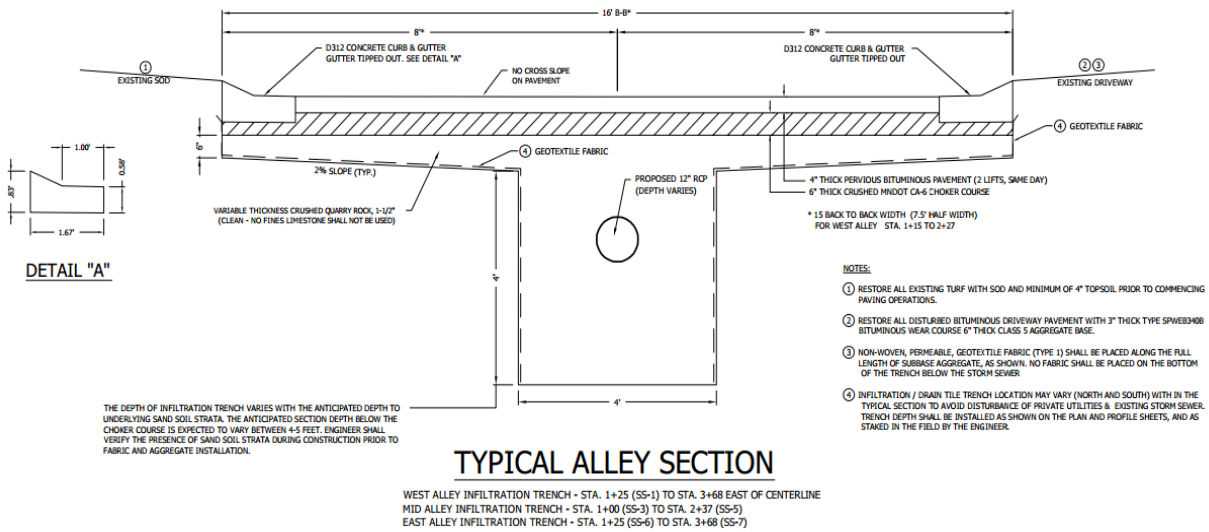
Figure 9.18. Typical cross-section in St. Paul alley project.

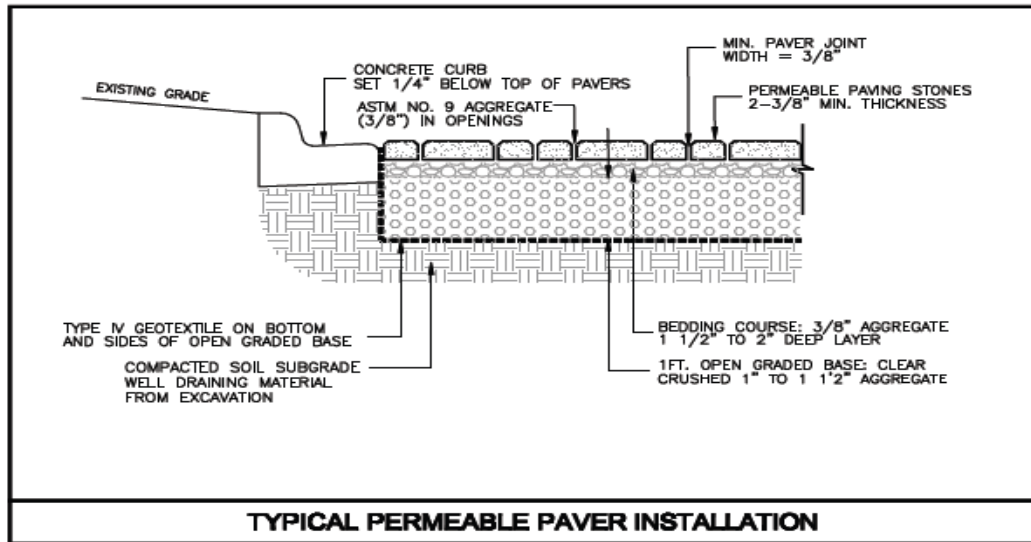
Figure 9.19. Permeable paver cross section used on Victoria Street project.

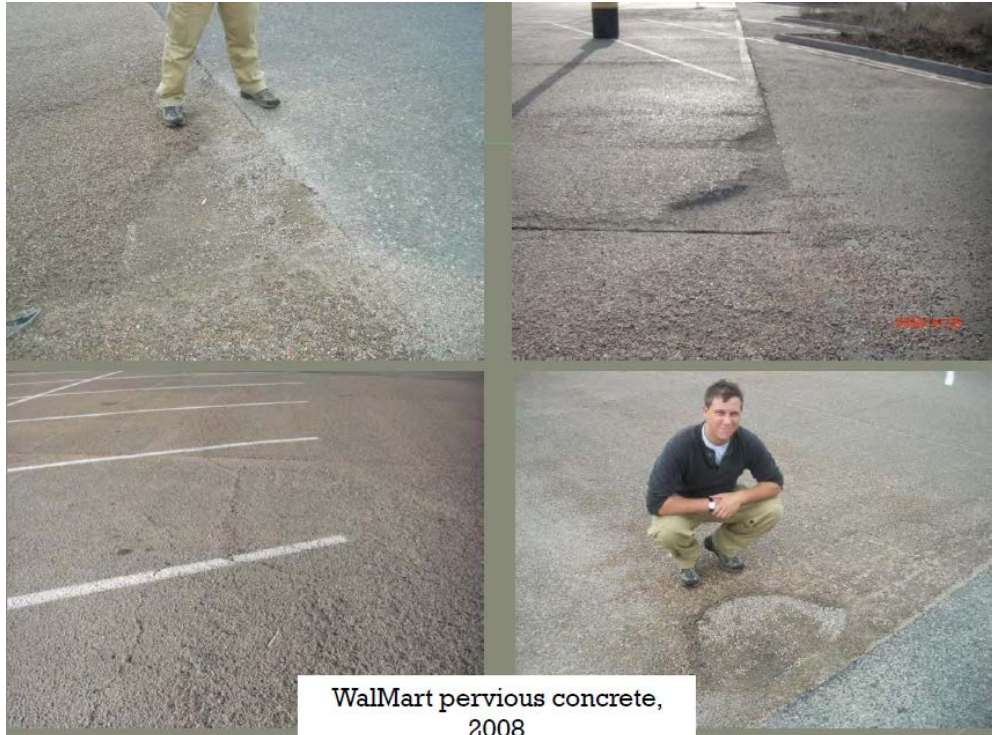
Figure 9.20. Aurora Wal-Mart pervious concrete parking lot in 2008 (photo courtesy of K. MacKenzie, UDFCD).

1. Raveling was observed at the joints in the Aurora Wal-Mart parking lot (Figure 9-20). At least some of these joints were noted to be saw cut.
2. Surface erosion in the Denver Safeway parking lot (Figure 9-21)
3. Surface erosion of the University Plaza parking lot (Figure 9-22)

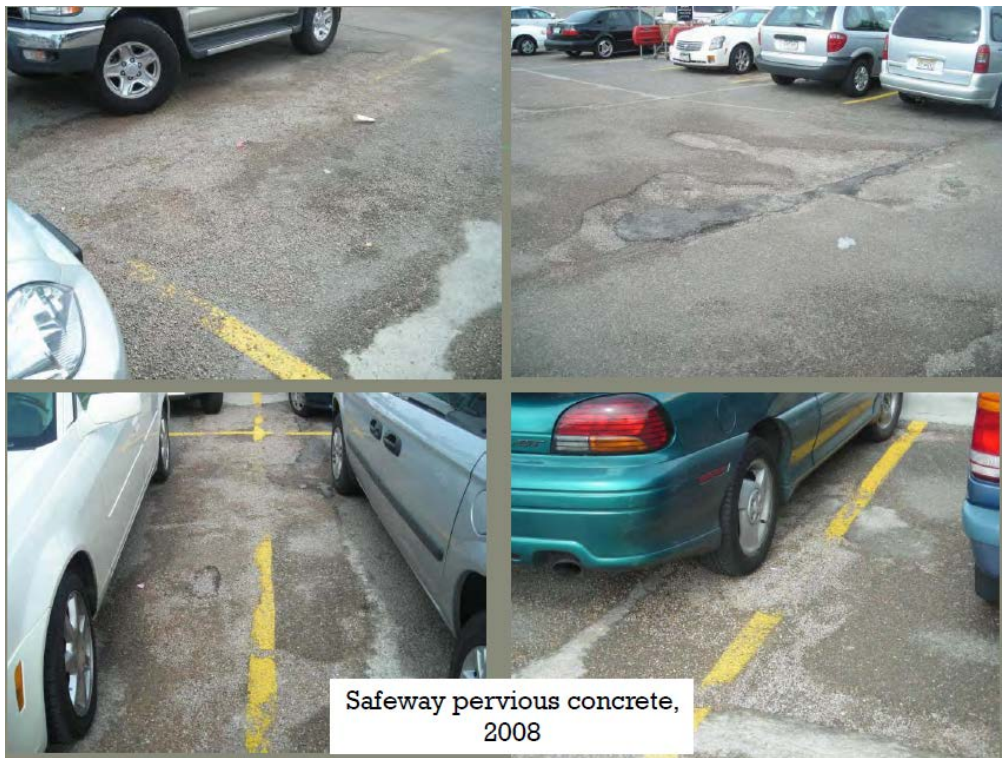
Figure 9.21. Denver Safeway pervious concrete parking lot in 2008 (photo courtesy of K. MacKenzie, UDFCD).
