Permeable Pavements in Cold Climates: State of the Art and Cold Climate Case Studies

John S. Gulliver, Principal Investigator
Department of Civil, Environmental, and Geo- Engineering
University of Minnesota

Research Project
Final Report 2015-30

Minnesota
Department of
Transportation

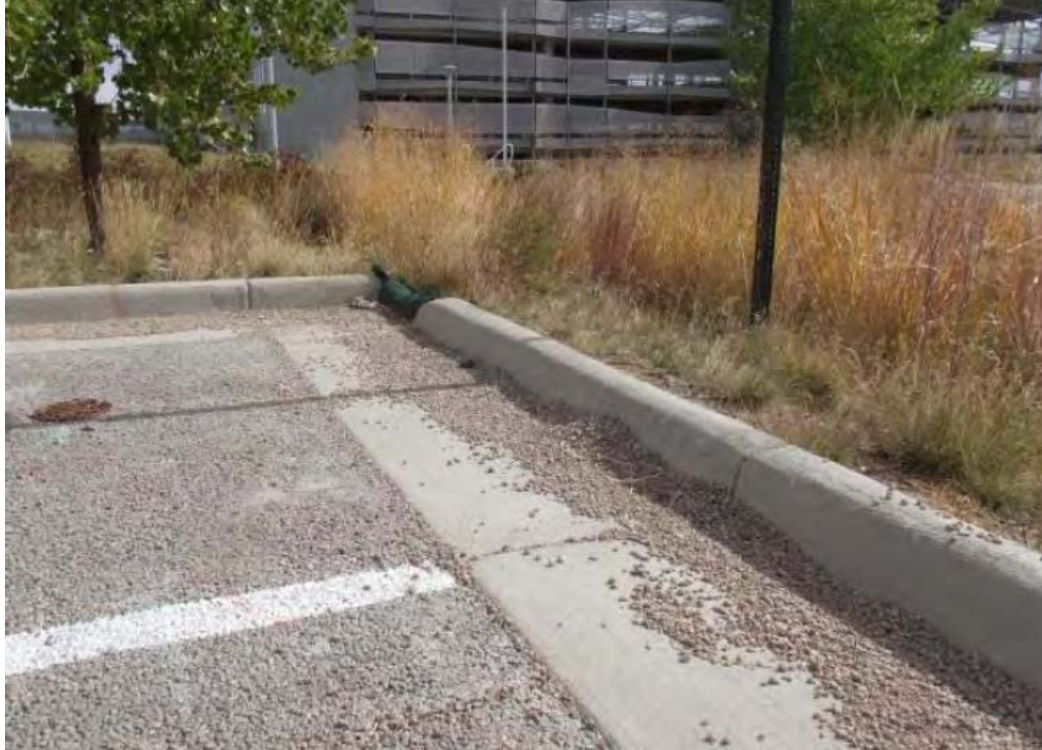
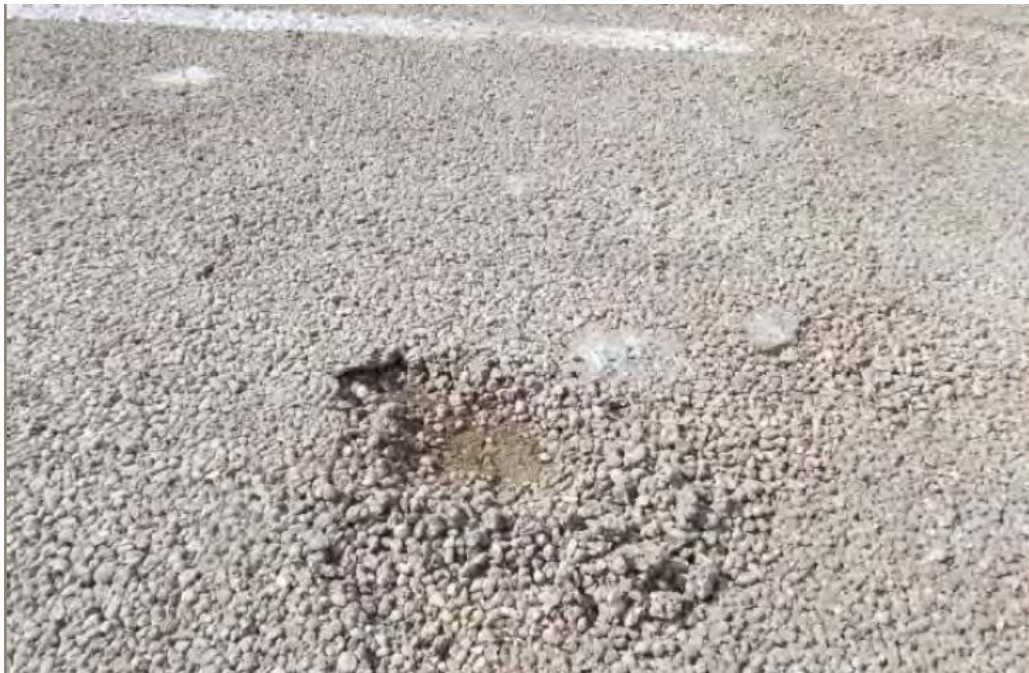
Figure 9.23. Pervious concrete parking lot at National Renewable Energy Lab in 2011. a) Deteriorated surface with loose aggregate, b) Close-up of parking stall (photos courtesy of K. MacKenzie, UDFCD).

In 2009 a pervious concrete demonstration pad was constructed according to the new design specifications (specified above) at the National Renewable Energy Laboratory (NREL) in Golden, CO. In 2011, after only two years of service, the surface of this pervious concrete was heavily deteriorated as shown in Figure 9-23.

As a result of the structural failure at the NREL site with new design specifications and with the unfavorable structural performances from the other sites using old design guidelines, the UDFCD issued a memo in a January 2013 to remove pervious concrete as a possible SCM from their stormwater SCM manual. This decision will stand until the pervious concrete industry demonstrates that a pervious concrete installation in Colorado can perform at least for five years with no sign of failure.

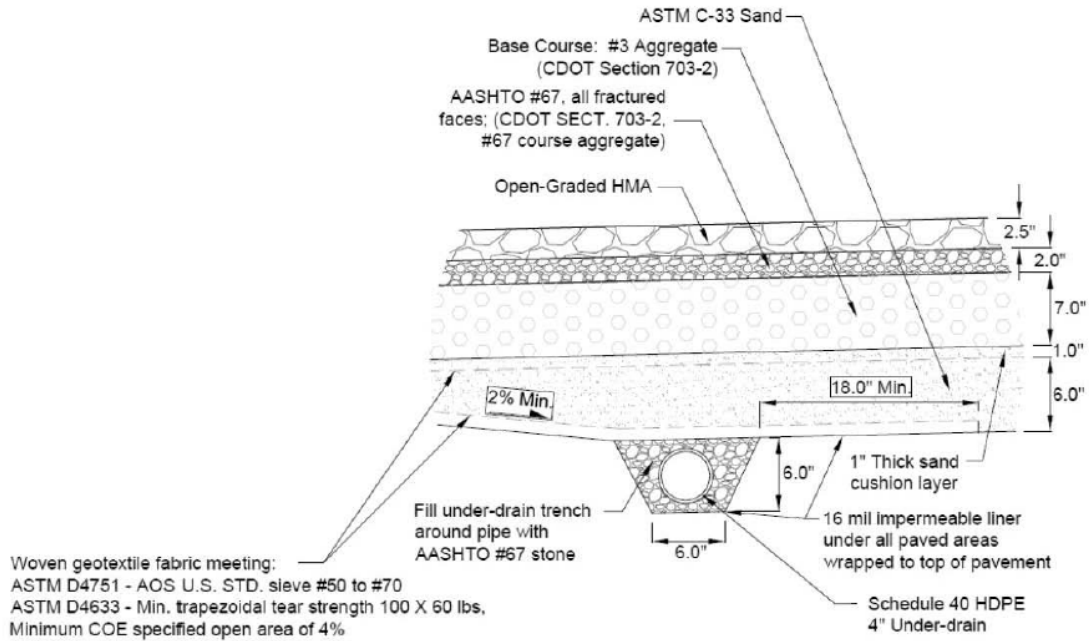
Figure 9.24. Cross-section of porous asphalt pavement at the Denver Waste Management building (UDFCD 2011b).

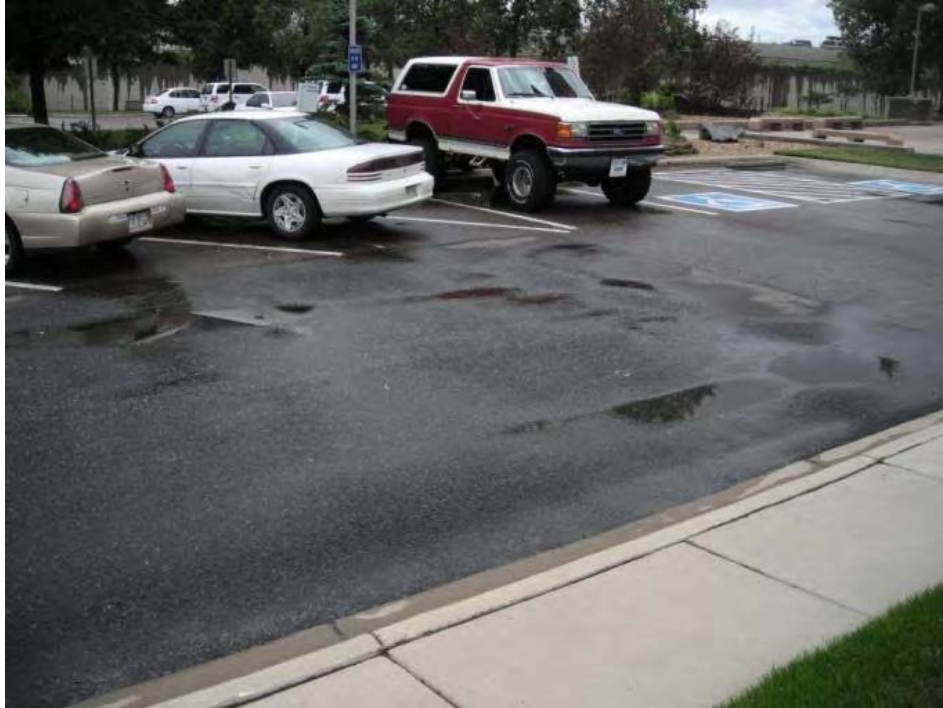
Figure 9.25. Porous asphalt pavement at Denver Waste Management building after a light rain (photo courtesy of K. MacKenzie, UDFCD).

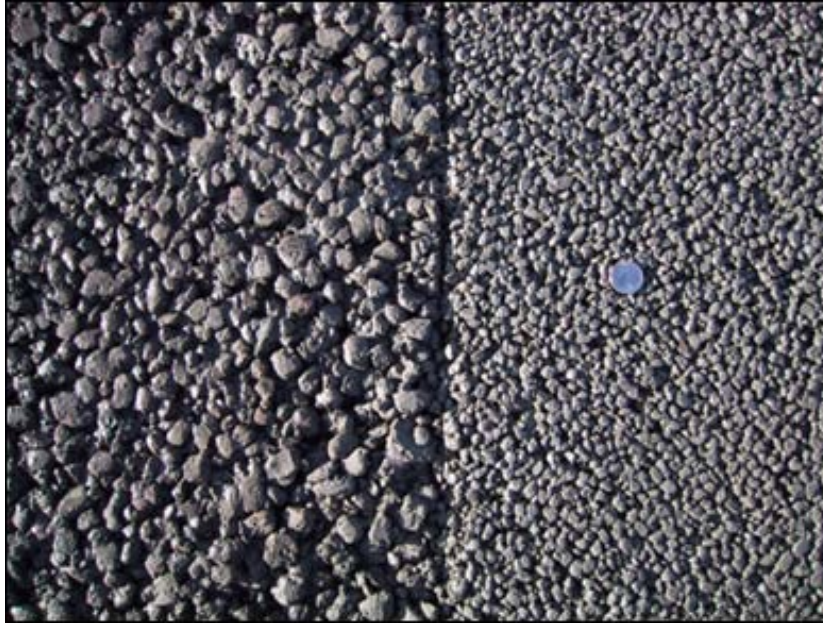
Figure 9.26. Pervious concrete at Lakewood City Shops maintenance building. AASHTO #67 mix is on the left and AASHTO #8 is on the right (UDFCD 2011a). A quarter is placed on the AASHTO #8 pavement for scale.

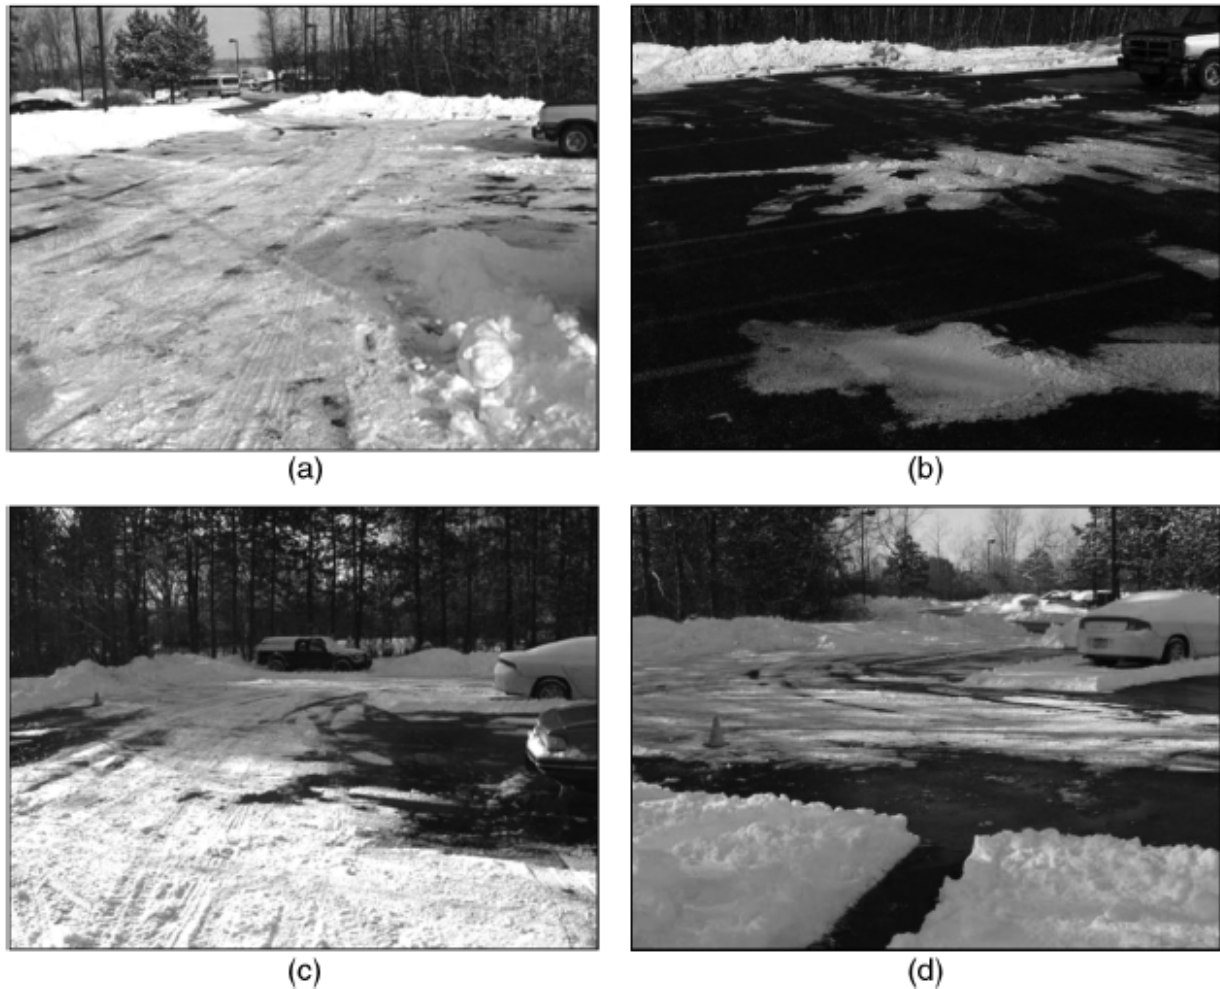
Figure 9.28. Comparison of porous asphalt and dense mix asphalt lot surface cover as a function of time. (a) PA lot at 11:20 a.m. and (b) PA lot 100 minutes later; (c) DMA lot at 11:20 a.m. and (d) DMA lot 100 minutes later (Roseen et al. 2014).

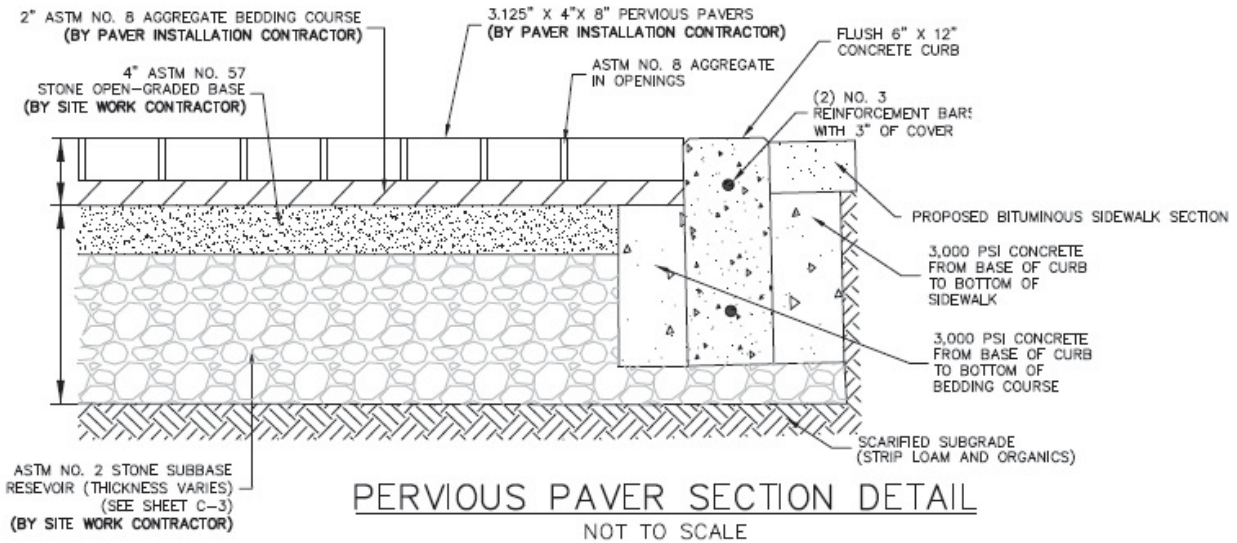
Figure 9.29. Typical PICP cross section (Rosen et al. 2013).

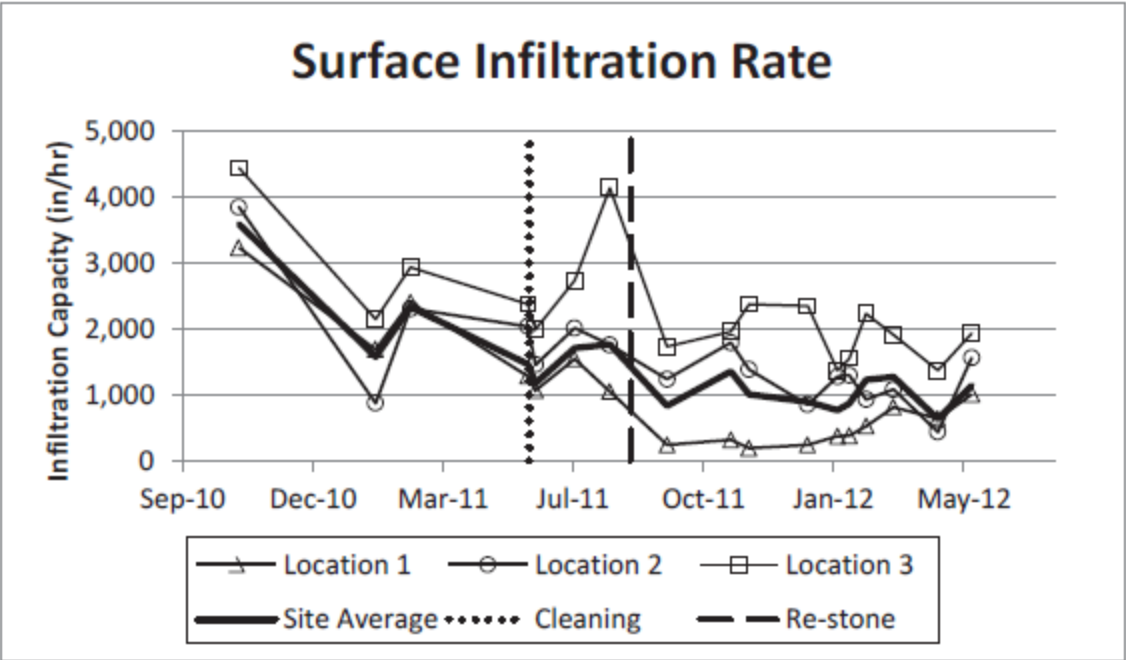
Figure 9.30. Surface infiltration monitoring results (Roseen et al. 2013).

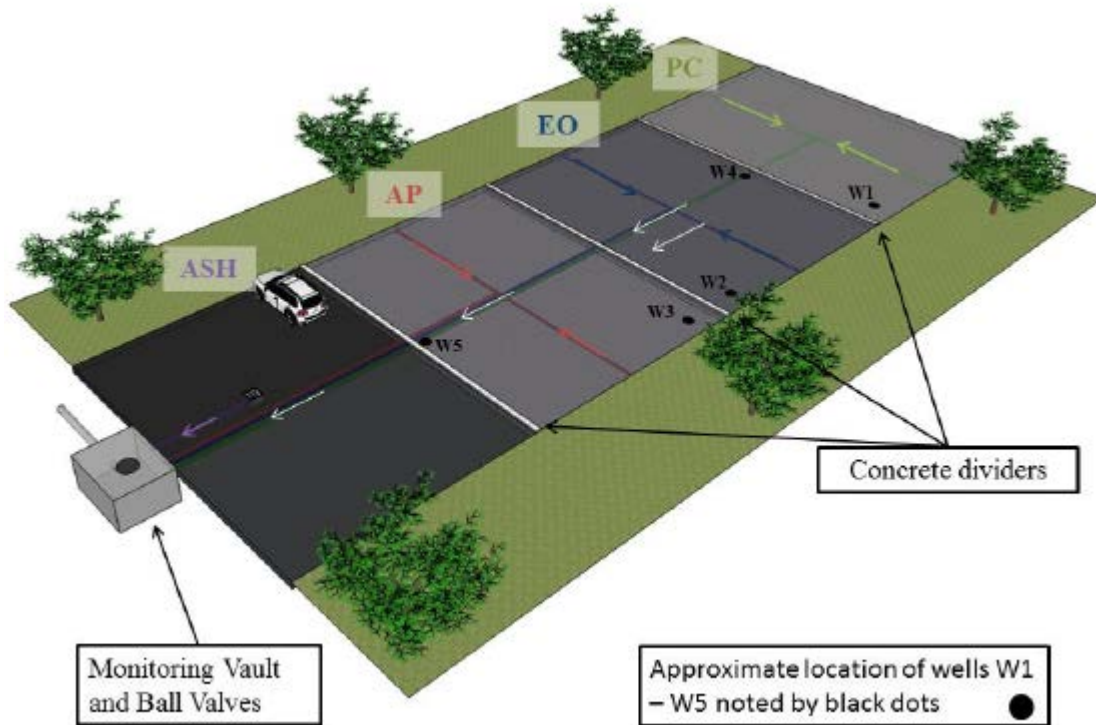
Figure 9.32. Parking lot and permeable pavement cell schematic, ASH = conventional non-porous asphalt, AP = AquaPave pavers, EO = Eco-Optic pavers, PC = Pervious concrete (Drake 2013).

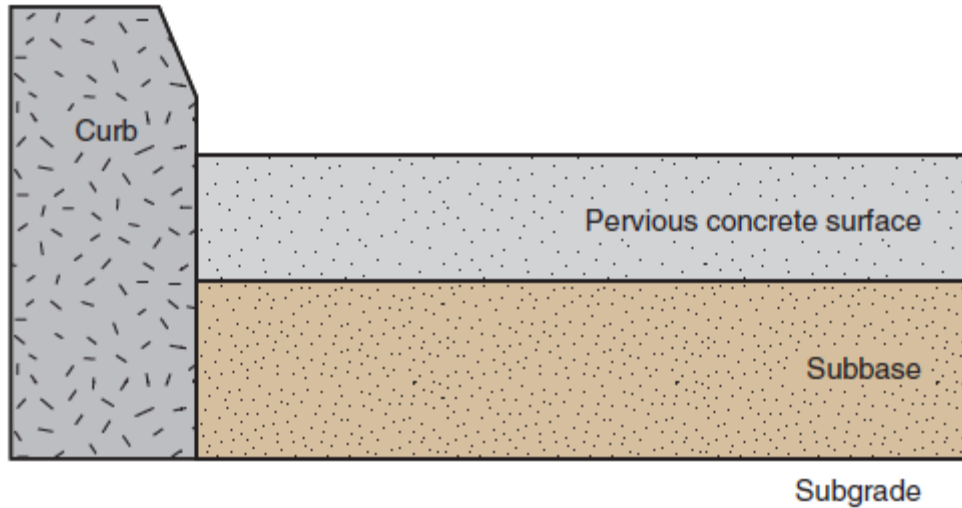
Figure B2-1. Typical cross-section of pervious concrete pavement. Concrete surface layer is 15-25% voids, subbase is 20-40% voids, and subgrade is 5-20% voids (ACPA 2009).

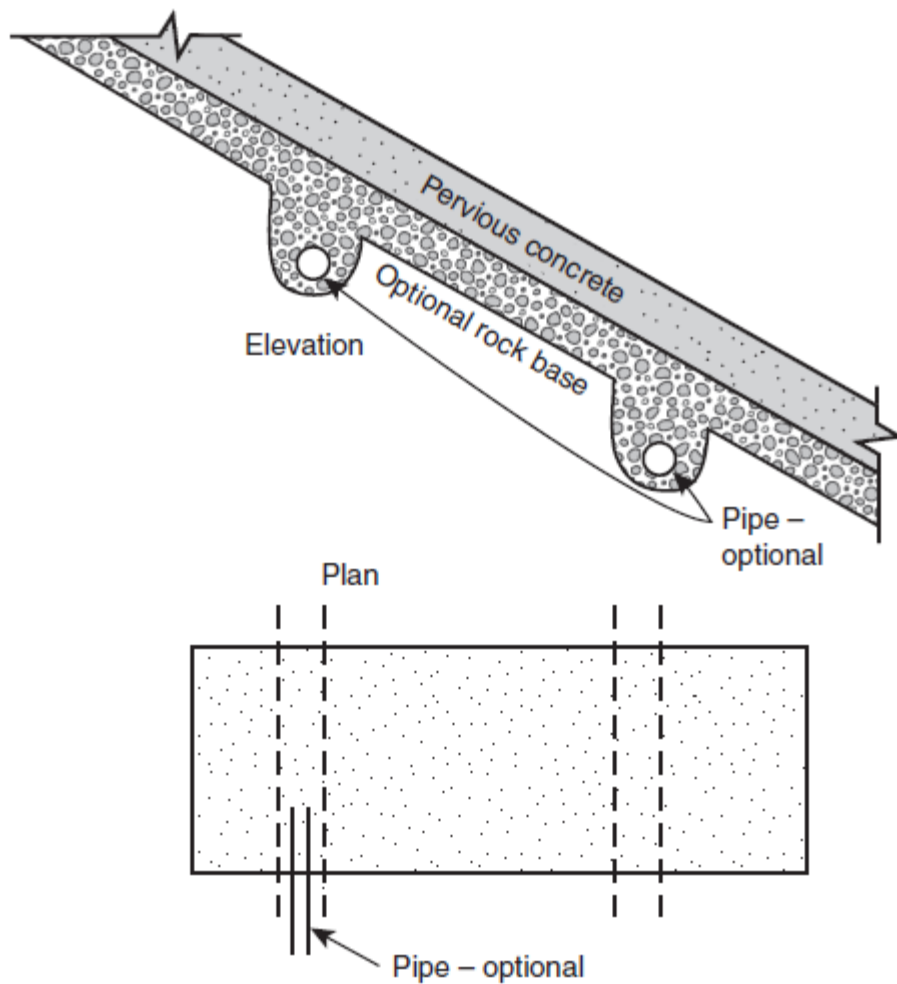
Figure B2-2. Elevation (top) and plan (bottom) views of typical pervious concrete installation on a steep slope (ACPA 2009).

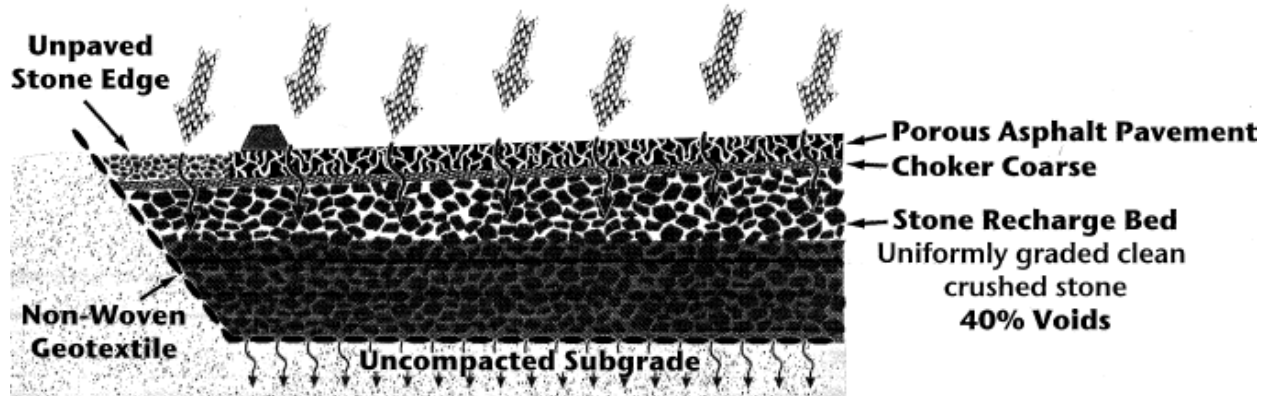
Figure B2-3. Typical porous asphalt cross-section (NAPA 2008)

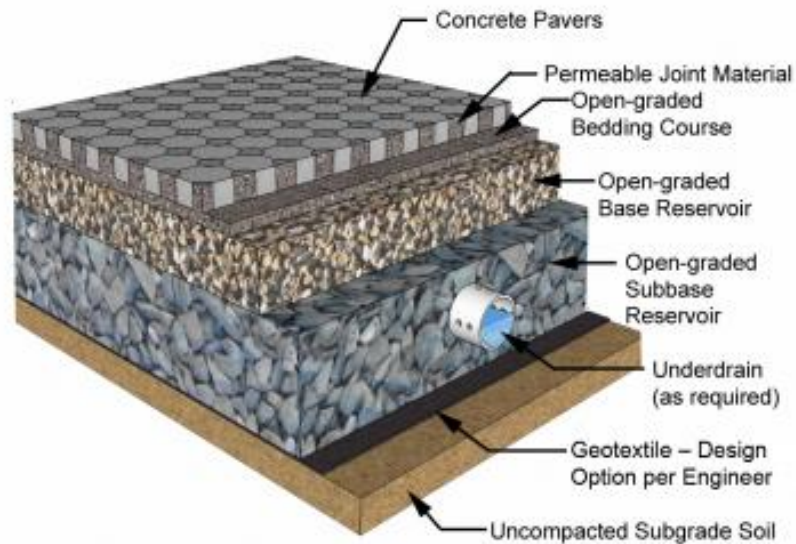
Figure B2-4. Typical cross-section of a permeable interlocking concrete paver system (Smith 2011).

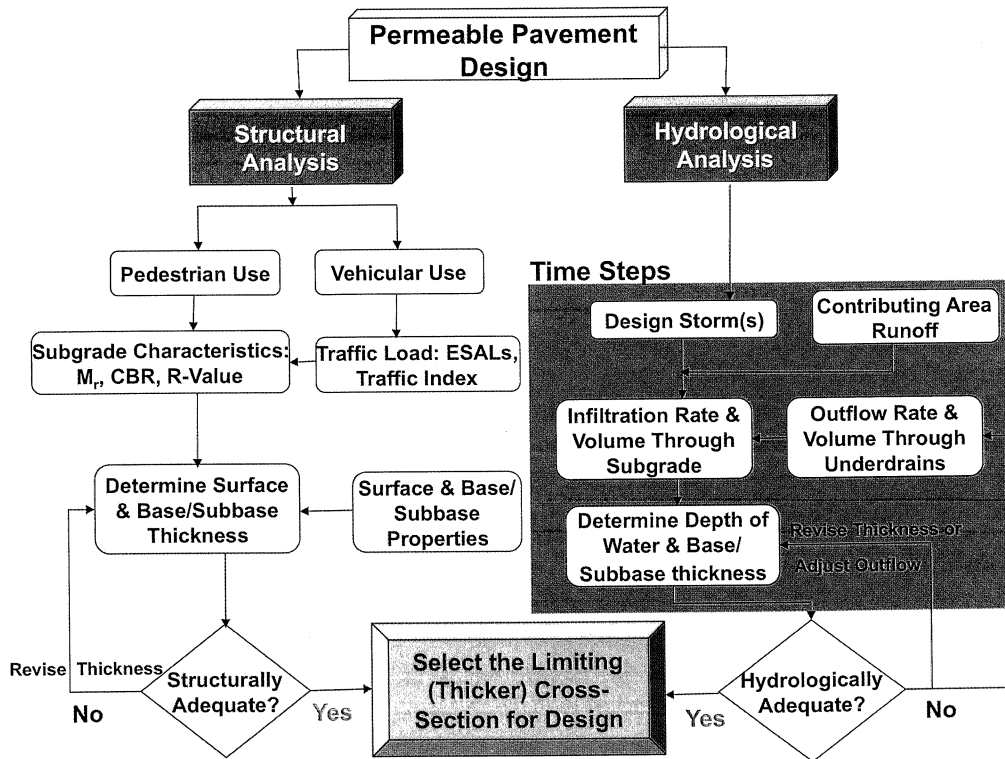
Figure B2-5. PICP design flow chart (ICPI 2011).

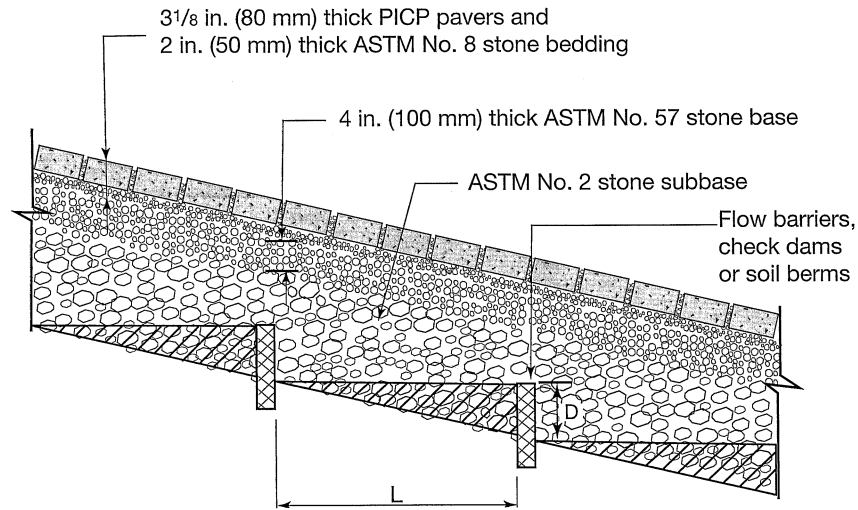
Figure B2-6. One available design for using concrete pavers on sloped surfaces (ICPI 2011).

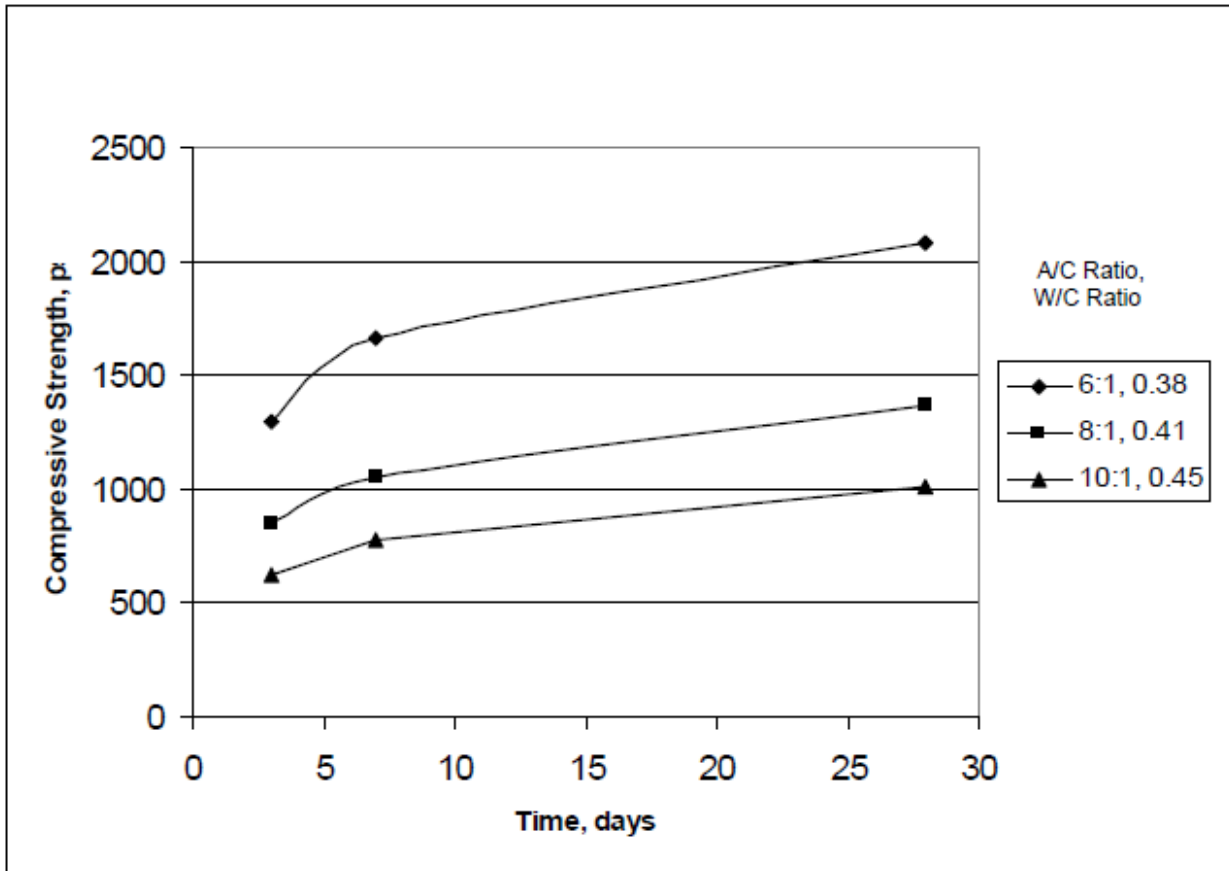
Figure B3-1. Compressive strength of pervious concrete as a function of time for different A/C and W/C ratios (Wanielista and Chopra 2007a).

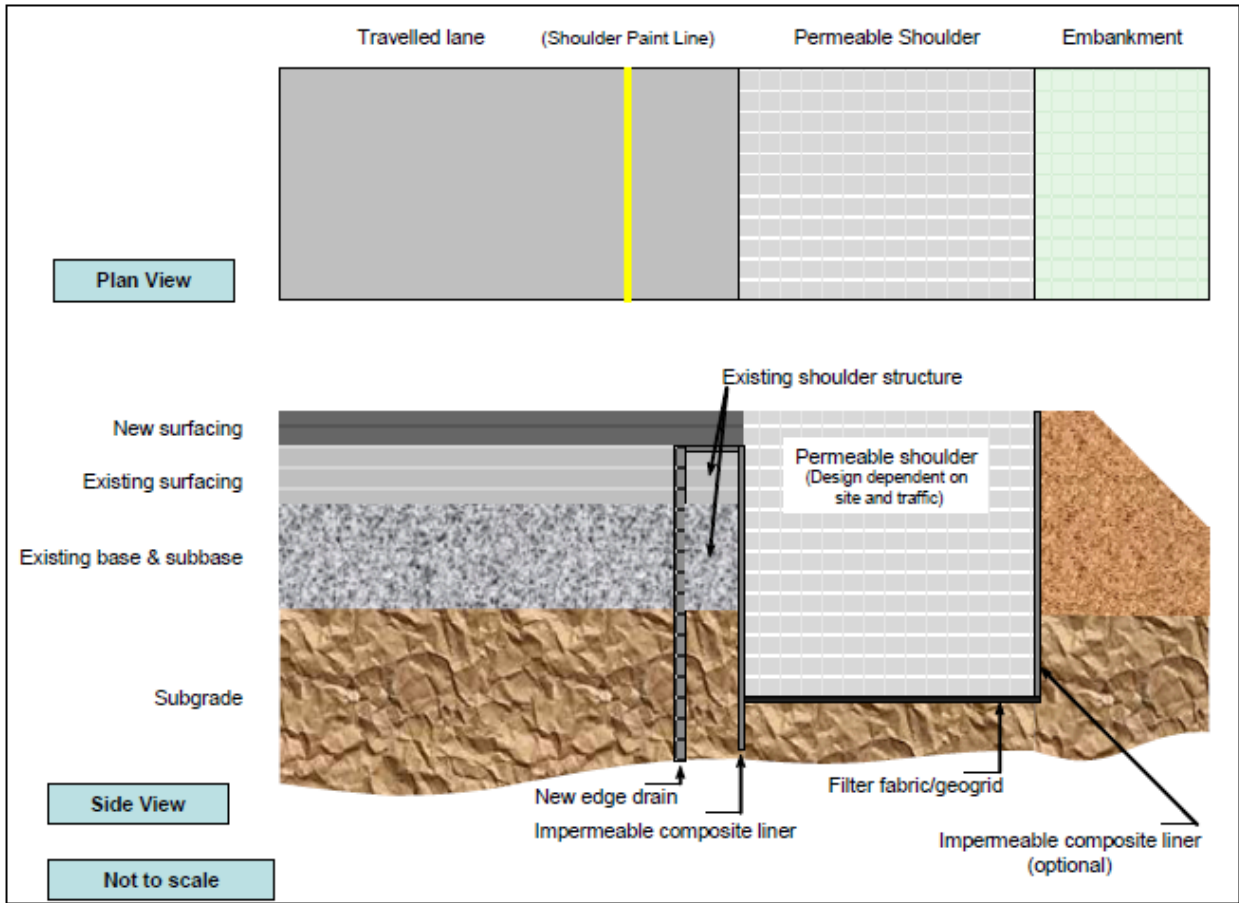
Figure B3-3. Proposed fully permeable pavement shoulder retrofit design configuration 1 (Jones et al. 2010).

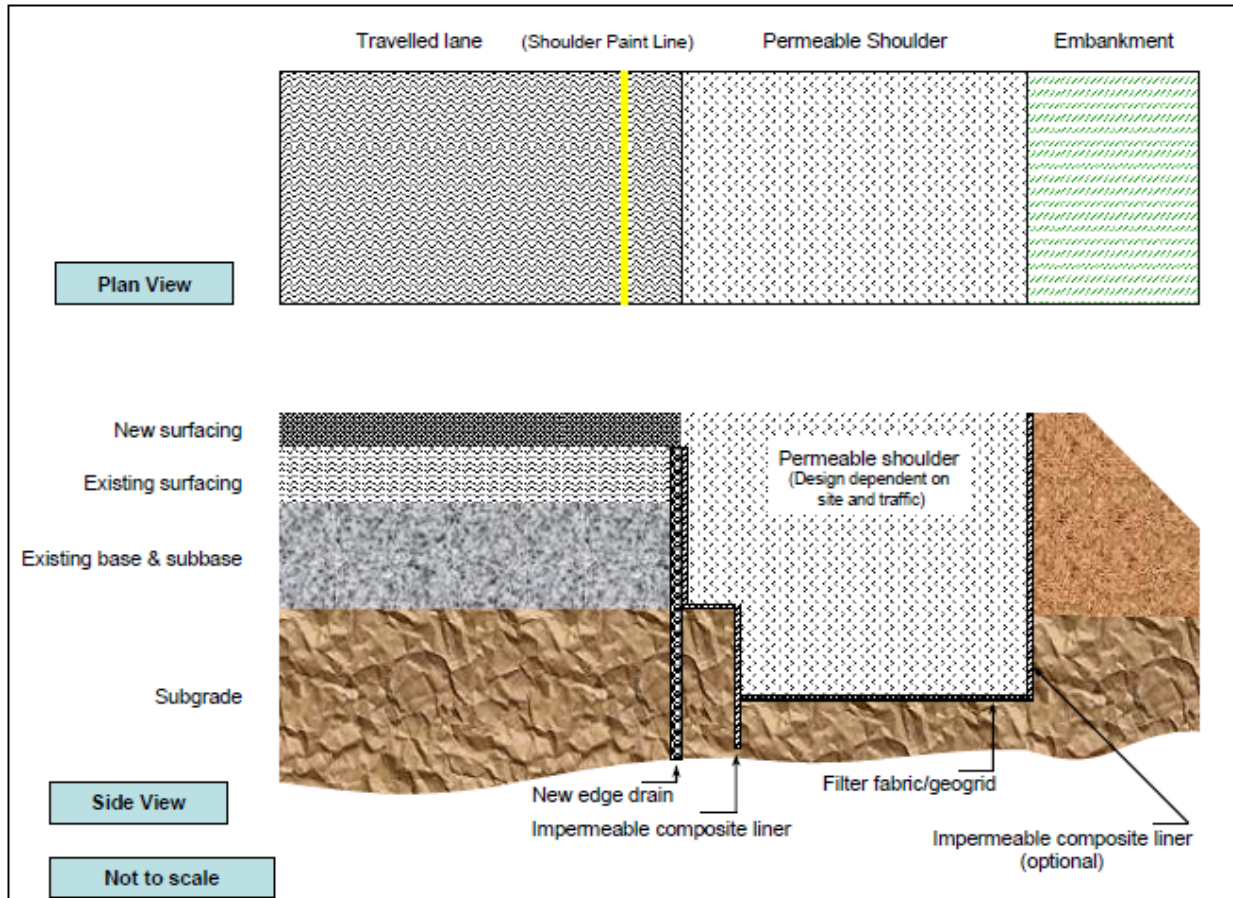
Figure B3-4. Proposed fully permeable pavement shoulder retrofit design configuration 2 (Jones et al. 2010).

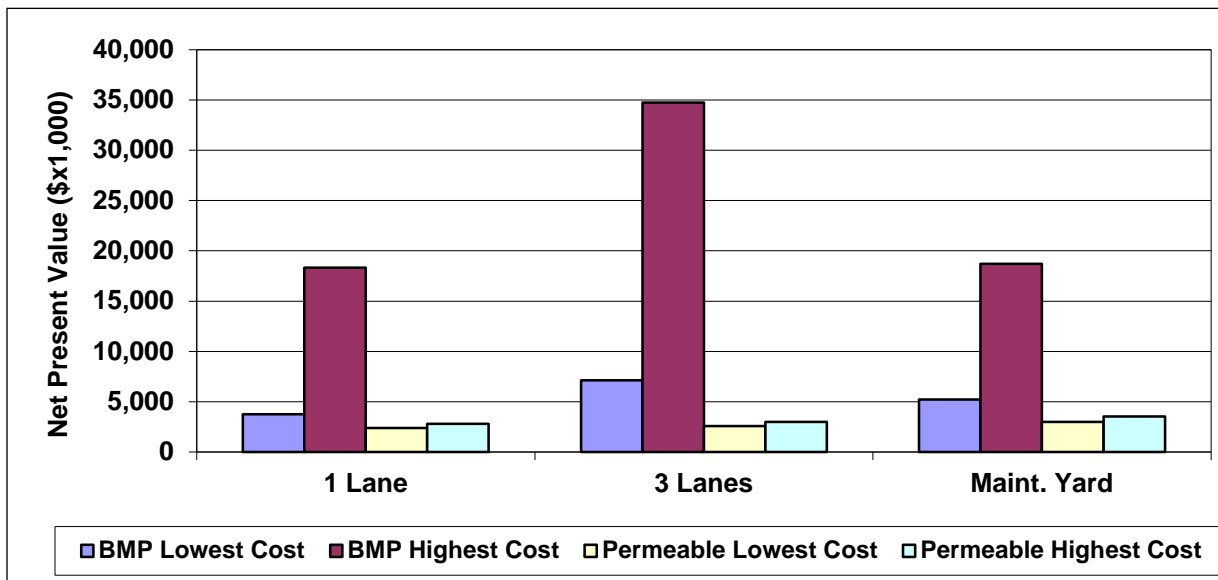
Figure B3-5. Cost comparison for BMP and fully permeable pavement (low and high cost options) (Jones et al. 2010).

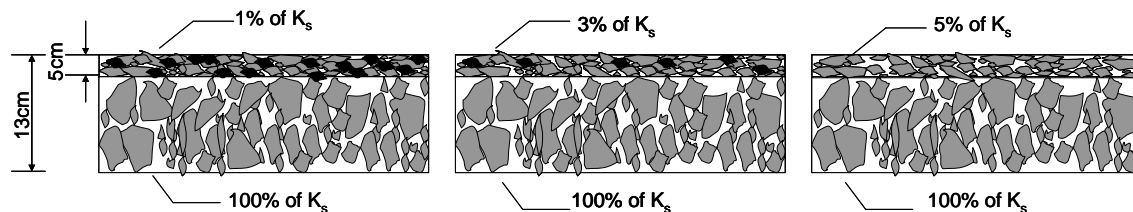
Figure B3-7. Graphic illustration of three clogging surface profiles (Kayhanian et al. 2010).

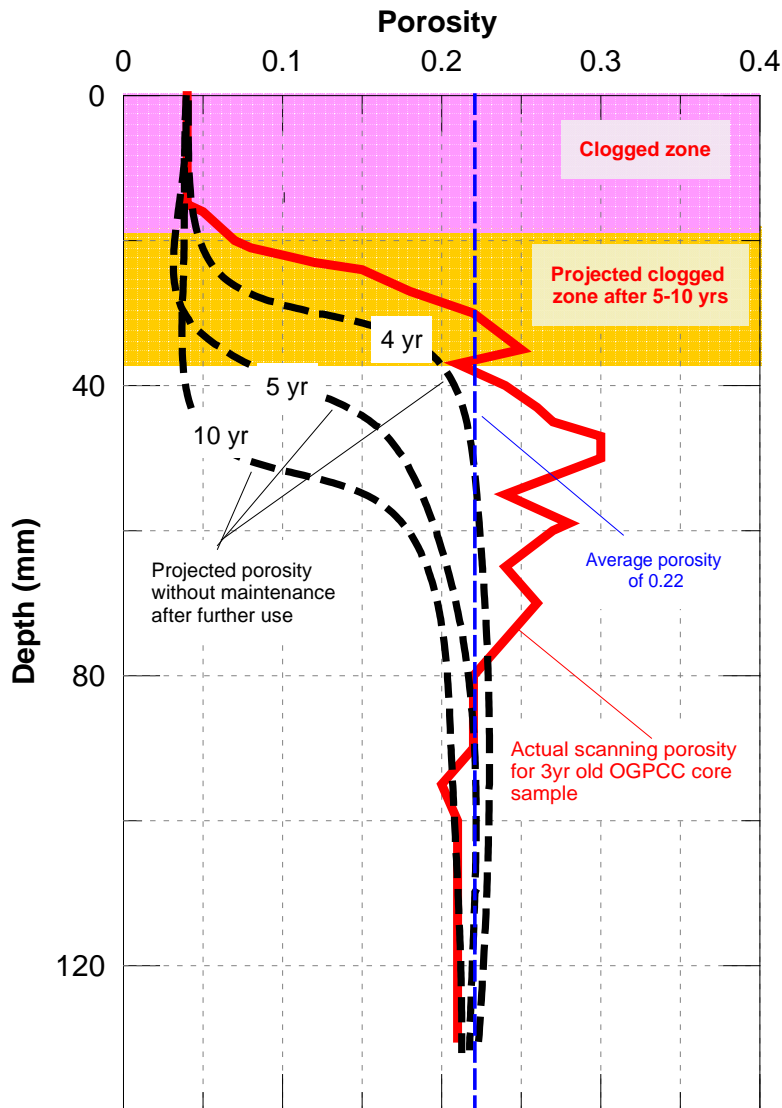
Figure B3-8. Porosity profile of an actual PCC-O core sample compared with estimated porosity profile without maintenance after further use (Kayhanian et al. 2010).

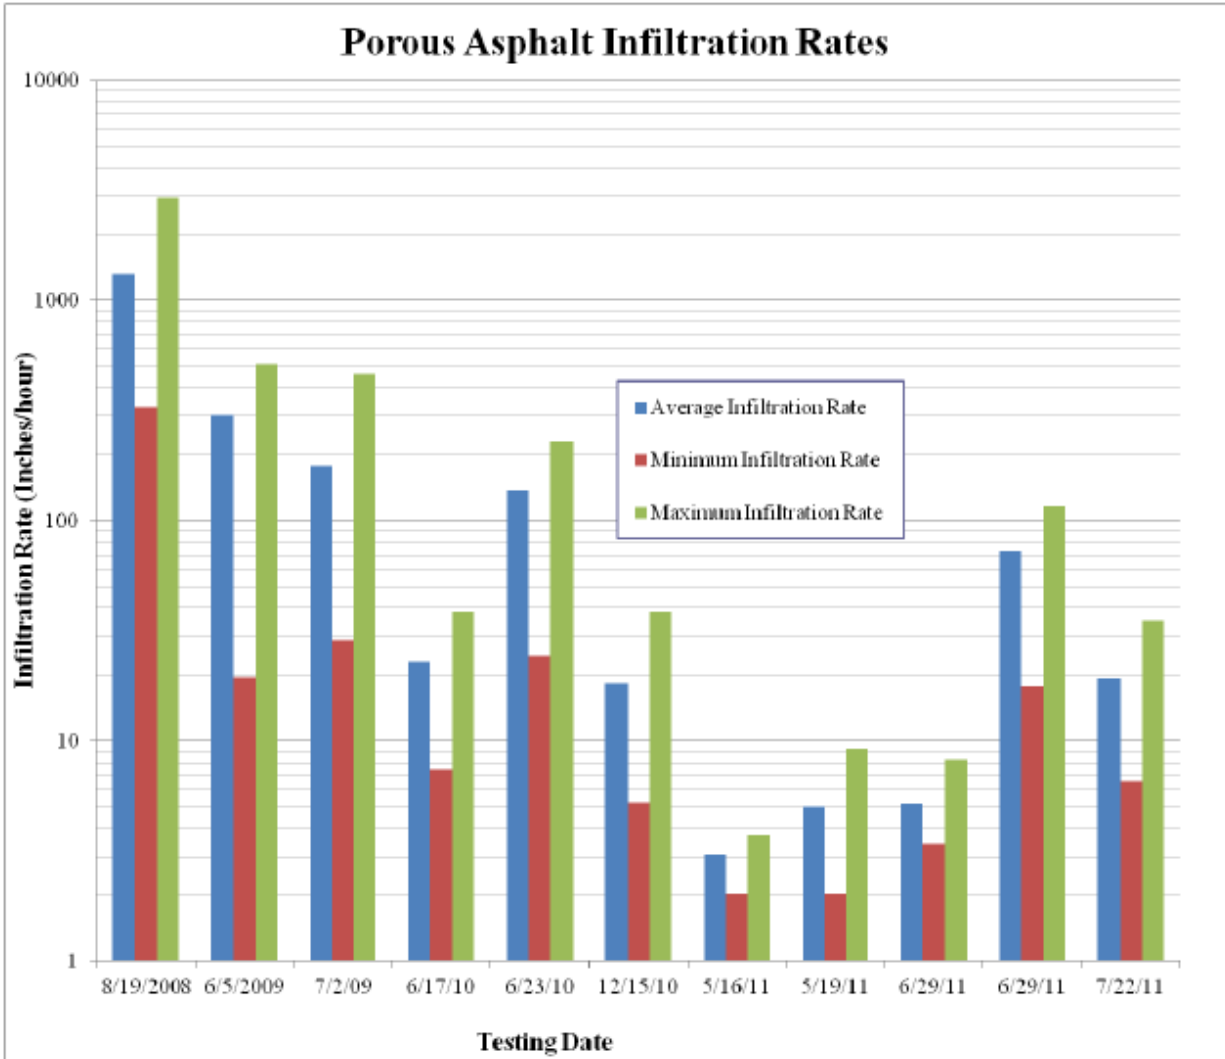
Figure B3-9. Porous asphalt infiltration rates (UDFCD 2011b).

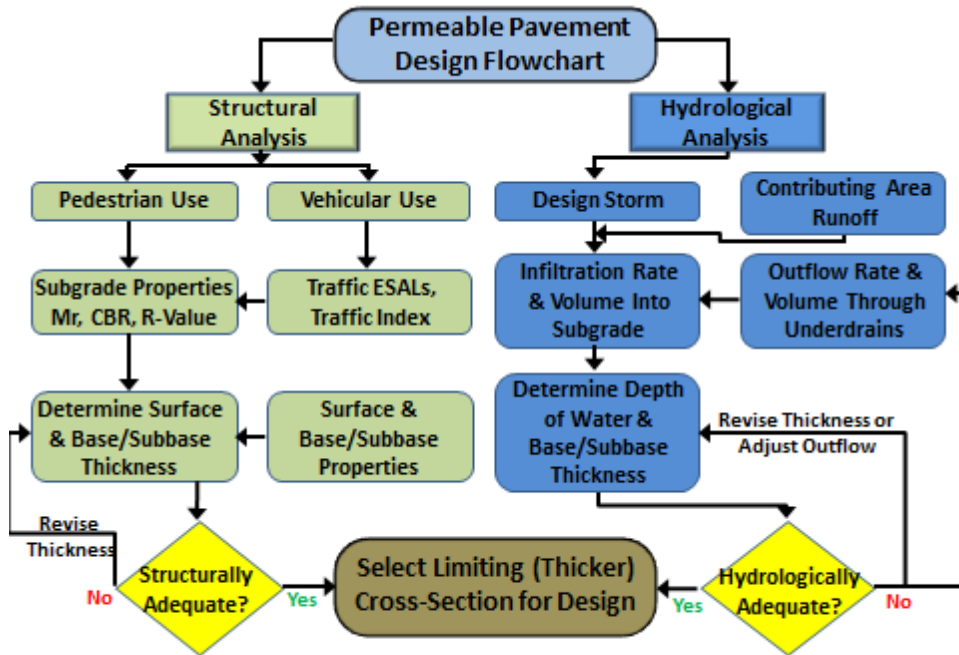
Figure B3-10. Structural and hydrological design flowchart (Hein et al. 2013a).

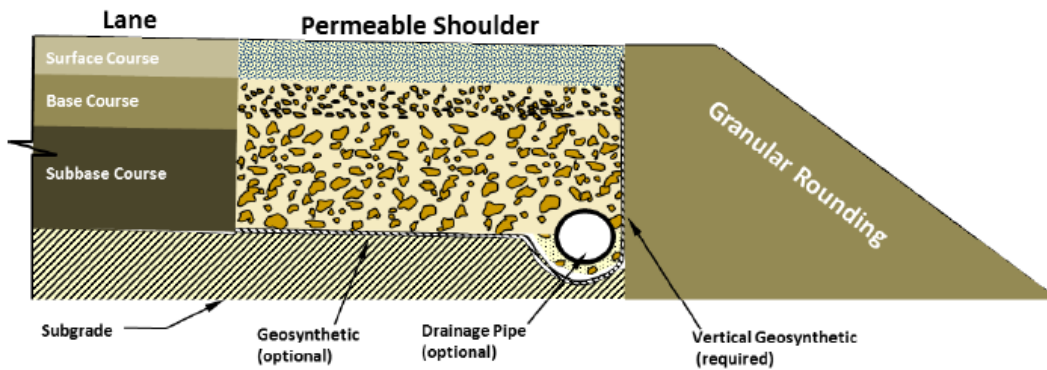
(a) Basic design

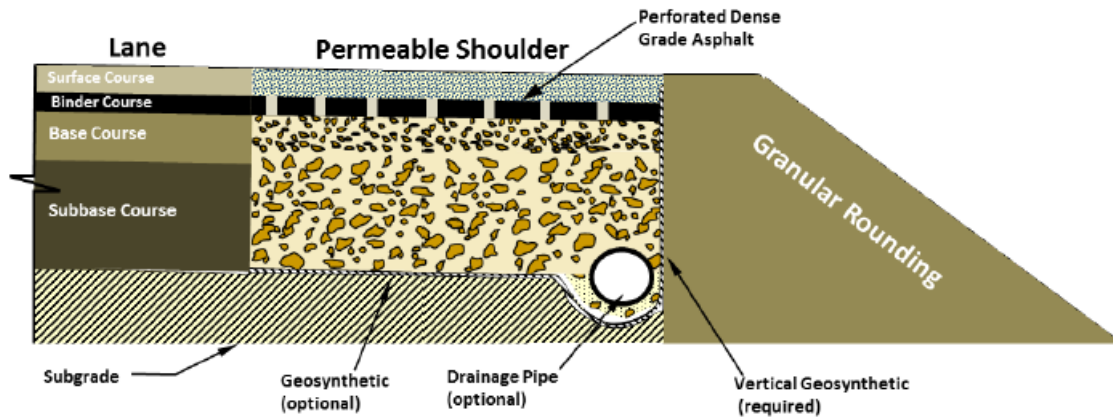
(b) Strengthened design

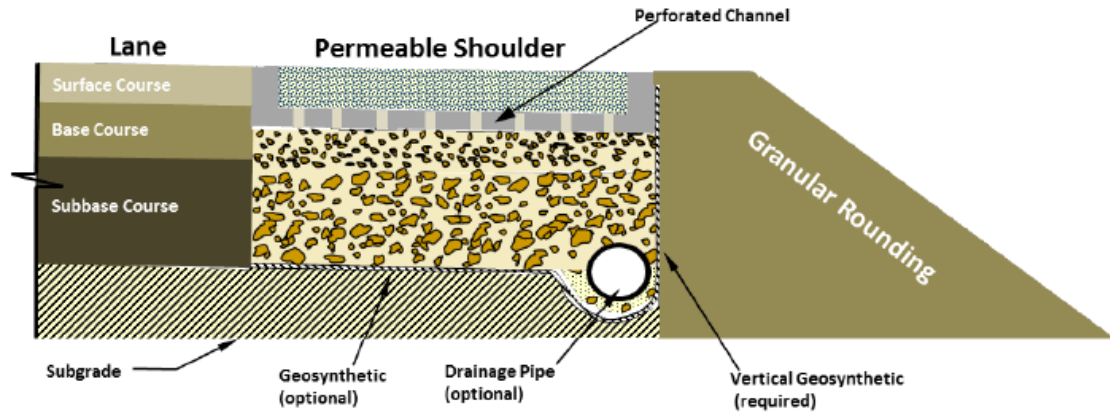
(c) Channeled design

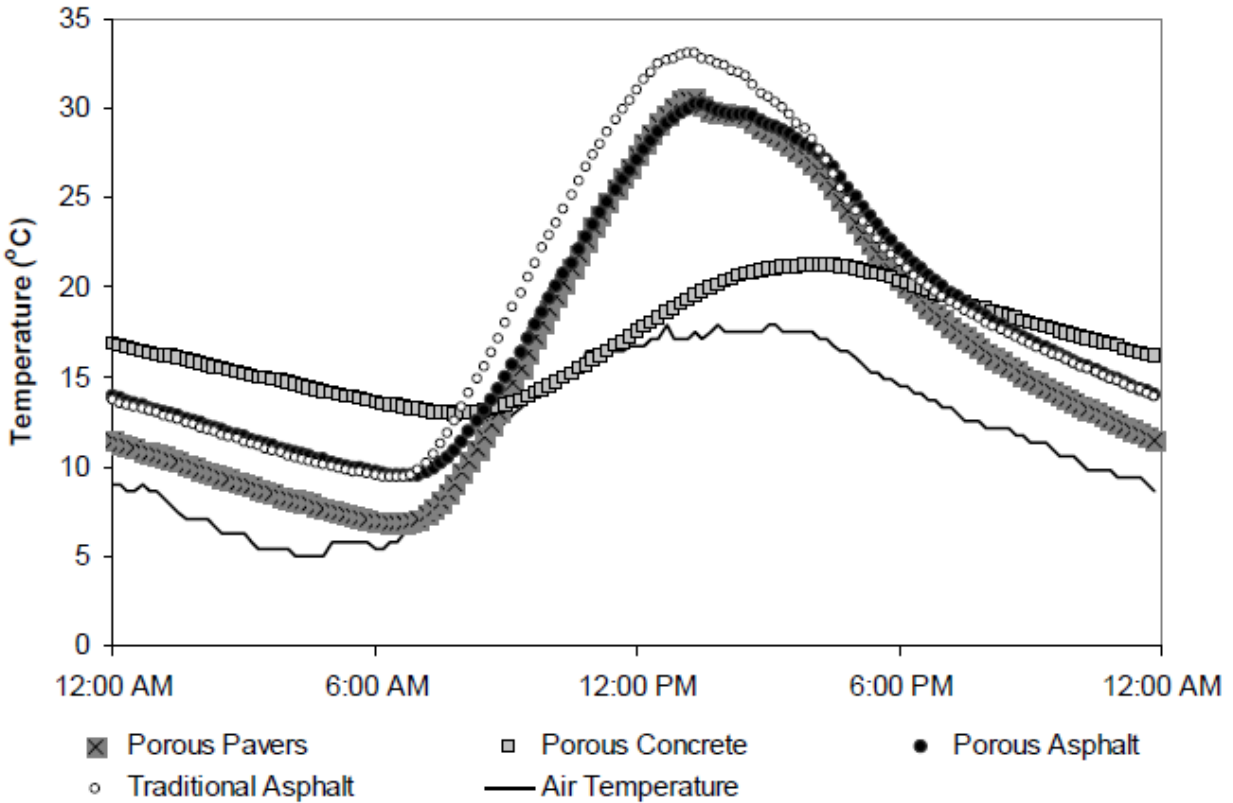
Figure B4-2. Average temperature readings at the surface of each permeable pavement and overlying air temperature (Rowe et al. 2010).

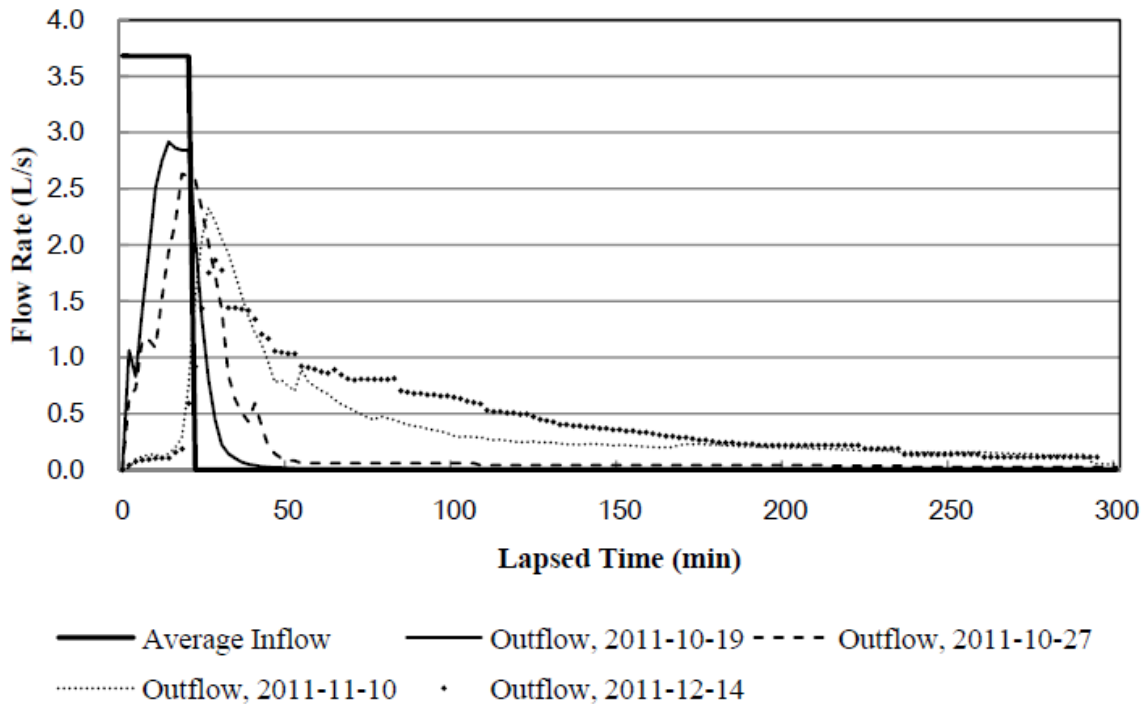
Figure B4-3. Inflow and outflow hydrographs for inter-locking concrete pavers (Huang et al. 2012).

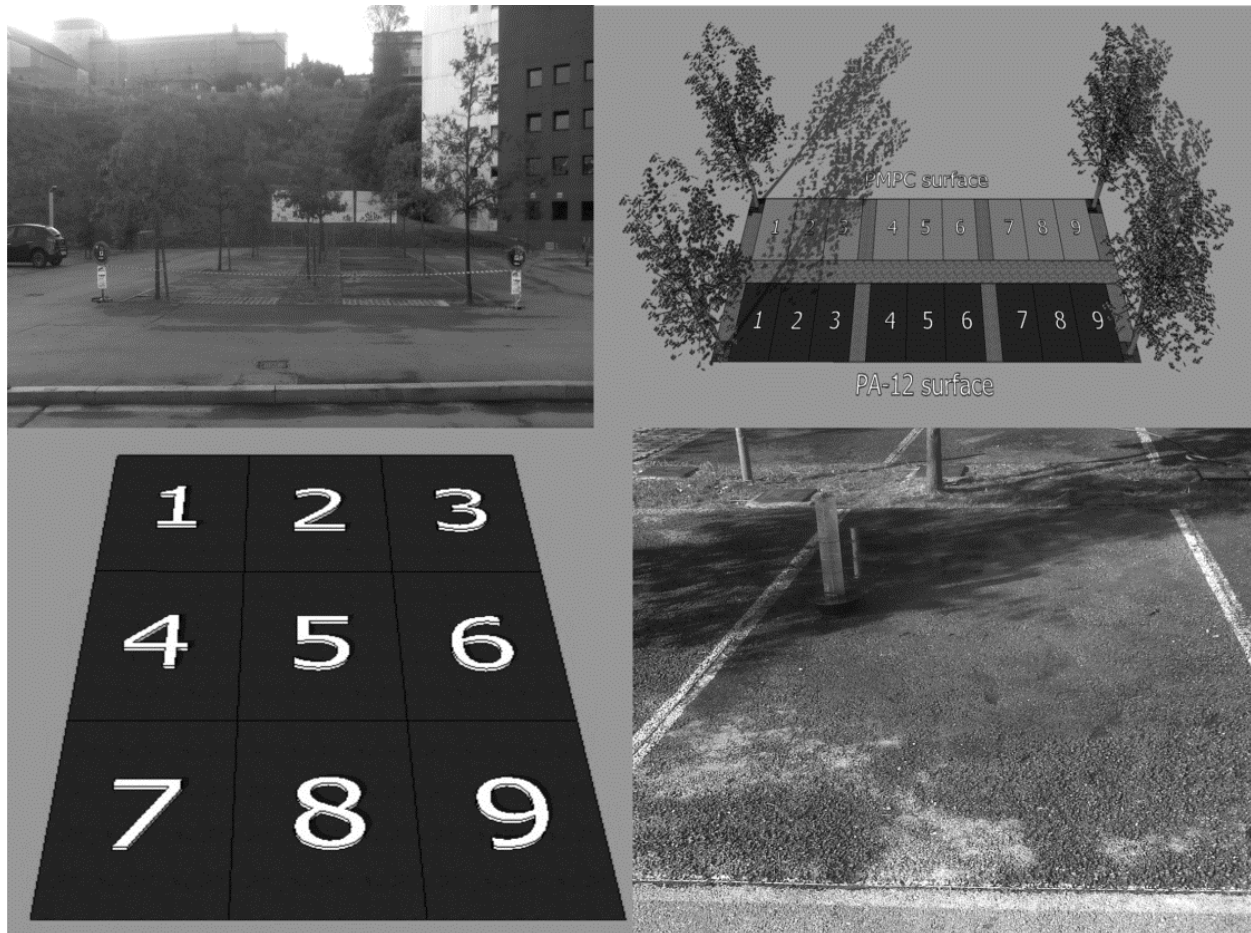
Figure B4-4. (A) Scheme of the eighteen car parking bays analyzed; and (B) measurement zones selected within each car park bay and LCS on-site (Sañudo-Fontaneda et al. 2014).
