Permeable Pavements in Cold Climates: State of the Art and Cold Climate Case Studies

John S. Gulliver, Principal Investigator
Department of Civil, Environmental, and Geo- Engineering
University of Minnesota

Research Project
Final Report 2015-30

Minnesota
Department of
Transportation

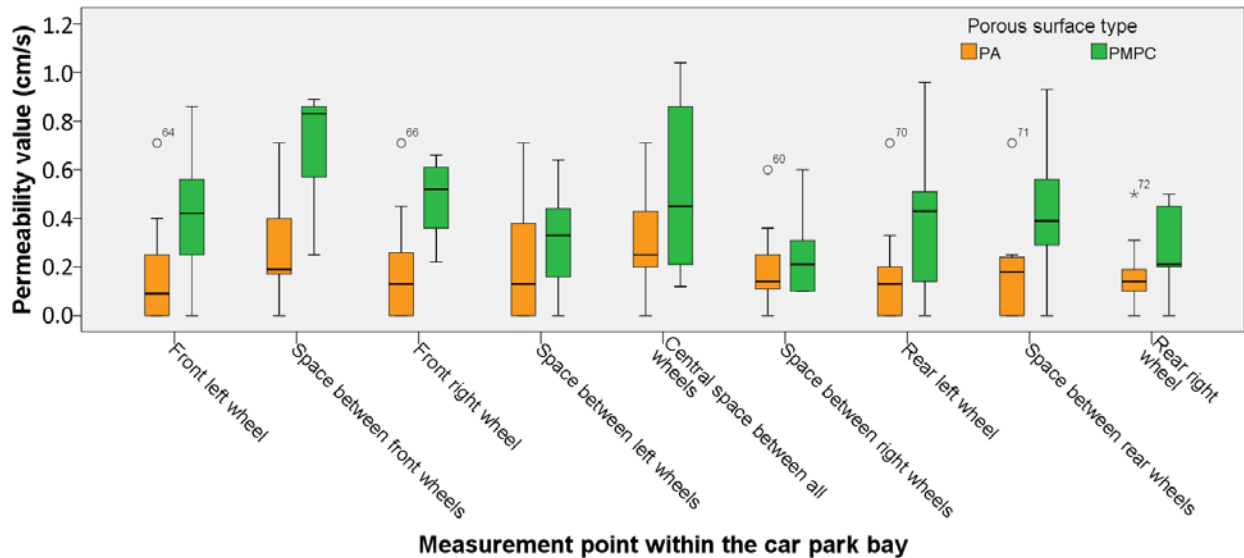
Figure B4-5. Box-plots of the average values of permeability in each measurement zone of parking bays (Sañudo-Fontaneda et al. 2014).
