IMAGE ANALYSIS OF CORROSION PIT INITIATION ON ASTM  
TYPE A240 STAINLESS STEEL AND ASTM TYPE A 1008  
CARBON STEEL

A THESIS

February 2016

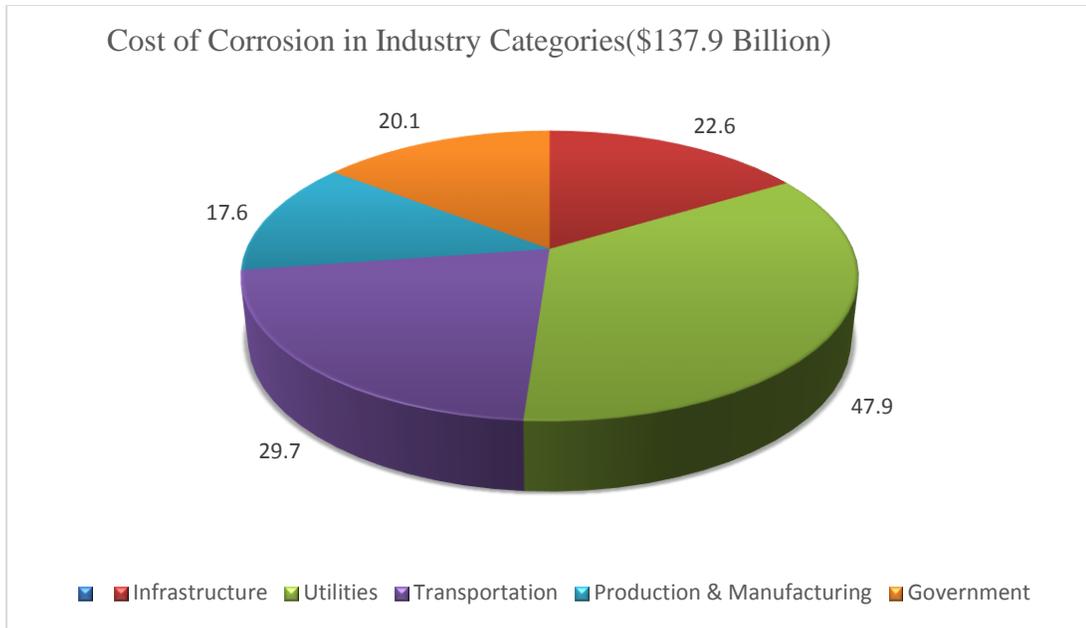
Figure 1.1: Sector-wise direct corrosion cost distribution in the United States. Recreated from data provided in [4]

Figure 1.1 demonstrates direct corrosion cost across the five top industrial categories of US economy with a total value of \$137.9 billion. From this figure, the cost of corrosion was extrapolated to the overall US economy (\$8.79 trillion) for an annual cost of corrosion of \$276 billion. However, this figure only shows the direct cost of corrosion, while the indirect costs are more severe probably even greater and are summarized in next section.

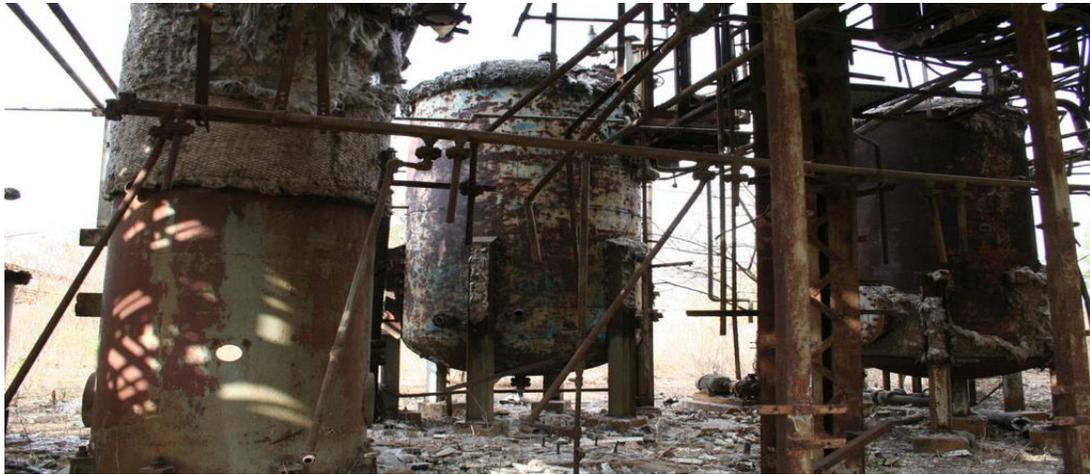
Figure 1.2: Deteriorating section of the MIC plant, decades after the gas leak (By Simone.lippi at it.wikipedia [CC BY-SA 2.0 (<http://creativecommons.org/licenses/by-sa/2.0>)], from Wikimedia Commons) [25]

By far regarding death, injury and long-term health issues, the explosion of a chemical plant, Union Carbide India Limited (UCIL) in Bhopal, India in 1984 was the worst. The plant was established to produce fertilizers and insecticides and was part of India's Green Revolution [7]. The design flaw and management problem were the ultimate reasons for the disaster. It is reported that the steel pipes containing water, were corroded and water leaked into methyl isocyanate (MIC) tanks. Iron came with water as a corrosion product and acted as a catalyst for the explosion [44]. The sign of corrosion was evident in many pieces of equipment of the plant. The aftermath was a massacre.

Perhaps if the workers had a simple way to monitor that pipeline corrosion; a camera to capture the image and send to the management, it could have prevented the disaster.

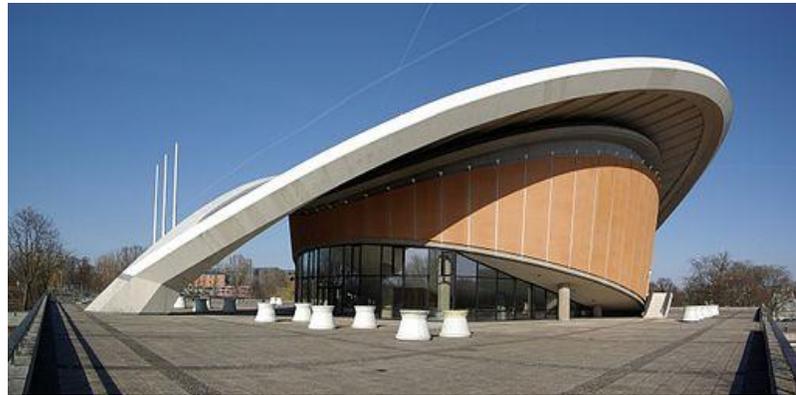
Figure 1.3: Previous and Post images of Berlin Congress Hall By Berthold Werner (Own work) [GFDL (<http://www.gnu.org/copyleft/fdl.html>) or CC-BY-SA 3.0 (<http://creativecommons.org/licenses/by-sa/3.0>)], via Wikimedia Commons [26]

In 1980, the spectacular Berlin Congress Hall, a sign of friendship between USA and Germany collapsed due to the failure of corrosion prevention. It was built in 1957 and was a unique architecture with a curved canopied concrete panel. In this type of panel, a metal or plastic duct forms the framework and high strength steels are inserted into the duct and are fixed at one end. After that, the concrete is placed and hardened, while the other free end is pulled in tension and anchored. Grout is used to fill the duct to allow load sharing between concrete and steel. The steel is protected from active corrosion by high alkaline concrete and grout.

The post analysis of the collapse discovered that the steels were not placed correctly, therefore, they were not properly surrounded by concrete. Due to this factor, the passivation

didn't work all over the surface, and the supports were subject to cracking after several years. One person died in that accident, and five were injured.

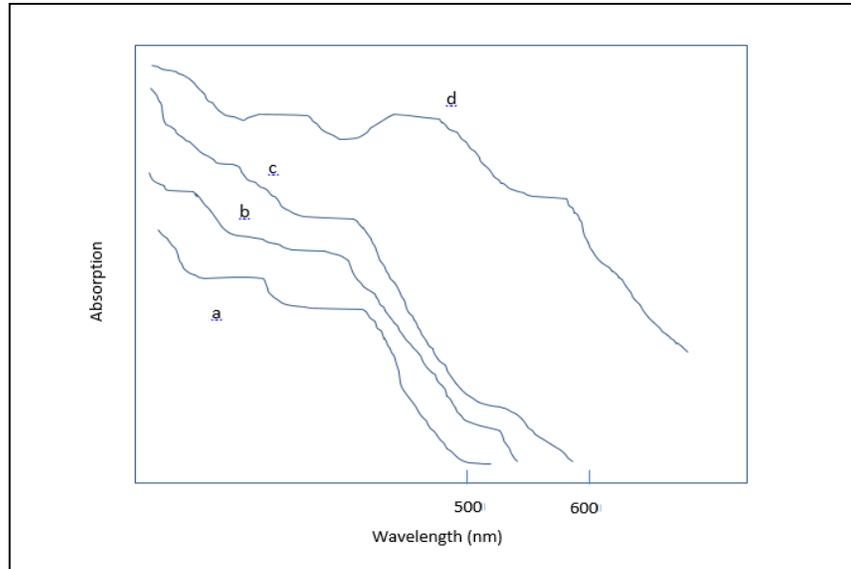
Figure 1.6: Visible and near-UV absorption spectra of (a) goethite (b) lepidocrocite (c) maghemite and (d) hematite. Recreated from [10]

It is interesting to mention that in their comprehensive research work, Ronen Levinson, Paul Berdahl, and Hashem Akbari experimented with 87 samples of coating pigments (iron oxide, chrome oxide, cobalt aluminate, chrome titanate, etc.) and characterized their optical properties i.e. reflectance, transmittance, and absorption. As we know, the most common corrosion products of stainless steel exposed to the aqueous and atmospheric environment are iron (III) oxide i.e.  $\text{Fe}_2\text{O}_3$  and based on stainless steel composition chrome oxide. Now in this article, the researchers predicted the reflectance and found a good match with the measured reflectance in visible solar spectrum range for  $\text{Fe}^{3+}$  oxides having reddish color while  $\text{Cr}^{3+}$  oxides are showing green color [39].  $\text{Fe}_2\text{O}_3$  is known as hematite that is a mineral, brown to red in color and is considered as the main ore of iron [11]. Researcher David M. Sherman and David Waite from MIT analyzed the electronic spectra of  $\text{Fe}^{3+}$  oxides, and they found the visible and near-UV absorption spectra of different iron oxides in Figure 1.6

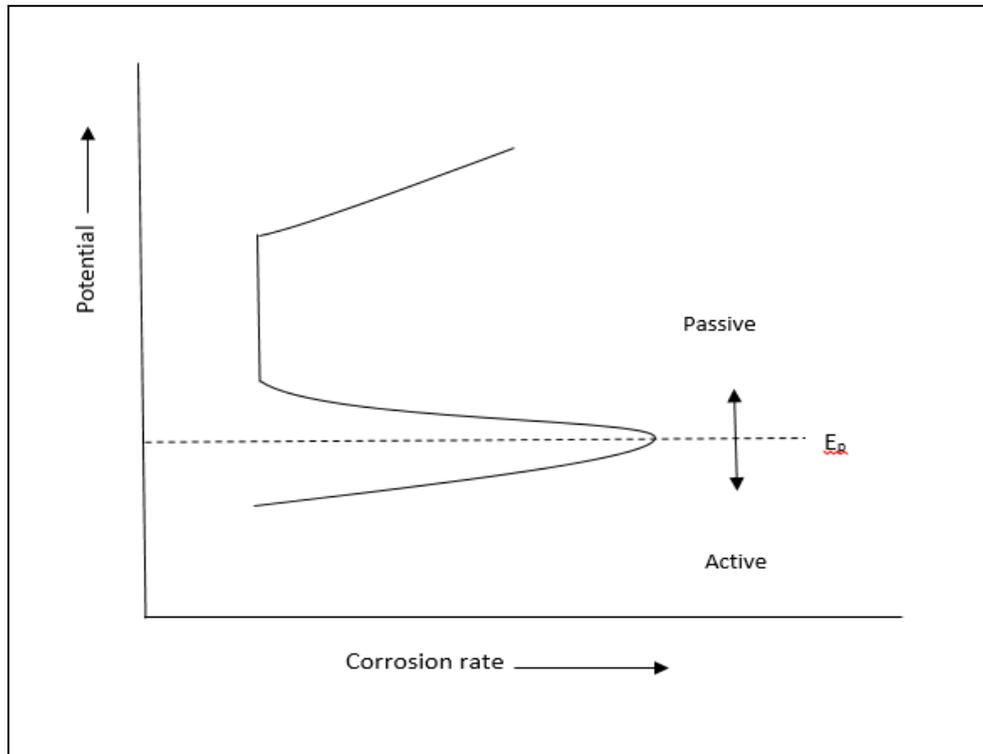
Figure 2.1: Passivity. Recreated from [40]

In some metallic corrosion like Fe, Ni, Cr, Ti the rate of corrosion decreases after some critical potential ( $E_p$ ) as shown in Figure 2.1 despite high anodic driving force this is called passivity.

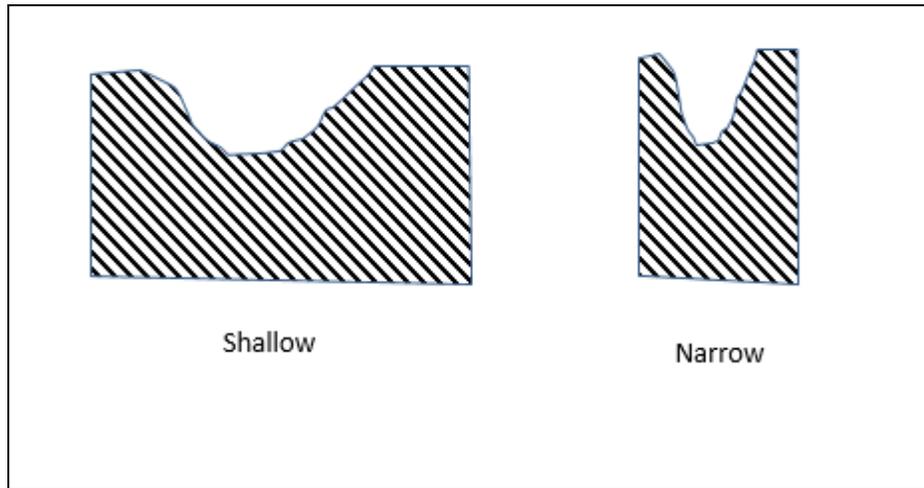
Figure 2.2: Variations of cross sectional shape of pits. Recreated from [41]

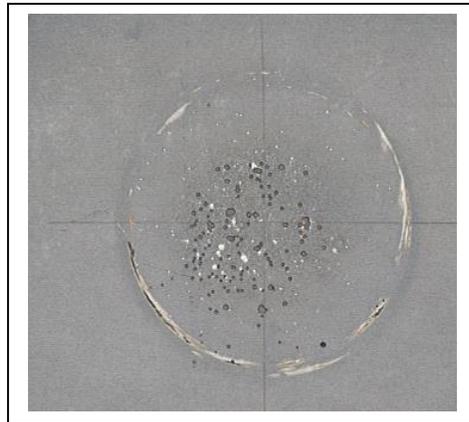
Figure 2.3: Shallow type pit formed in SS 304

Pitting corrosion is a process of causing a deep localized attack on metal surfaces, including perforations of thin-walled structures. The reason to concentrate on pitting of passive metals is its outstanding practical importance for safety considerations. In contrast to uniform corrosion, whose rate is frequently predictable from vast experience, pitting corrosion proceeds at an unexpected and high rate of localized metal dissolution [17]. Based on the alloy metallurgy and the surrounding environmental chemistry, pits form differently. It can be shallow, elliptical, deep, undercut or subsurface. Figure 2.2 shows some typical pit morphologies, and Figure 2.3 shows a shallow pit causing surface penetration in stainless steel 304.

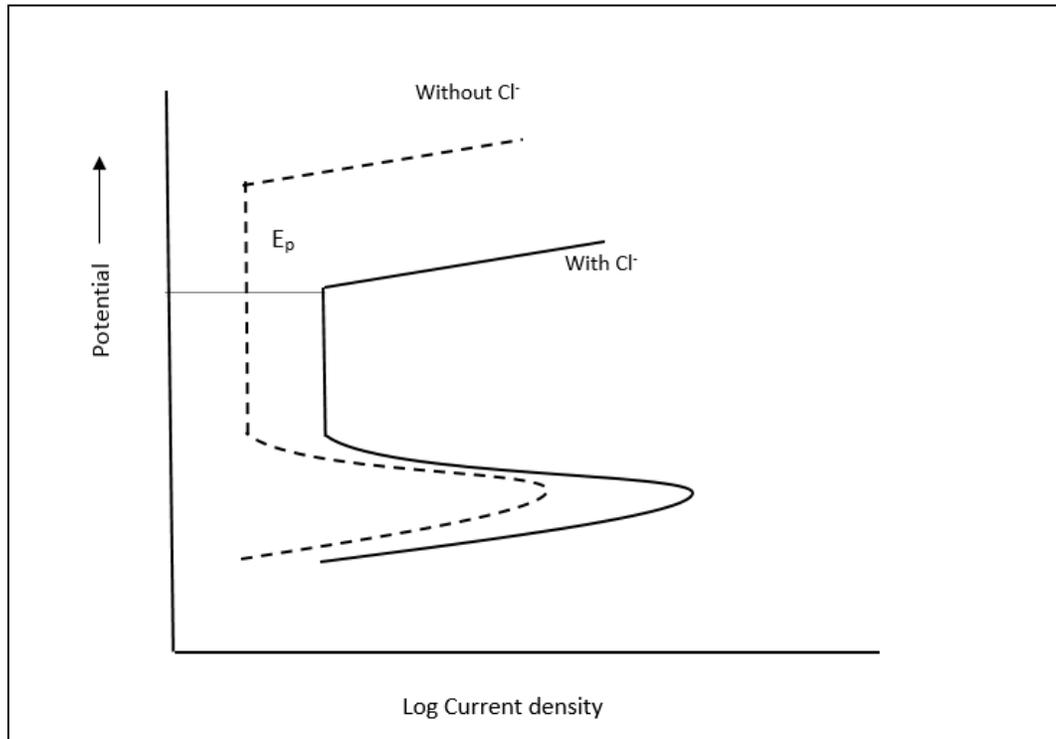
Figure 2.4: Critical pitting potential,  $E_{pit}$  determination from anodic polarization. Recreated from [1]

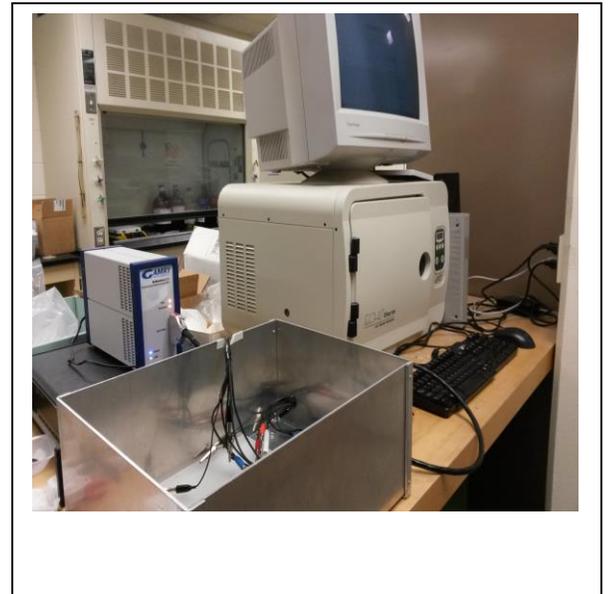
Figure 3.4: Gamry ECM 8™ Multiplexer

3. Distilled water
4. Half-saturated sodium chloride solution
5. Saturated sodium chloride solution
6. KEYENCE VHX-100 digital microscope as shown in Figure 3.3
7. ECM 8<sup>TM</sup> Electrochemical Multiplexer as shown in Figure 3.4
8. Gamry Framework (data acquisition software)
9. Gamry Echem Analyst
10. Ag/AgCl reference electrode
11. 3M 600 and 1000 grit sand paper.

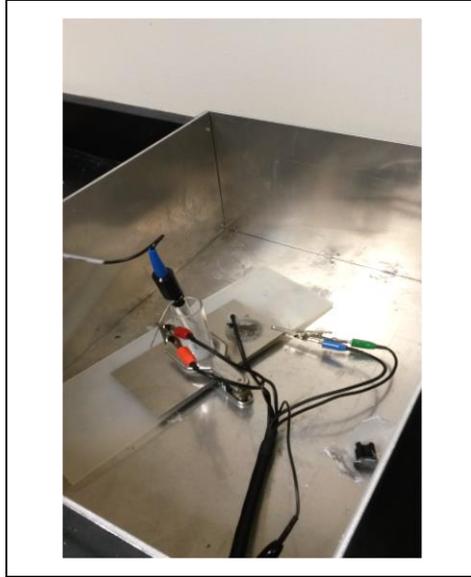
Figure 3.5: Customized experiment set up

1. The panel and the bottom of the multiplexer were separated by using Teflon to prevent electrochemical interaction between them as shown in Figure 3.5.
2. Using customized set up, each panel, was set for the experiment.
3. Periodically each panel was removed from the solution

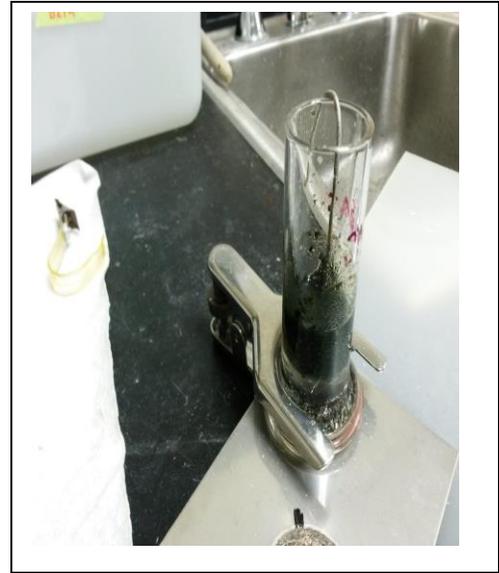
Figure 3.6: Corroded solution

4. After taking the panels out of the solution, they were cleaned with distilled water and let dry for 15 minutes.
5. Each panel was put on the customized Teflon frame, and the experimental area was observed under the digital microscope.
6. The microscope was set at 100x magnification, and the images were taken with default lighting setup.
7. After taking the images, the panels were put back to the solutions again.
8. Procedures 1 to 7 were repeated until the panels were entirely corroded and the solution became cloudy with corrosion products shown in Figure 3.6
9. The images were imported into Matlab.

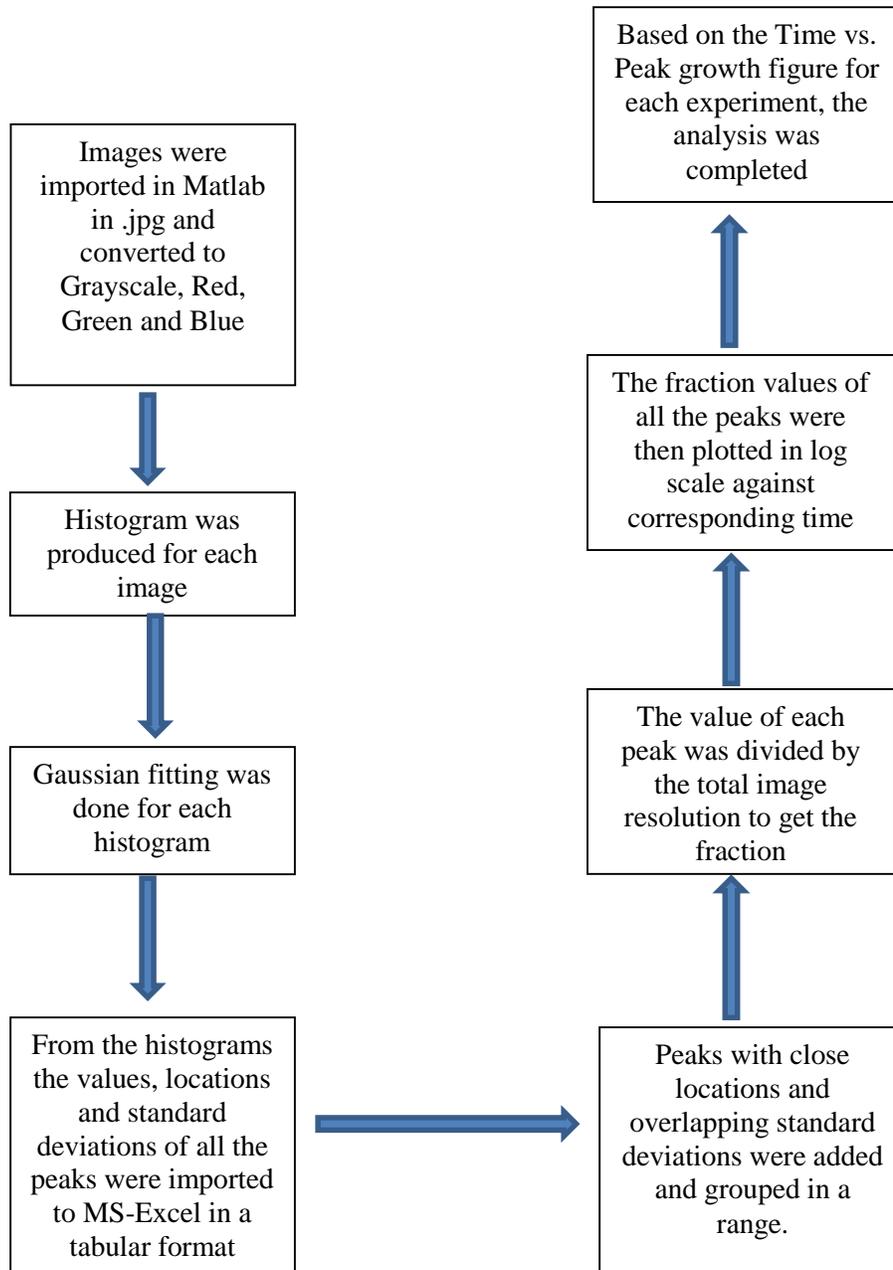
Figure 4.1: Flowchart of algorithm

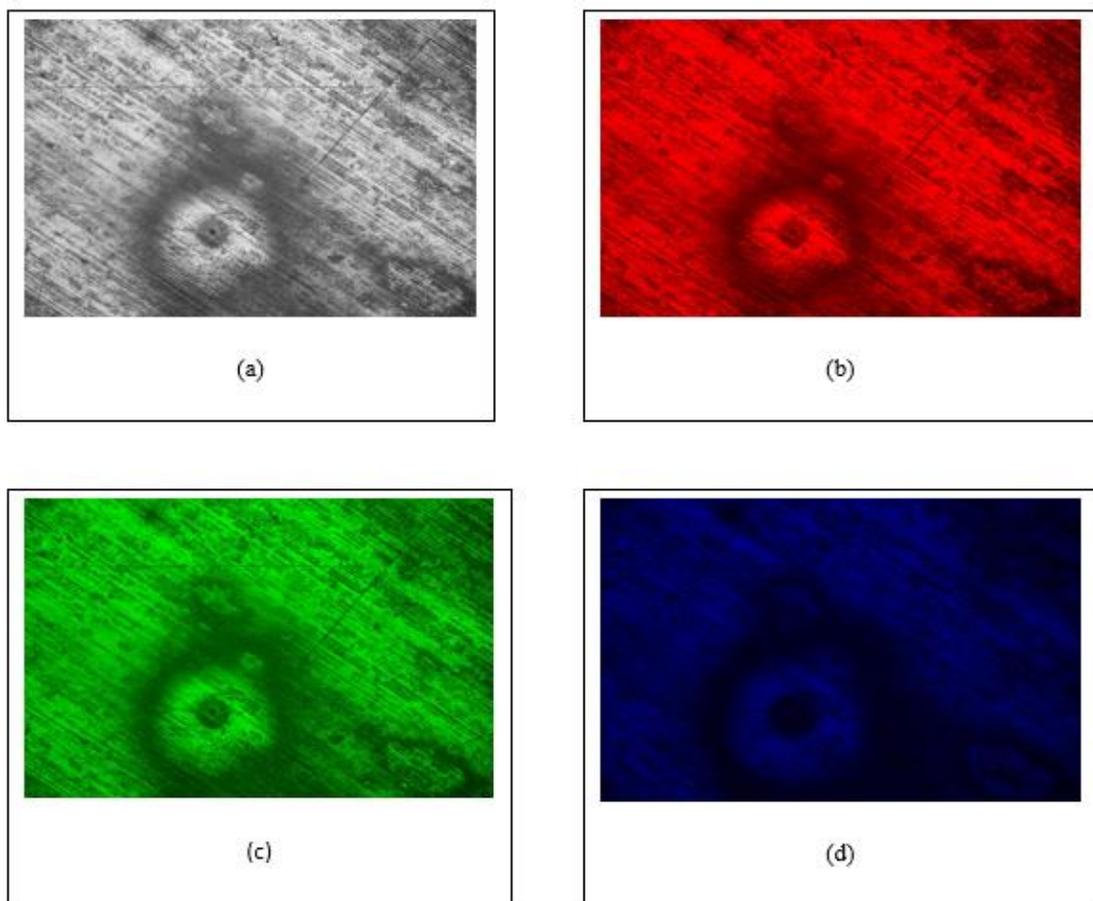
Figure 4.2: (a) Grayscale, (b) Red, (c) Green and (d) Blue images

**Step 1:** A code was developed to take the images in Matlab as input and convert them into grayscale, red, green and blue images as shown in Figure 4.2. All the images were of 1600 x1200 resolution and .jpg format. As any image is an arrangement of a matrix, 'strcat' command was used to concatenate the corresponding elements of the image matrix. After that, 'imread' command took the image as an input. To convert to grayscale image, 'rgb2gray' command was used. A coded loop was developed to get the R, G & B values. All images were stored in the drive location by using 'imwrite' command. Finally, one set of grayscale, red, green and blue images are shown below.

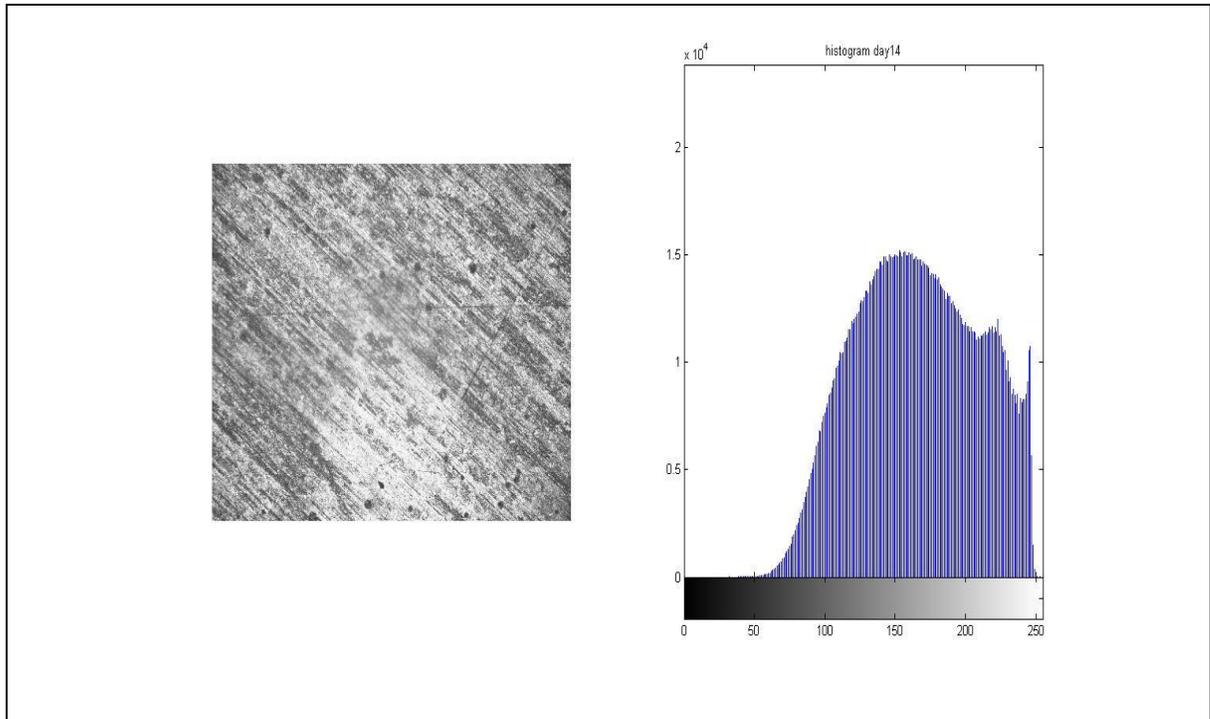
Figure 4.3: Histogram of a Grayscale image

In this step, the histogram was produced for each grayscale, red, green and blue image through a Matlab code. The ‘imread’ command used to take an image as input and ‘imhist’ command was used to create a histogram of the image. Figure 4.3 shows a snapshot of histogram for a grayscale image.

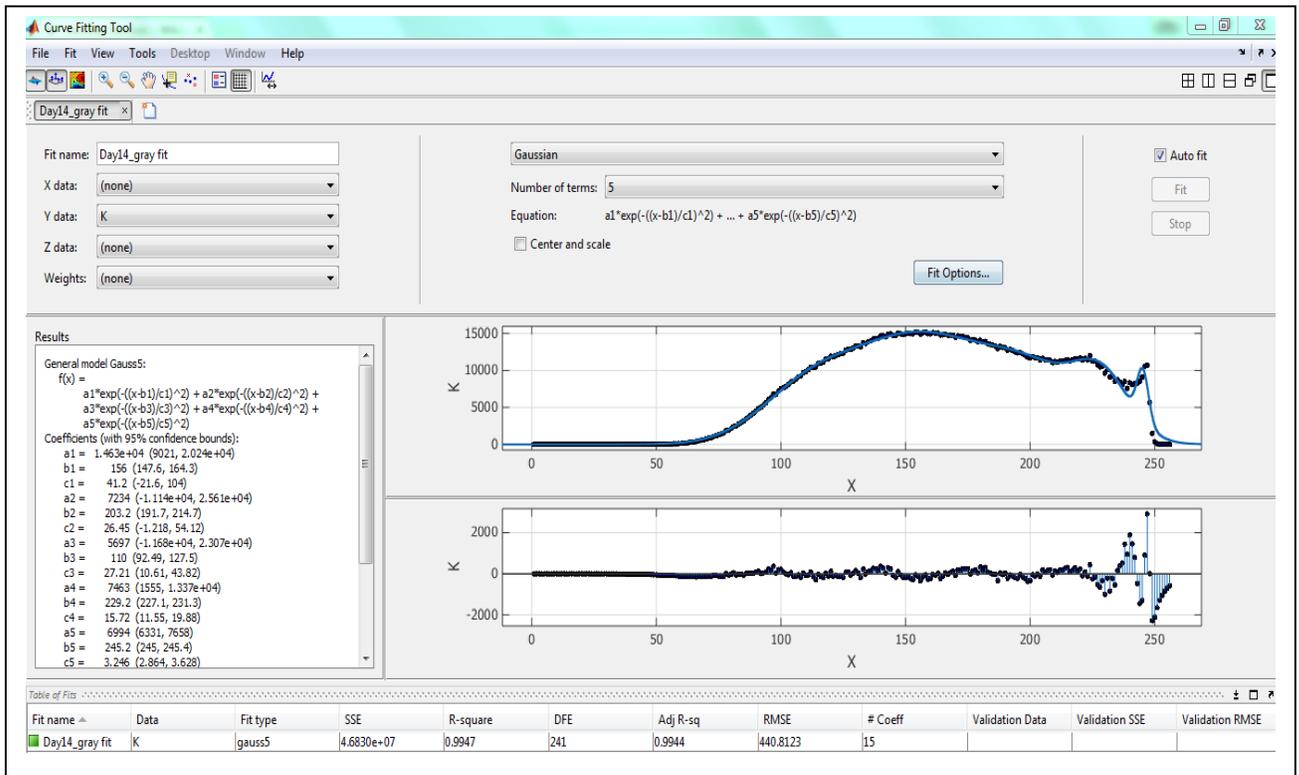
Figure 4.5: Curve fitting tool for Gaussian fit.

Figure 4.5 shows the snapshot of 'cftool' used in Matlab for Gaussian fitting.

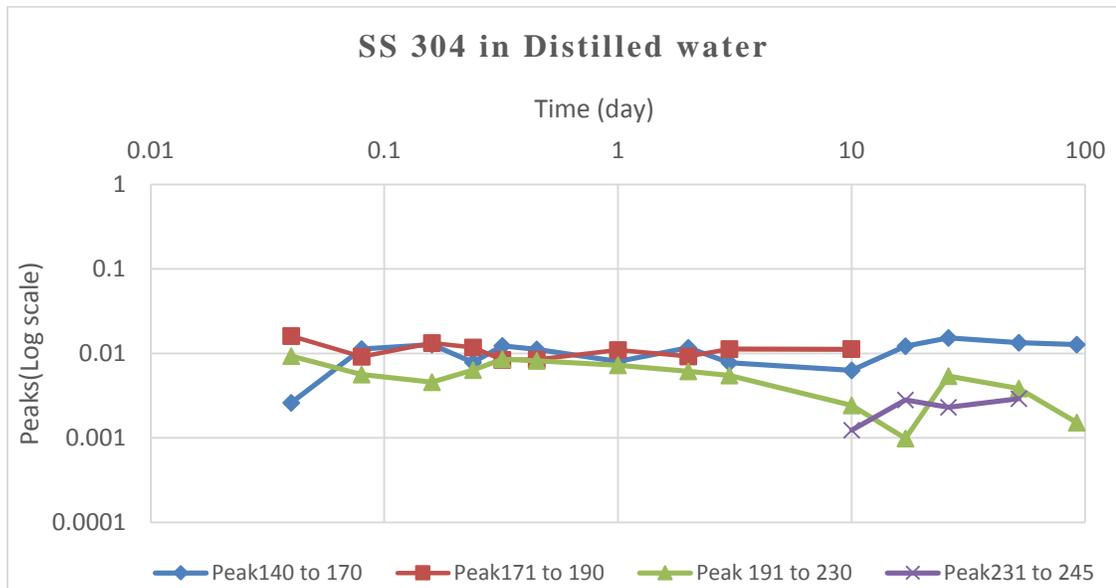
Figure 5.1: Time vs. Peak growth of SS304 in distilled water (Grayscale)

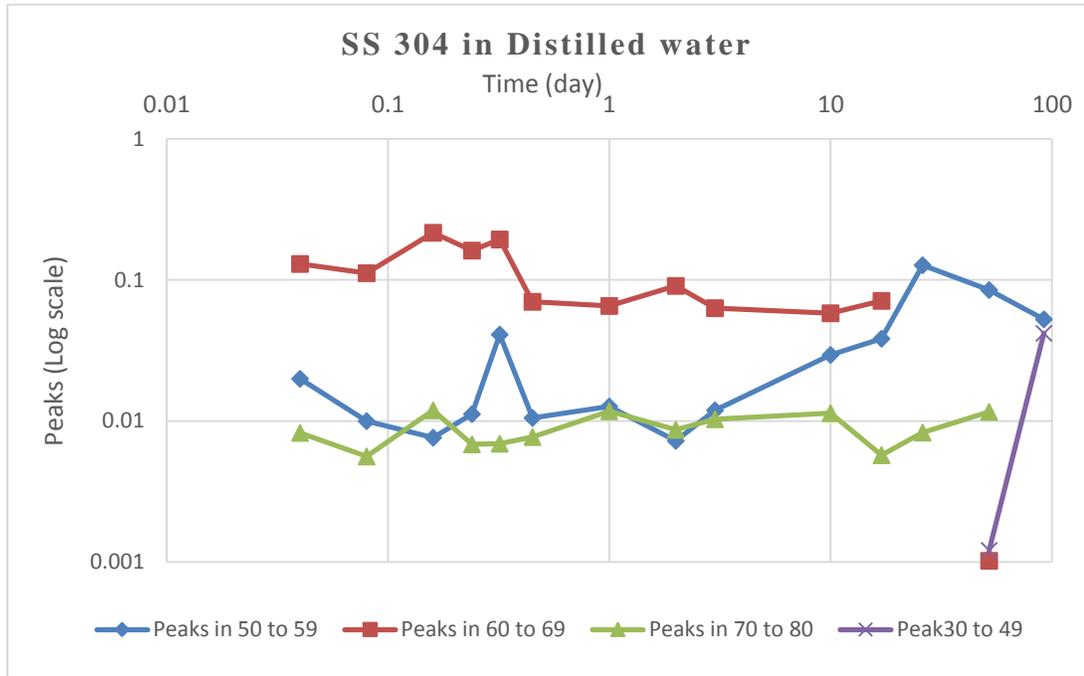
Figure 5.2: Time vs. Peak growth of SS 304 in distilled water (Red)

Figure 5.2 shows the morphological analysis of different peaks based on various light intensities in the red image. From the literature review, we know that  $\text{Fe}^{3+}$  oxides i.e.  $\text{Fe}_2\text{O}_3$  is red in color and is responsible for the growth of different sets of peaks in red image. For example, in 30 to 49 color range, peaks started to grow from 0.001 to almost 0.1 value in Log scale. It means in this dark area peaks rose nearly 100%. Peaks in 50 to 59, 60 to 69 and 70 to 80 ranges also show a growing trend.

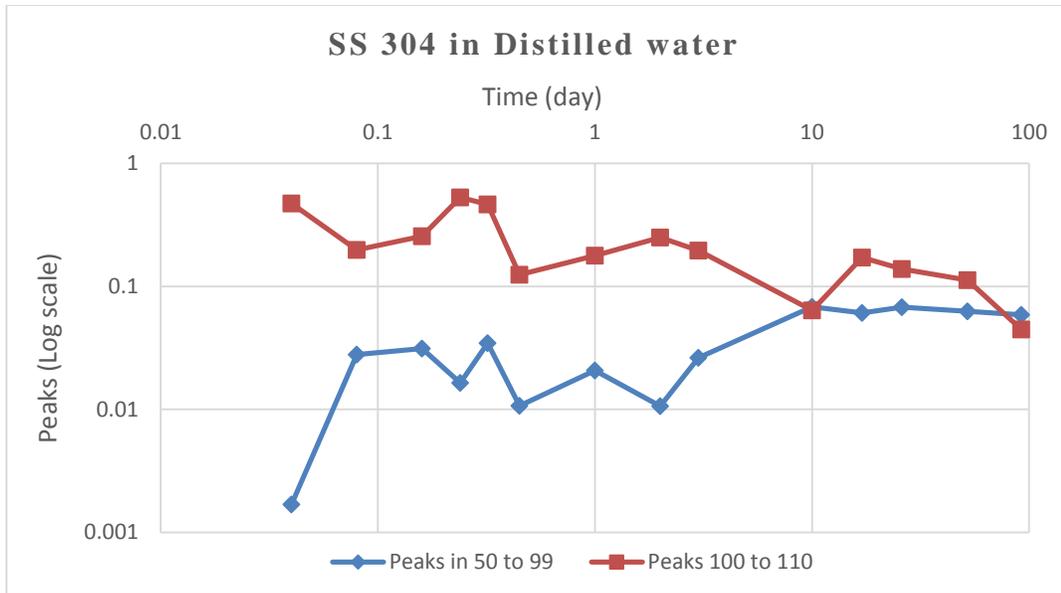
Figure 5.3: Time vs. Peak growth of SS 304 in distilled water (Green)

In Figure 5.3 two sets of peaks are visible at 50-99 and 100-110 ranges. These peaks are due to the formation of  $\text{Cr}_2\text{O}_3$  and  $\text{MnO}$  [39] [54]. These peaks are of high amplitude values and at 100-110 ranges the peaks went over log 0.1. The overall upward and downward trend indicates the effect of protective oxide layers at different times.

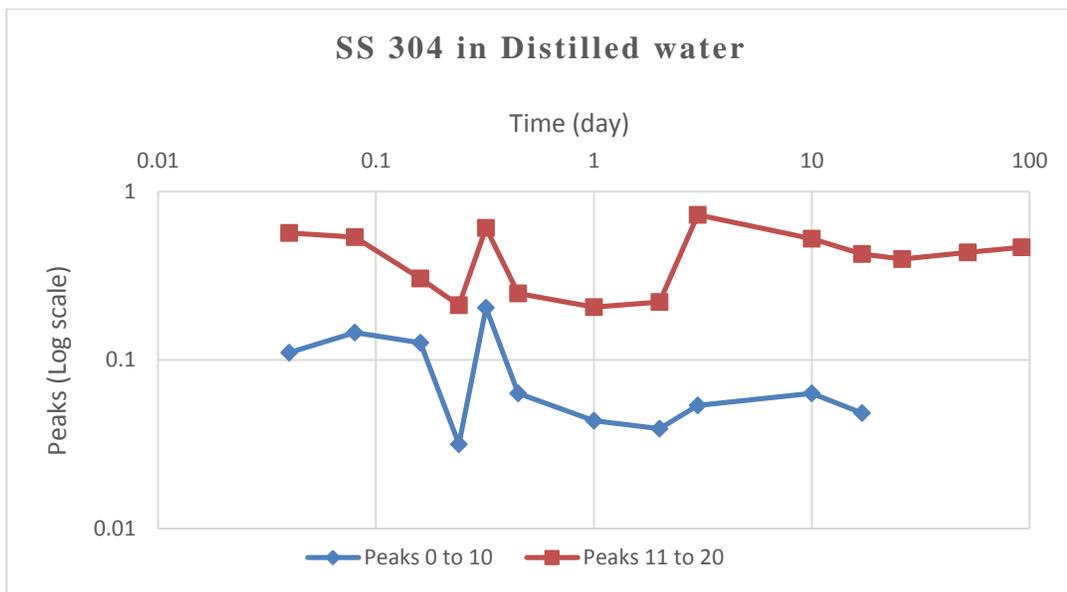
Figure 5.4: Time vs. Peak growth of SS 304 in distilled water (Blue)

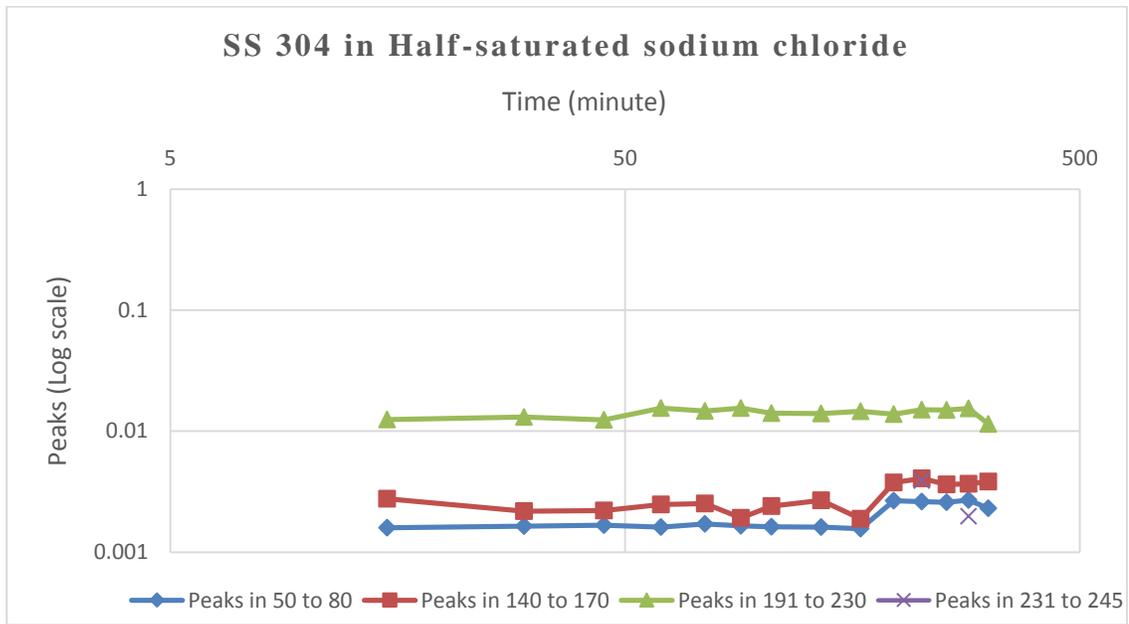
Figure 5.5: Time vs. Peak growth of SS 304 in half saturated NaCl (Grayscale)

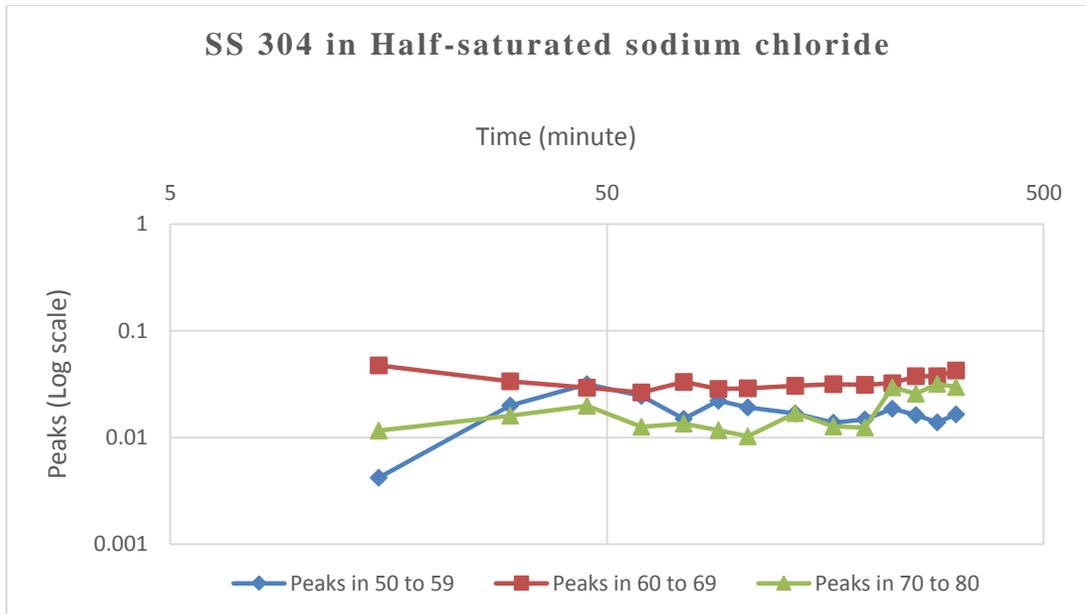
Figure 5.6: Time vs. Peak growth of SS 304 in half saturated NaCl (Red)

The presence of  $Fe_2O_3$  accelerates the corrosion process and from Figure 5.6, we see the significant growth of peaks in 60 to 69 intensity along with 50 to 59 and 70 to 80 ranges. The overall trend in the red image is increasing in nature with over log 0.01 value.

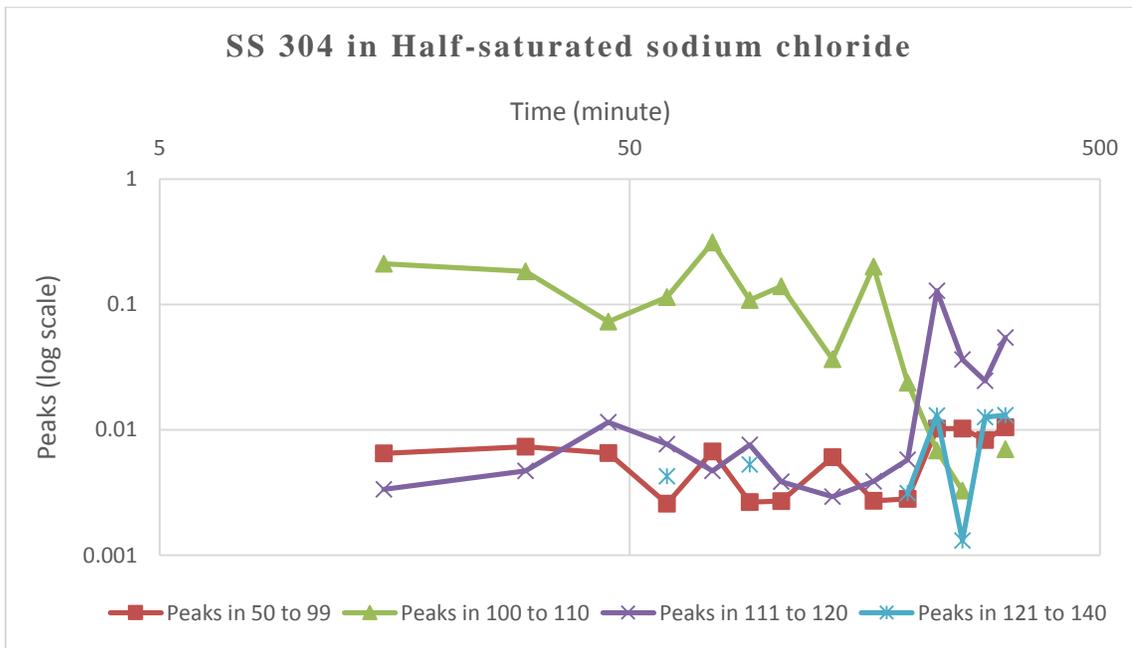
Figure 5.7: Time vs. Peak growth of SS 304 in half saturated NaCl (Green)

The green image, Figure 5.7 shows the existence of different sets of peaks. In chloride environment, the formation of several compounds like  $\text{Cr}_2\text{O}_3$ ,  $\text{CrCl}_2$ ,  $\text{CrCl}_3 (\text{H}_2\text{O})_x$ ;  $x=1, 5, 6$ ,  $\text{FeCl}_2$ ,  $\text{FeCl}_3$ ,  $\text{MnO}$ ,  $\text{Ni (II)}$  chlorides, etc. cause the high growth of peaks [12],[16],[17]. As a result, peaks are visible in 50 to 99, 100 to 110, 111 to 120 and 121 to 140 show the increasing trend at the end. This image displays the significant contribution of greenish colored corrosion products into the overall chemical process.

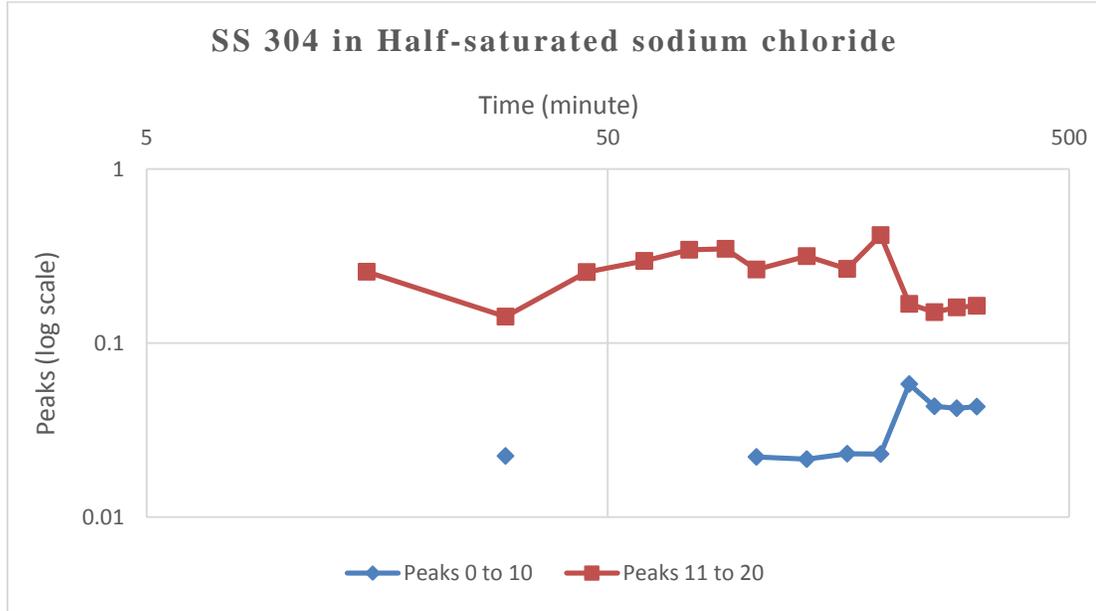
Figure 5.8: Time vs. Peak growth of SS 304 in half saturated NaCl (Blue)

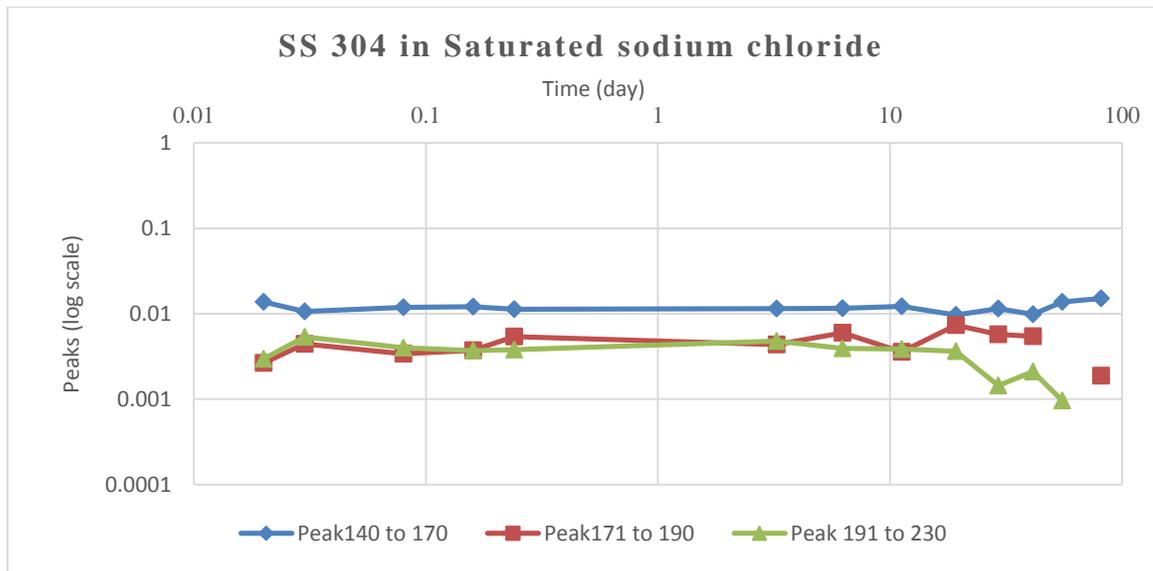
Figure 5.9: Time vs. Peaks of SS 304 in saturated NaCl solution (Grayscale)

The grayscale image shown in Figure 5.9 depicts the growth of various peaks. In 140 to 170 range, the peaks are dominating with log 0.01 values. Peaks in two other ranges; 171 to 190 and 191 to 230 are also following a similar trend. Unlike half saturated NaCl experiment, in saturated NaCl solution, peaks in 191 to 230 range are lower than log 0.01 value and show a decreasing trend. The RGB image analysis explains the growth of peaks in details.

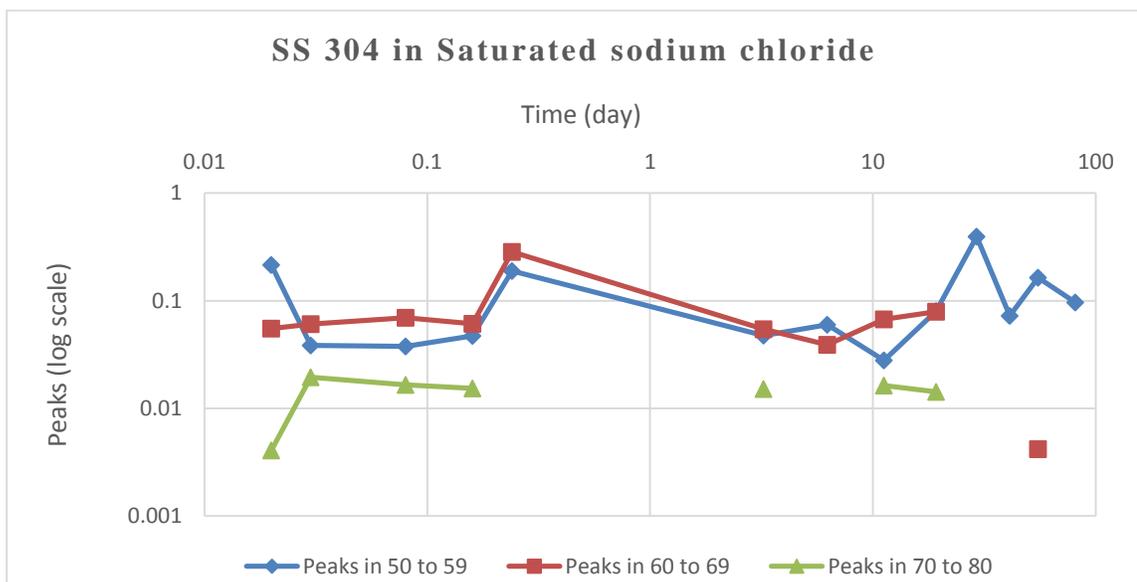
Figure 5.9: Time vs. Peaks of SS 304 in saturated sodium chloride solution (Red)

In Figure 5.9, three sets of peaks are visible in 50 to 59, 60 to 69 and 70 to 80 color intensities. However, in saturated NaCl solution, peaks look more dominant i.e. close to log 0.1 value than half saturated experiment. Therefore, the formation of  $\text{Fe}_2\text{O}_3$  perhaps contributing more in corrosion process compared to half saturated chloride experiment. The overall trend shows increasing.

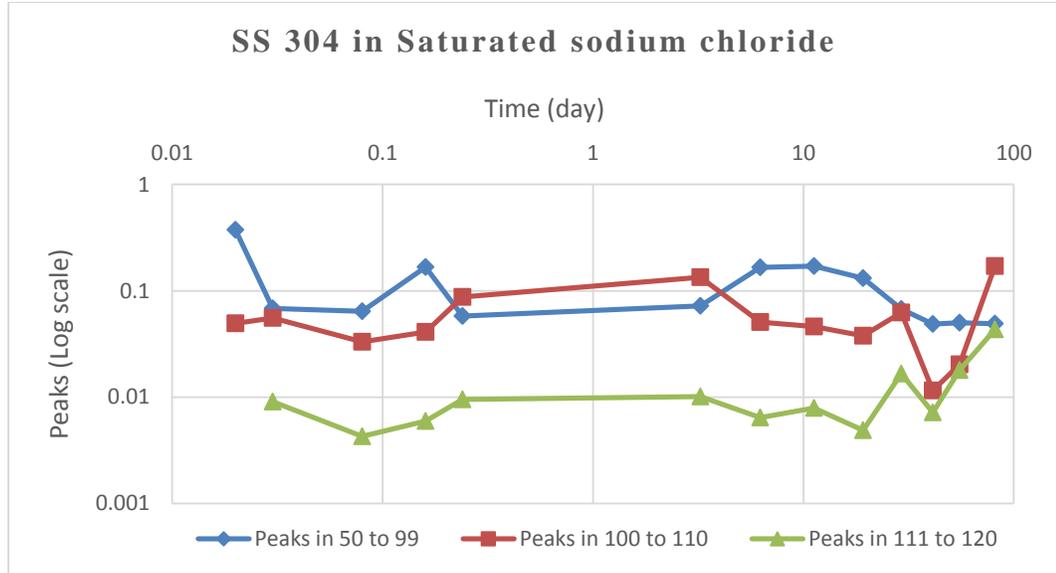
Figure 5.10: Time vs. Peaks of SS 304 in saturated sodium chloride solution (Green)

Similar to the green image from half saturated NaCl experiment, several sets of peaks are noticeable in Figure 5.10. The chloride ions contribute to the formation of different corrosion product i.e.  $\text{CrCl}_2$ ,  $\text{CrCl}_3 (\text{H}_2\text{O})_x$ ;  $x=1, 5, 6$ ,  $\text{FeCl}_2$ ,  $\text{FeCl}_3$ ,  $\text{MnO}$ ,  $\text{Ni (II) Chlorides}$  etc. to accelerate the corrosion process in 50 to 99, 100 to 110 and 111 to 120 intensity ranges. An overall growing trend in the green image shows the major contribution of greenish colored corrosion products into the overall chemical process.

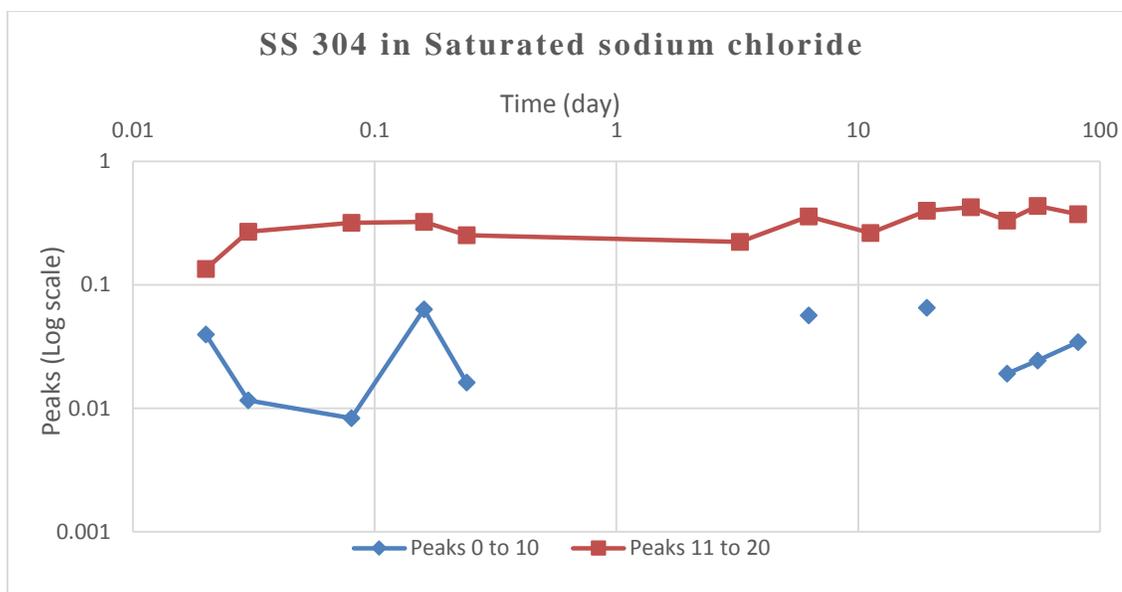
Figure 5.11: Time vs. Peaks of SS 304 in saturated sodium chloride solution (Blue)

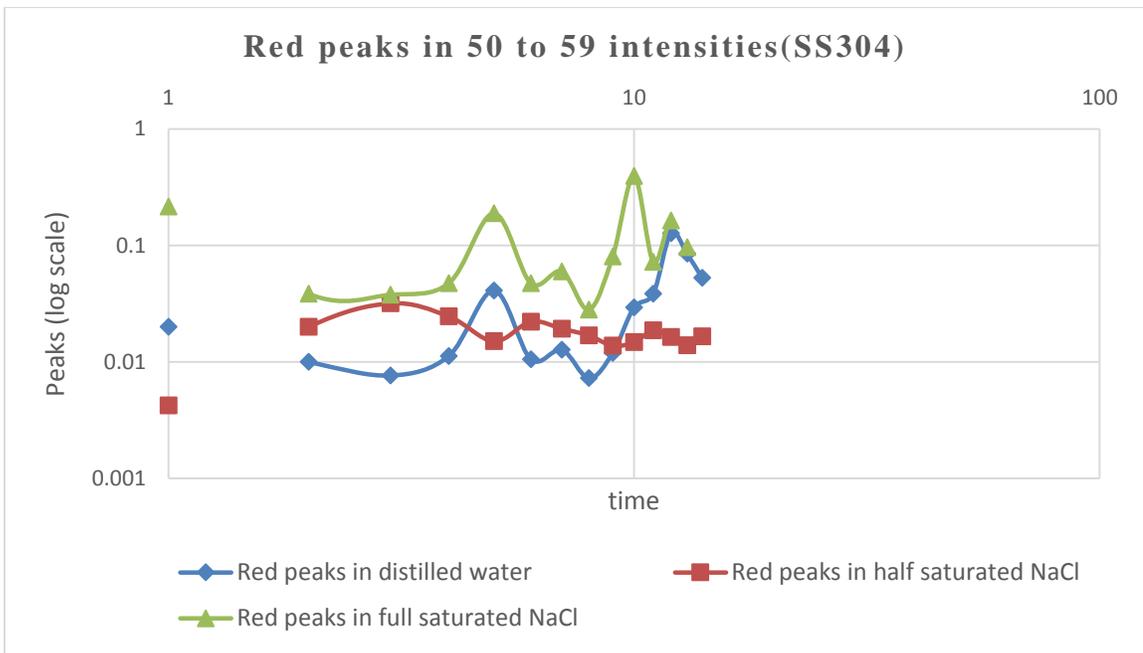
Figure 5.12: Comparison of peaks in 50 to 59 intensities in SS 304 experiments

Moreover, the dominance of red (R) image in all three experiments also deserves extra attention. Therefore, one major set of peaks (50 to 59 ranges) from the three red images of SS304 experiments has been selected as shown in Figure 5.12.

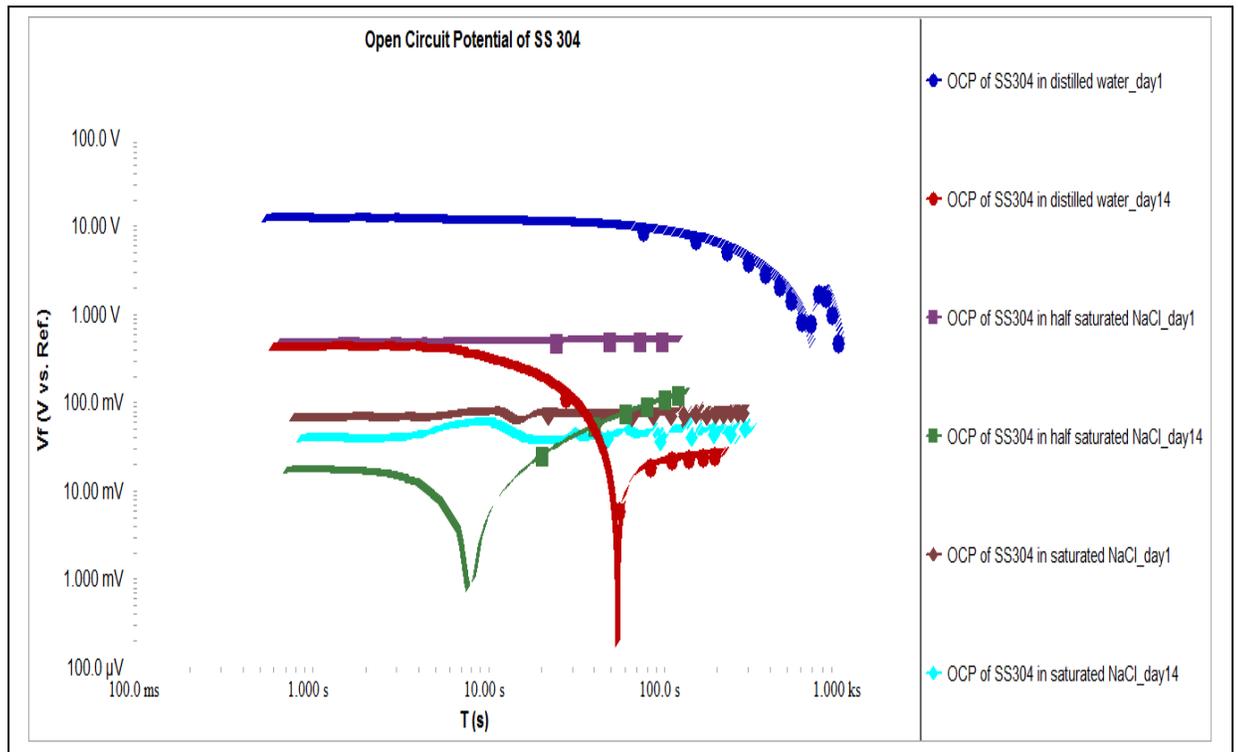
Figure 5.13: Open circuit potentials of SS 304 in distilled water, half saturated NaCl & saturated NaCl solutions

Open circuit potential (OCP) indicates the corrosion potential of the metal compared to the reference electrode in the absence of electrical connection. It is an excellent way to understand the presence of passivity and protective layers of a pitting corrosion reaction and can be used to measure the corrosion rate. Below figure shows the comparison of different corrosion potentials of SS 304 in three solutions. Here, the potentials were measured in volt (V) against Ag/AgCl reference electrode and by setting up in Gamry Framework data acquisition software.
