IMAGE ANALYSIS OF CORROSION PIT INITIATION ON ASTM  
TYPE A240 STAINLESS STEEL AND ASTM TYPE A 1008  
CARBON STEEL

A THESIS

February 2016

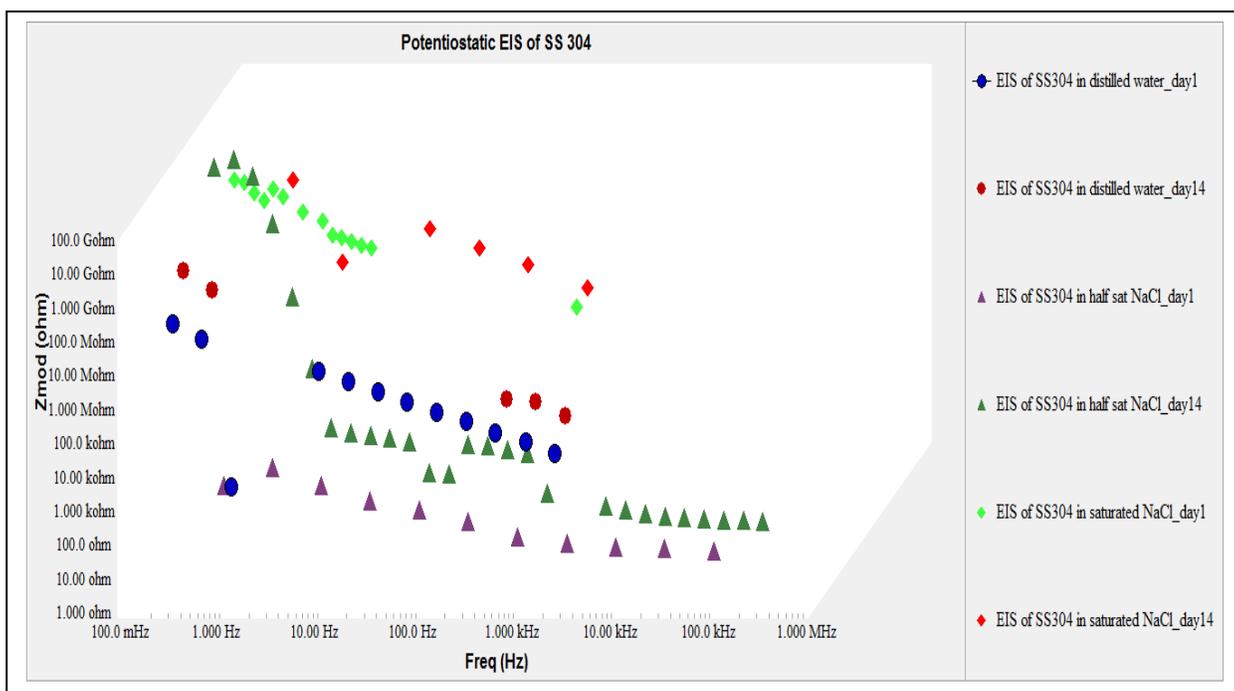
Figure 5.14: Electrochemical impedance spectroscopy of SS 304 in distilled water, half saturated NaCl & saturated NaCl solutions

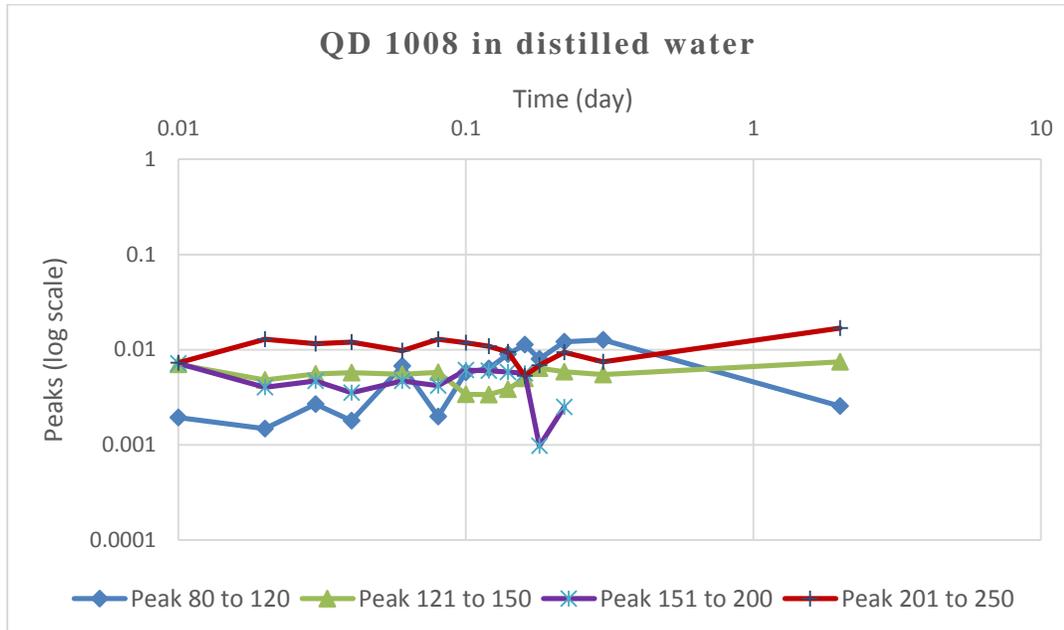
Figure 5.15: Time vs. Peaks growth of QD 1008 in distilled water (Grayscale)

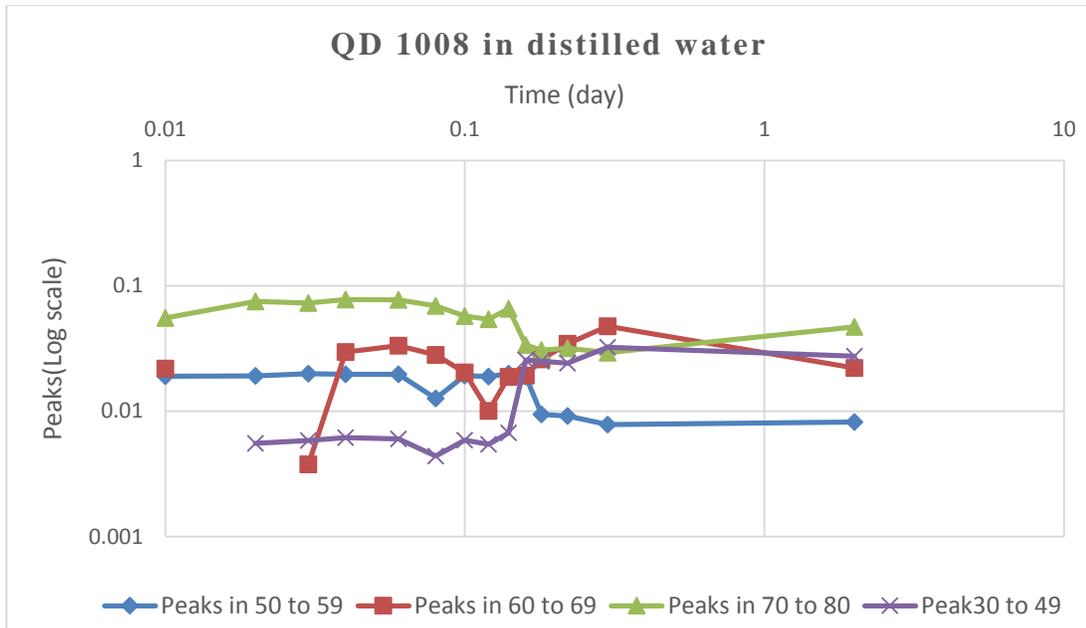
Figure 5.16: Time vs. Peaks growth of QD 1008 in distilled water (Red)

From the red image shown in Figure 5.16 the presence of four sets of peaks in 50 to 59, 60 to 69, 70 to 80 and 30 to 49 intensities is visible. Compared to the SS304 in distilled water experiment, in low carbon steel, the peaks have increased consistently. The protective oxide layer formed in QD 1008 is not strong enough to inhibit corrosion attack and as a result, corrosion product like  $Fe_2O_3$  forms and initiates pitting on the metal surface.

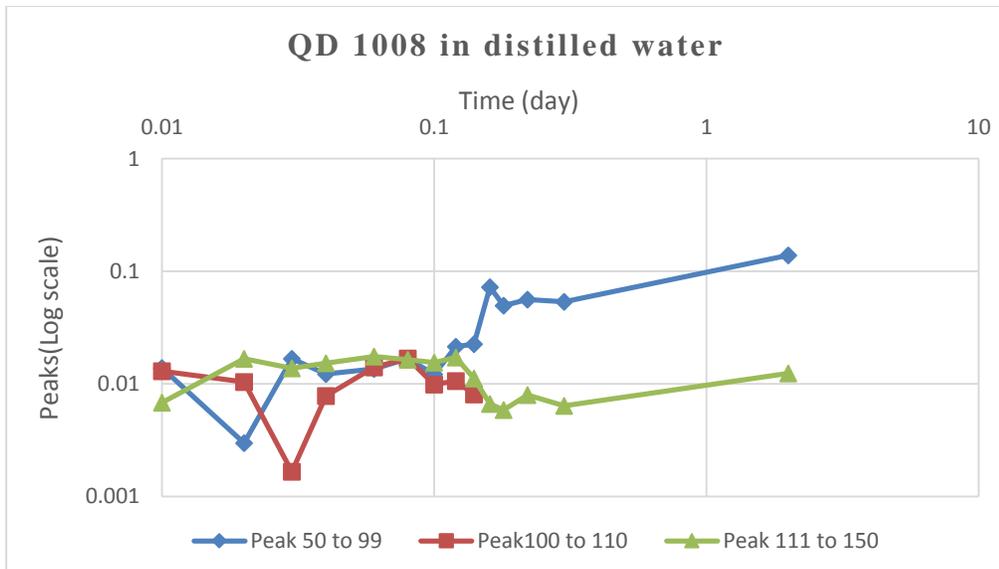
Figure 5.17: Time vs. Peaks growth of QD 1008 in distilled water (Green)

Figure 5.17 shows the growth of peaks in 50 to 99, 100 to 110 and 111 to 150 intensities in the green image.

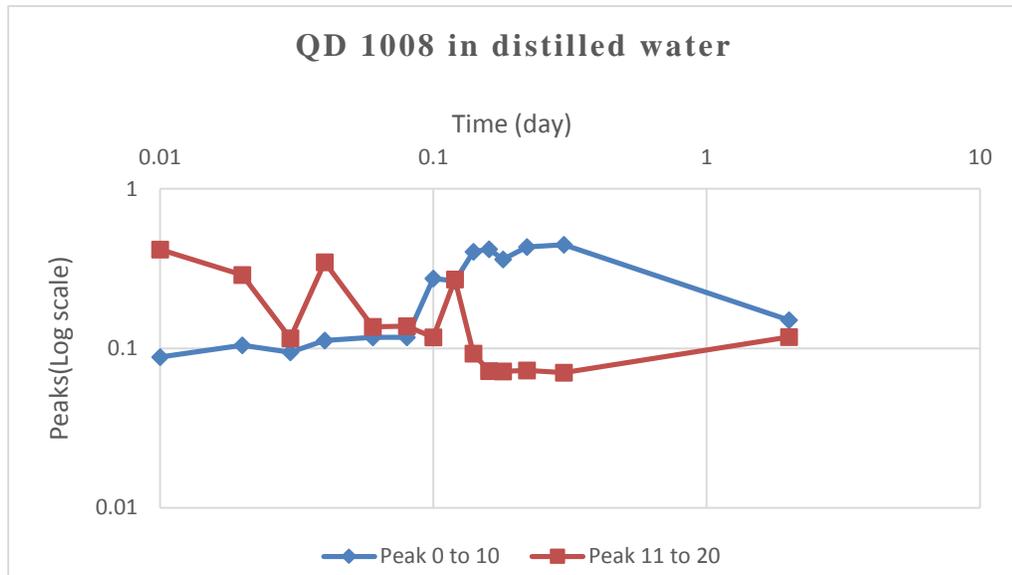
Figure 5.18: Time vs. Peaks growth of QD 1008 in distilled water (Blue)

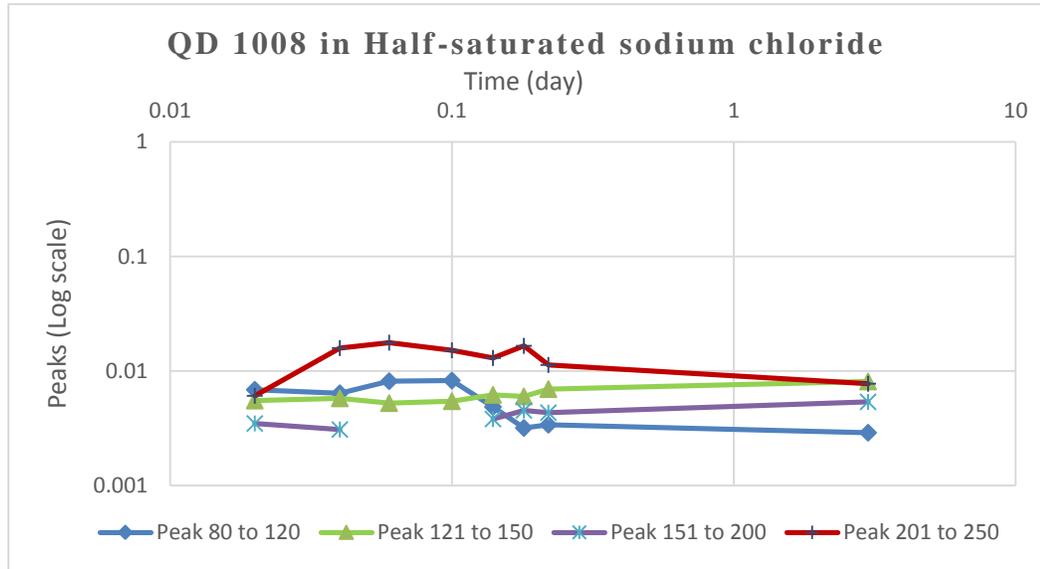
Figure 5.19: Time vs. Peaks growth of QD 1008 in half saturated NaCl (Grayscale)

The grayscale image in Figure 5.19 shows the increase of peaks in different intensities. The presence of chloride ions accelerates the corrosion process along with iron oxides. However, the RGB image analysis gives more insights about the growth of peaks.

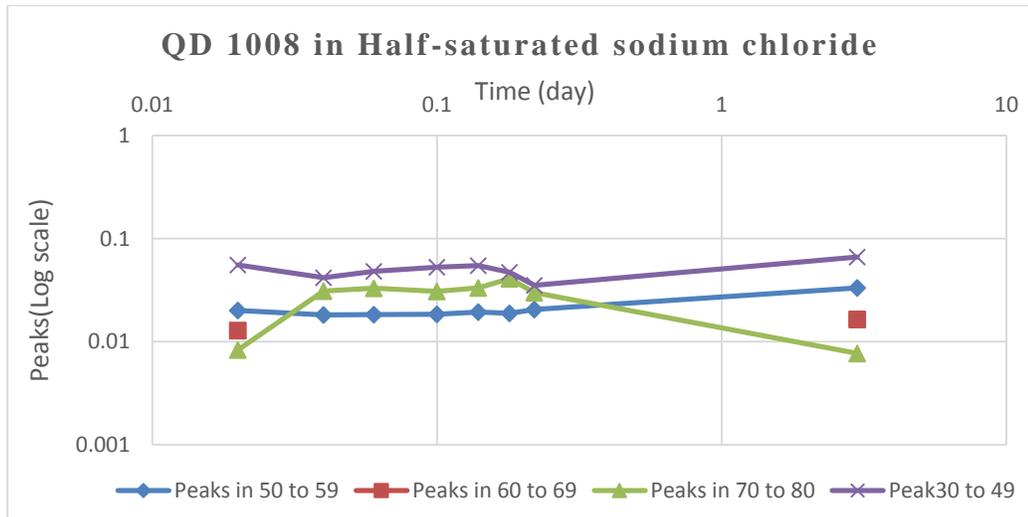
Figure 5.20: Time vs. Peaks growth of QD 1008 in half saturated NaCl (Red)

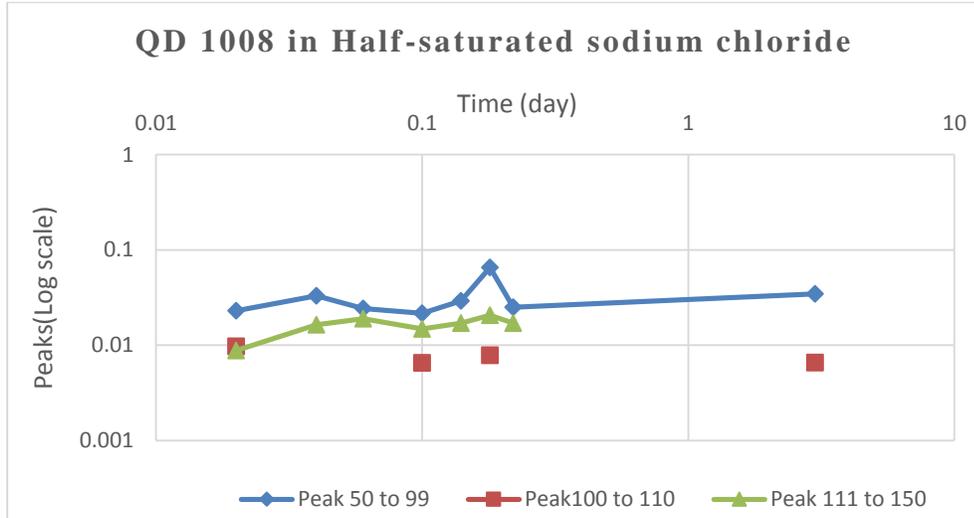
Figure 5.21: Time vs. Peaks growth of QD 1008 in half saturated NaCl (Green)

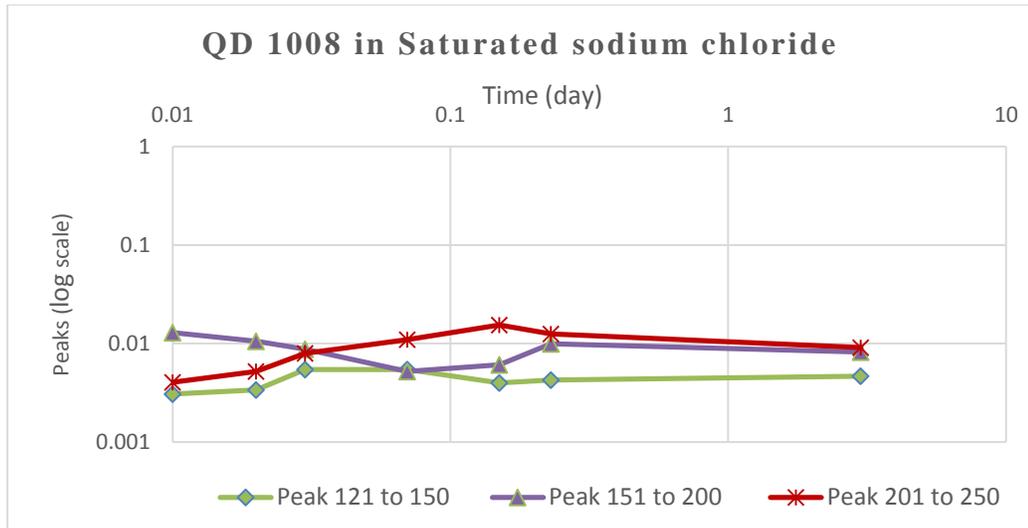
Figure 5.23: Time vs. Peaks growth of QD 1008 in saturated NaCl (Grayscale)

Three sets of peaks are visible in 121 to 150, 151 to 200 and 201 to 255 intensities showing a steady growth over time as shown in Figure 5.23. The presence of chloride ions plays a vital role along with iron (iii) oxide. RGB image analysis will be helpful to get more insights and are presented below.

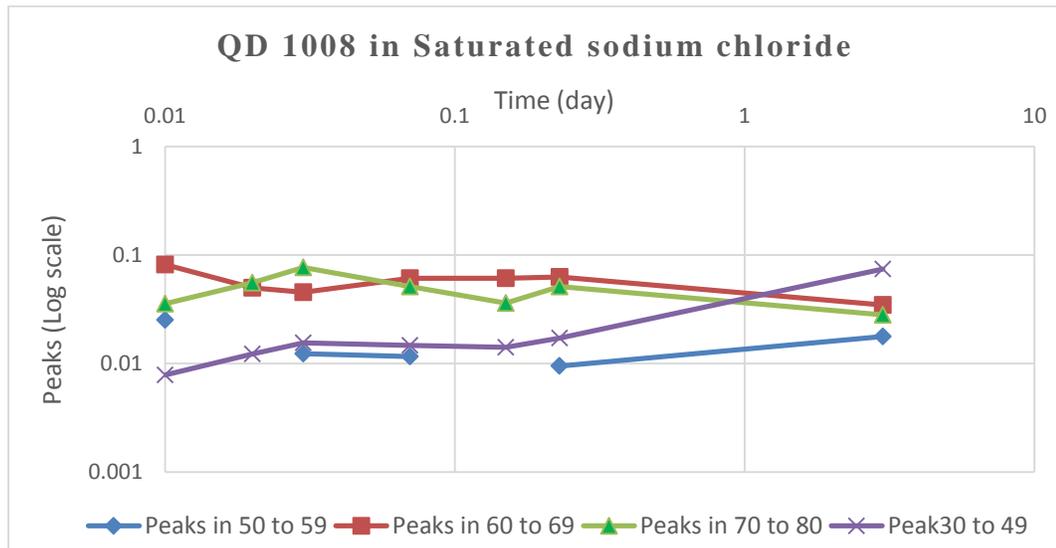
Figure 5.24: Time vs. Peaks growth of QD 1008 in saturated NaCl (Red)

In Figure 5.24 four sets of peaks are growing in 30 to 49, 50 to 59, 60 to 69 and 70 to 80 intensities; show the domination of corrosion products on the metal surface. Active chloride ions mix with iron and form  $\text{FeCl}_2$  and  $\text{FeCl}_3$ , which initiate the corrosion attack in saturated sodium chloride solution.

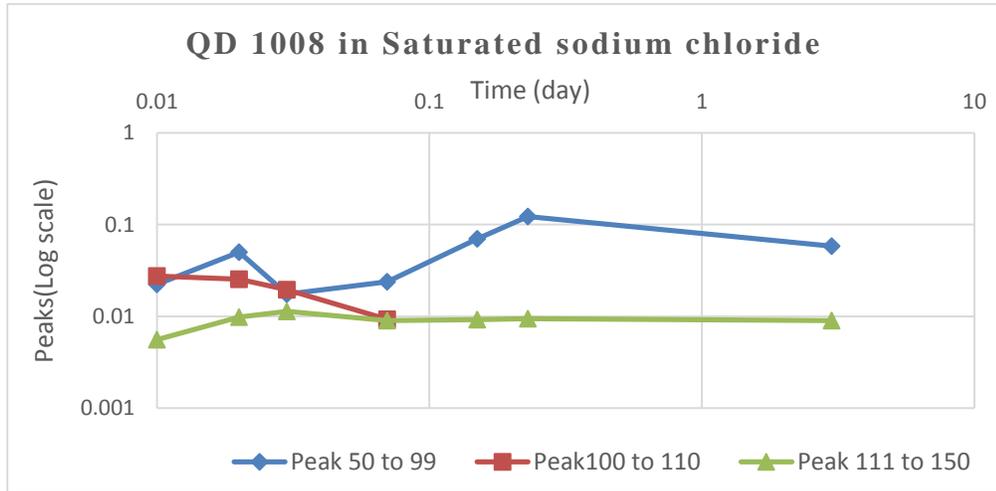
Figure 5.25: Time vs. Peaks growth of QD 1008 in saturated NaCl (Green)

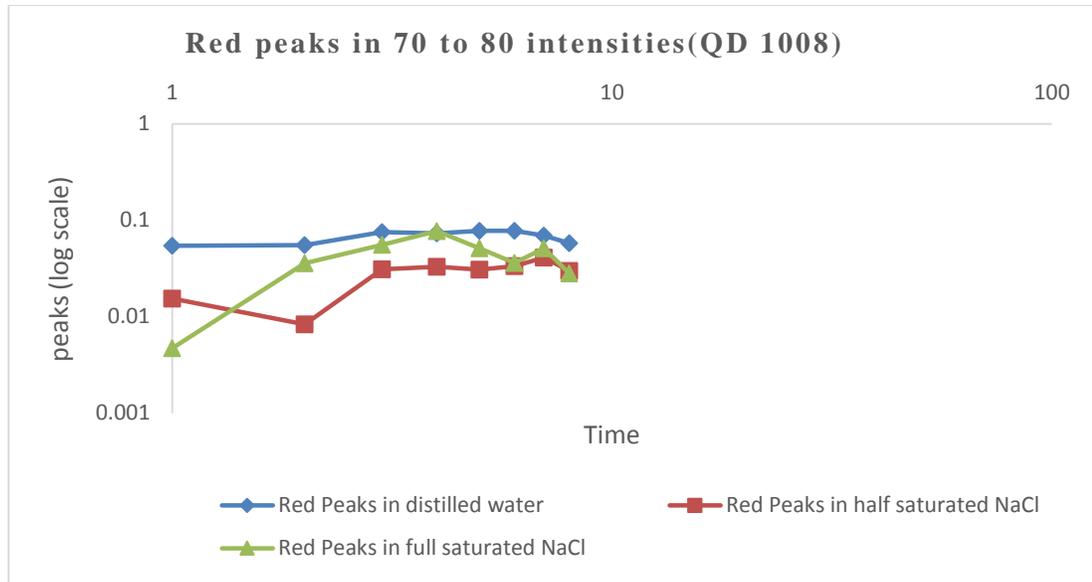
Figure 5.27: Comparison of peaks in 70 to 80 intensities in QD 1008 experiments

Additionally, the dominance of red (R) image in all three experiments also deserves extra attention. Therefore, one major set of peaks (70 to 80 ranges) from the three red images of QD 1008 experiments has been selected as shown in Figure 5.27.

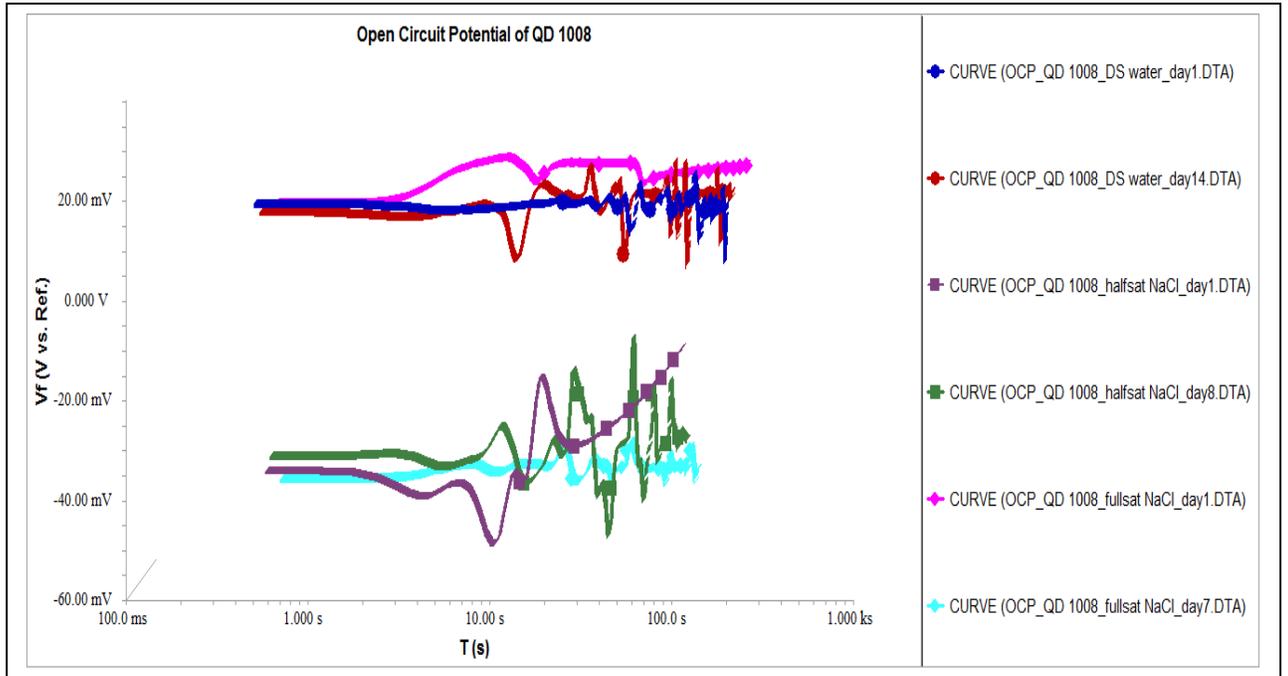
Figure 5.28: Open circuit potentials of QD 1008 in distilled water, half saturated NaCl & saturated NaCl solutions

The open circuit potential (OCP) as shown in Figure 5.28 measures the potential of QD 1008 in distilled water, half saturated and saturated sodium chloride solutions compared to Ag/AgCl reference electrode.

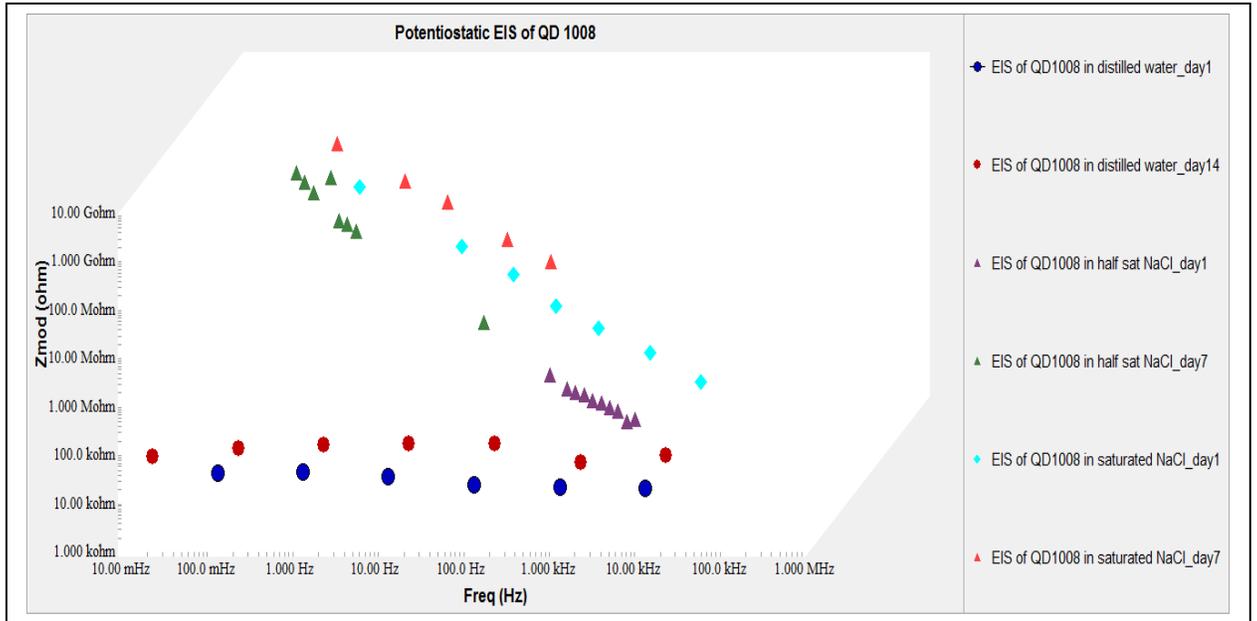
Figure 5.29: Electrochemical impedance spectroscopy of QD 1008 in distilled water, half saturated NaCl & saturated NaCl solutions

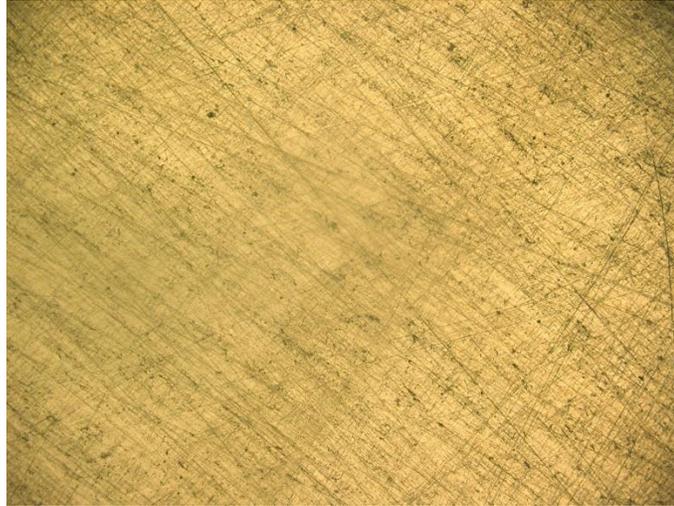
Day 0

### Stainless Steel SS 304 in distilled water experiment images
