Final Report

Use of Adhesives to Retrofit  
Out-of-Plane Distortion Induced  
Fatigue Cracks

1. Report No. <b>MN/RC-2006-04</b>	2.	3. Recipients Accession No.	
4. Title and Subtitle <b>Use of Adhesives to Retrofit Out-of-Plane Distortion Induced Fatigue Cracks</b>		5. Report Date <b>February 2006</b>

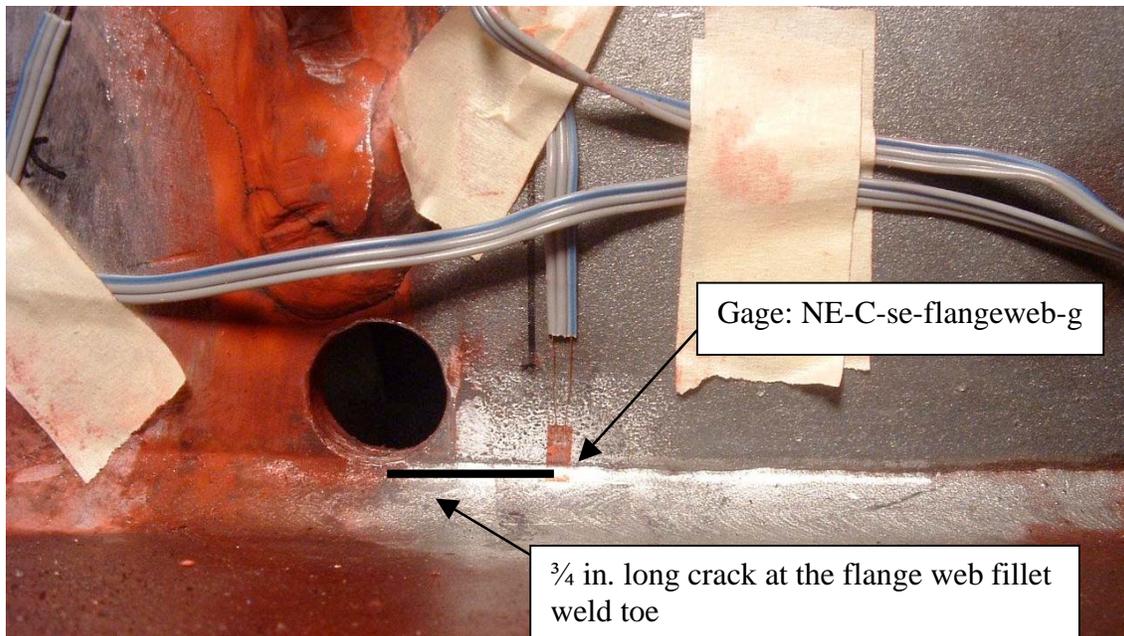
Figure 4.13 Strain gages that measure strains at the tip of the crack for web gaps

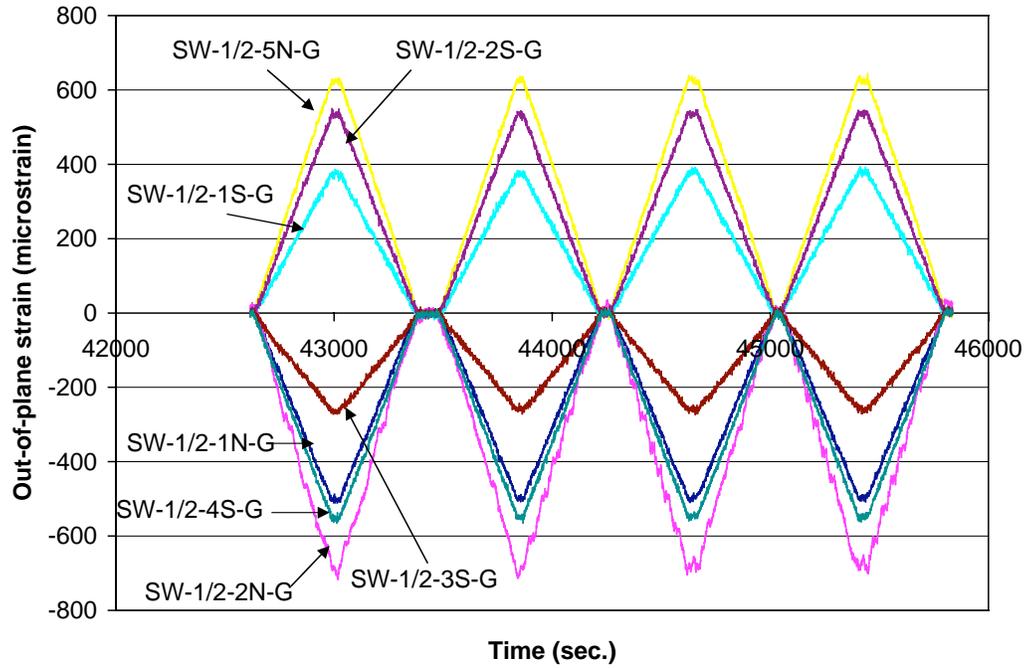
Figure 4.14 Measured out-of-plane strains at SW-1/2 web gap before cyclic loading

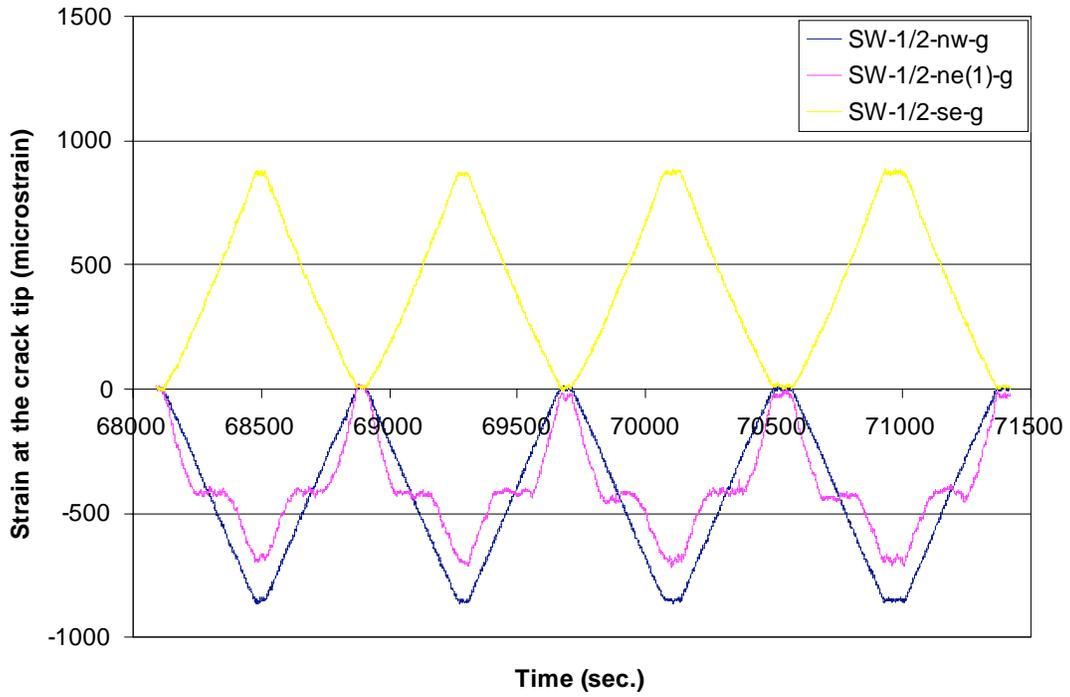
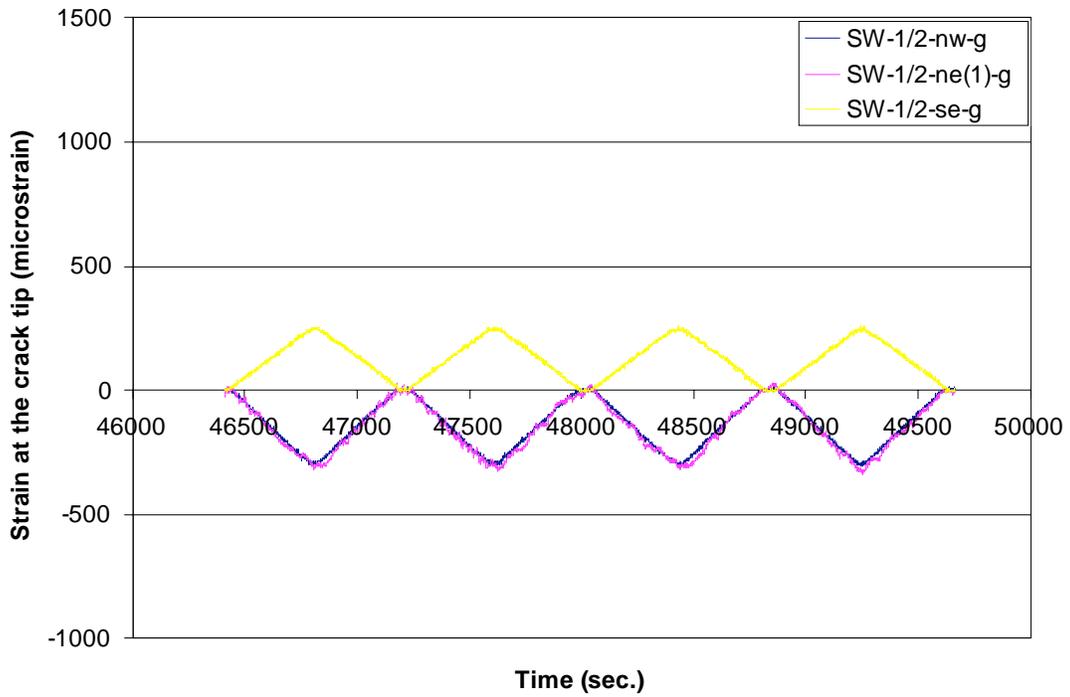
Figure 4.19 Measured strains at the crack tips at web gap SW-1/2

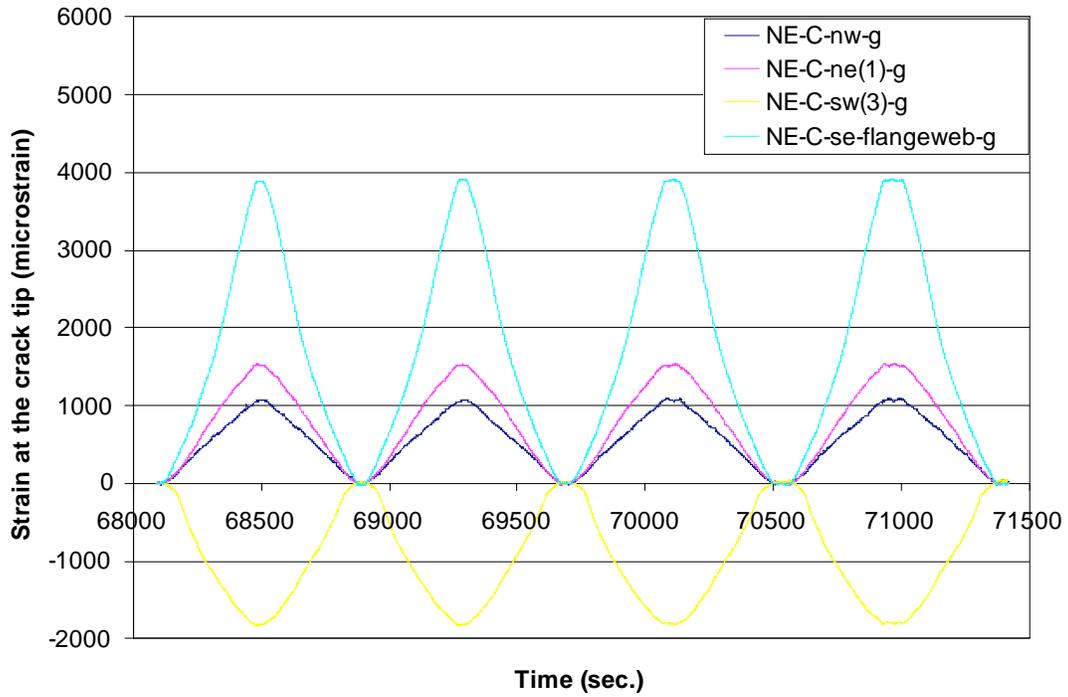
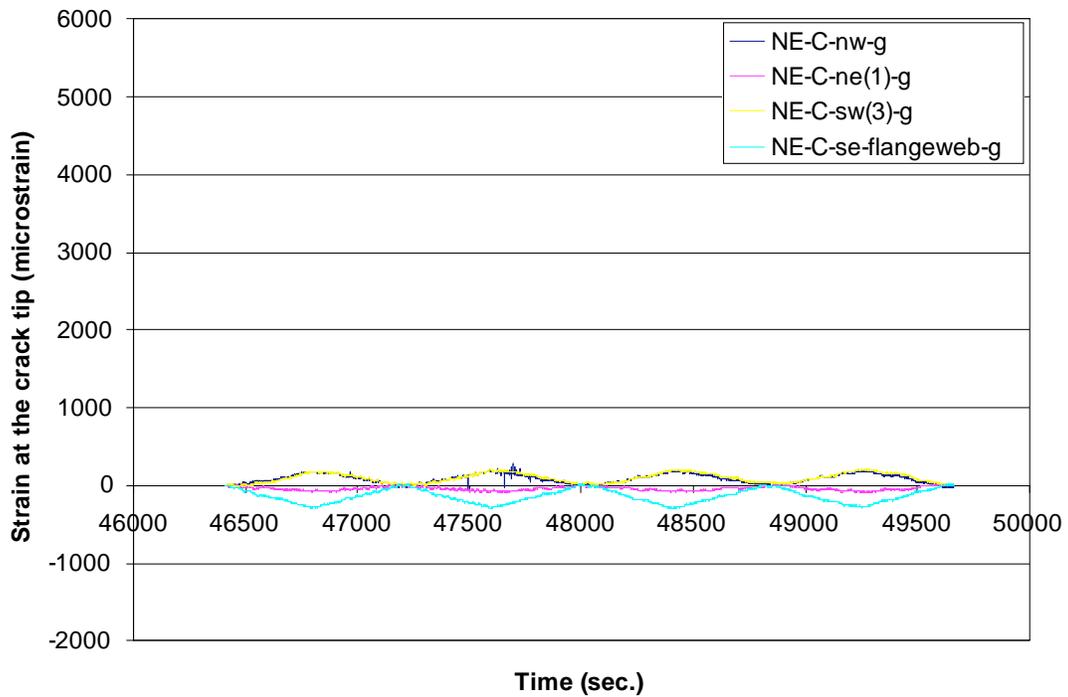
Figure 4.21 Measured strains at the crack tips at web gap NE-C

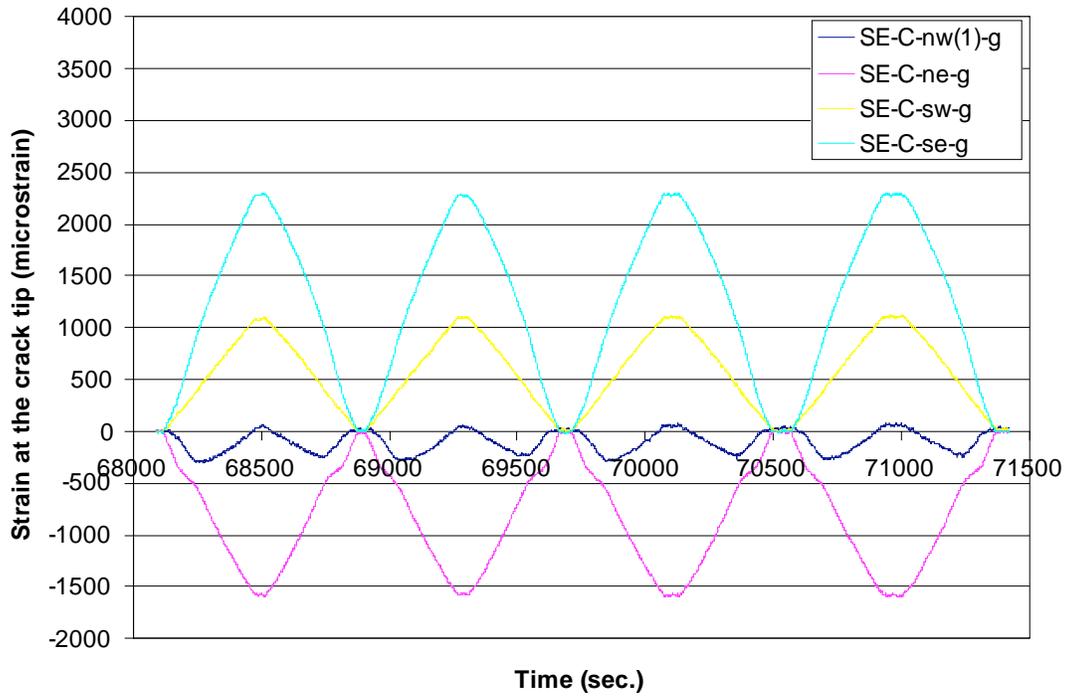
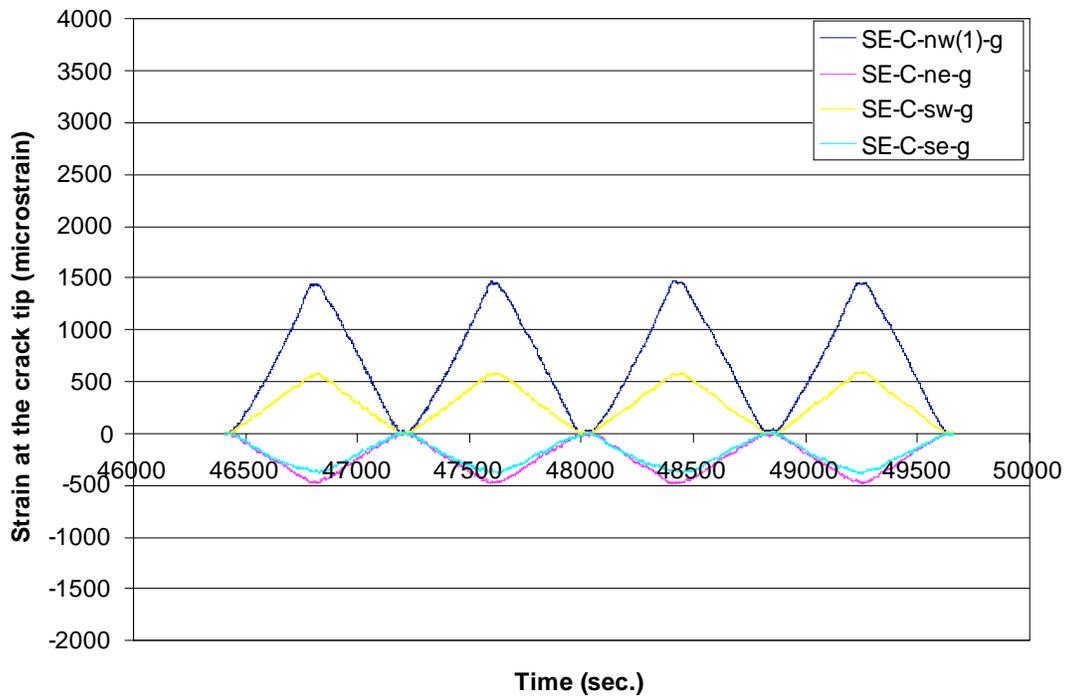
Figure 4.23 Measured strains at the crack tips at web gap SE-C

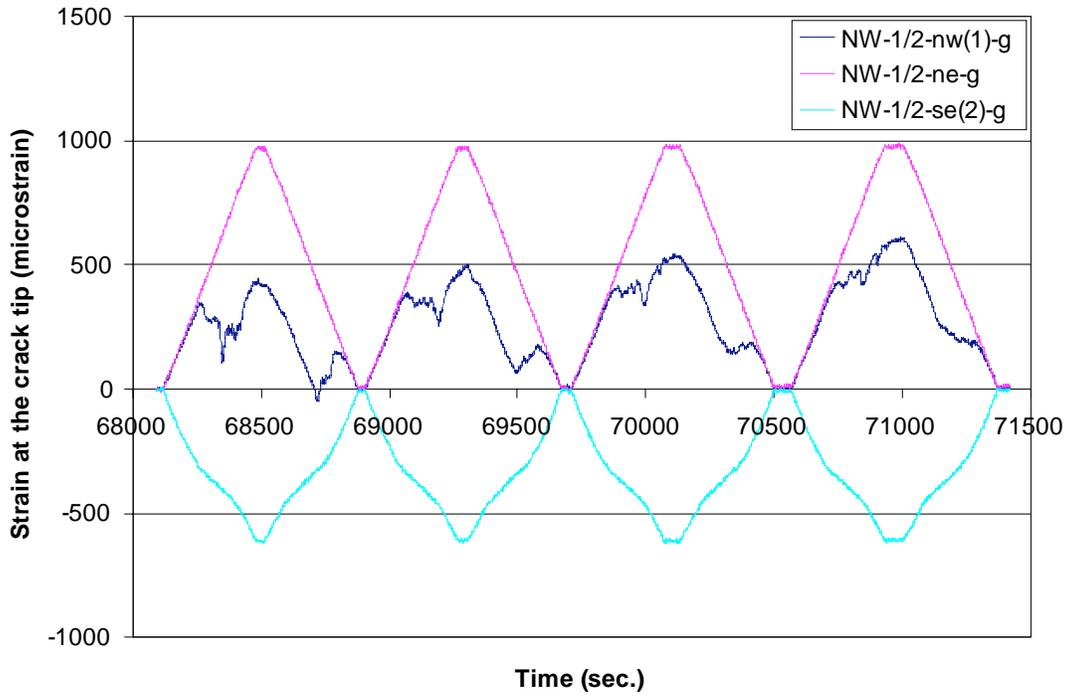
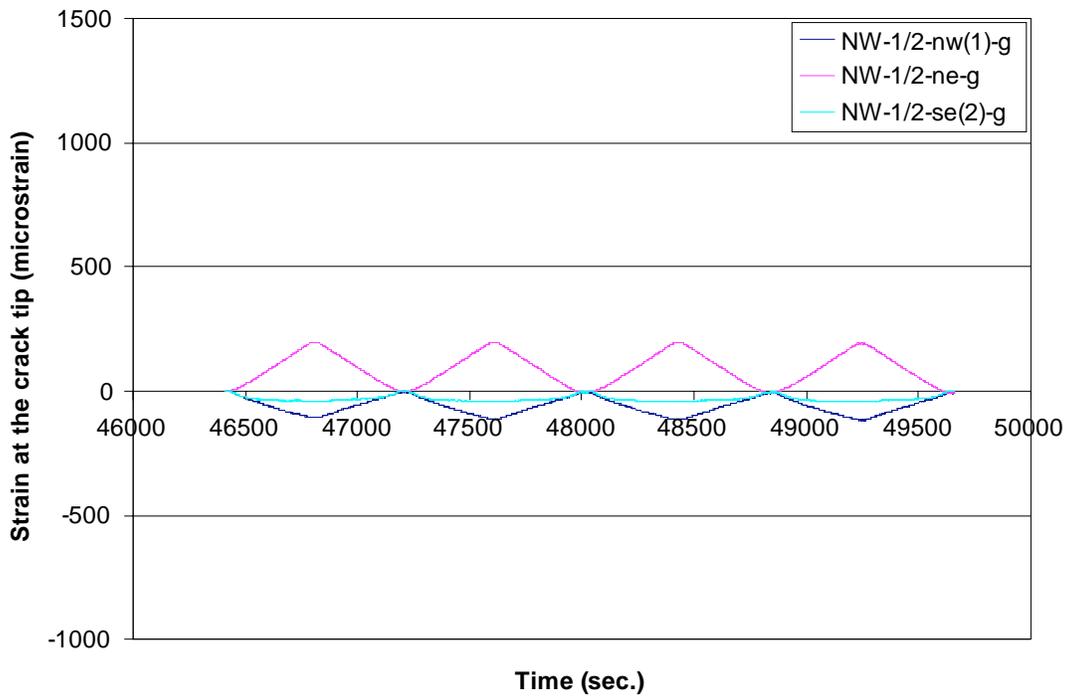
Figure 4.25 Measured strains at the crack tips at web gap NW-1/2

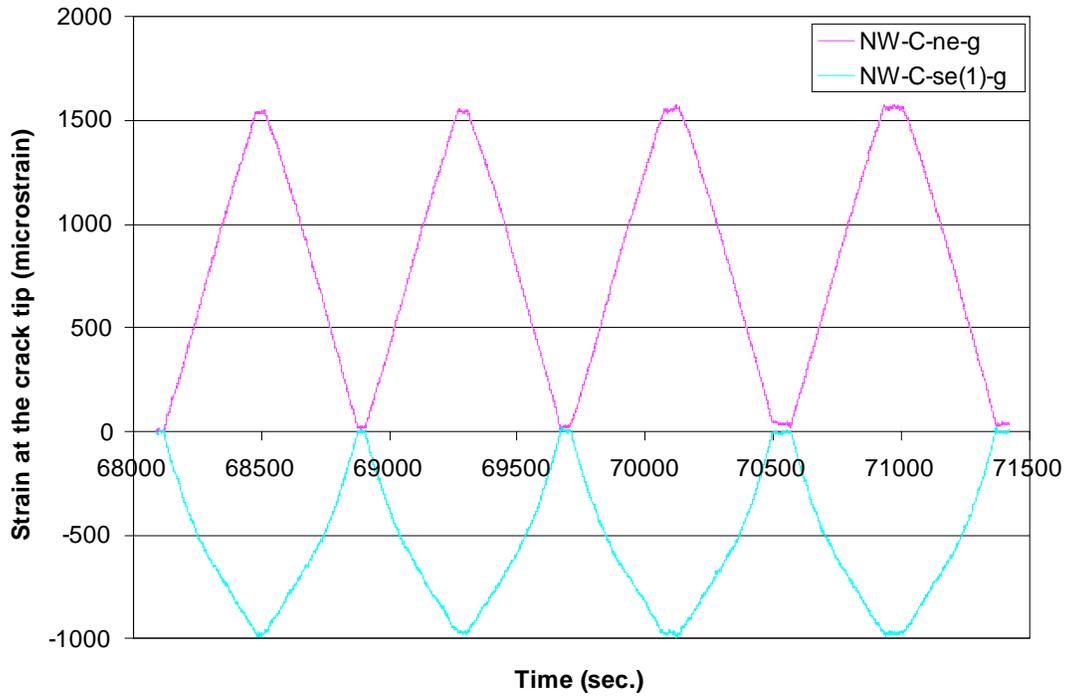
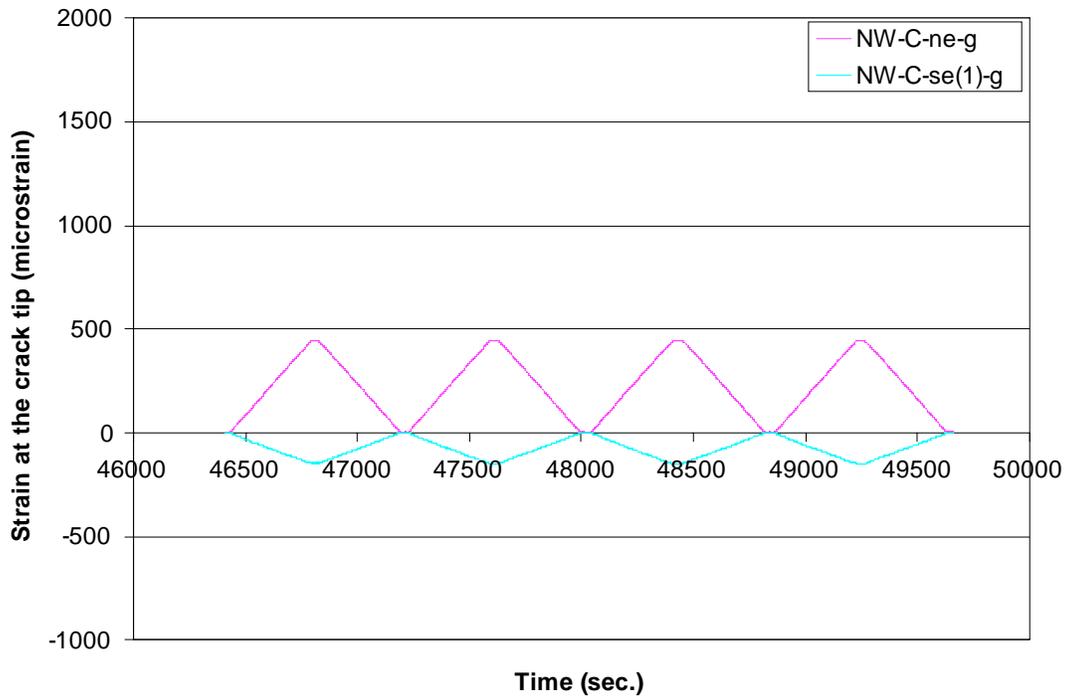
Figure 4.27 Measured strains at the crack tips at web gap NW-C

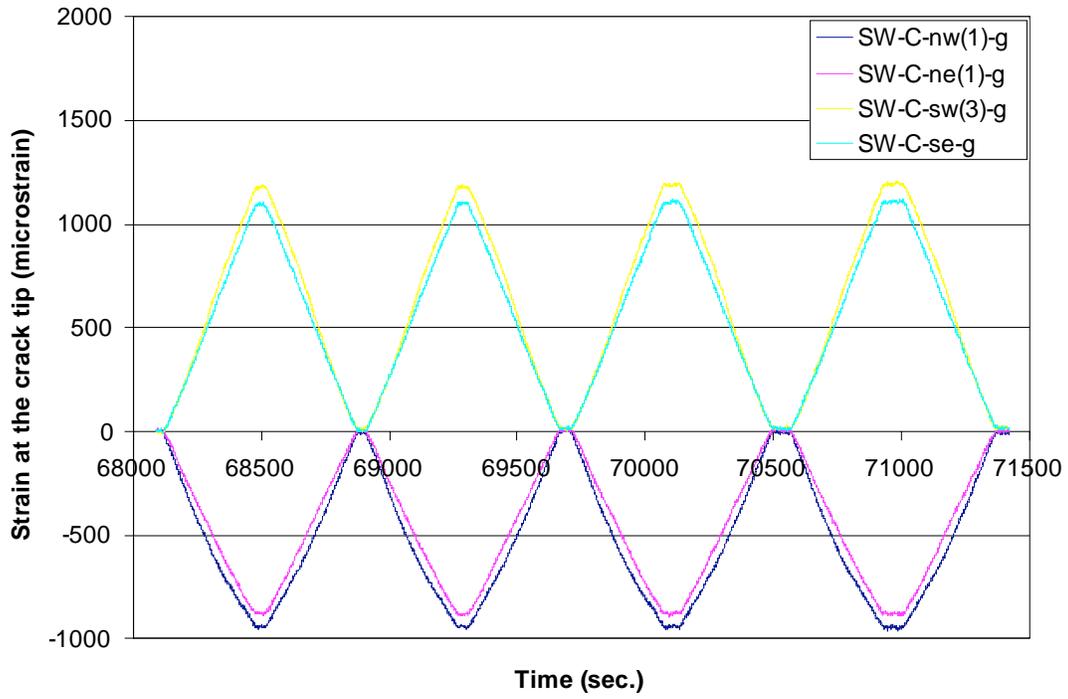
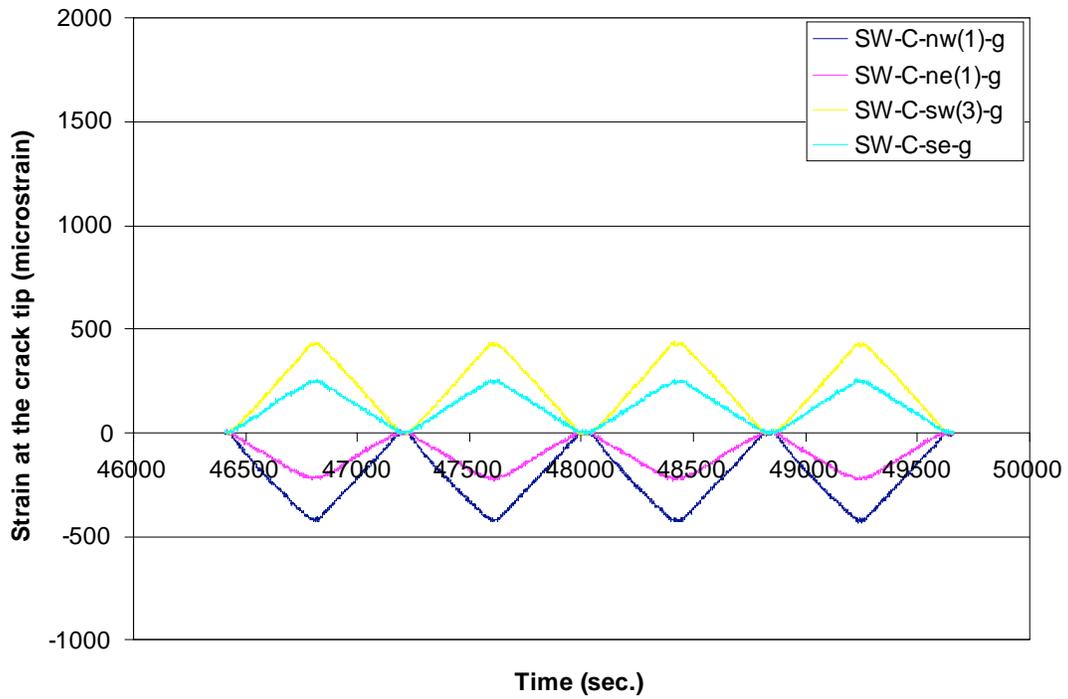
Figure 4.29 Measured strains at the crack tips at web gap SW-C

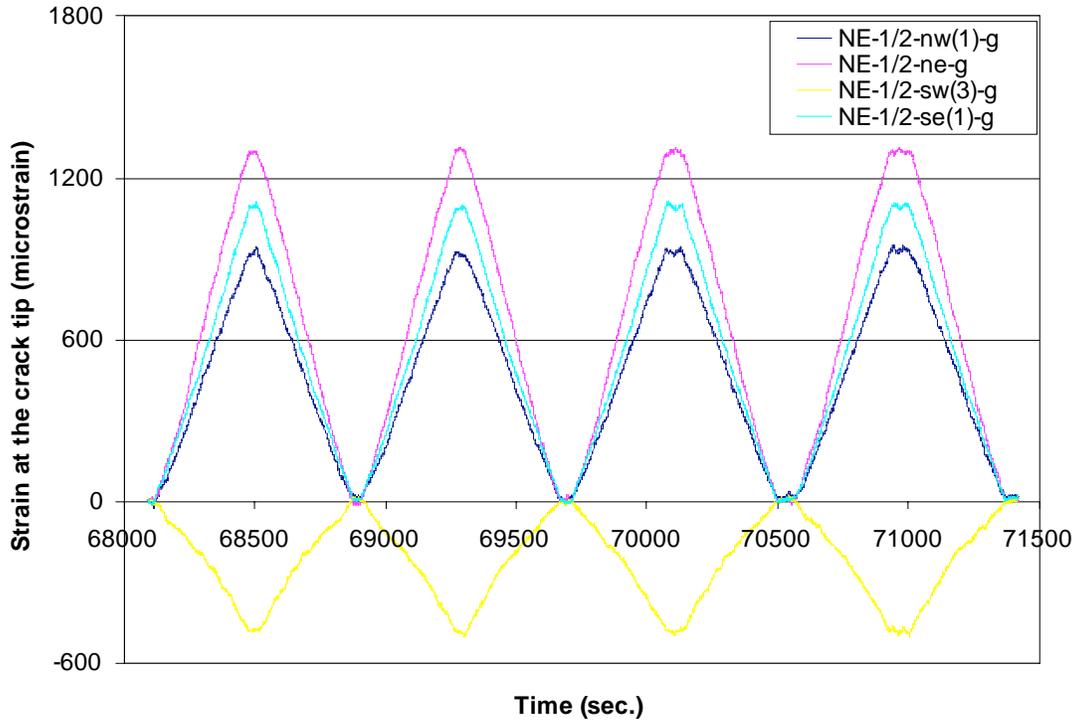
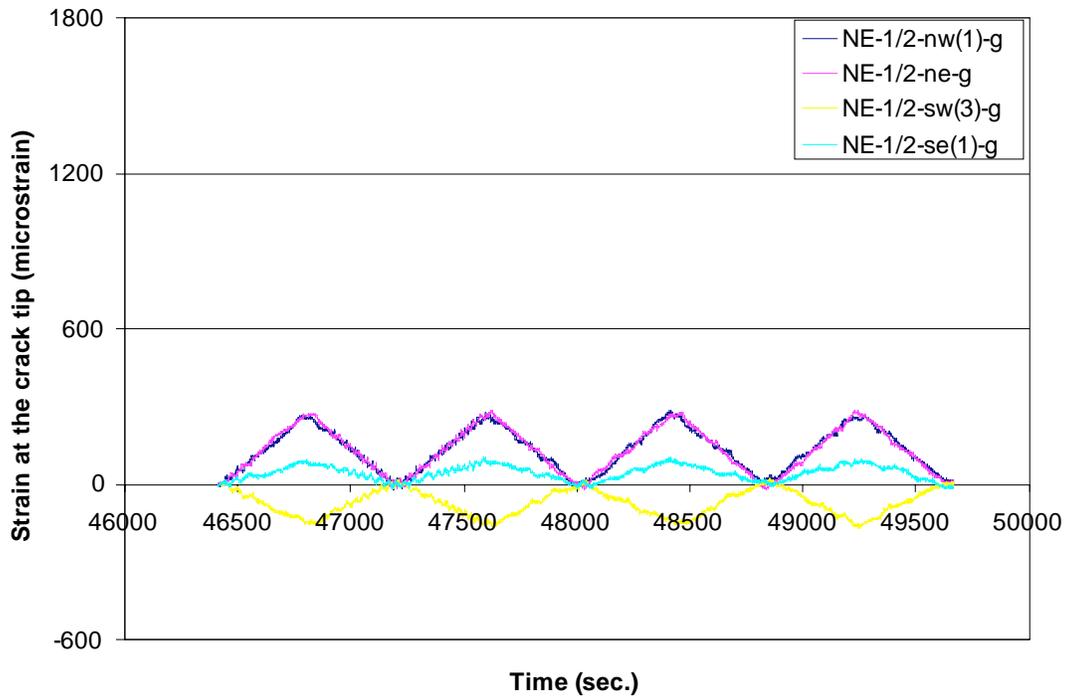
Figure 4.31 Measured strains at the crack tips at web gap NE-1/2

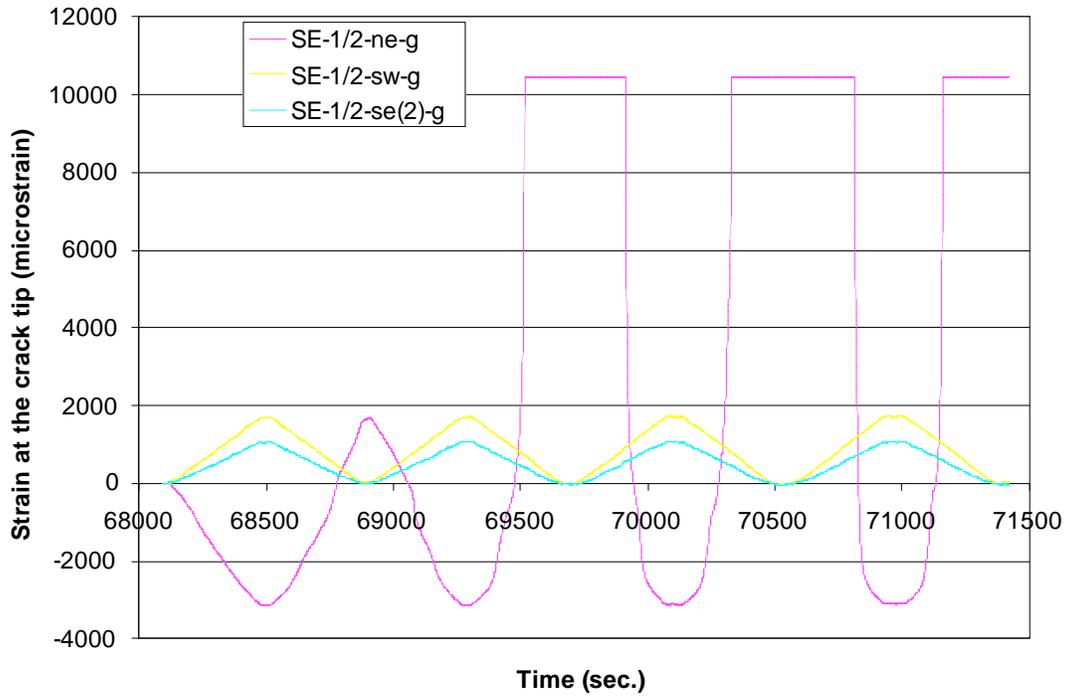
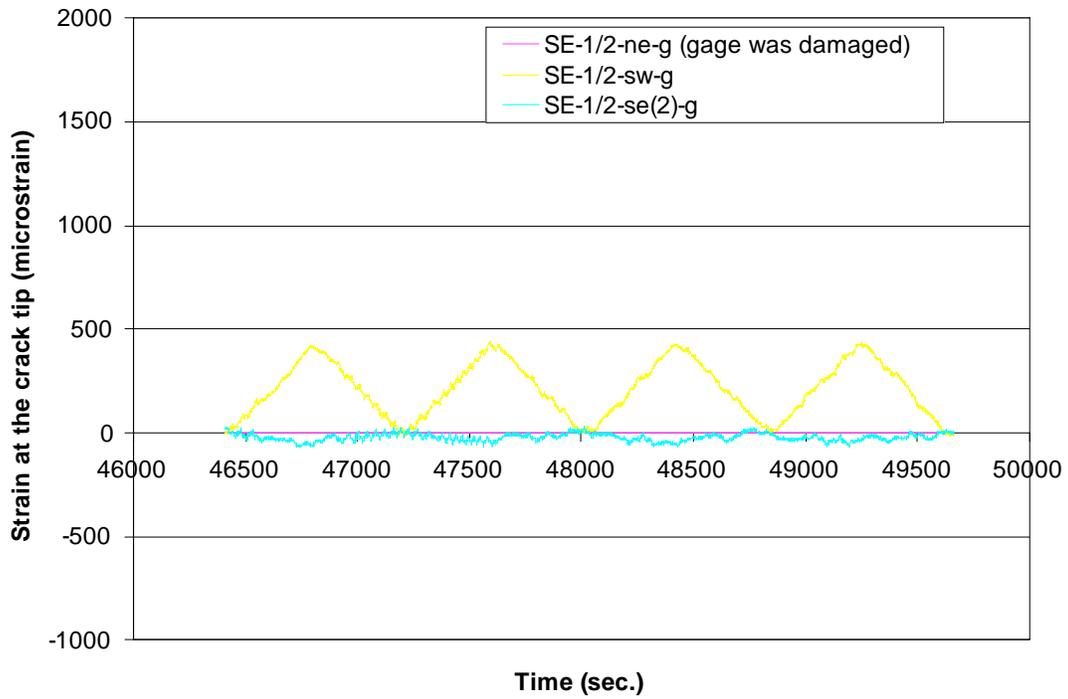
Figure 4.33 Measured strains at the crack tips at web gap SE-1/2

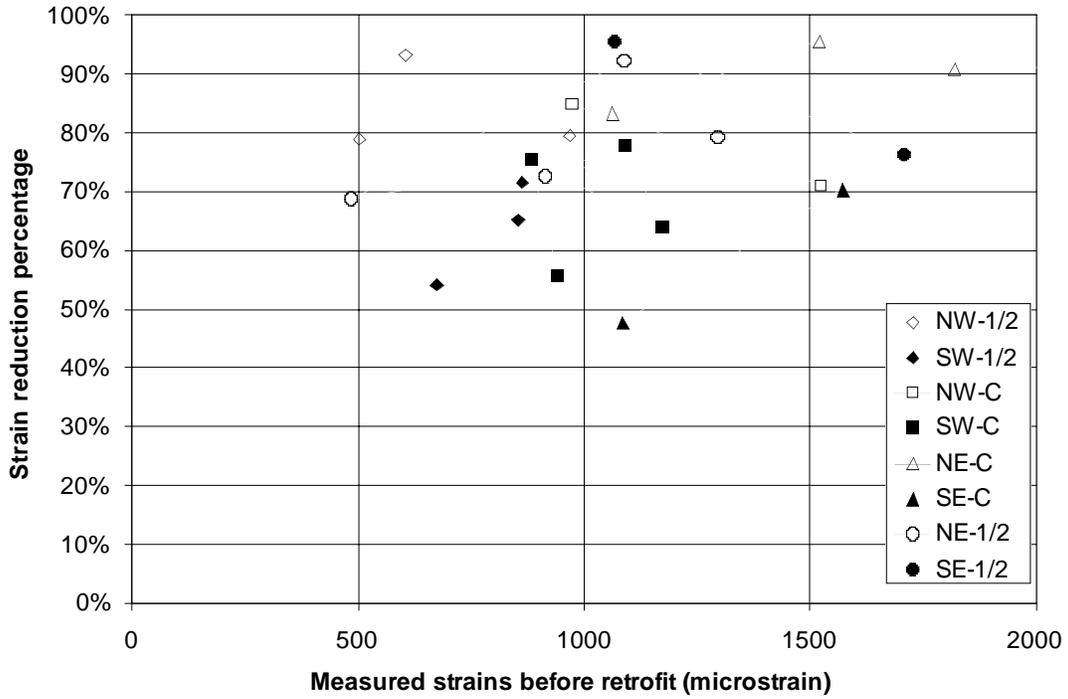
Figure 4.34 Crack tip strain reduction vs. original crack tip strain

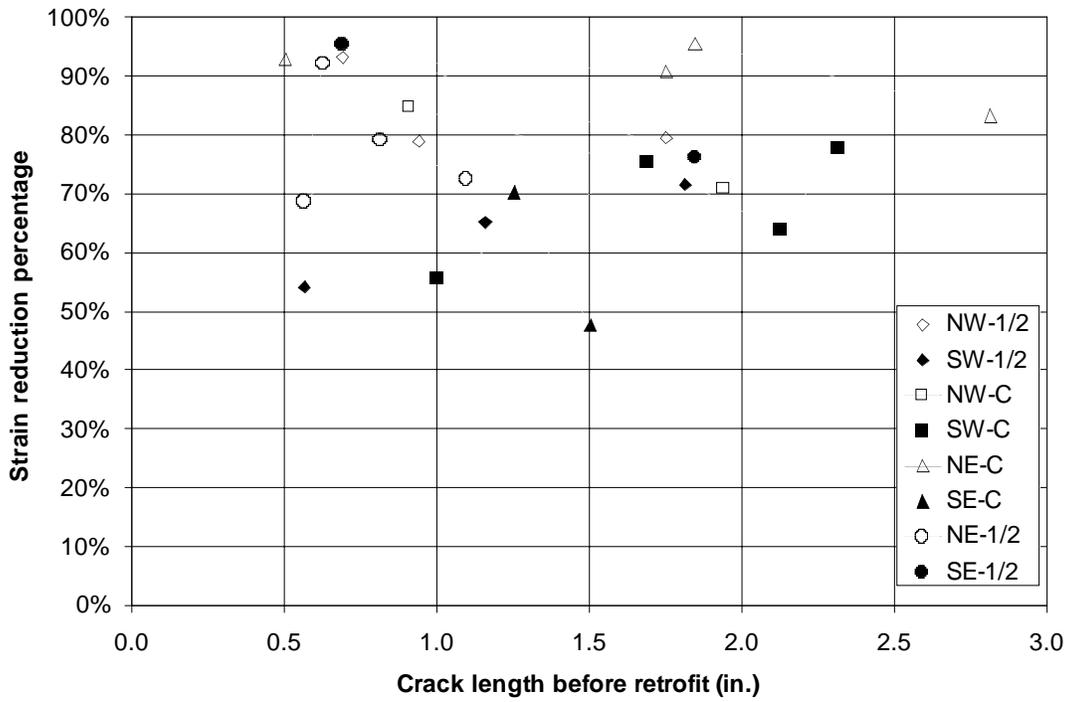
Figure 4.35 Crack tip strain reduction vs. crack length

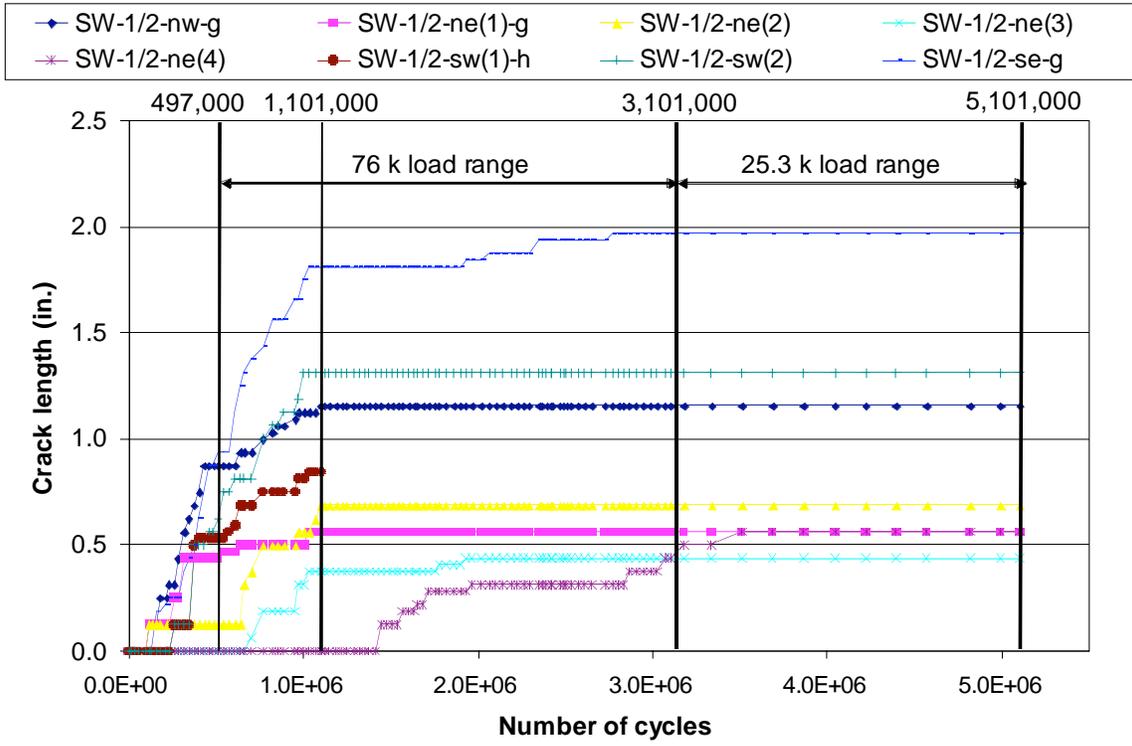
Figure 4.36 Crack growth at web gap SW-1/2

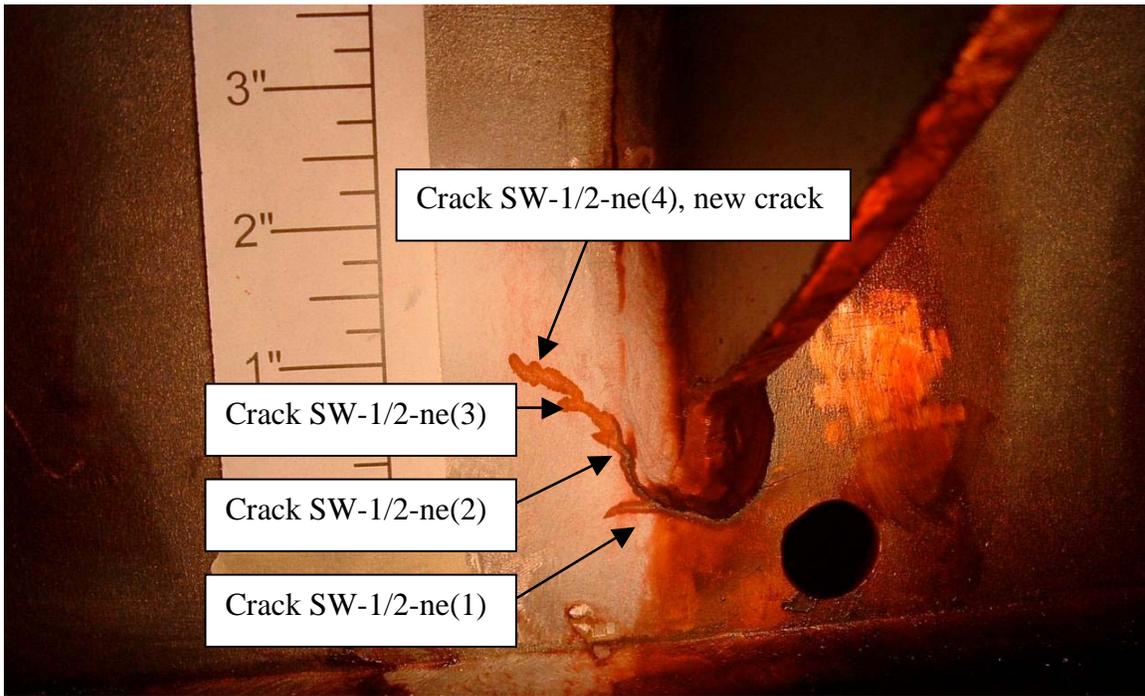
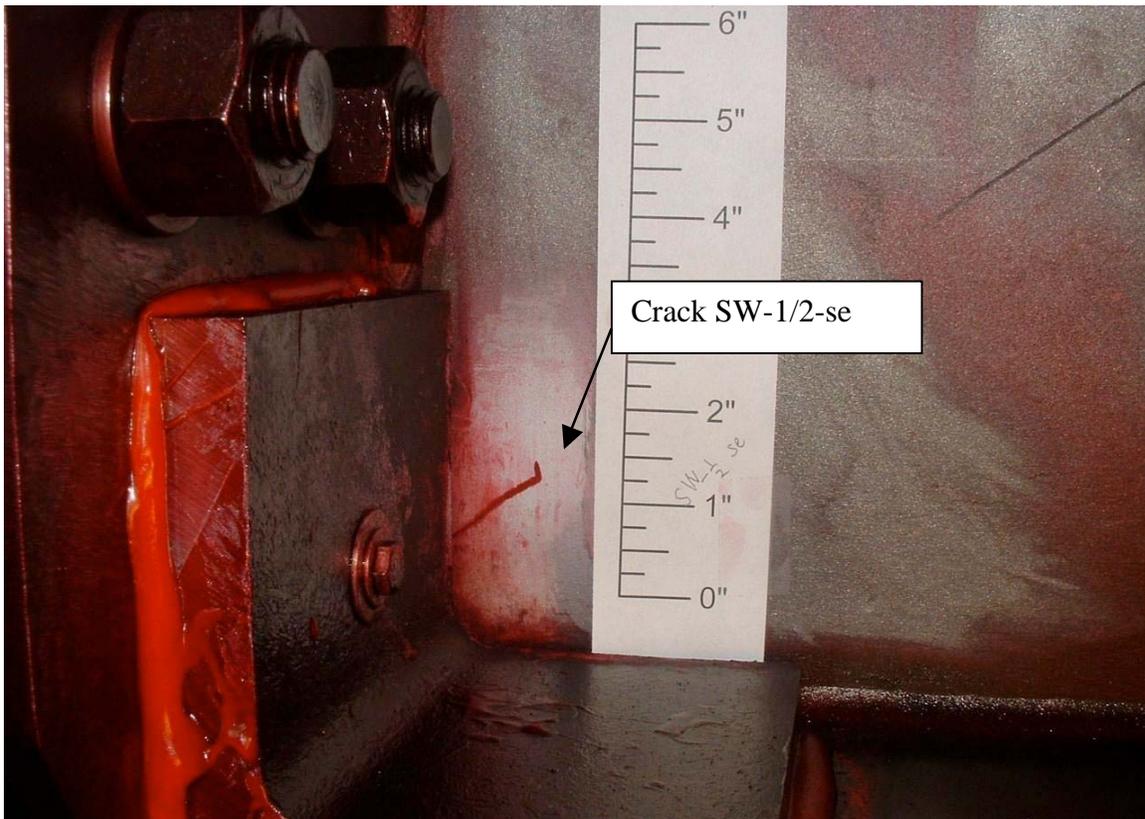
Figure 4.37 Cracks at web gap SW-1/2 at 3,101,000 cycles

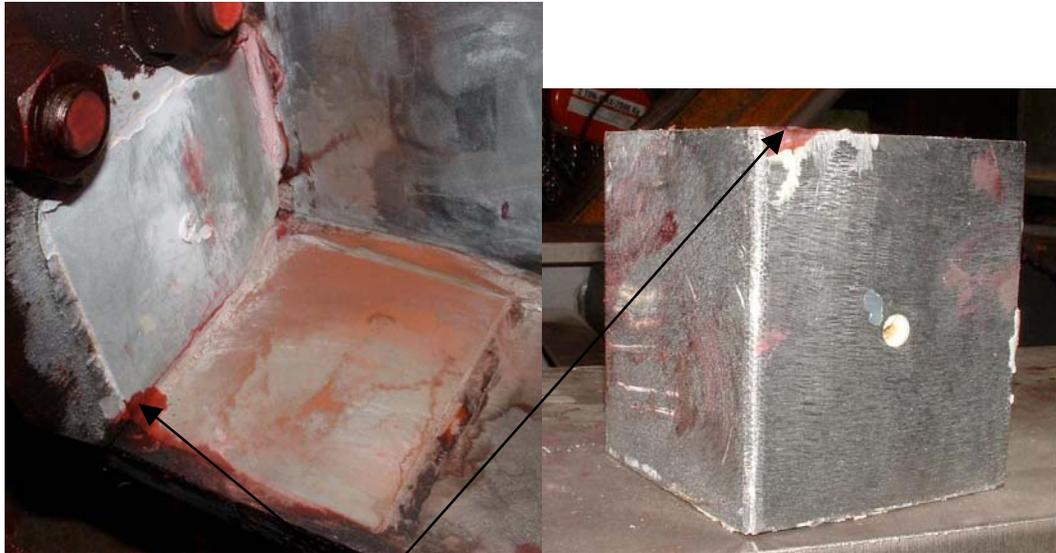
Dye had penetrated a small area at the boundary of the angle

Figure 4.38 Detached angle at web gap SW-1/2

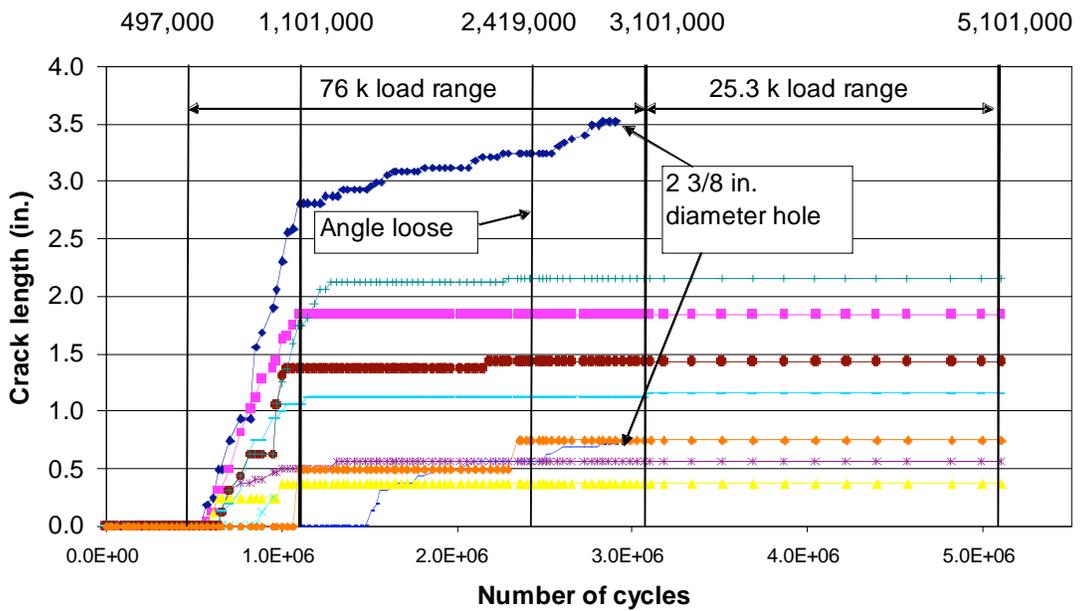
Figure 4.39 Crack growth at web gap NE-C

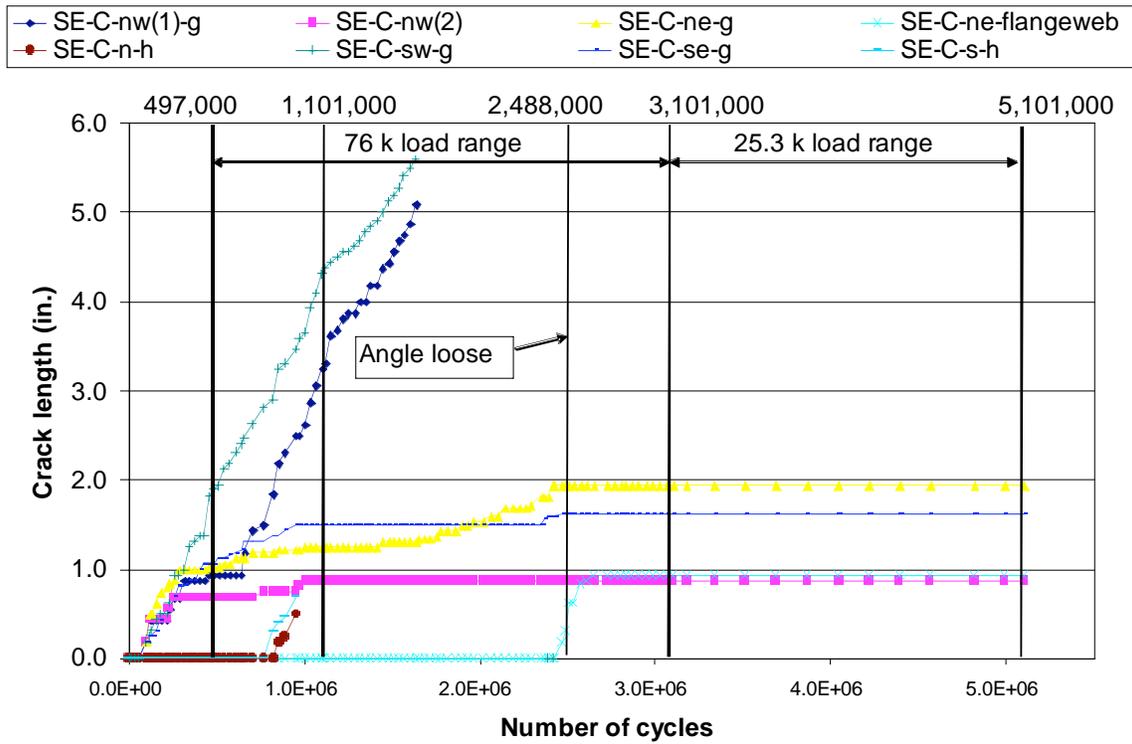
Figure 4.41 Crack growth at web gap SE-C

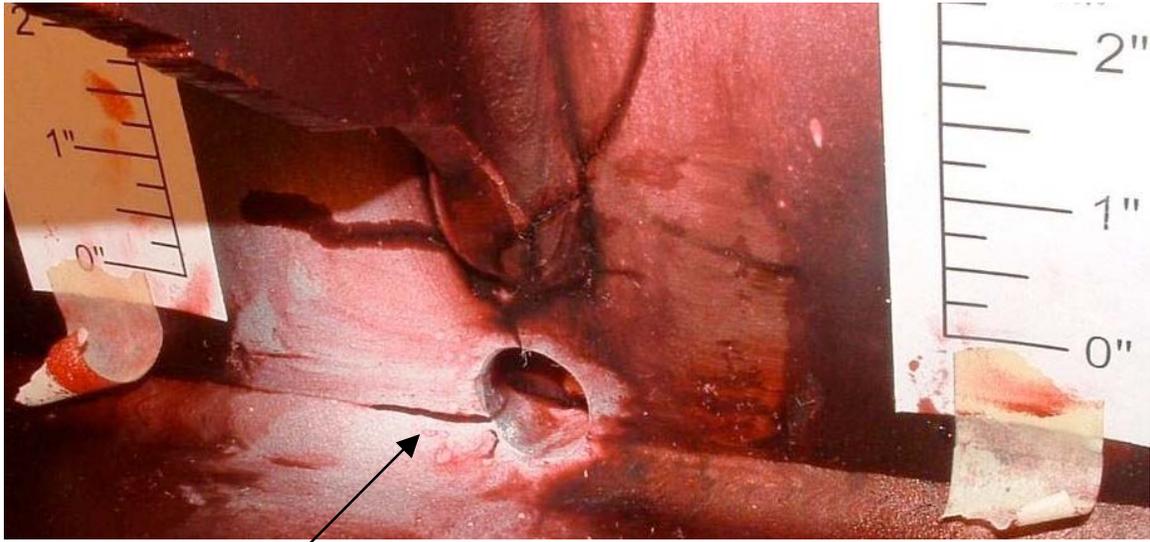
Crack SE-C-ne-flangeweb, new crack

Figure 4.42 New crack at web gap SE-C at 3,101,000 cycles

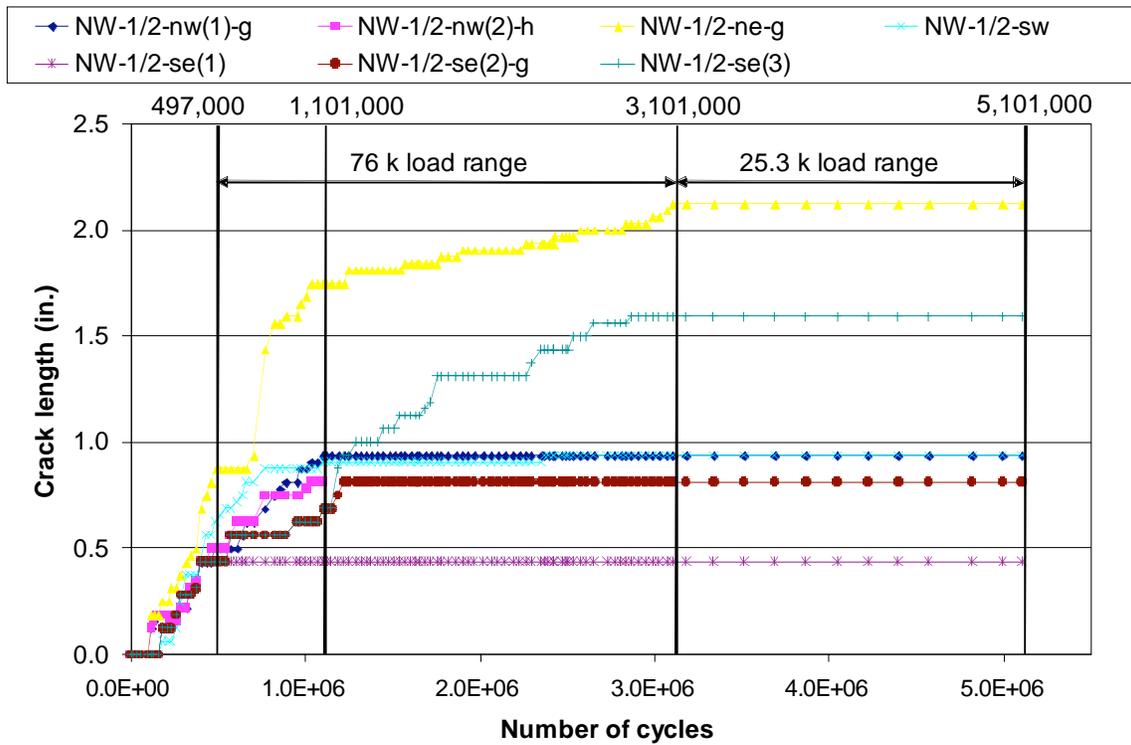
Figure 4.43 Crack growth at web gap NW-1/2

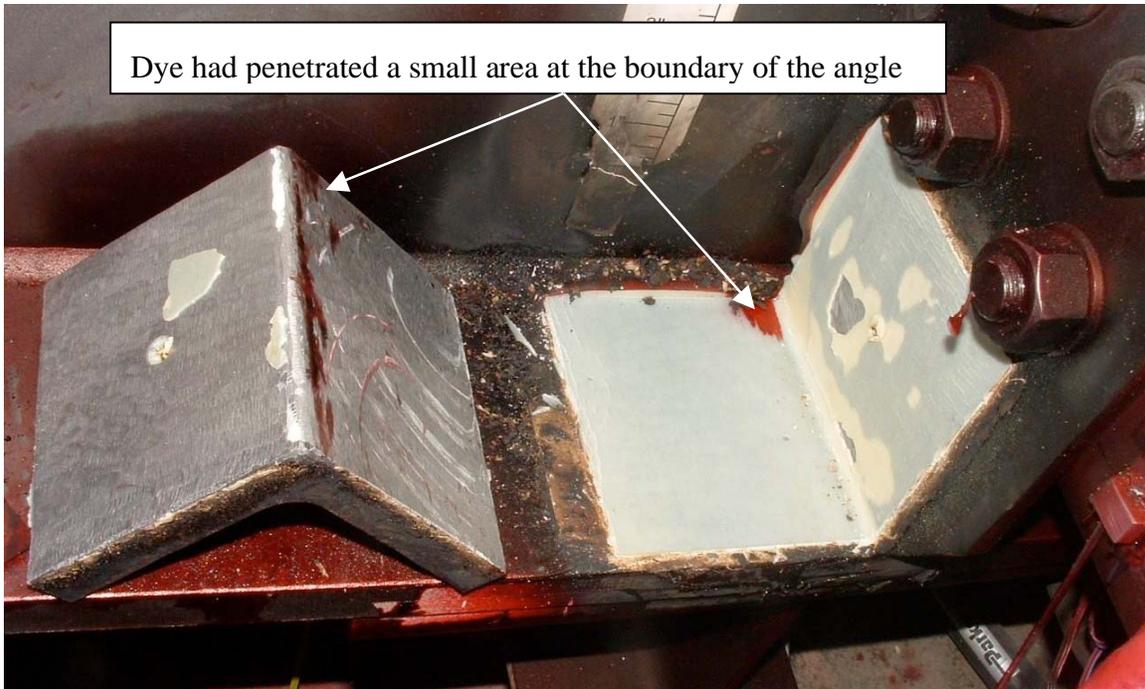
Figure 4.44 Detached angle at web gap NW-1/2

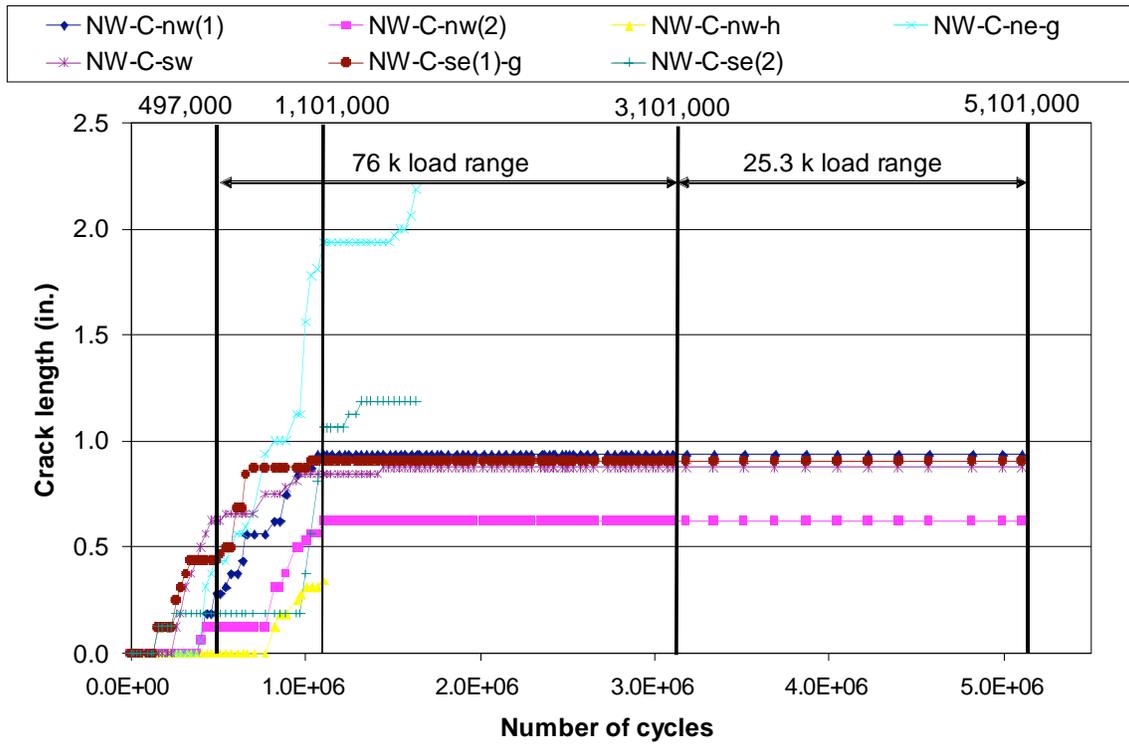
Figure 4.45 Crack growth at web gap NW-C
